MEMORANDUM

TO: Nathan Pence and Rick Illgner
FROM: Ed Oborny (BIO-WEST)
DATE: **November 1, 2013**
SUBJECT: EA HCP Bio-monitoring Update – **Week 12**

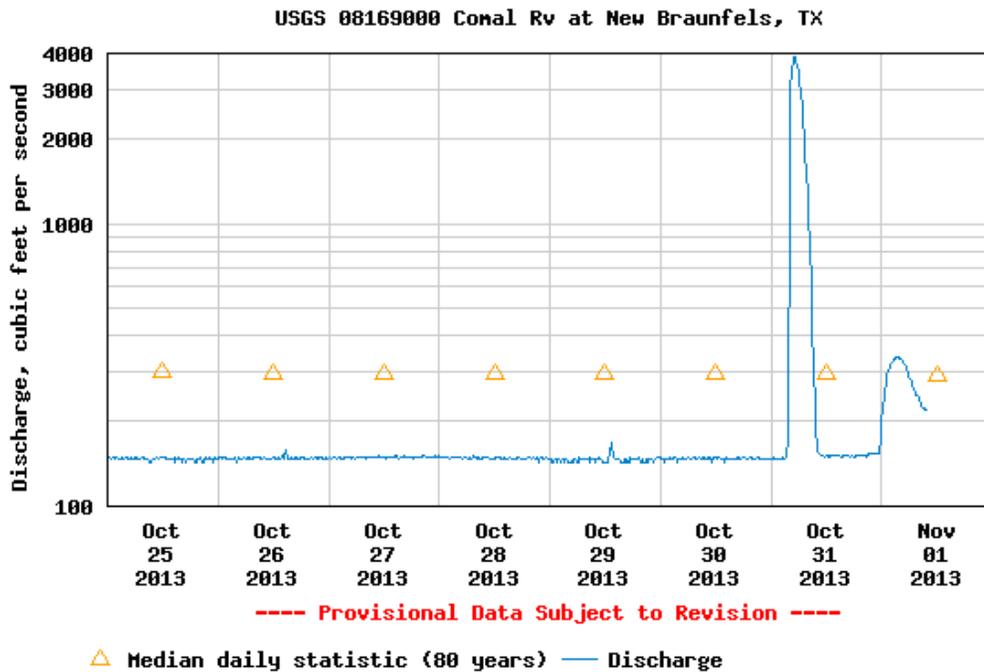
The total system discharge at Comal Springs is currently receding (Figure 1) following this week's large rainfall event and subsequent high flow pulses. Should total system discharge stabilize above 150 cfs, it will trigger the termination of this weekly Critical Period habitat evaluation that has been performed for the past 12 weeks.

Figure 1: Screen shot of USGS webpage for the *COMAL* gage (08169000) showing total system discharge over the past week.

Since last week's memorandum, a few minor rainfall events occurred early in the week followed by one major event on Wednesday, October 30th (Figure 1). Although total system discharge spiked to near 4,000 cfs, by Thursday afternoon it had already receded back to 151 cfs. Subsequently, a subsequent pulse of ≈ 350 cfs followed Friday morning as water from Dry Comal Creek reached the Comal River.

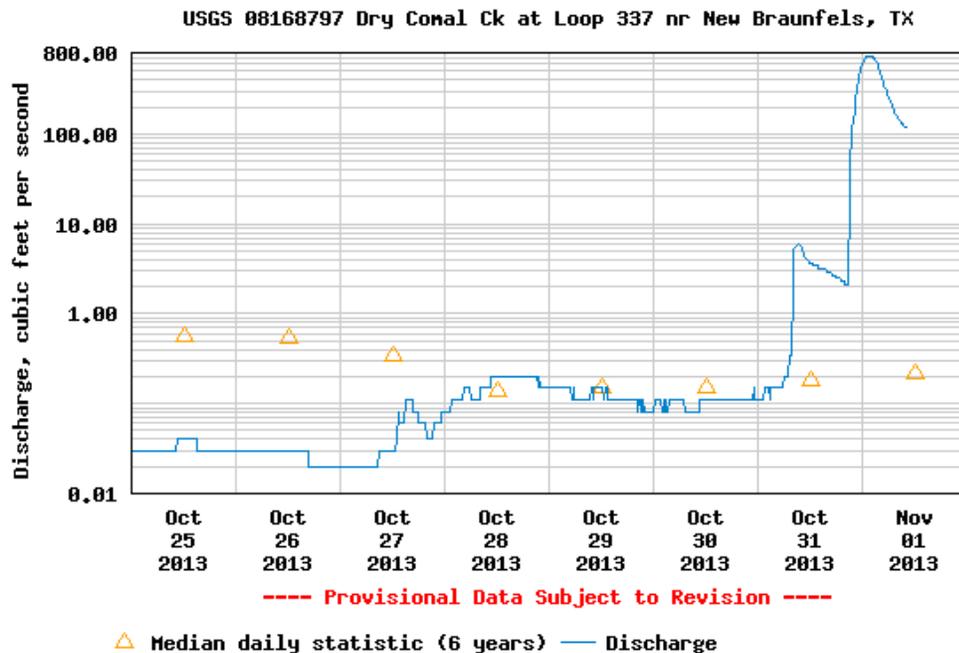
Subsequently, a second pulse (Figure 1) occurred, this time apparently from the flow coming down Dry Comal Creek (Figure 2) that had not yet made it to the Comal River by Thursday afternoon. BIO-WEST staff reported this morning that there were no changes from yesterday afternoon in the Upper Spring run area through Landa Lake or in the Old Channel. They did note that the New Channel was considerably more turbid this morning than yesterday afternoon. We will evaluate aquatic vegetation in the New Channel next week when the turbidity subsides, but it is unlikely the second pulse of ≈ 350 cfs caused extensive scour in the New Channel.

Figure 2: Screen shot of USGS webpage for the *DRY COMAL* gage (08168797) showing total system discharge over the past week.

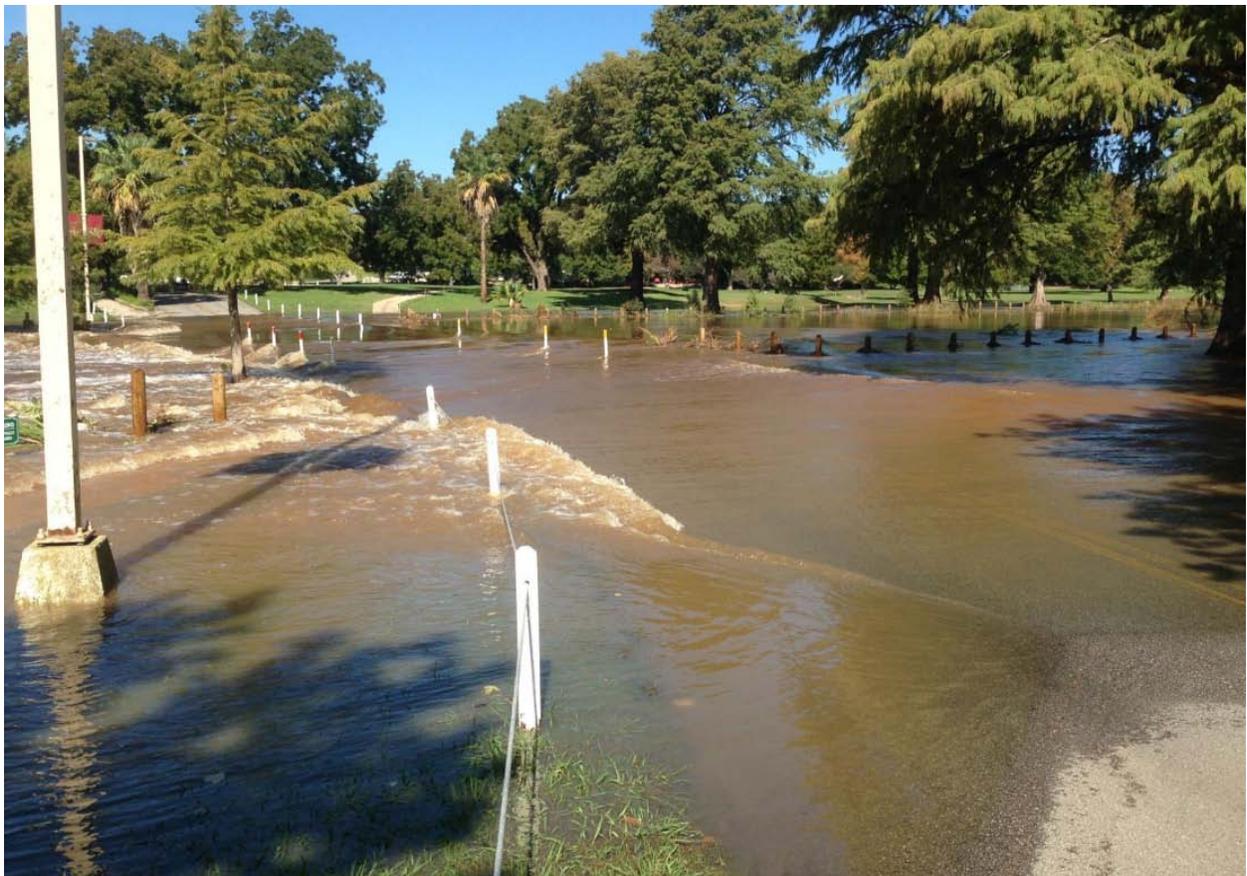
Figure 3: Spring Lake – Slough arm over the road at Aquarena entrance. (October 31st)

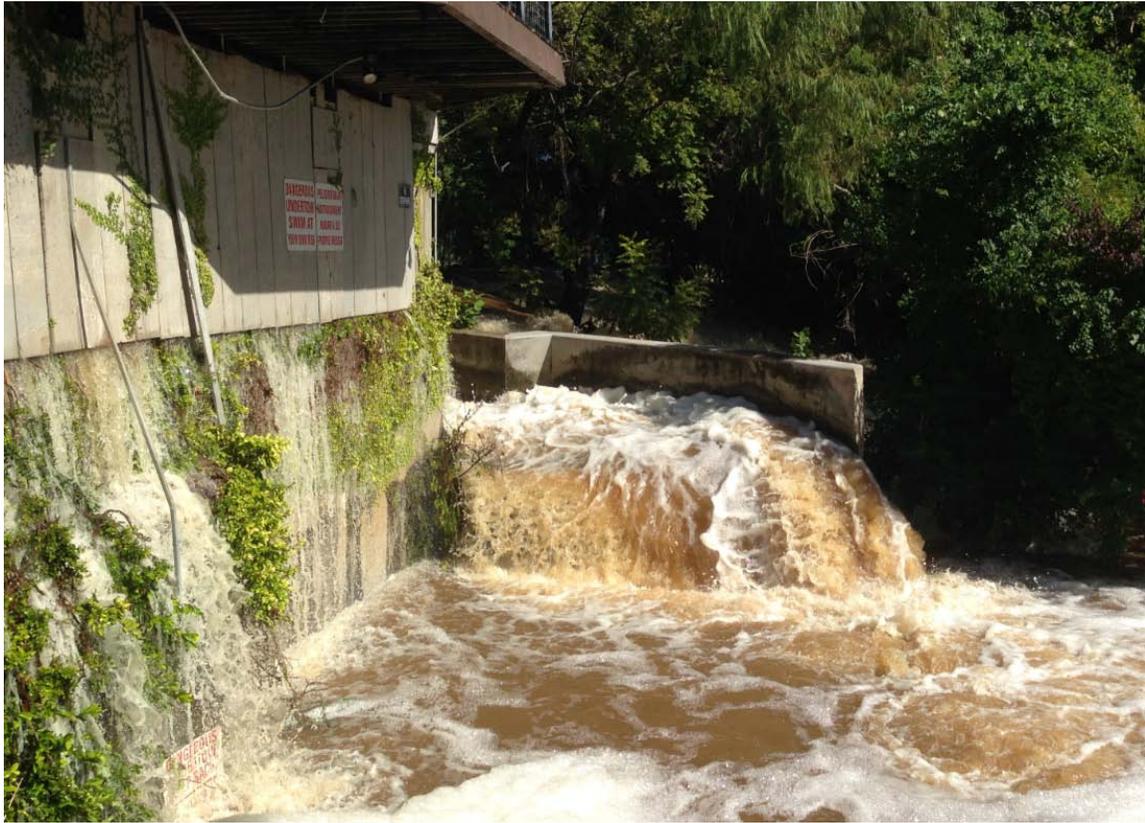
Figure 4: San Marcos River – Chute at Western Spillway. (October 31st)

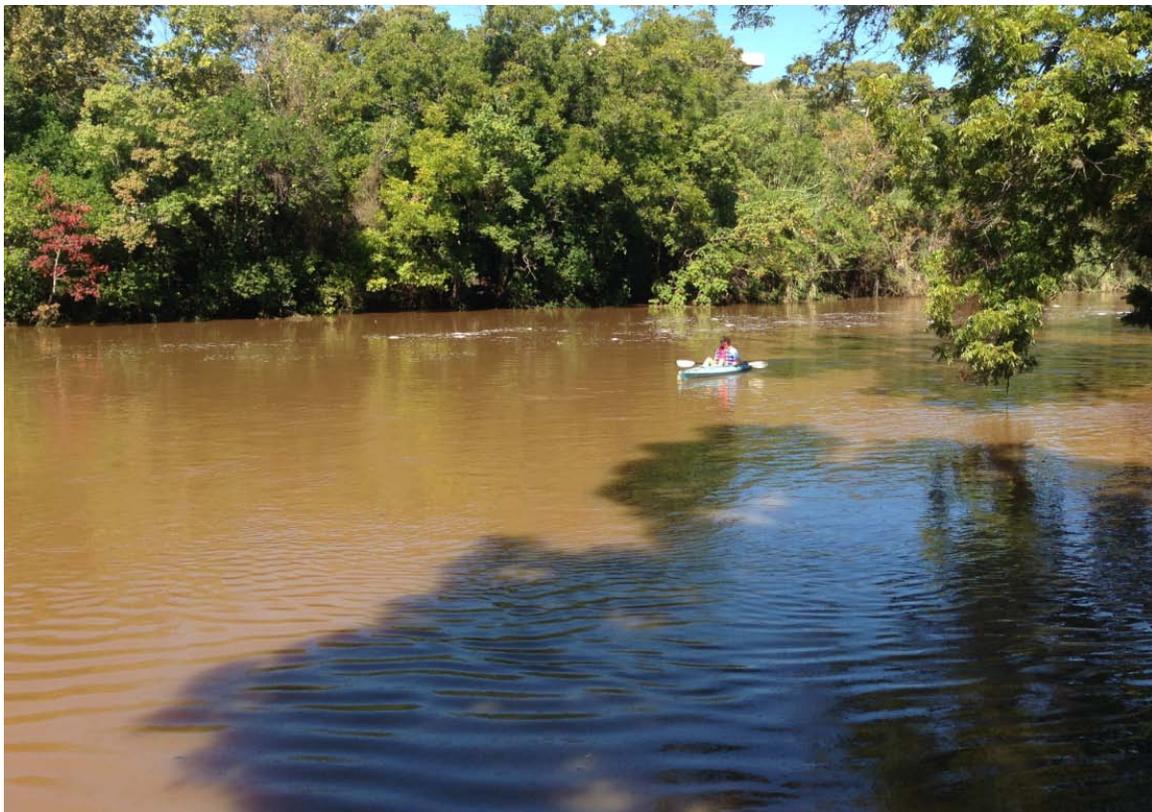
Figure 5: San Marcos River - Looking upstream from City Park. (October 31st)

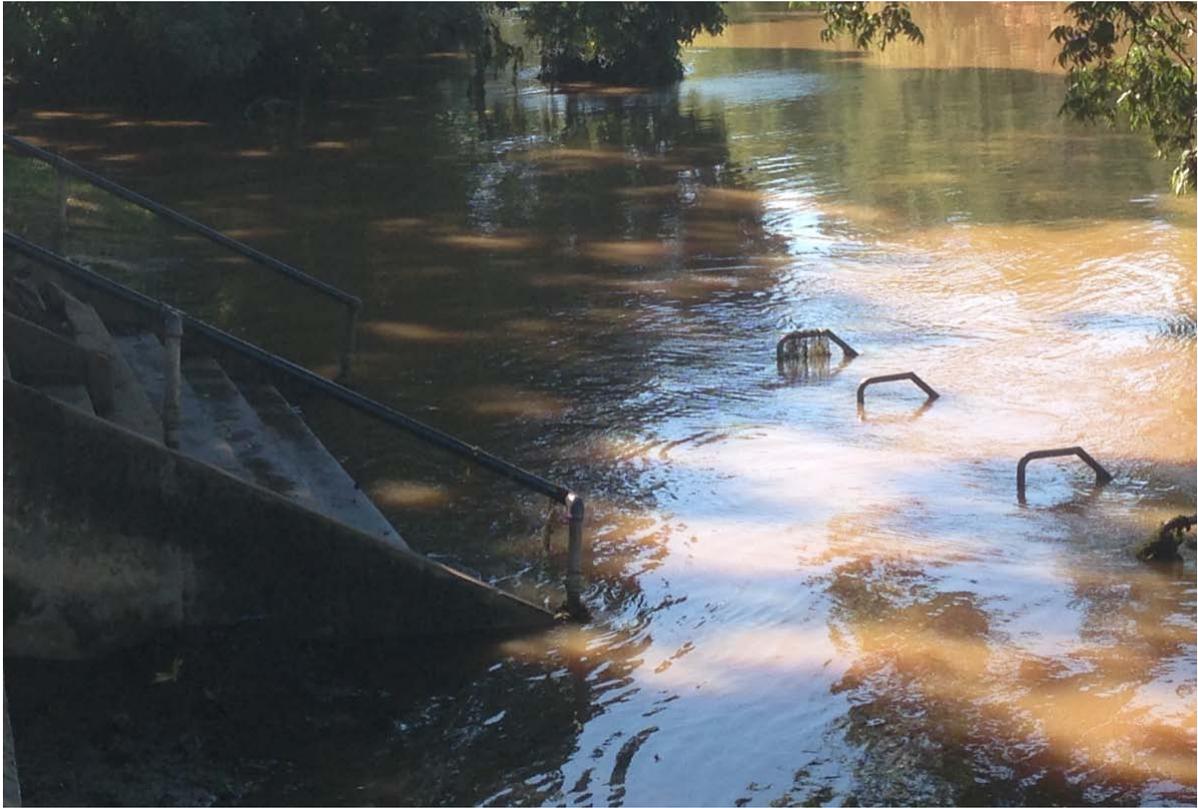
Figure 6: San Marcos River – Concrete steps at City Park. (October 31st)

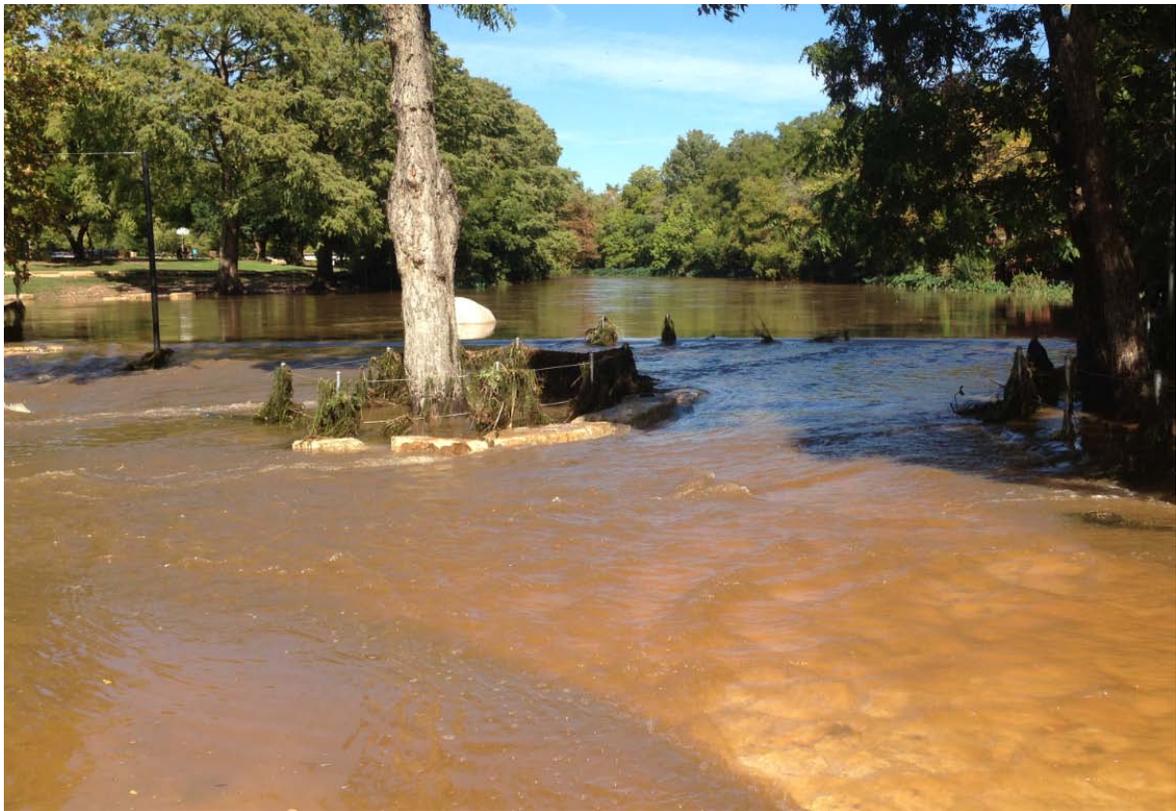
Figure 7: San Marcos River - Looking upstream at Rio Vista near River Pub. (October 31st)

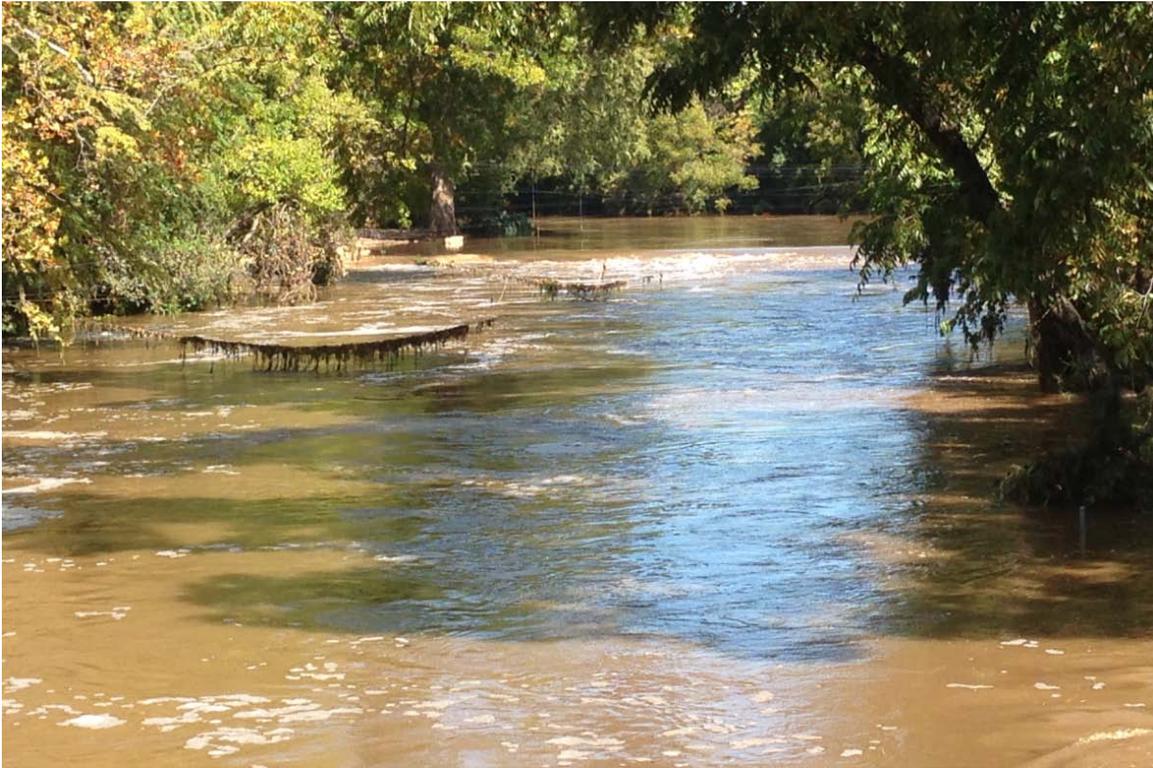
Figure 8: San Marcos River – Looking upstream from Cheatham Street Bridge. Note: Rapids are submerged. (October 31st)

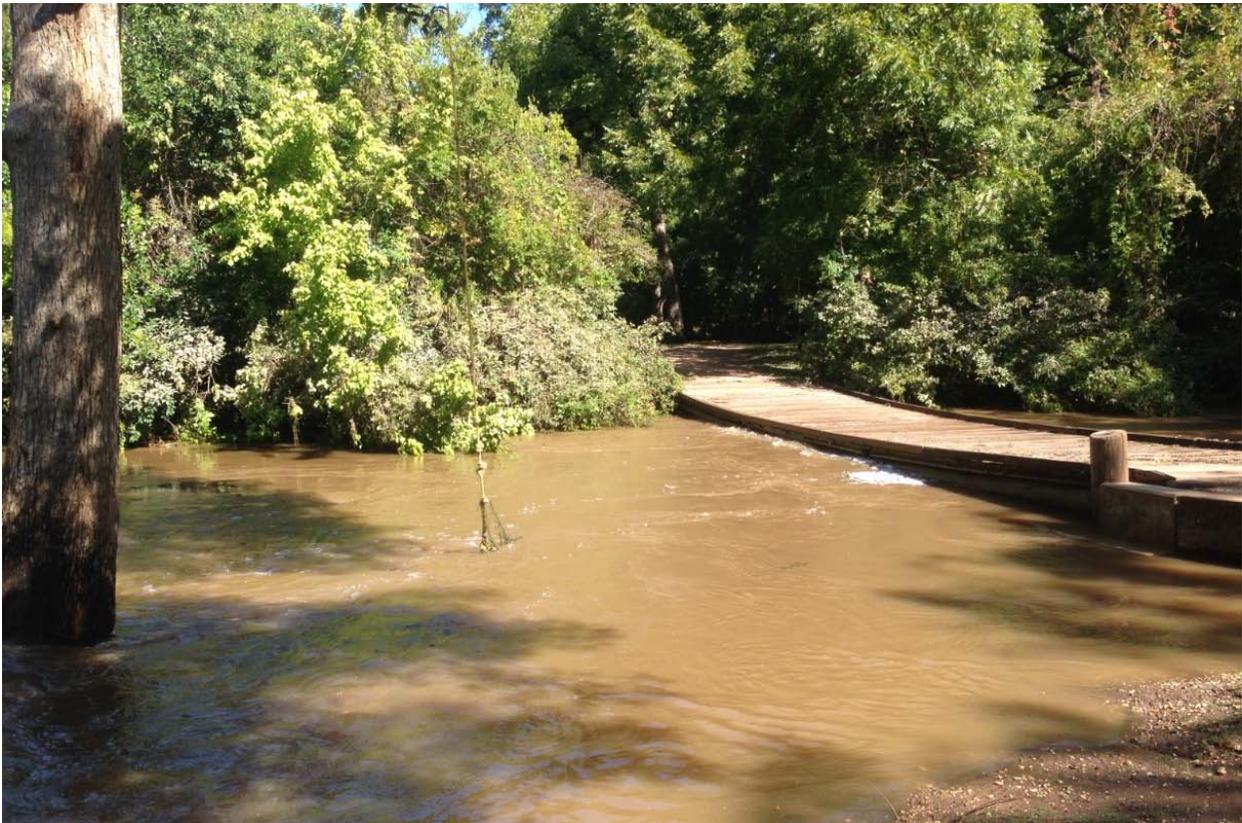
Figure 9: San Marcos River – Pedestrian Bridge in I35 reach. (October 31st)

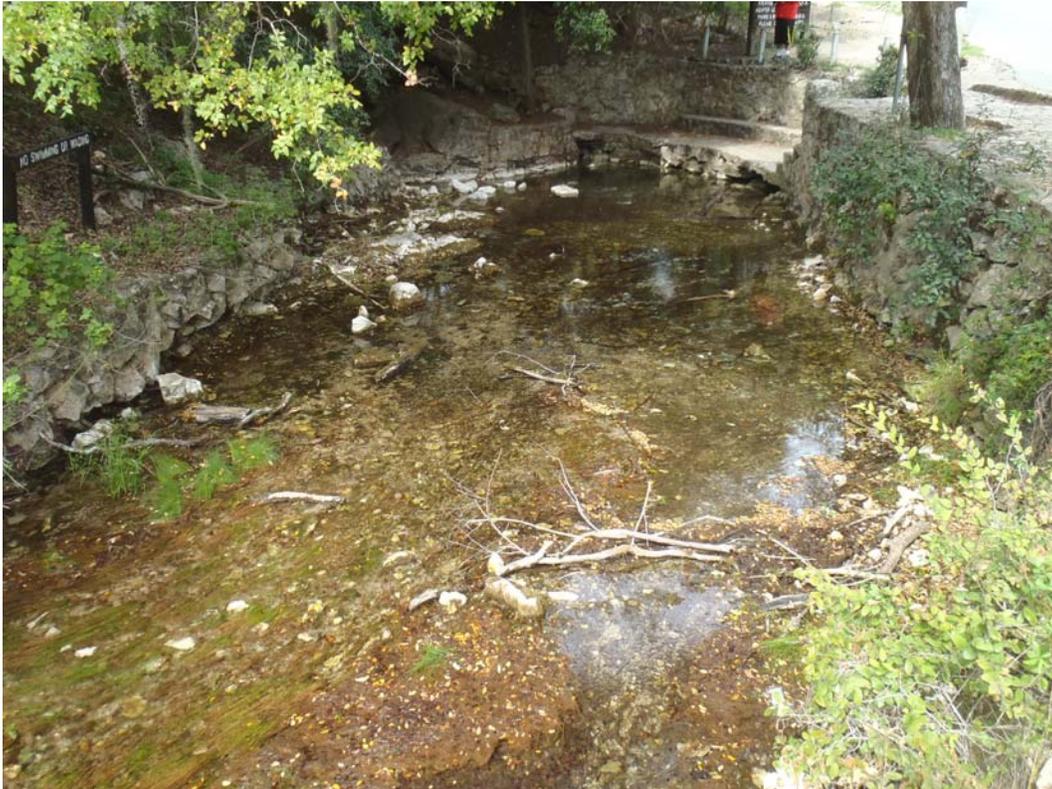
Surface water flow in Spring run 1 continues to improve with increasing springflow (Figure 10). As in all previous weeks, Spring run 3 continues to maintain connectivity throughout the run. Some additional restoration work along Spring run 3 has been completed to reduce sedimentation into salamander and riffle beetle habitat (Figure 11). With the rise in aquifer levels this week, Spring run 5 had a trickle of water flowing over the concrete structure this morning (Figure 12). This is the first time this has been witnessed in nearly 12 weeks. Algae is still present in portions of the Upper Spring run reach (Figure 13) but not to the levels experienced in August or even recent weeks. Increased surface water level and springflow continue to maintain near full inundation around the Spring Island area as well as surface flow in both the northern and southern (Figure 14) runs of Spring run 6.

Figure 10: Looking upstream toward Spring run 1 main orifice (continuous surface flow extending bank to bank). (October 29th)

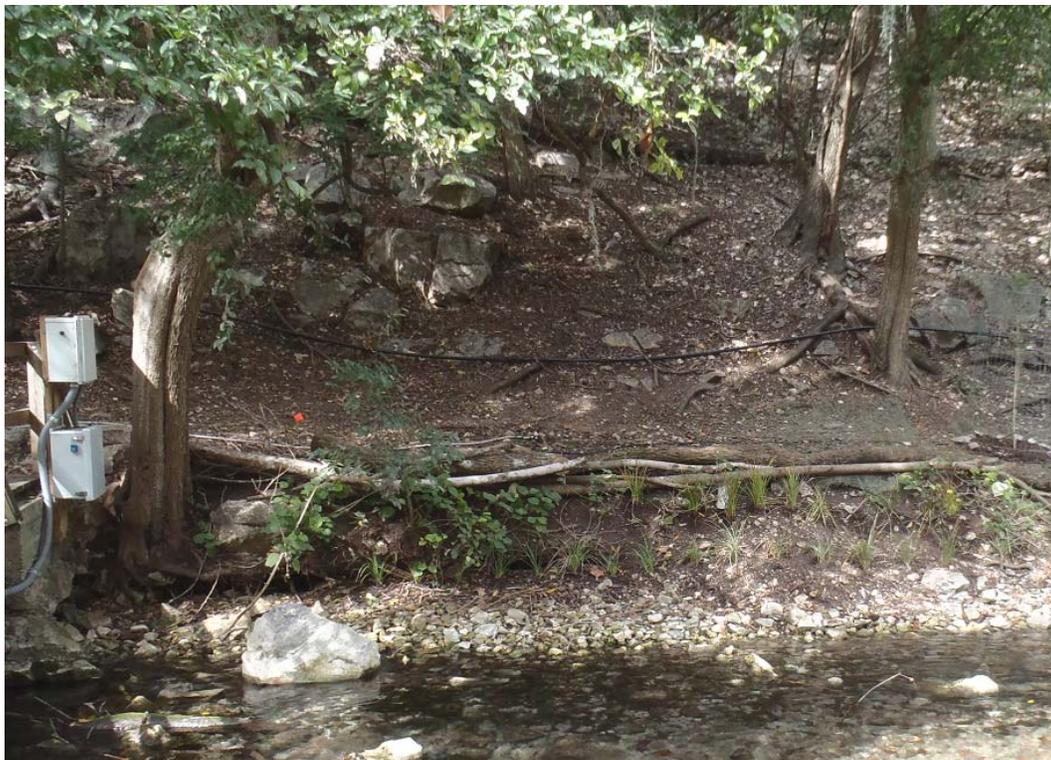
Figure 11: Spring run 3 restoration – Natural erosion control and sedge plantings where elephant ears used to be. (October 29th)

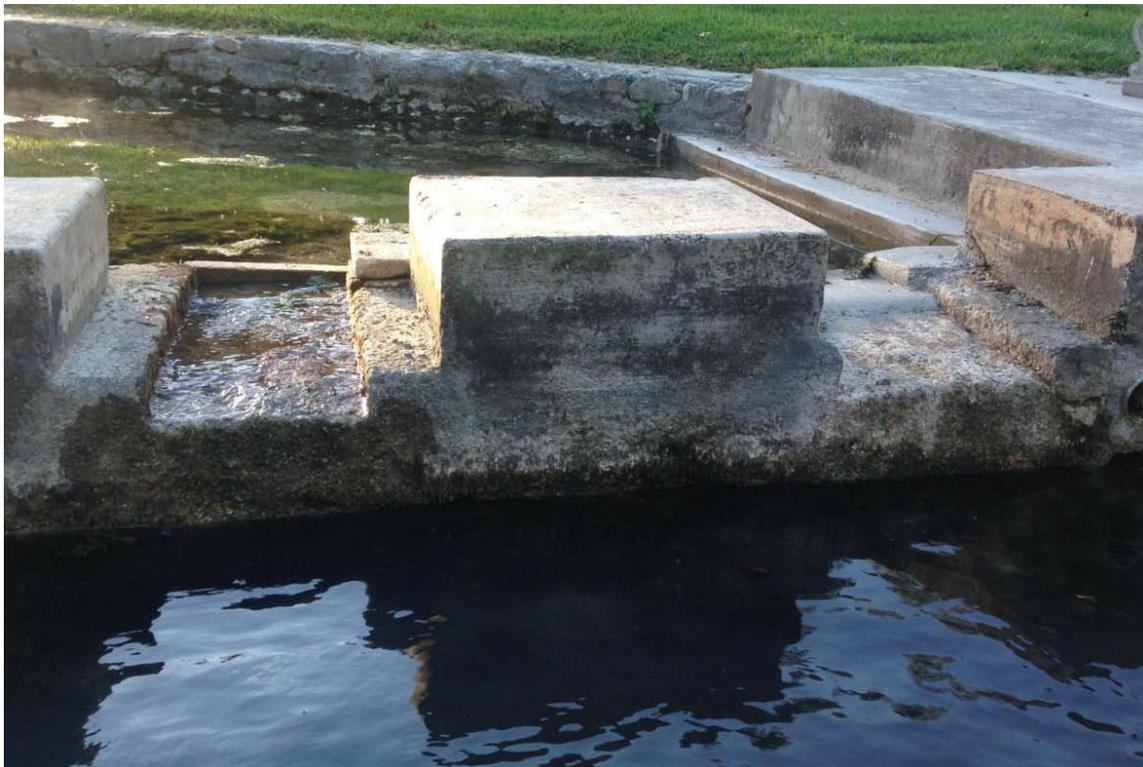
Figure 12: Spring Run 5 – Upper Spring Run (trickle of flow) (November 1st)

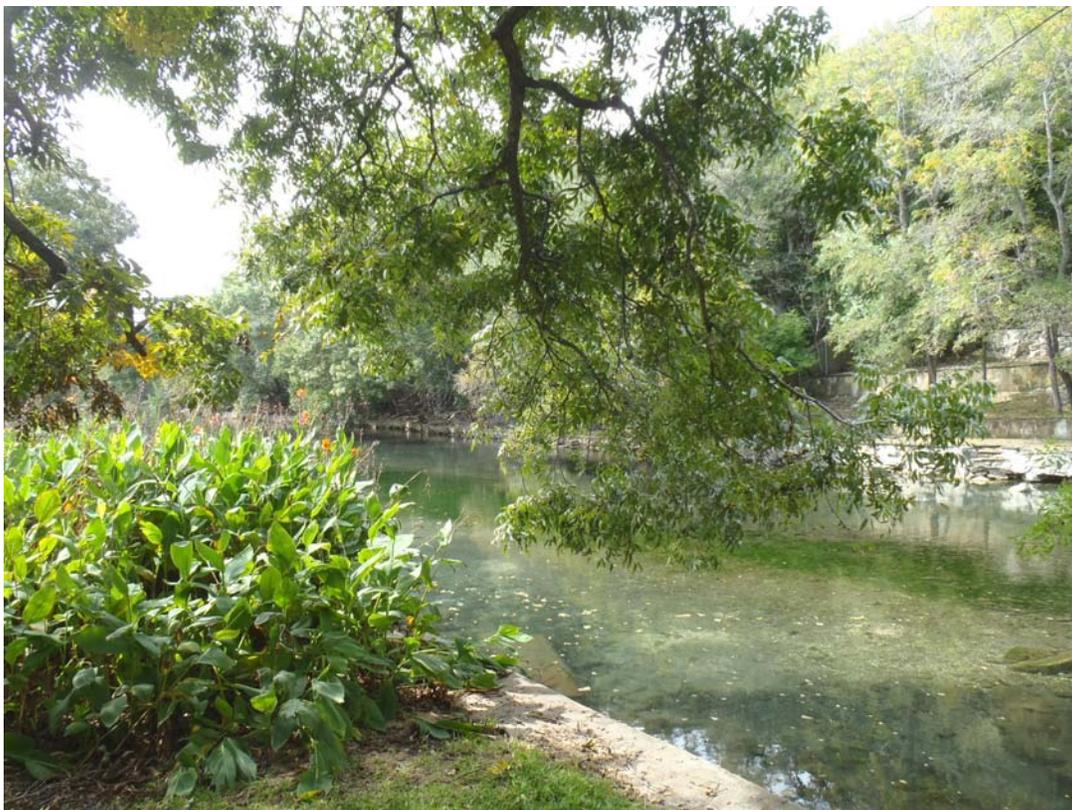
Figure 13: Upper Spring run reach adjacent to Spring run 5. (October 29th)

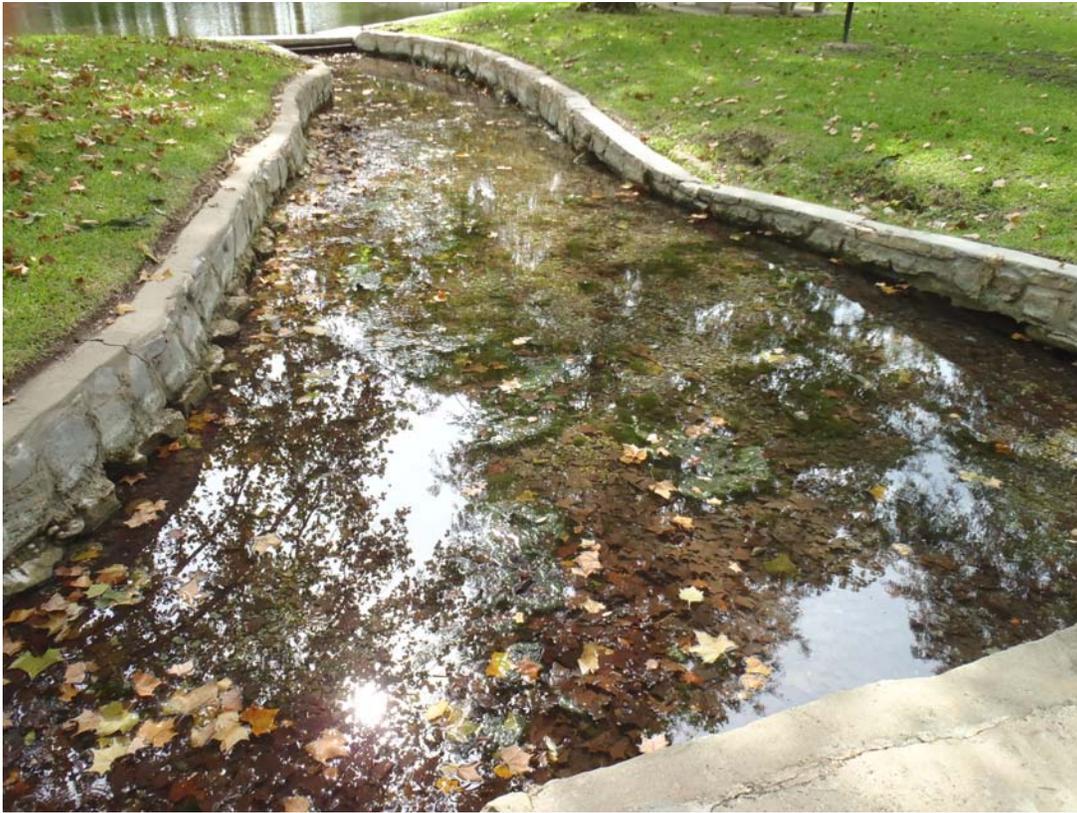
Figure 14: Spring run 6 – southern spring run. (October 29th)

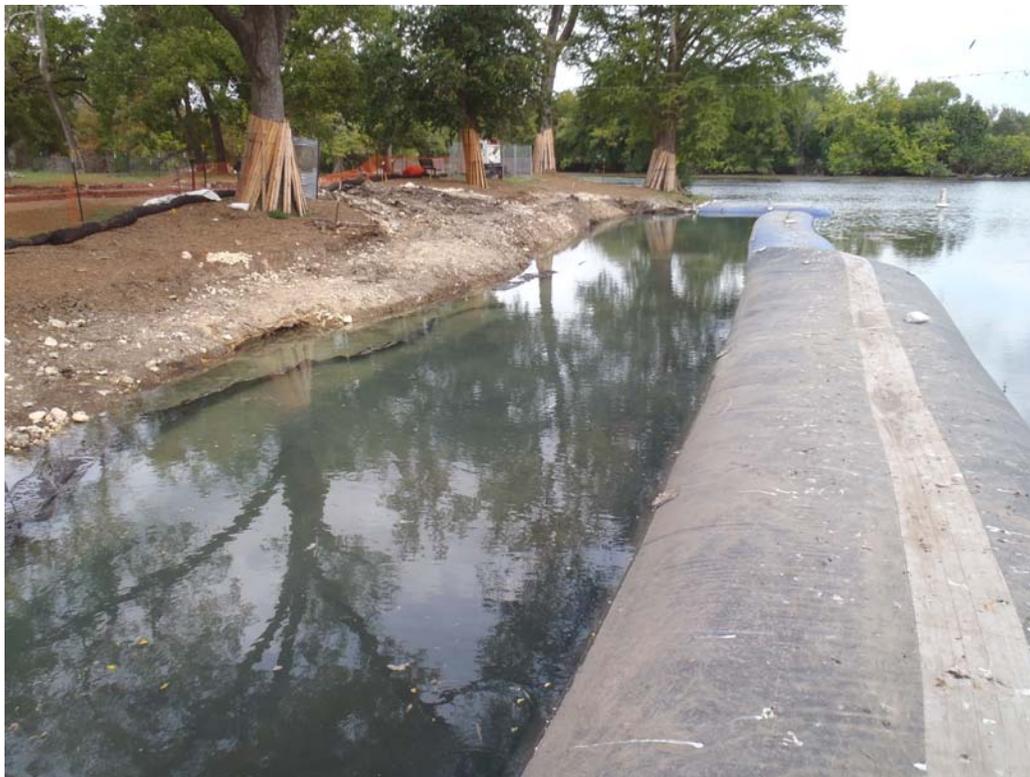
As a considerable amount of dirt work took place for the Landa Lake walls construction project since last week, I have included a few photographs showing the area of wall removal (Figure 15) on river left just above the confluence of the combined Spring run 1 and 2 with Landa Lake and the pile of sediment in the park being loaded and removed (Figure 16).

Figure 15: Landa Lake walls construction project - downstream view towards the lake.

Extensive areas of sediment removed along shoreline. (October 29th)

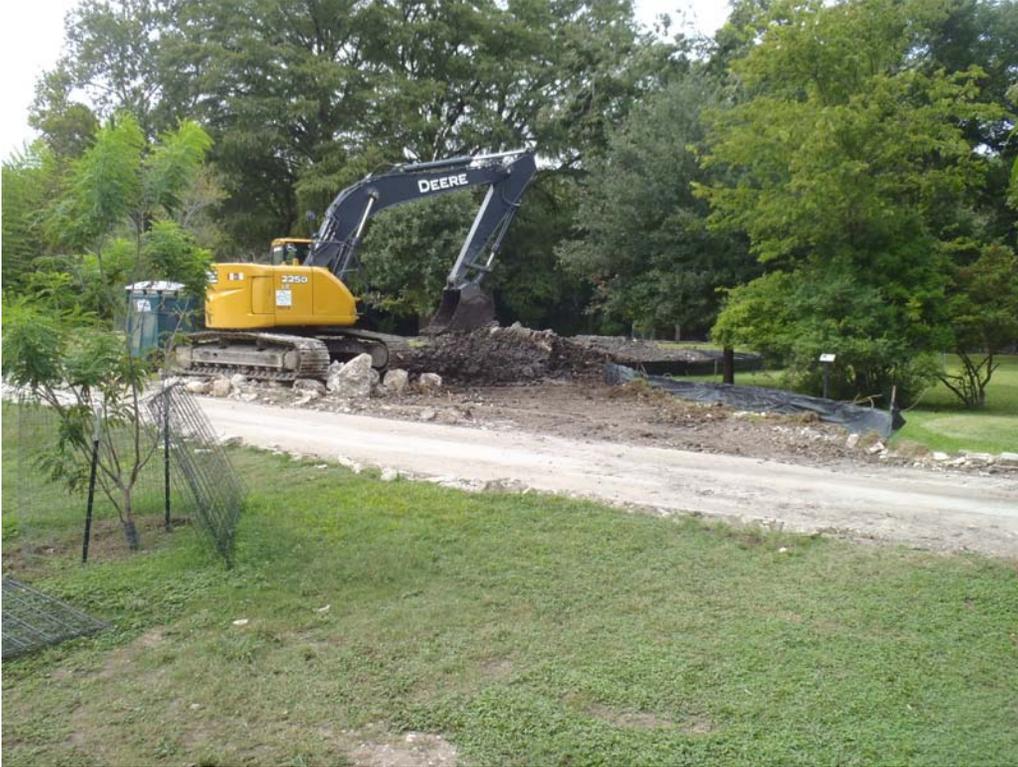
Figure 16: Landa Lake walls construction project – Sediment being loaded into trucks. (October 29th)

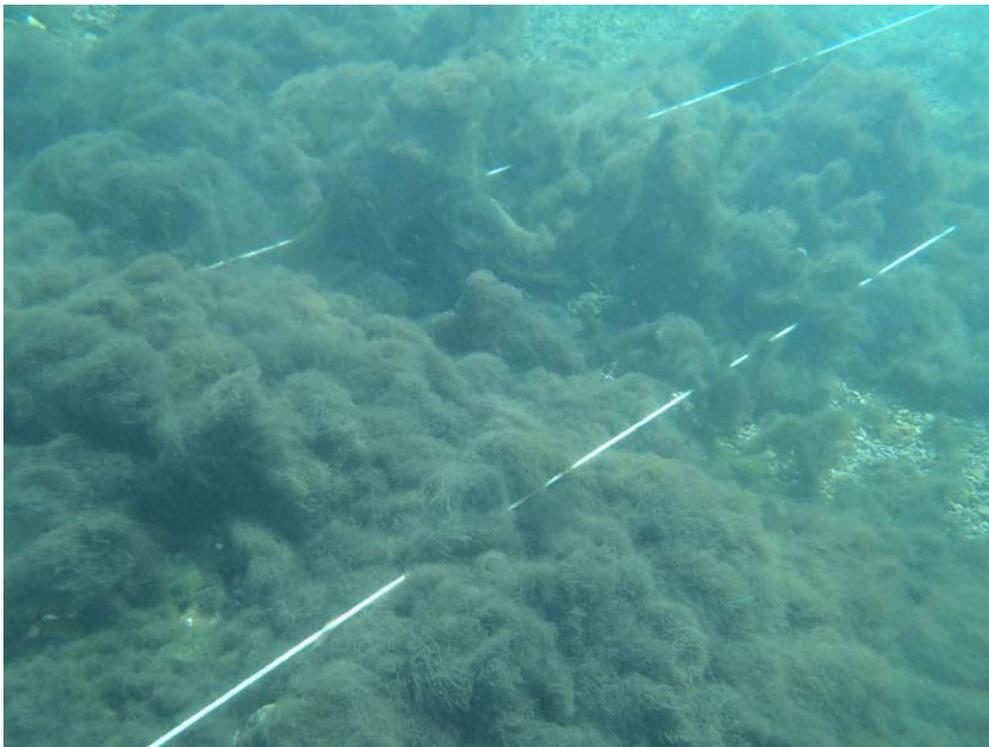
Figure 17: Bryophytes within fountain darter transect survey in Landa Lake. (October 29th)

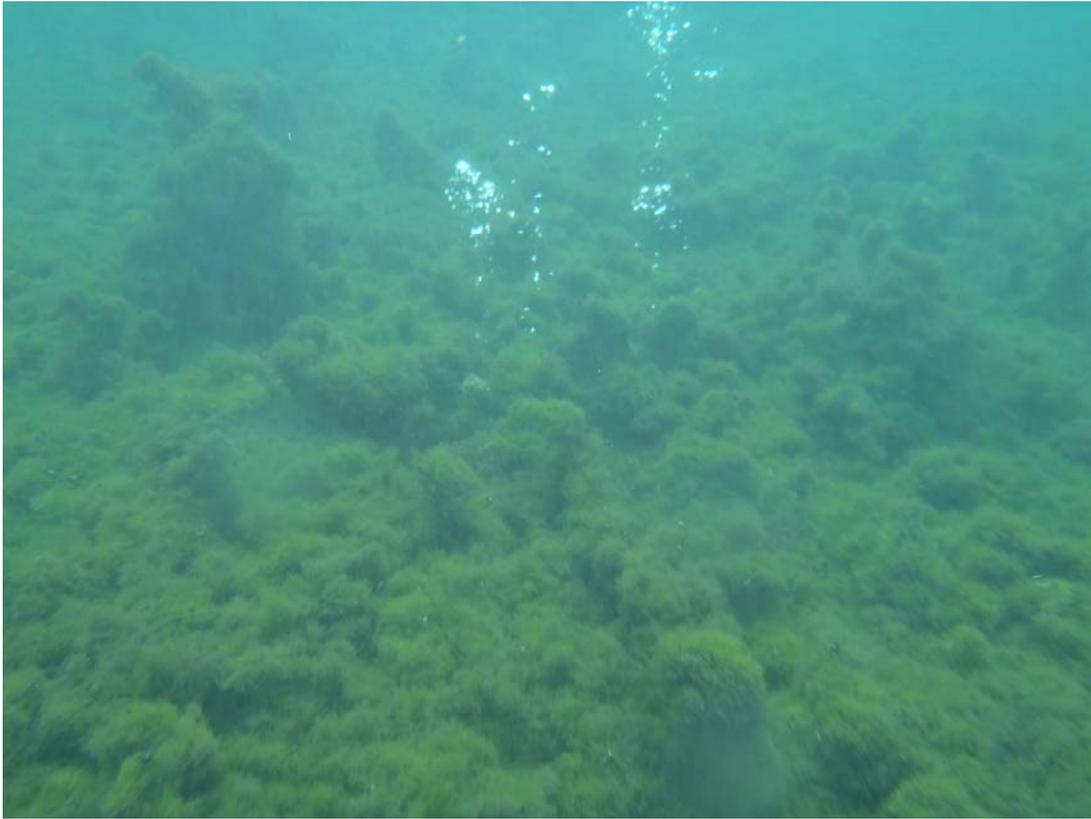
Figure 18: Extensive bryophyte patches in Landa Lake. (October 29th)

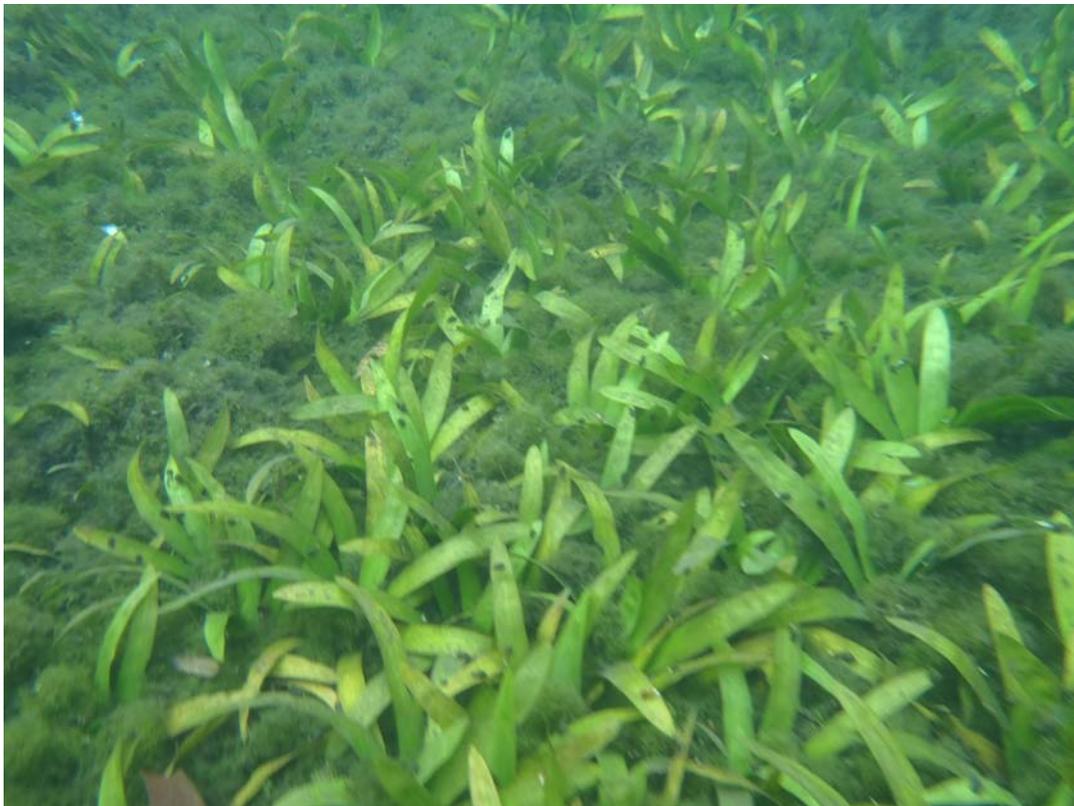
Figure 19: Bryophytes within *Sagittaria* in Landa Lake. (October 29th)

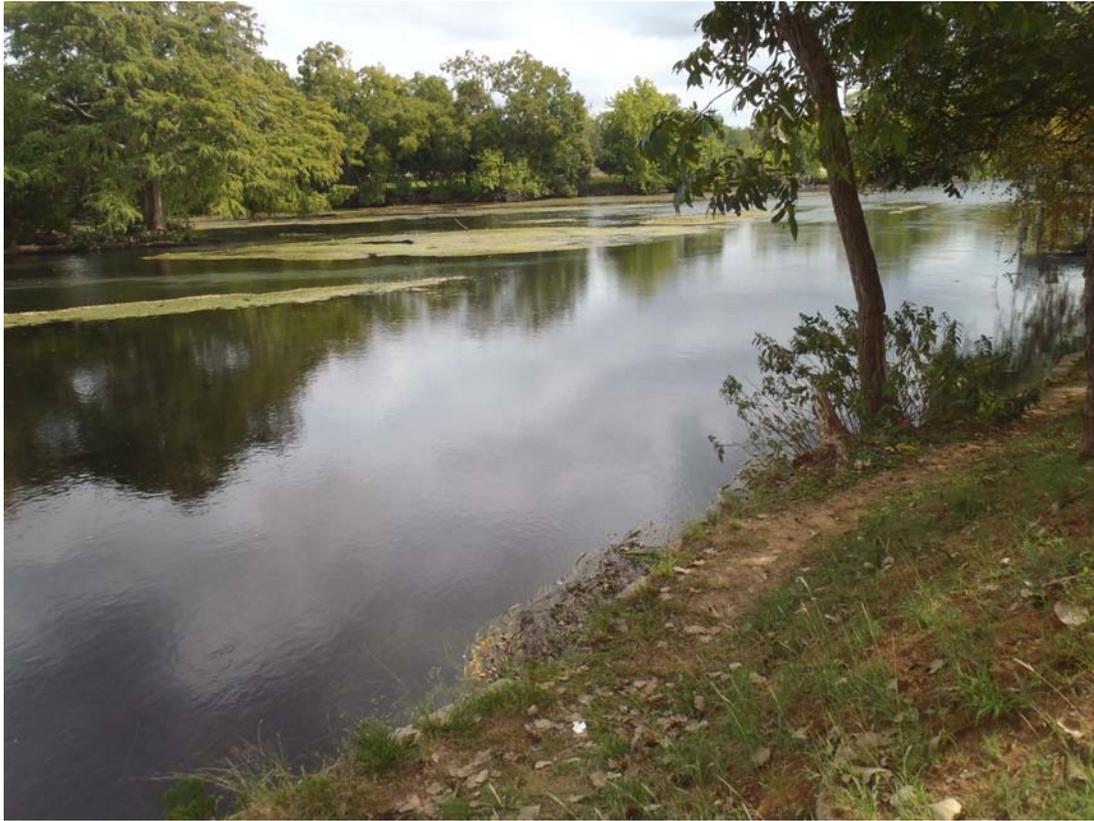
Figure 20: Floating vegetation mat condition in Landa Lake. (October 29th)

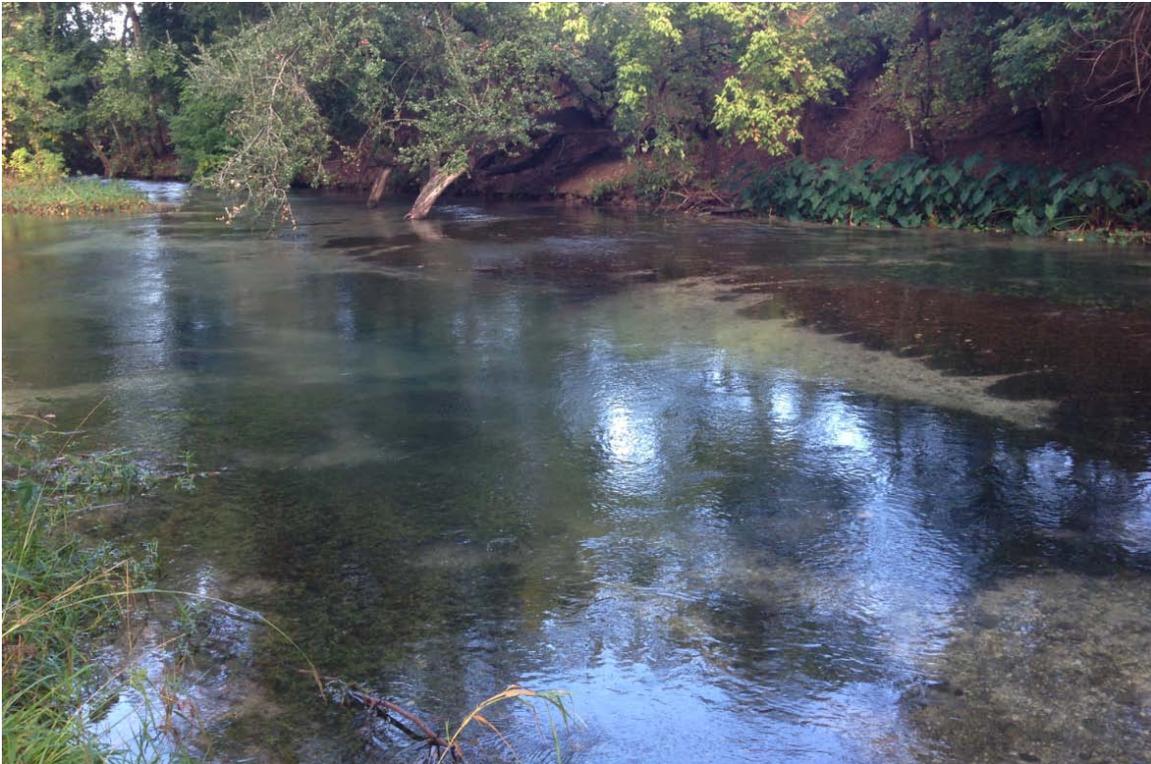
Figure 21: Restored aquatic vegetation in Old Channel – Photo taken after high flow pulse event. (October 31st)
