MEMORANDUM

TO: Nathan Pence
FROM: Ed Oborny (BIO-WEST)
DATE: **June 27, 2014**
SUBJECT: EA HCP Biological Monitoring – **Week 11**

COMAL SPRINGS/RIVER - WEEK 11 CONDITIONS:

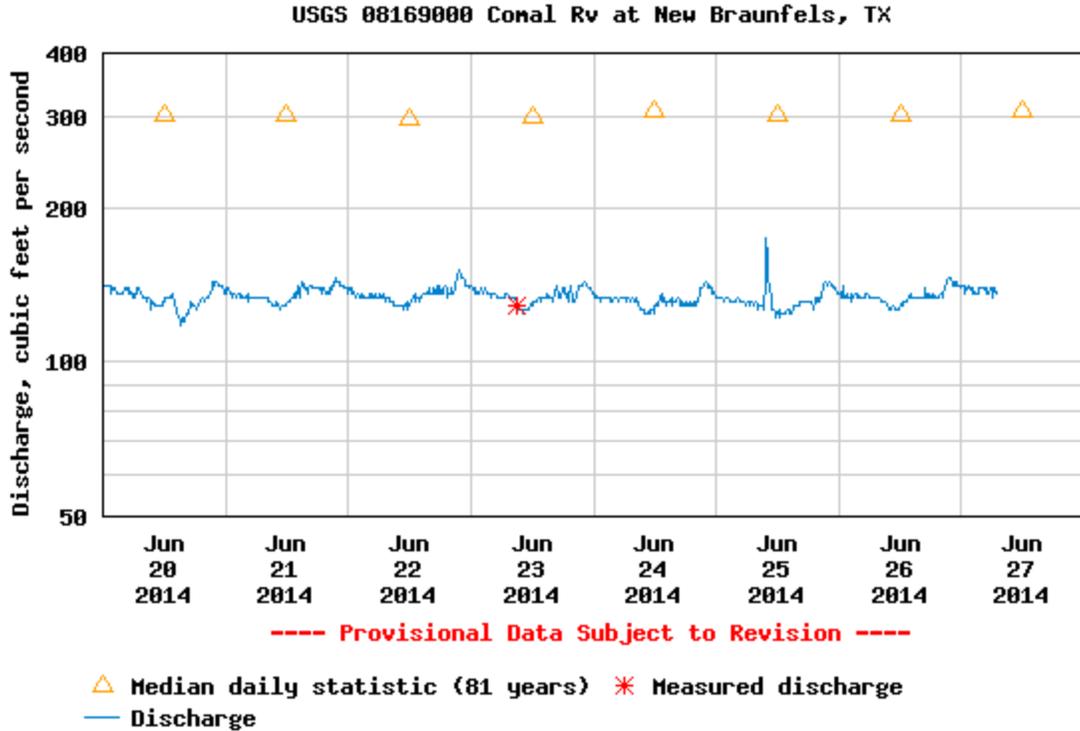
This week, the J17 water level reached a low of approximately 635' but had rebounded to over 639' following rain over the watershed mid-week. At the time of this memo, J17 reads just slightly higher than it did last Friday. As a result, habitat conditions throughout the system this week are very similar to last weeks.

Figure 1: Screen shot of USGS webpage for the *COMAL* gage (08169000) showing total system discharge over the past week.

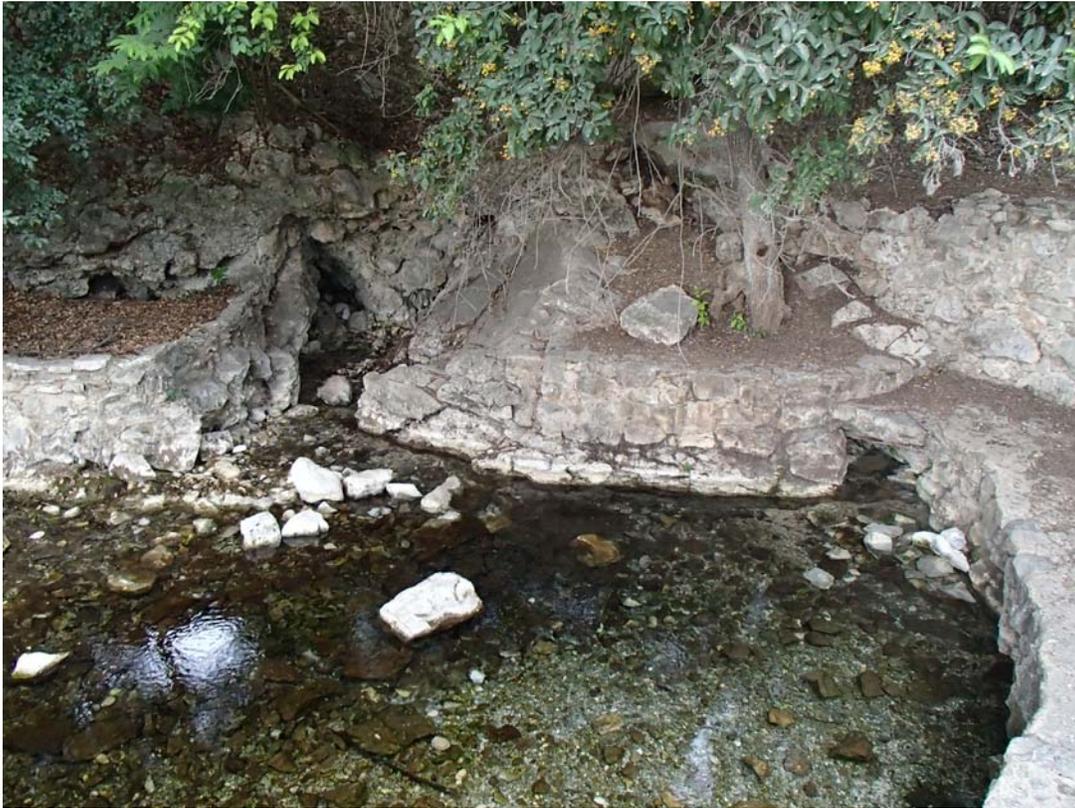
As noted last week, the two major orifices at Spring Run 1 both are maintaining surface discharge (Figure 2) with the Spring Run 1 channel also maintaining complete surface flow connectivity (Figure 3). Spring Run 2 continues to maintain surface flow for the main portion of the channel and Spring Run 3 continues to maintain connectivity throughout the run. At present, algae is thick and getting thicker in the Upper Spring Run reach making it difficult for native bryophytes to compete (Figure 4). Unless there is a significant change in flow conditions, this will likely only get worse in coming weeks, as previous experience has shown that algae coverage is worst during the hottest part of the summer. However, fountain darter movement study observations conducted this week confirmed that darters are still relatively common in this reach. The surface water level in the Spring Island area was similar to last week with continued exposed surface habitat in the area along the eastern side of the island (Figure 5). Additionally, the northern spring run on Spring Island is essentially dry with only a few small surface puddles left and no observable surface flow, while the southern spring run maintains surface flow but is becoming increasingly stagnant (Figure 6).

Figure 2: Spring Run 1 main orifices.

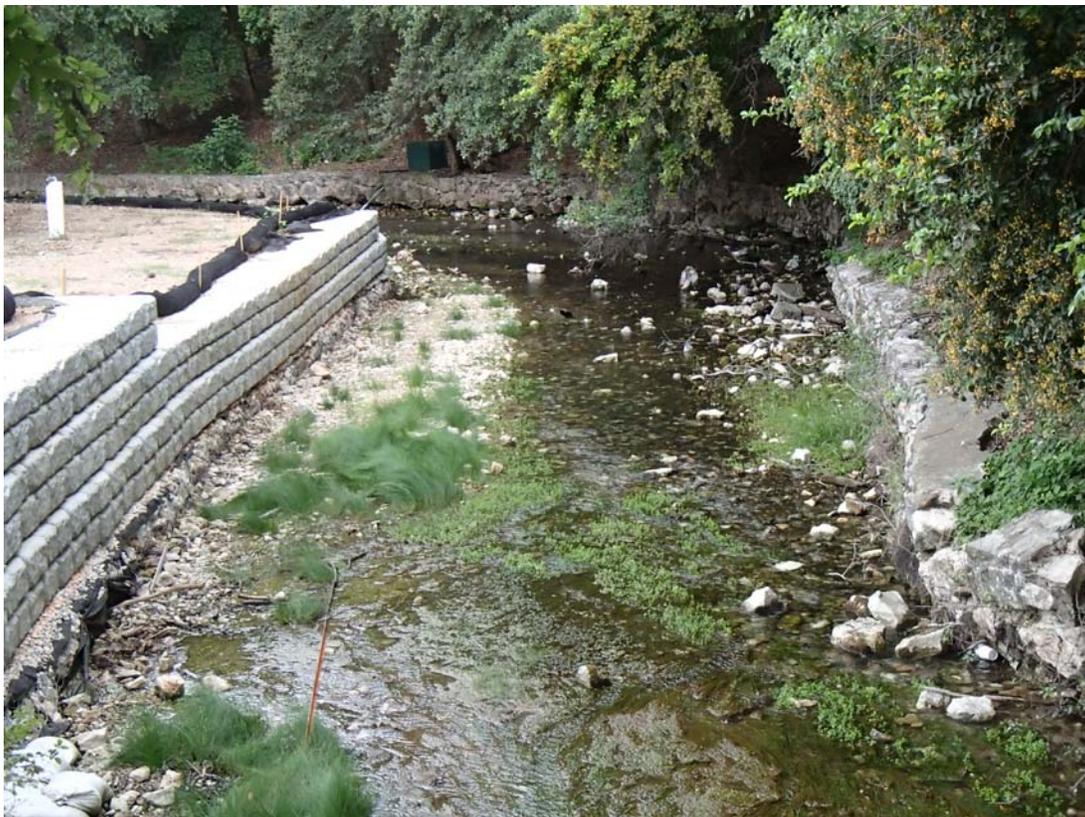
Figure 3: Spring Run 1 main channel looking downstream.

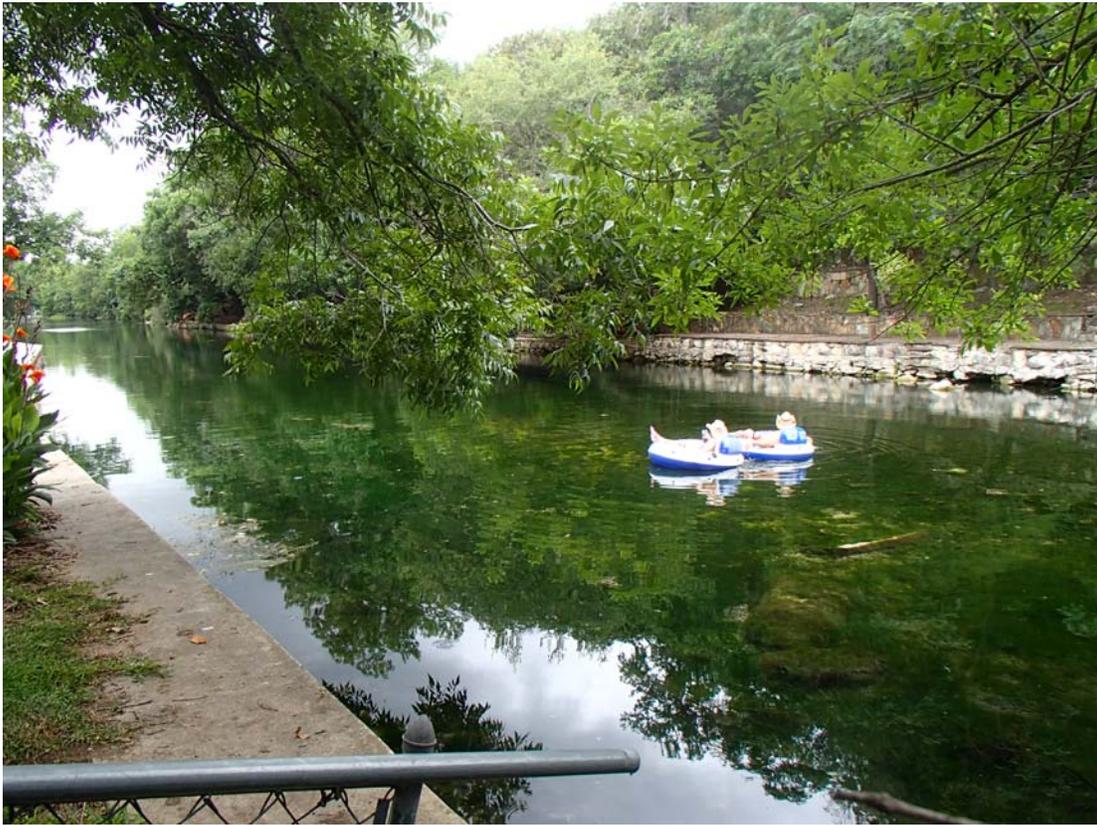
Figure 4: Algae continuing to proliferate in the Upper Spring Run Reach.

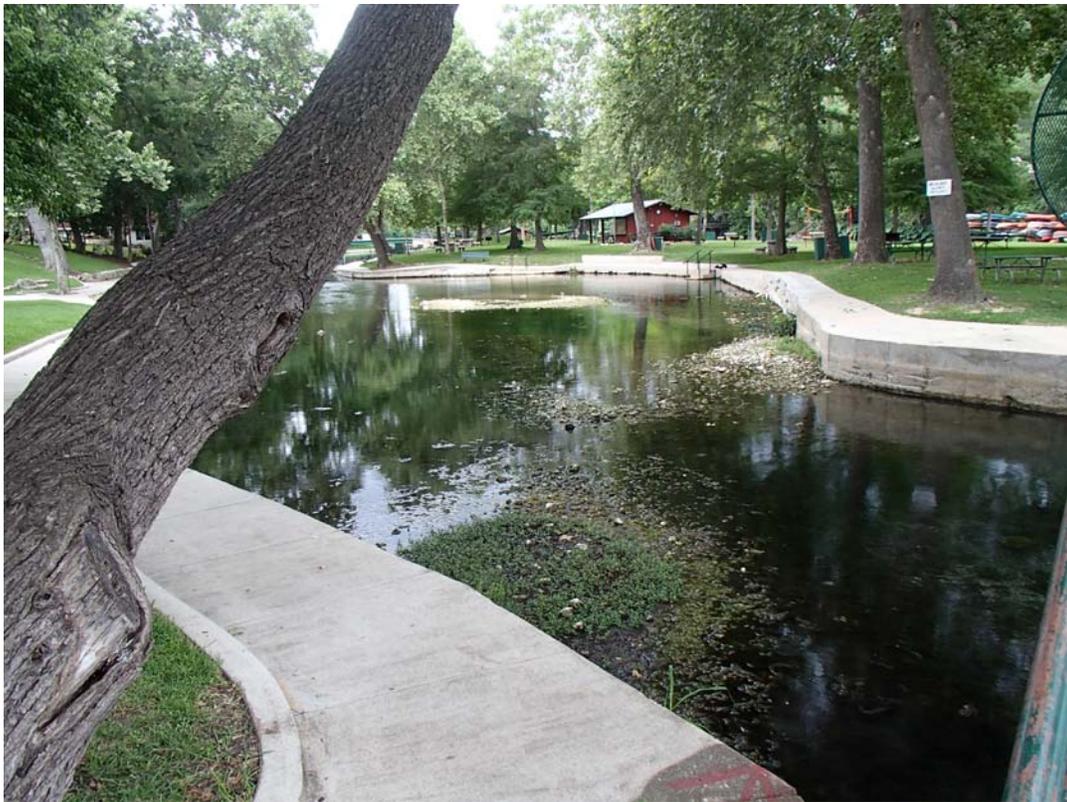
Figure 5: Continued exposed surface habitat adjacent to Spring Island.

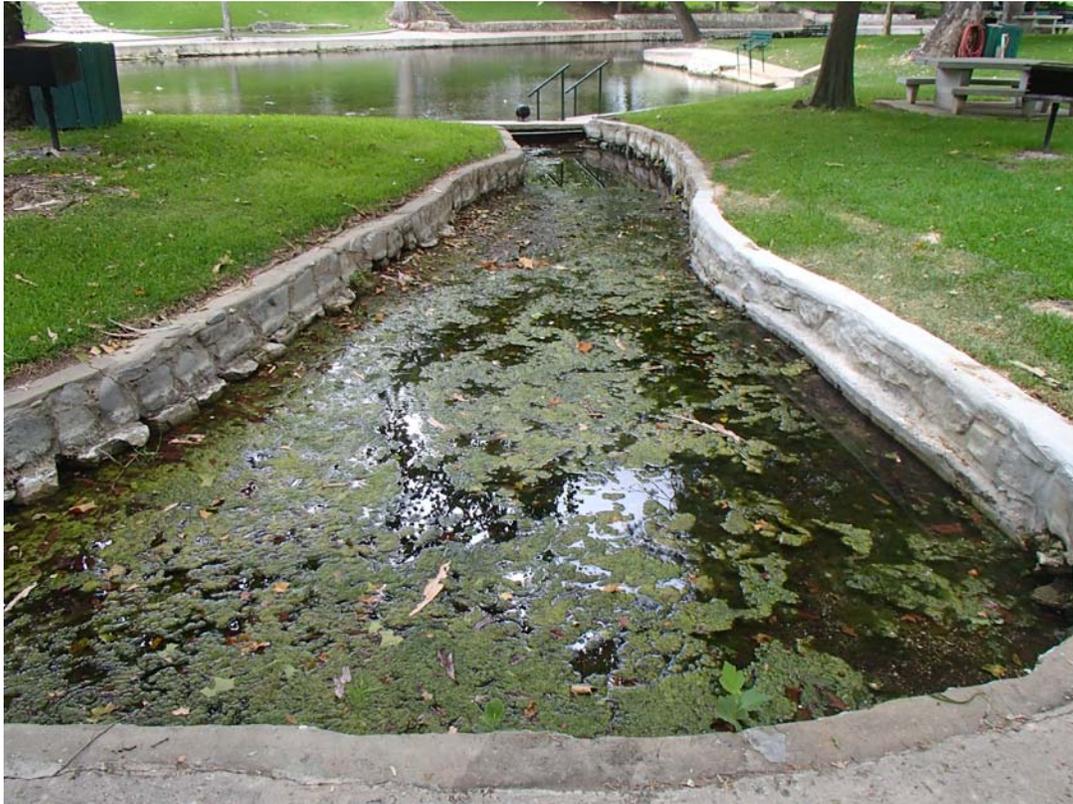
Figure 6: Stagnant conditions within the southern spring run on Spring Island.

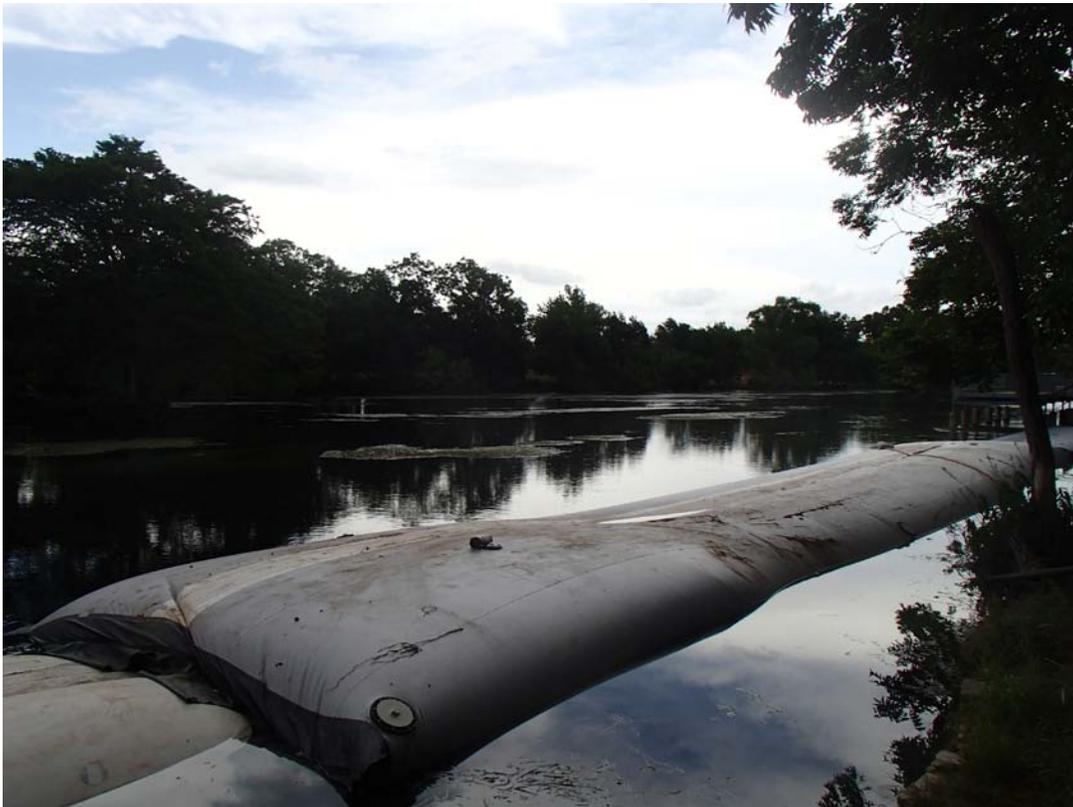
Although increased algae continues to be observed in Landa Lake, the bryophytes in the upper portion of the lake and restored *Ludwigia* areas are doing well, and in general fountain darter habitat conditions look good. As expected with continued low-flow conditions, floating vegetation mats in Landa Lake continue to accumulate and will require attention to prevent impacts to underlying habitat (Figure 7). The large bladders being used in the walls construction project are quite evident in figures 7 and 8, with the latter photo showing where the Landa Circle gazebo used to be.

Figure 7: Floating vegetation mats in Landa Lake behind the large bladder for the walls project.

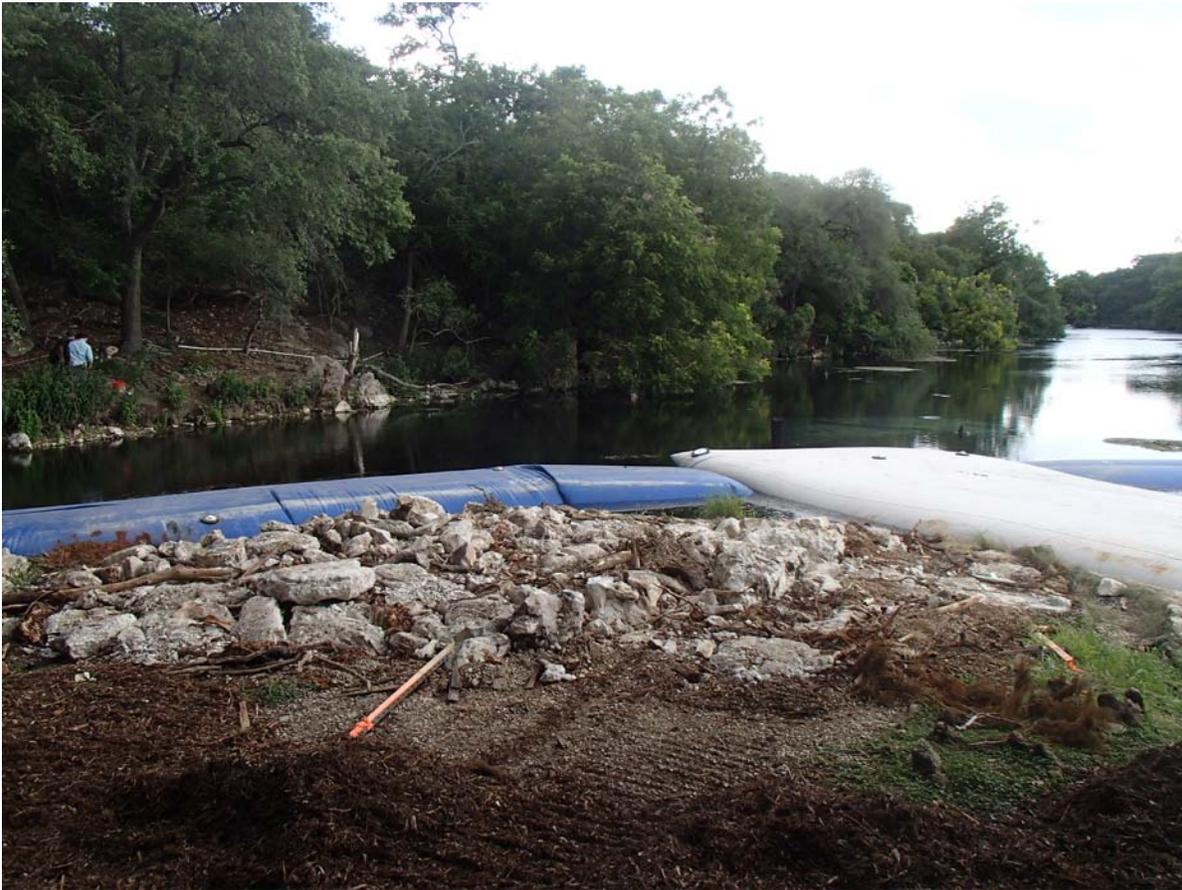
Figure 8: Gazebo area at the confluence of Spring Run 3 and Landa Lake.

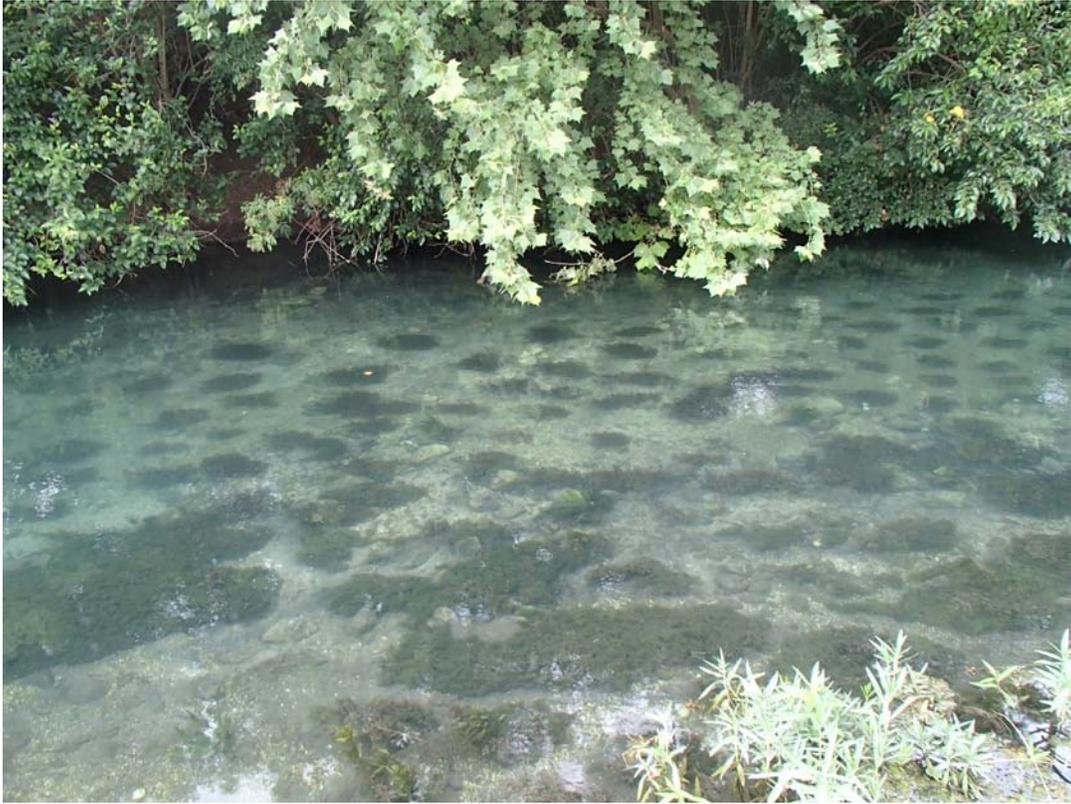
In addition to the lake, fountain darter habitat continues to thrive throughout the Old Channel with recent aquatic vegetation restoration work (Figure 9) improving darter habitat conditions in this reach. Despite continued heavy, summer recreational traffic, the New Channel above Clemens Dam continues to maintain extensive patches of *Cabomba* which provide high quality fountain darter habitat (Figure 10).

Figure 9: Restored vegetation growth occurring in the Old Channel.

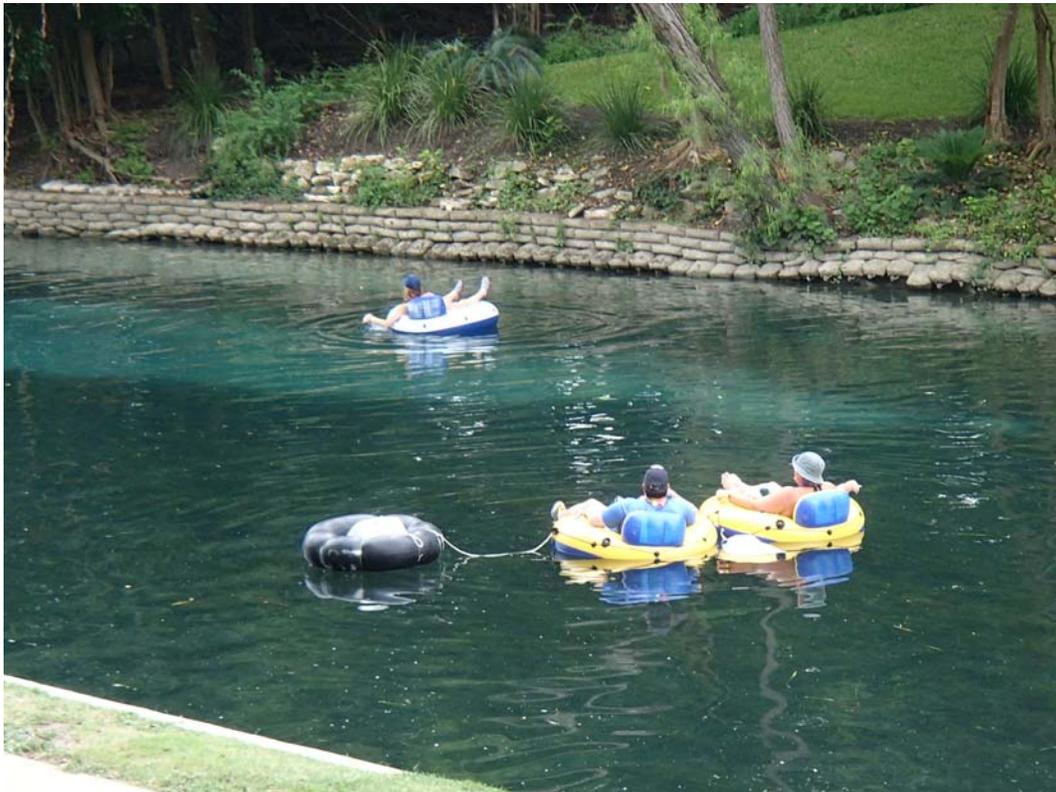
Figure 10: Thick *Cabomba* in the New Channel interspersed with open areas along far bank.

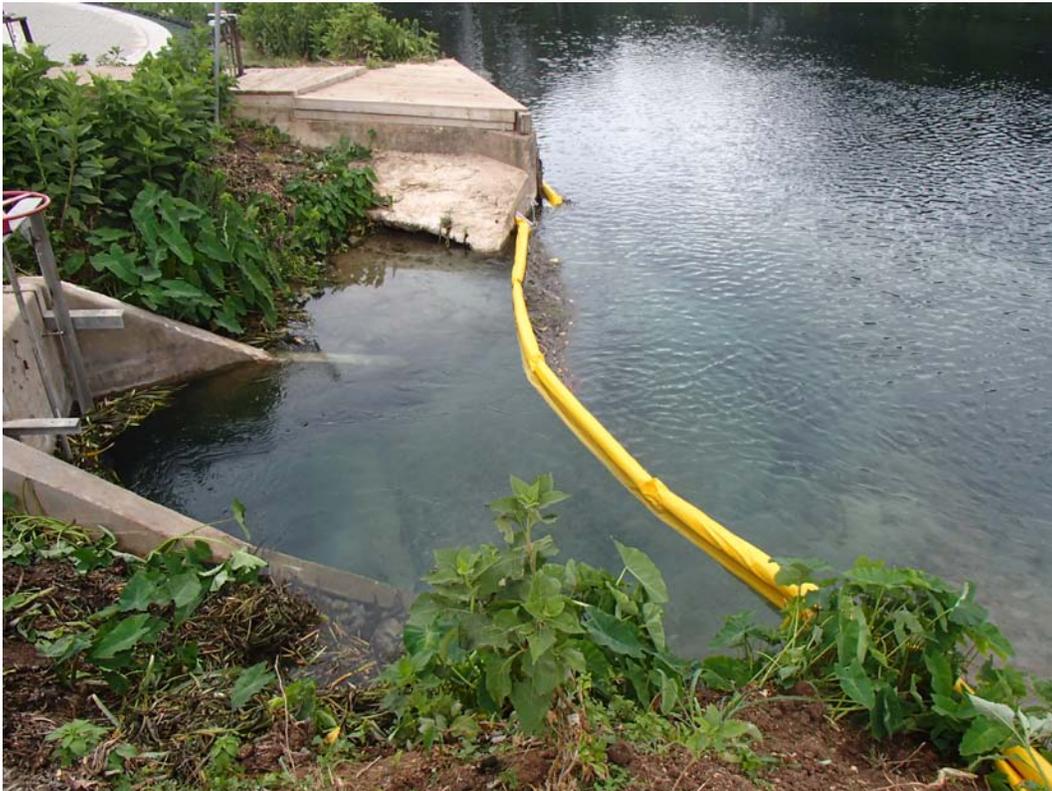
Finally, I have included a couple of photos from the Flow Split Management project showing the completed new culvert (Figure 11 – Hooray) and the soon to be sealed off old culverts (Figure 12).

Figure 11: New Culvert completed for Flow Split Management Project.

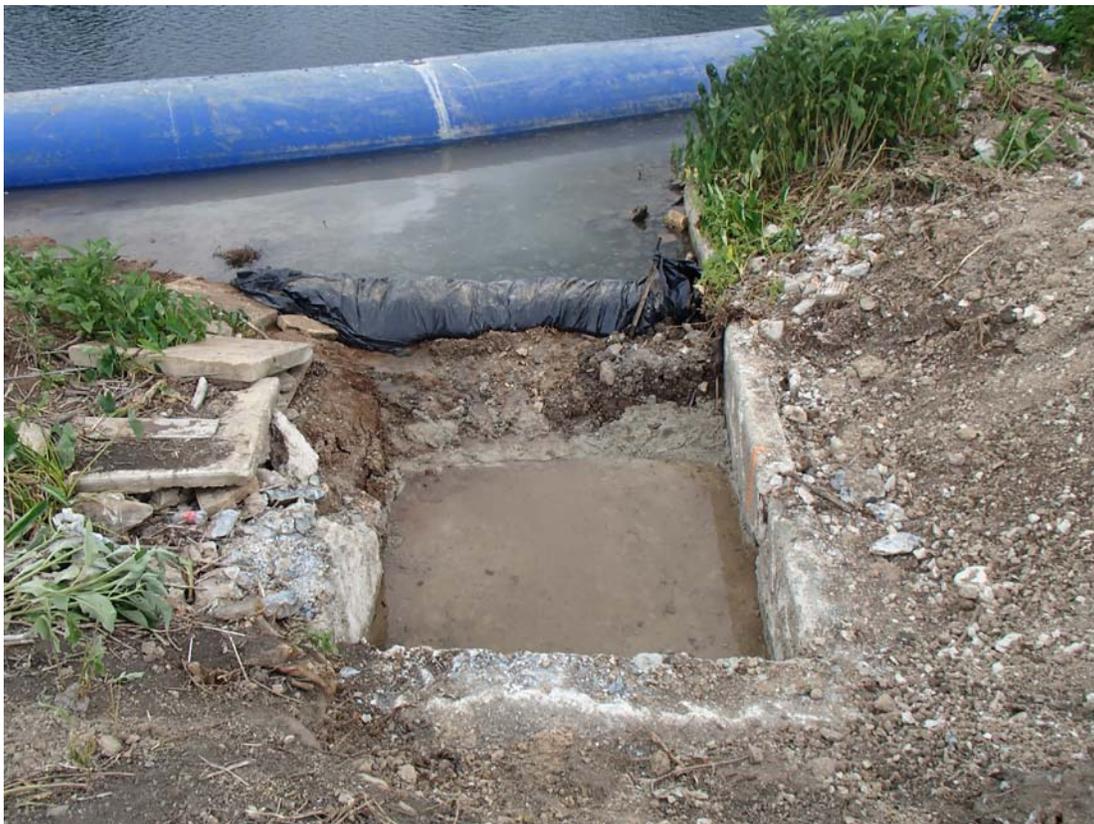
Figure 12: Small culverts area awaiting repair on the Flow Split Project.
