TO: Nathan Pence
FROM: Ed Oborny (BIO-WEST)
DATE: **July 4, 2014**
SUBJECT: EA HCP Biological Monitoring – **Week 12**

COMAL SPRINGS/RIVER - WEEK 12 CONDITIONS:

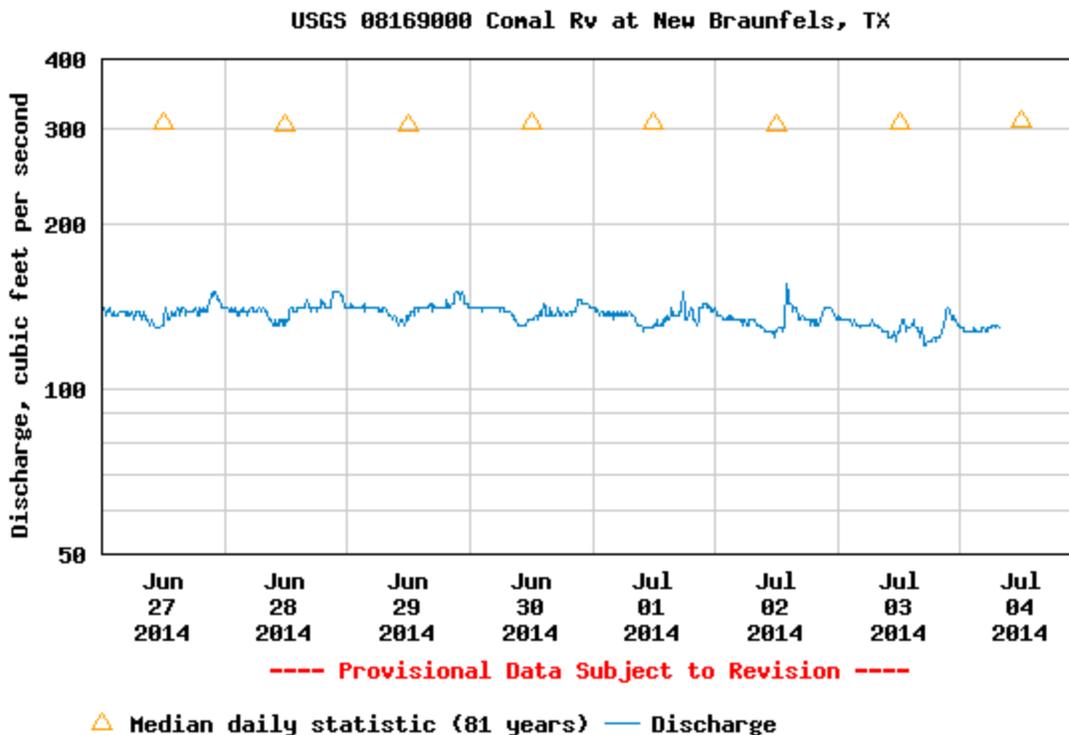
At the time of this memorandum, the total system discharge at Comal Springs was 129 cfs (Figure 1). This makes the twelfth consecutive week below 150 cfs, and therefore, the required weekly habitat evaluation was conducted on July 3rd. Weekly habitat evaluations and memorandums will continue to occur until total system discharge at Comal Springs/River increases and consistently stays above 150 cfs. Should total system discharge decline below 120 cfs (which is possible next week with no significant rainfall over the weekend), Comal Springs riffle beetle, Comal Springs salamander, and Comal discharge measurements/sampling will be triggered. As described in previous weeks, the next Critical Period full sampling event is not triggered until the total system discharge declines below 100 cfs. The next scheduled routine monitoring is fountain darter dip netting later this month.

Figure 1: Screen shot of USGS webpage for the *COMAL* gage (08169000) showing total system discharge over the past week.

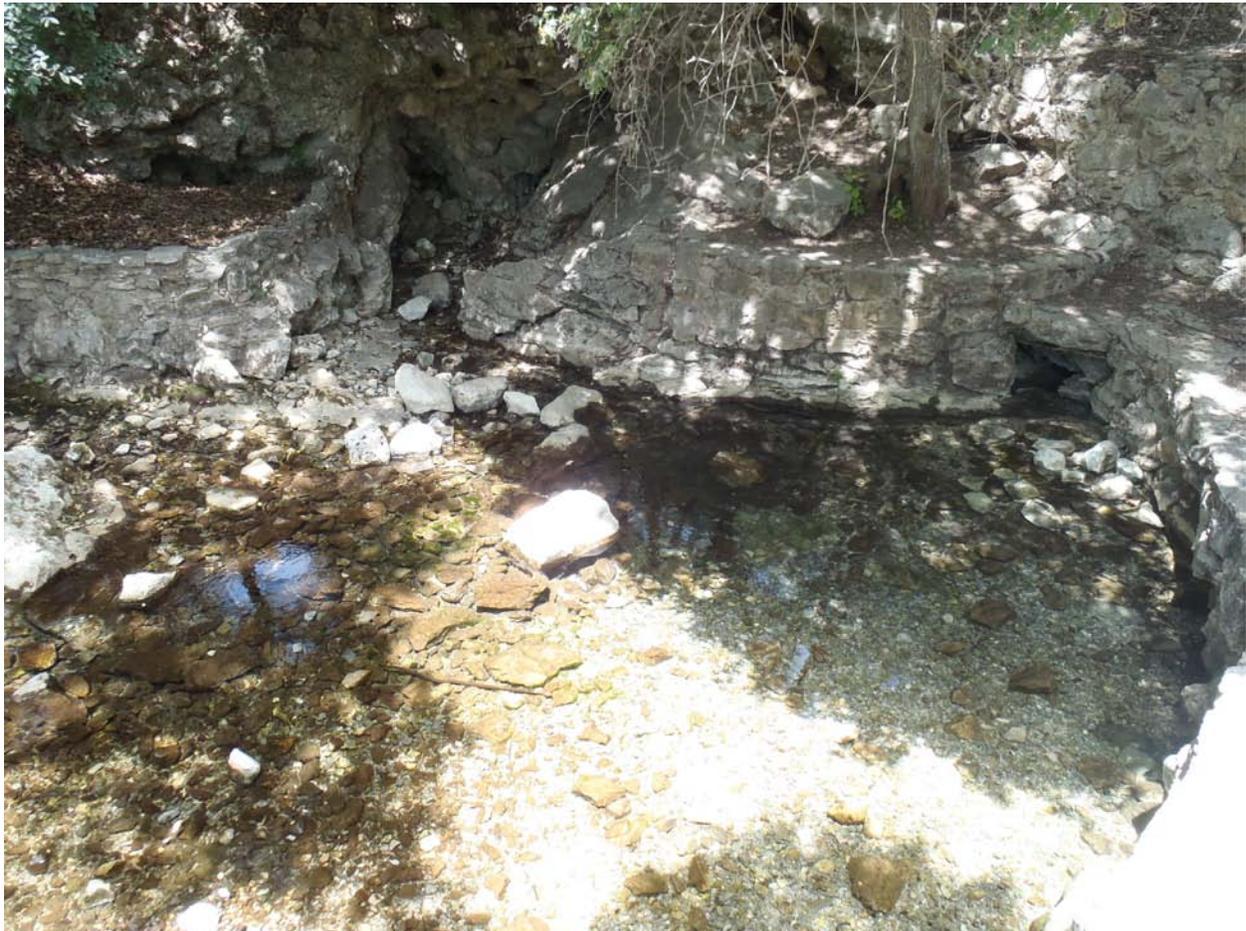
The two major orifices at Spring Run 1 continue to maintain surface discharge (Figure 2), although the western most orifice (upper left in photo) is very shallow. The Spring Run 1 channel continues to maintain surface flow connectivity (Figure 3) throughout the run but has declined in horizontal extent from previous weeks. It is encouraging that after 12 weeks of total system discharge below 150 cfs and extensive construction activities within Spring Run 1; native aquatic vegetation continues to be supported in the run (Figure 4). As in previous weeks, Spring Run 2 continues to maintain surface flow for the main portion of the channel and Spring Run 3 continues to maintain connectivity throughout the run. At present, algae is extremely thick in the Upper Spring Run reach eliminating most native bryophytes at this time (Figure 5). As mentioned last week, unless there is a significant change in flow conditions, this will likely only get worse in coming weeks, as previous experience has shown that algae coverage is worst during late July / early August. However, even with thick and expansive algae in this reach, a night dive for the fountain darter movement study conducted this week confirmed that darters are still present in this reach.

Figure 2: Spring Run 1 main orifices (upper left orifice is very shallow).

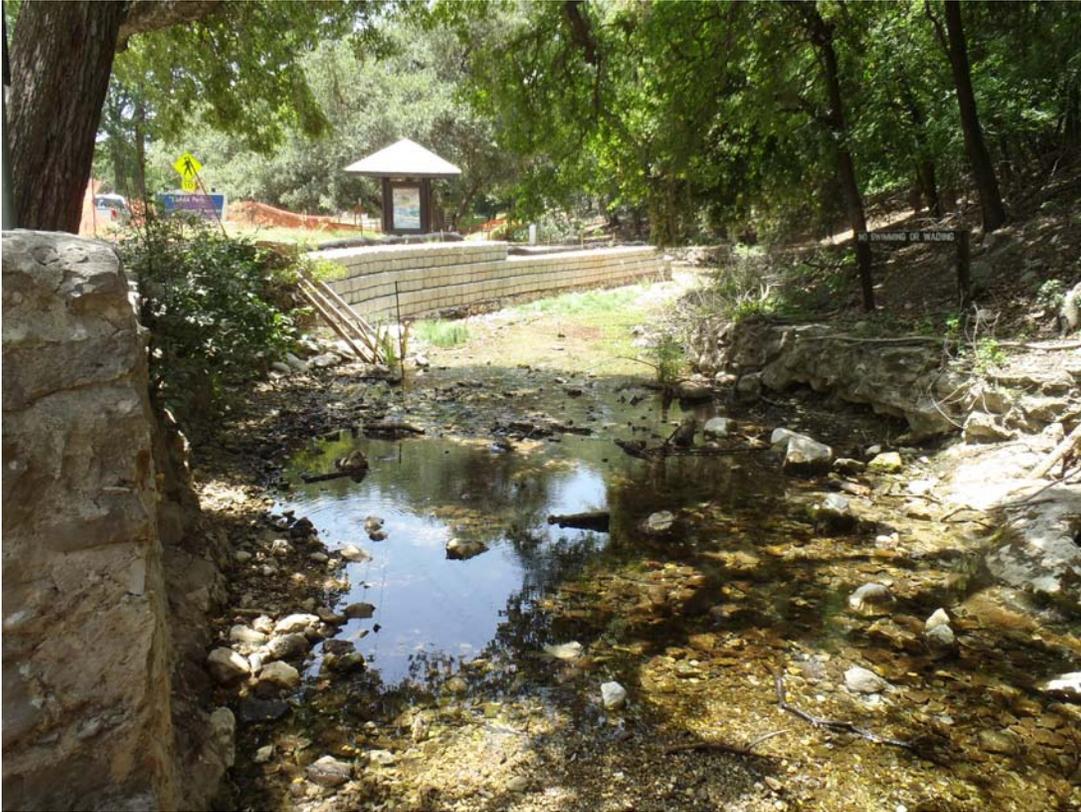
Figure 3: Spring Run 1 main channel looking downstream.

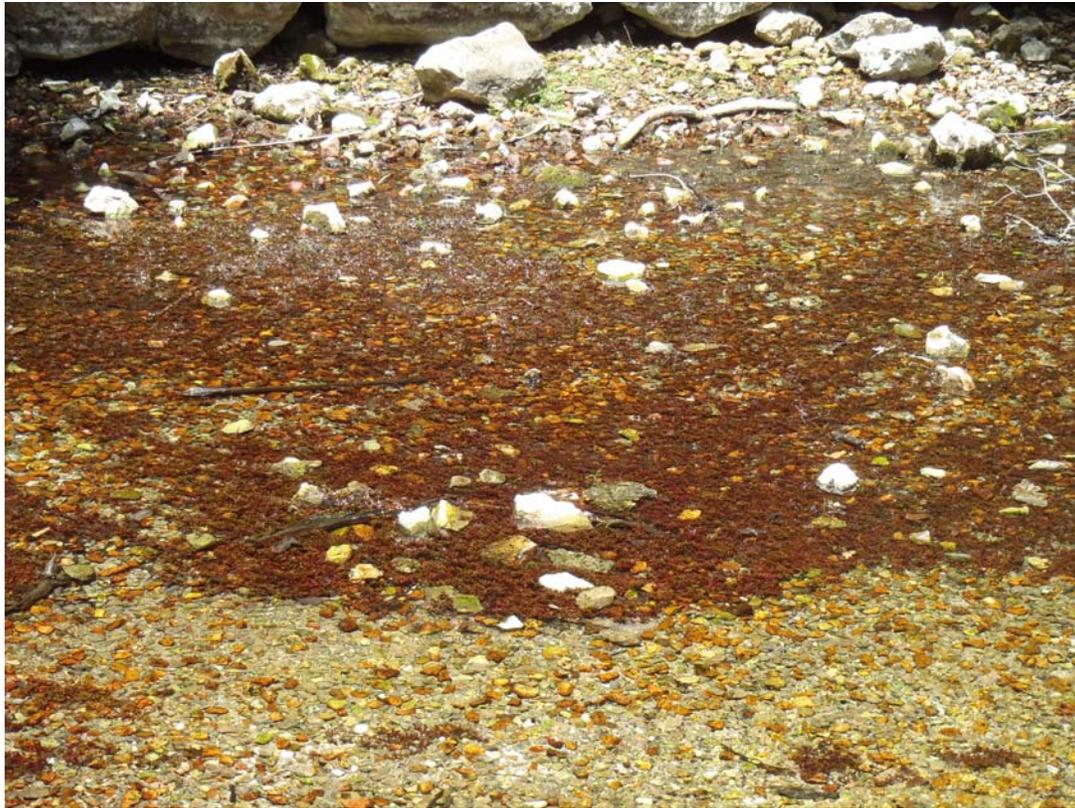
Figure 4: Native aquatic vegetation (*Ludwigia*) in very shallow Spring Run 1 area.

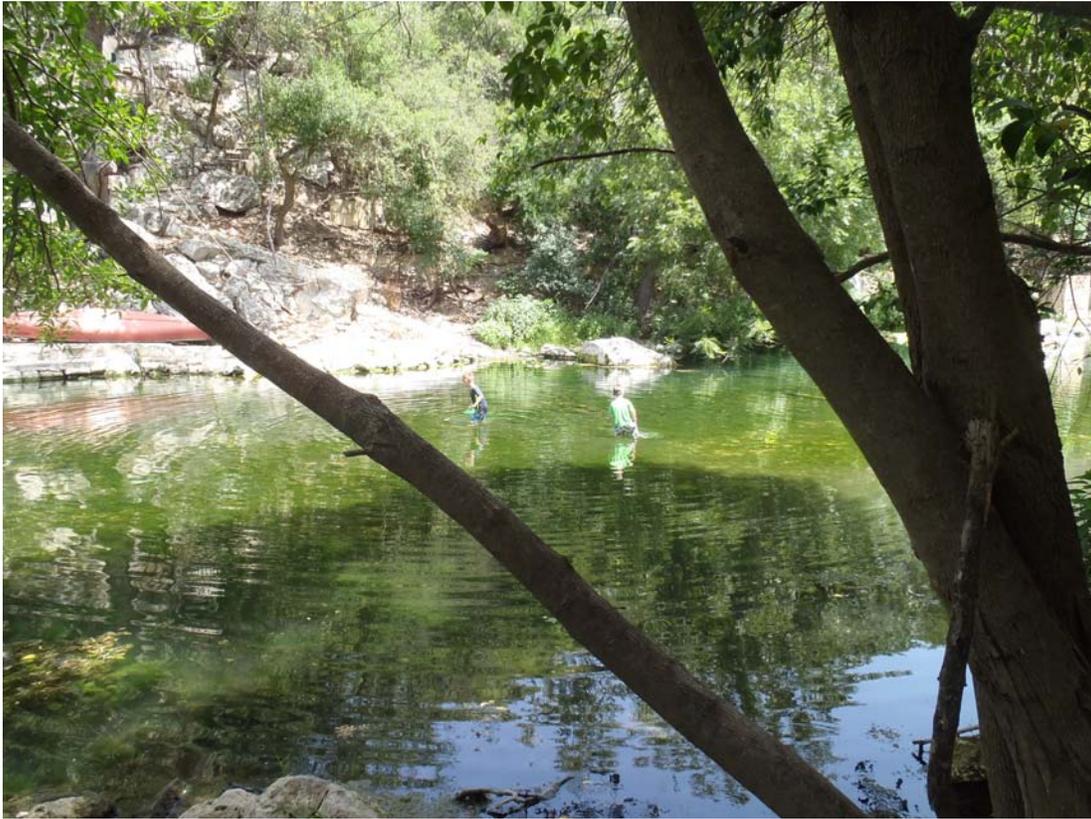
Figure 5: Thick algae - Upper Spring Run Reach. Note: Aspiring young fisheries biologists.

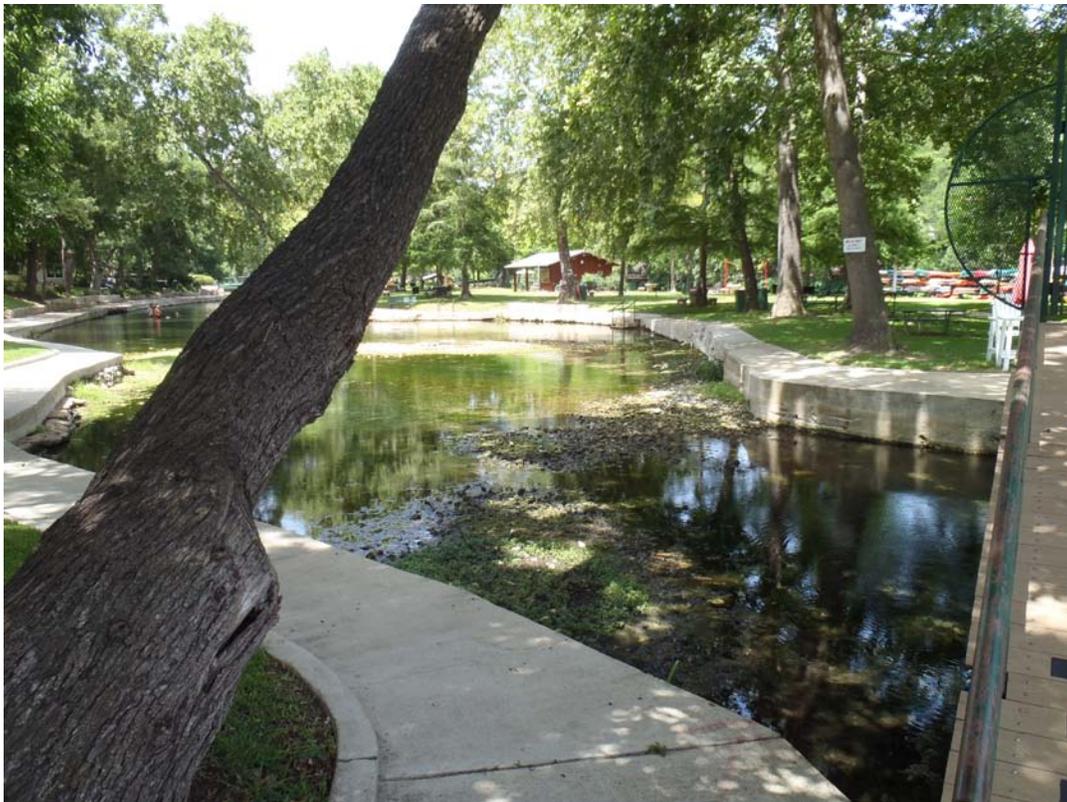
The surface water level in the Spring Island area was slightly less than last week resulting in slightly greater exposed surface habitat in the area along the eastern side of the island (Figure 6). The northern spring run on Spring Island continues to be mostly dry with only a few small surface puddles left and no observable surface flow. The southern spring run is barely maintaining surface flow and is becoming increasingly covered in algae, leaf litter, and grass clippings (Figure 7).

Figure 6: Continued exposed surface habitat adjacent to Spring Island.

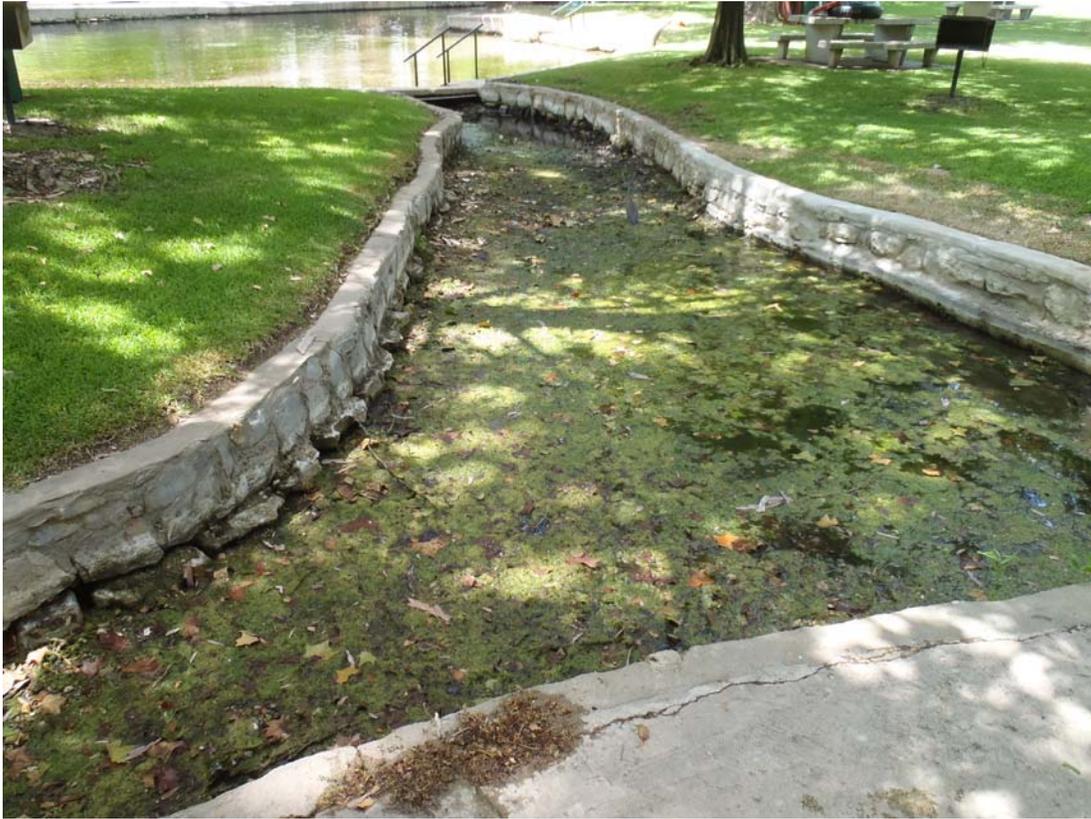
Figure 7: Stagnant conditions within the southern spring run on Spring Island.

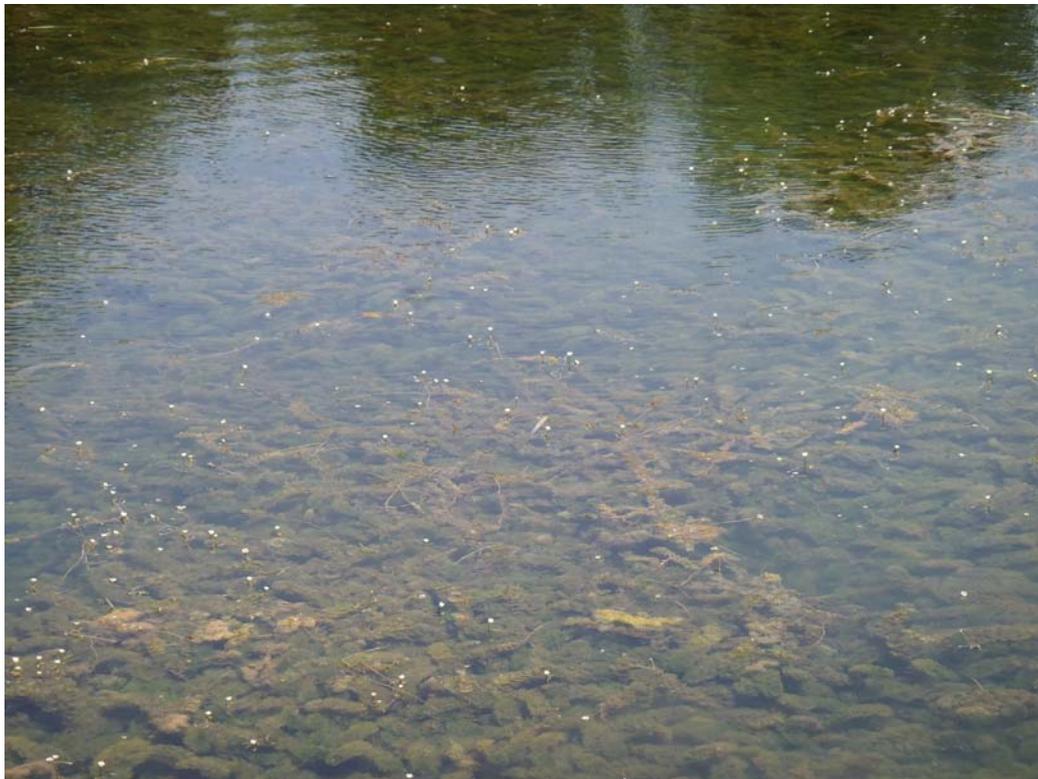
With longer, warmer days, algae continues to increase in portions of Landa Lake, yet aquatic vegetation including bryophytes in the lake continues to support quality fountain darter habitat. Figure 8 shows a thick *Cabomba* patch that is flowering in Landa Lake. With summer time conditions, increased paddle boat traffic also occurs. A paddle boat trail through a floating mat of aquatic vegetation is evident in Figure 9. Breaking up floating mats via paddle boats is likely a benefit to moving that disconnected vegetation downstream. However, paddle boat trails through shallow areas (caused by lower than average water level conditions) of restored native aquatic vegetation are quite disruptive. Overall, floating vegetation mats in Landa Lake were well controlled this past week (Figure 10), but certain areas like the fishing pier can quickly become buildup locations (Figure 11) especially with ongoing walls construction. Regardless, at the present total system discharge, weekly attention to floating mats will be necessary all summer to prevent impacts to underlying habitat.

Figure 8: Extensive patch of native aquatic vegetation (*Cabomba*) in Landa Lake.

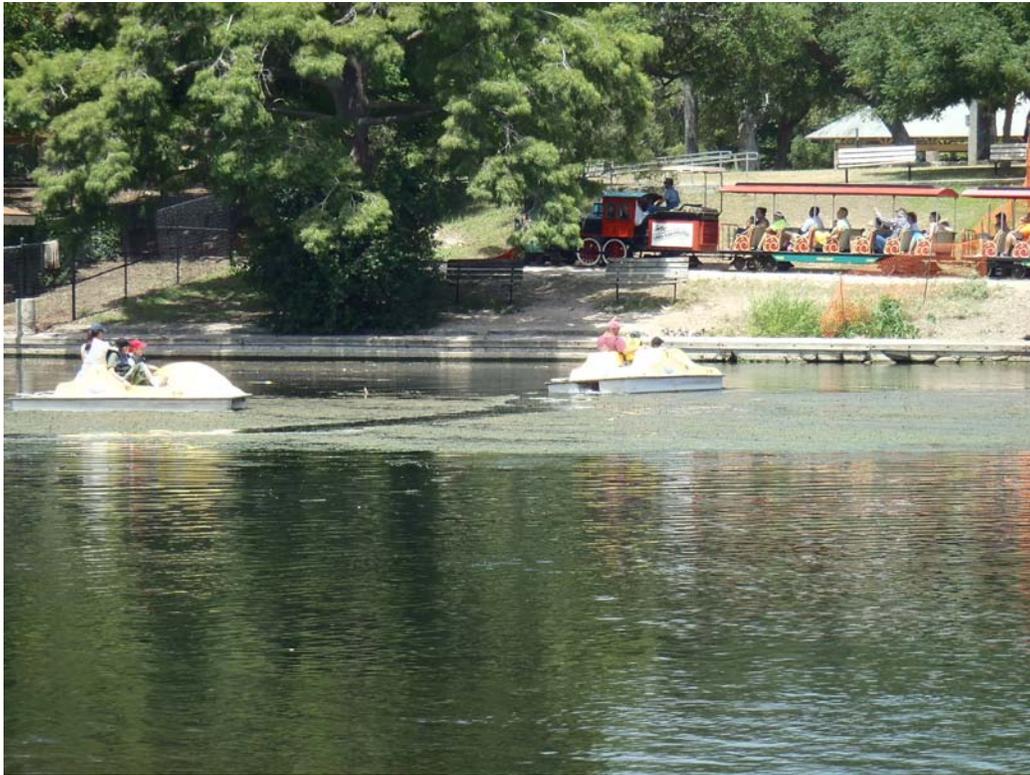
Figure 9: Paddle boat traffic in Landa Lake. Note: Trail through floating vegetation mat.

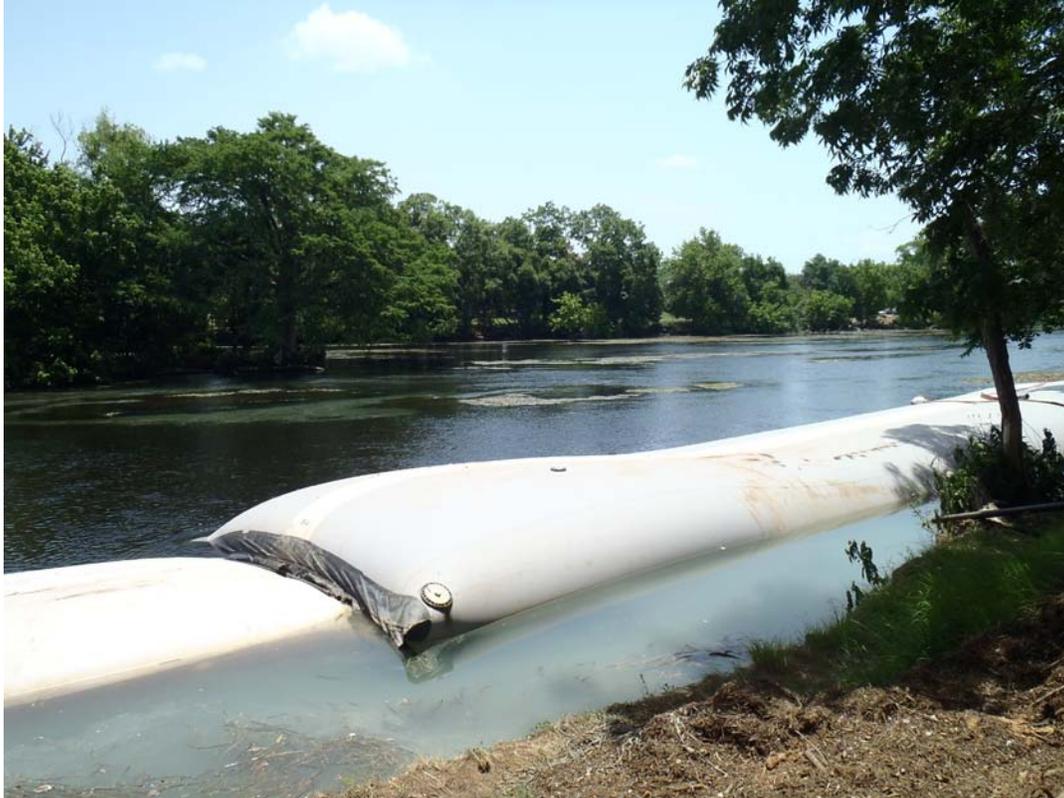
Figure 10: Floating aquatic vegetation mat condition in Landa Lake.

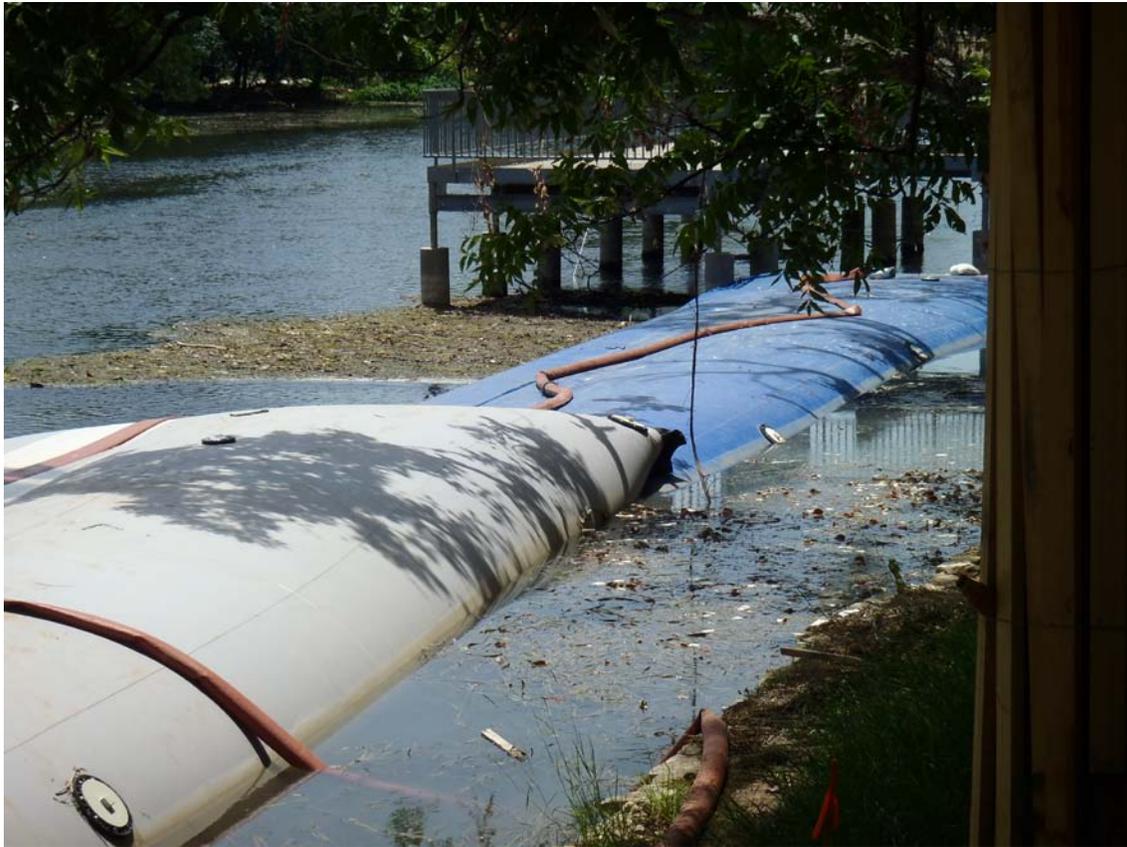
Figure 11. Build up of floating aquatic vegetation at Landa Lake fishing pier.

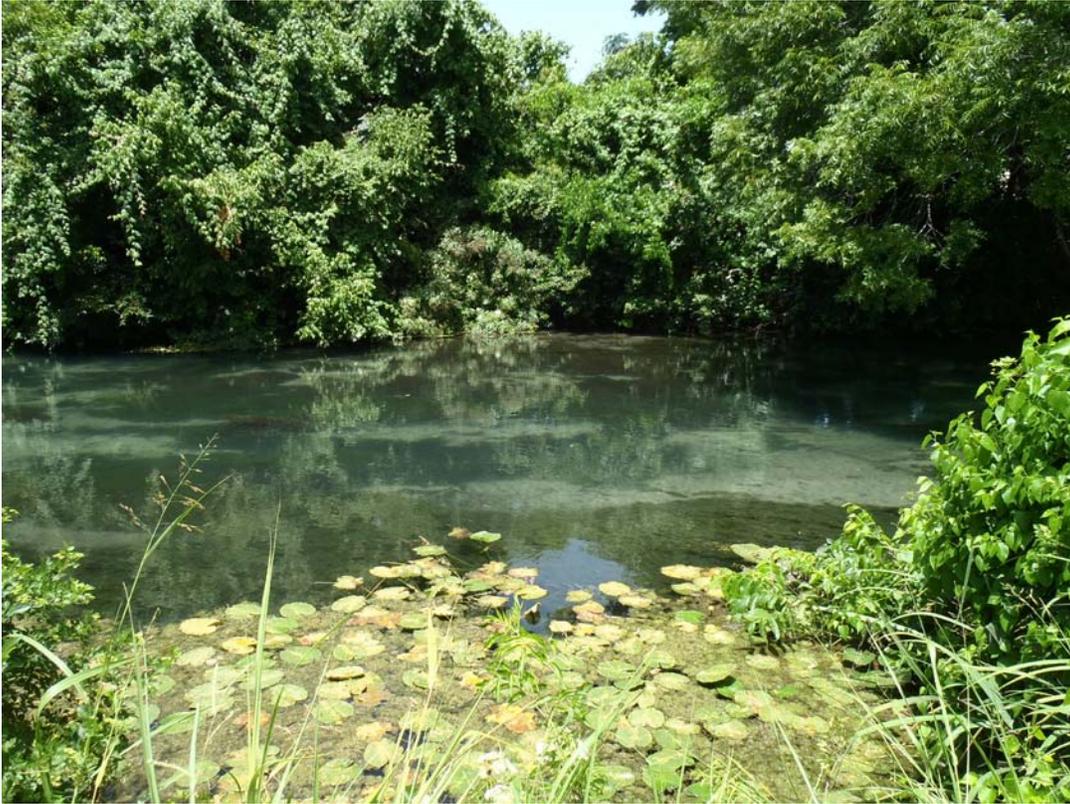
In addition to the lake, fountain darter habitat continues to thrive throughout the Old Channel. Figure 12 shows an area once completely covered in non-native *Hygrophila* that upon restoration is supporting four different types of native aquatic vegetation. Despite continued heavy, summer recreational traffic, the New Channel above Clemens Dam continues to maintain extensive patches of *Cabomba* which provide quality fountain darter habitat (Figure 13).

Figure 12: Restored native aquatic vegetation growth occurring in the Old Channel.

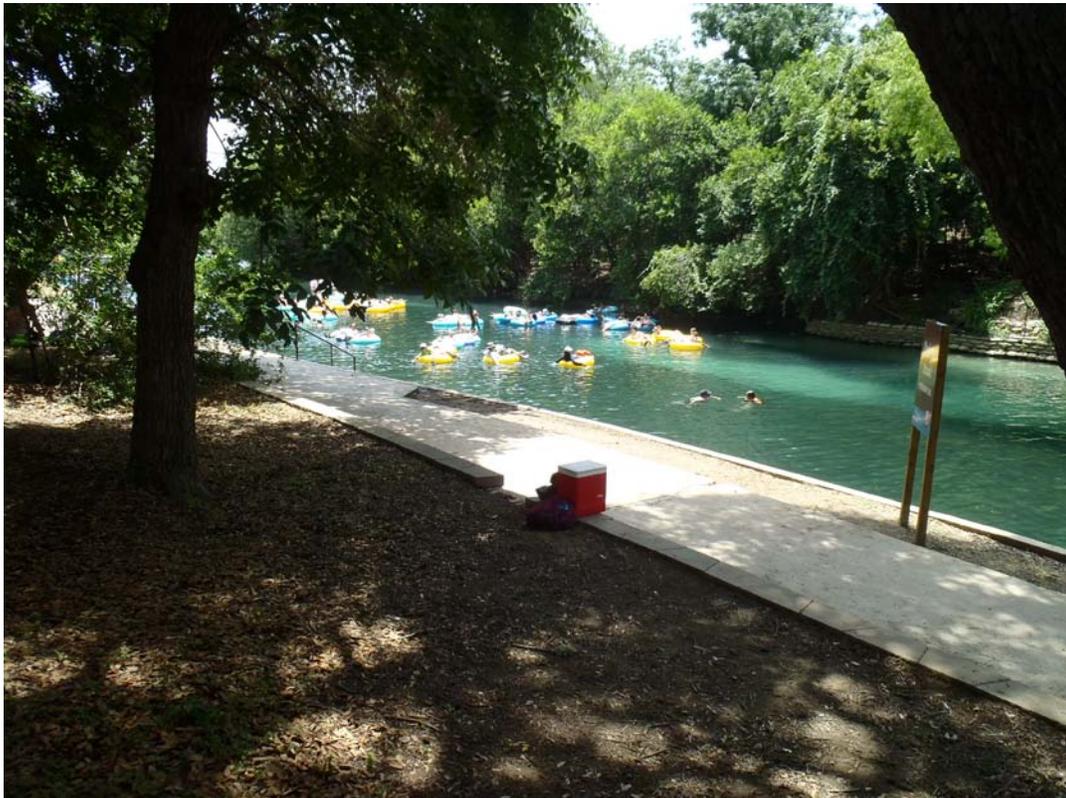
Figure 13: Thick *Cabomba* in the New Channel interspersed with human tubers throughout.

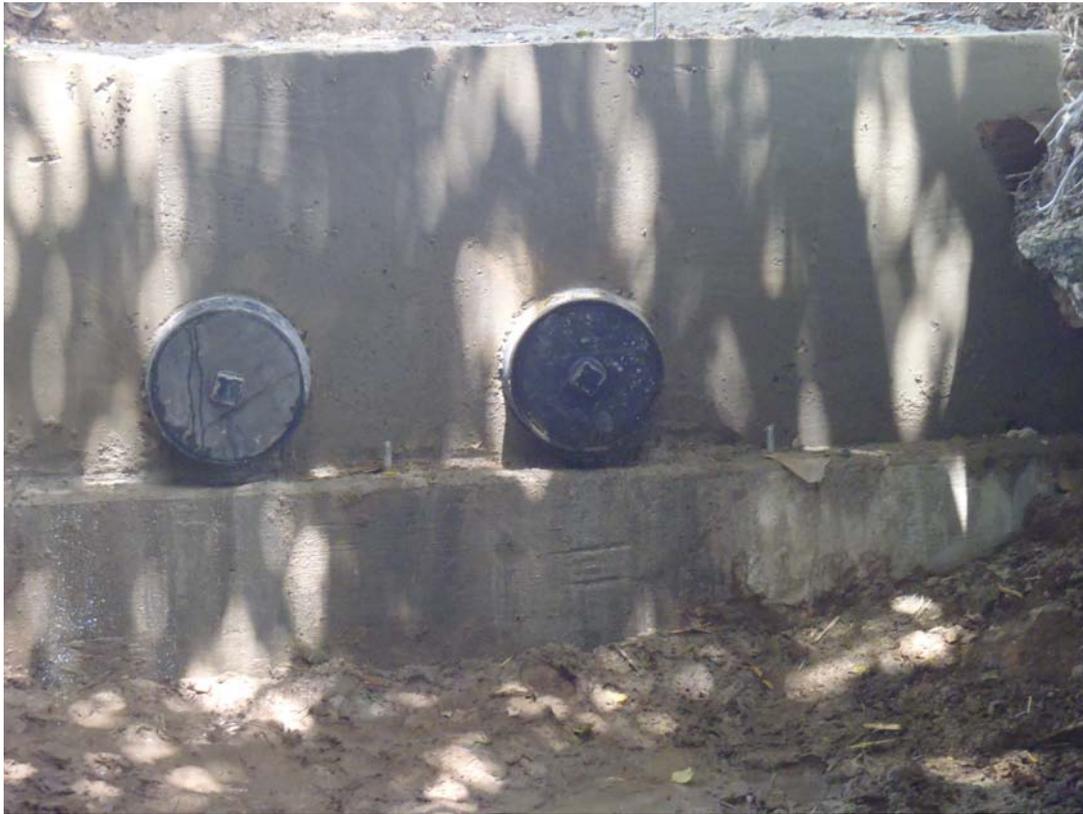
Figure 14: Sealed off old culverts in Landa Lake – photo of the Old Channel side.
