MEMORANDUM

TO: Nathan Pence
FROM: Ed Oborny (BIO-WEST)
DATE: **November 28, 2014**
SUBJECT: EA HCP Biological Monitoring – **Week 33**

COMAL SPRINGS/RIVER - WEEK 33 CONDITIONS:

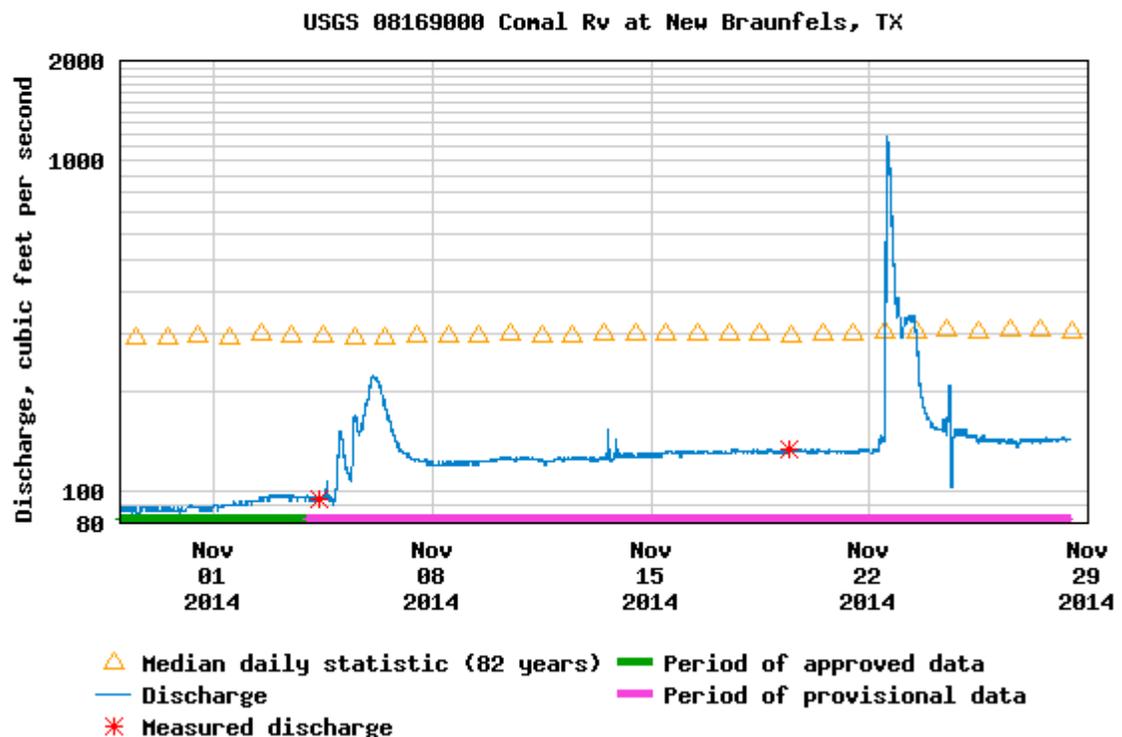
Figure 1: Screen shot of USGS webpage for the *COMAL* gage (08169000) showing total system discharge over the past month.

OBSERVATIONS AND ACTIVITIES: Total system discharge spiked to above 1,000 cfs on Saturday following heavy localized rainfall in the New Braunfels area. Following the pulse, total system discharge stabilized in the low 140 cfs range (Figure 1). The heavy localized rain caused some flash flooding of the Comal system as visually documented throughout this memorandum. Starting at the main spring orifices in Landa Park, Figures 2-4 show the water coming down Panther Canyon, levels in Spring Run 1 above and below Landa Park Drive, and flowing down Spring Run 2 towards the kiddie pool. In contrast, Figure 5 and 6 show conditions in Spring Run 1 downstream of Landa Park Drive and looking towards the kiddie pool in Spring Run 2 less than a week later, respectively. The flushing flows in spring runs 1 and 2 did a nice job of moving fine materials downstream while not ripping out aquatic vegetation or bryophytes. Thus, flushing flows in these areas created improved habitat conditions this week. Additionally, this was the first week since early summer that the entire Spring Run 1 channel was connected to the headwater springs via surface flow. This expanded the habitat for all Comal Springs surface dwelling invertebrates.

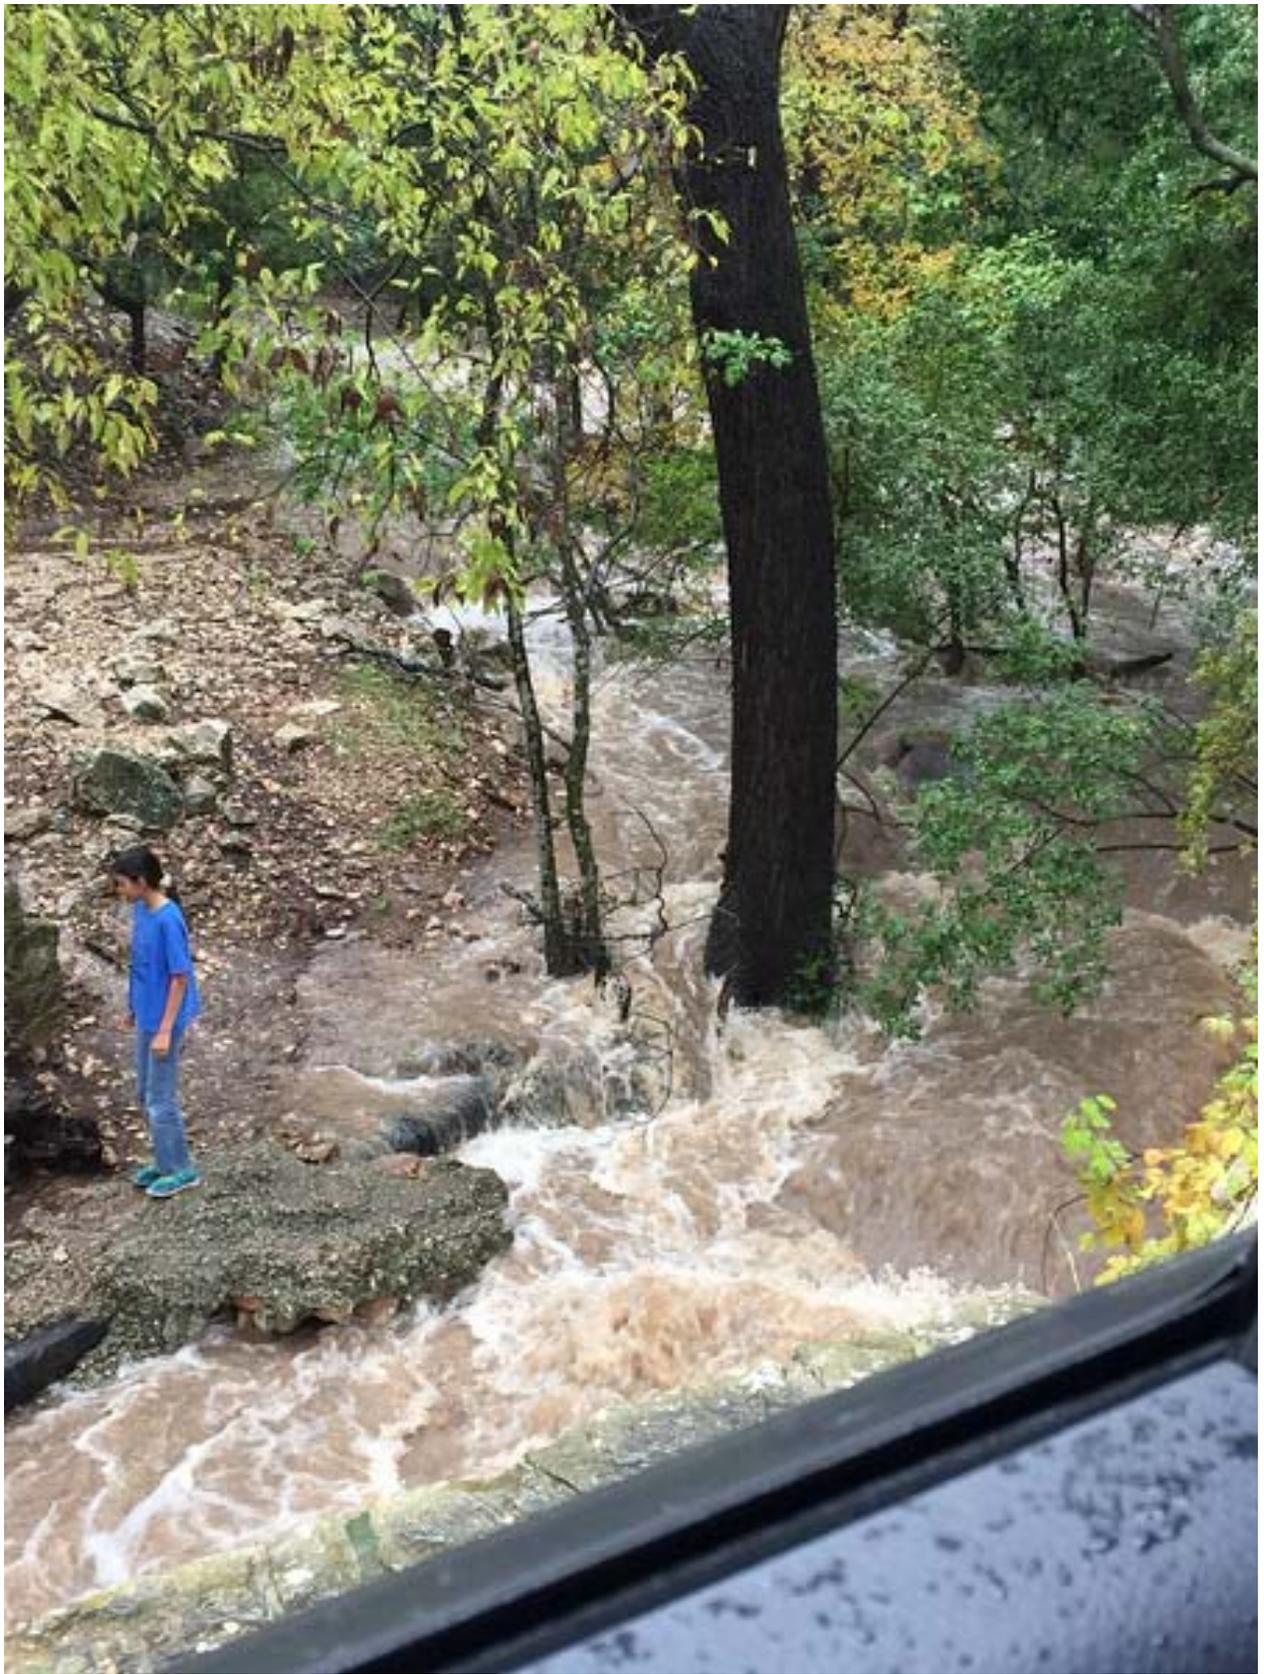
Figure 2: Water coming down Panther Canyon under the road towards Spring Run 2.

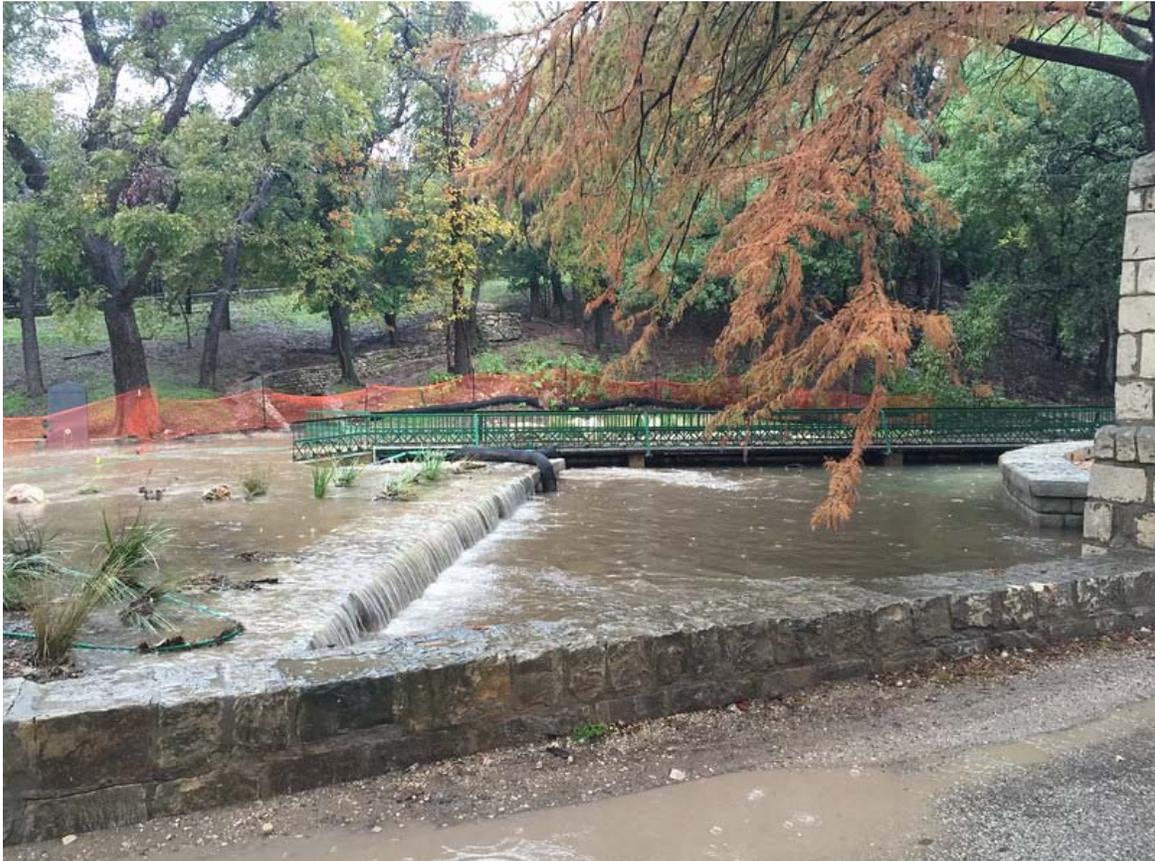
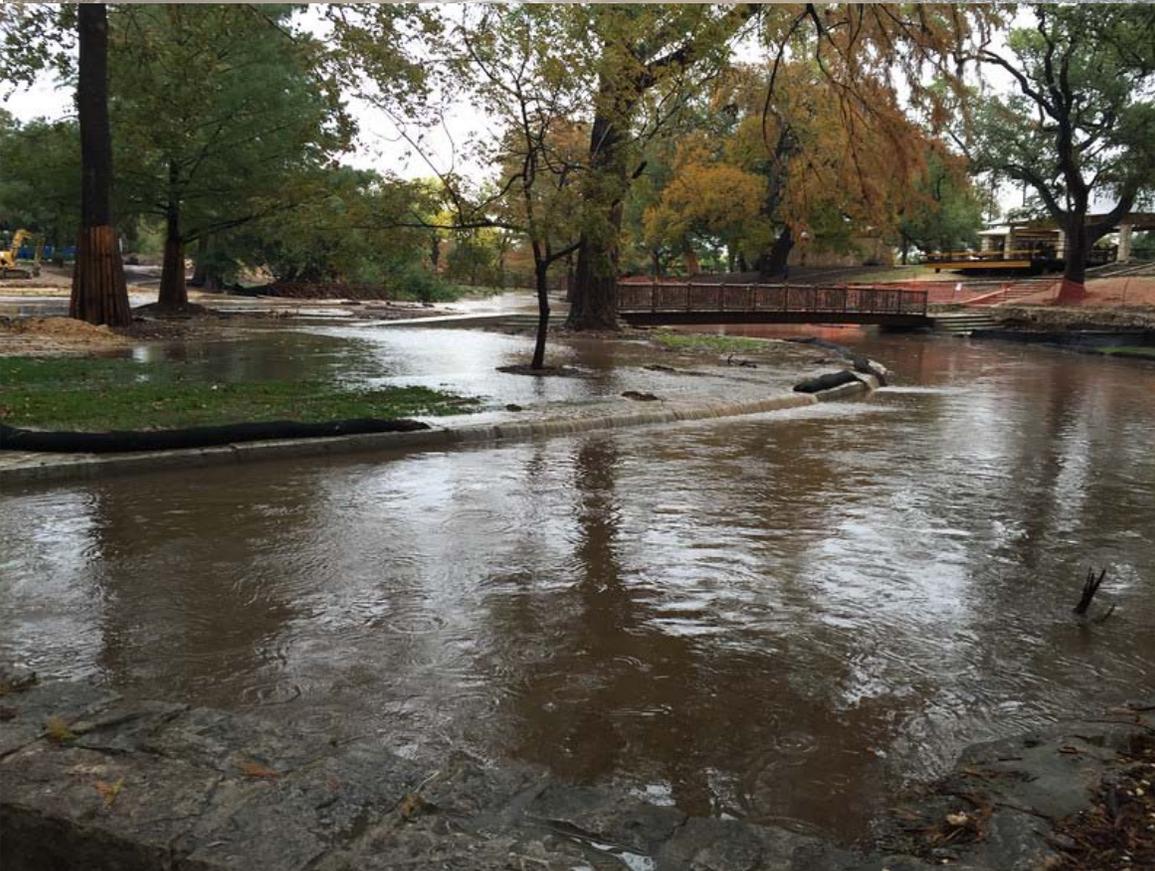
Figure 3: Spring Run 1 upstream (Top) and downstream (Bottom) of Landa Lake Drive during pulse event

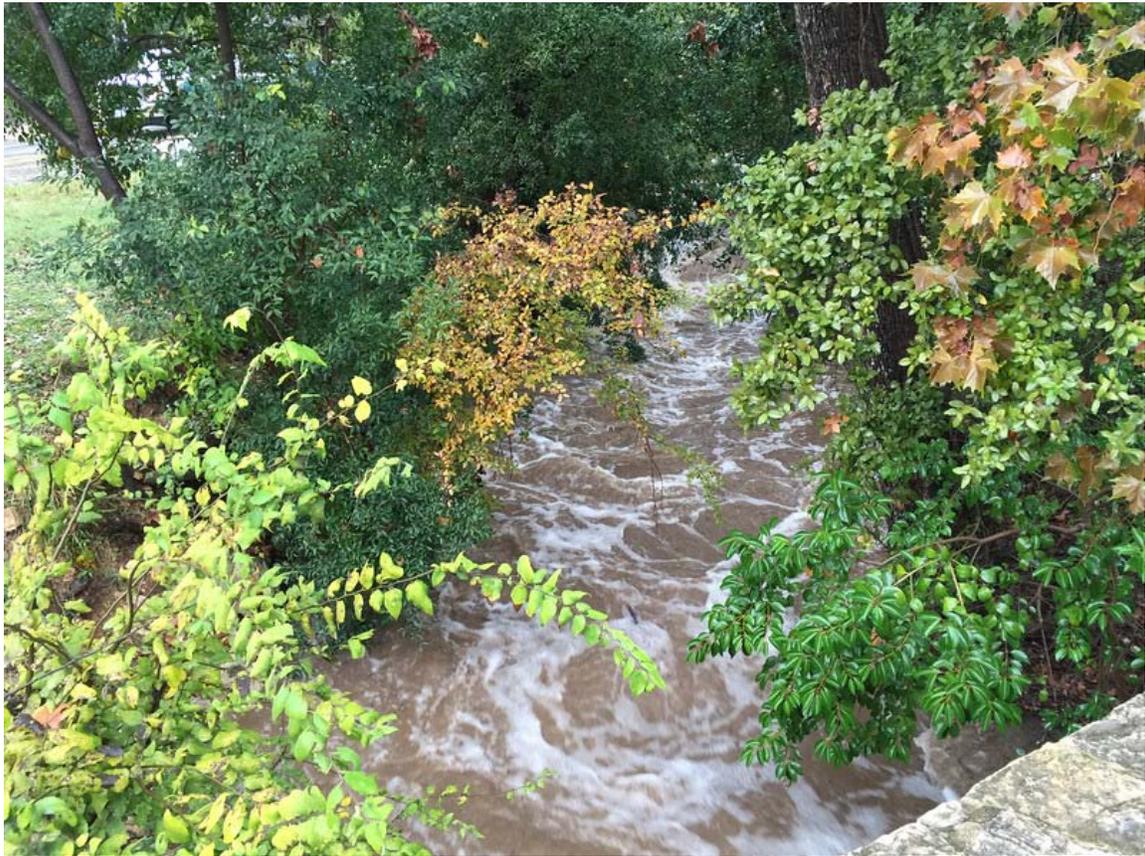
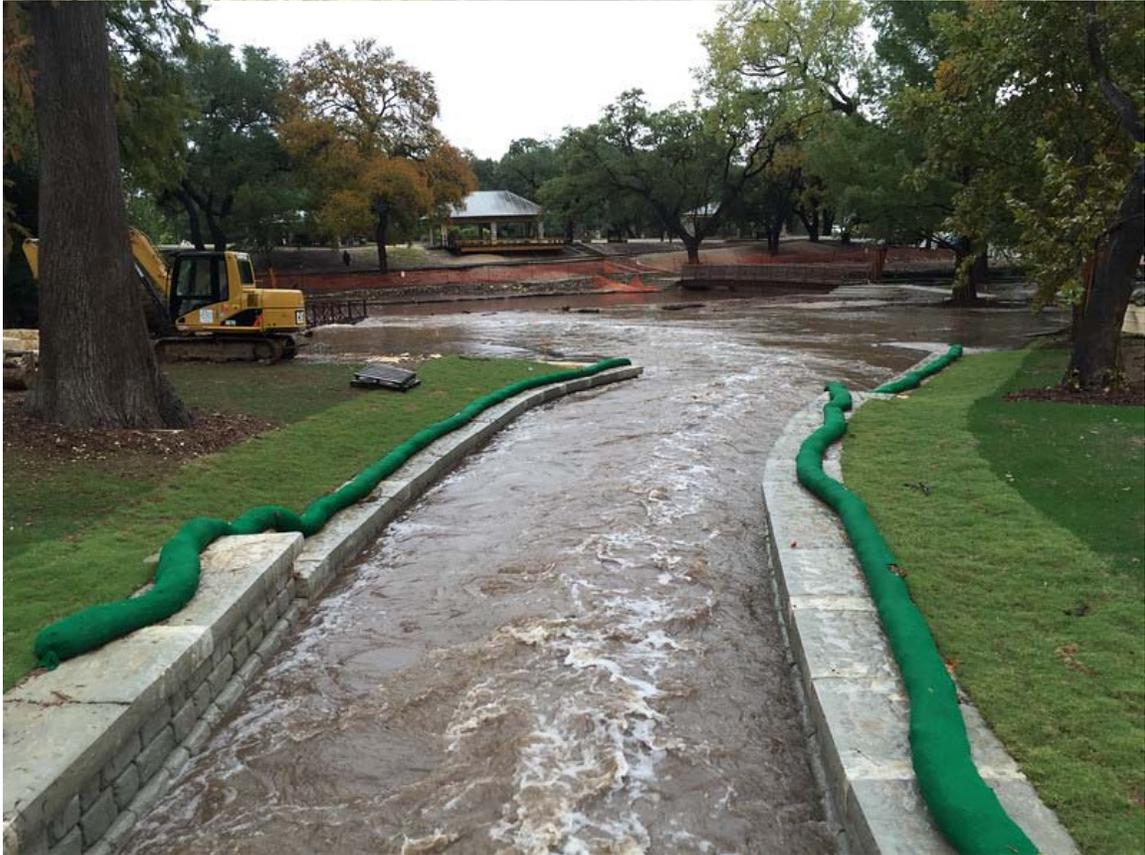
Figure 4: Spring Run 2 looking upstream (Top) and downstream (Bottom) from park entrance road.

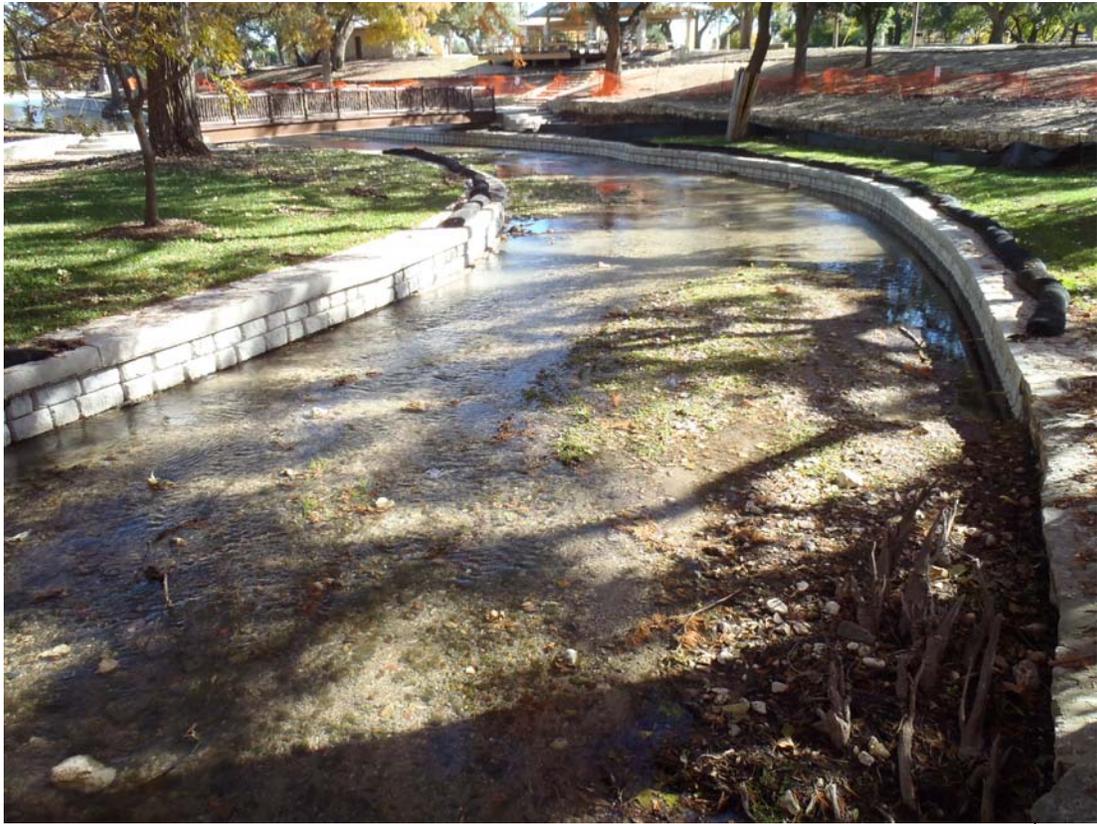
Figure 5: Spring Run 1 downstream of Landa Lake Drive on November 28th.

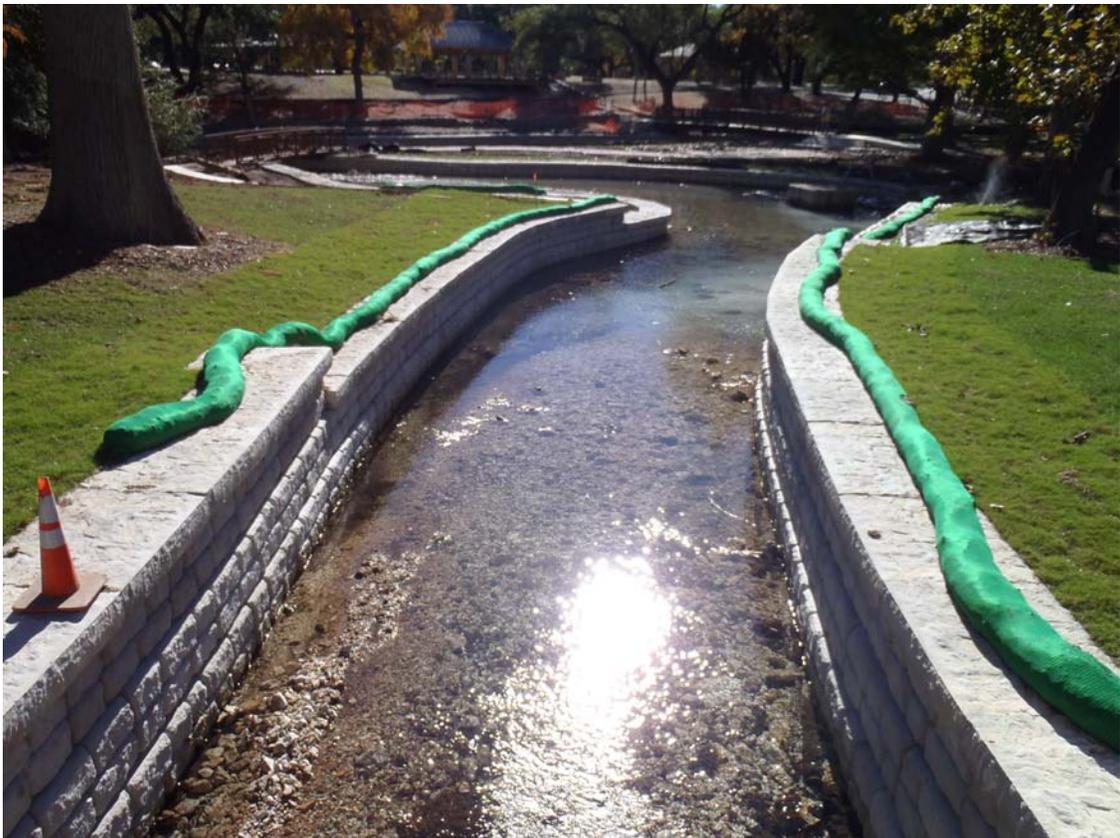
Figure 6: Spring Run 2 downstream towards kiddie pool on November 28th.

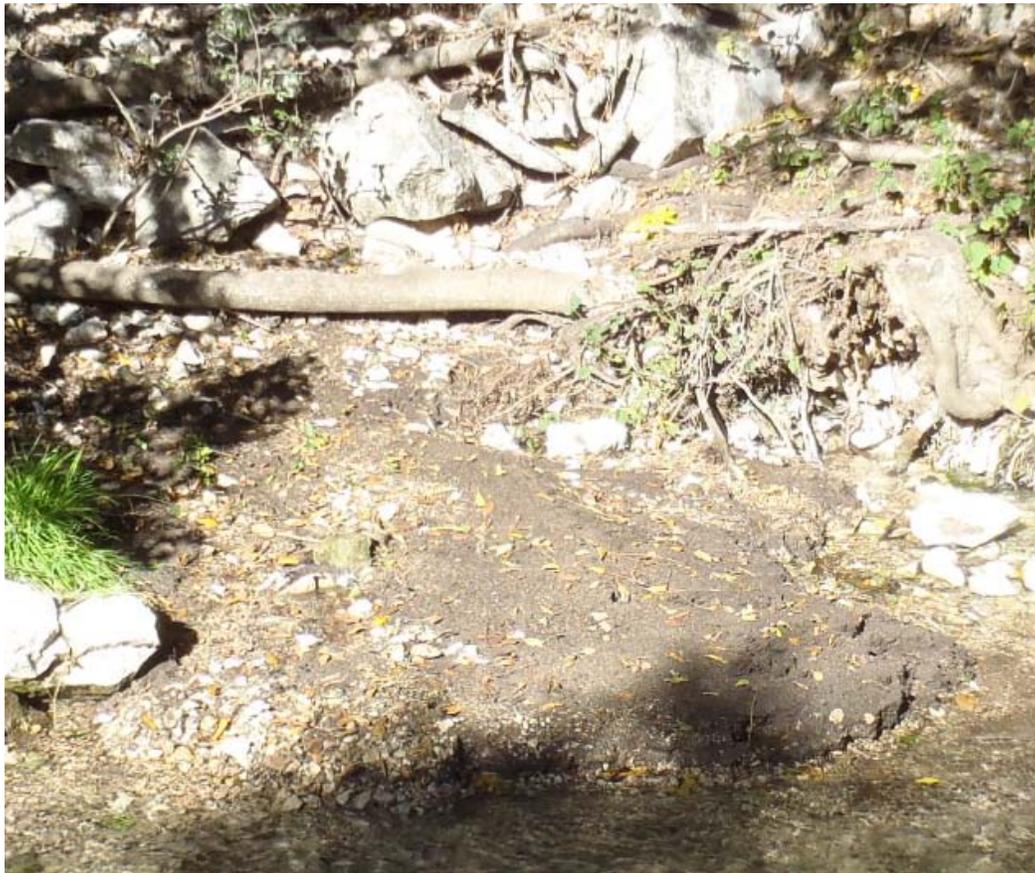
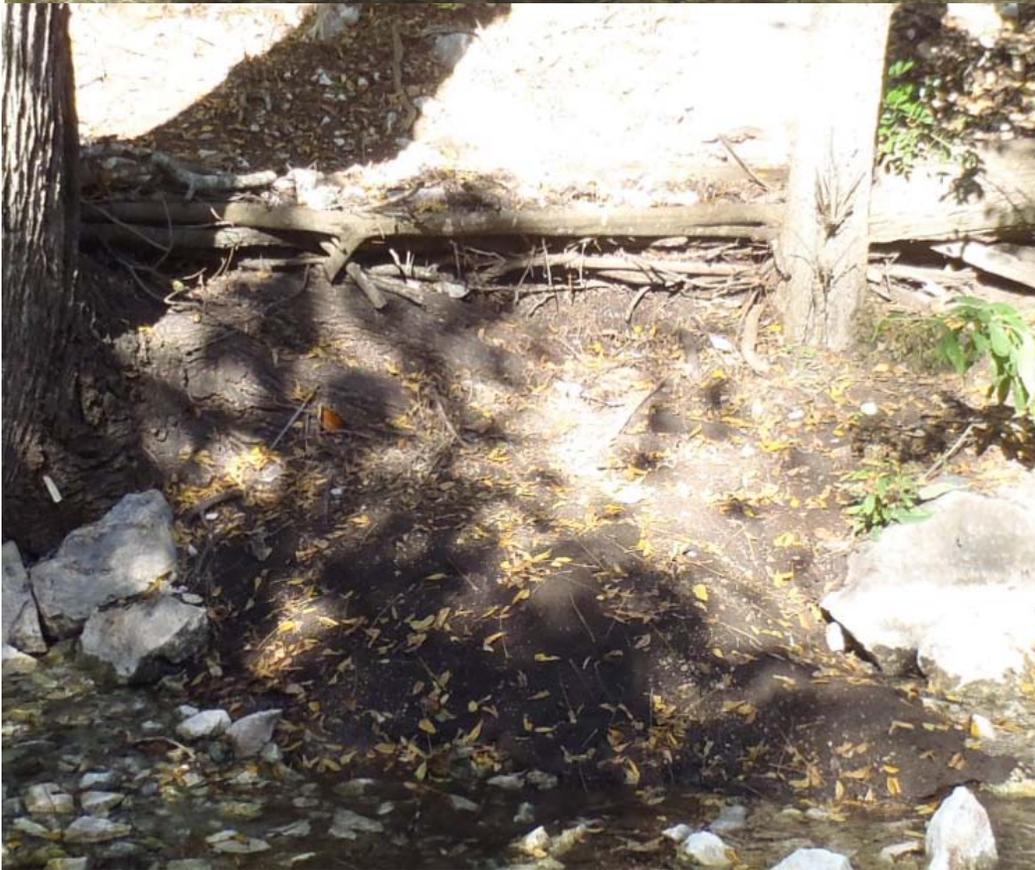
Conversely, the heavy rainfall event last weekend caused a considerable amount of sediment to enter Spring Run 3 from the adjacent hillside. Figure 7 documents piles of excessive sediment that made its way through or over the erosion control structures and into or at water's edge in Spring Run 3. However, overall the erosion control structures captured a lot of sediment preventing it from entering Spring Run 3 (Figure 8). In our opinion these structures are a valuable HCP mitigation measure for just such rainfall events. Several of these structures will require maintenance and sediment removal prior to the next storm event to maintain their continued effectiveness. With the increase in discharge, lateral connectivity was also expanded in Spring Run 3 creating more available surface habitat than in previous months even with the sedimentation occurring from the heavy rains.

Figure 7: Spring Run 3 breaches of control zones and sediment build-up.

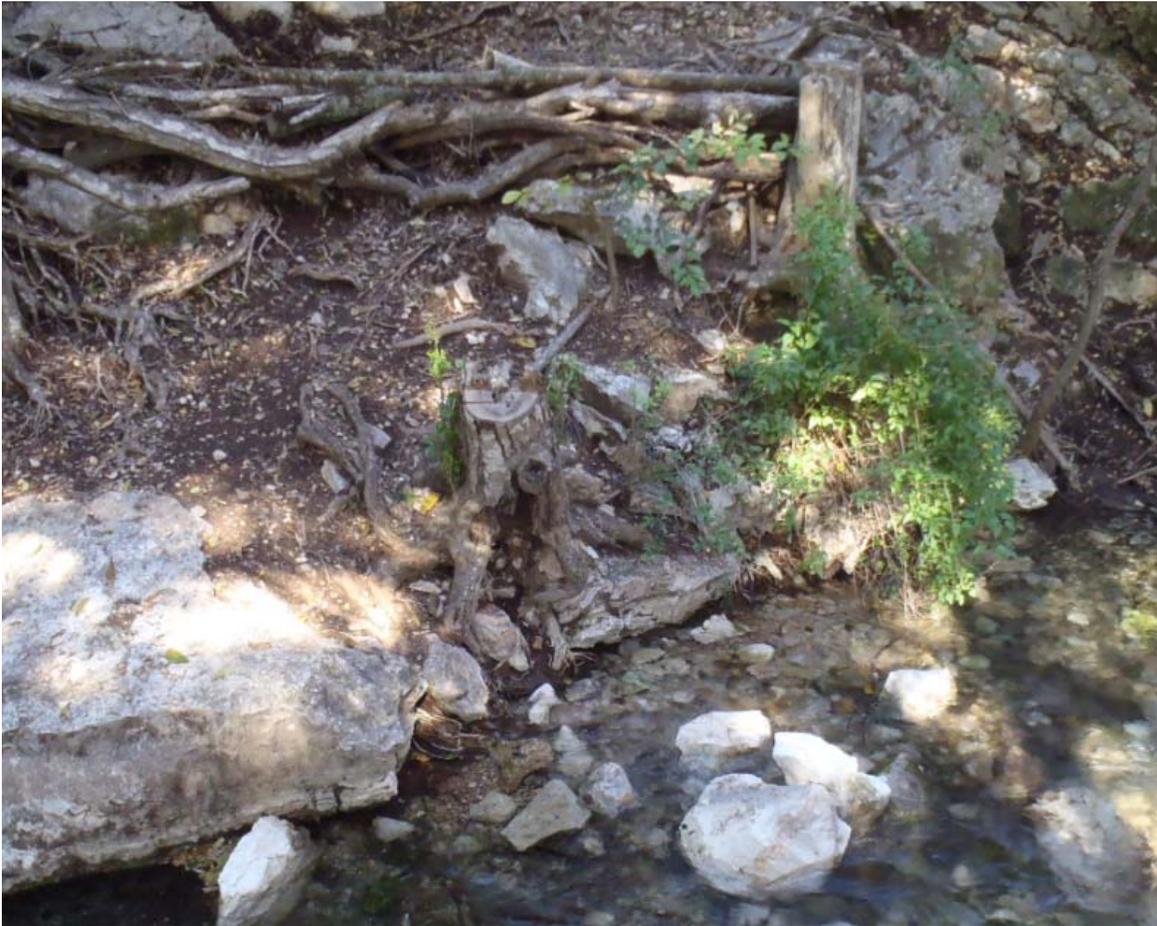
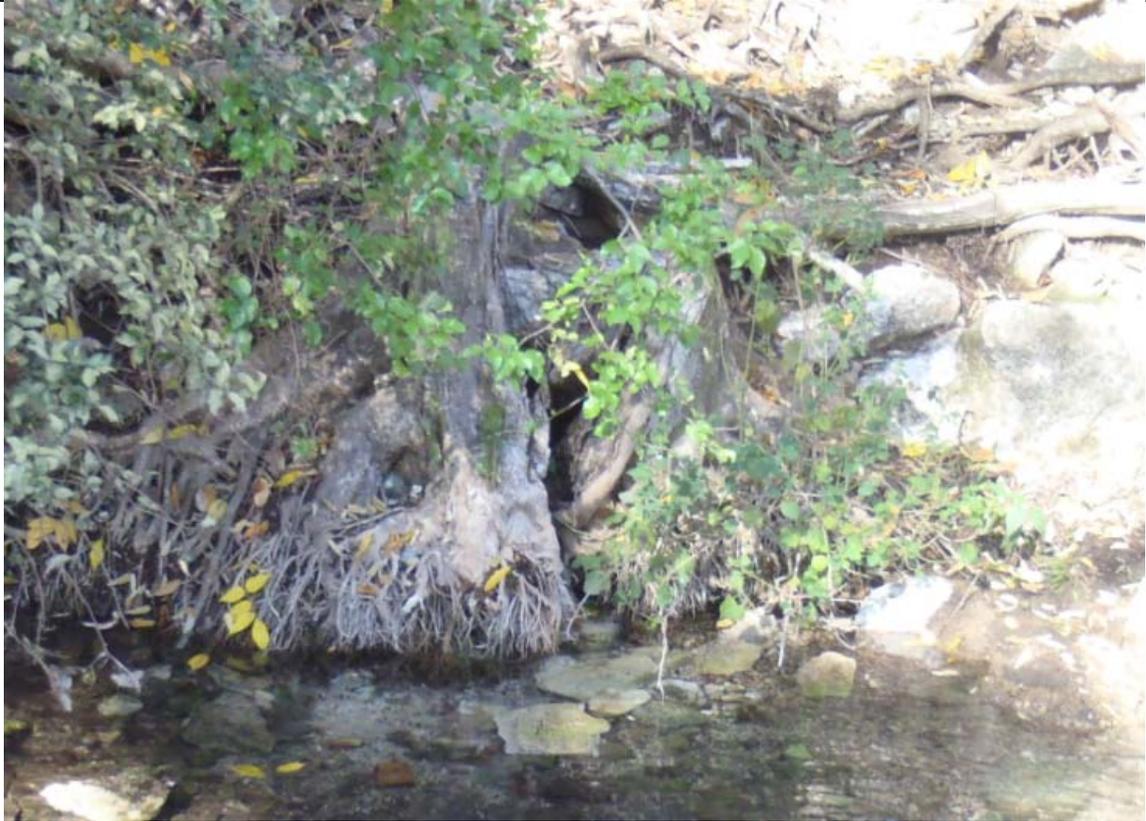
Figure 8: Spring Run 3 erosion control structures that worked great above key beetle habitat.

It is always exciting to get a natural test of HCP mitigation/restoration projects to judge their benefit. The amount of sediment captured by the erosion control structures along Spring Run 3 was impressive and protected several key riffle beetle habitat areas. Additionally, this event provided a great lesson on how to improve upon the work currently being done in that area. It was also extremely encouraging to see the response of the native aquatic vegetation that was established in Old Channel restoration areas with a design that was intended to withstand high water levels and rushing flows in the Old Channel. For the most part, even though tree stumps were moved (Figure 14), the restoration areas in both Landa Lake and the Old Channel were unscathed.

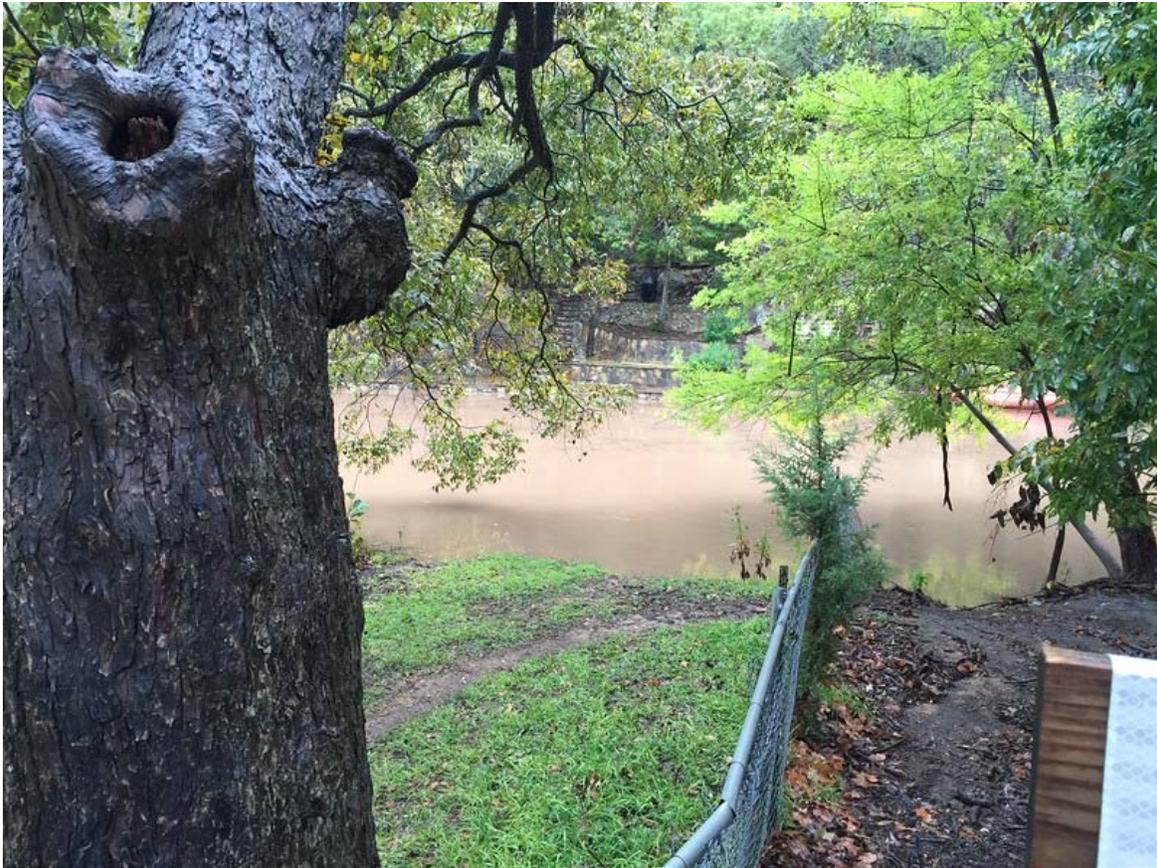
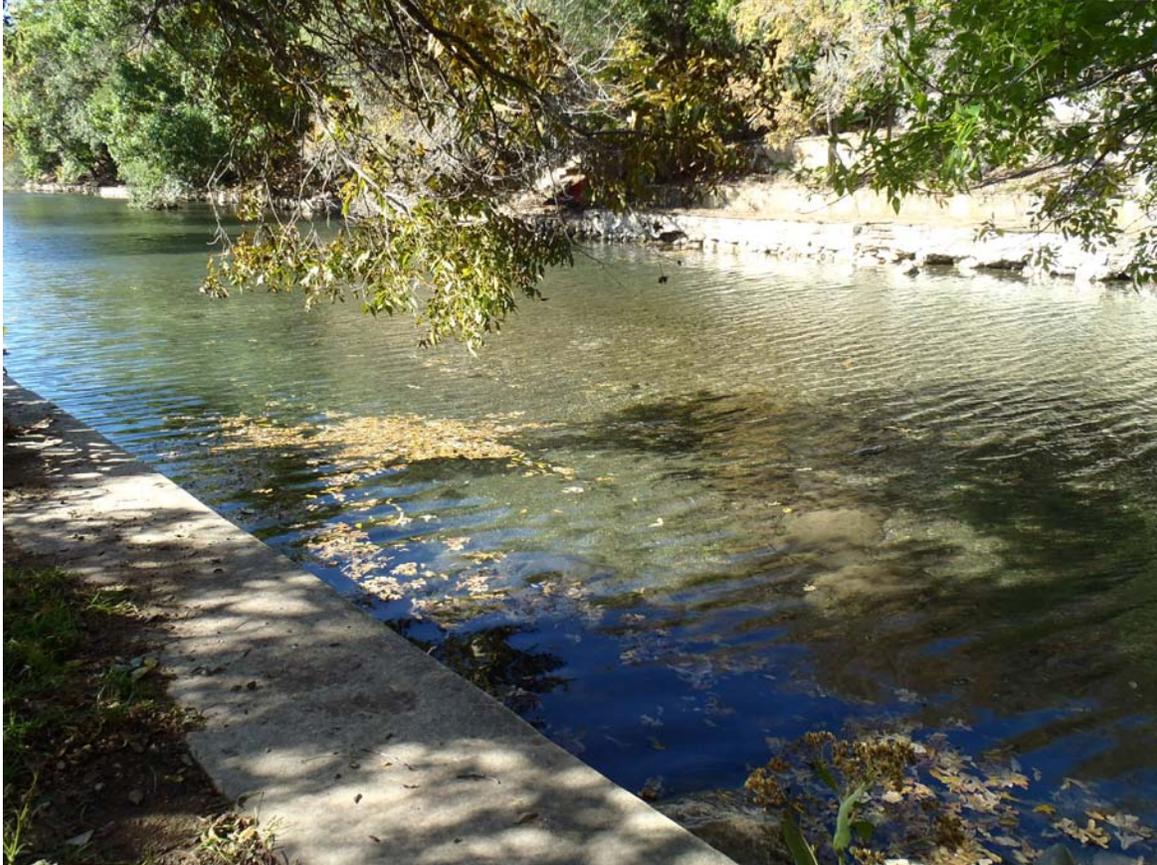
The heavy rains and flash flooding this past weekend caused Blieders Creek to run over the road and cause a pulse of water through the Upper Spring Run reach towards Spring Island. Figure 9 shows the Upper Spring Run reach during the pulse event and this past Wednesday. Figure 10 shows the same sequence for Spring Run 5 which is adjacent to this upper reach. Following the recession of water in these areas it was evident that a nice scour of algae and fine materials occurred and rooted macrophytes were still in place. The pulse of water from Blieders Creek and localized runoff caused turbid conditions in the Spring Island area along with temporarily increased water levels (Figure 11). However, turbidity quickly gave way to clear water and water levels were back to where surface habitat was again exposed as shown in Figure 11. As observed in the Upper Spring Run reach, this pulse flow caused a nice scour of algae and fine sediments in the Spring Island area while leaving bryophytes intact (Figure 12).

Figure 9: Upper Spring Run reach during pulse (Top) and last Wednesday (Bottom).

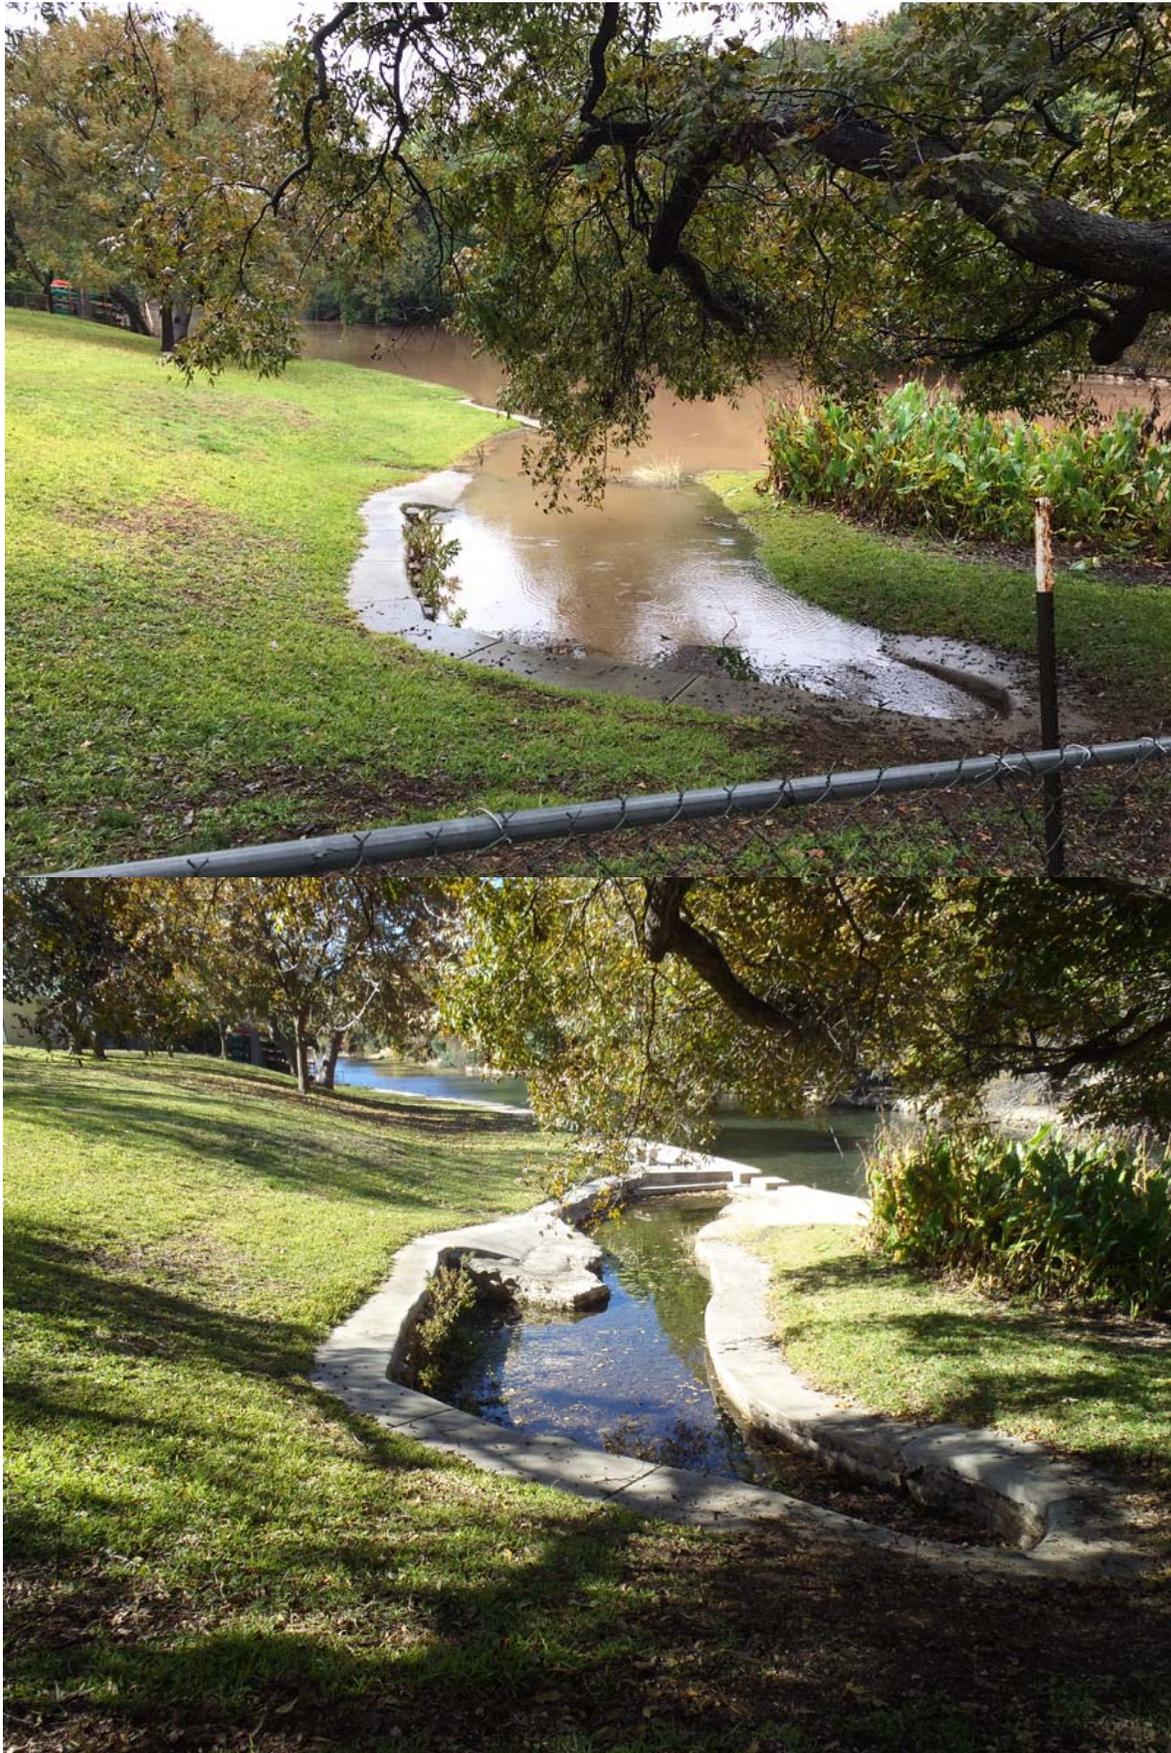
Figure 10: Spring Run 5 during pulse (Top) and last Wednesday (Bottom).

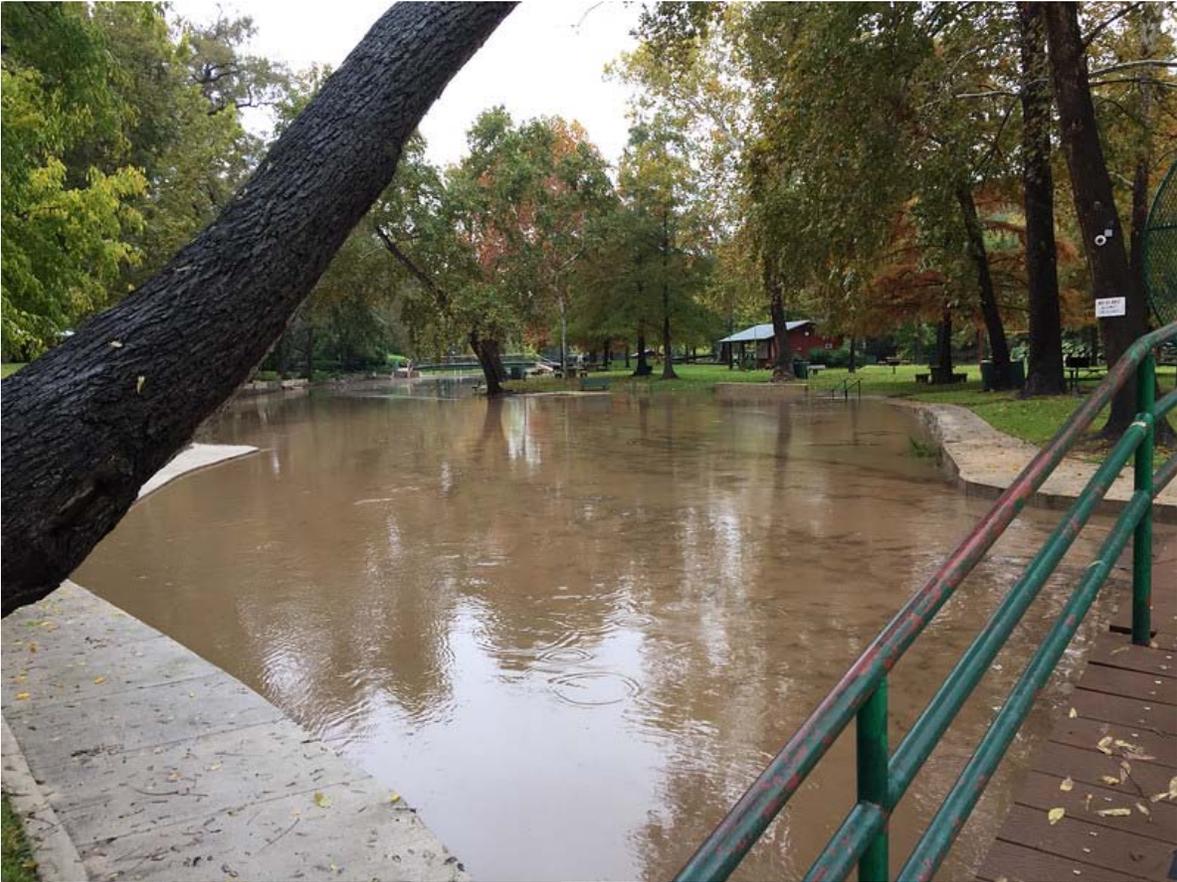
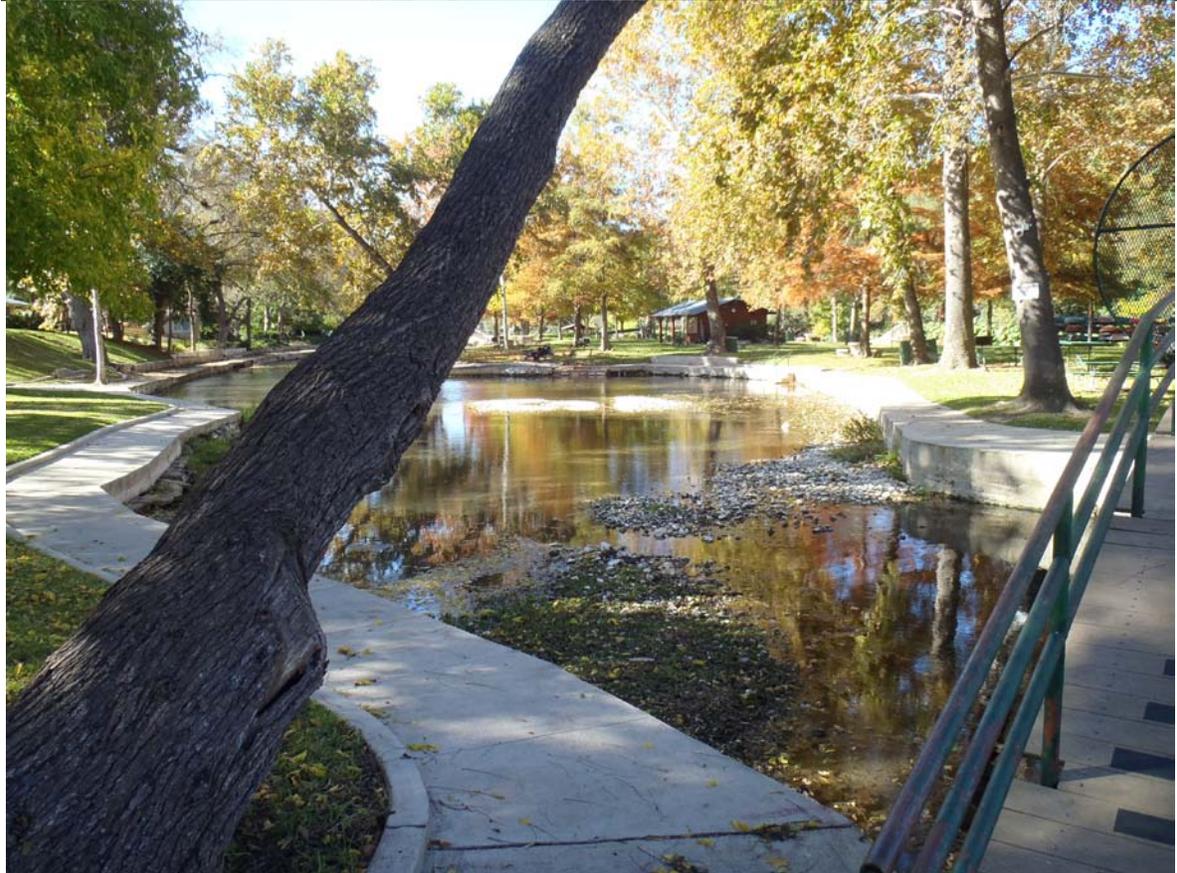
Figure 11: Eastern outfall of Spring Island during pulse (Top) and last Wednesday (Bottom).

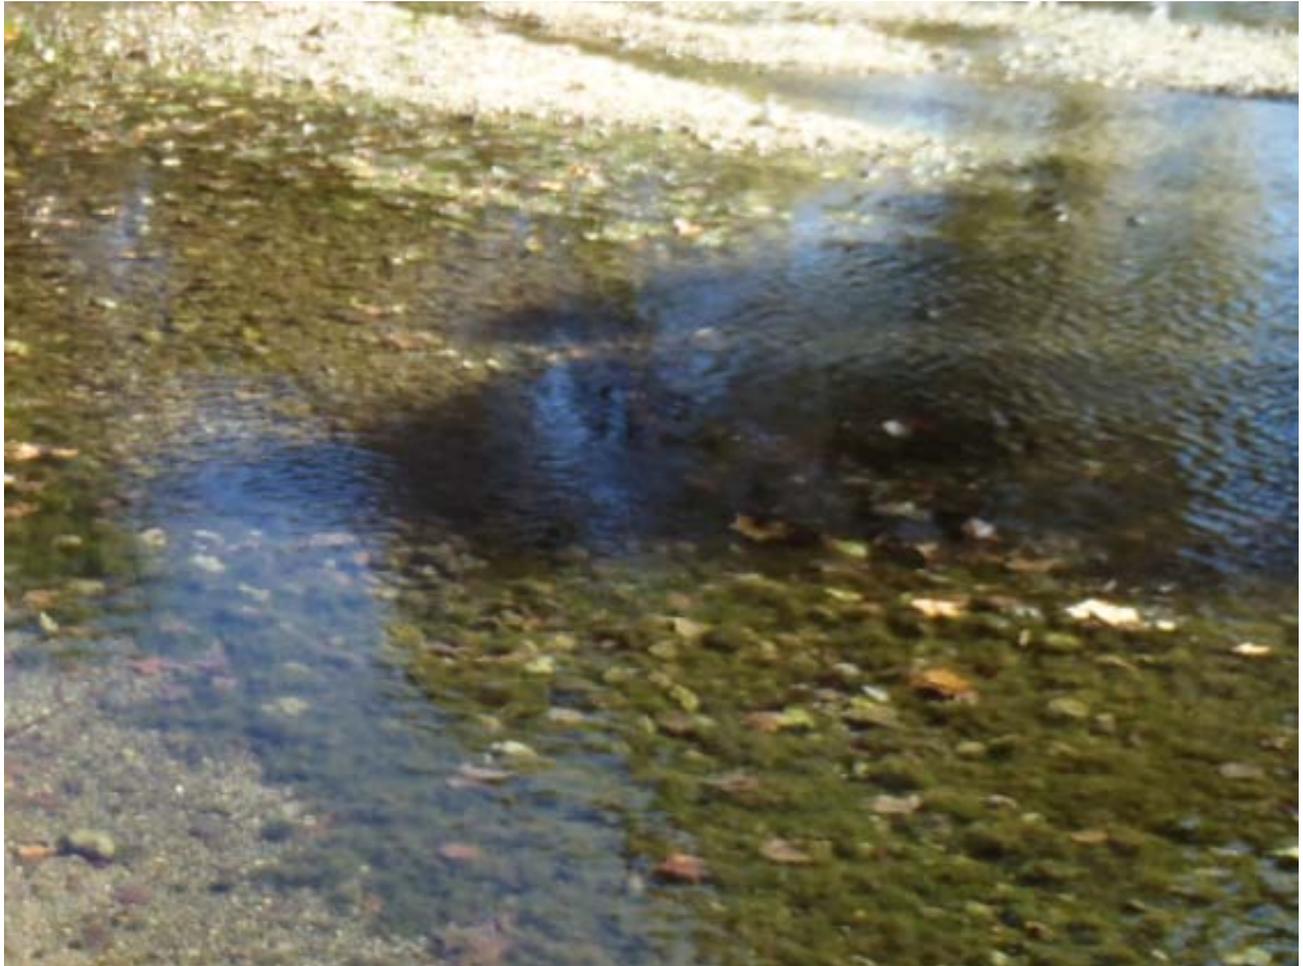
Figure 12: Healthy bryophytes intact following pulse in the Eastern outfall of Spring Island.
