MEMORANDUM

TO: Nathan Pence
FROM: Ed Oborny (BIO-WEST)
DATE: **November 28, 2014**
SUBJECT: EA HCP Biological Monitoring – **Week 33**

COMAL SPRINGS/RIVER - WEEK 33 CONDITIONS:

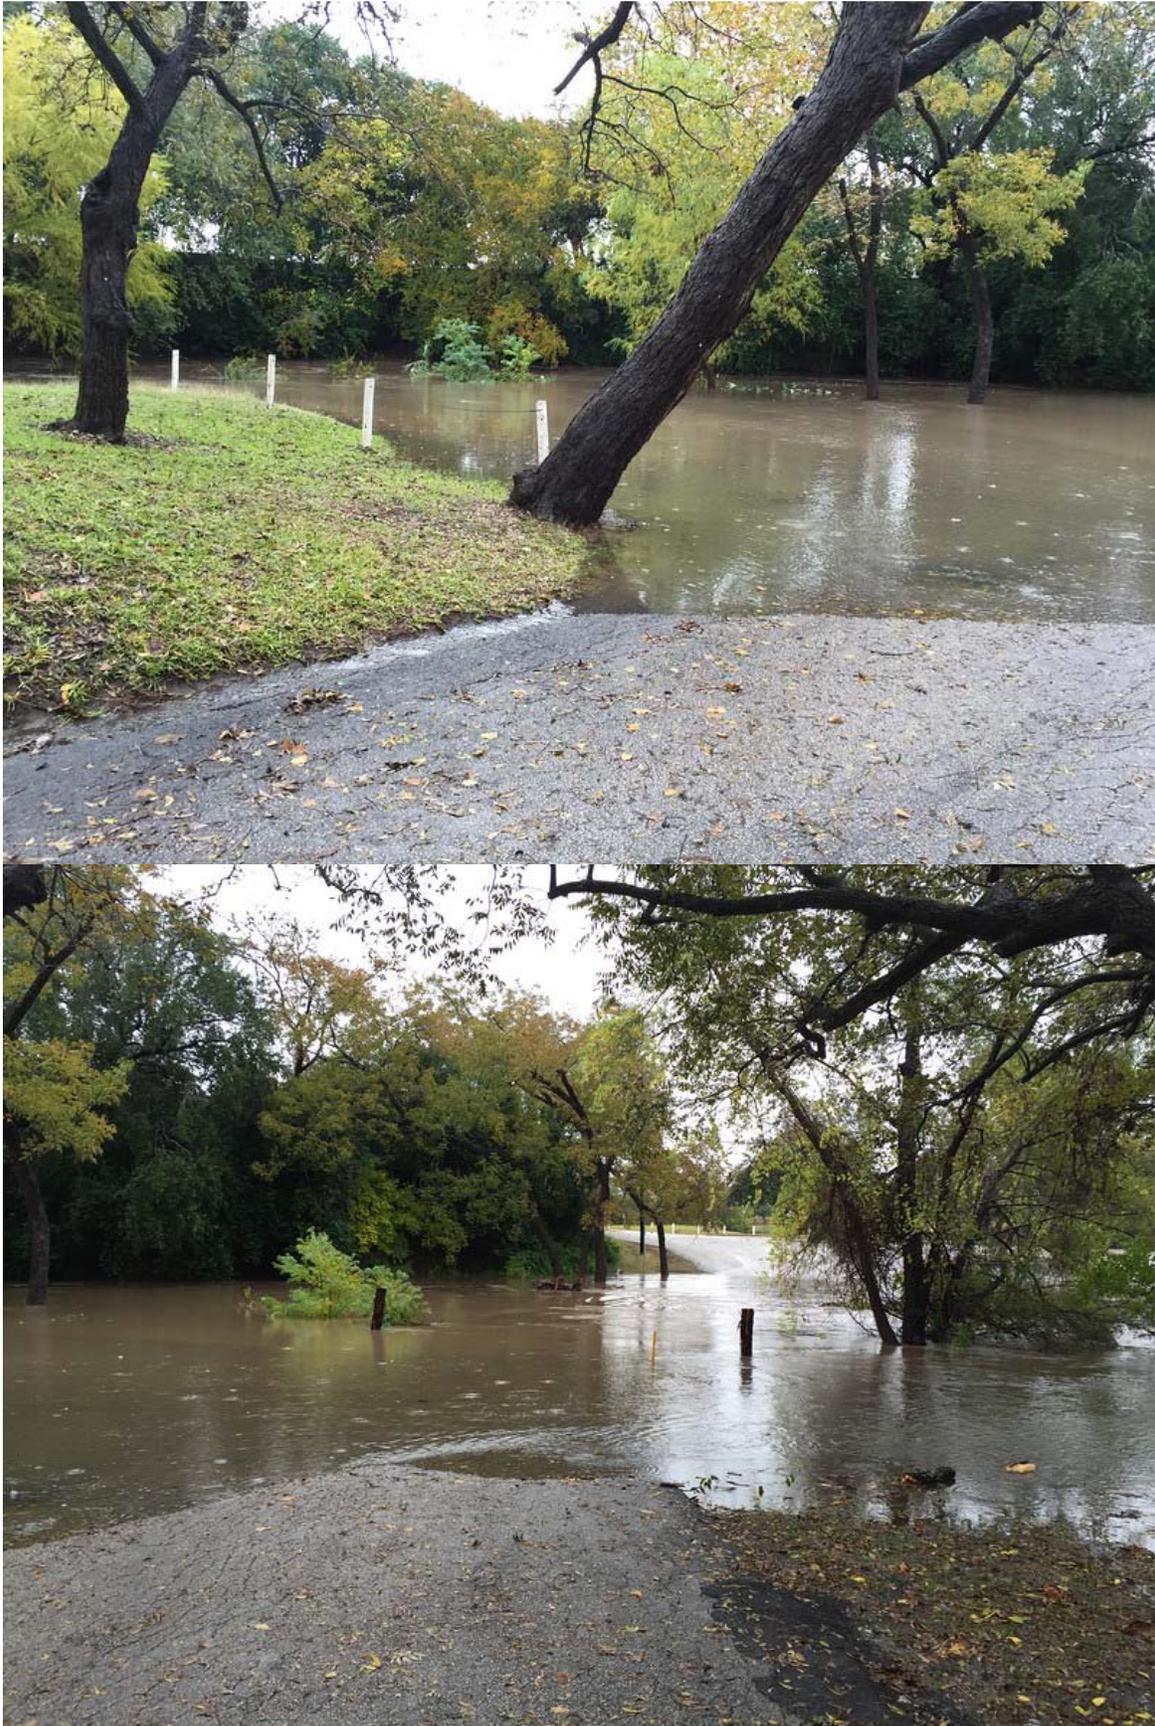
Figure 13: Old Channel Restored Native Vegetation area at Golf Course Road during pulse.

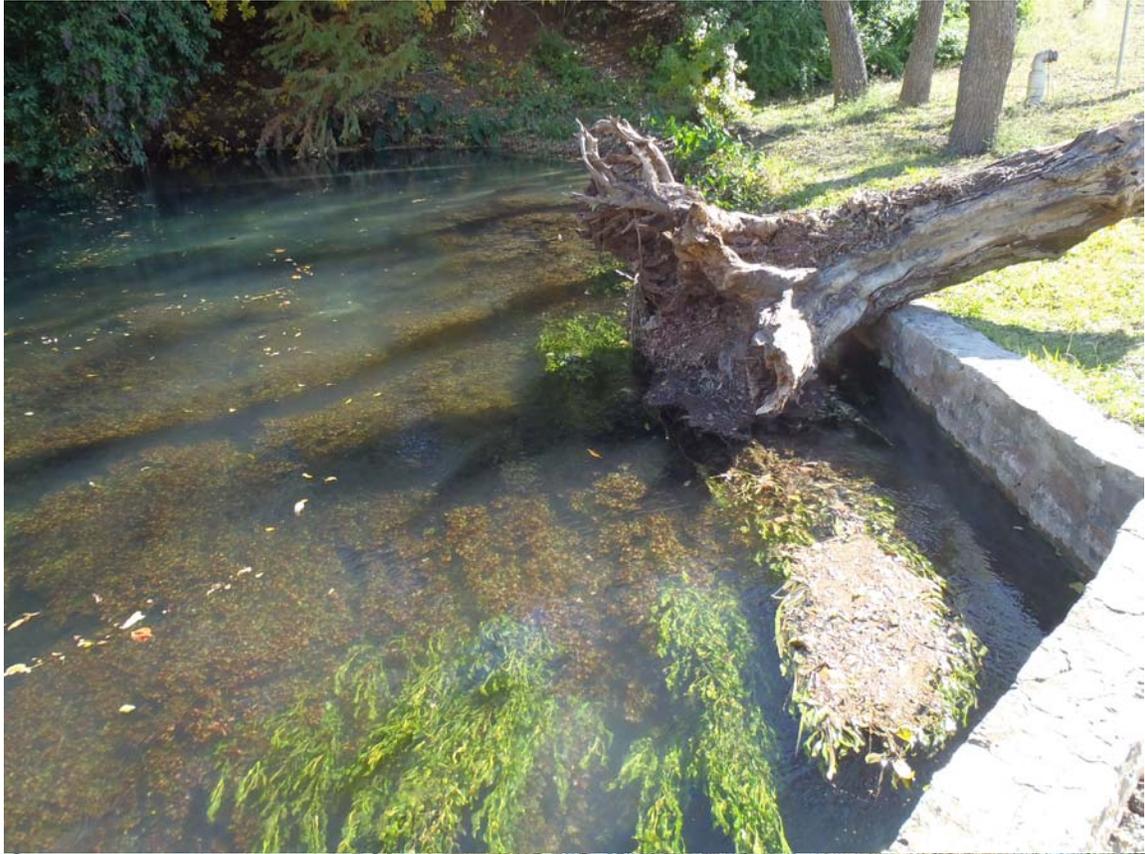
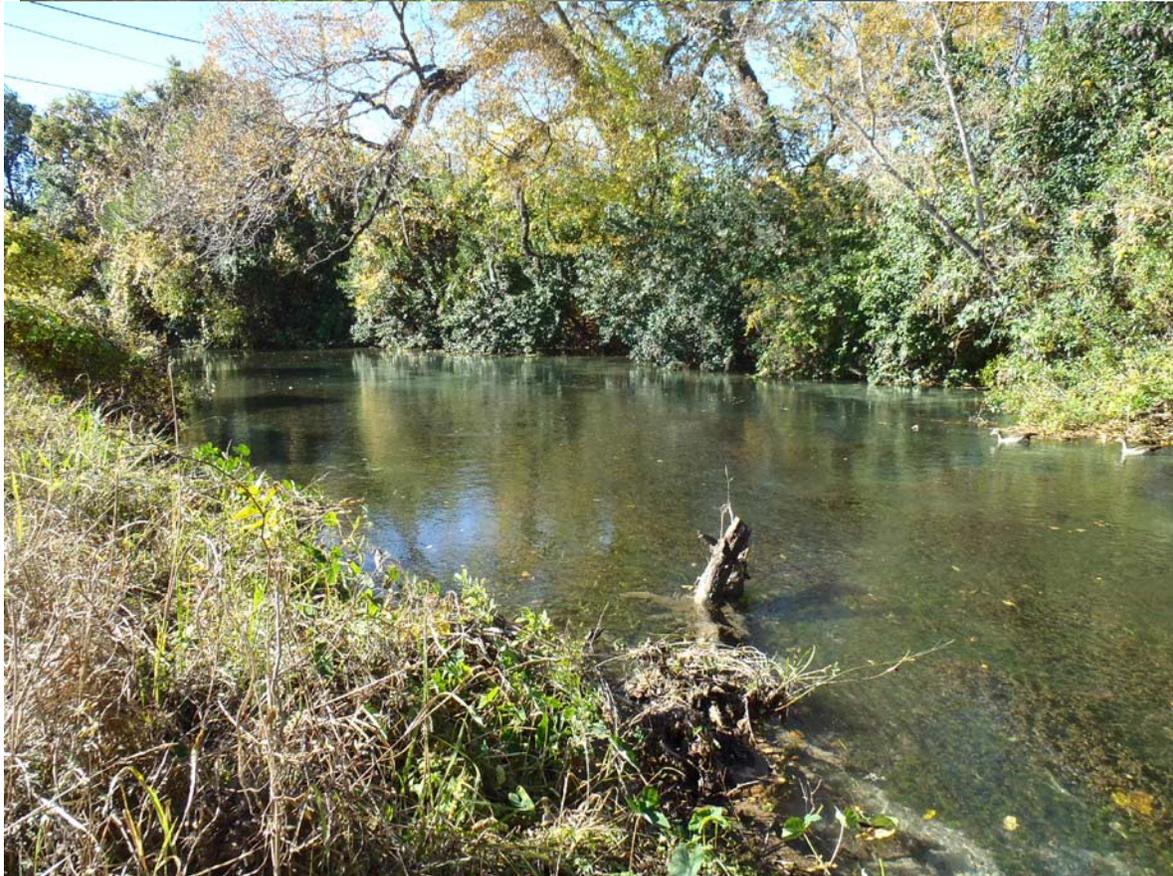
Figure 14: Old Channel Restored Native Vegetation area at Golf Course Road (Top) and just downstream (Bottom) on Wednesday.

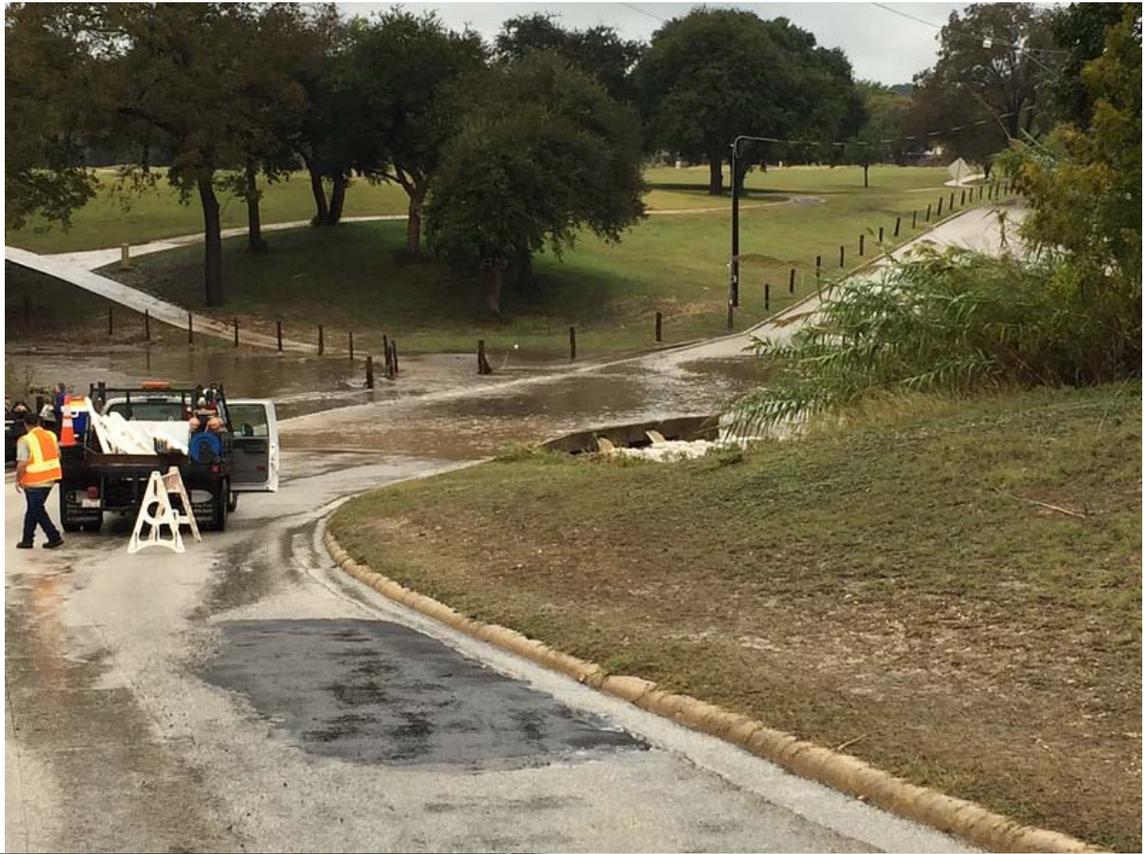
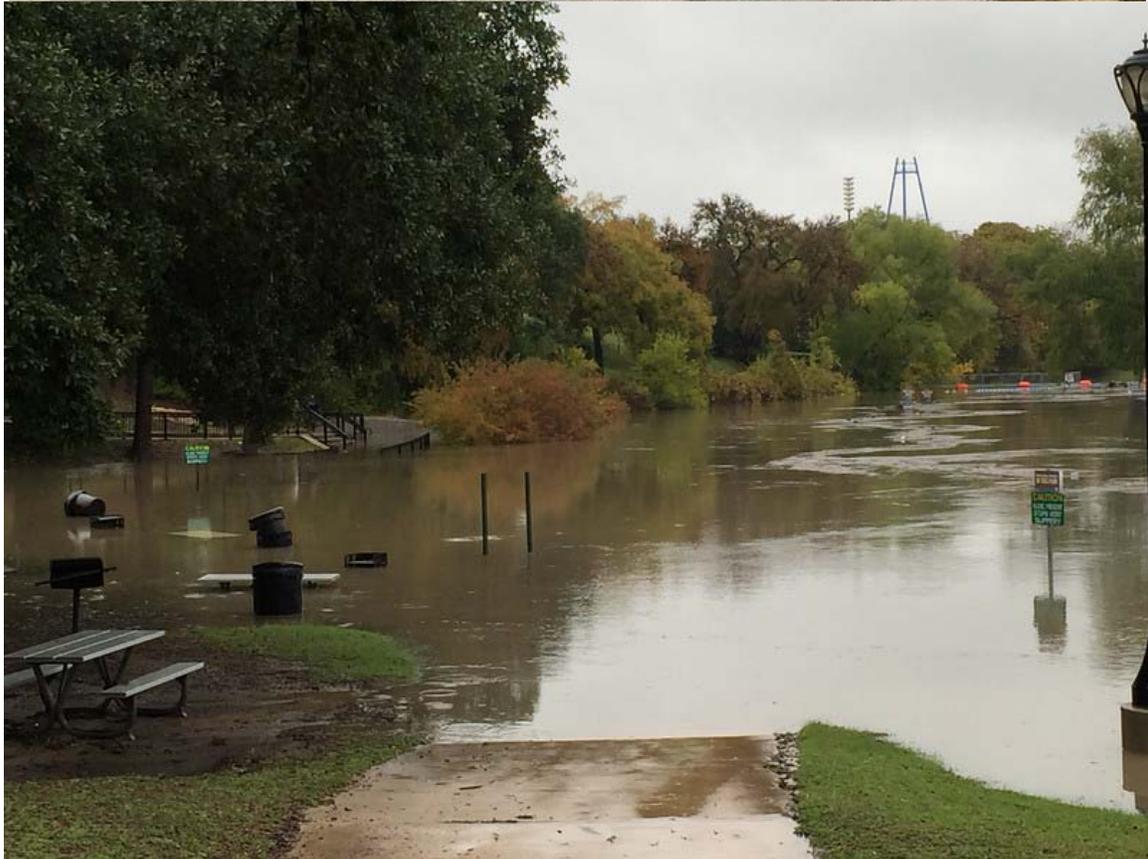
Further downstream in the Old Channel water was over the road at Elizabeth street and a muddy mess at the confluence of the Old and New Channels (Figure 15). However, on Wednesday when turbidity had settled, it appears the majority of aquatic vegetation in the New Channel study reach (albeit slightly trimmed and thinned) survived (Figure 16).

Figure 15: Old Channel over Elizabeth Street (Top) and over trash cans and sidewalks at the confluence of the Old and New Channels to the Comal River (Bottom).

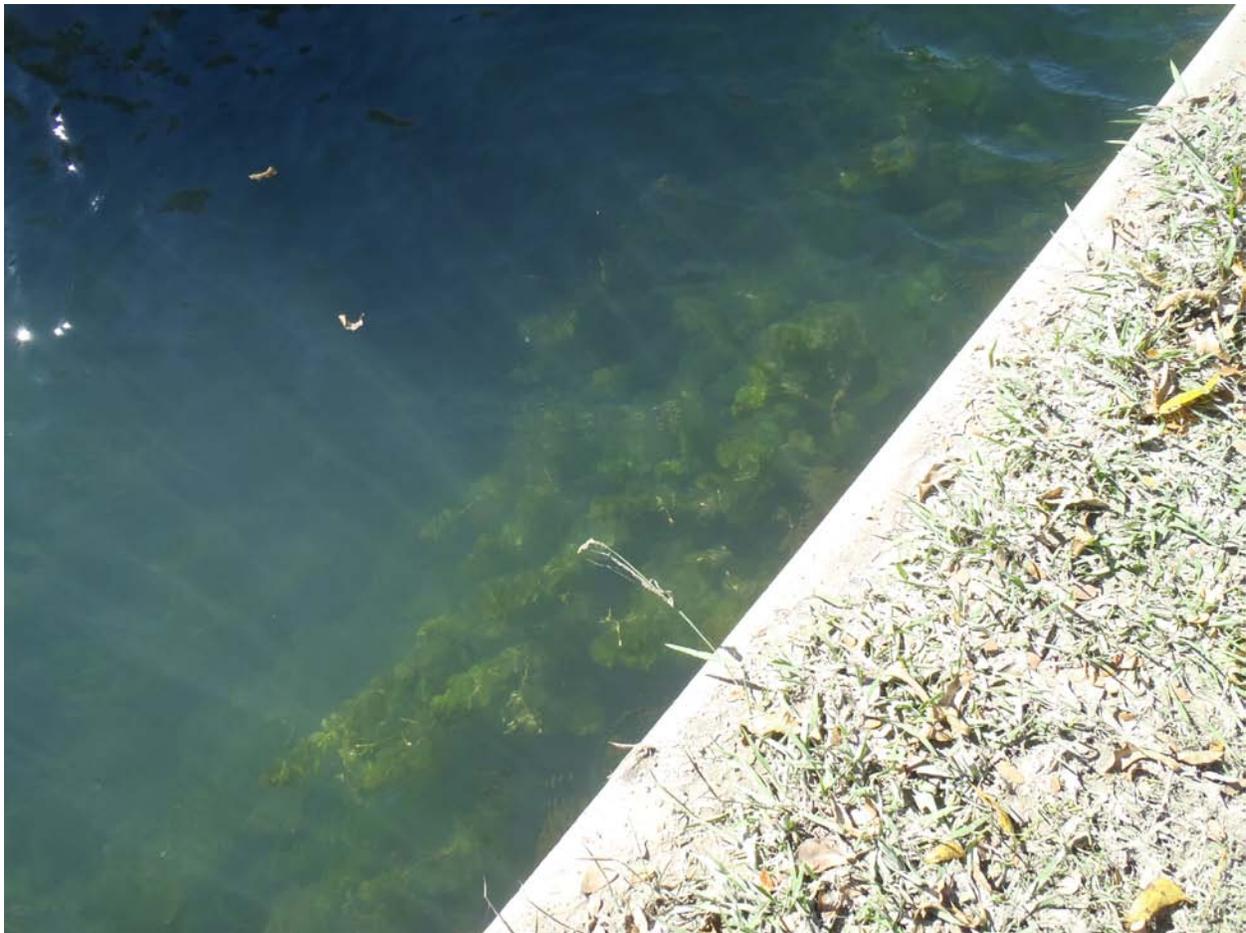
Figure 16: Aquatic Vegetation survived the pulse in the New Channel study reach.
