Appendix H | 2023 City of New Braunfels Reports

Appendix H1 | **Native Aquatic Vegetation Restoration in the Comal River System**

2023 Native Aquatic Vegetation Restoration and Maintenance in the Comal River

**BIO-WEST, Inc.
1812 Central Commerce Court
Round Rock, Texas 78664**

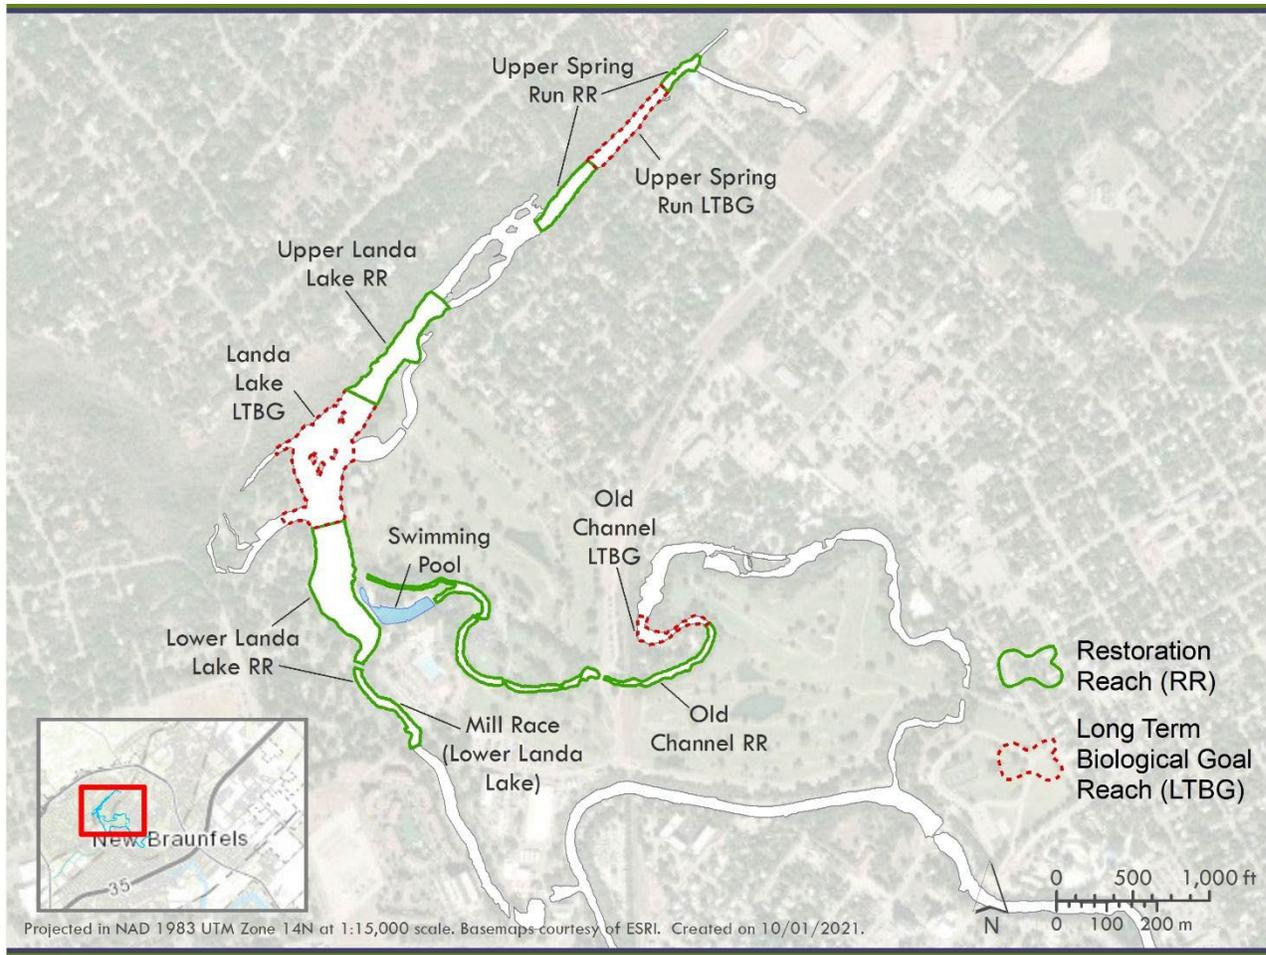
Figure 1 Location of the Landa Lake, Upper Spring Run and Old Channel Long Term Biological Goal (LTBG) Reaches (outlined in red). Green outlines the restoration areas.

The project area covers the upper two kilometers of the Comal River but is divided into multiple Restoration and Long Term Biological Goal (LTBG) Reaches (**Figure 1**). LTBG Reaches are the sampling sites in which routine biological monitoring is conducted. Fountain Darter sampling, water quality, discharge and various other data are collected specifically in the LTBG Reaches to support the HCP long-term monitoring program. The Restoration Reaches are included to expand restoration and habitat improvement in the system. The project area encompasses Blieders Creek through a spring run channel, referred to as Upper Spring Run, into lower Landa Lake. The project area also extends into the Old Channel and downstream approximately 1,100 meters from Landa Lake Dam. Each project reach has its own restoration timeline and goals as directed by annual work plans provided by the City of New Braunfels.

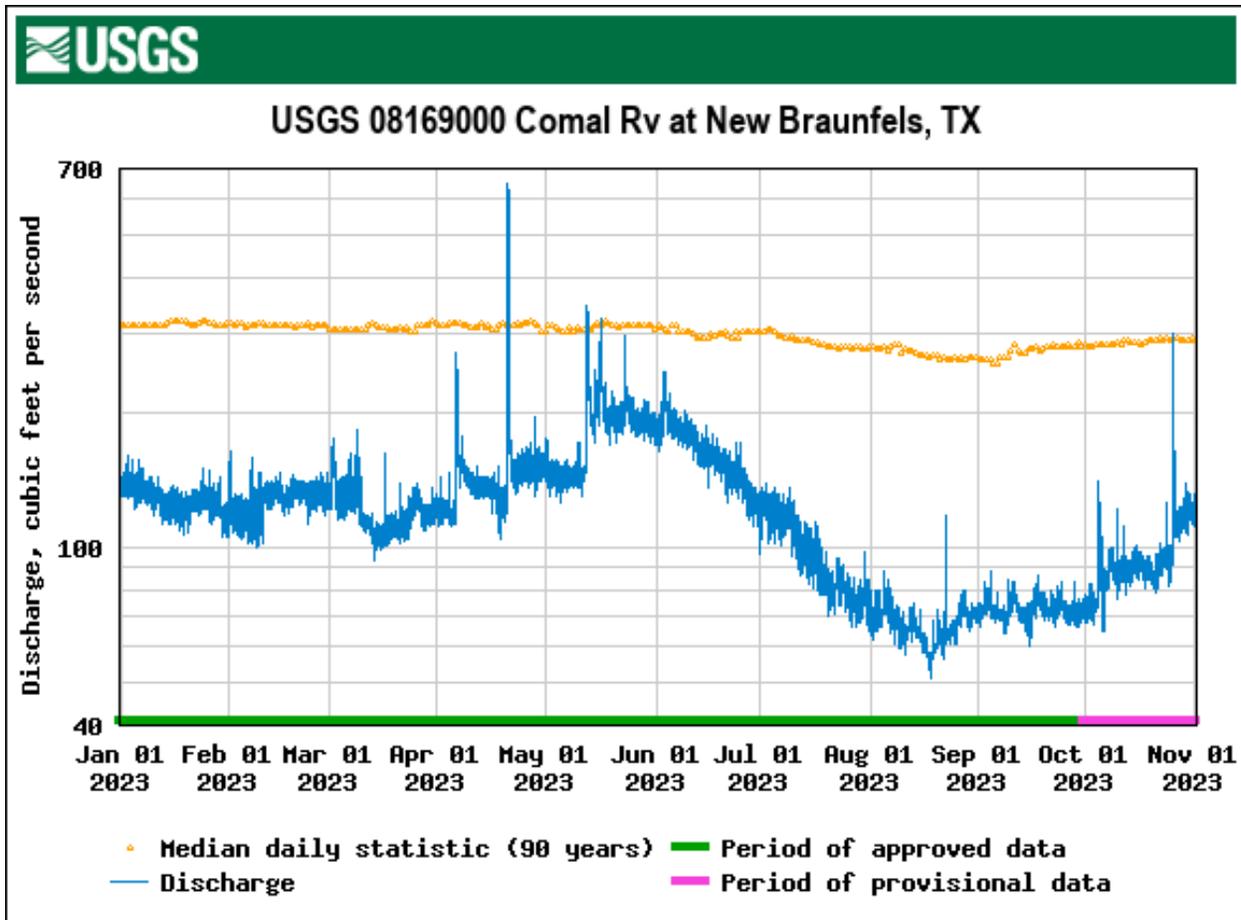
Figure 2 Discharge in the Comal River from January through November 2023 (USGS 2023).

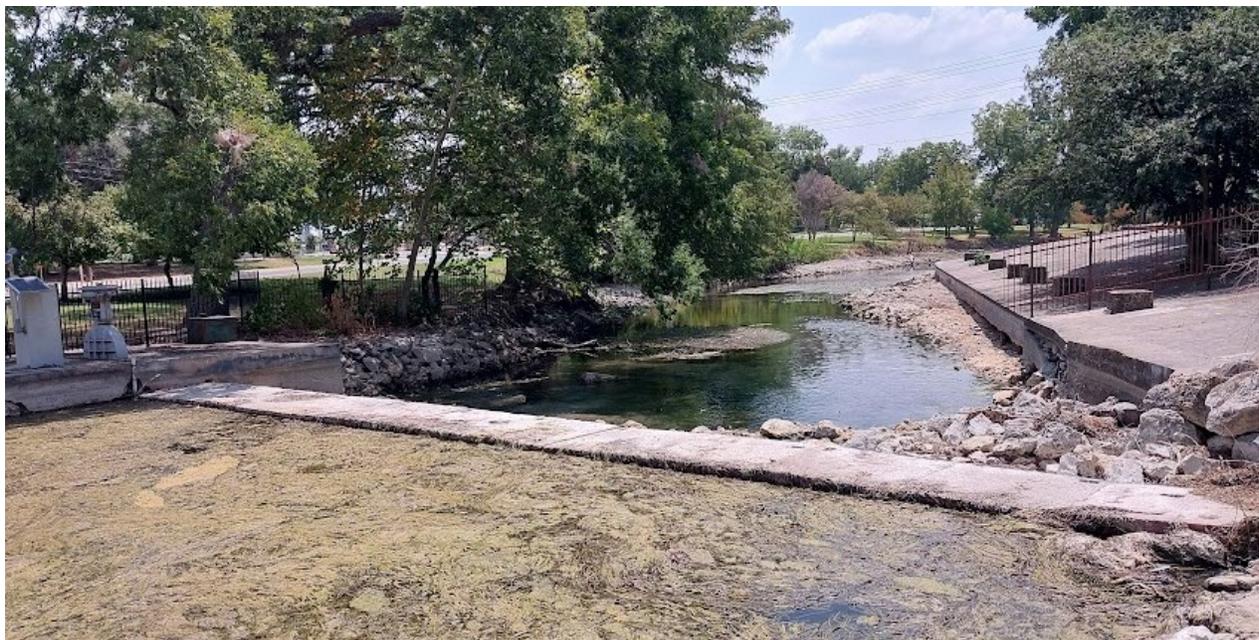
Figure 3 The New Channel stopped flowing at the weir in August.

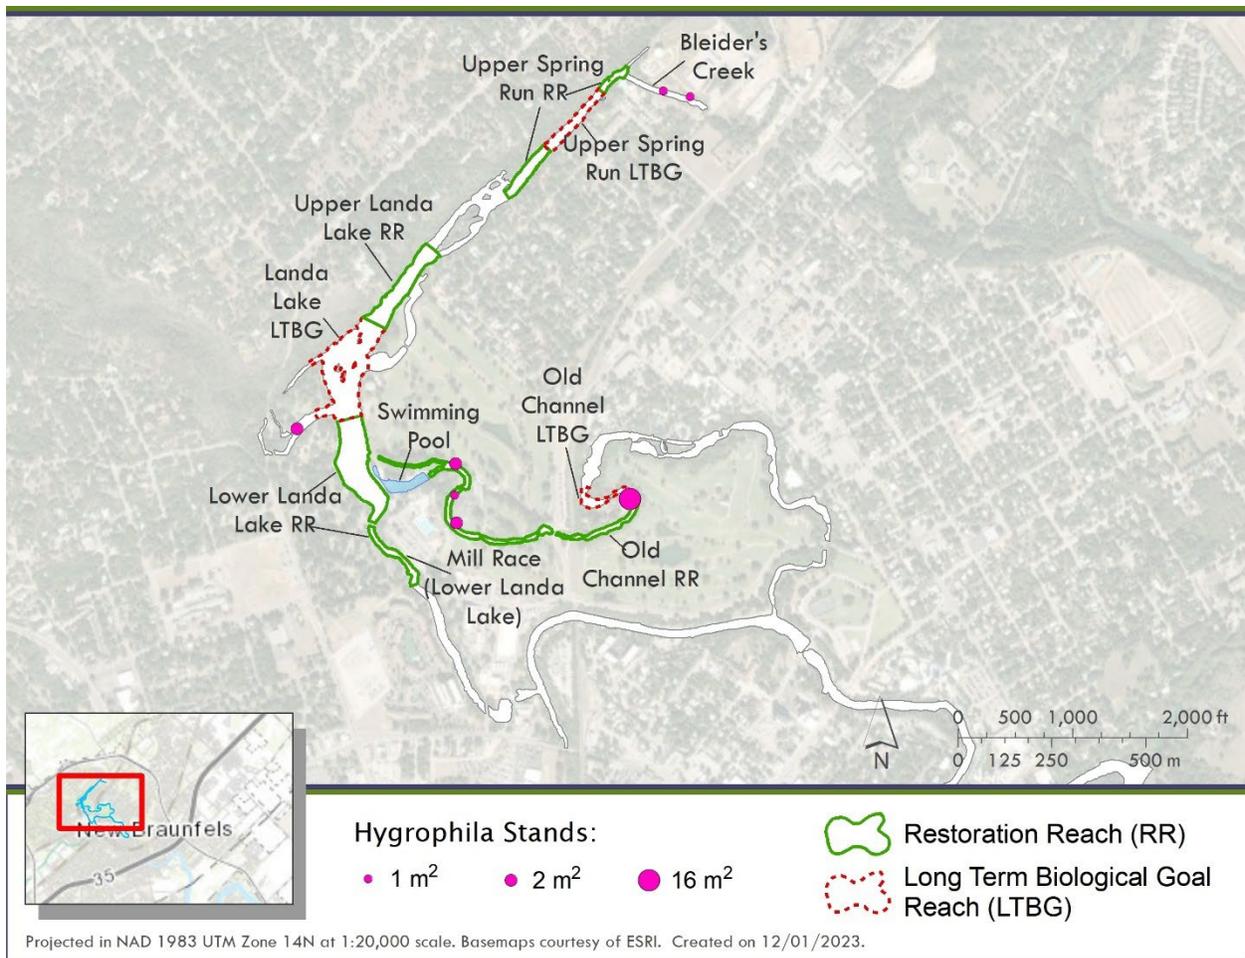
Figure 4 The 2023 distribution of Hygrophila in the study area.

From 2013 to 2018, significant effort was put into removing and eliminating Hygrophila from Blieders Creek, Upper Spring Run, Landa Lake and the first kilometer of the Old Channel Restoration Reach. Since 2019, the presence of Hygrophila has been greatly reduced and is now found in only a few locations in the project area but persists. Typical occurrences of Hygrophila are now limited to sprigs or small clumps, about a meter in diameter or smaller and usually along the stream edges (**Figure 4**).

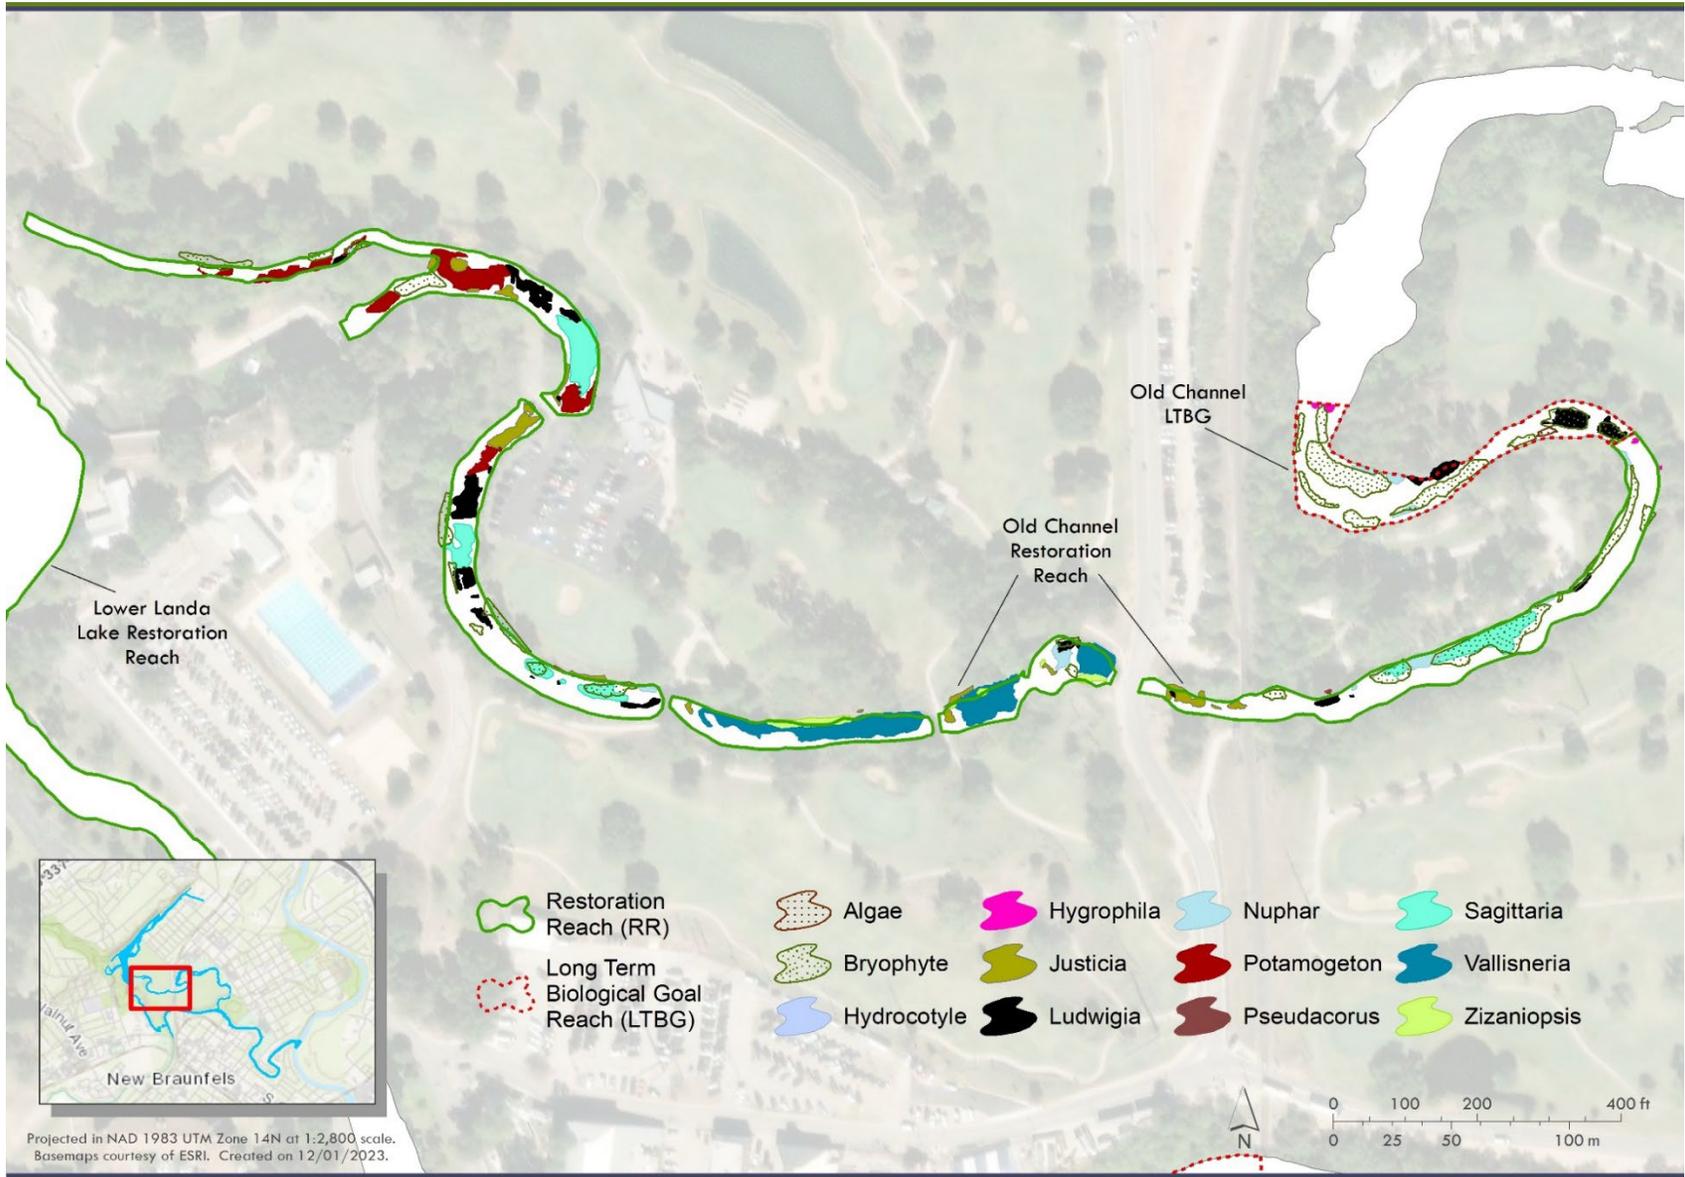
Figure 5 Restored aquatic vegetation in the Old Channel in January 2023.

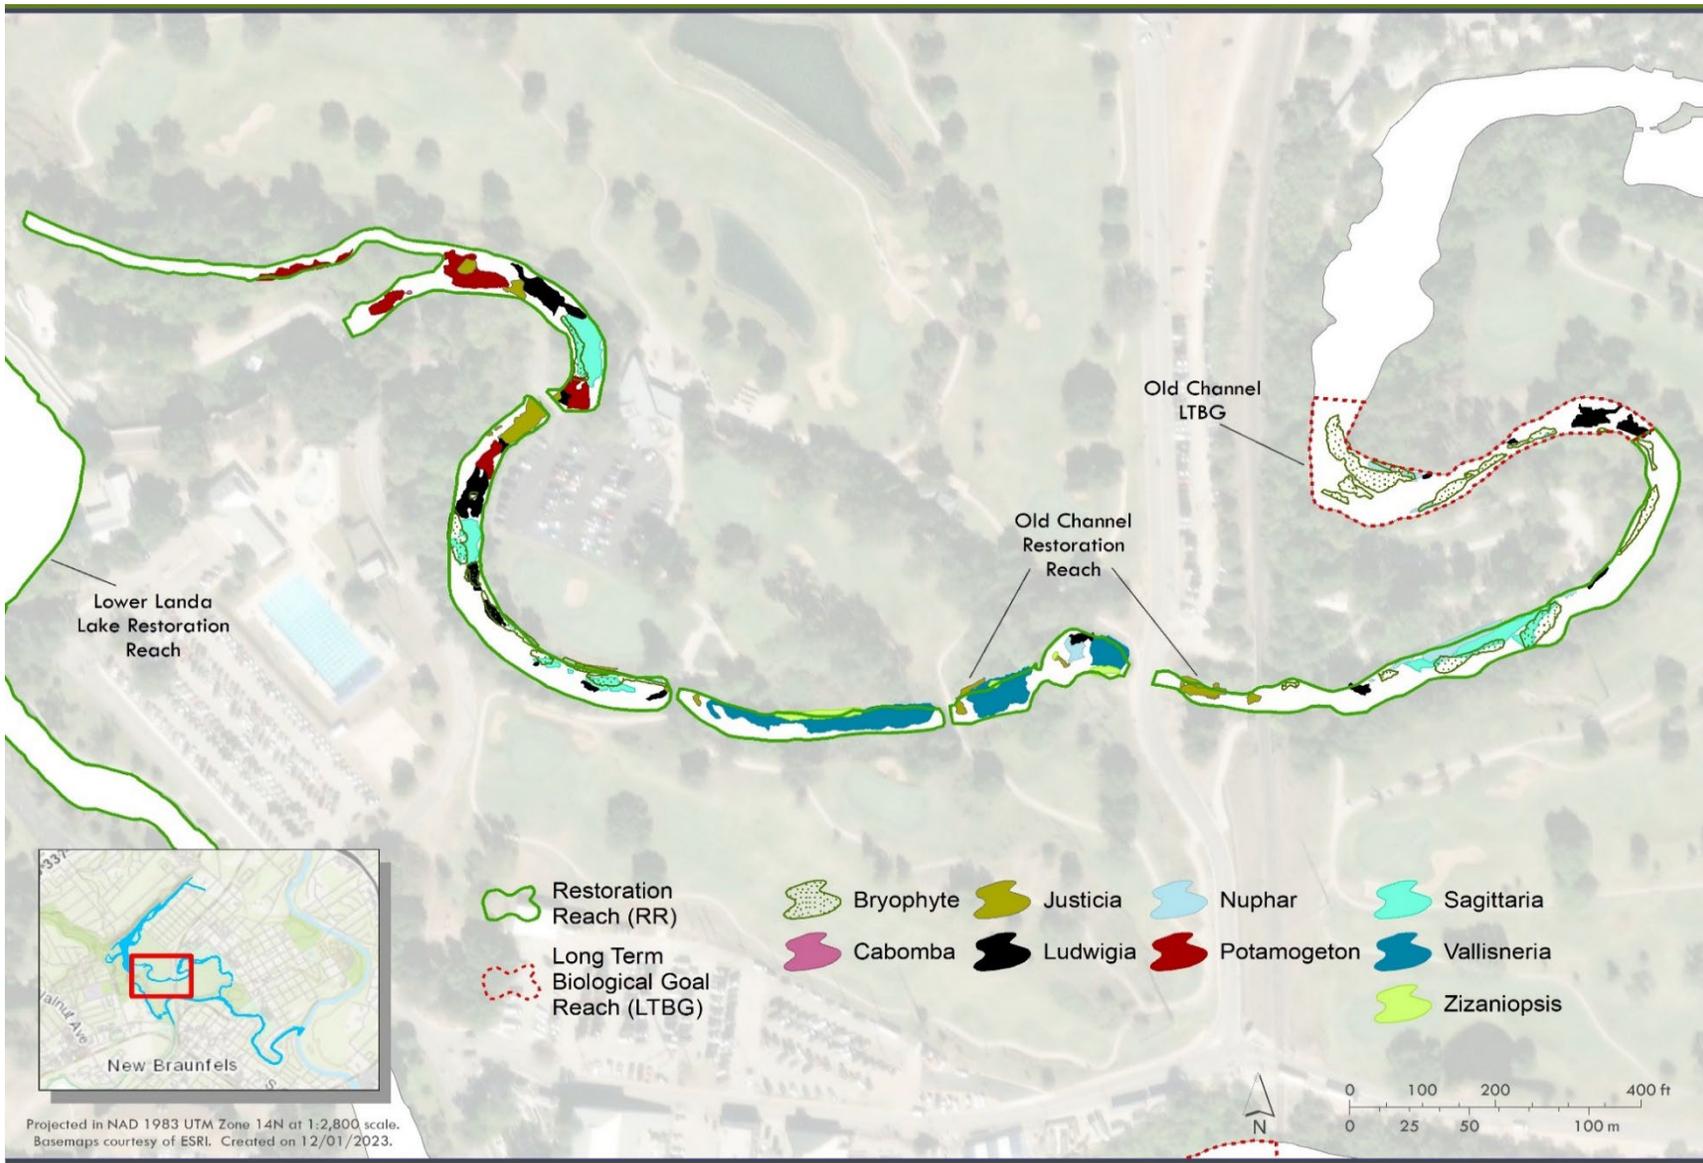
Figure 6 Restored aquatic vegetation in the Old Channel in April 2023.

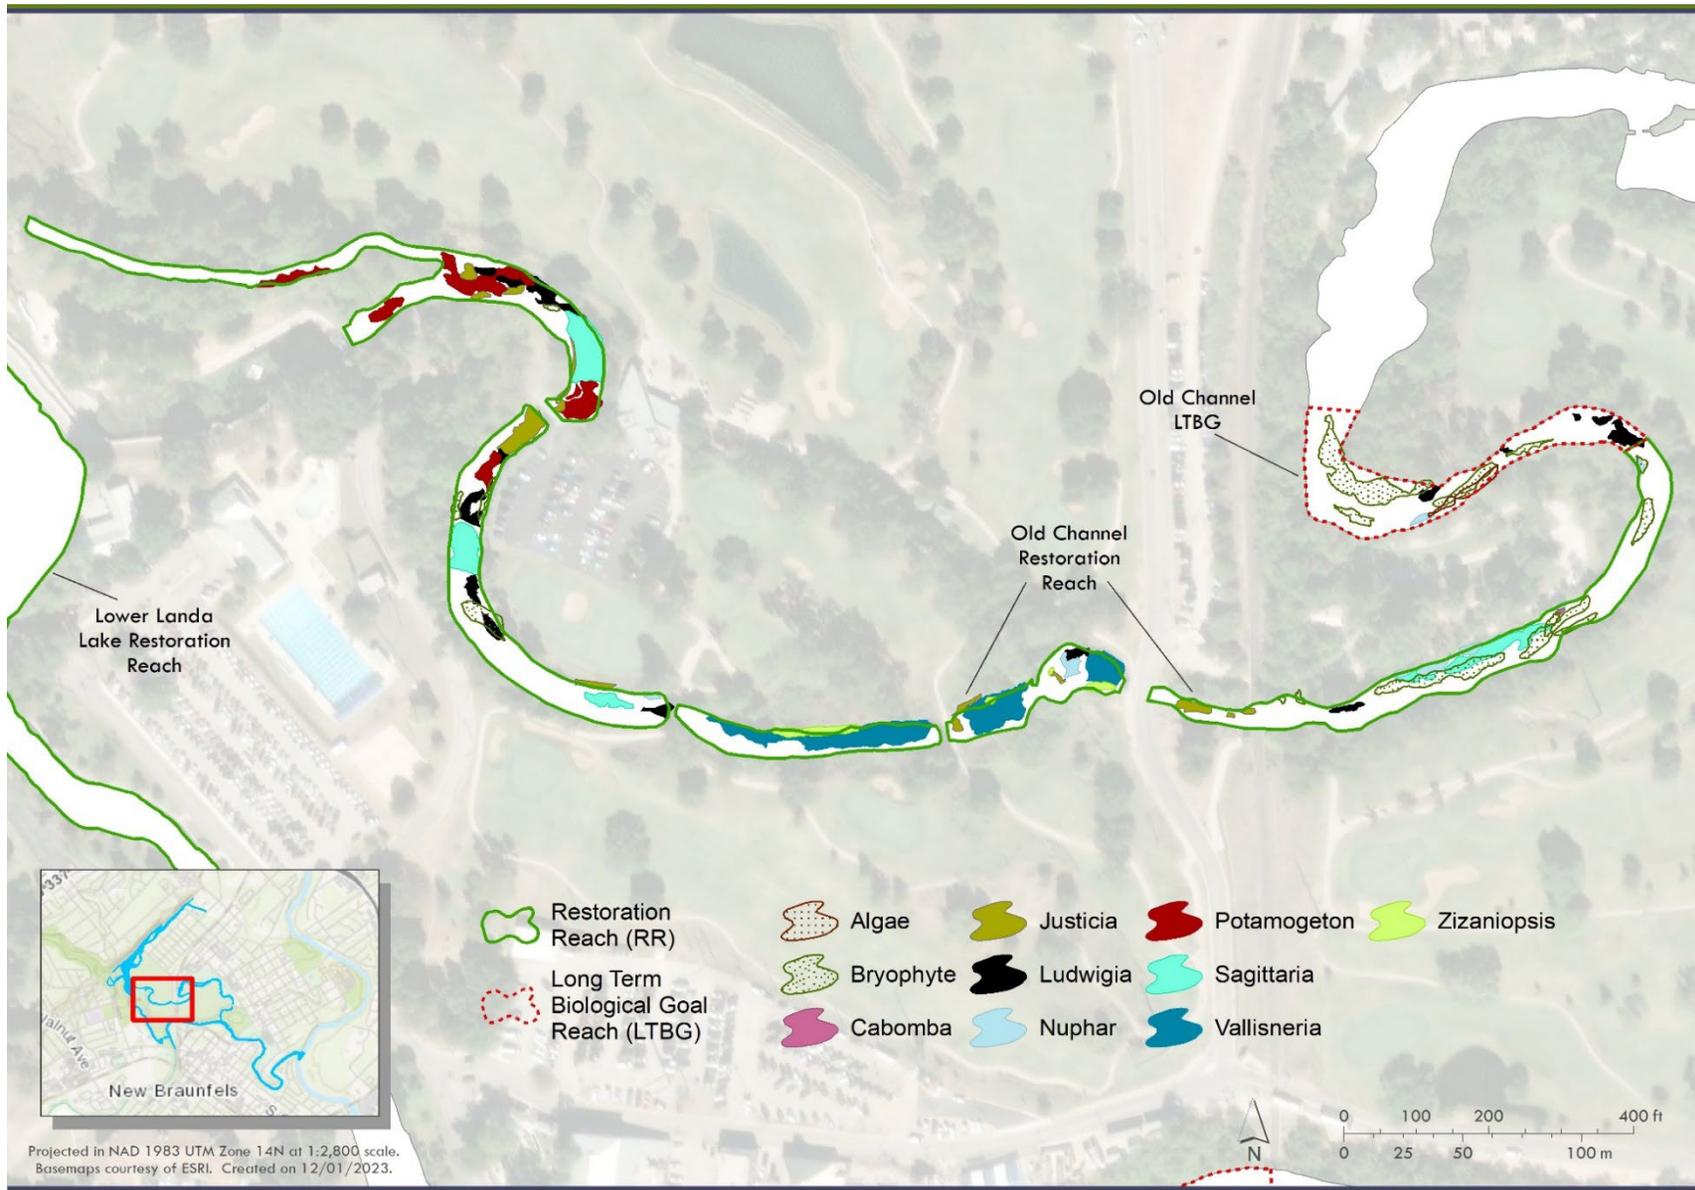
Figure 7 Restored aquatic vegetation in the Old Channel in July 2023.

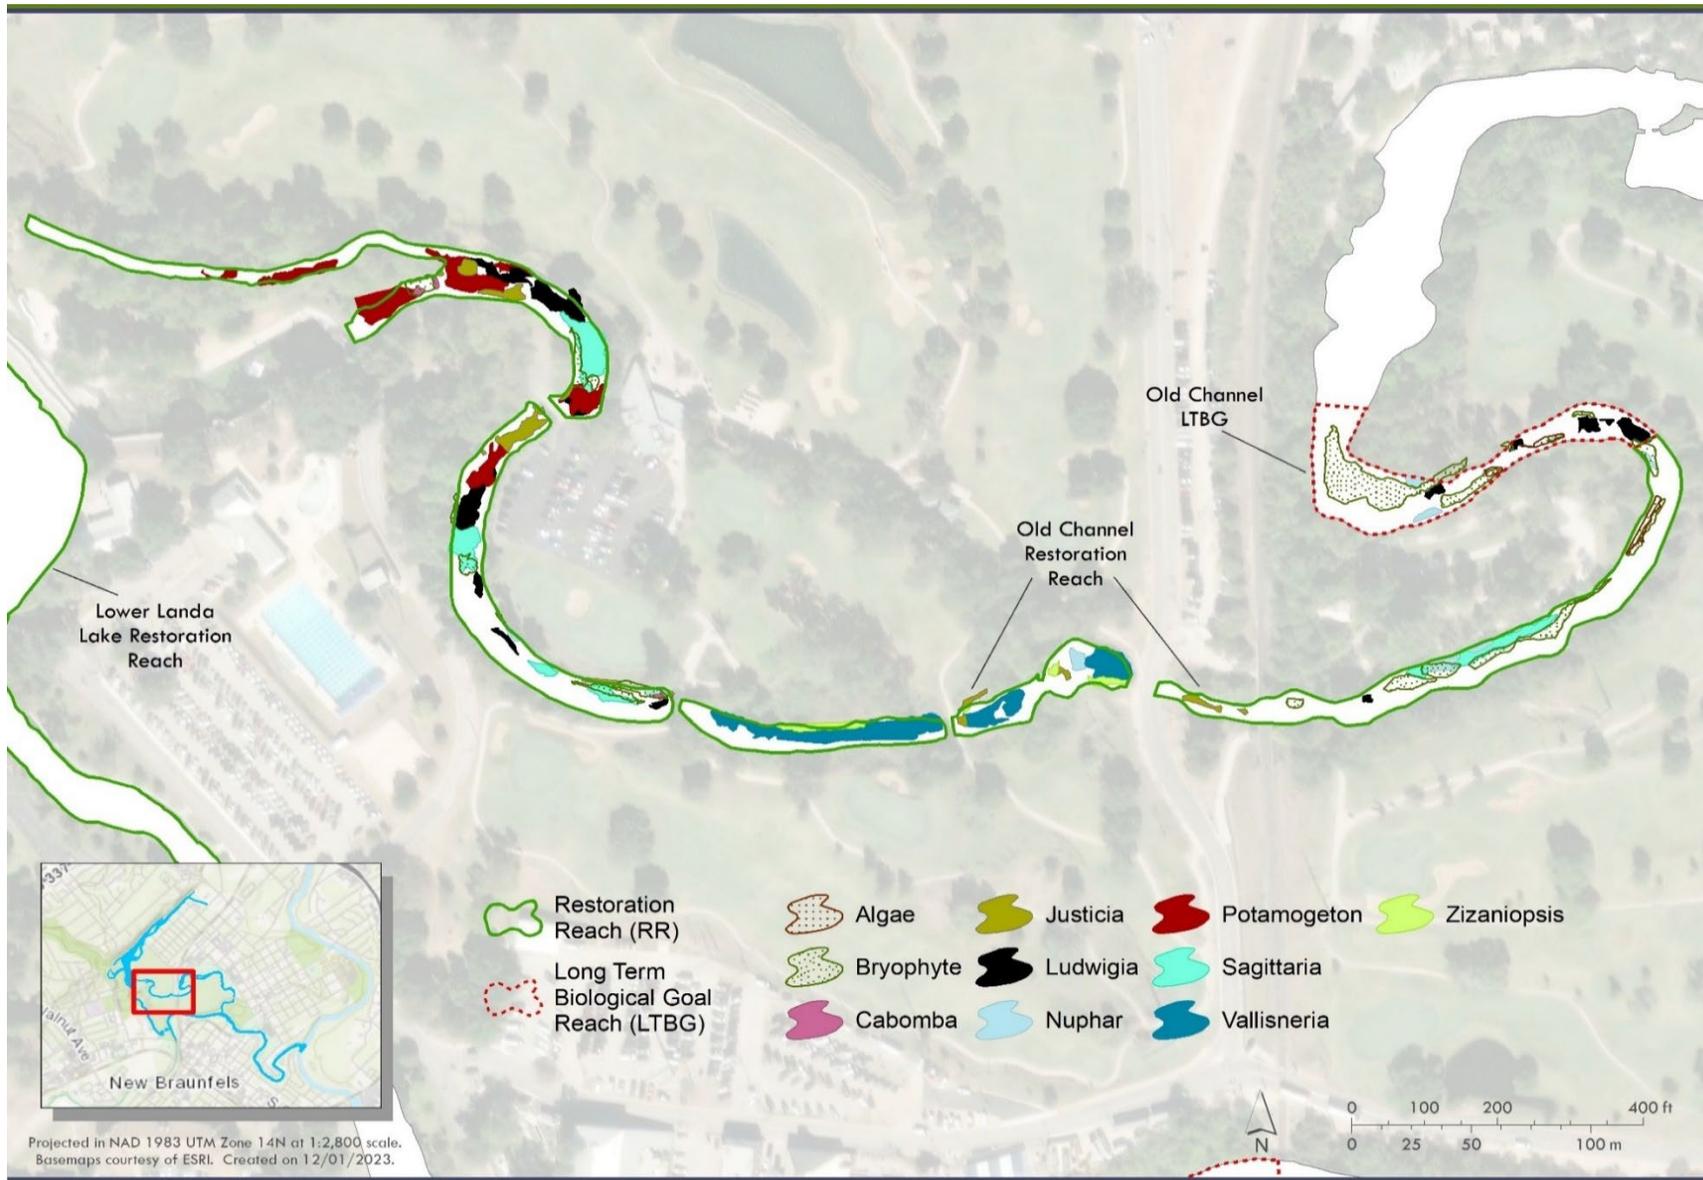
Figure 8 Restored aquatic vegetation in the Old Channel in October 2023.

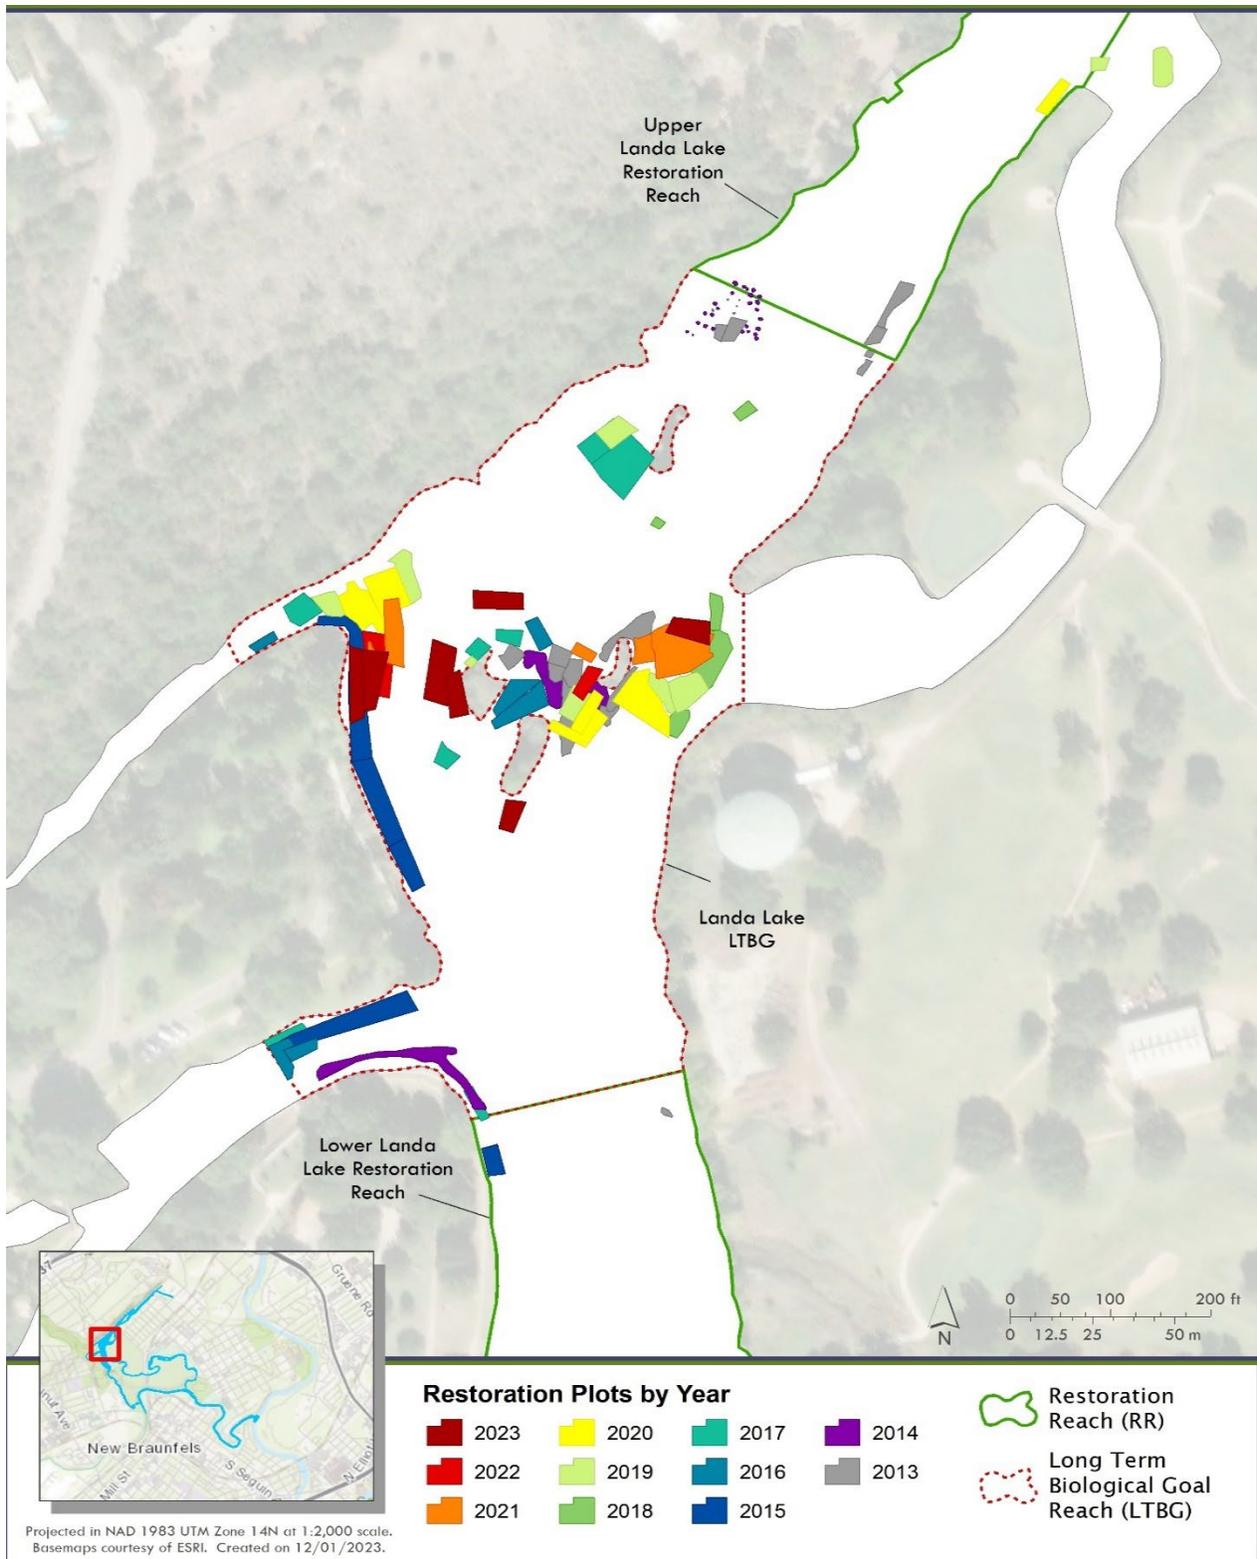
Figure 9 Restoration plots in the Landa Lake LTBG Reach.

This year’s plantings were limited to the Landa Lake LTBG Reach and resulted in a total of 1,020 Ludwigia, 4,300 Cabomba and 386 Potamogeton plants installed in the reach (**Table 4**). There were 7 new plots planted with a portion of plants installed as supplements to older plots. A combined area of 431 m² was planted in new restoration plots created from natural open areas within Vallisneria (**Figure 9, Appendix A**). Condition M limited the window for planting site preparation and large-scale plantings. The team was able to plant the majority of plants before Condition M was reached. Afterwards, regular trimming and supplemental sprigging of Ludwigia and Cabomba was the primary activity. Trimming is necessary to keep plants in a sprawling growth phase, which is especially beneficial during lower water levels. The trimmings were then planted by hand as sprigs. After July, activities in all the Landa Lake reaches were limited to gardening and maintenance. This included clearing vegetation mats, cleaning algae from newly planted plots and removing limbs and branches to prevent buildup of floating debris. Filamentous and epiphytic algae in Landa Lake was occasionally excessive and when problematic was flushed away by using hand-held SCUBA Scooters to the degree practical.

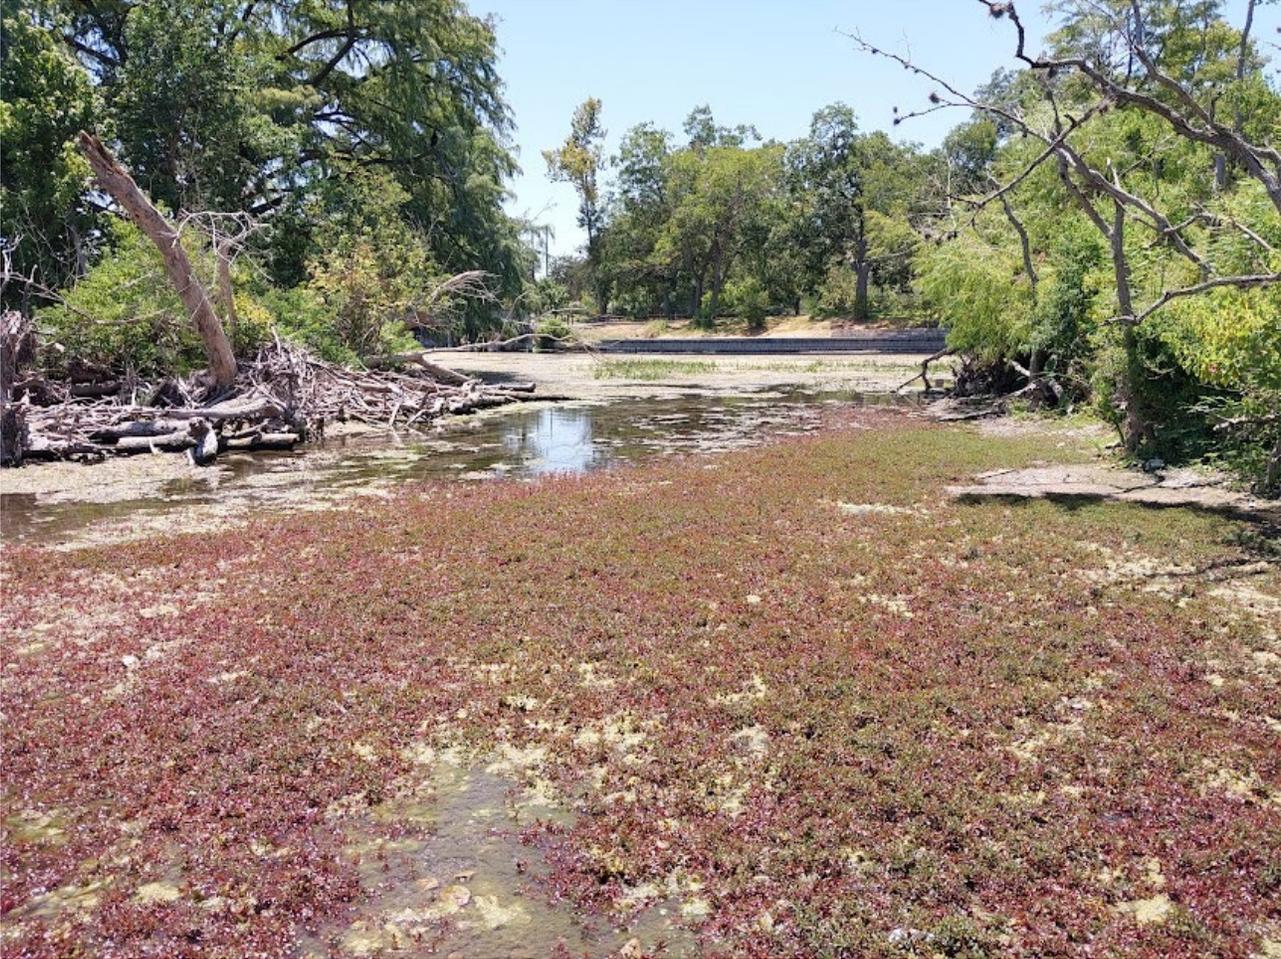
Figure 10 Emergent *Ludwigia* growing on exposed mud bank at the Three islands area of Landa Lake in August of 2023. This area is normally 10 to 12 inches in water depth.

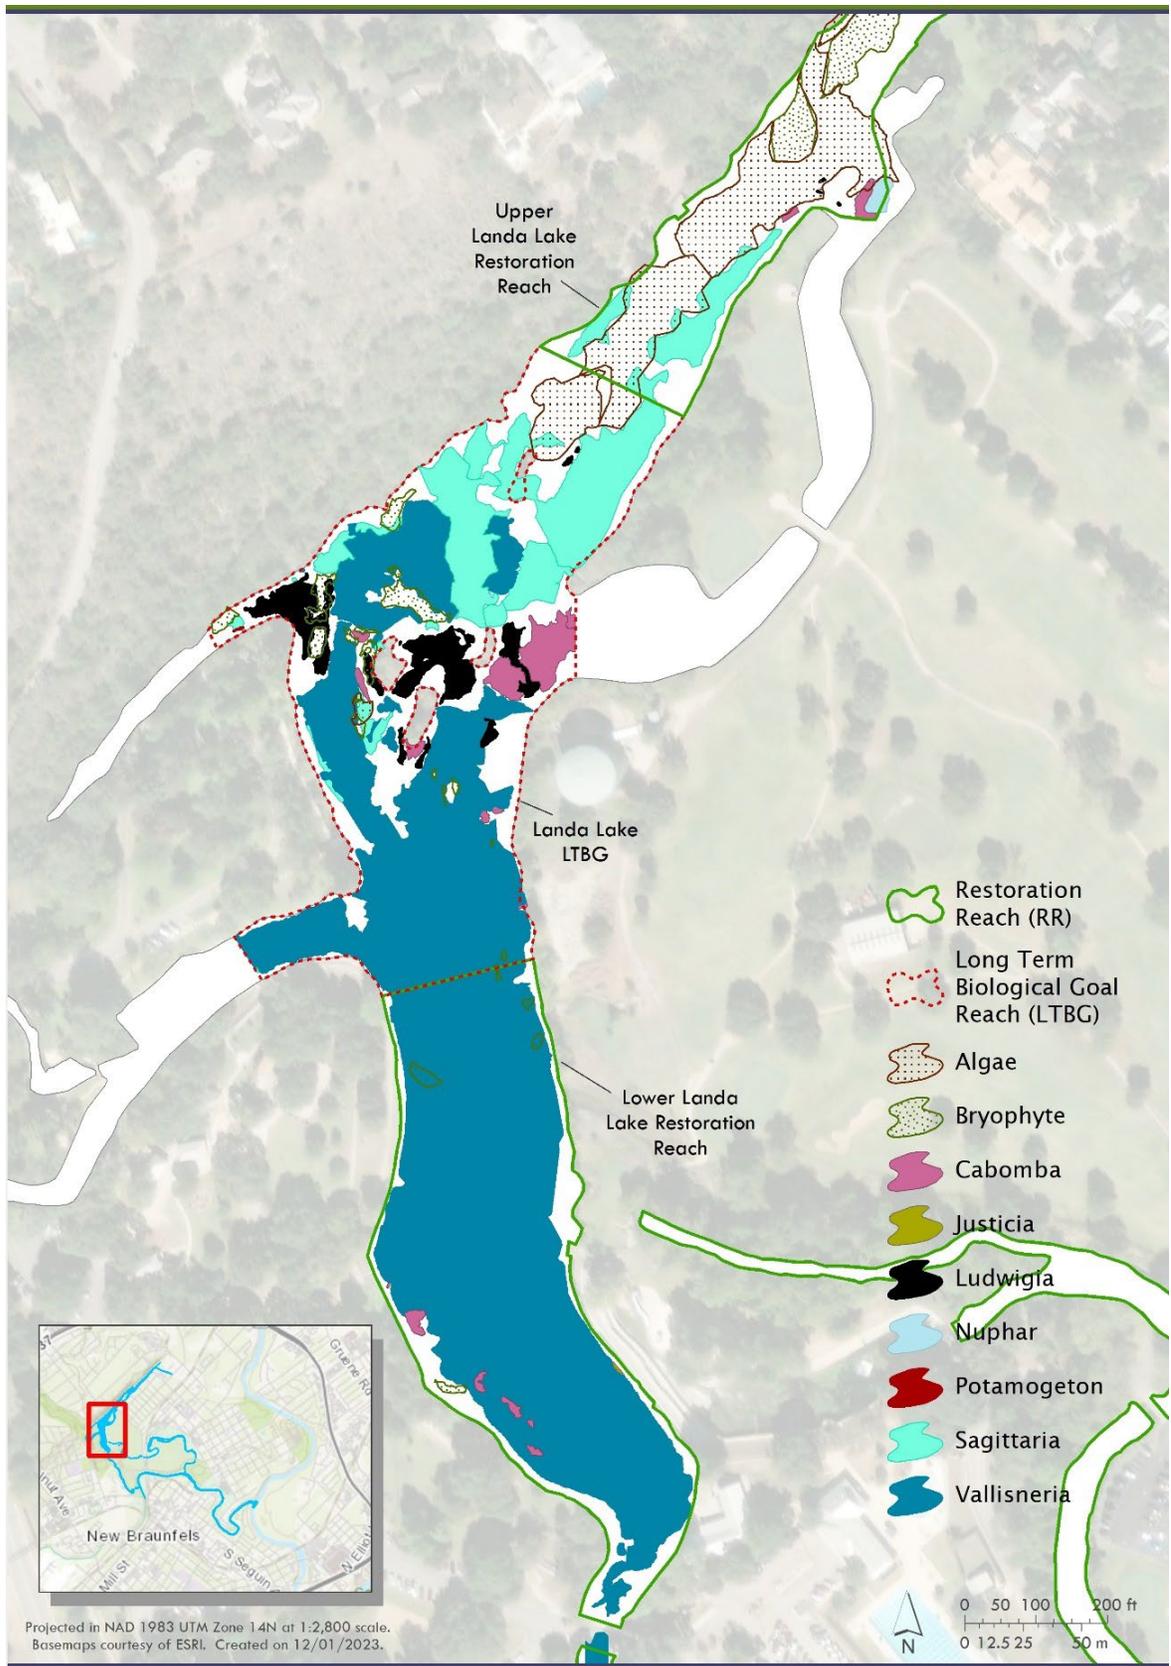
Figure 11 Cover of aquatic vegetation in Landa Lake in January 2023

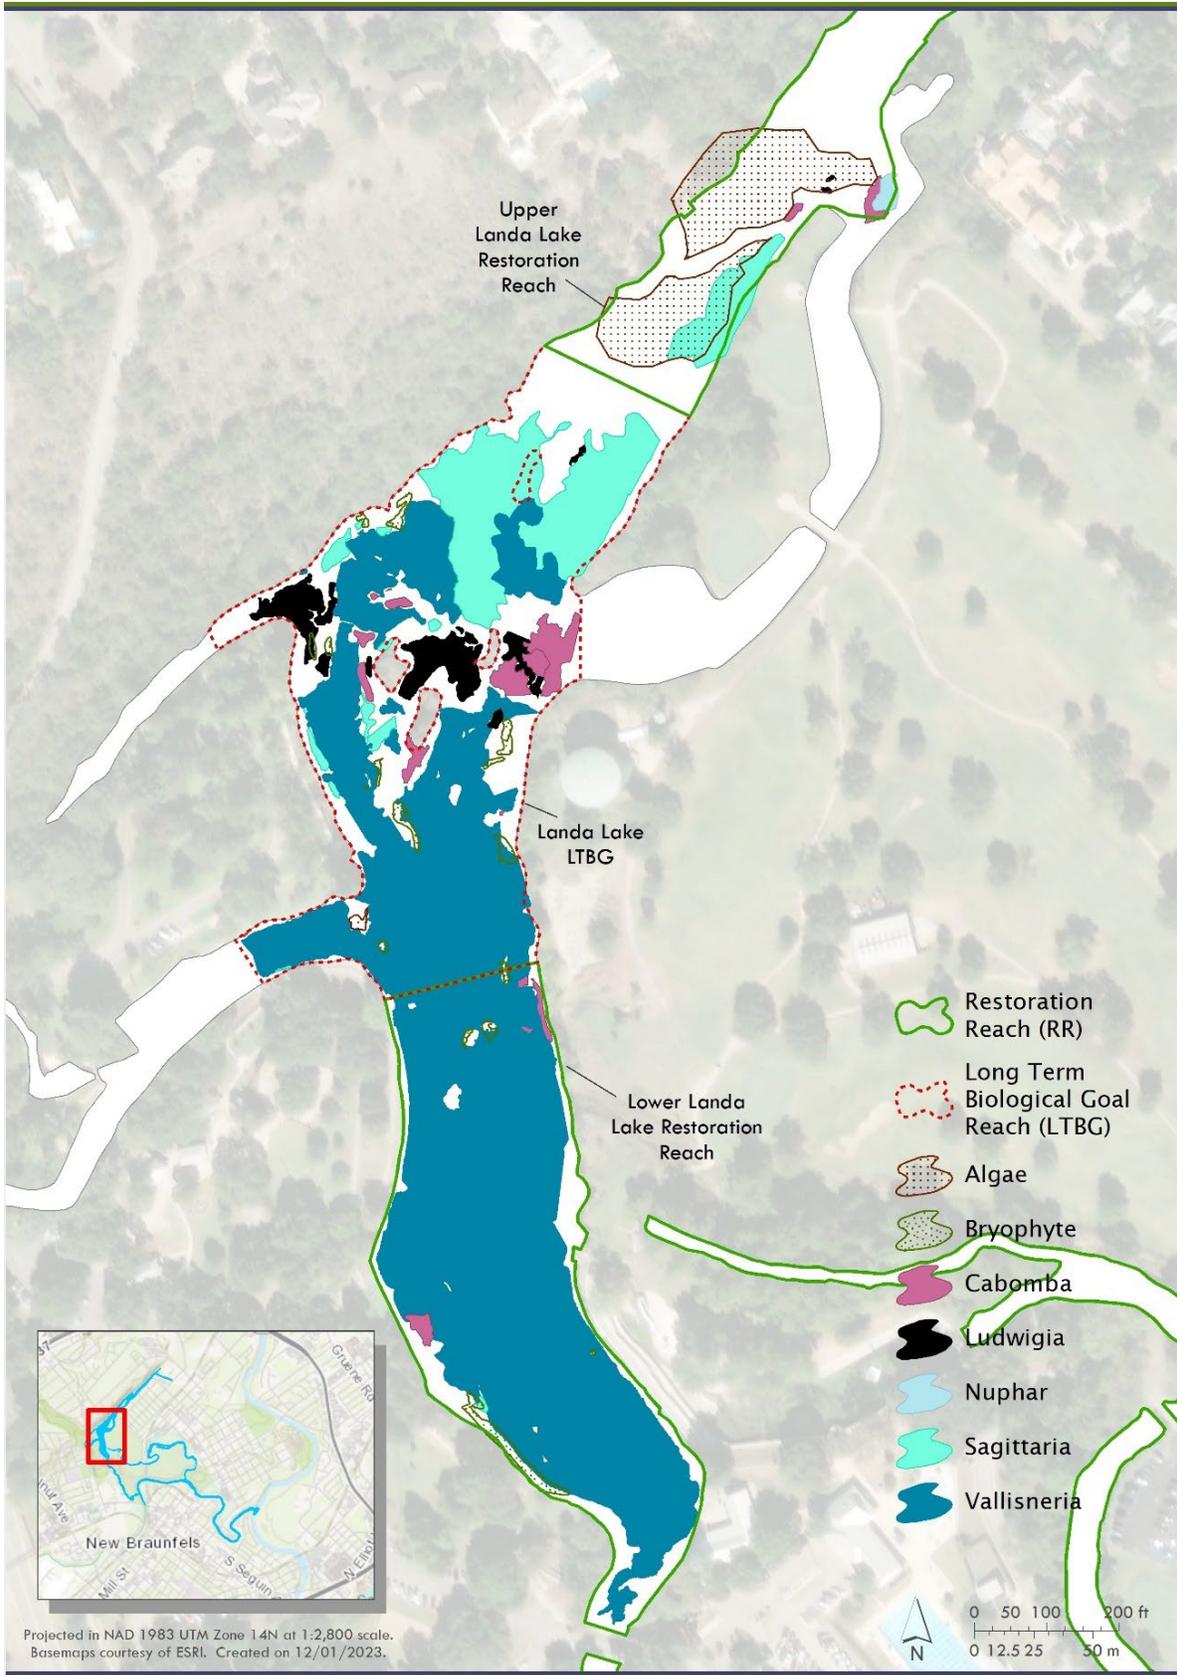
Figure 12 Cover of aquatic vegetation in Landa Lake in April 2023.

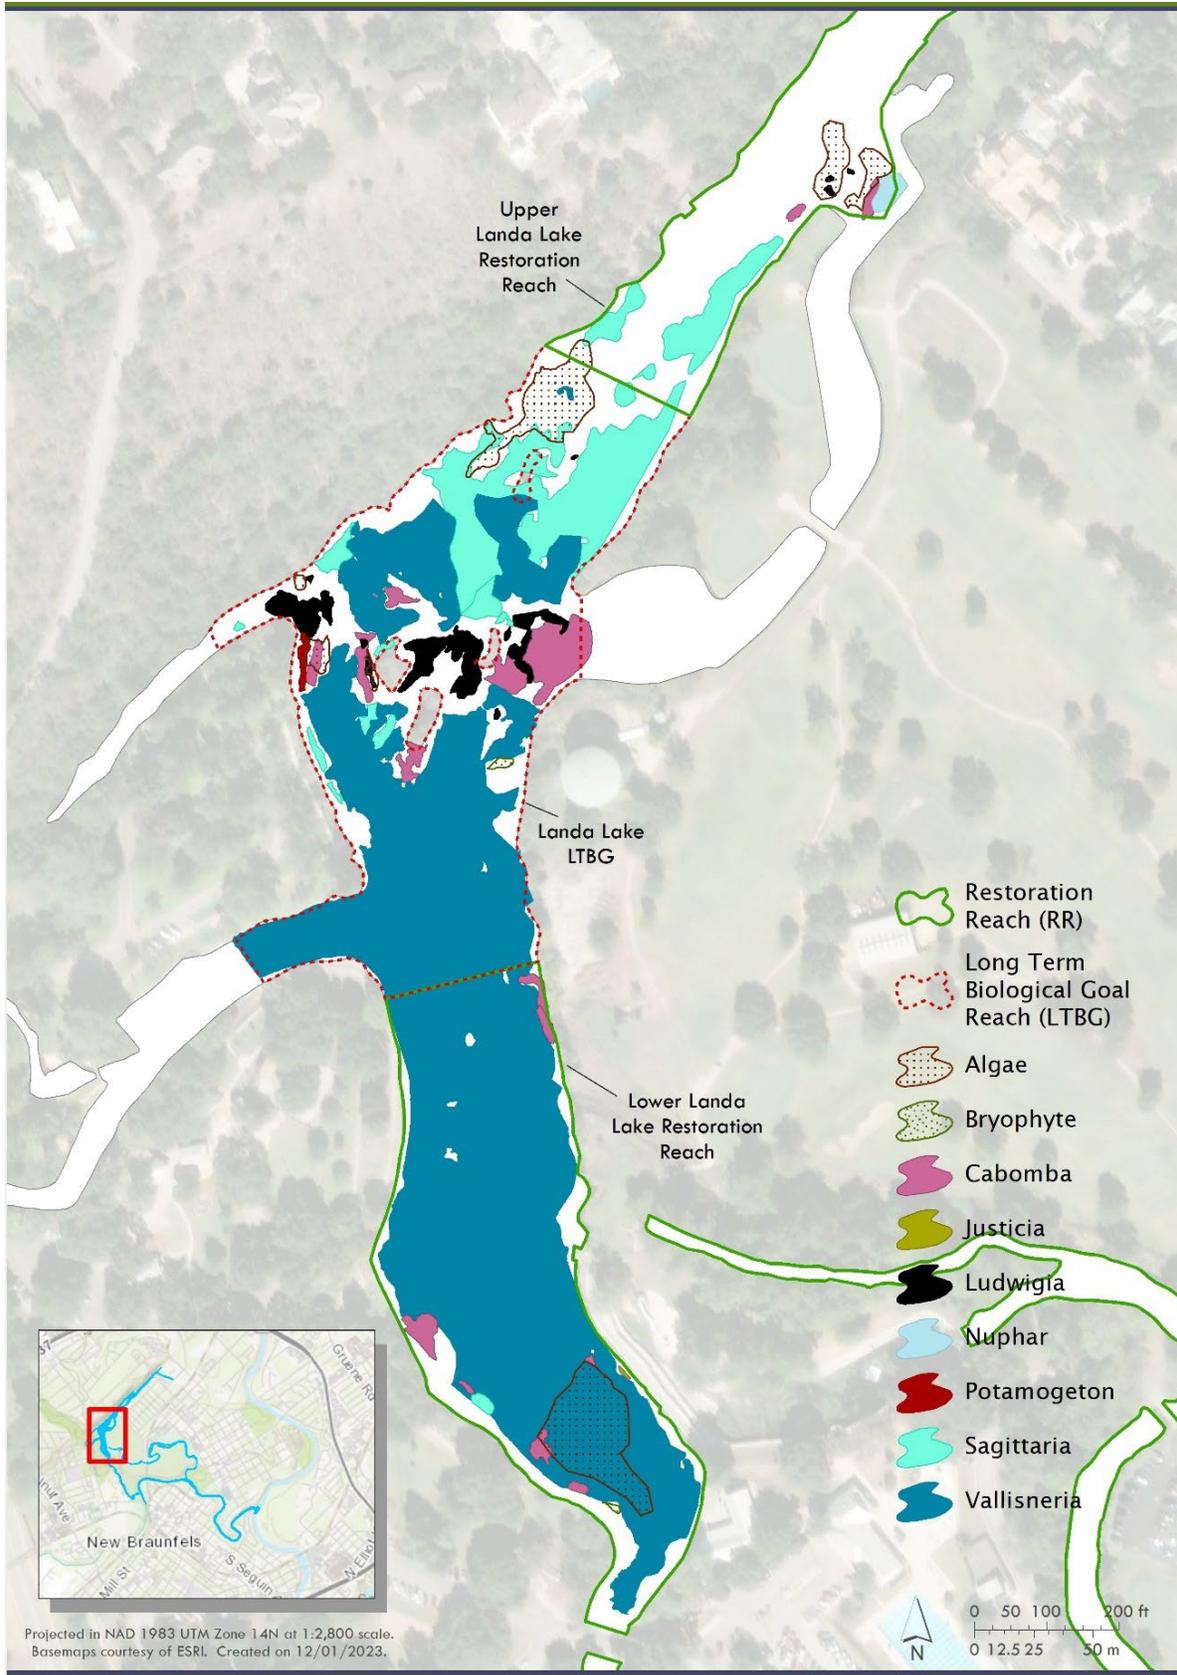
Figure 13 Cover of aquatic vegetation in Landa Lake in July 2023.
