Appendix H | 2023 City of New Braunfels Reports

Appendix H1 | **Native Aquatic Vegetation Restoration in the Comal River System**

2023 Native Aquatic Vegetation Restoration and Maintenance in the Comal River

**BIO-WEST, Inc.
1812 Central Commerce Court
Round Rock, Texas 78664**

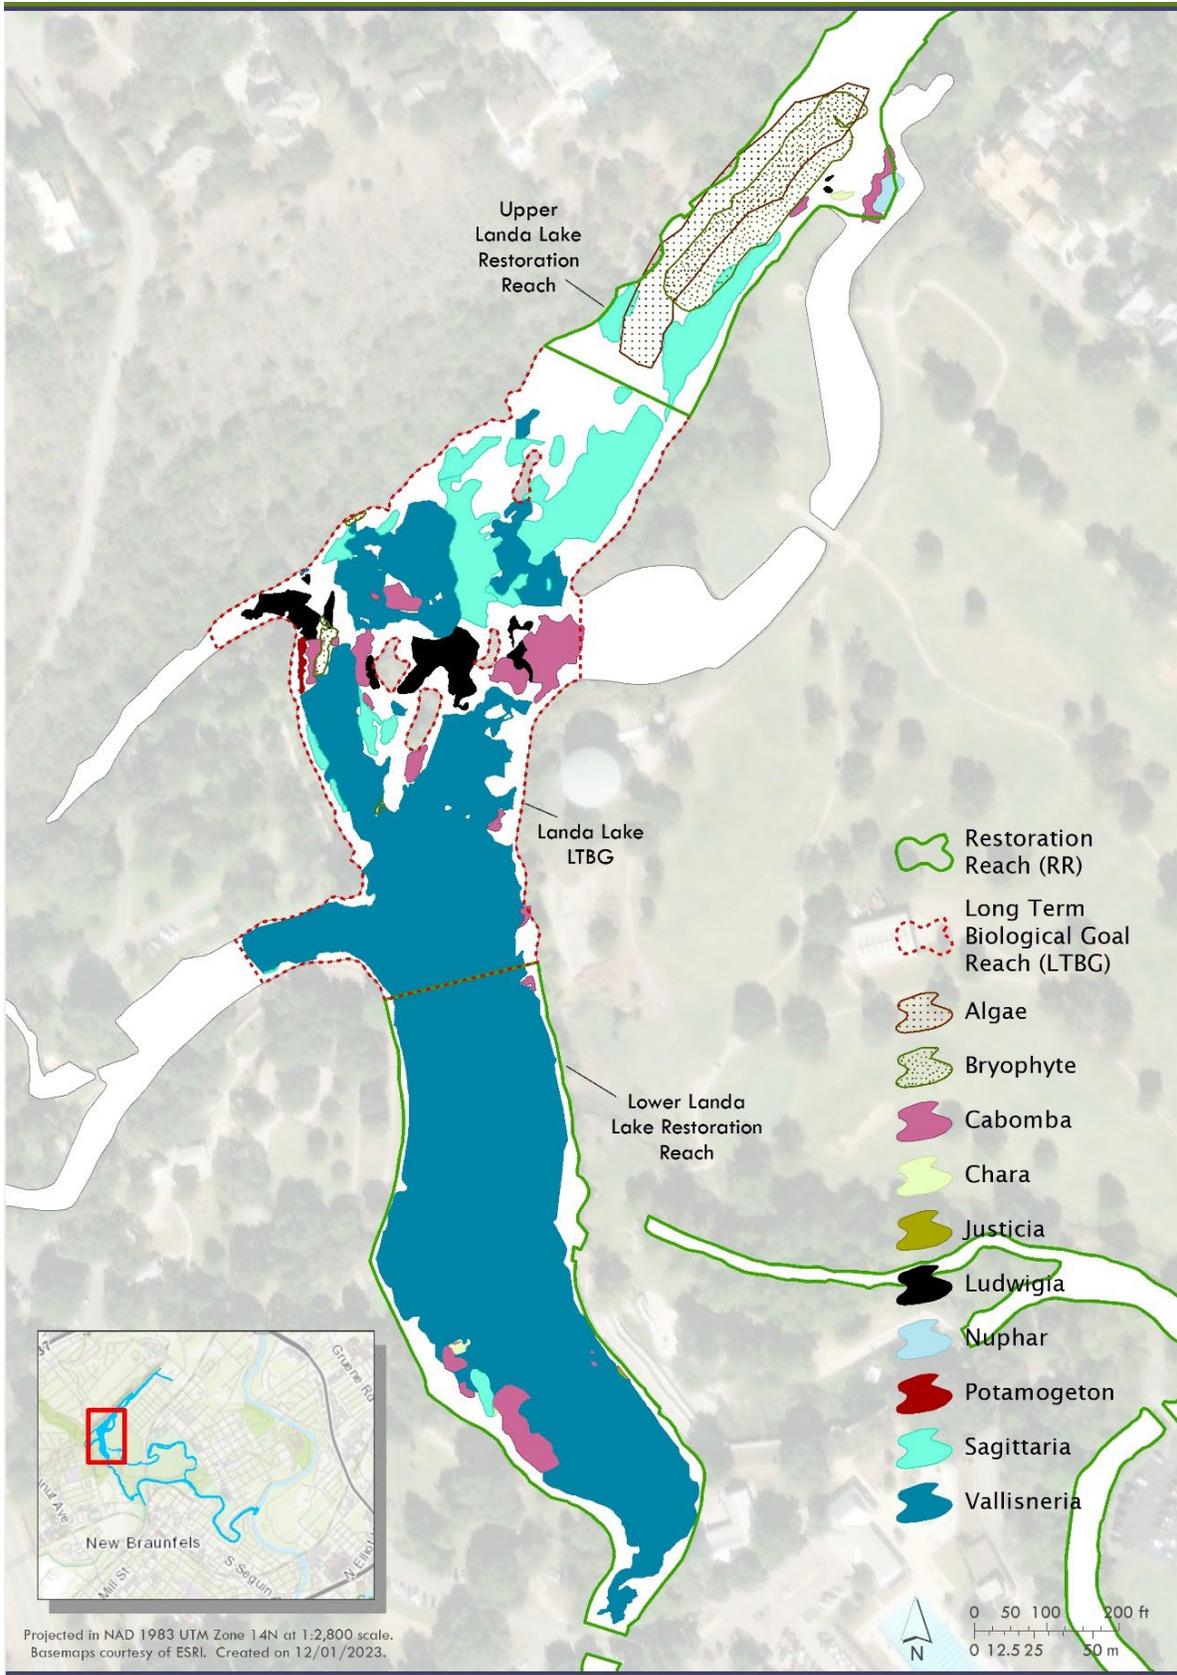
Figure 14 Cover of aquatic vegetation in Landa Lake in October 2023.

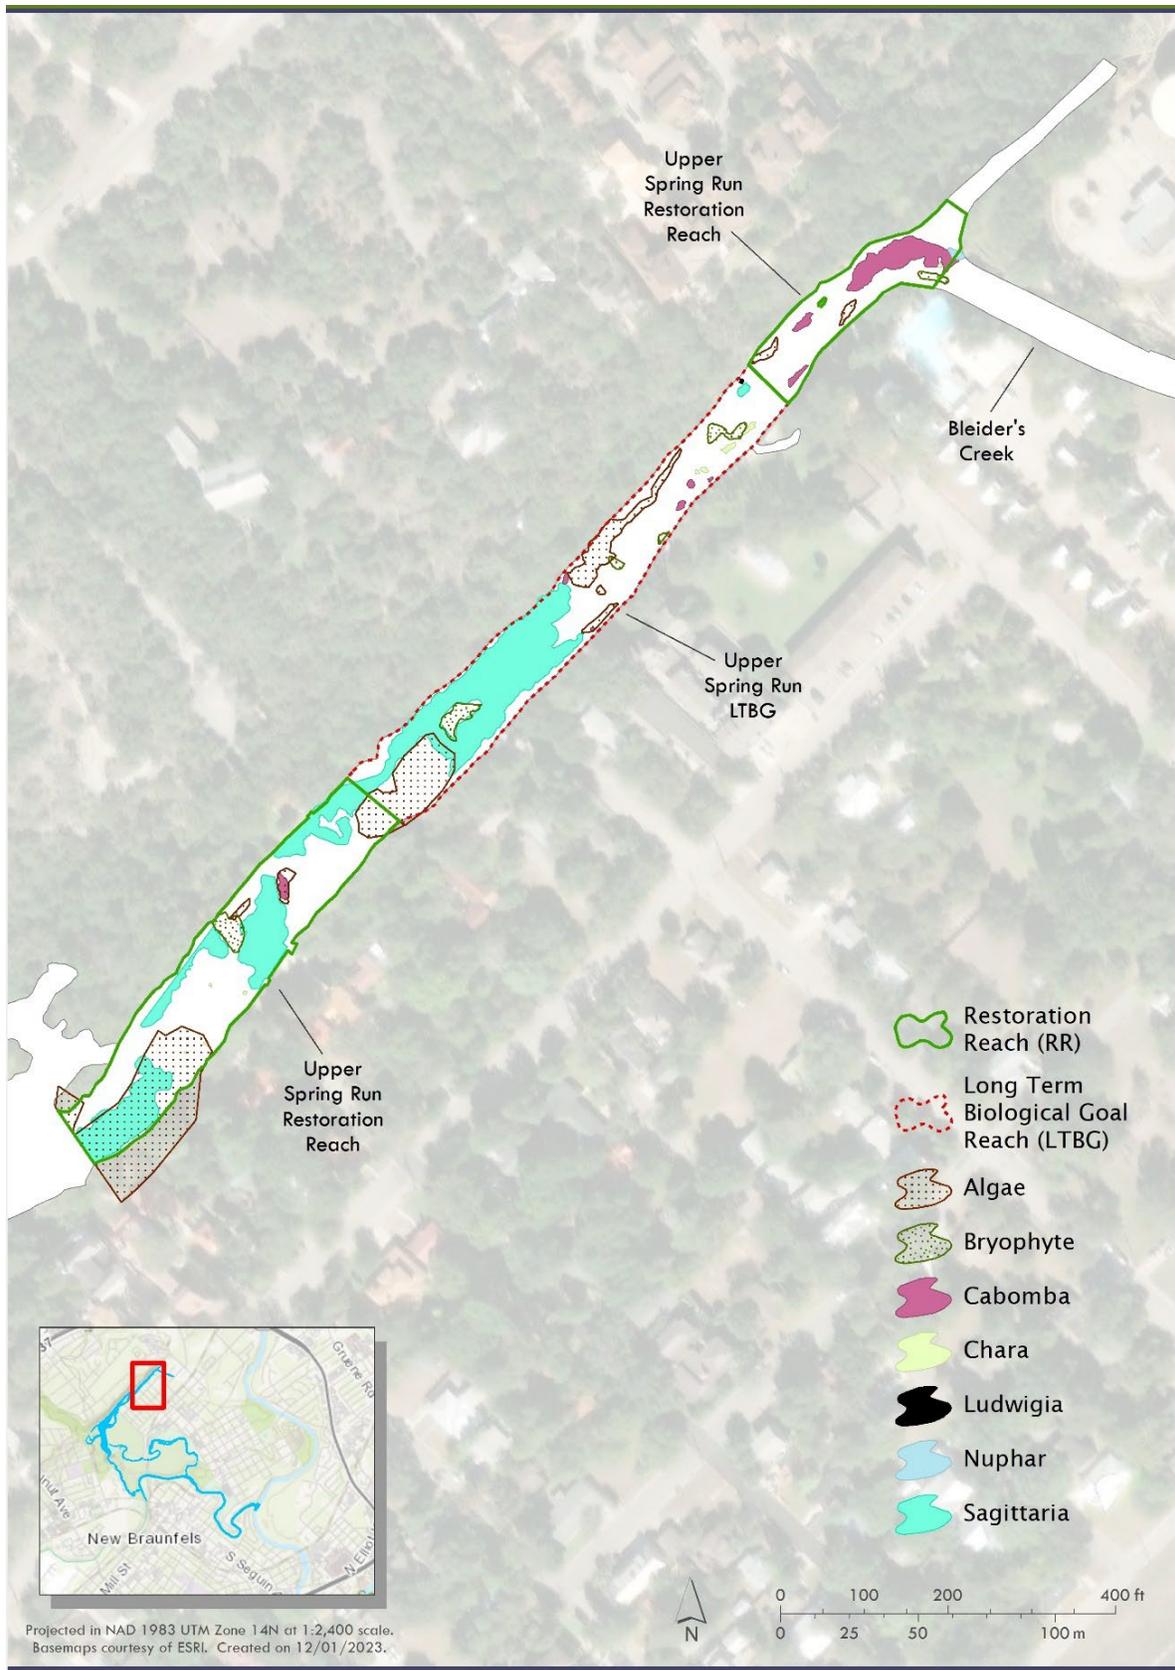
Figure 15 Cover of aquatic vegetation in the USR reaches in January 2023.

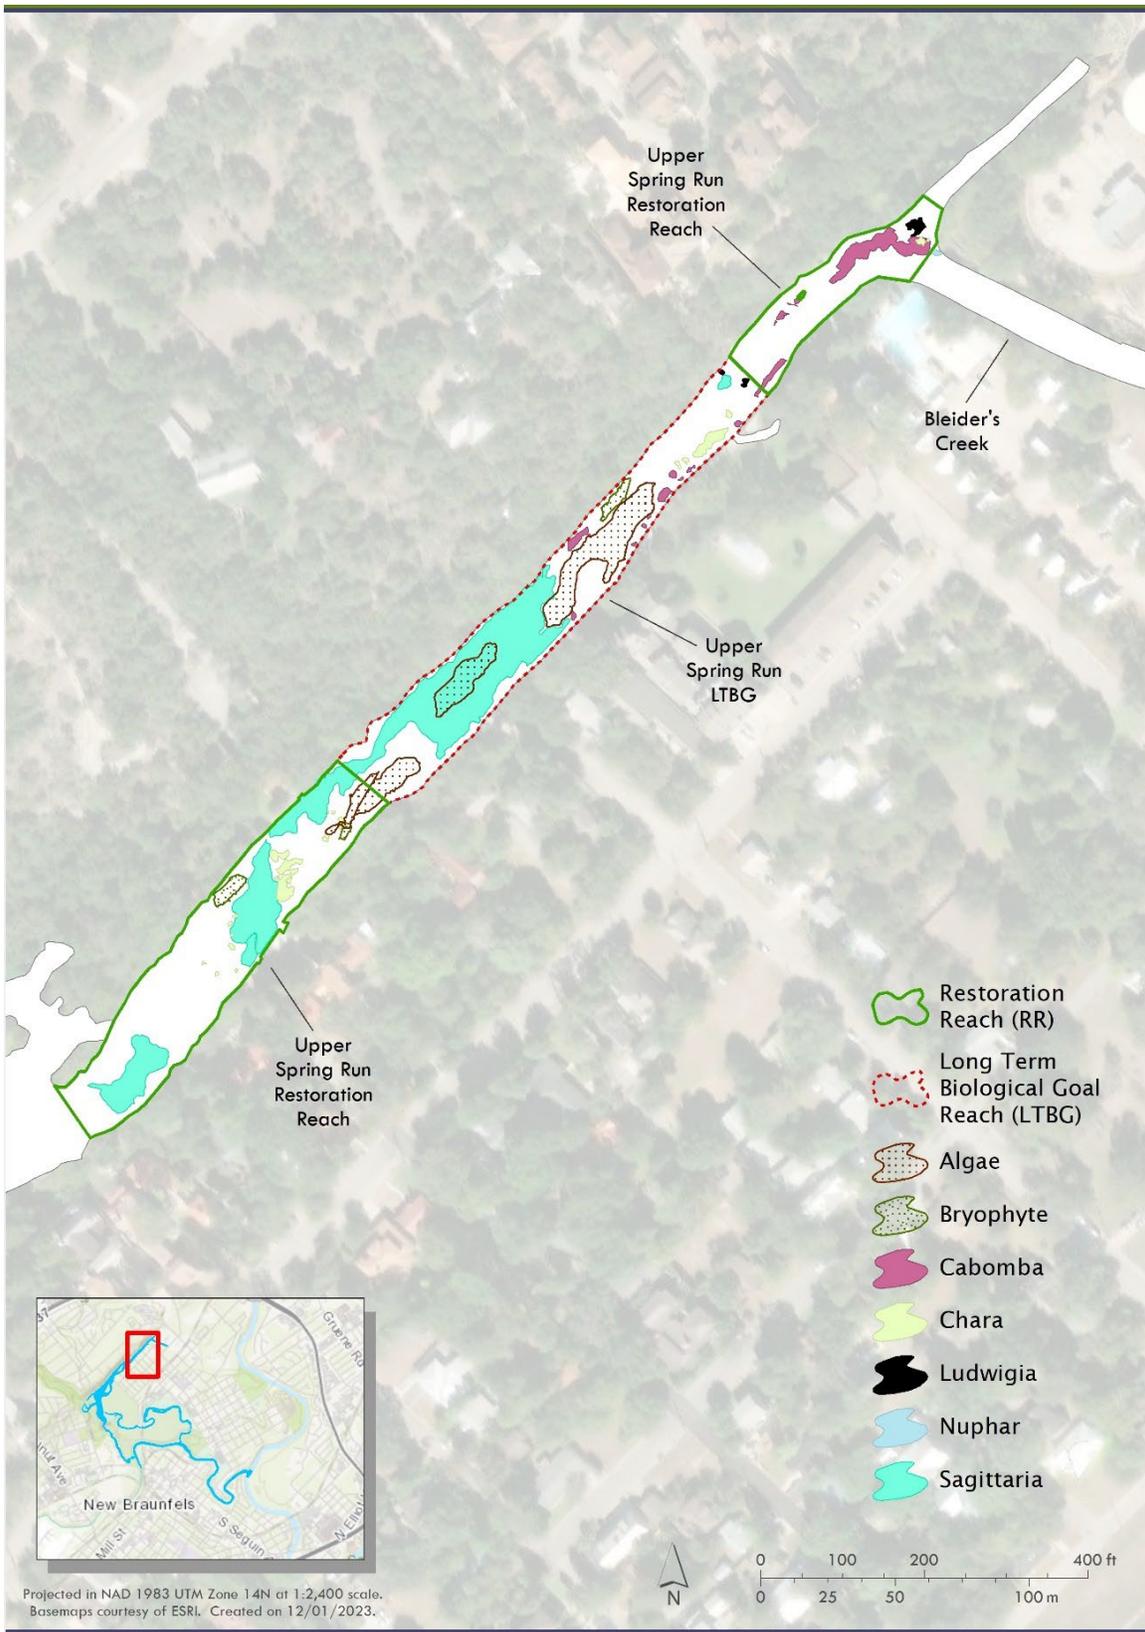
Figure 16 Cover of aquatic vegetation in the USR reaches in April 2023.

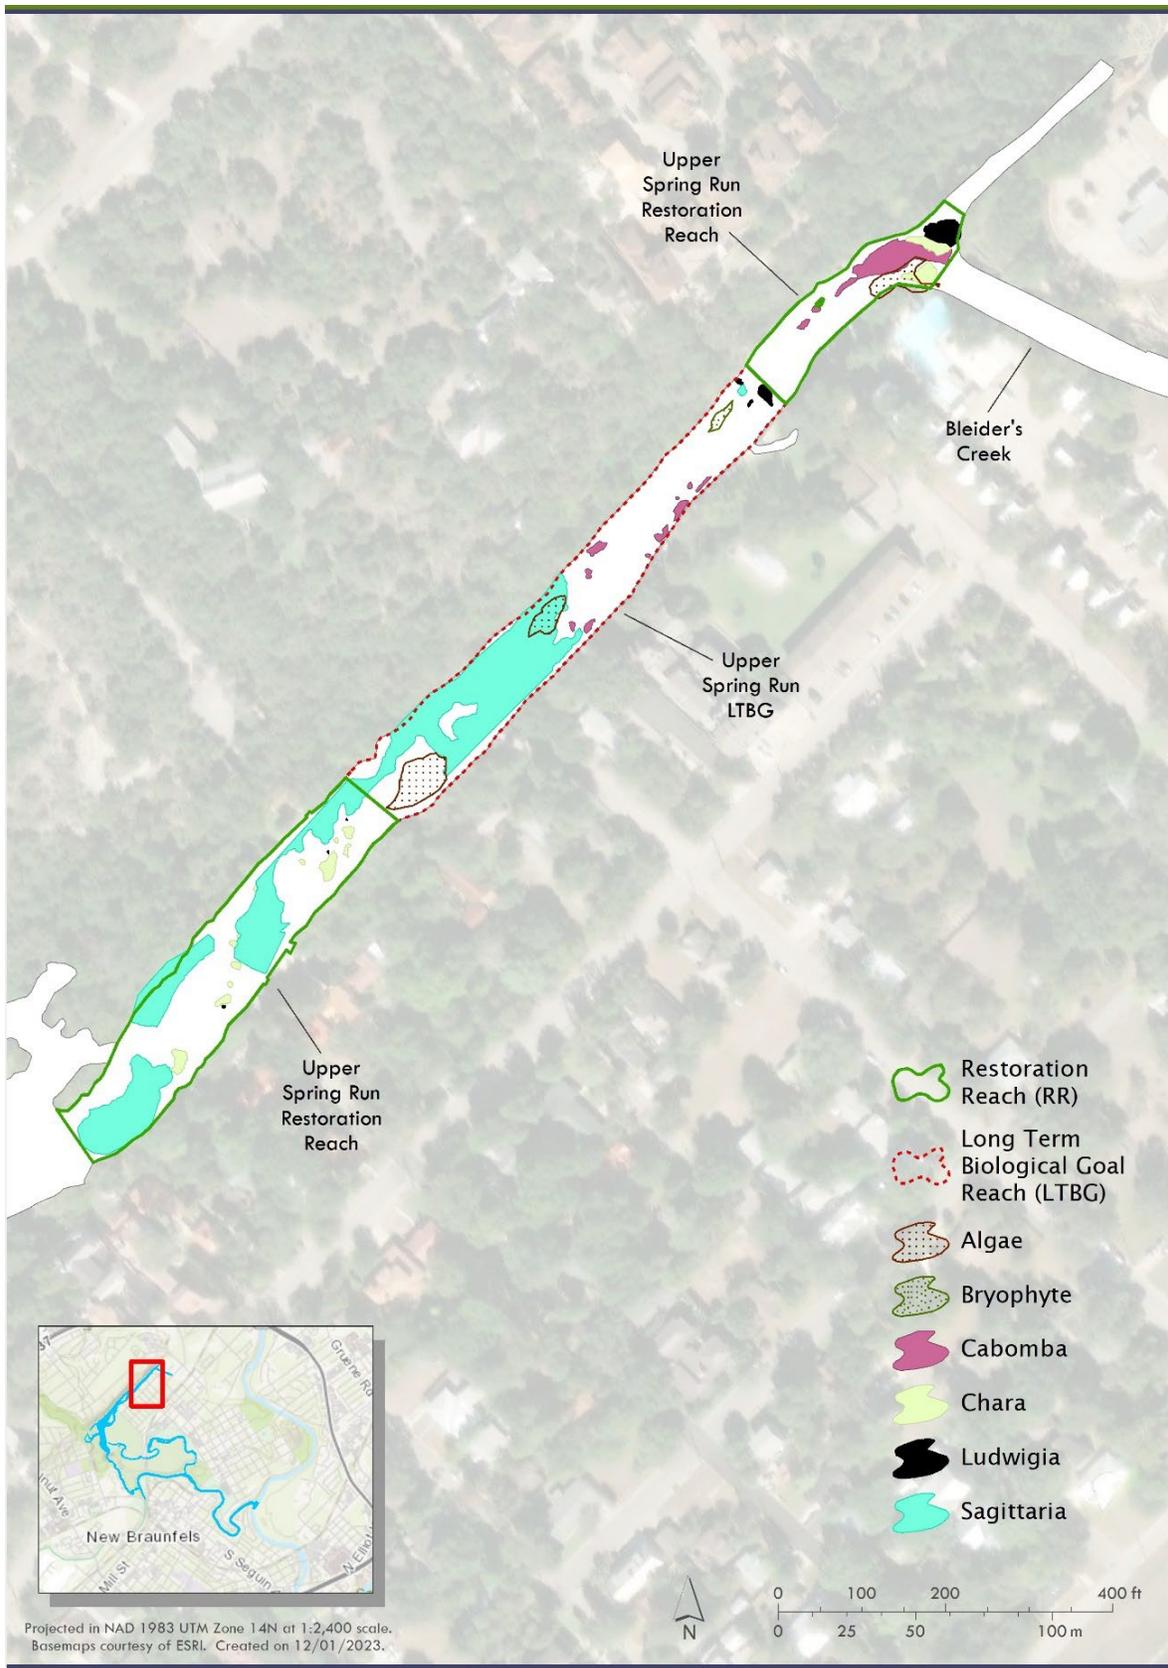
Figure 17 Cover of aquatic vegetation in the USR reaches in July 2023.

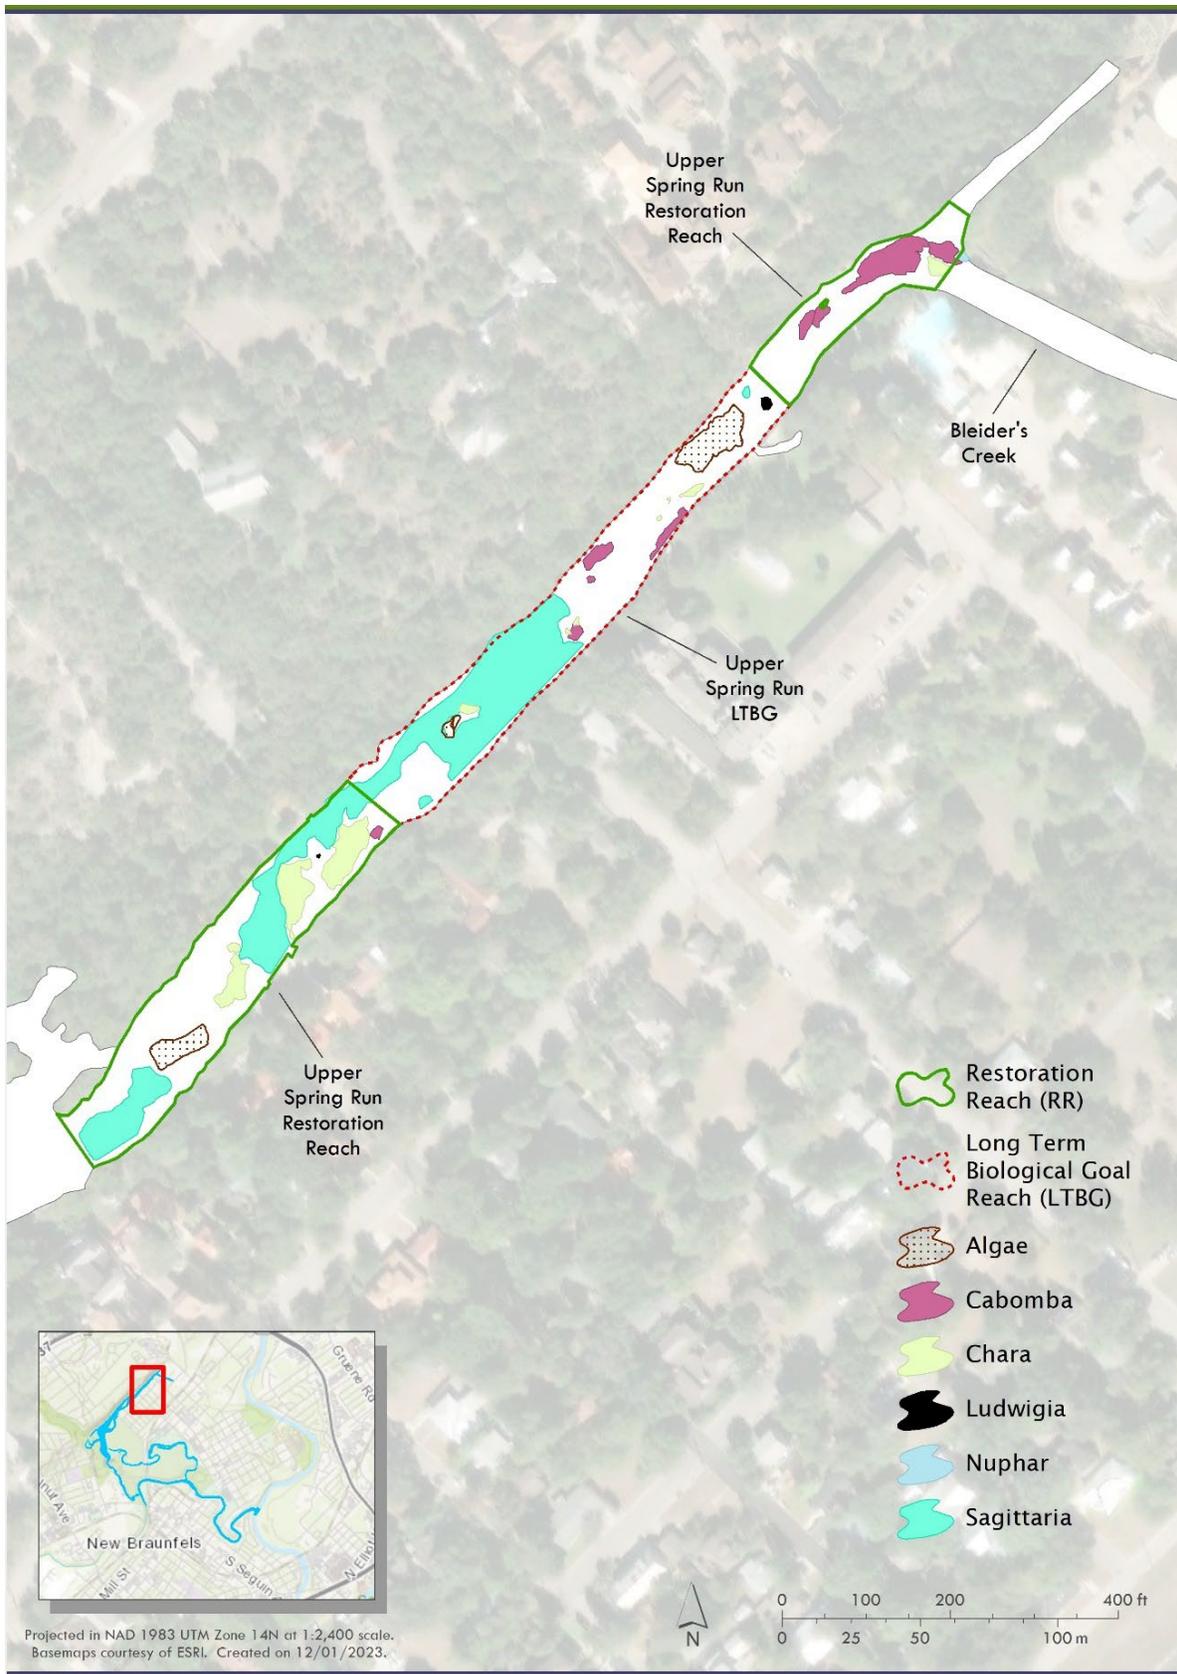
Figure 18 Cover of aquatic vegetation in the USR reaches in October 2023.

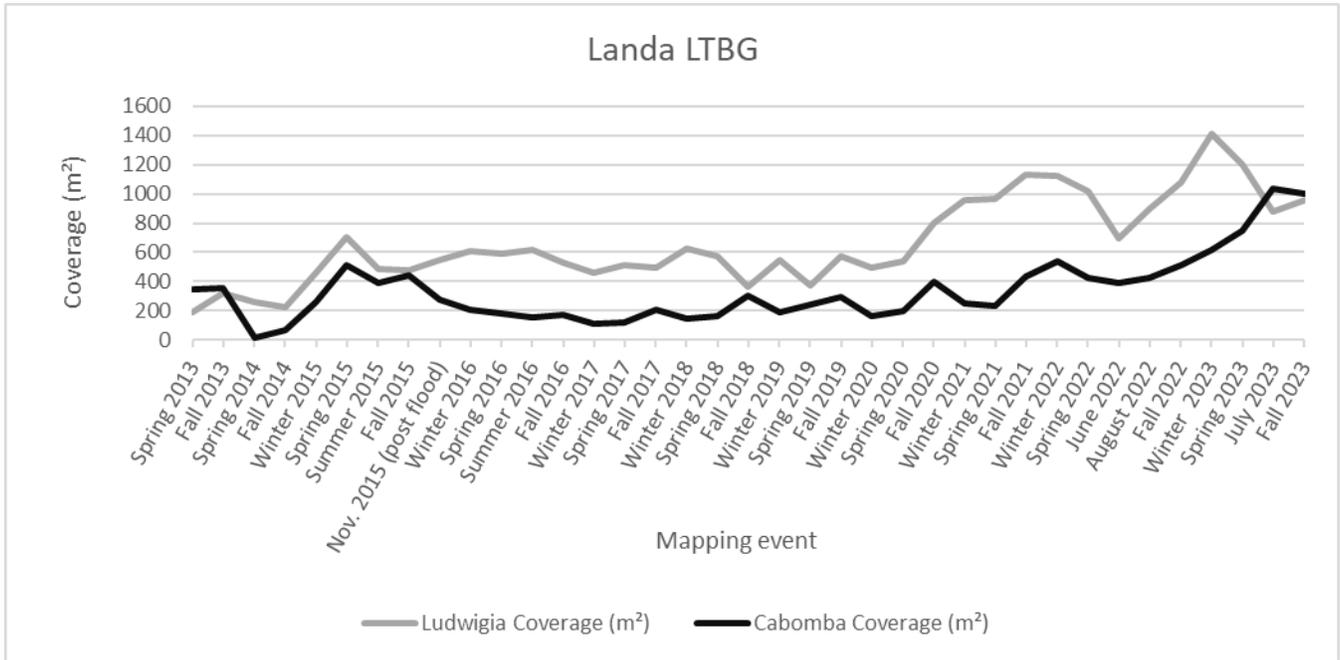
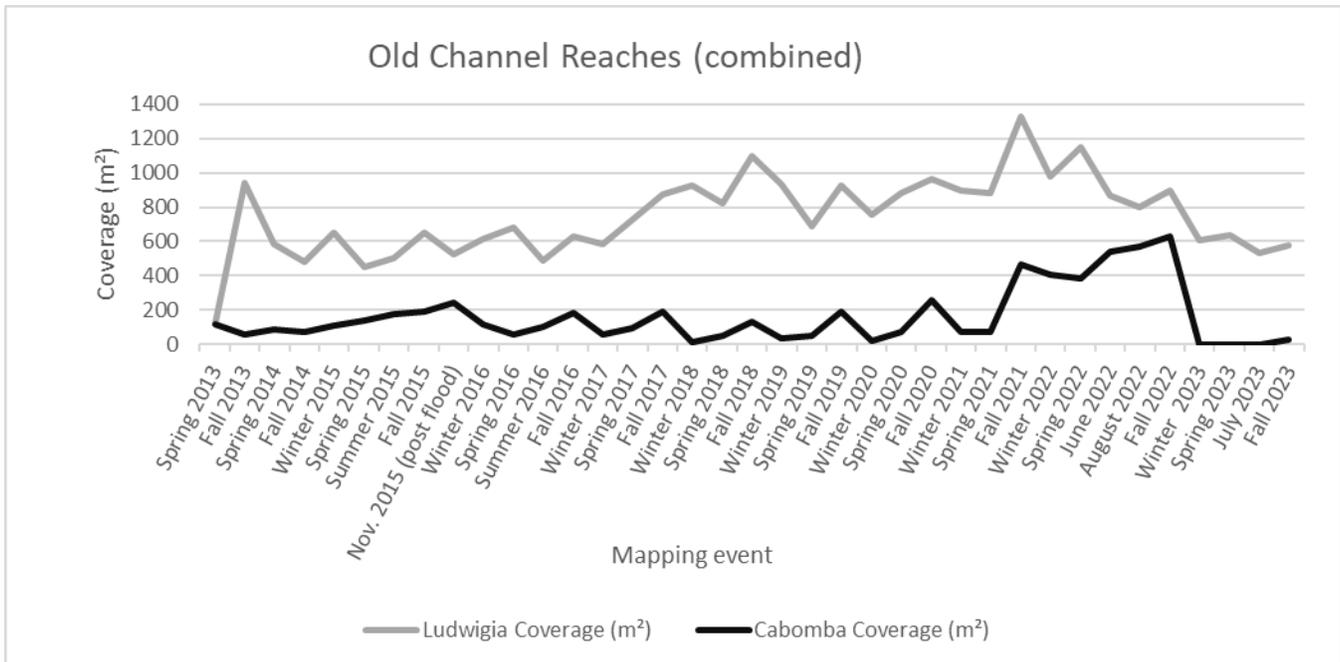
Figure 19 The ten-year trend for coverages for Ludwigia and Cabomba in the Landa Lake LTBG Reach (top) and the combined reaches of the Old Channel (bottom).

Figure 19 tracks the long-term changes in Ludwigia and Cabomba coverage since restoration began in 2013. These graphs highlight the inherent fluctuation in coverage of these two species. There are several explanations for this pattern. First, senescence is a natural process in which plants undergo a reduction in biomass as a seasonal reaction (reduced daylight, cooler water temperatures) or a life cycle change (maturation, post-blooming). Senescence can also be a response to changes in growing conditions. A strong senescence period was seen in June 2023 when low flow conditions set in. Inevitably, this caused a reduction in plant biomass. Sometimes the plants habituate to the changing conditions and may recover, while at other times, senescence leads to death as the plant has entered its final life stage and lacks the energy to recover. Second, loss of cover can be caused by competition and later complete exclusion due to the expansion of other, more aggressive native species, as previously detailed. These

making consistent year to year coverage difficult. In Landa Lake, the trend in coverage for Ludwigia and Cabomba is generally increasing. The alteration in methodology toward creating larger contiguous

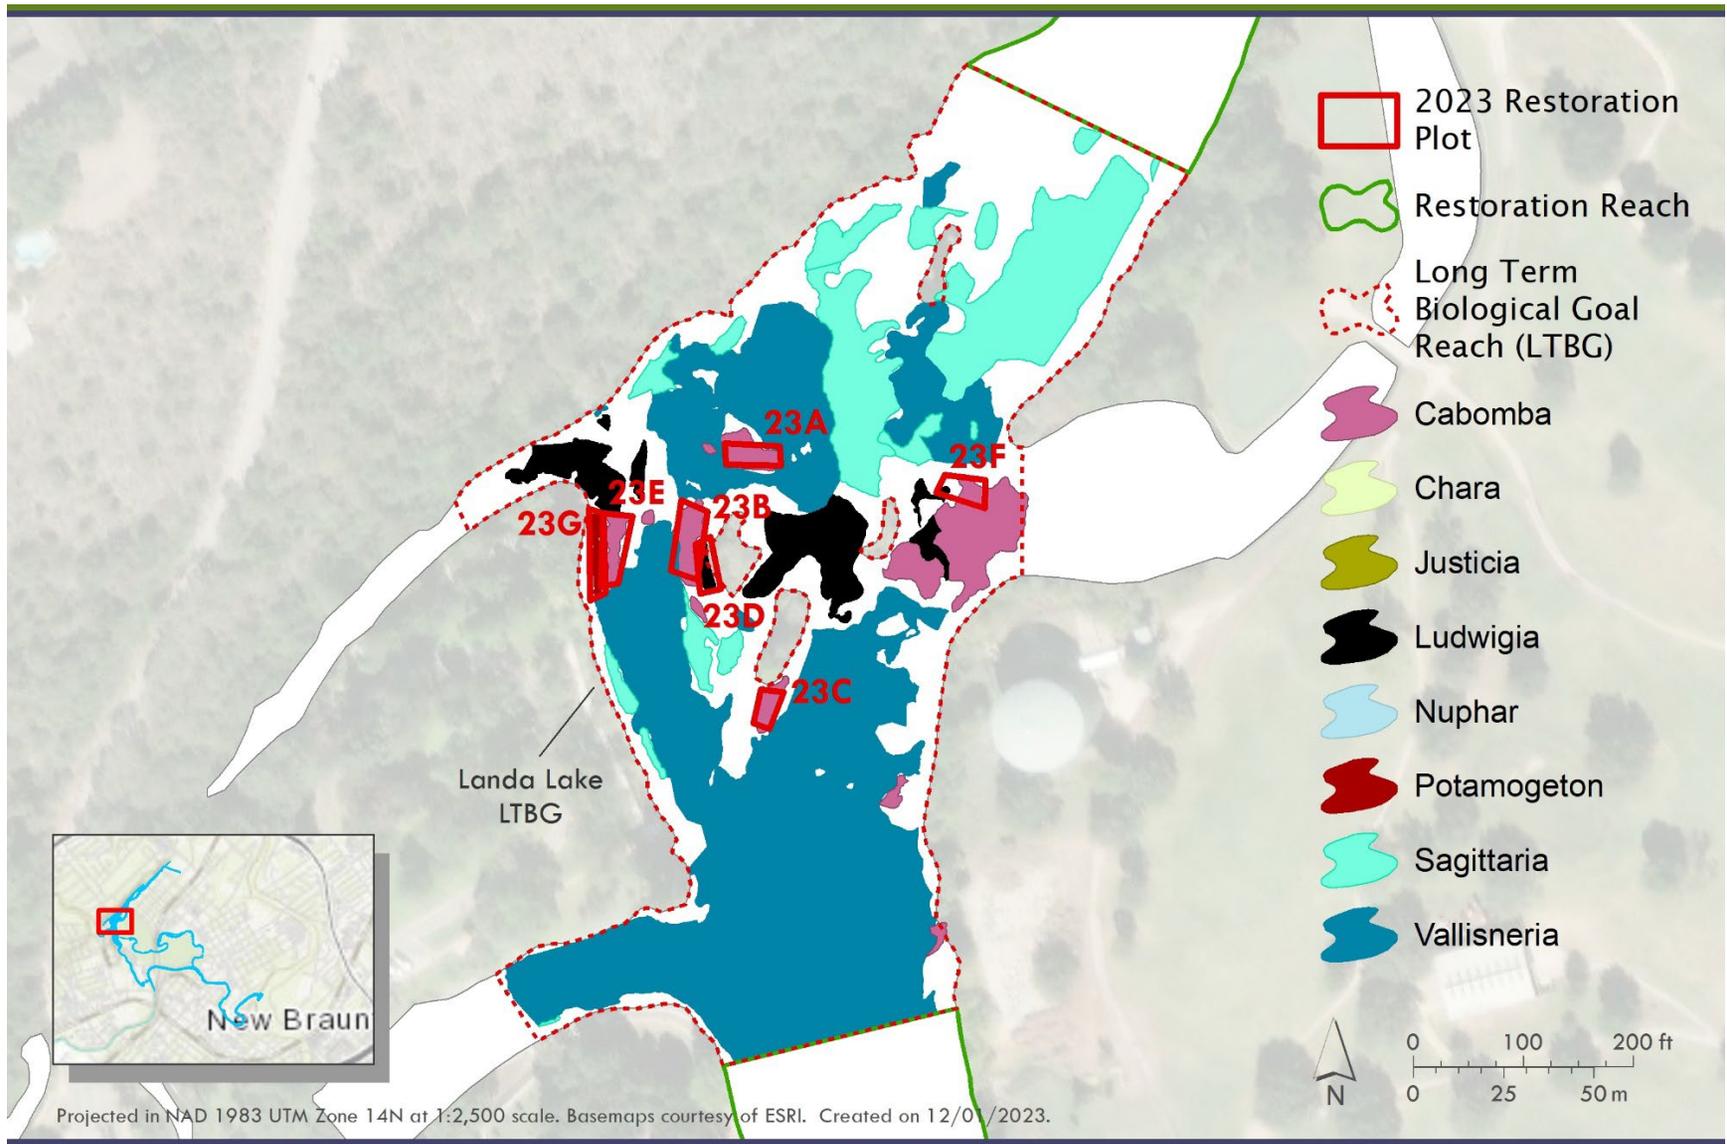
Figure A1 Plots planted in Landa Lake LTBG in 2023 and their resulting vegetation cover in fall 2023.

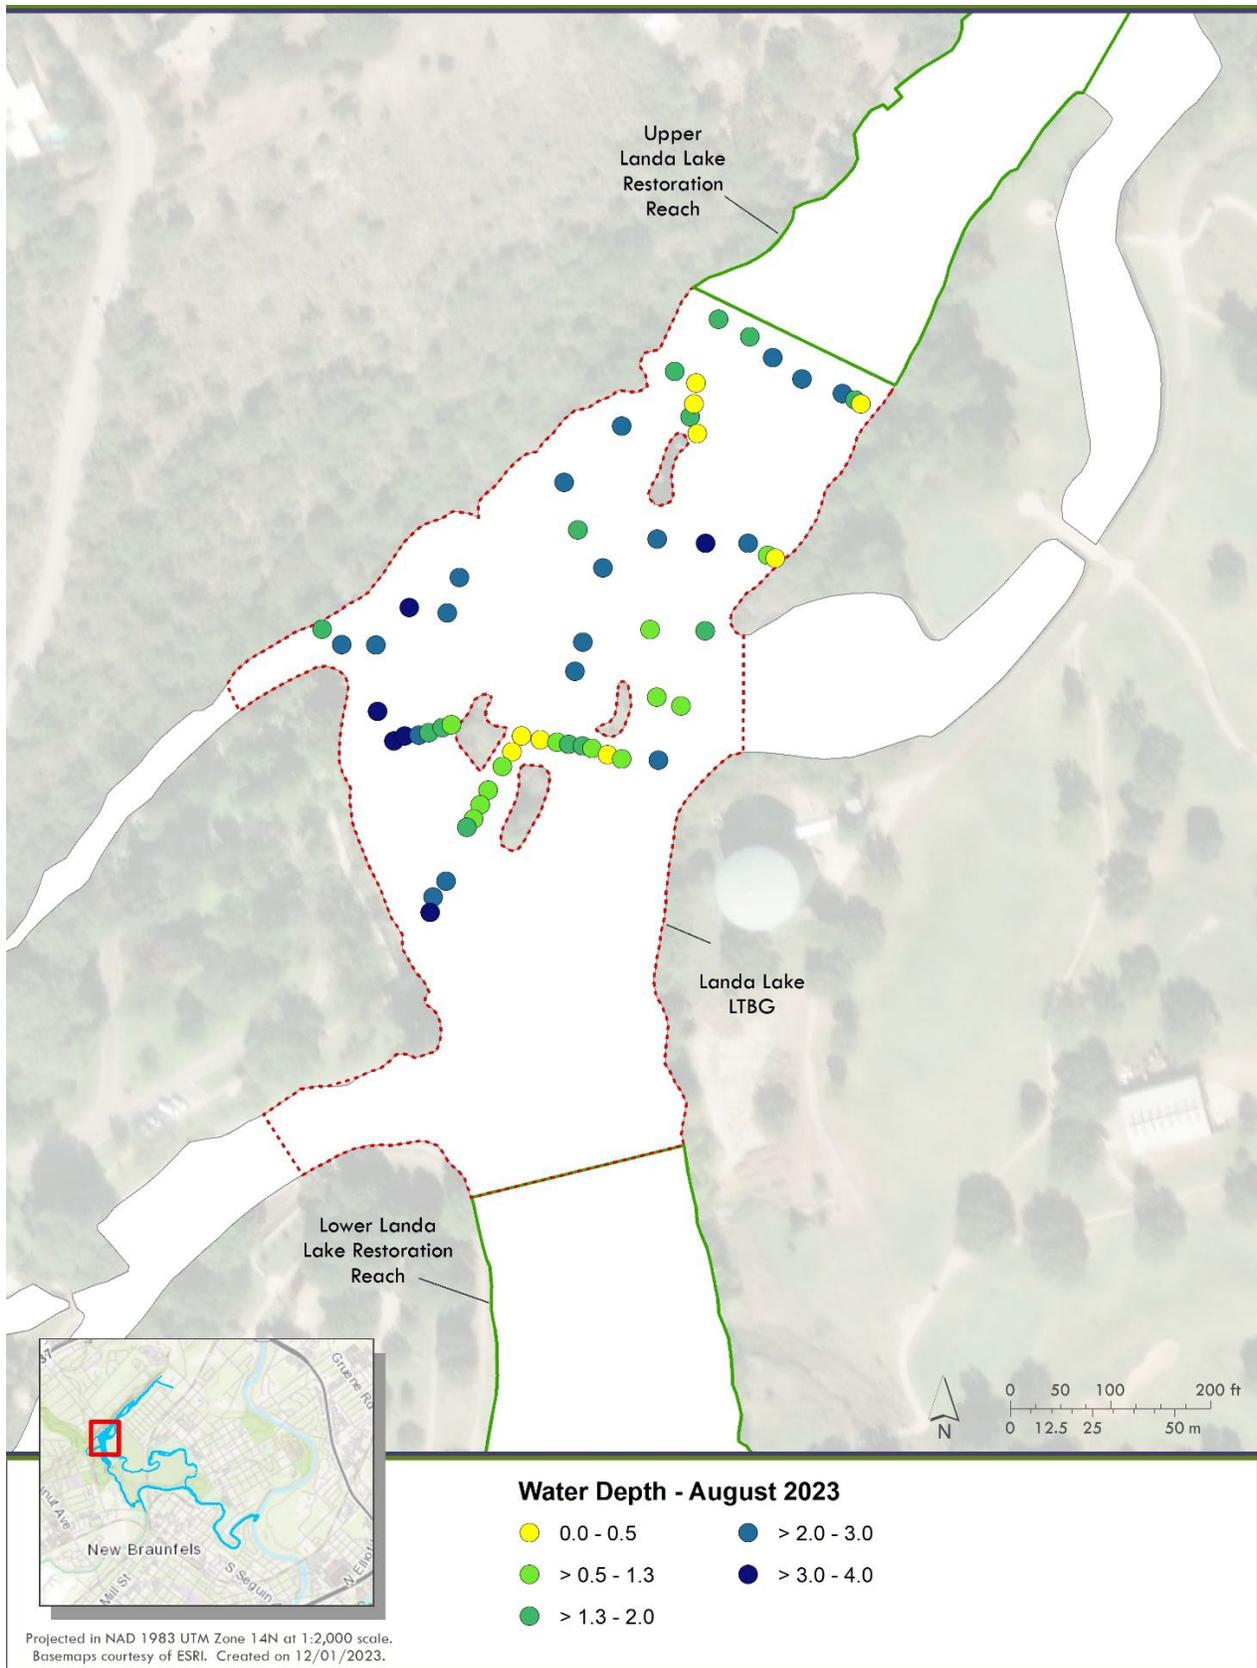
Figure B1 Measured water depths (ft) in Landa Lake in September.

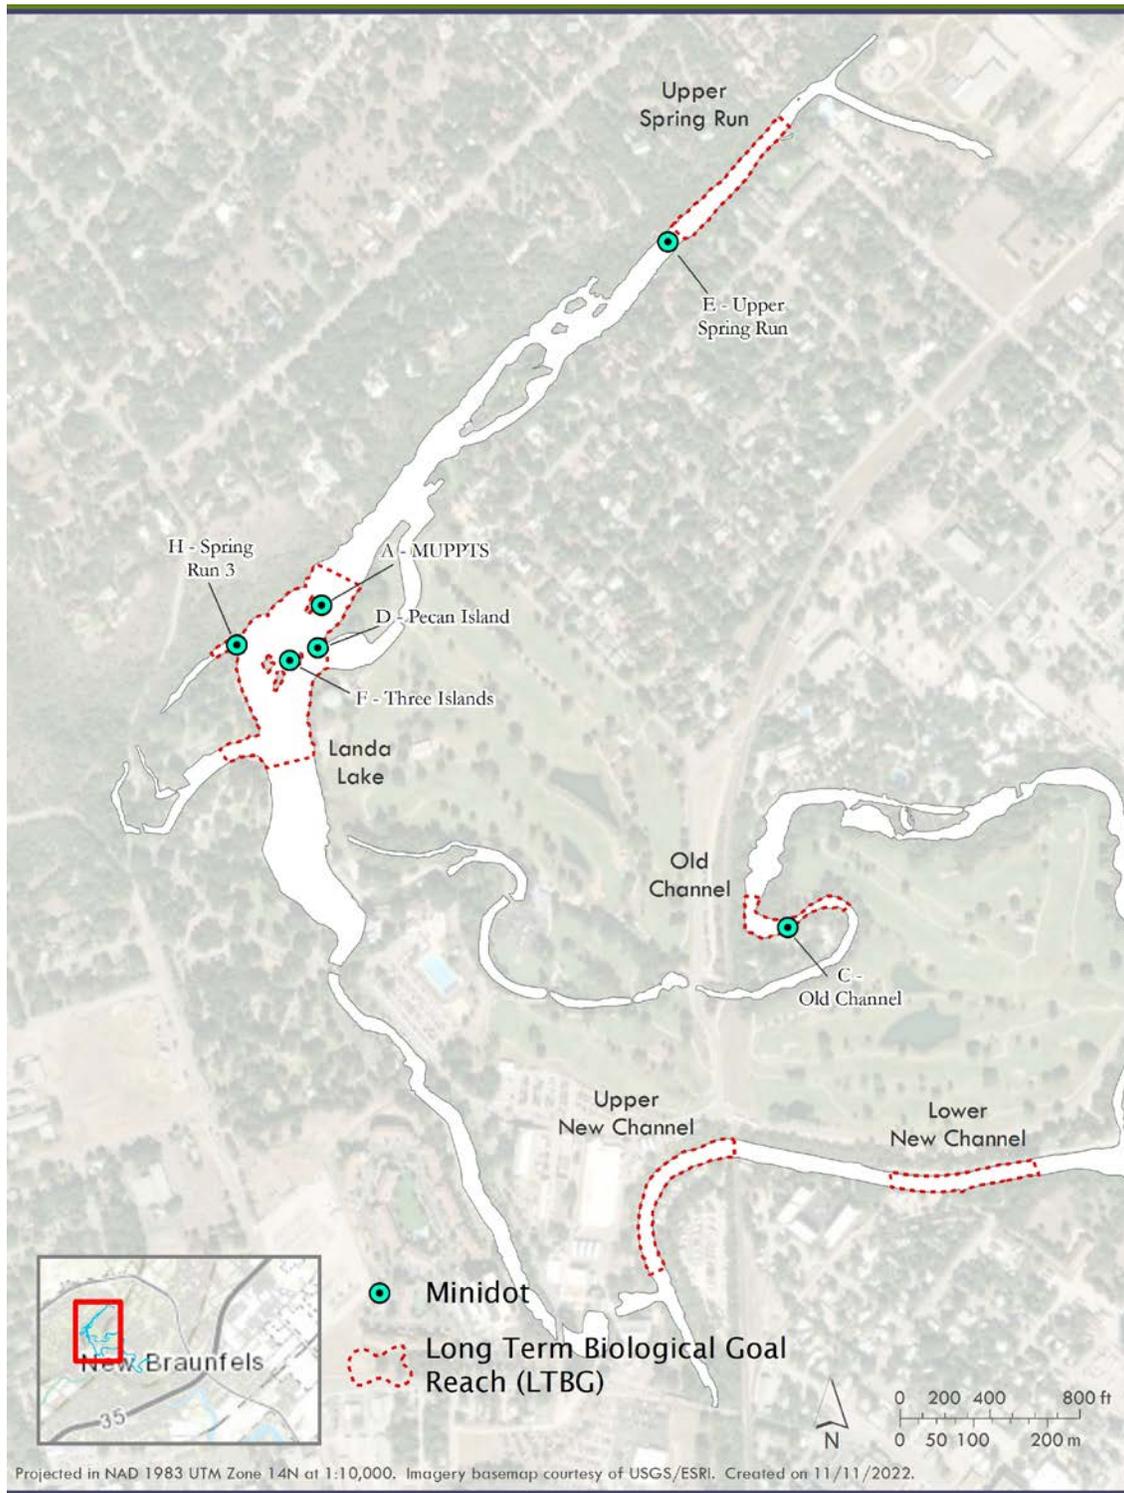
Figure 1. Six Dissolved Oxygen continuous monitoring Low flow sites in the Comal System.

Six strategic locations were again used in 2023 based on previous years sampling and continuously monitored when total system discharge declined below 100 cfs during the summer and early fall months. The six sites include one in the Upper Spring Run, four in Landa Lake, and one in the Old Channel (**Figure 1**).

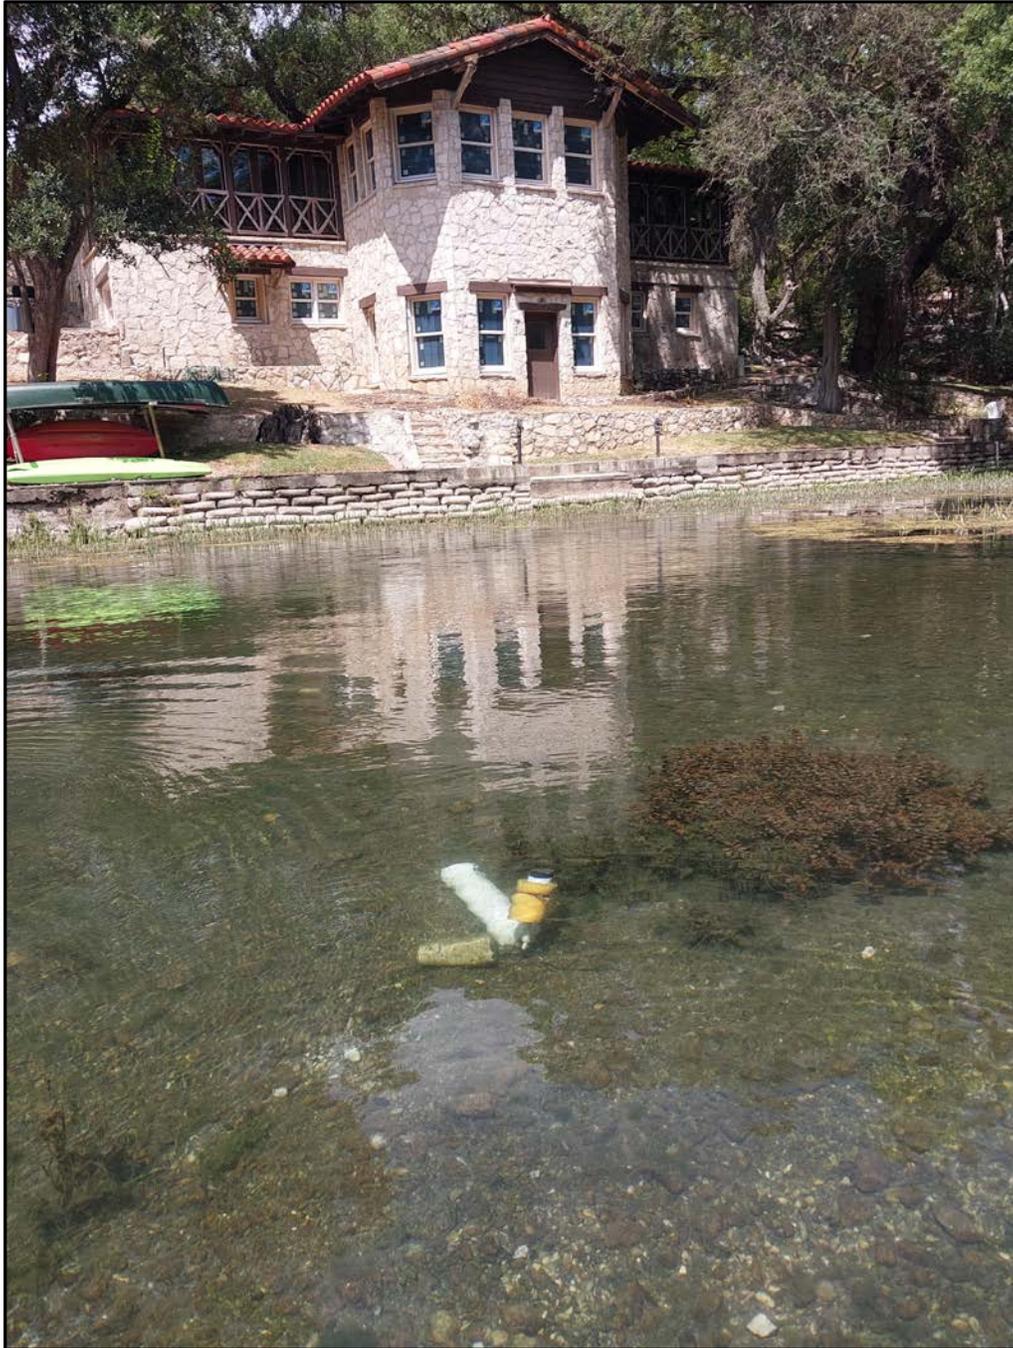
Figure 2. MiniDOT sonde deployed at Upper Spring Run Study Site.

With coordination and approval from the City of New Braunfels, BIO-WEST deployed all six MiniDOT sondes on July 21, 2023. Figure 2 shows a MiniDOT sonde deployed at the Upper Spring Run site. Solid anchoring devices were again used in 2023. The sensors were purposely installed just off the bottom to examine the portion of water column utilized directly by the Fountain Darter.

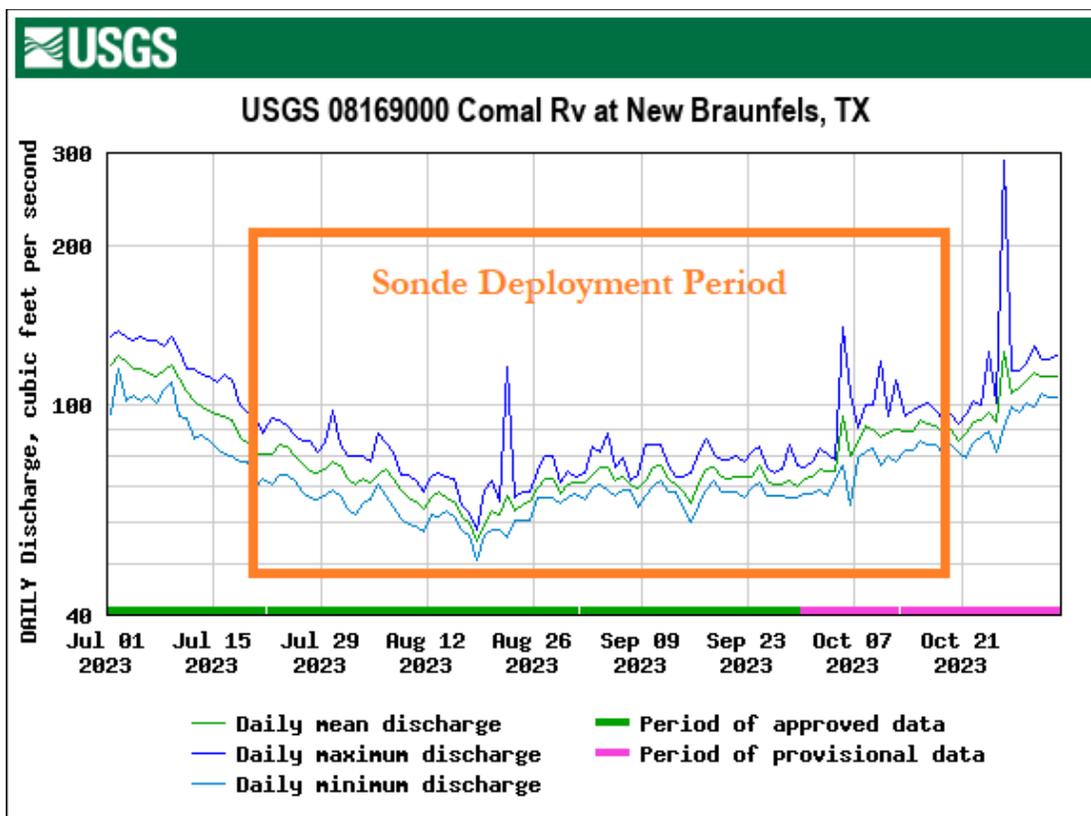
Figure 3. USGS recorded Total System Discharge at Comal River at the New Braunfels USGS gage over the MiniDOT deployment.

During the July 21st through October 17th deployment period, MiniDOTs were downloaded multiple times and cleaned approximately once per week in between downloads. Data for the Spring Run 3 location was only available through August 11th, as it was unfortunately stolen the following week. The remaining five sondes were downloaded, retrieved, cleaned and stored in late-October following an increase in Comal Total System Discharge to 100 cfs (**Figure 3**).

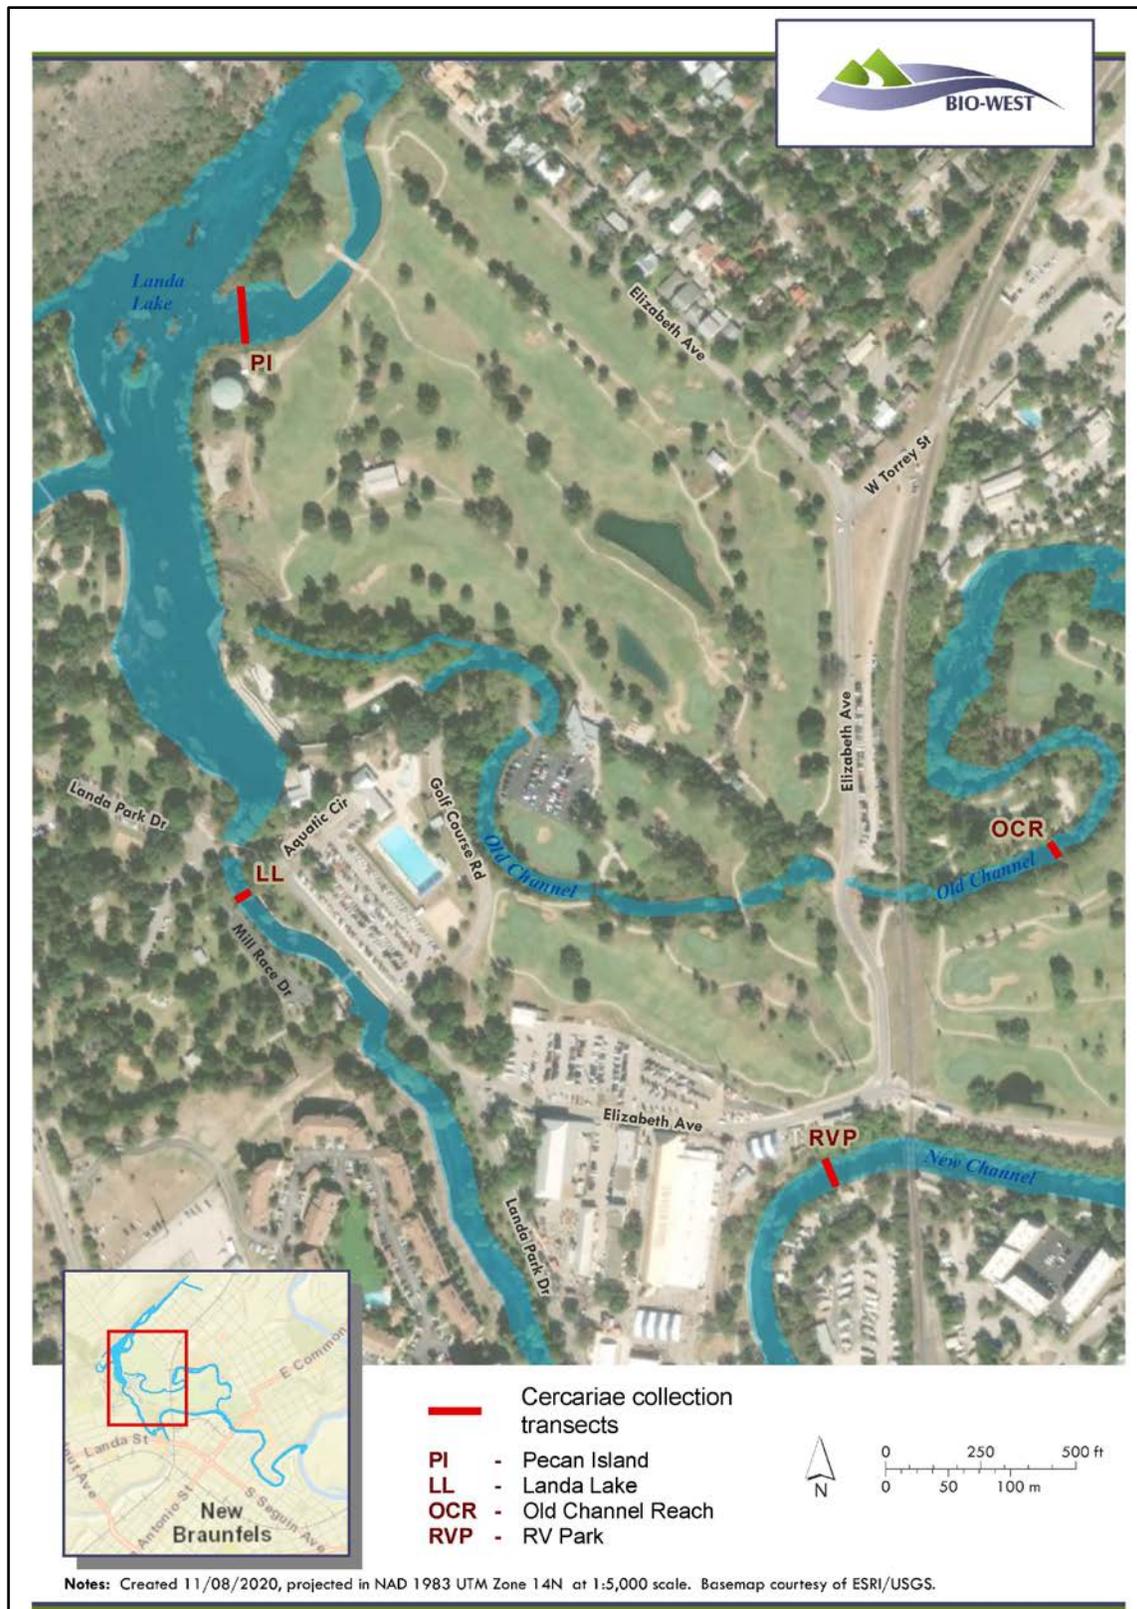
Figure 1. Map of cercariae collection transects in the Comal River system.
