Appendix H | 2023 City of New Braunfels Reports

Appendix H1 | **Native Aquatic Vegetation Restoration in the Comal River System**

2023 Native Aquatic Vegetation Restoration and Maintenance in the Comal River

**BIO-WEST, Inc.
1812 Central Commerce Court
Round Rock, Texas 78664**

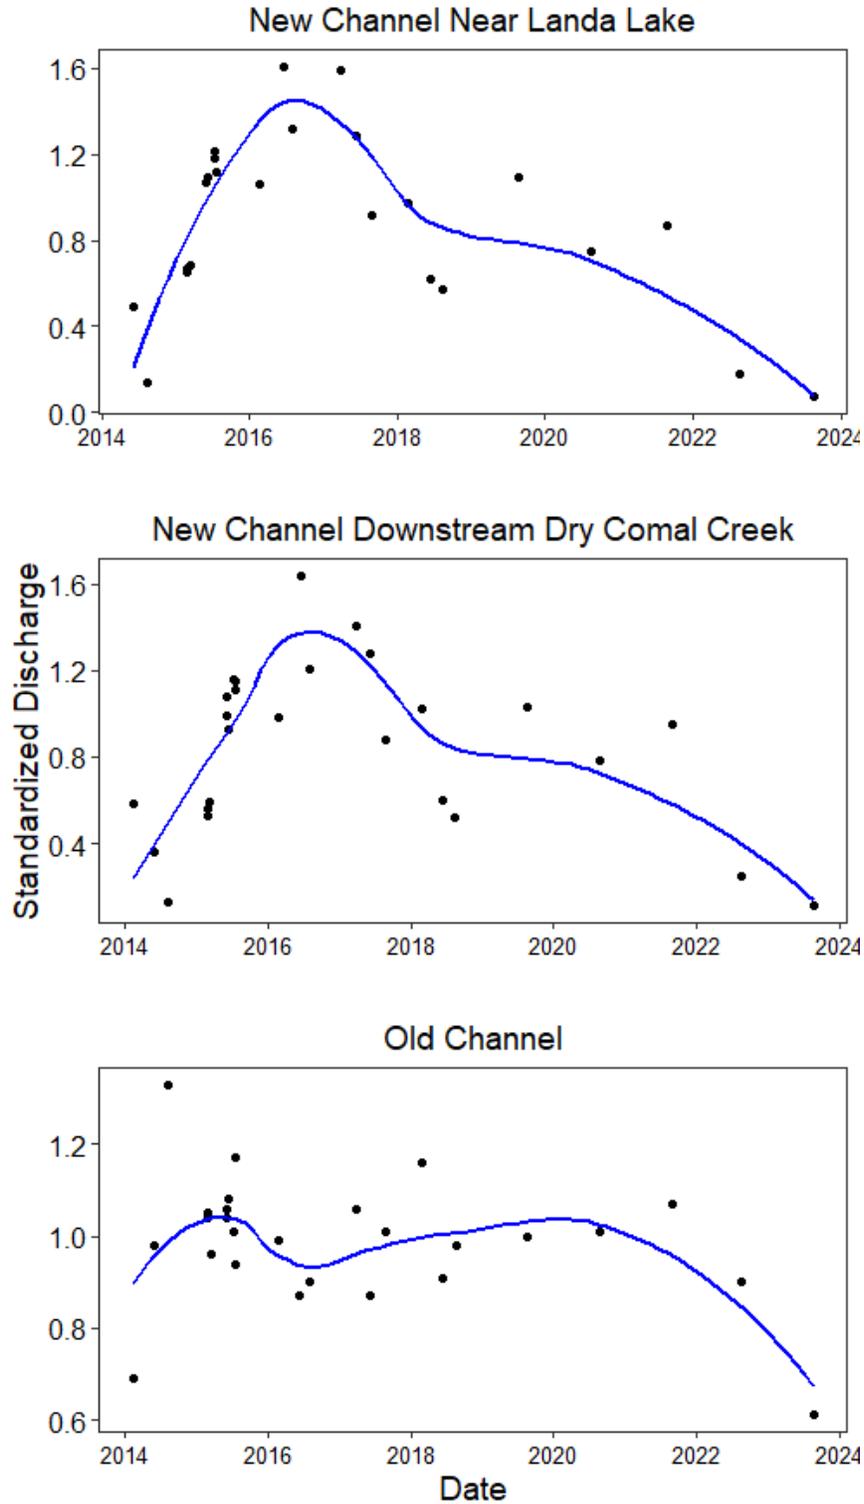
Figure 2. Times series displaying trends in standardized discharge during parasite monitoring at PI (top panel), LL (top panel), RVP (middle panel), and OCR (bottom panel). The blue line denotes LOESS smoothed regression fitted to observed standardized discharge values (black dots).

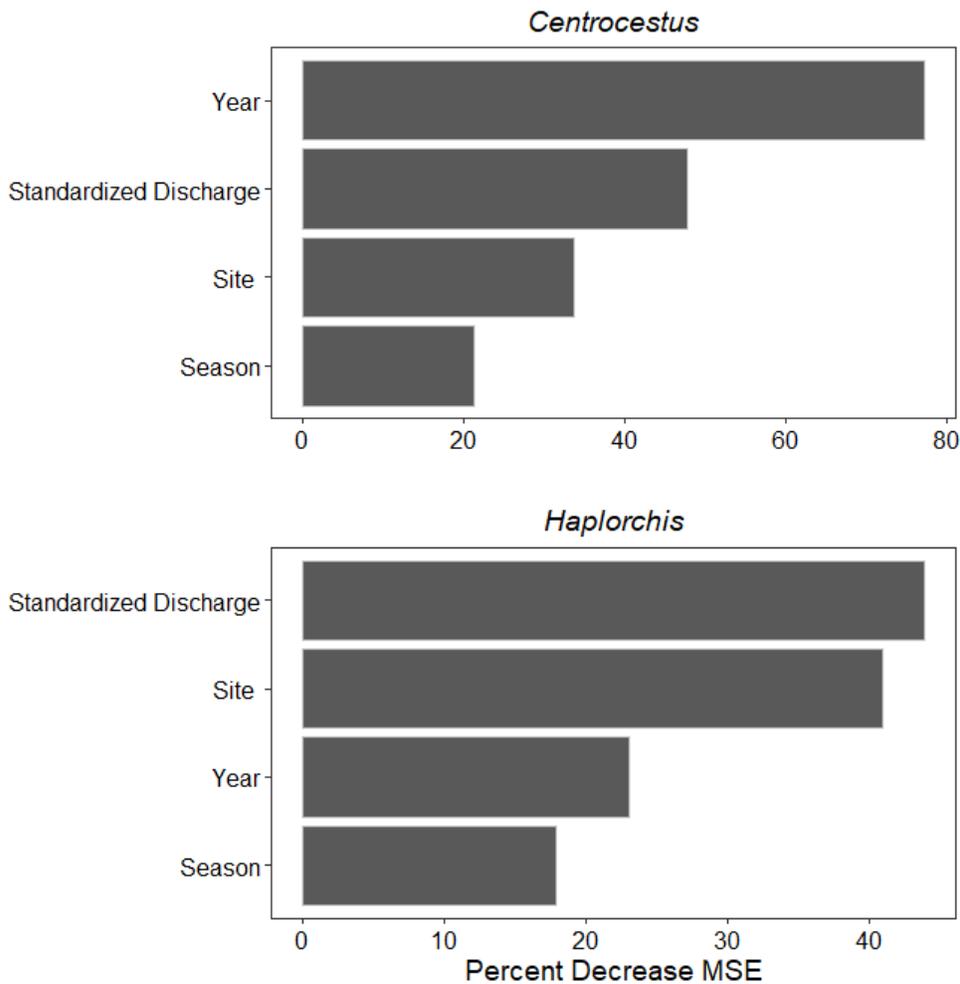
Figure 3. Bar graph displaying the percent decrease in mean squared error (MSE) of variables used to predict *Centrocestus formosanus* and *Haplorchis pumilio* density in the Comal Springs/River system.

density, though site was more important in 2023 and had an effect size similar to standardized discharge; both were more influential than year. Despite differences in predictor importance, density relationships with standardized discharge and year displayed similar trends with past analyses. Cercariae density displayed a negative nonlinear relationship with standardized discharge, which confirms expectations regarding parasite-flow relationships. If cercariae production is assumed constant, densities naturally become diluted under high flow conditions and thus would be expected to increase at lower flows. That being said, the increased importance of year on predictive performance of *C. formosanus* density suggests other environmental and/or biotic mechanisms unaccounted for by the model have resulted in decreased densities of this species over time. Additionally, lower percent variation explained for *H. pumilio* indicates other important covariates not included in this analysis are likely missing for this species.

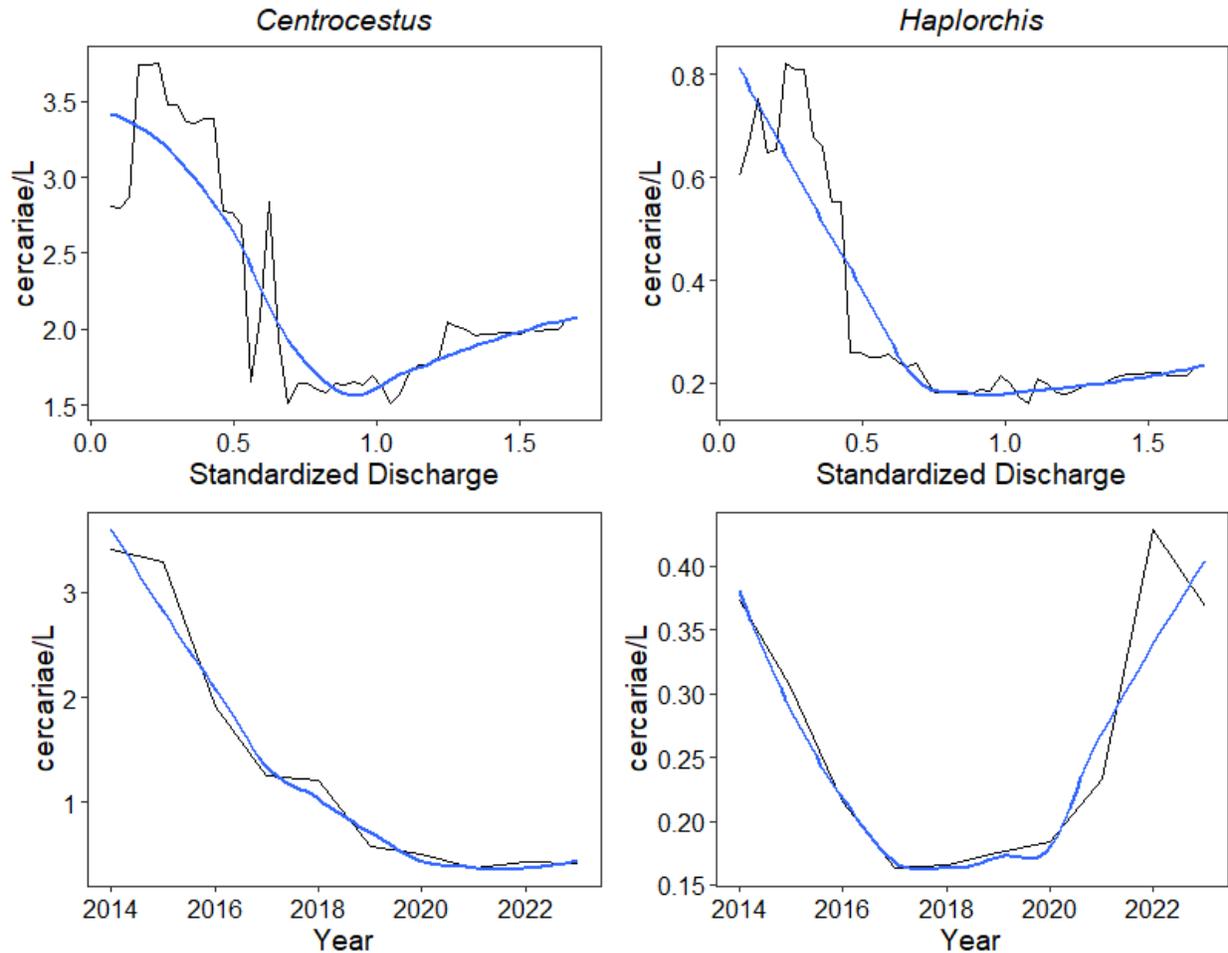
Figure 4. Partial dependence plots displaying the response of cercariae density as a function of standardized discharge and year for *Centrocestus formosanus* and *Haplorchis pumilio* in the Comal Springs/River system. The blue line denotes a loess smoothed regression of the fitted function. Note differences in y-axis scales for each panel.

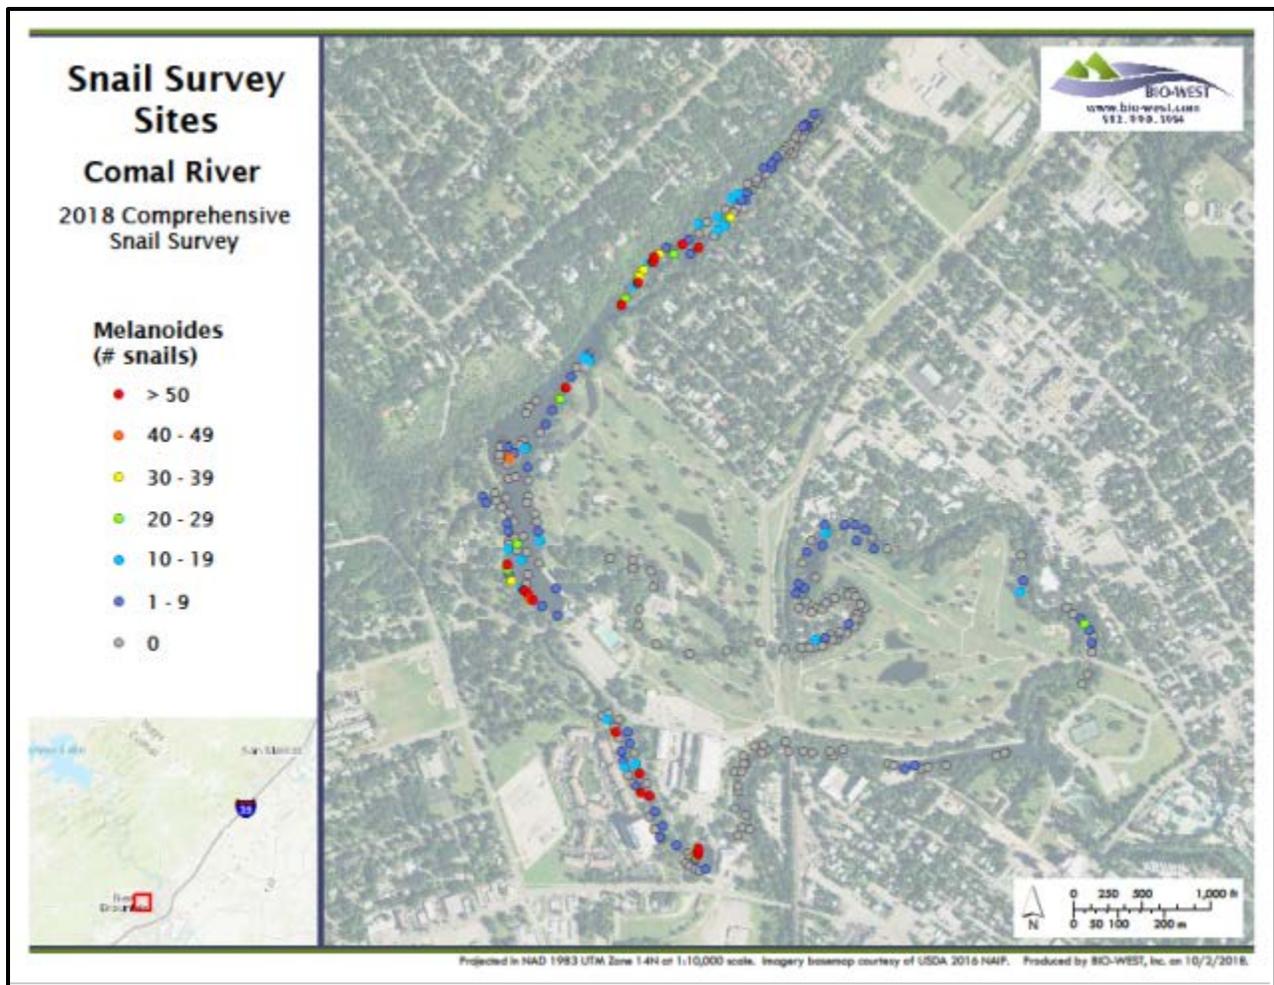
Figure 5. 2018 comprehensive survey of *M. tuberculata* in the Comal River.

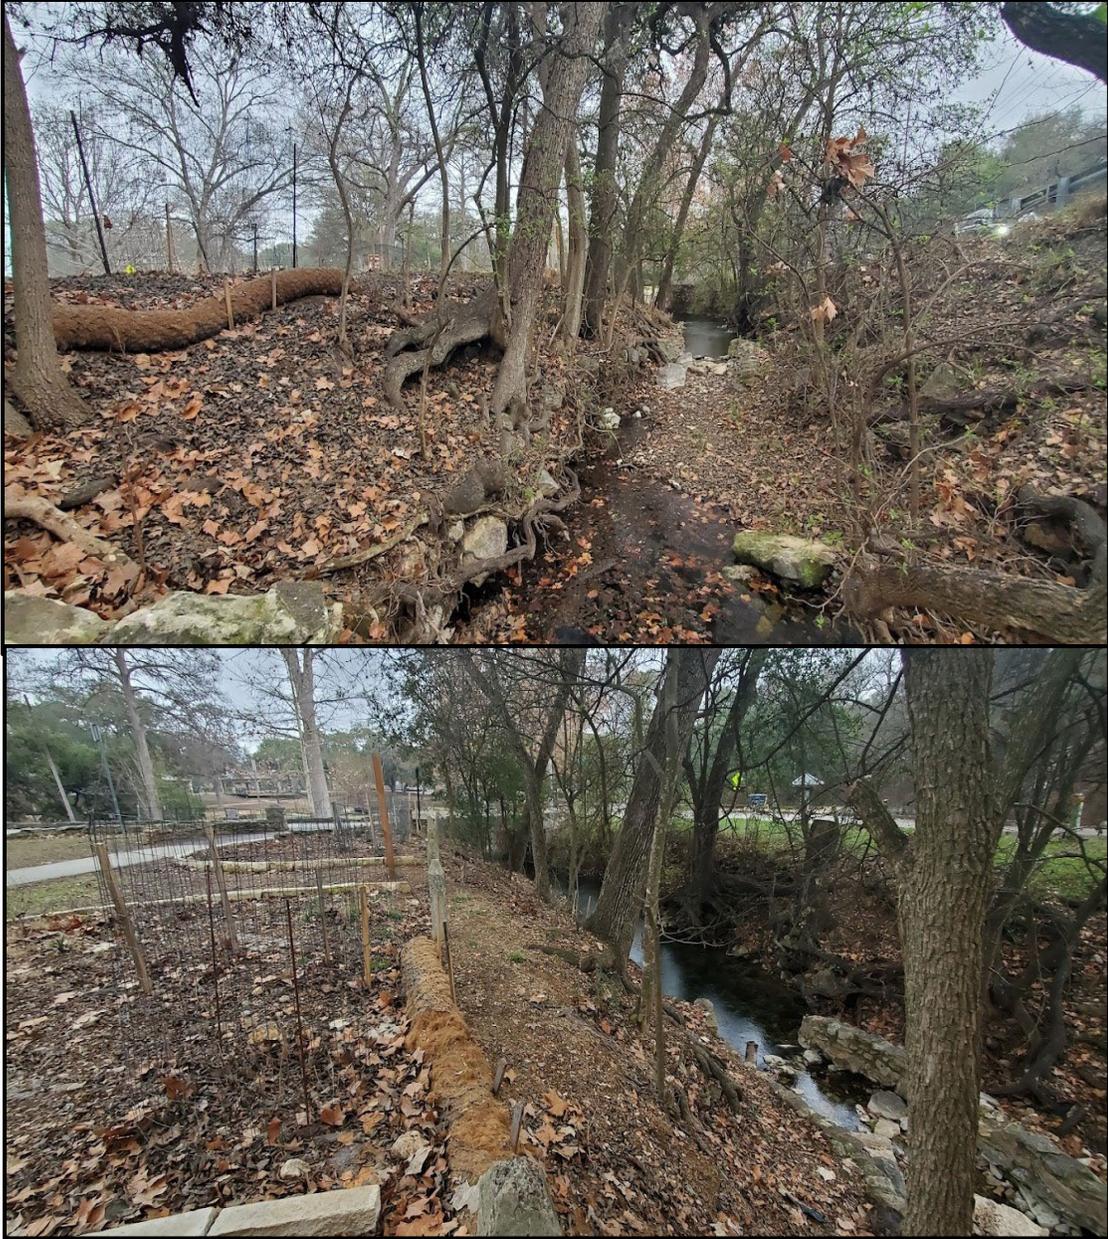
Figure 1. Spring run 2 slope and beds in the winter of 2023.

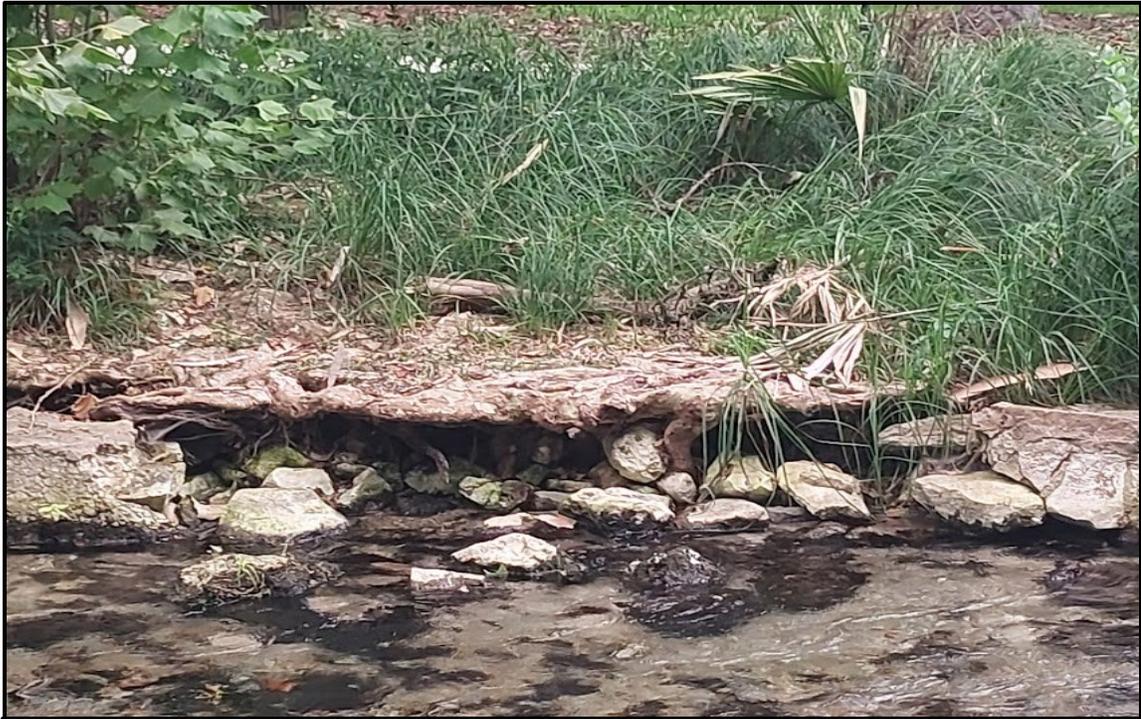
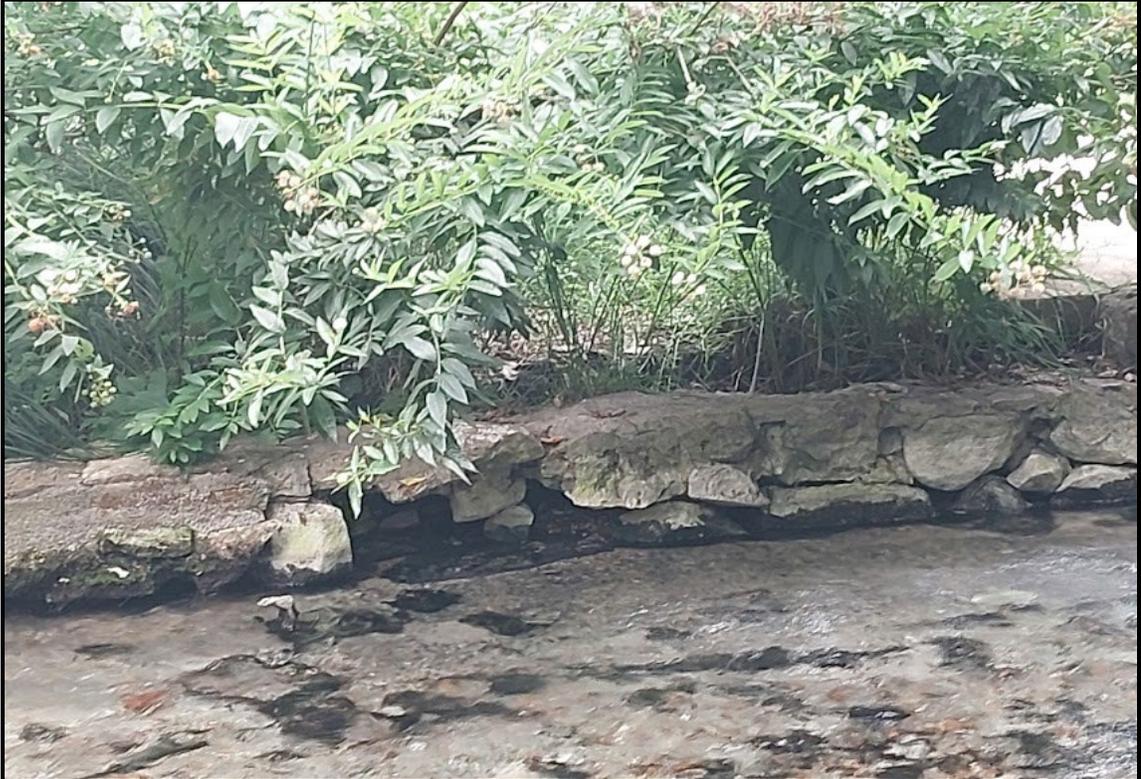
Figure 2. Low water levels have undermined several portions of the rock wall along Spring run 3. Some areas of the wall have completely caved in undermining vegetation roots. Areas like this are susceptible to collapse and further erosion.

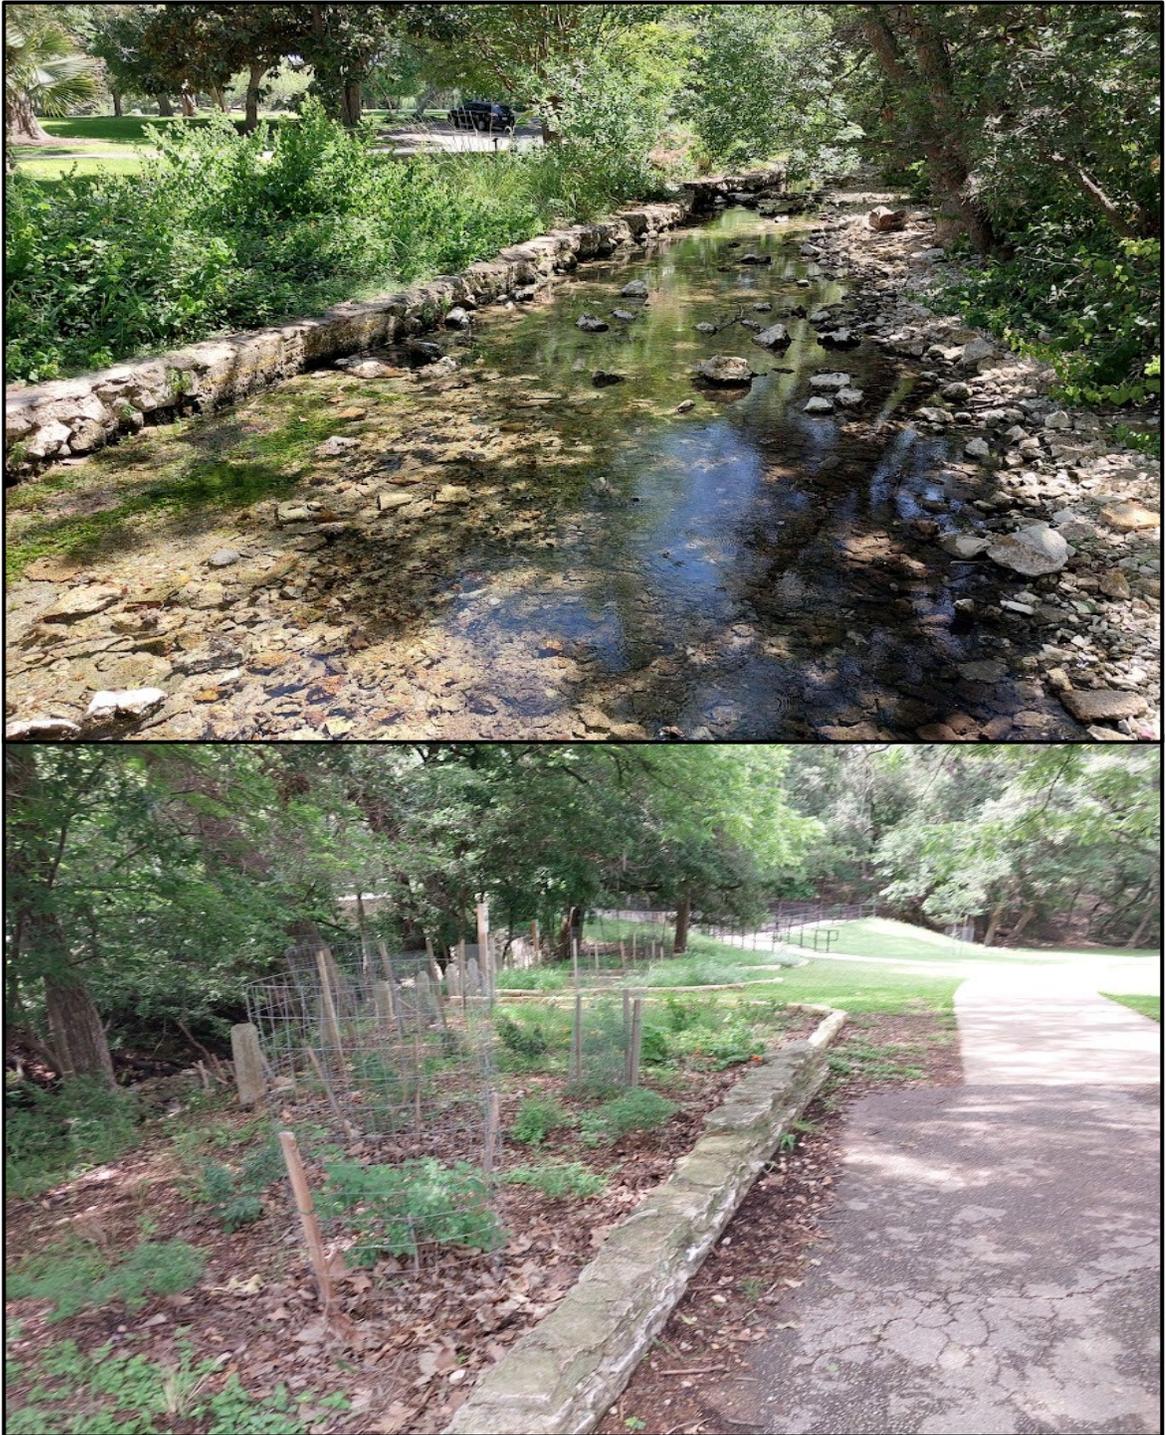
Figure 3. Vegetation buffer along Spring run 2 during one of the lowest discharge rates for Comal Springs (top). Area along Spring run 2 during growing season (bottom).

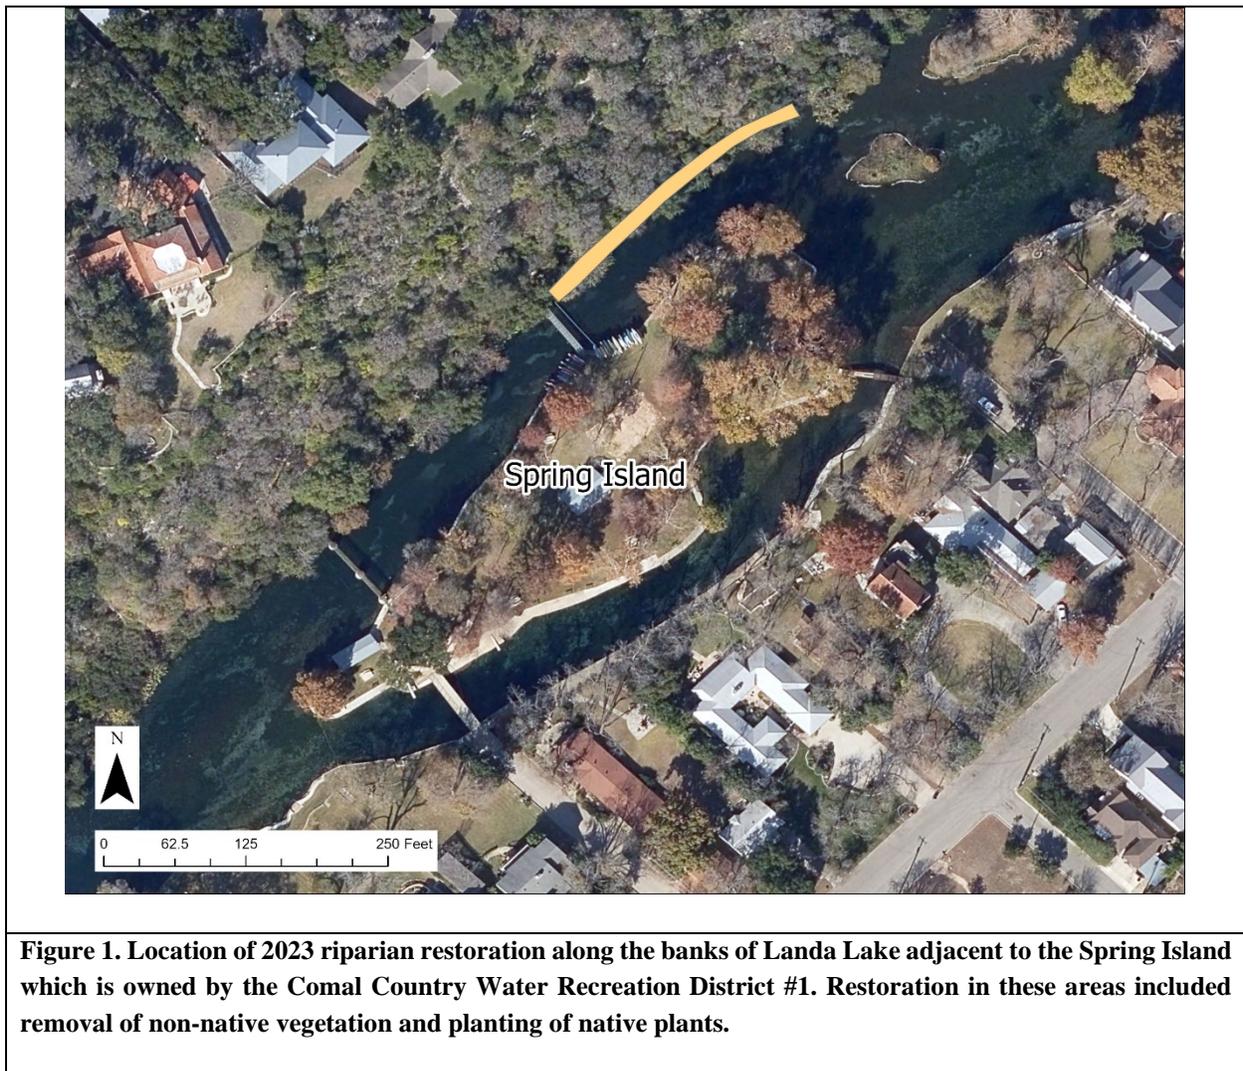
Figure 1. Location of 2023 riparian restoration along the banks of Landa Lake adjacent to the Spring Island which is owned by the Comal County Water Recreation District #1. Restoration in these areas included removal of non-native vegetation and planting of native plants.

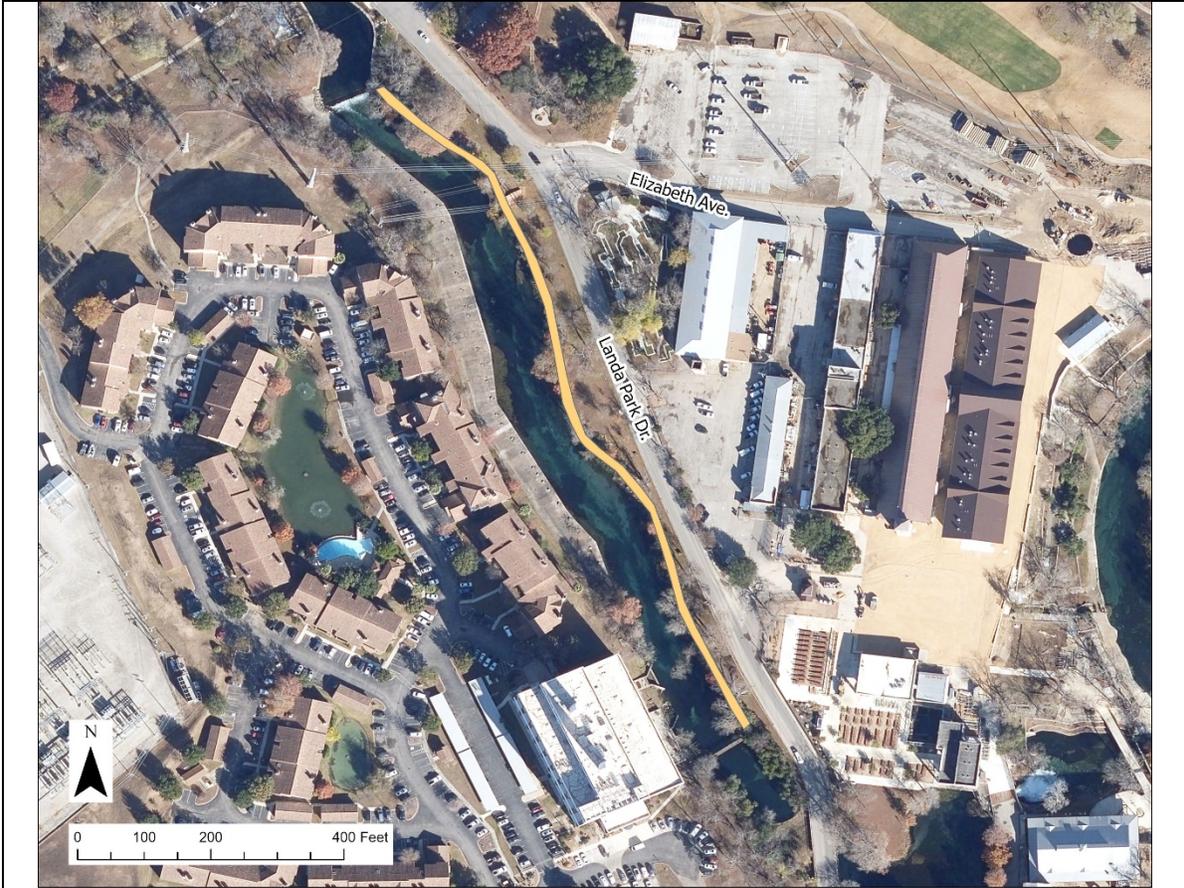
Figure 2. Location of 2023 riparian restoration along New Channel/ Mill Race of the Comal River. Restoration in this area to include removal of non-native vegetation, installation of erosion/ sediment control berms, and planting of native plants.

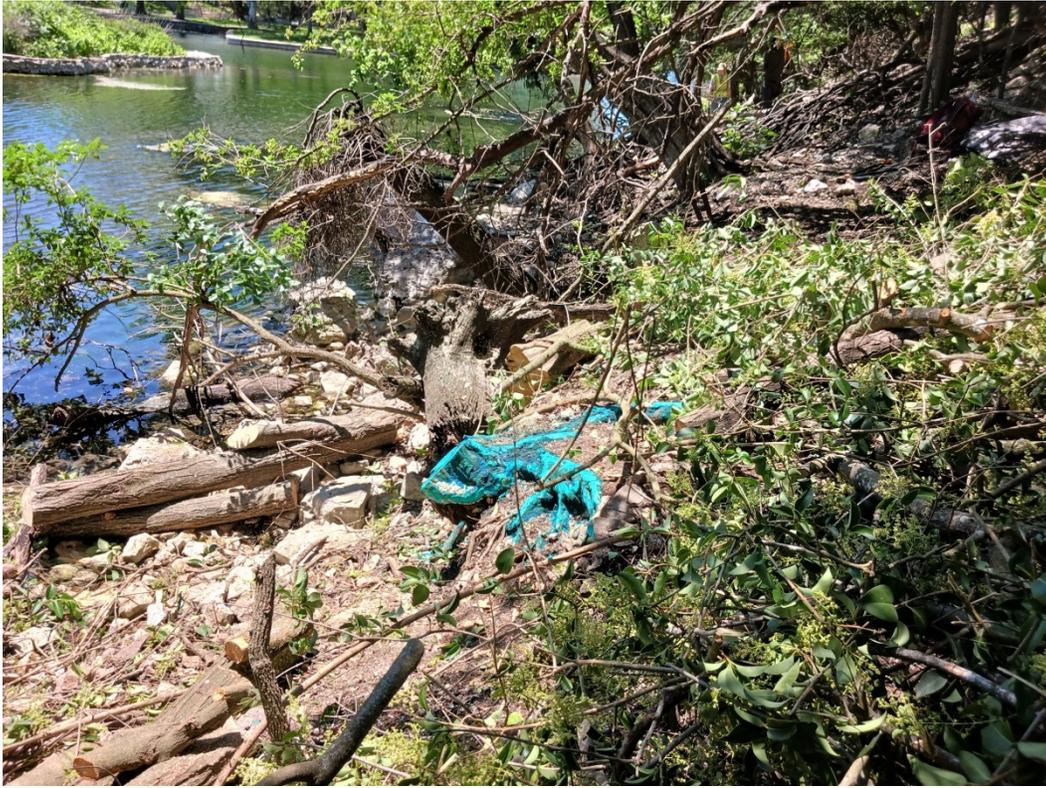
Photo 1 Example photo of a treated stump of a Ligustrum near Spring Island (Figure 1).

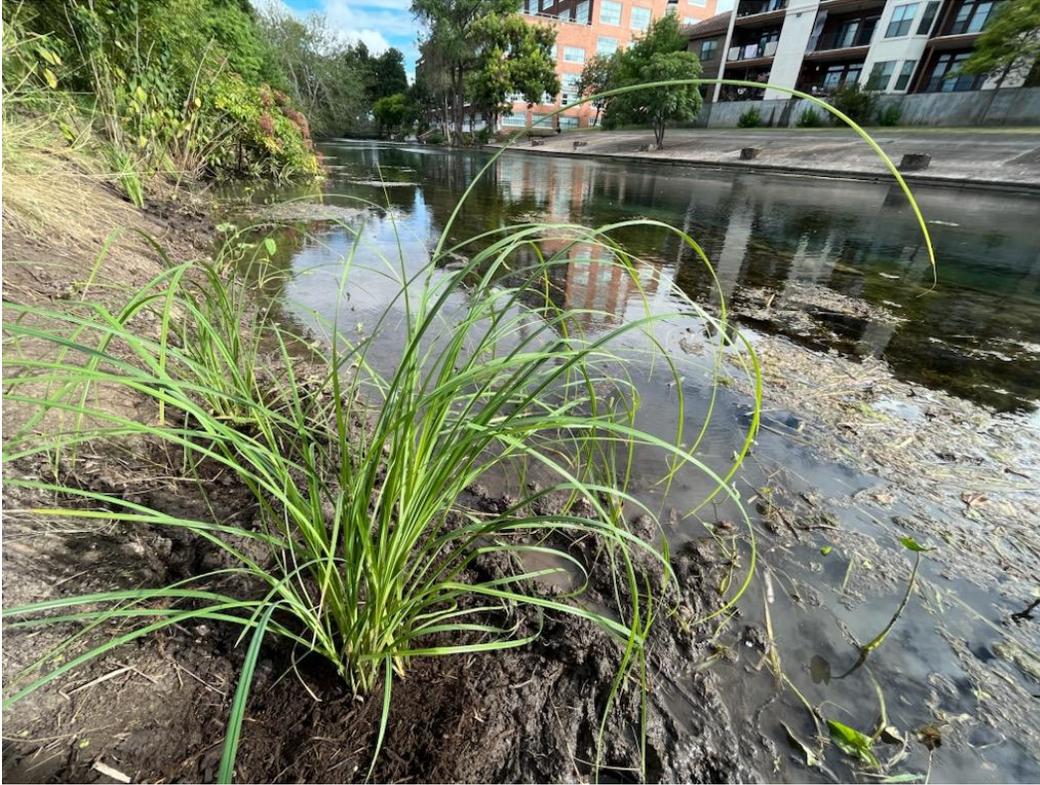
Photo 2. Photo of a newly-planted Emory Sedge along Mill Race in Landa Park (Figure 2).

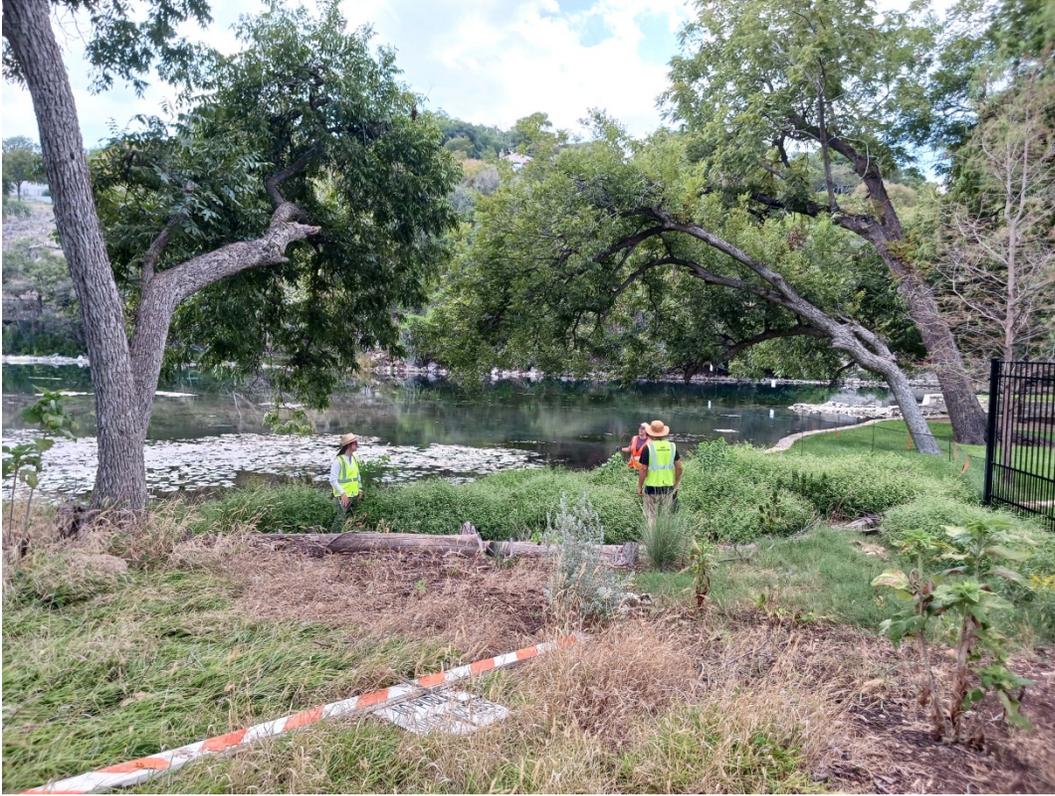
Photo 3. Photo of contractors removing various nonnative plant species near Spring Island (Figure 1).

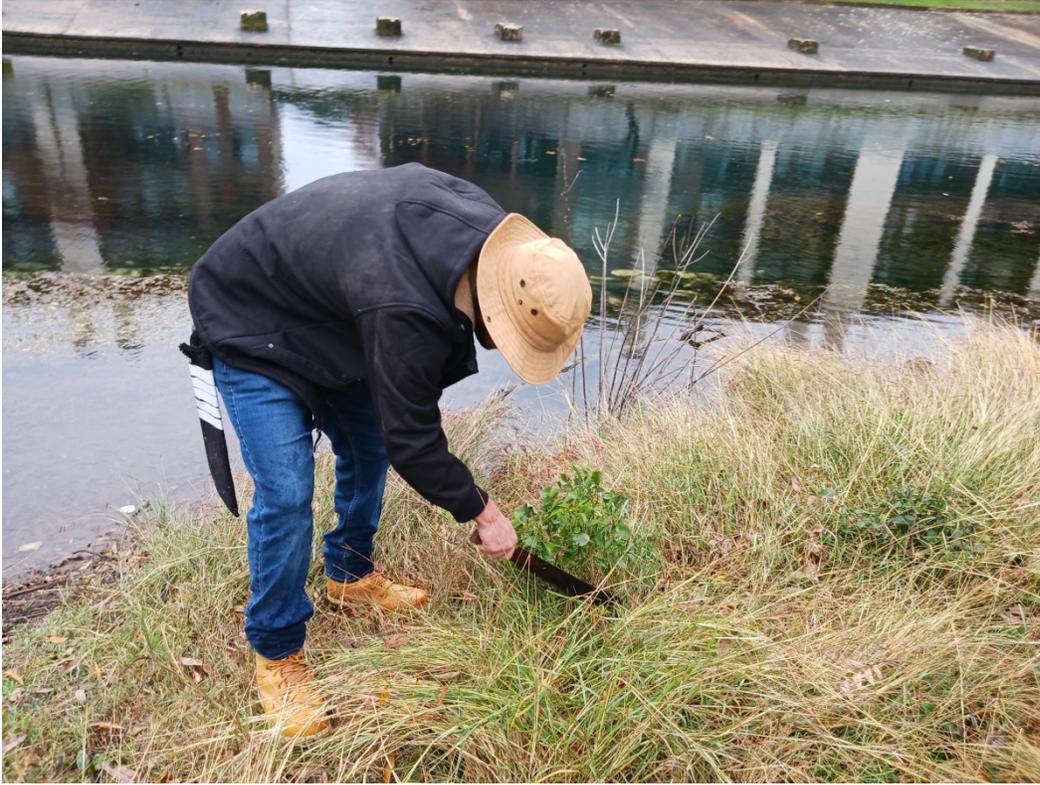
Photo 4. Photo of contractor planting a Texas Mountain Laurel along Mill Race in Landa Park (Figure 2).

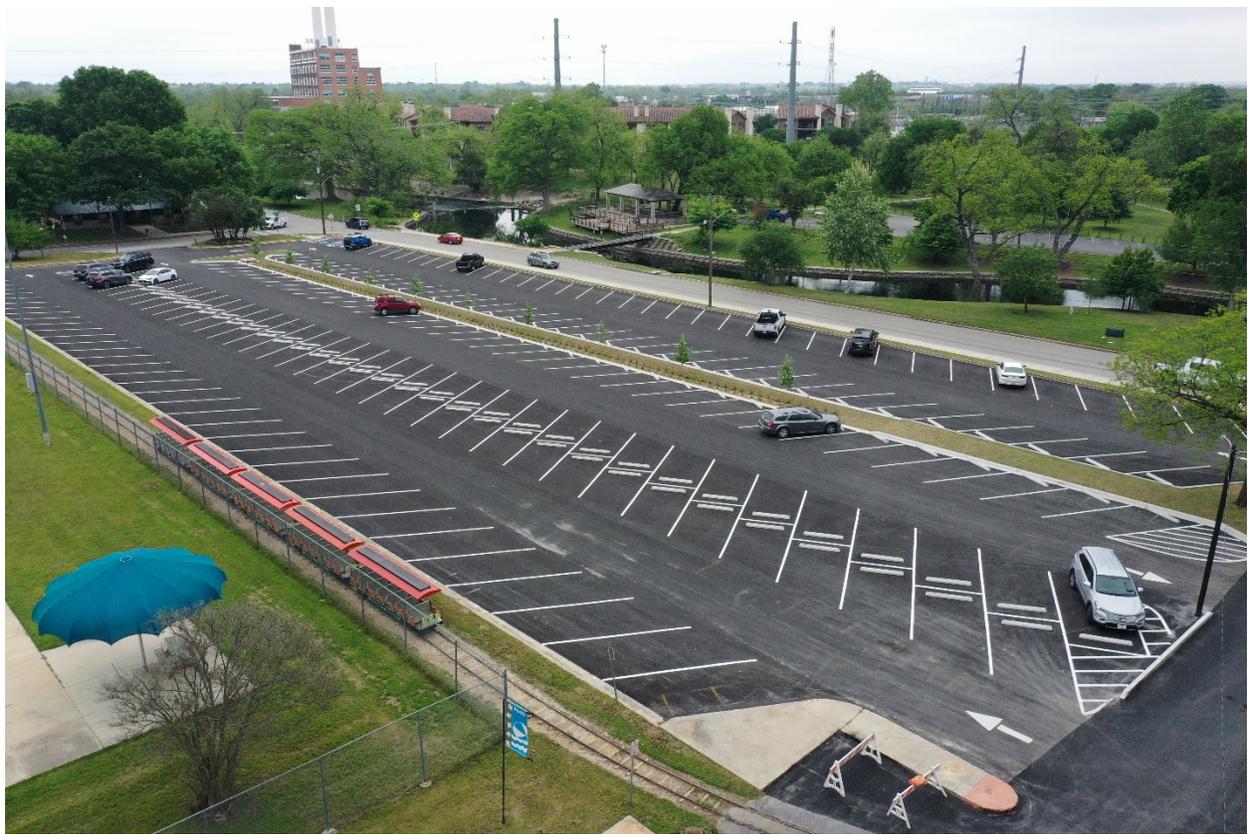
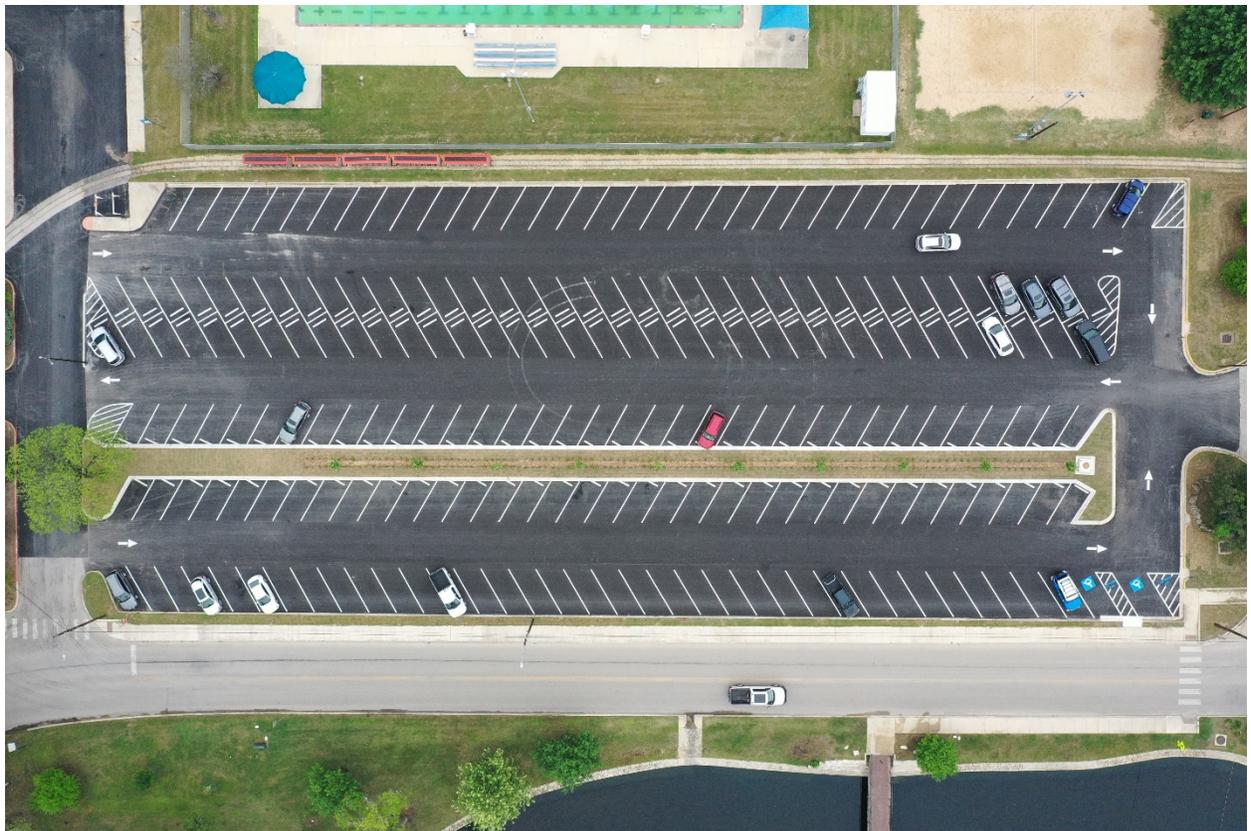
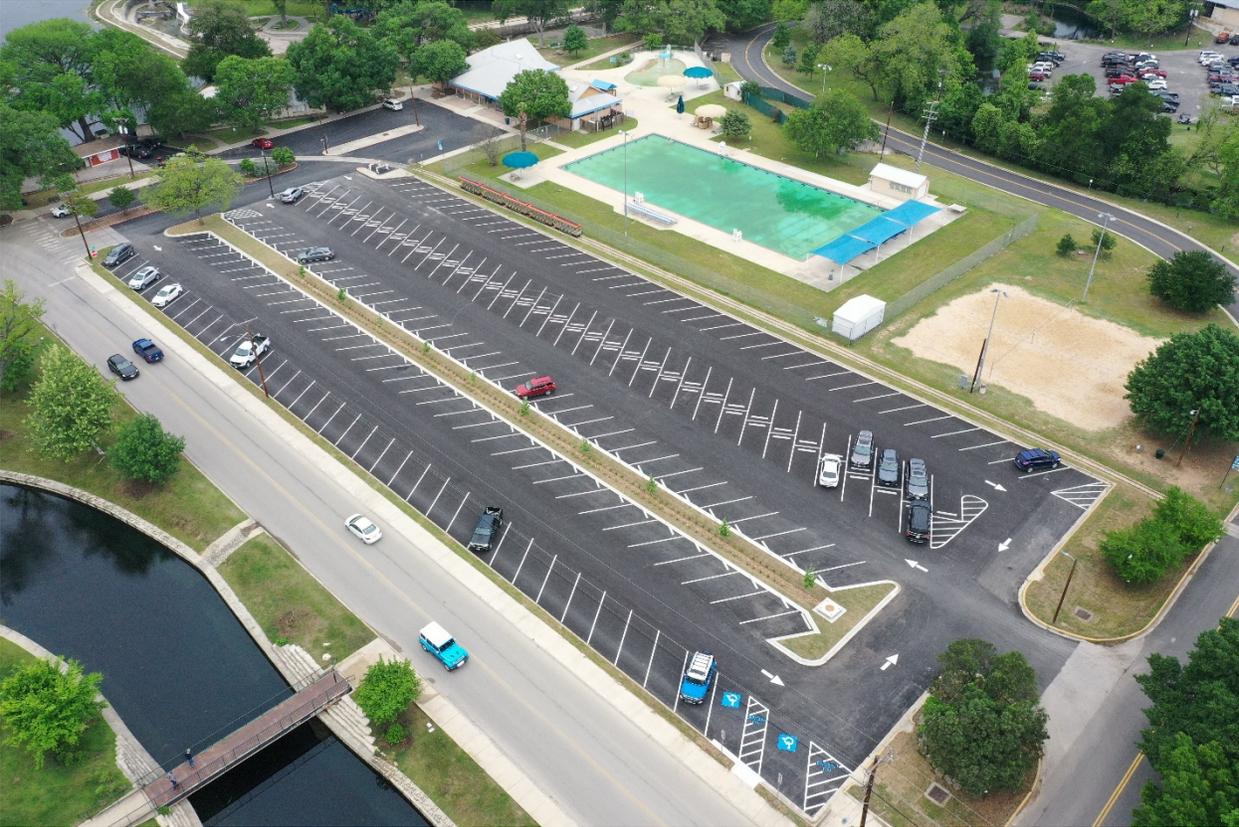
Landa Park Aquatic Center parking lot rehabilitation and biofiltration system was completed in April 2023. The following are example photos of the completed project:

The bioretention basin water quality component was designed per the TCEQ Edwards Aquifer Protection Program, RG-348 Manual. Bioretention soil media per the TCEQ guidance is proposed to promote infiltration and support long-term pollution management. Upgradient of the biofiltration component, a bioswale is proposed at a slope of 0.6% to promote filtering and nutrient uptake.
