BIO-WEST, Inc.
1812 Central Commerce Court
Round Rock, Texas 78664

MEMORANDUM

SUBJECT: **ITEM M NET DISTURBANCE AND INCIDENTAL TAKE
ASSESSMENT FOR 2017 EARIP ITP ANNUAL REPORT**

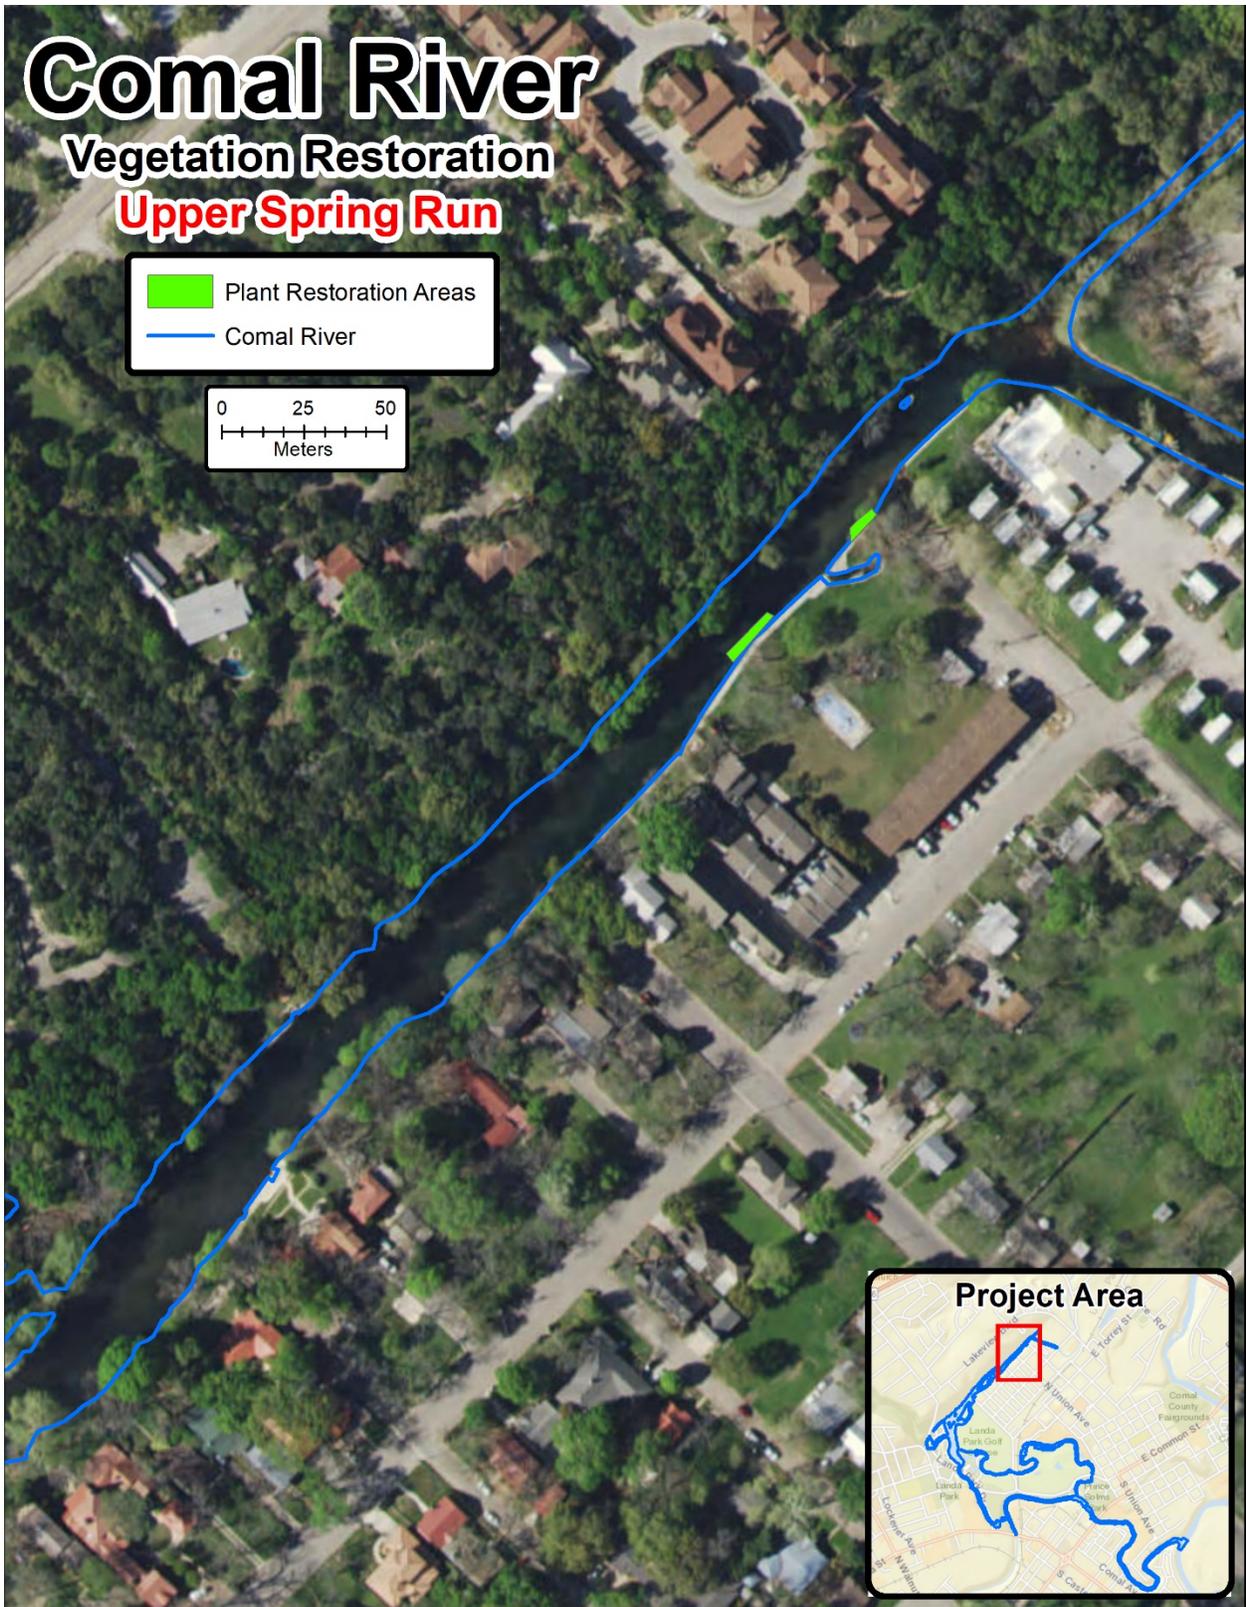
Figure 1b. Restoration and Maintenance of Native Aquatic Vegetation project – Upper Spring Run (Comal system).

The **restoration and maintenance of native aquatic vegetation** project involved restoration activities in Landa Lake and New Channel (Figure 1a), the Upper Spring Run (Figure 1b) and the Old Channel (Figure 1c) of the Comal system. These activities included the removal of non-native aquatic vegetation and subsequent restoration of native aquatic vegetation. The 2017 project footprints for native vegetation restoration are depicted in the aforementioned figures with areas (m²) quantified in Table 2. Additionally, the MUPPT nursery area used to propagate native aquatic vegetation for restoration activities is also considered part of the project footprint (Figure 1a).

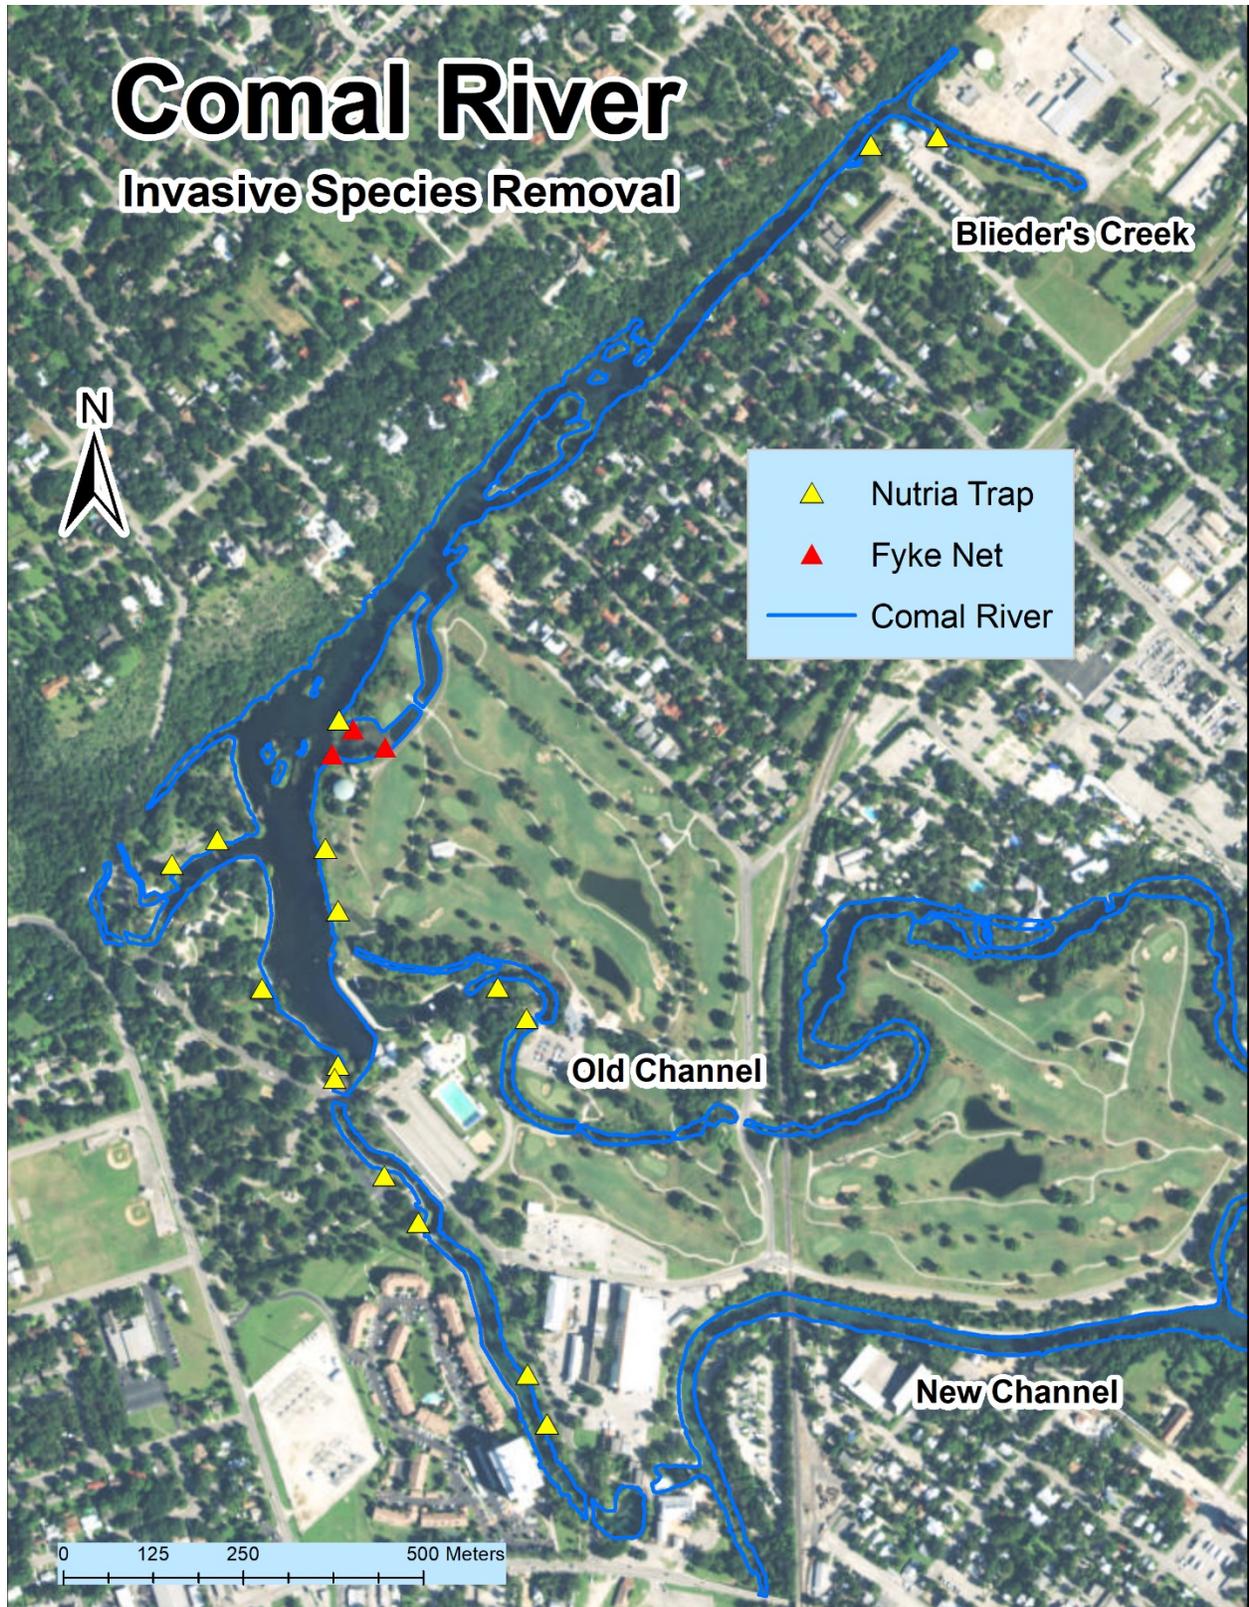
Figure 4. Non-native Animal Species Removal Project – Comal System.

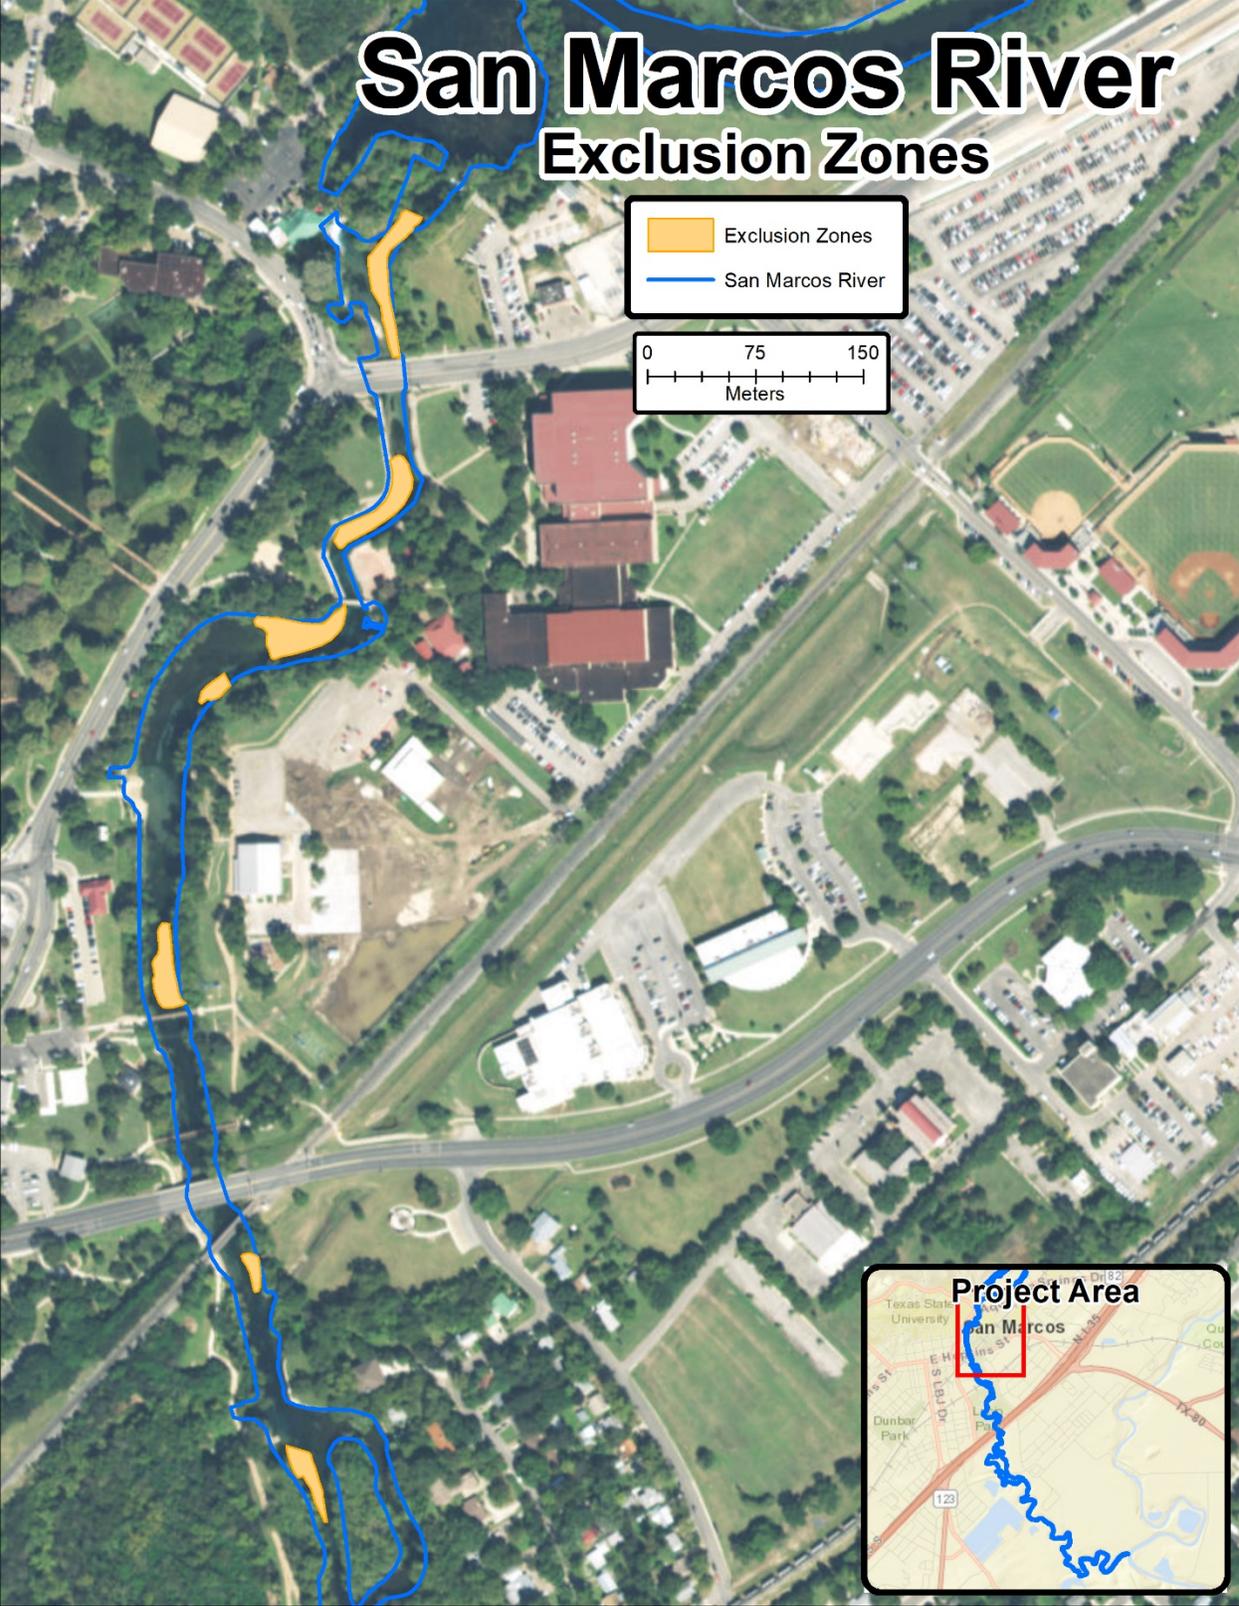
Figure 7. Texas wild rice Exclusion Zones within State Scientific Area for Recreation control in 2017 – San Marcos River.

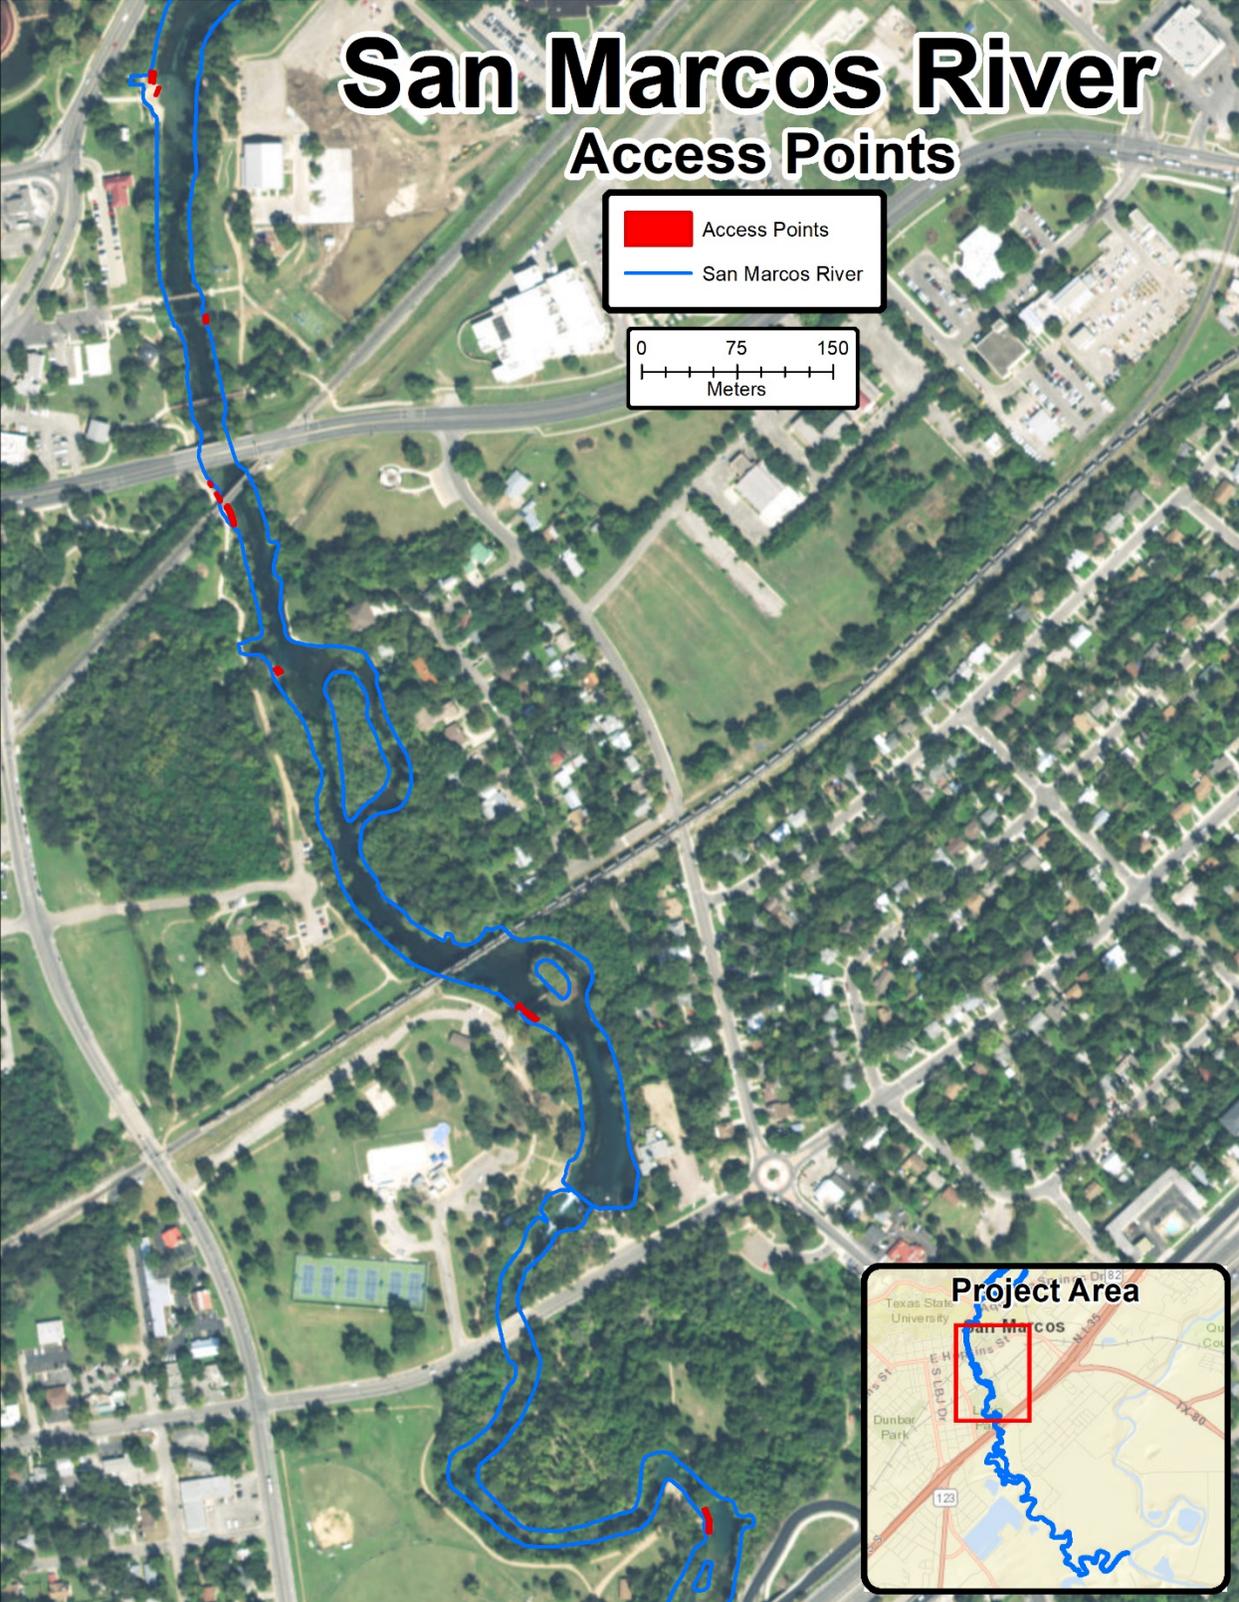
Figure 8. Access Point activity zones in 2017 – San Marcos River.

Work zones associated with **Access Points** are depicted in Figure 8. The cumulative project footprint and overlapping Fountain Darter occupied habitat are quantified in Table 2. The majority of all work was completed out of the water resulting in very limited net disturbance. As with several projects, temporary disturbance of slightly elevated turbidity to downstream areas occasionally resulted from onshore activities or foot traffic to establish turbidity curtains in select locations.

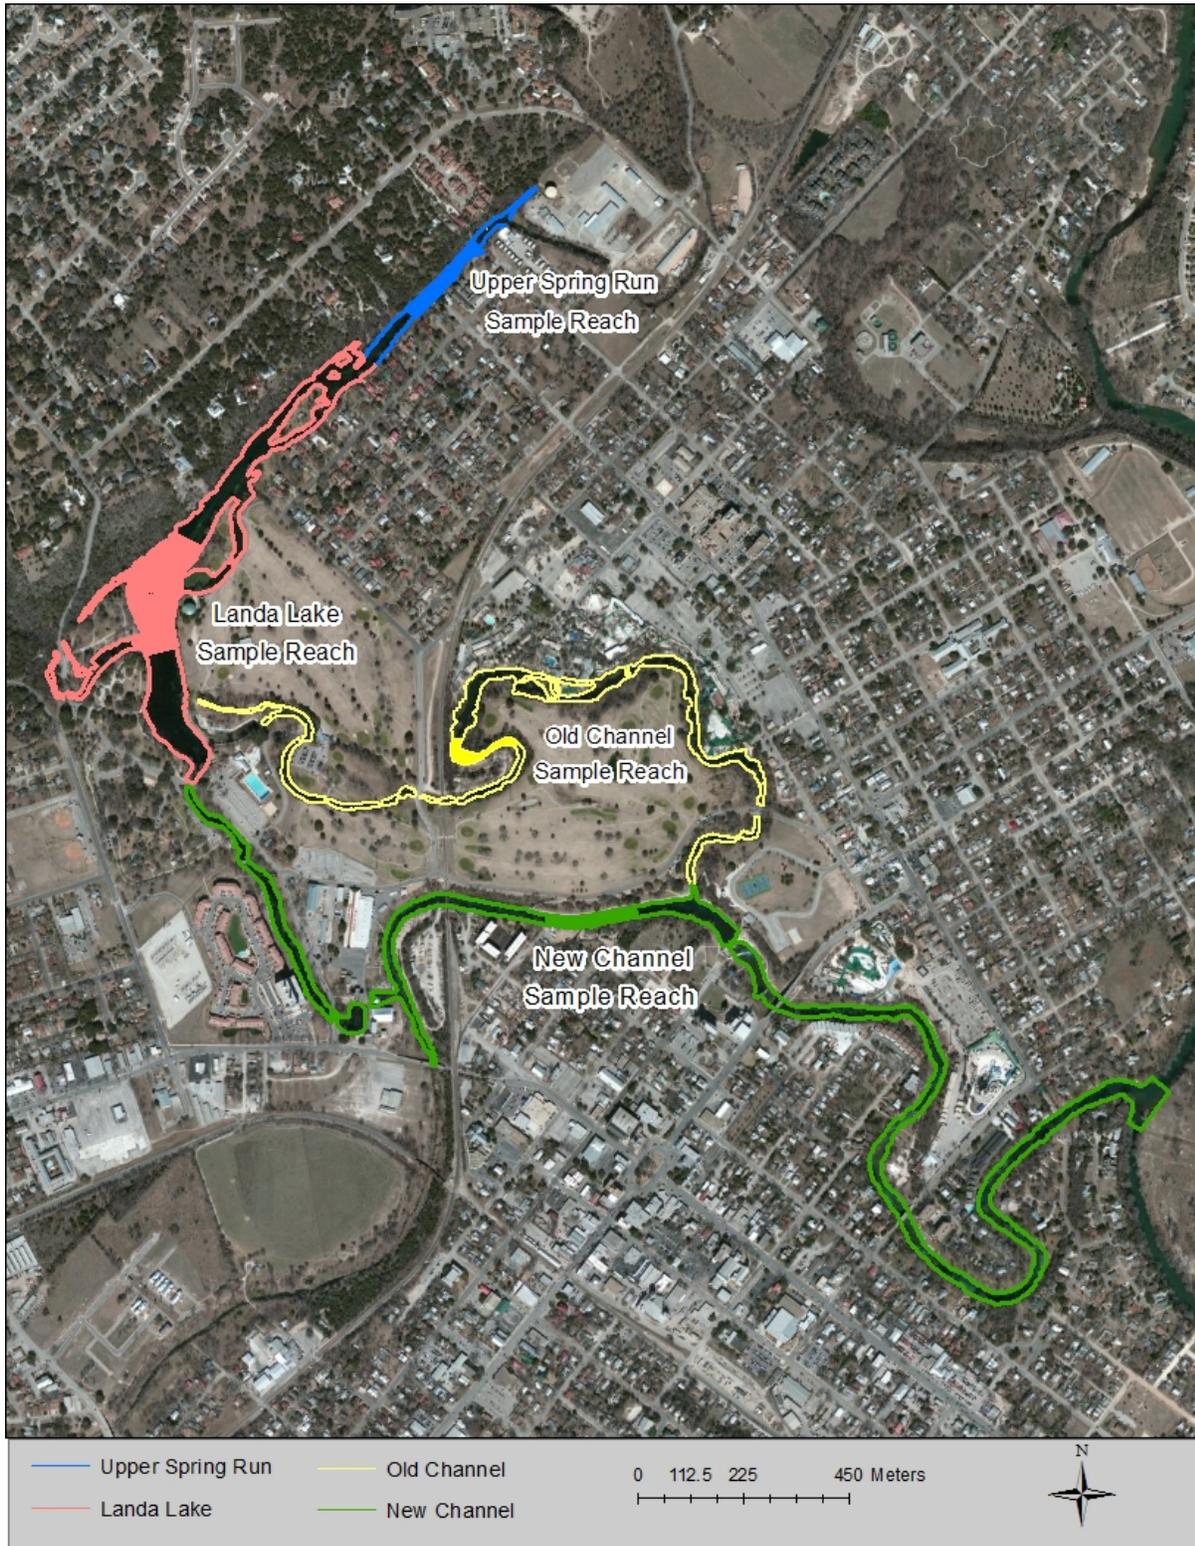
Figure 10. Sample Reaches (4) for the Comal System and Corresponding River Section.

the Spring Lake Dam sample reach, City Park sample reach, and the I35 sample reach. For both systems (Figures 10 and 11), the corresponding river section that corresponds to each sample reach is also shown.

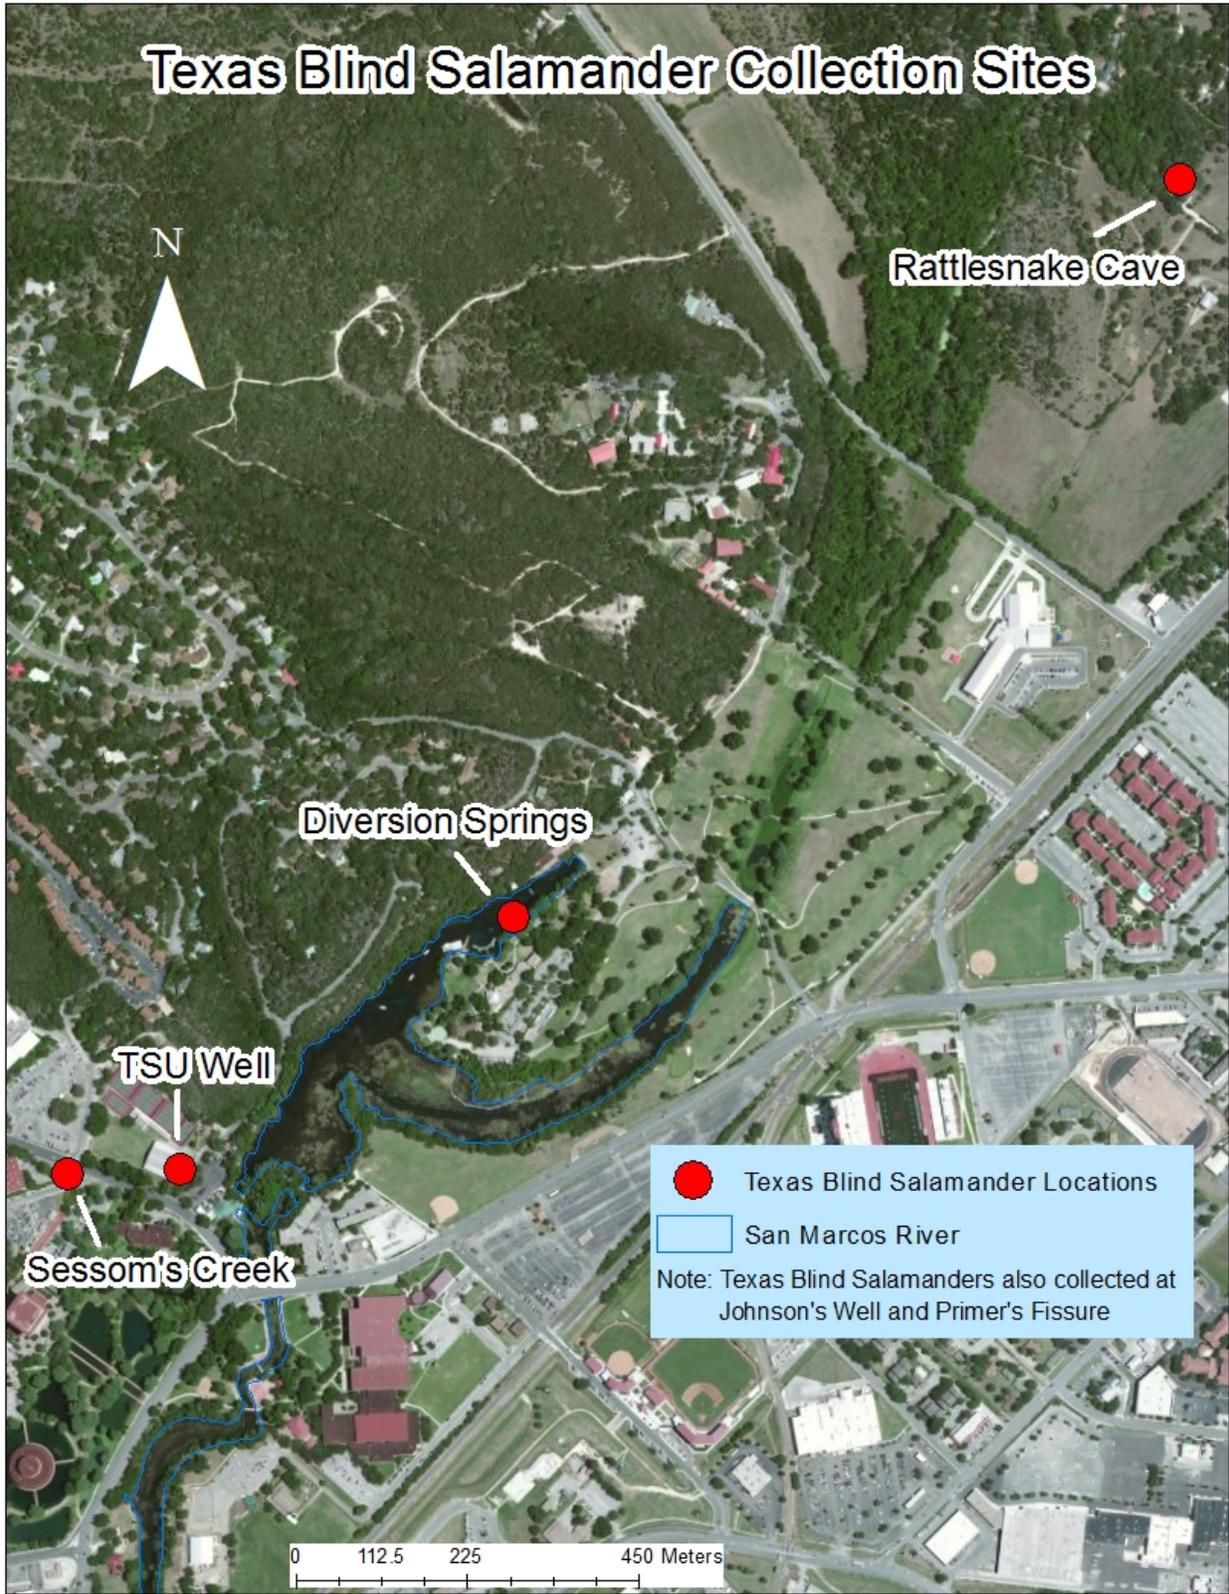
Figure A7: Texas Blind Salamander Routine Collection Locations – San Marcos System

The San Marcos salamander has been routinely sampled over the years by both the EAA biological monitoring program as well as by the USFWS SMARC for refugia collection purposes. The known collection locations and occupied habitat are depicted in Figure A6 and quantified in Table 1. As documented in the HCP, the Texas blind salamander is an aquifer/cave dwelling species. Unlike the subterranean Comal invertebrates which can be found in and around orifices in surface habitat at times, blind salamanders are collected as they are expelled from the aquifer. As such, there is no surface habitat designated for the Texas blind salamander as footnoted in Table 1. Known collection areas are depicted in Figure A7 for later use in the net disturbance assessment.
