## Appendix L

### City of New Braunfels Reports

## City of New Braunfels Standard Operating Procedures for Managing Flow Partitioning between the Old and New Channels of the Comal River

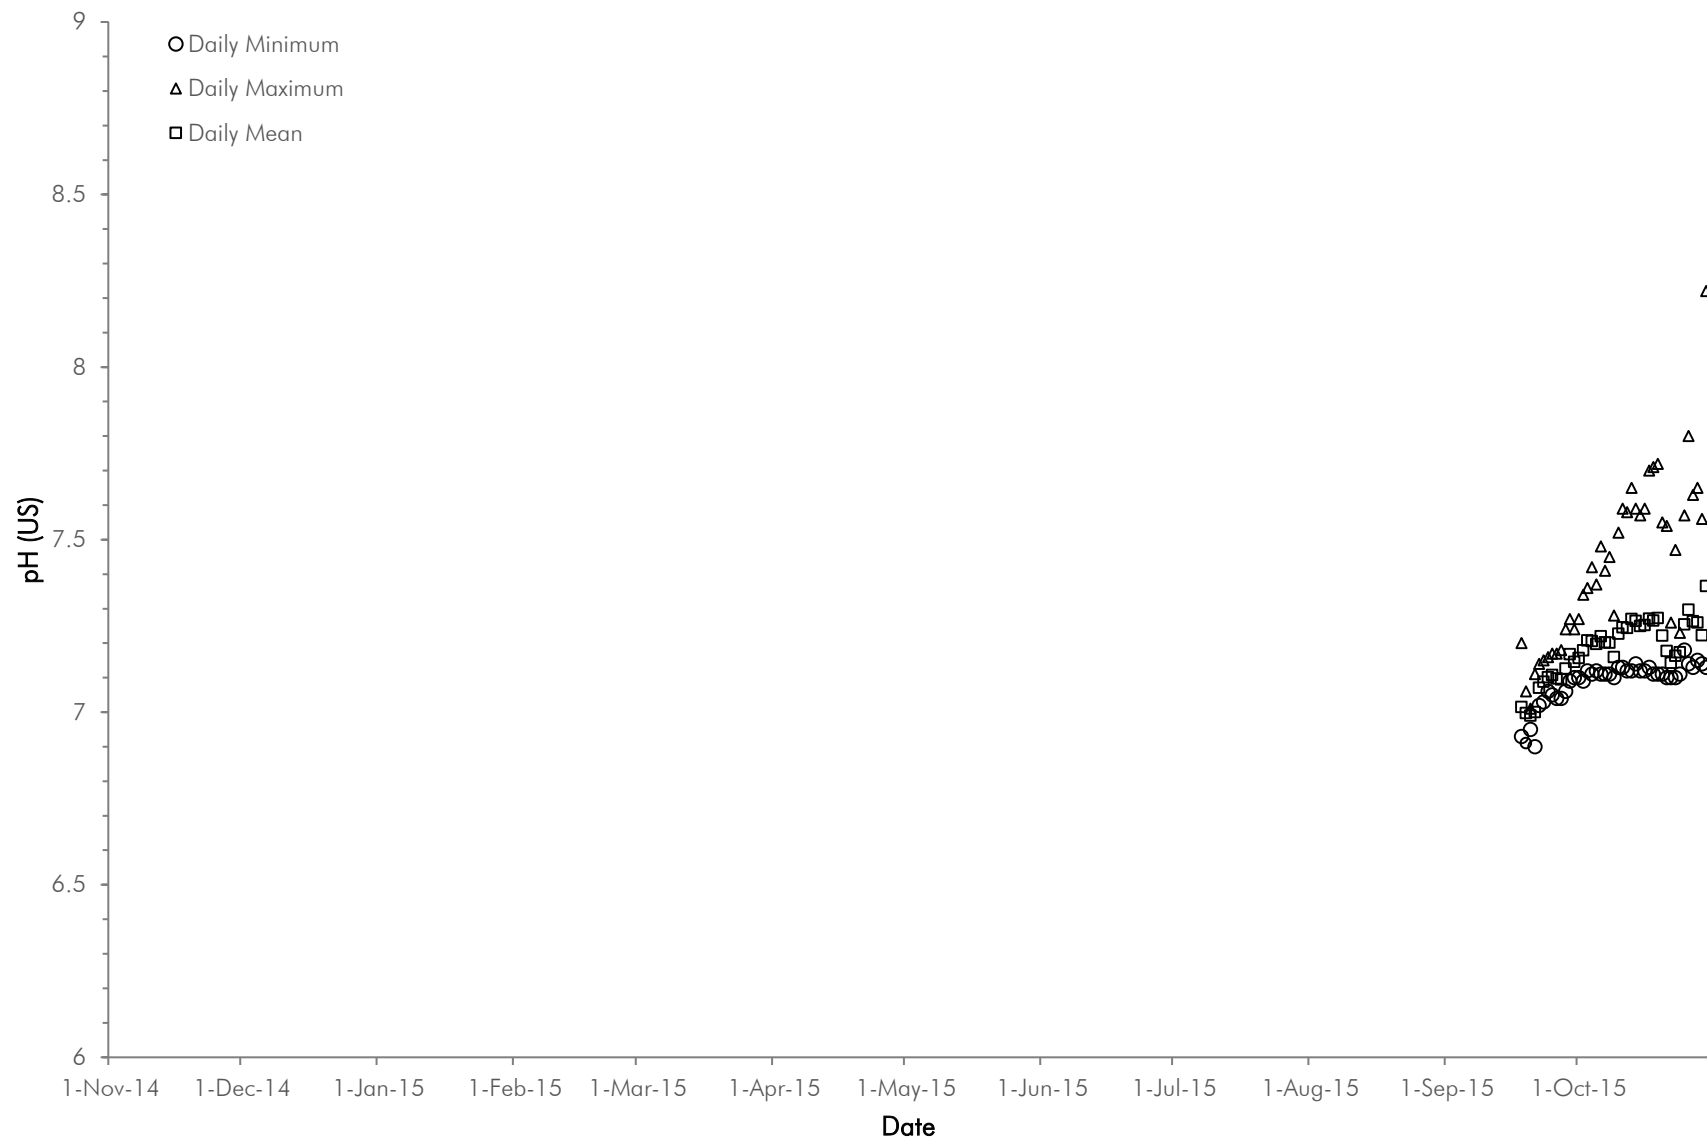
Figure 5. Daily pH in Landa Lake during 2015 (all data).

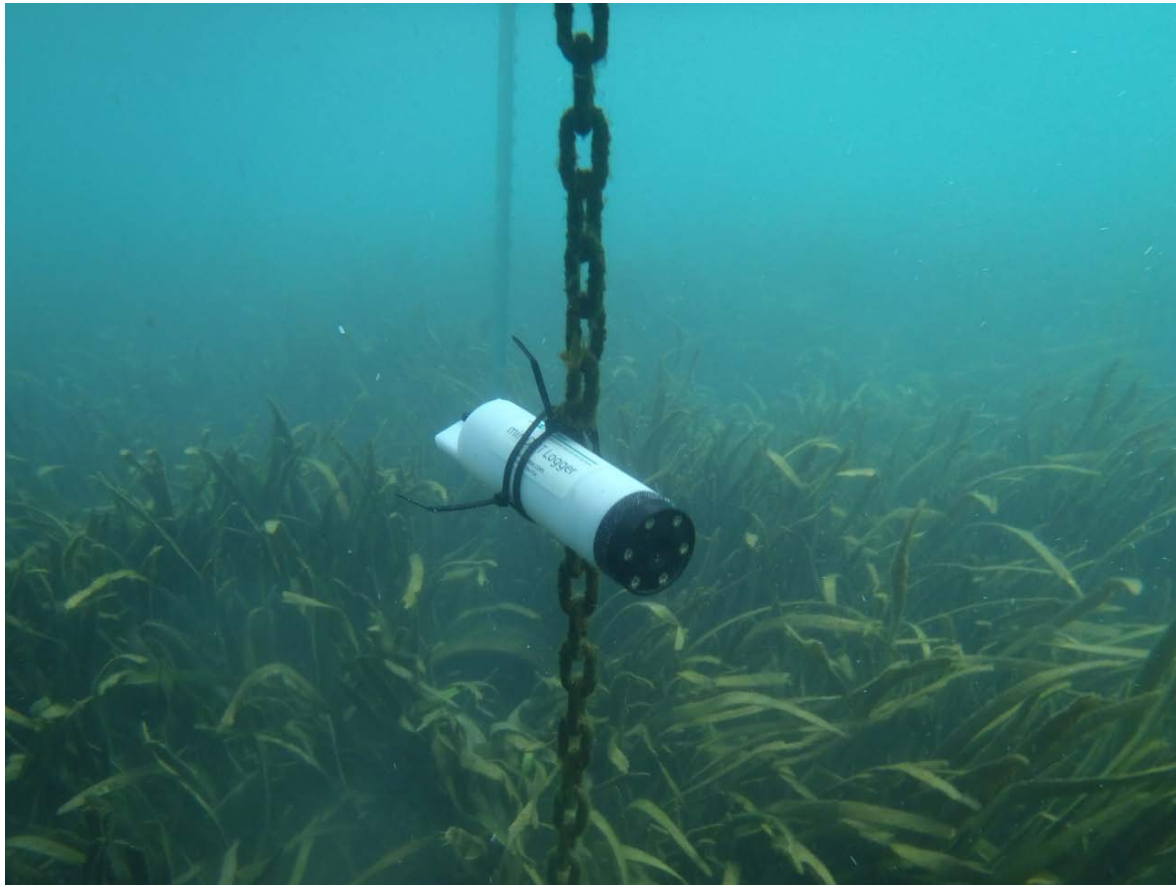
**Figure 3:** MiniDOT dissolved oxygen sensor deployed during spatial expansion study

To investigate how representative existing DO measurements in the center of Landa Lake is to surrounding areas, a one-week spatial evaluation of DO was conducted within Landa Lake and the Upper Spring Run reach. For this investigation, 14 MiniDOT DO sensors were installed in the Comal system in late July and set to record measurements on 10 minute intervals. The MiniDOT logger is a completely submersible instrument that logs DO and water temperature measurements. MiniDOT DO sensors are made by Precision Measurement Engineering (PME, Vista CA) and utilize the newer optical fluorescence technology to measure DO concentrations. The sensors have been widely used by the USGS and were tested in the labs at Baylor University prior to deployment. Our tests show that the MiniDOTS are equivalent to a YSI datasonde utilizing similar optical technology. We logged data while bubbling sequentially with air and nitrogen to produce air-saturated and anoxic conditions. The MiniDOT values were within a few percent of the YSI at all measurement periods. The oxygen sensor is an optode that measures DO concentration in water through a fluorescence method. Figure 3 shows a MiniDOT DO sensor deployed at a mid-column location in Landa Lake.

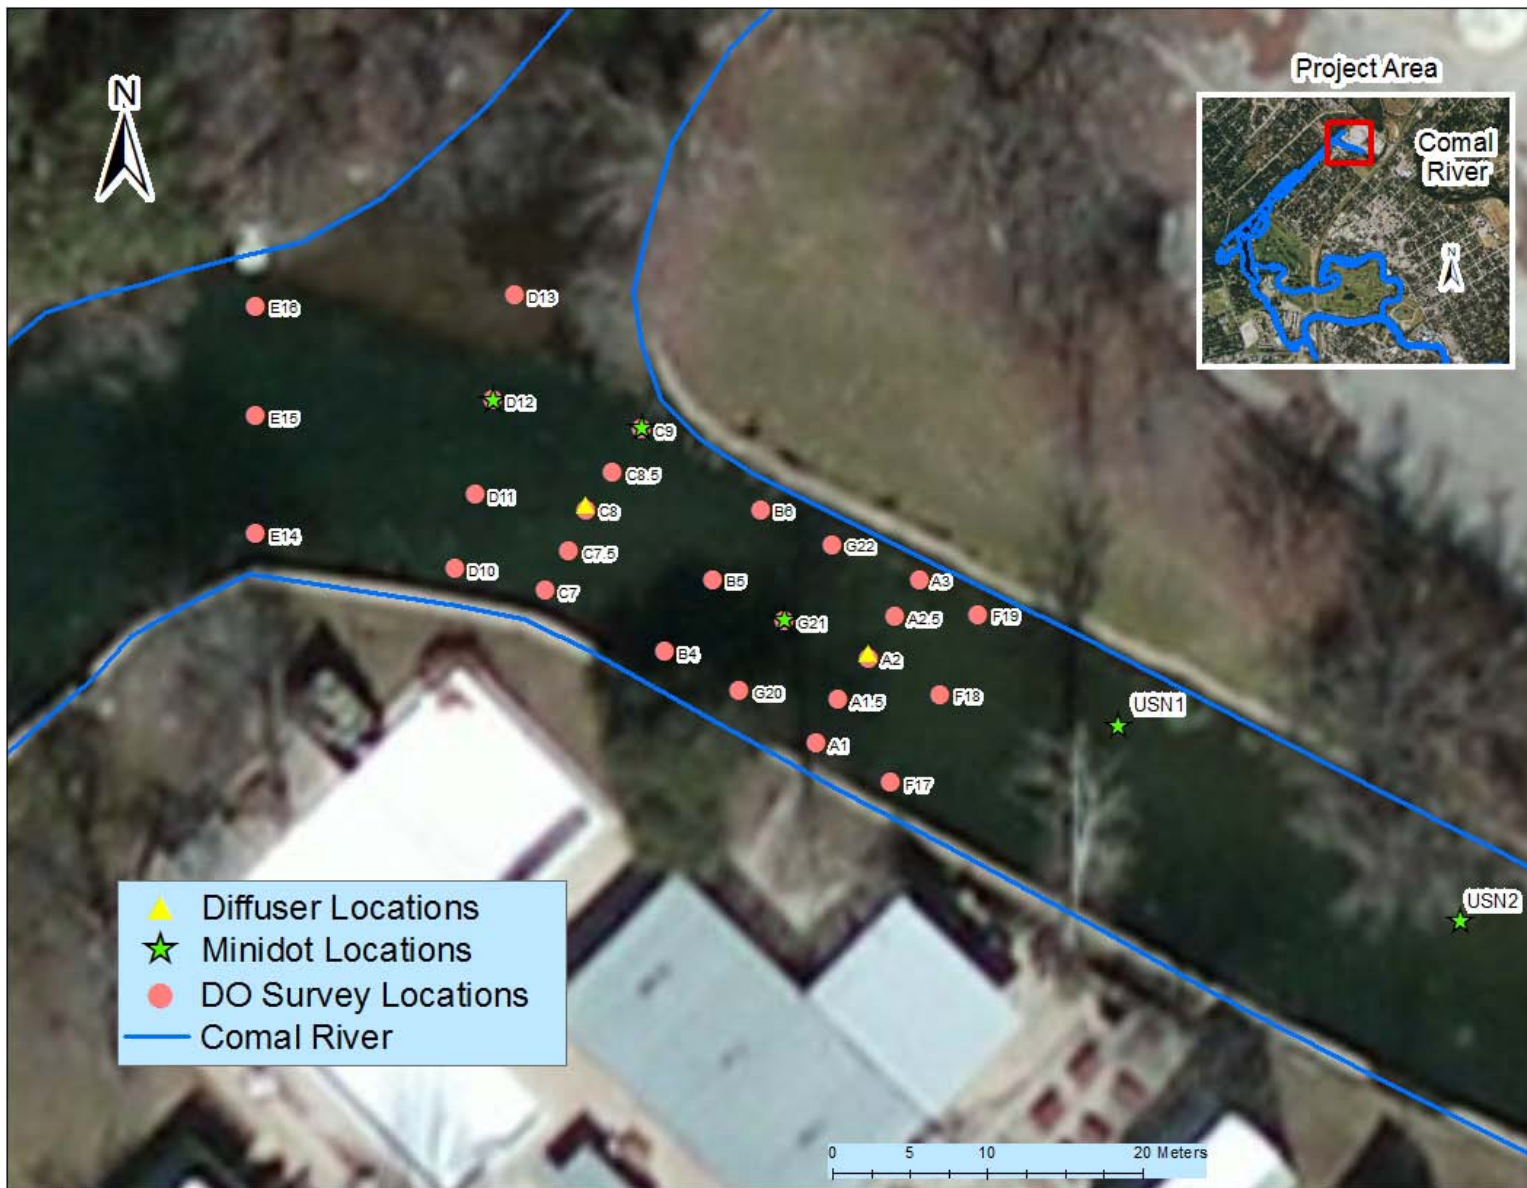
**Figure 8:** Sampling transects, diffuser and MiniDOT sensor locations for formal diffuser trial on September 17-18.

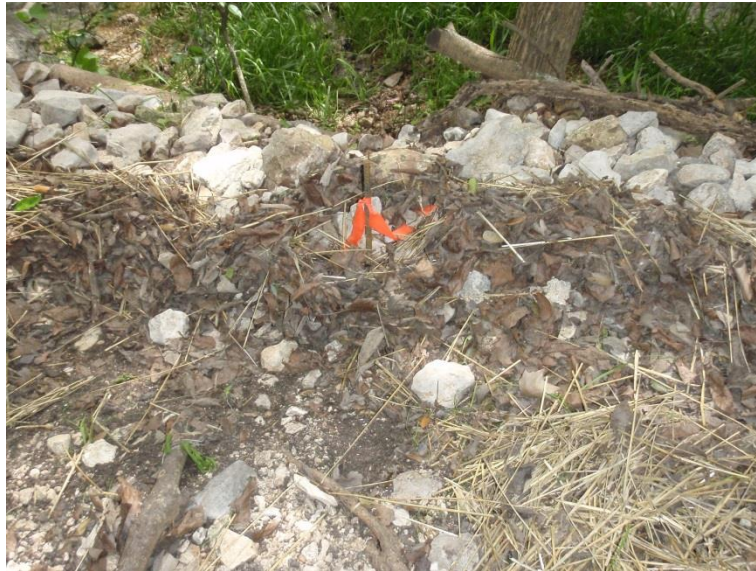
**Figure 6.1. Erosion control structure at Location 227 with rack line of leaf matter**
