Item M Net Disturbance and Incidental Take Assessment for 2015 EARIP ITP Annual Report

SUBJECT: **ITEM M NET DISTURBANCE AND INCIDENTAL TAKE
ASSESSMENT FOR 2015 EARIP ITP ANNUAL REPORT**

BIO-WEST: EAA ITP – 2015 Item M and Incidental Take Assessments

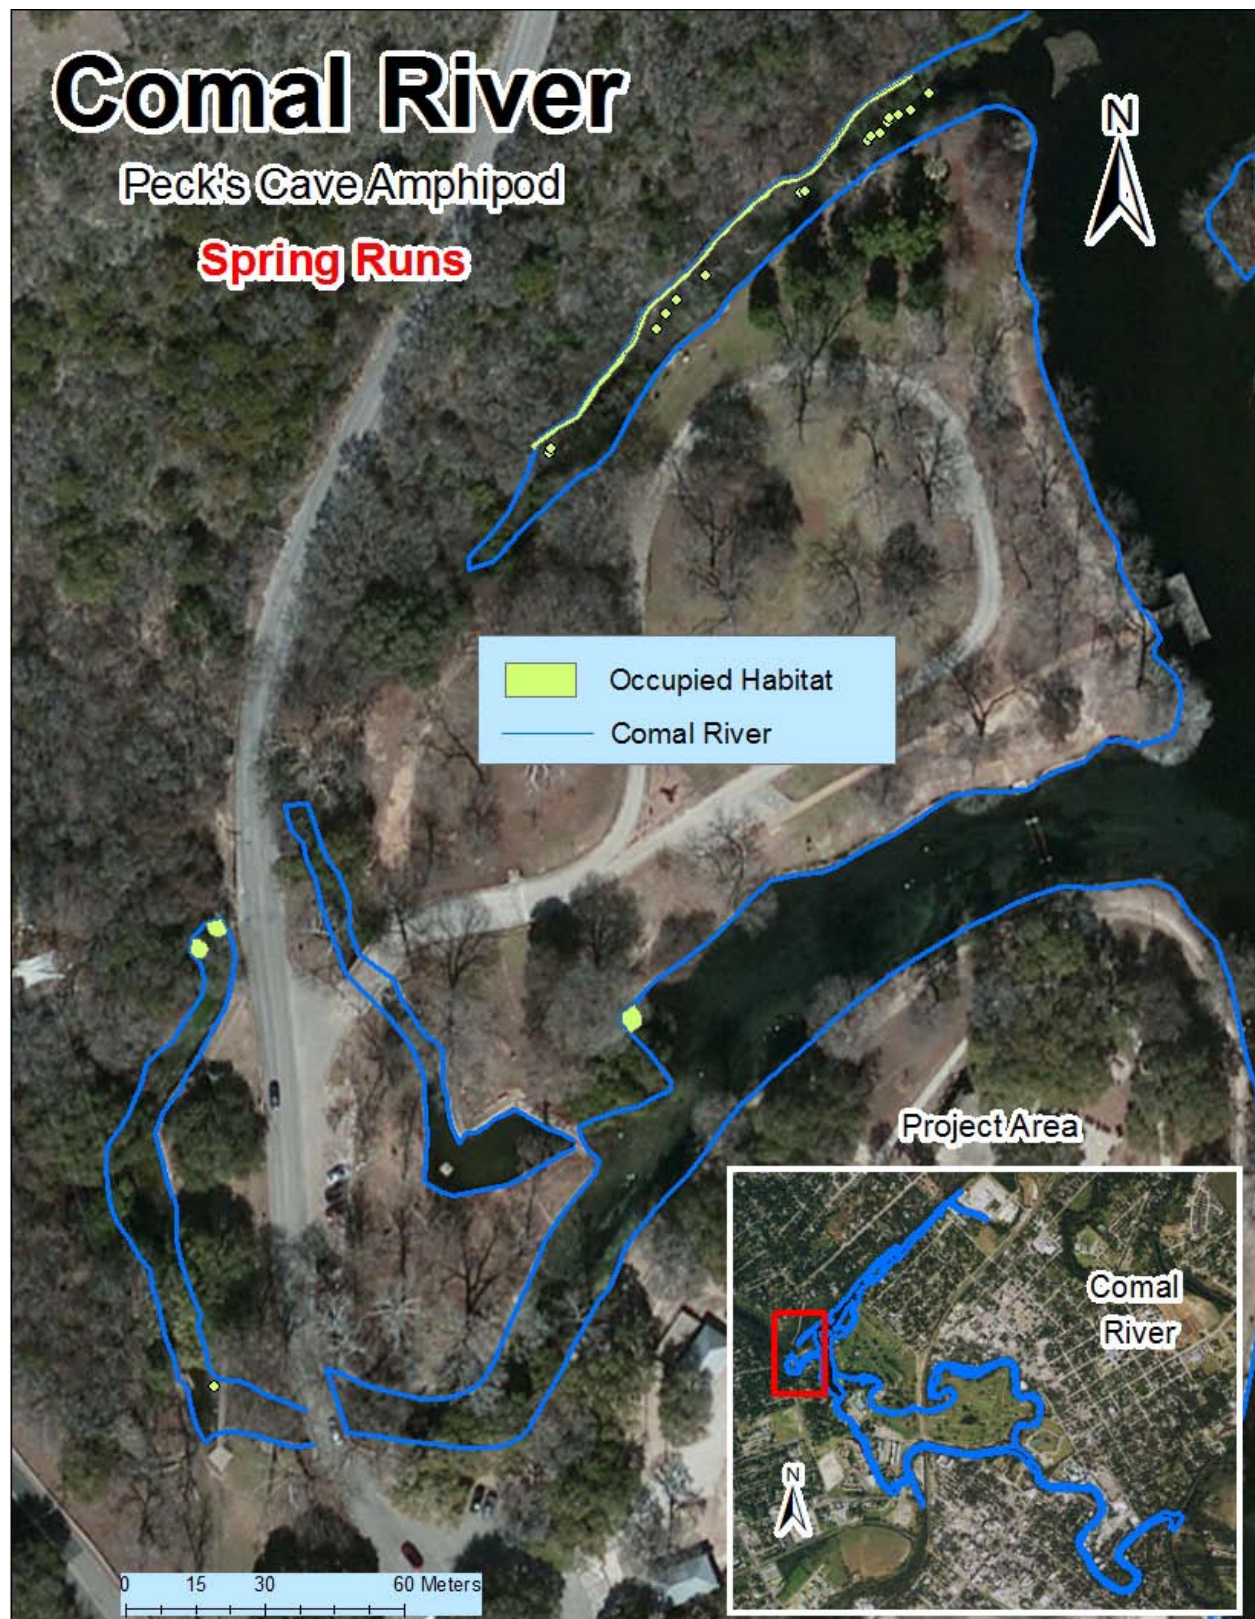
Figure 3: Peck's Cave Amphipod Occupied Surface Habitat – Upper Spring Run (top) and Spring Island and Western Shoreline areas (bottom) - (Comal System).

Figure 3 (continued): Peck's Cave Amphipod Occupied Surface Habitat – Spring Runs (Comal System).

As described in the HCP, both the Peck's cave amphipod and Comal Springs dryopid beetle are subterranean species. Peck's cave amphipods are frequently found at the surface primarily in areas that Comal Springs riffle beetles are collected, whereas the Comal Springs dryopid beetle is less commonly found. As it is presumed that these subterranean invertebrates are not suited for survival in surface conditions, the decision was made to quantify 0.5 m² around the orifices that these species have been collected in the Comal system. As for the riffle beetle, sampling for these species over the years has been conducted by quadrats, drift netting, and cotton lures. Dr. Bowles and Mr. Gibson's data were again reviewed in detail as was the EAA biological monitoring database. For these two species, it is presumed that the majority of their occupied habitat is located subsurface. However, it is not possible to quantify the subsurface occupied habitat for these species at this time. Rather, the orifices where they have been collected are documented for further evaluation of potential impacts to these areas later in this memorandum. Figures 3 and 4 show occupied habitat for the Peck's Cave amphipod and Comal Springs dryopid beetle, respectively, throughout the Comal System with the quantification of surface habitat area presented in Table 1.

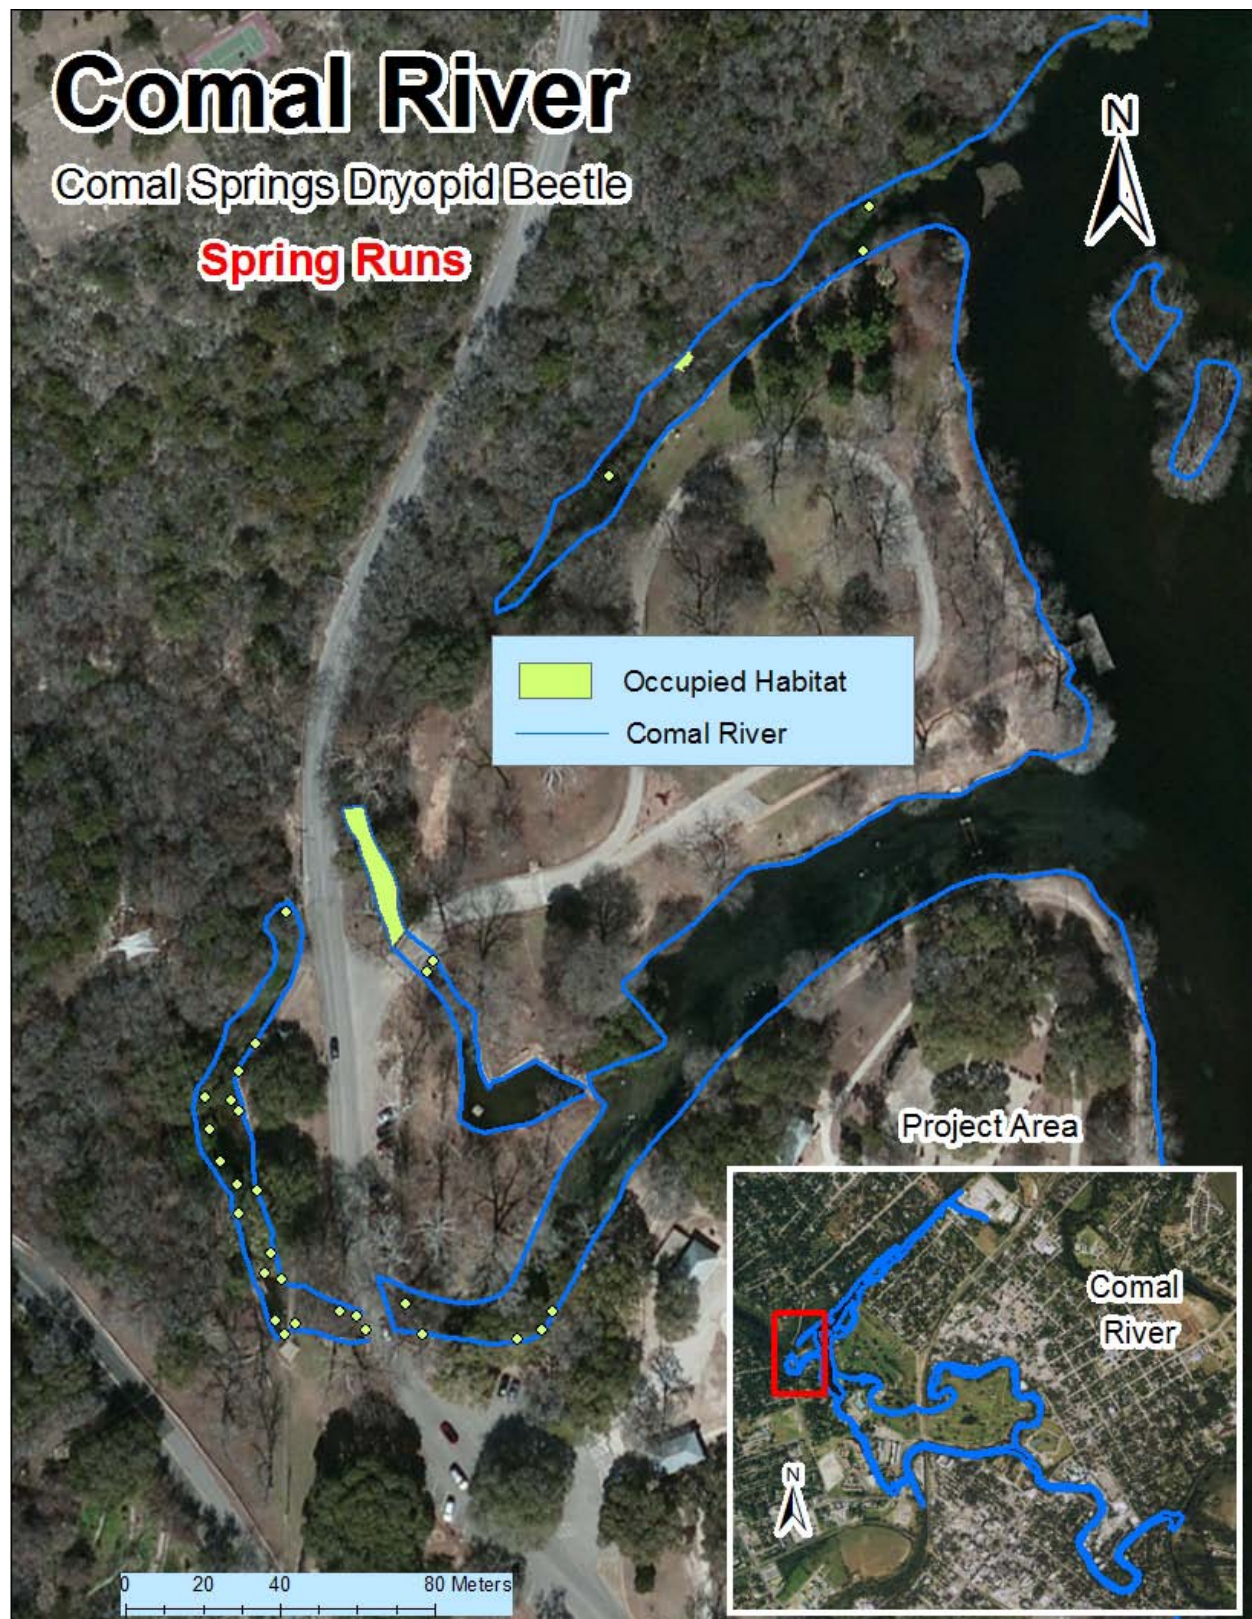
Figure 4: Comal Springs Dryopid Beetle Occupied Surface Habitat – Upper Spring Run (top) and Spring Island and Western Shoreline areas (bottom) - (Comal System).

Figure 4 (continued): Comal Springs Dryopid Beetle Occupied Surface Habitat – Spring Runs (Comal System).

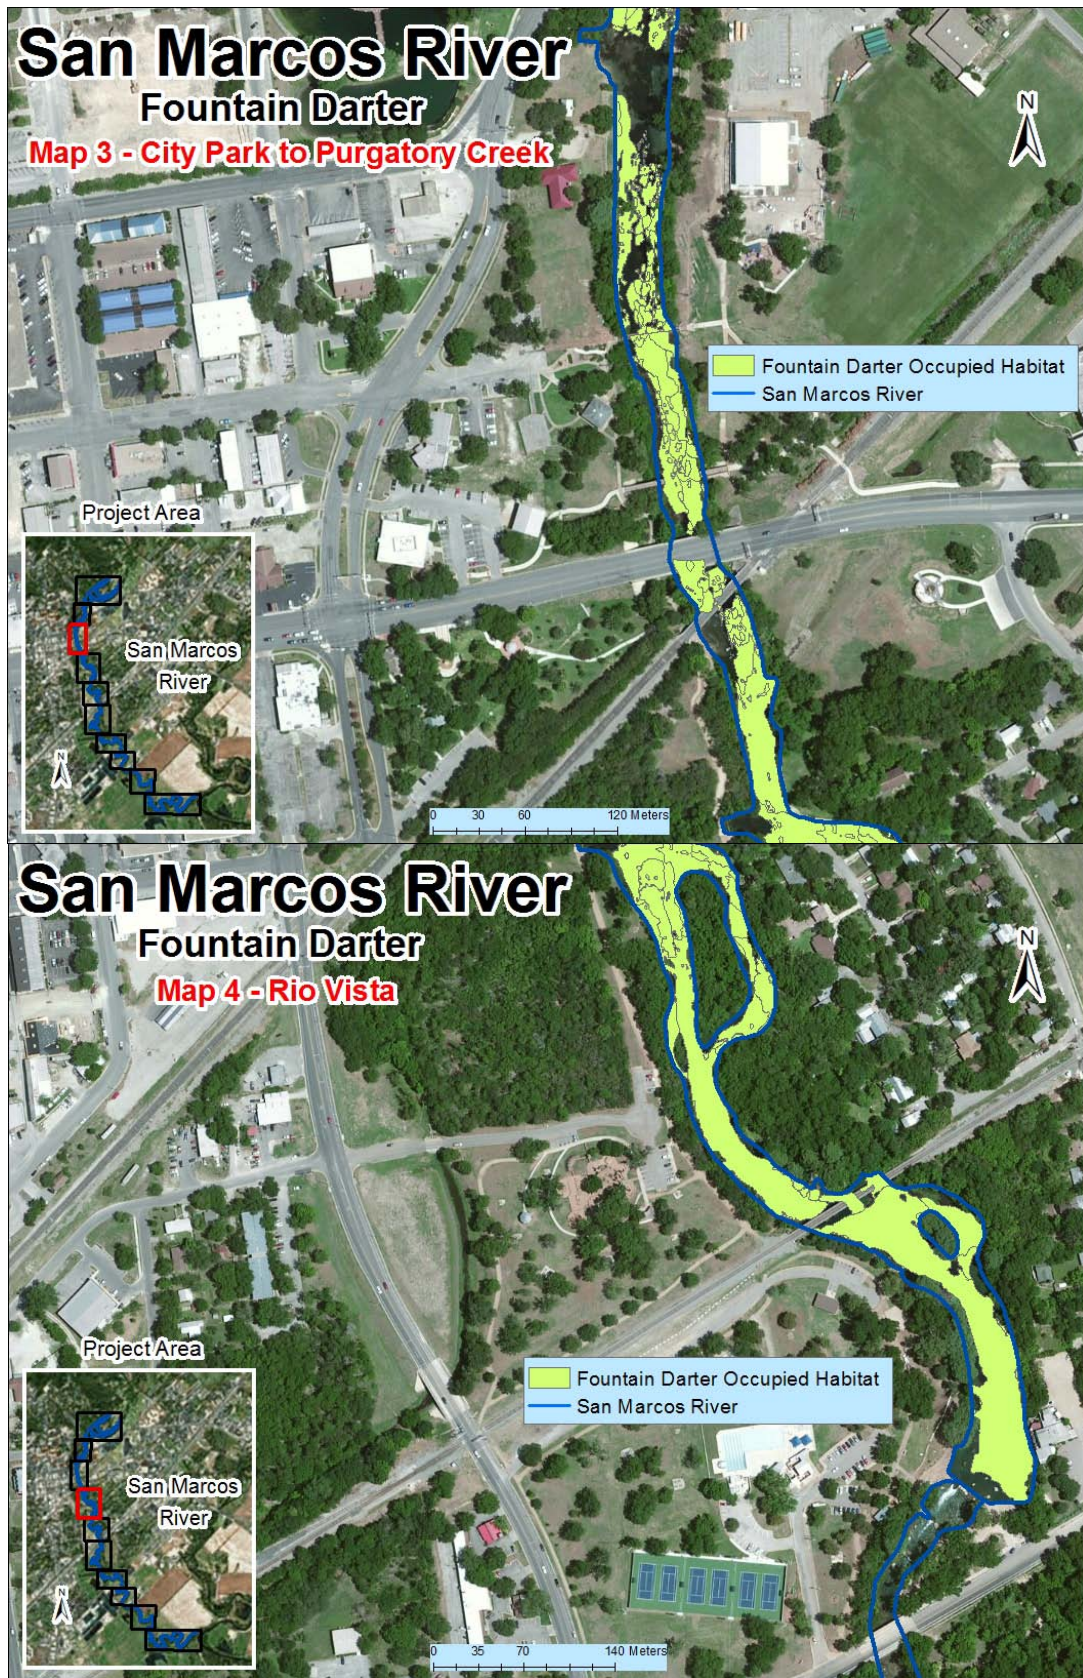
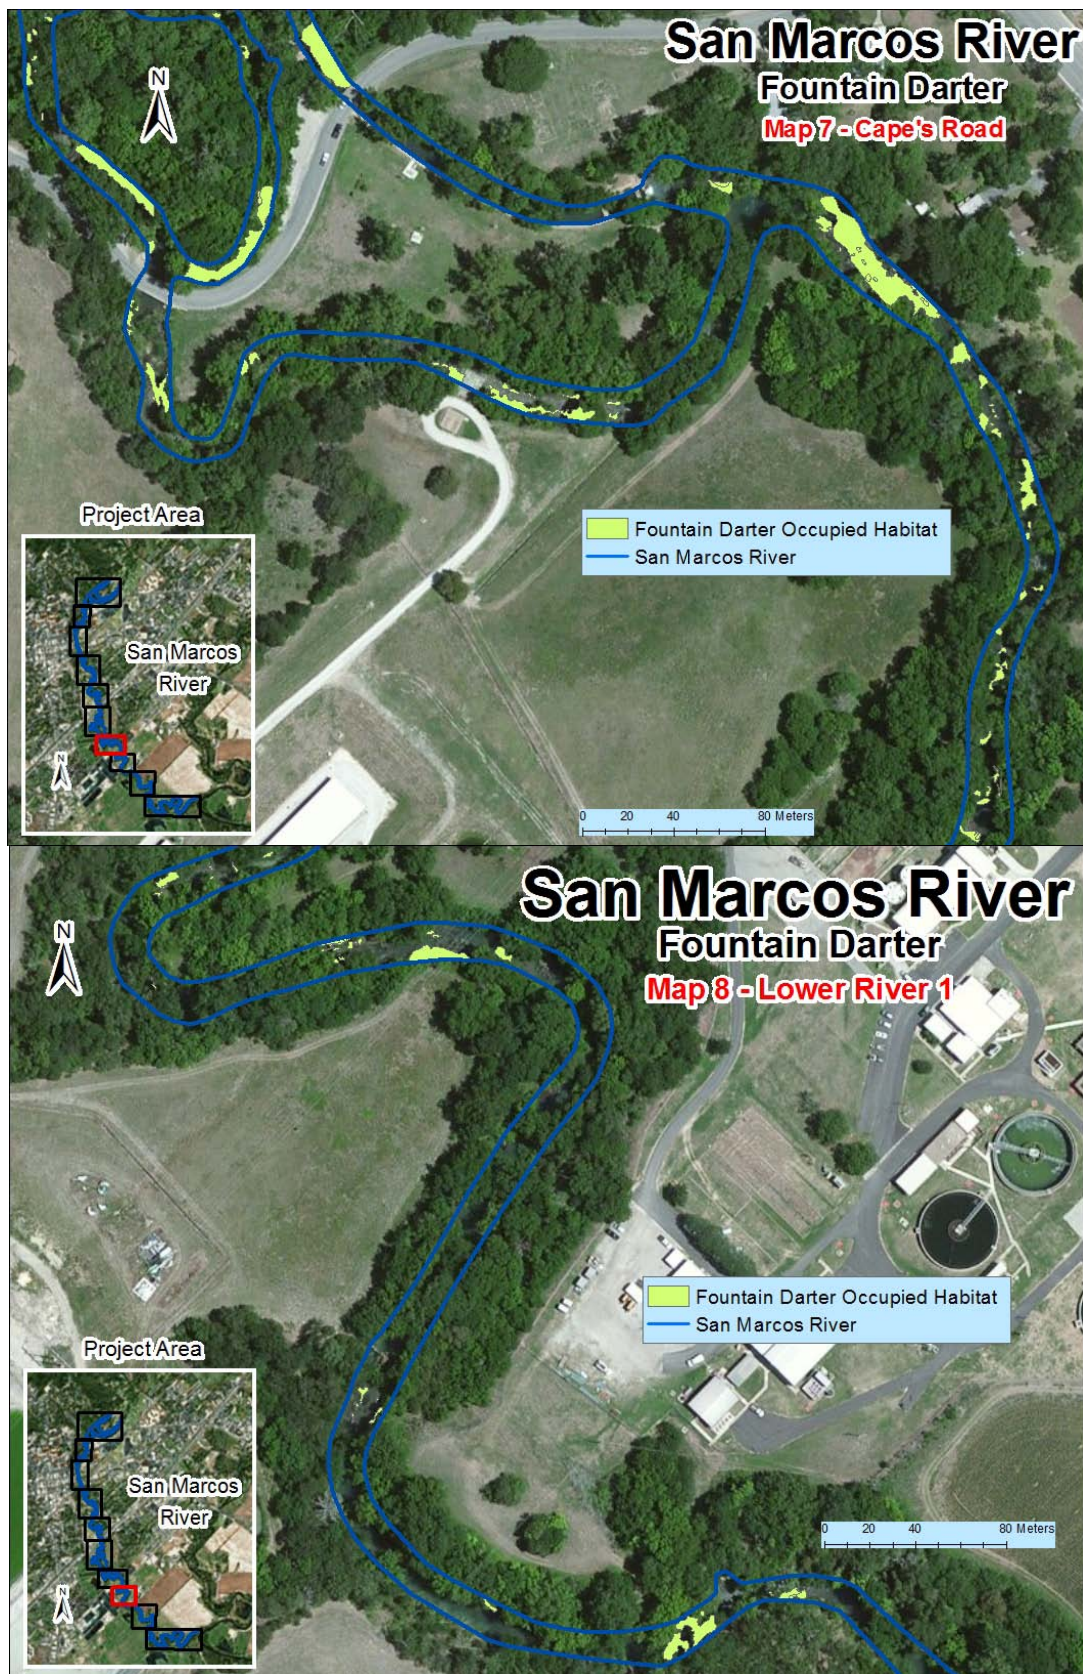
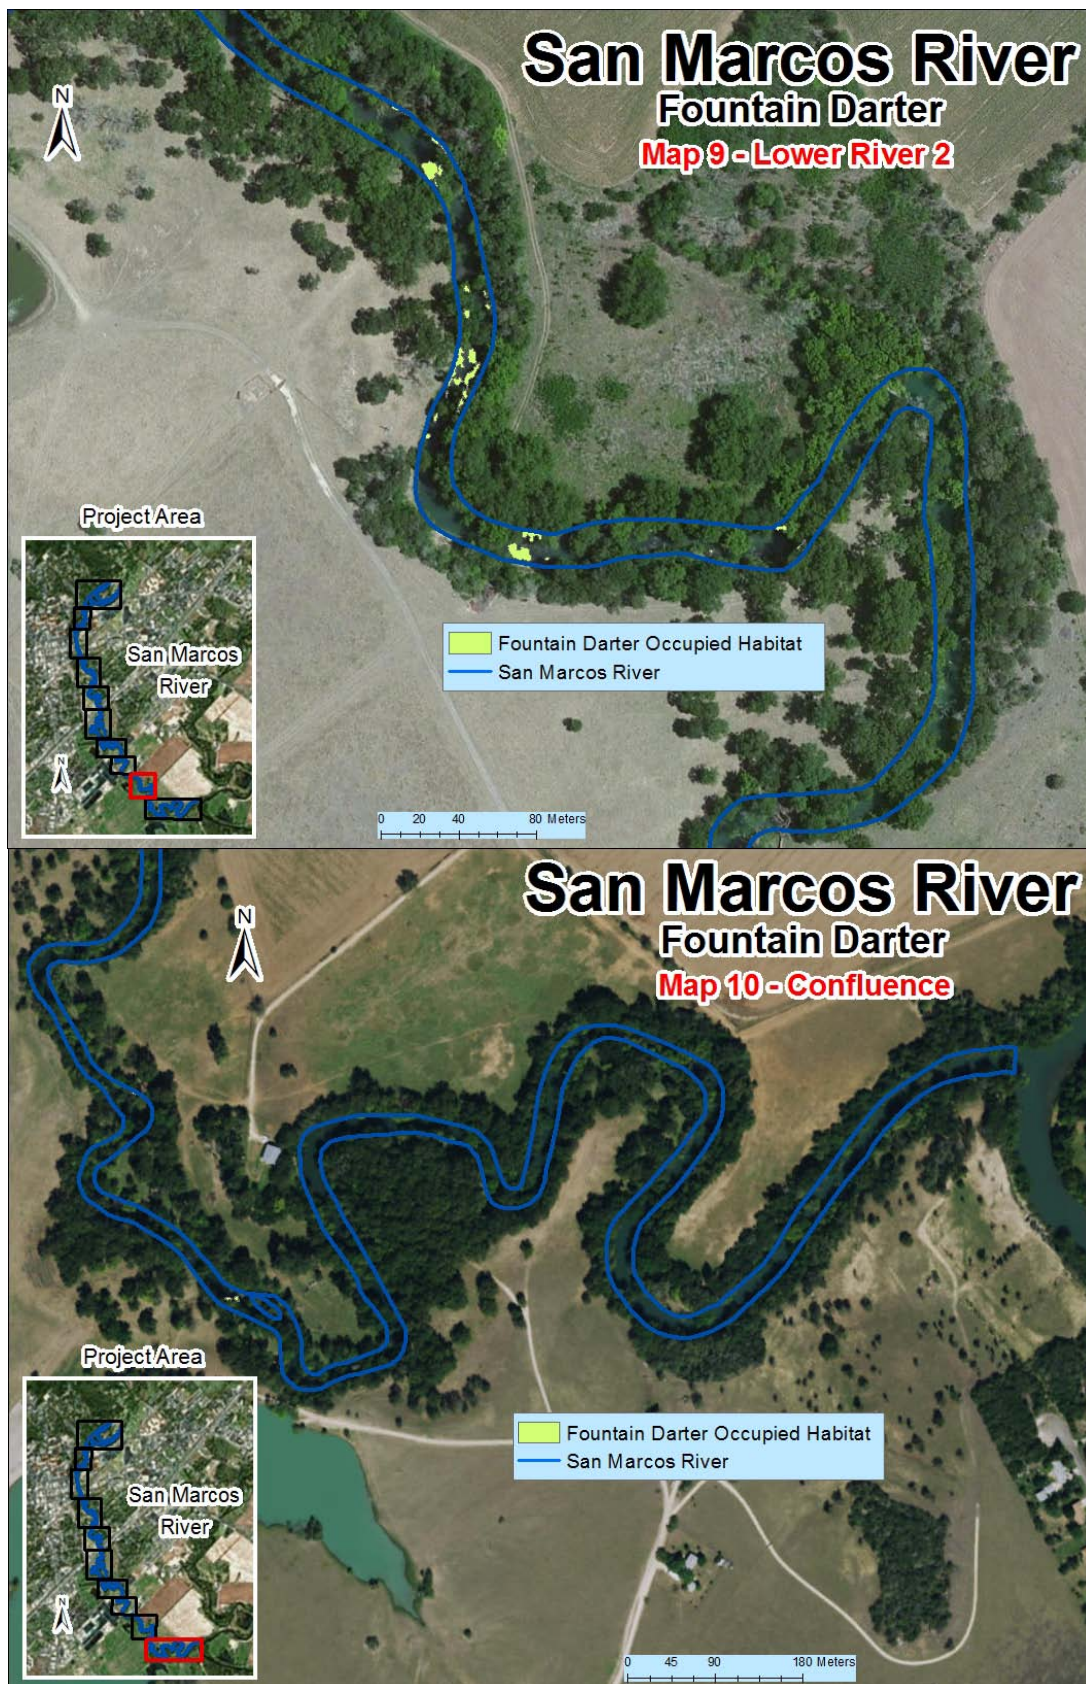
Figure 5: Fountain Darter 2015 Occupied Habitat – San Marcos System

Figure 5 (continued): Fountain Darter 2015 Occupied Habitat – San Marcos System

Figure 5 (concluded): Fountain Darter 2015 Occupied Habitat – San Marcos System

Similar to the Comal system, although fountain darters have been physically collected and visually documented on bare substrate in the San Marcos River, this is not a common occurrence in the river. As such, bare substrate was not counted as occupied habitat for the fountain darter in the San Marcos River. In contrast, bare substrate and algae areas in Spring Lake were included for this assessment as fountain darters have frequently been observed inhabiting these areas within Spring Lake. Finally, although fountain darters have been collected further upstream in the slough arm of Spring Lake, those collections are considered seasonal at this time and thus were not included in the overall area calculated. Figure 5 shows the occupied habitat for the fountain darter throughout the San Marcos system with the quantification of area presented in Table 1.

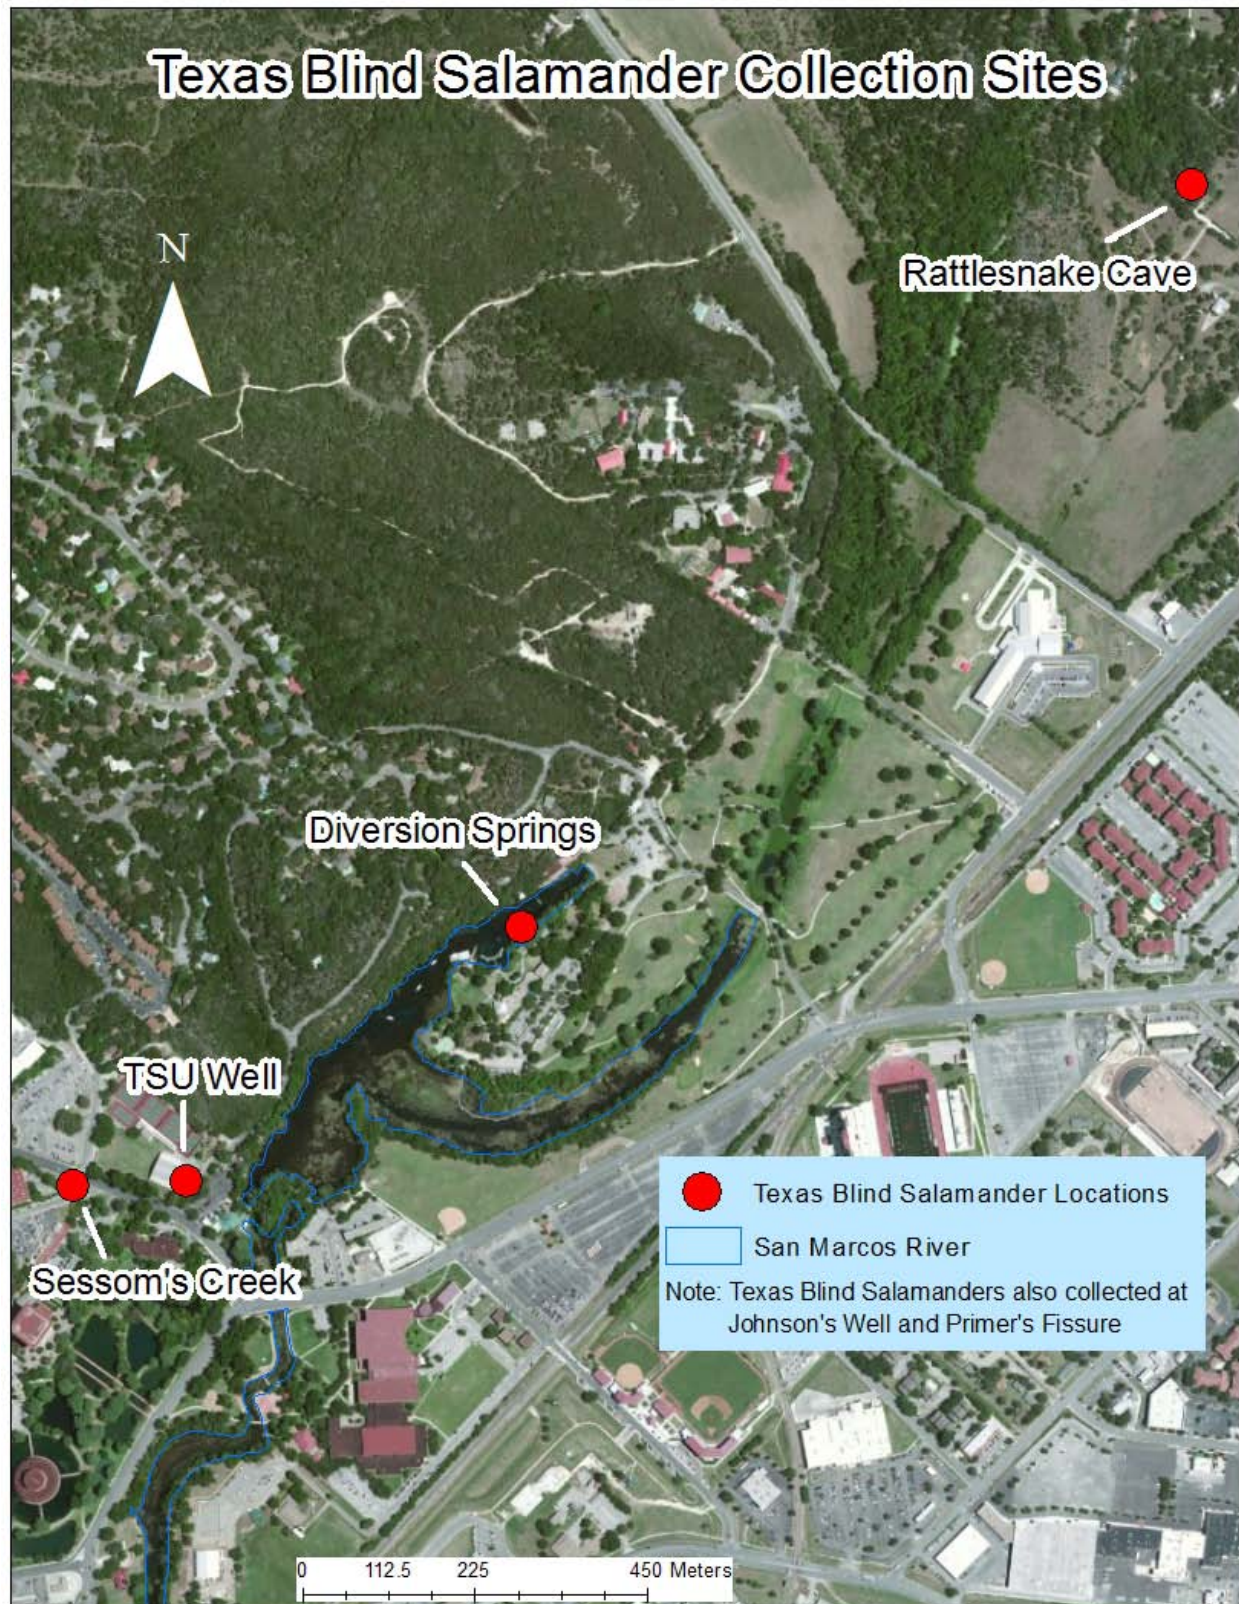
Figure 7: Texas Blind Salamander Routine Collection Locations – San Marcos System

As documented in the HCP, the Texas blind salamander is an aquifer/cave dwelling species. Unlike the subterranean Comal invertebrates which can be found in and around orifices in surface habitat at times, blind salamanders are collected as they are expelled from the aquifer. As such, there is no surface habitat designated for the Texas blind salamander as footnoted in Table 1. Known collection areas are depicted in Figure 7 for later use in the net disturbance assessment.

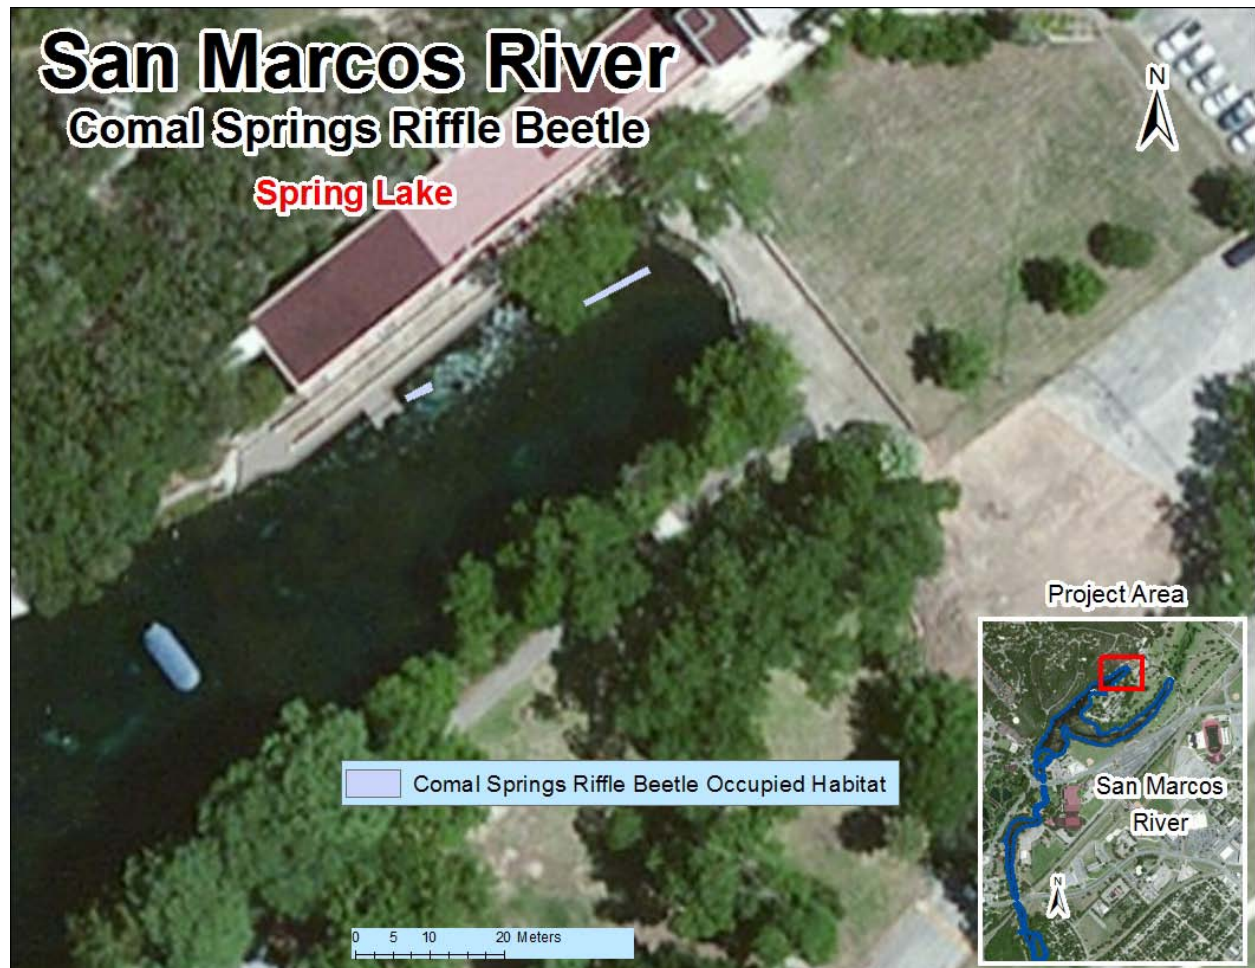
Figure 8: Comal Springs riffle beetle Surface 2015 Occupied Habitat – San Marcos System

Figure 8 shows the occupied habitat for the Comal Springs riffle beetle in the San Marcos system with the quantification of area presented in Table 1.

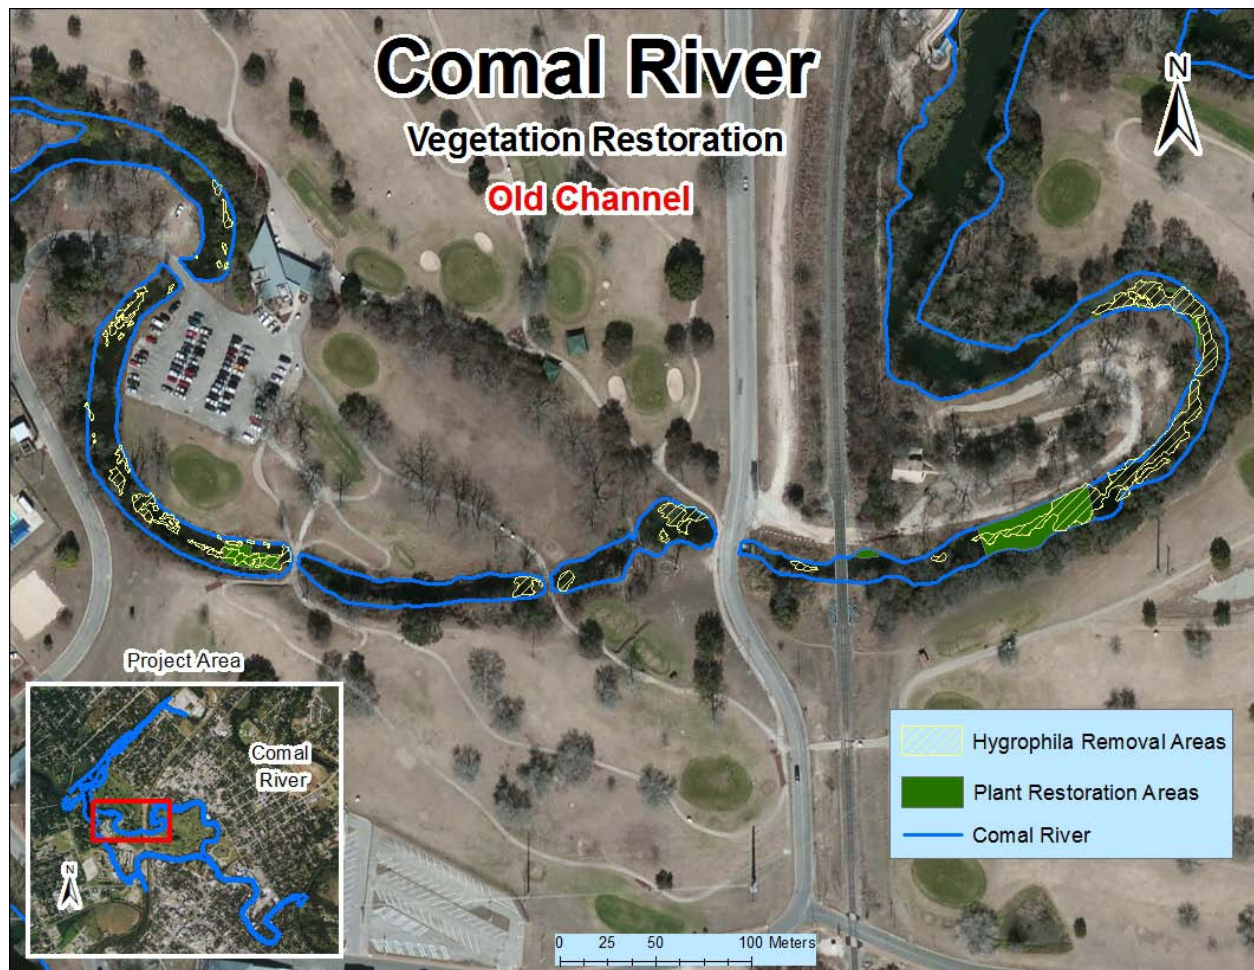
Figure 10: Restoration and Maintenance of Native Aquatic Vegetation project and Sediment Island removal project – Old Channel (Comal River)

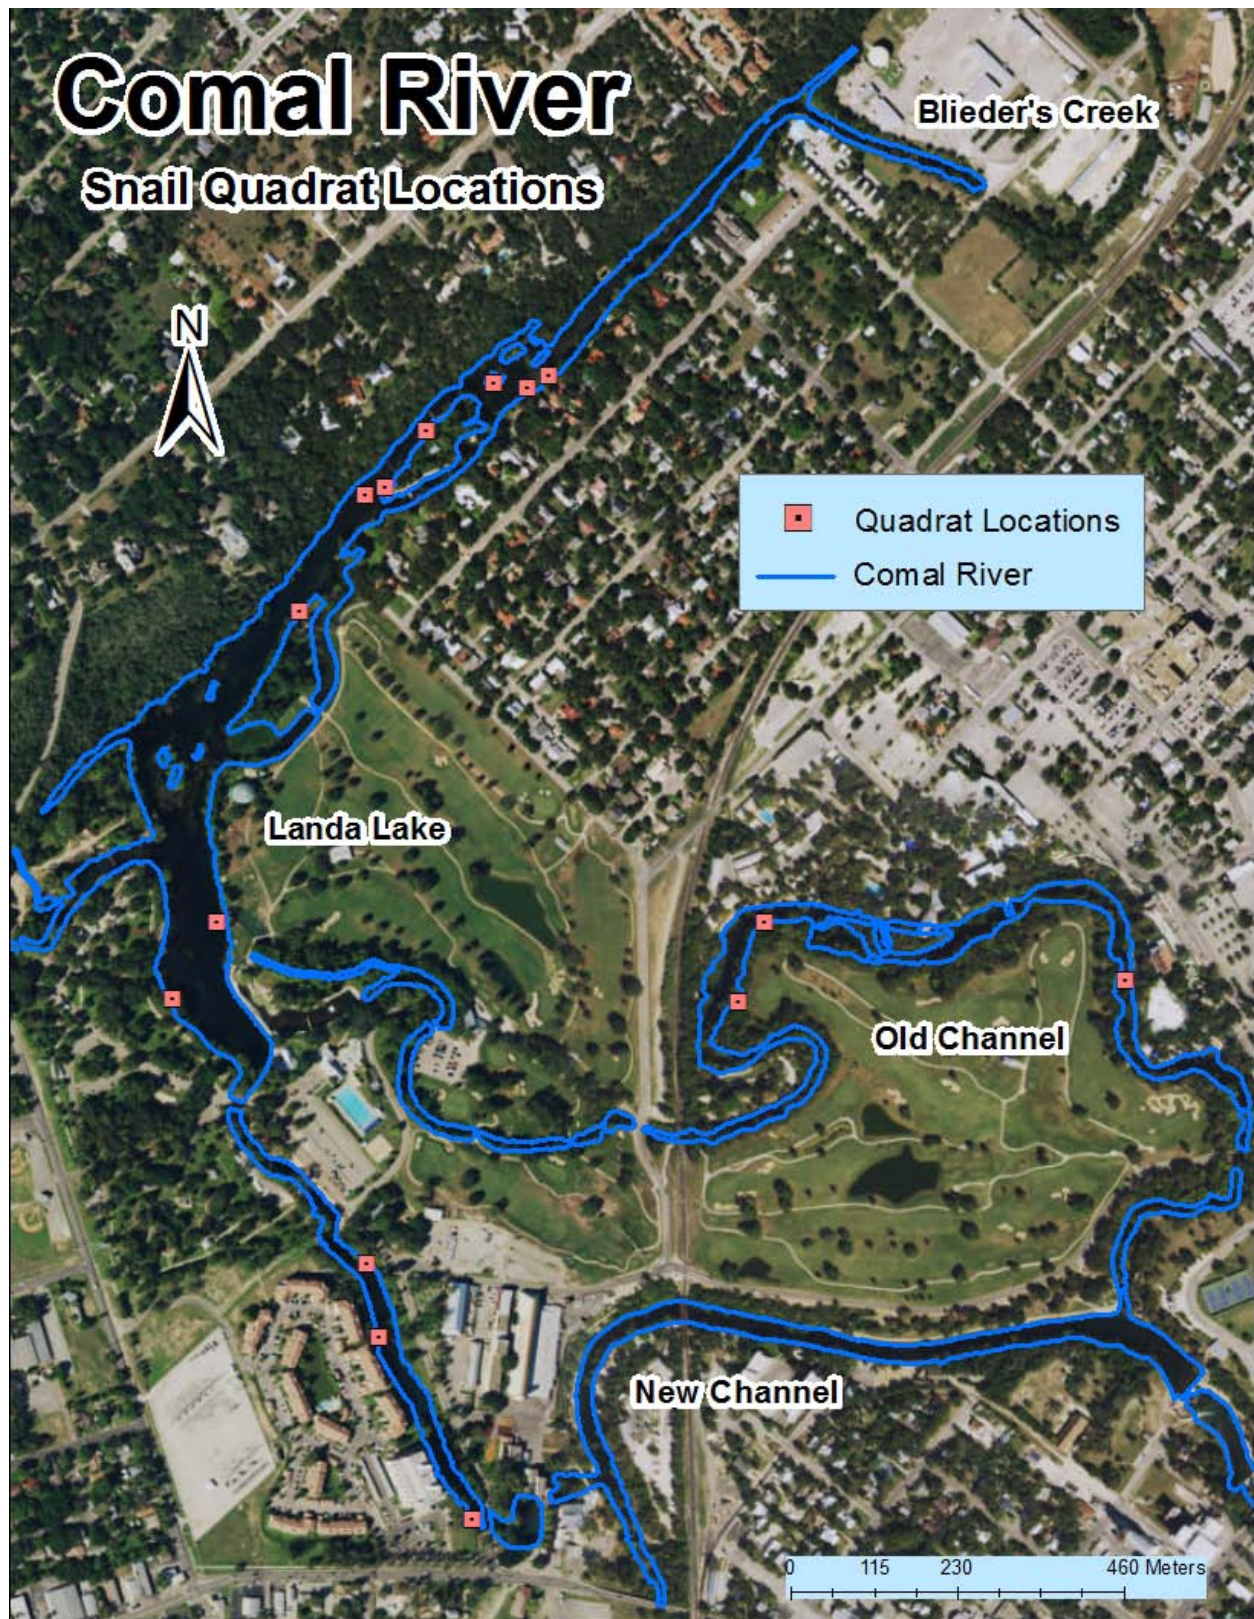
Figure 11: Gill Parasite project – Snail Quadrat Locations

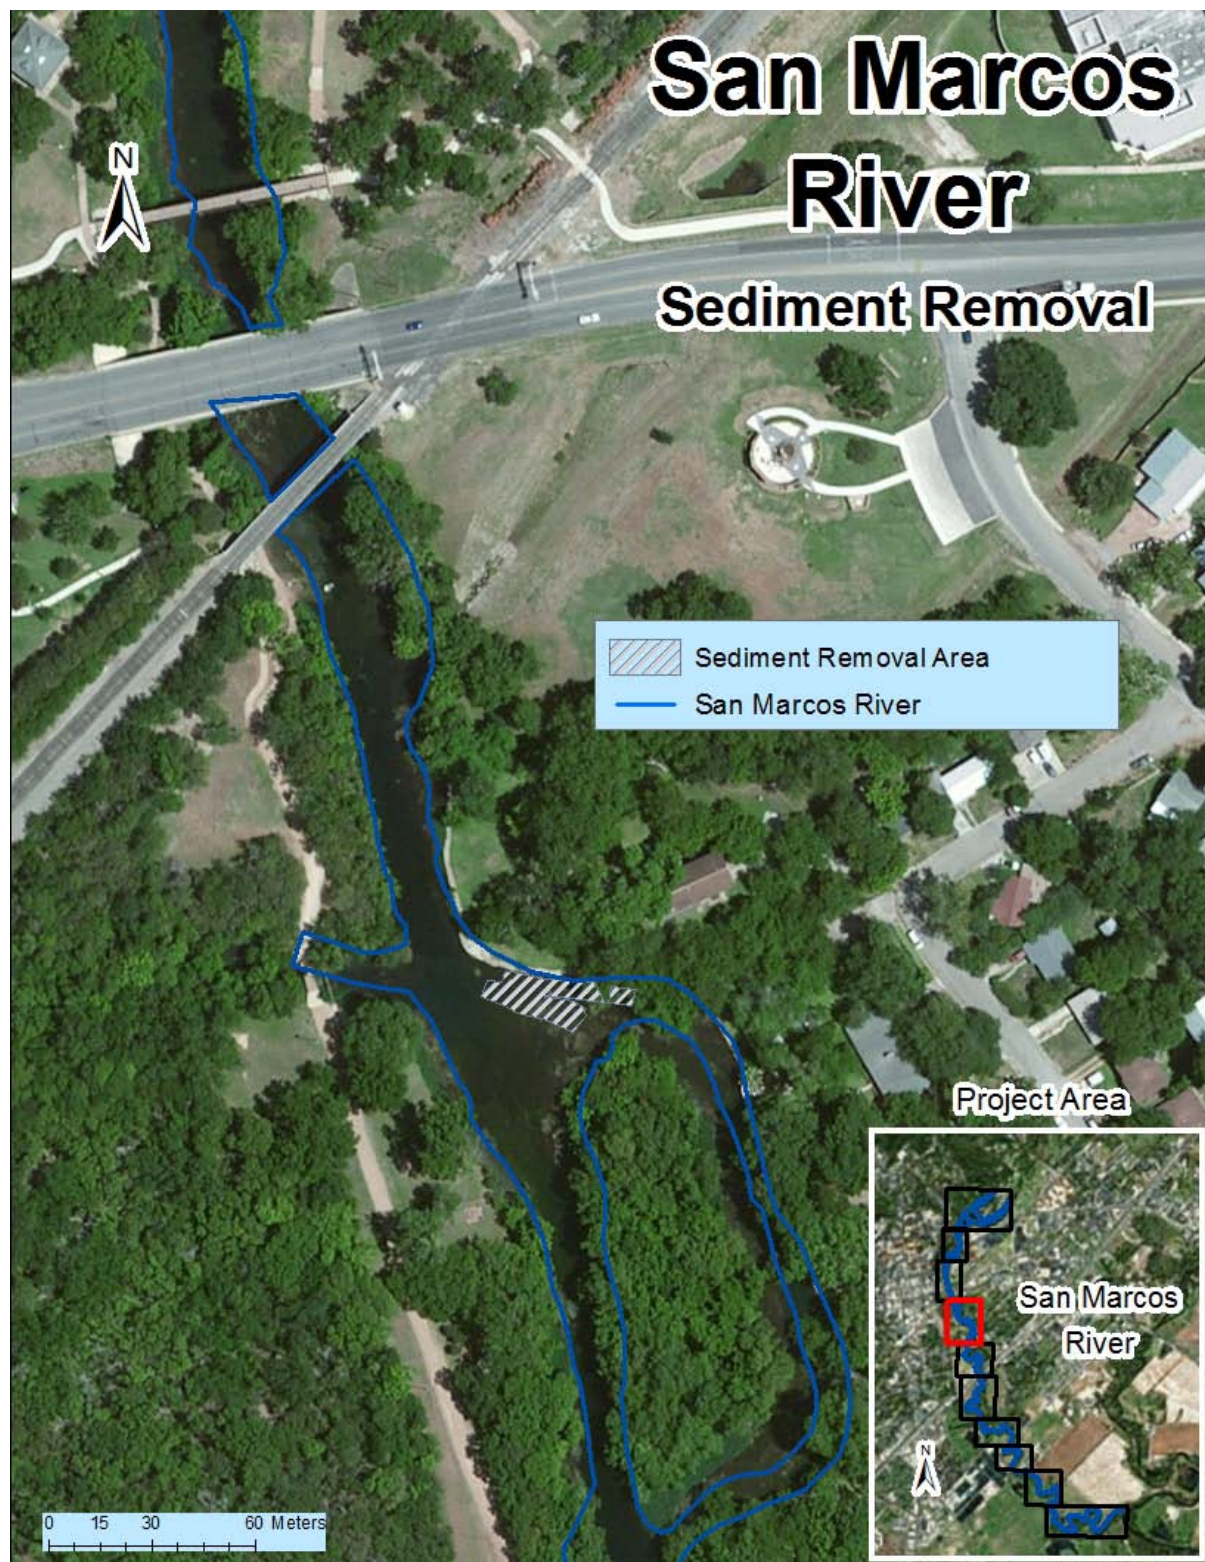
Figure 16: 2015 Sediment Removal areas – San Marcos River.

The **Sediment Removal** project areas are depicted on Figure 16. Fine sediment was carefully removed from within these boundaries following the protocols described in HCP annual work plans. The overall project footprint was 272 m² of which 264 m² overlapped with fountain darter occupied habitat in the San Marcos River (Table 2). Temporary disturbance from foot traffic to and from these locations and from slightly elevated turbidity during fine sediment removal did occur. The **Bank stabilization** projects were completed in 2014 and thus no project footprint was reported this year.

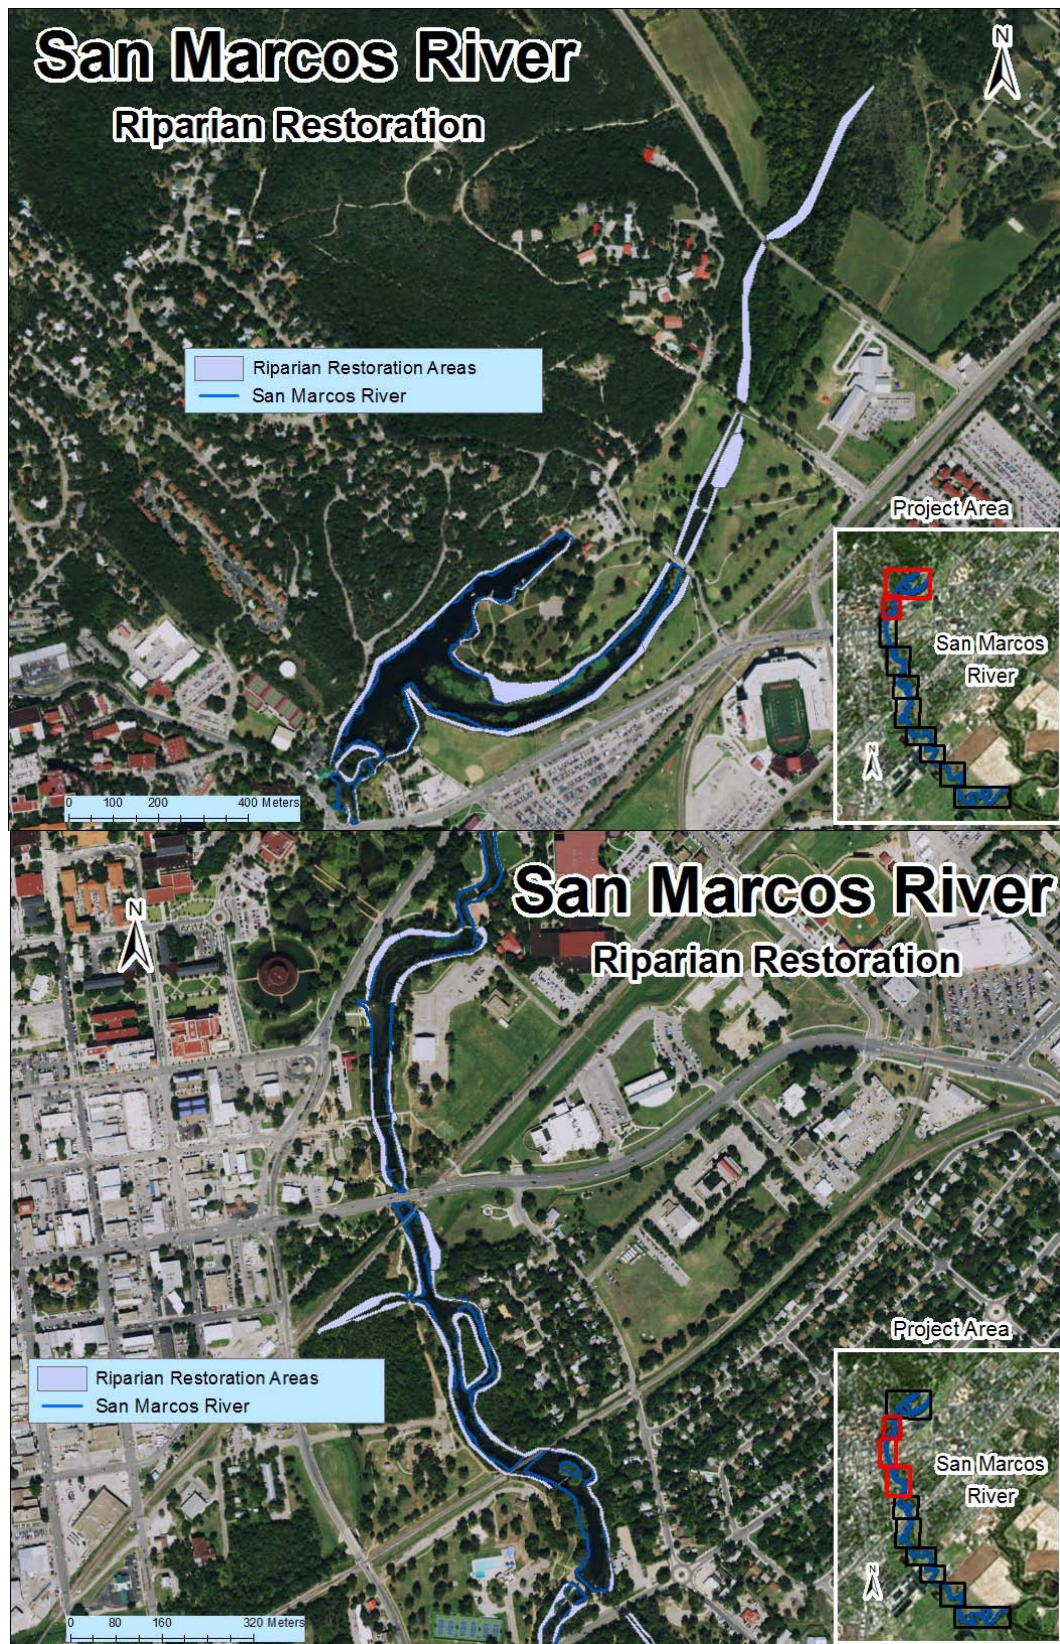
Figure 17: 2015 Riparian Restoration areas – San Marcos River.

Figure 17 (continued): 2015 Riparian Restoration areas – San Marcos River.

The **Riparian restoration** project along the San Marcos River in 2015 involved the largest project footprint (103,096 m²) of any HCP restoration project in either spring system to date. The restored areas are depicted on Figure 17 and quantified in Table 2. As in years past, the riparian restoration project took place on the banks and water's edge and did not overlap with any occupied habitat for the covered species.

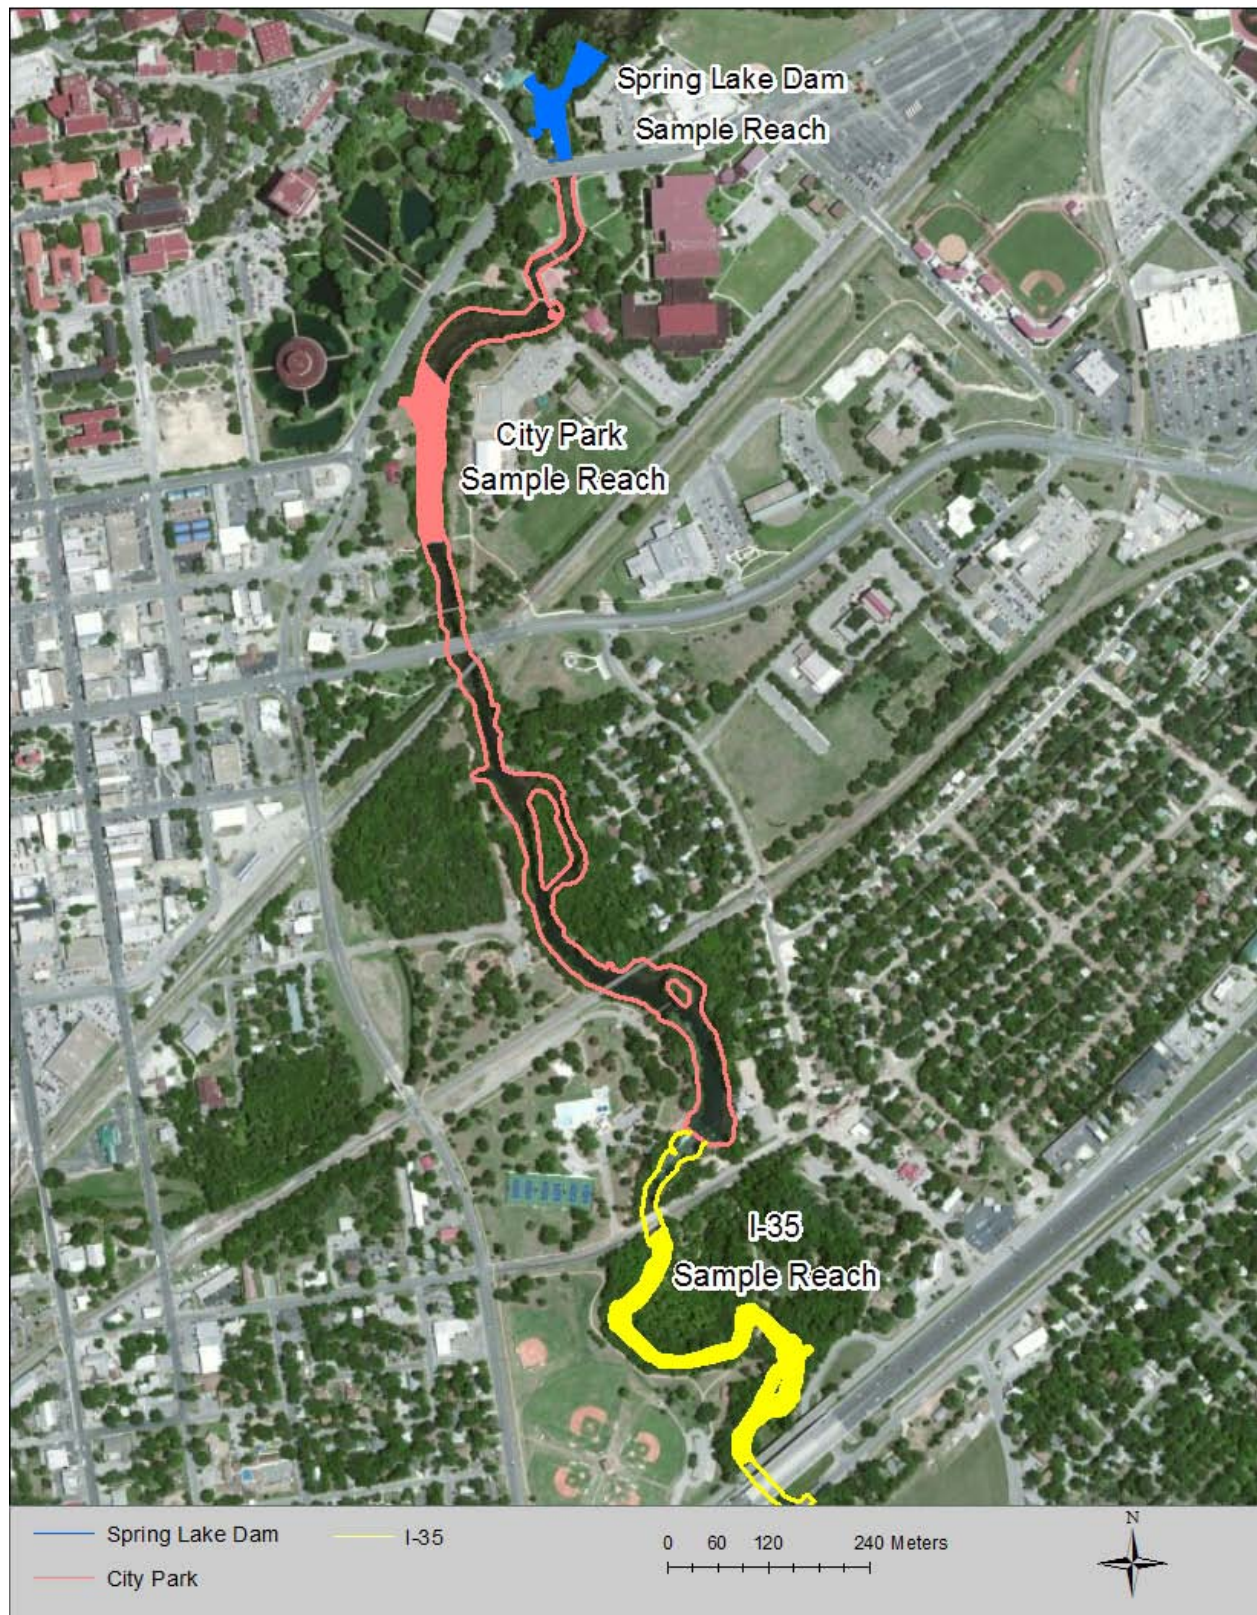
Figure 19. Sample Reaches (3) for the San Marcos System and Corresponding River Section.

Figure 19 cont. I35 Sample Reach and Corresponding Lower River Section in the San Marcos System.
