BIO-WEST, Inc.
1812 Central Commerce Court
Round Rock, Texas 78664

MEMORANDUM

SUBJECT: **ITEM M NET DISTURBANCE AND INCIDENTAL TAKE
ASSESSMENT FOR 2018 EARIP ITP ANNUAL REPORT**

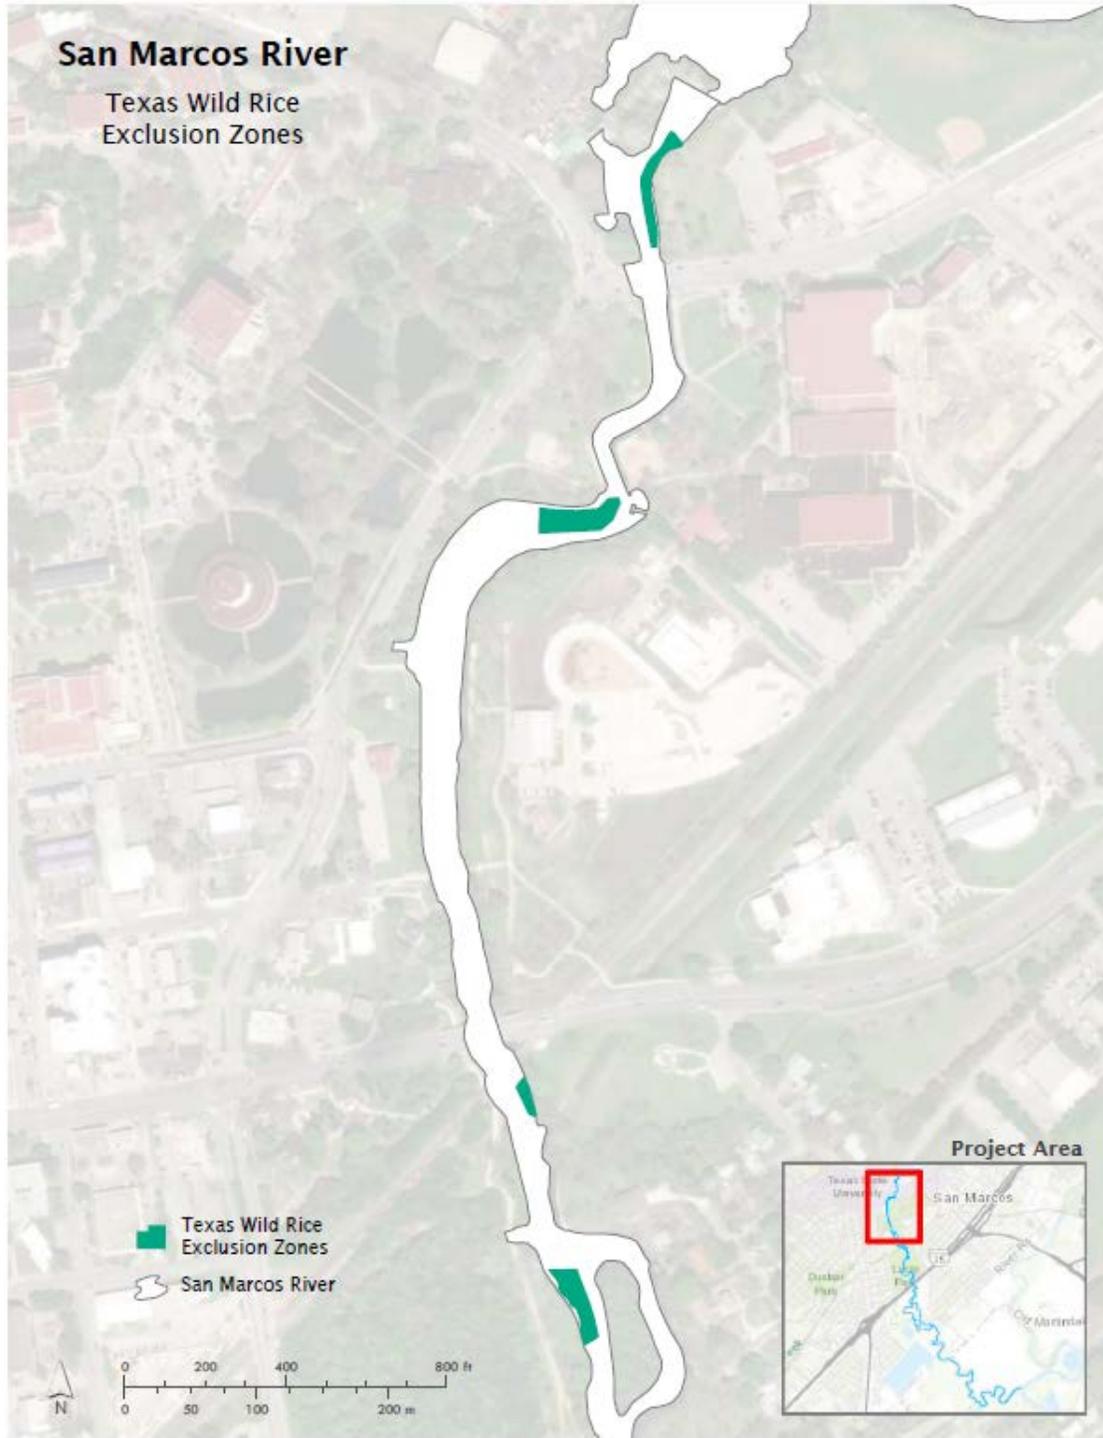
Figure 5. Four Texas wild-rice Exclusion Zones within State Scientific Area for Recreation control in 2018 – San Marcos River.

There were four **Exclusion zones** incorporated for 21 days in the summer within the State Scientific Areas in 2018 for the management of recreation (Figure 5). These areas included Clear Springs river left; immediately below Sewell Park river right; directly across from the Veramendii access point river left; Bicentennial Park river right. The total footprint of these areas resulted in the protection of approximately 2,856 m². The upstream exclusion zone in the eastern spillway below Spring Lake Dam was strategically placed over Fountain Darter and San Marcos salamander occupied habitat as well as Texas wild-rice. Although this area overlaps each of these covered species occupied habitats, the majority of the project footprint is a net benefit from the exclusion of recreation in these areas. The impact areas listed in Table 2 represent a 0.5 m swath across the upstream and river side perimeter of the exclusion zones to account for the placement of the signs and booms as well as foot traffic to patrol these areas. As such the total disturbance area for the four exclusions zones was 154 m² for the Fountain Darter and 15 m² for the San Marcos salamander which is only impacted by the upper portion of the exclusion zone just below Spring Lake dam. Temporary disturbance of slightly elevated turbidity to downstream areas did result from foot traffic to patrol and maintain these areas.
