MEMORANDUM

TO: Nathan Pence and Rick Illgner
FROM: Ed Oborny (BIO-WEST)
DATE: **October 25, 2013**
SUBJECT: EA HCP Bio-monitoring Update – **Week 11**

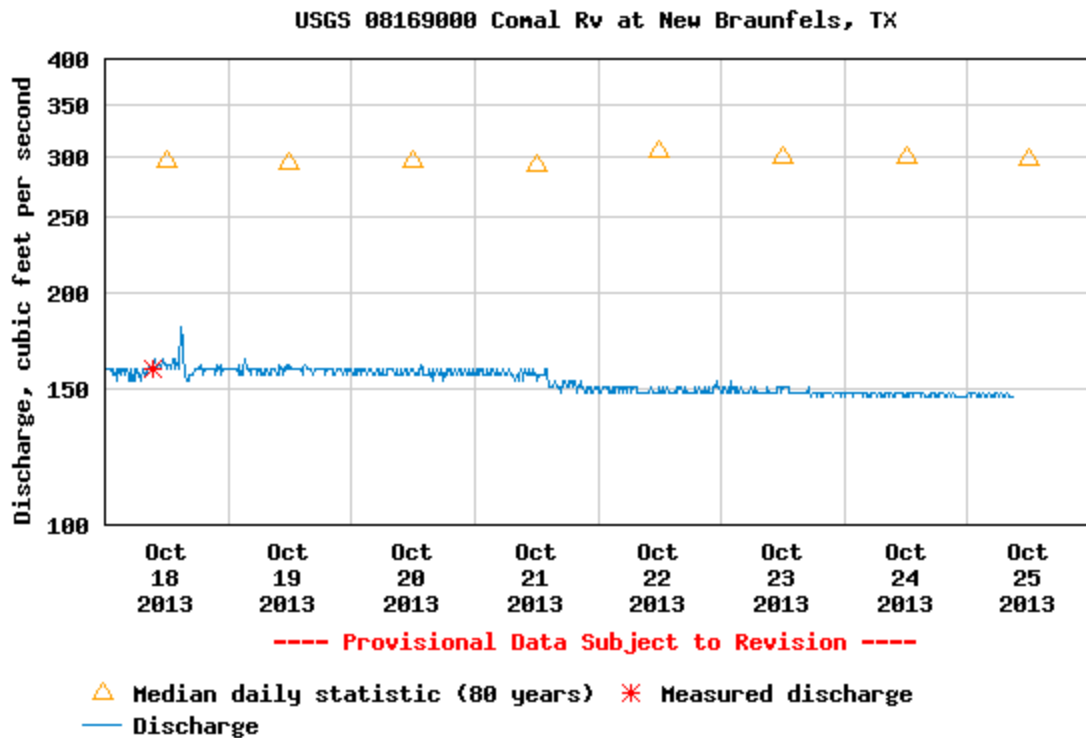
Since last week's memorandum, only minor rainfall occurred but the USGS did adjust the Comal gage based on field measurements as evident in the Figure 1 screen capture from the USGS streamflow website. With this adjustment upwards, total system discharge is now approximately 146 cfs.

Figure 1: Screen shot of USGS webpage for the Comal gage (08169000) showing total system discharge over the past week.

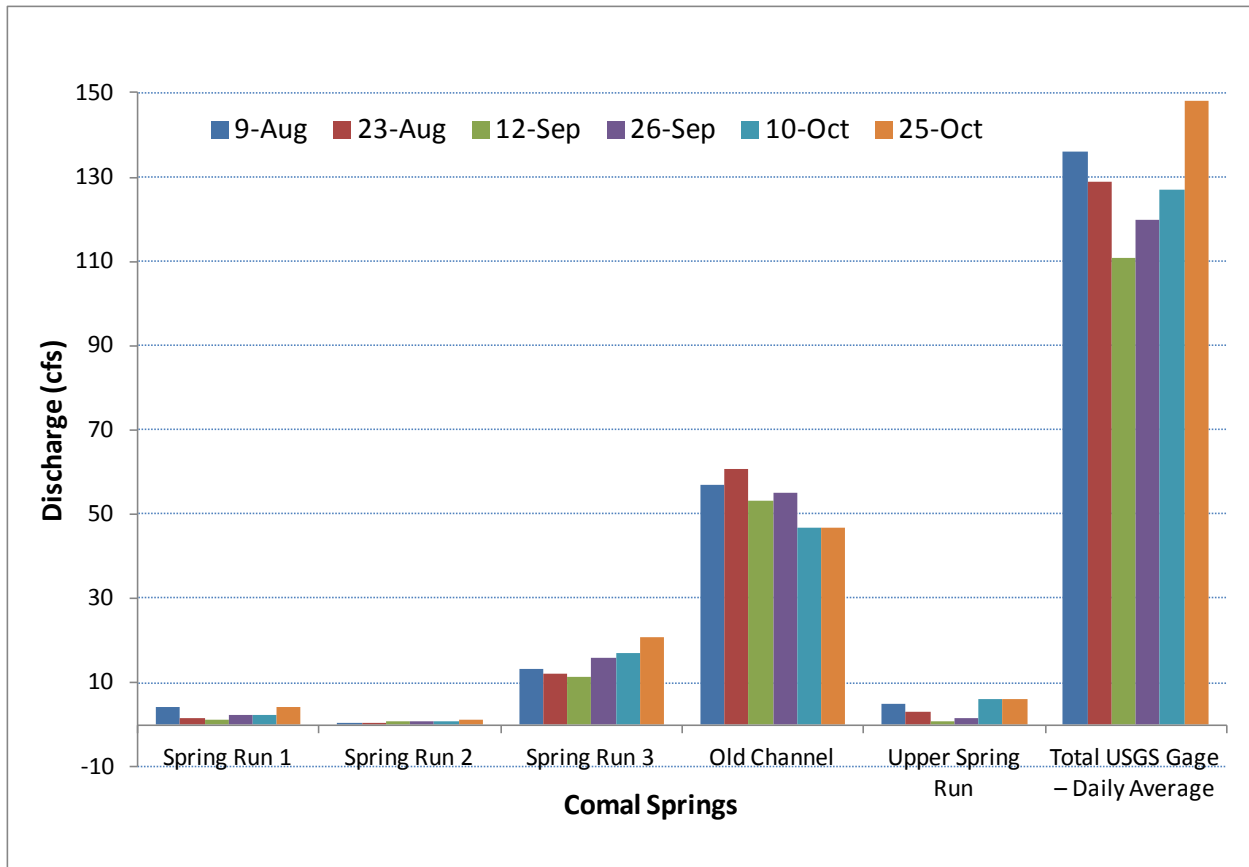
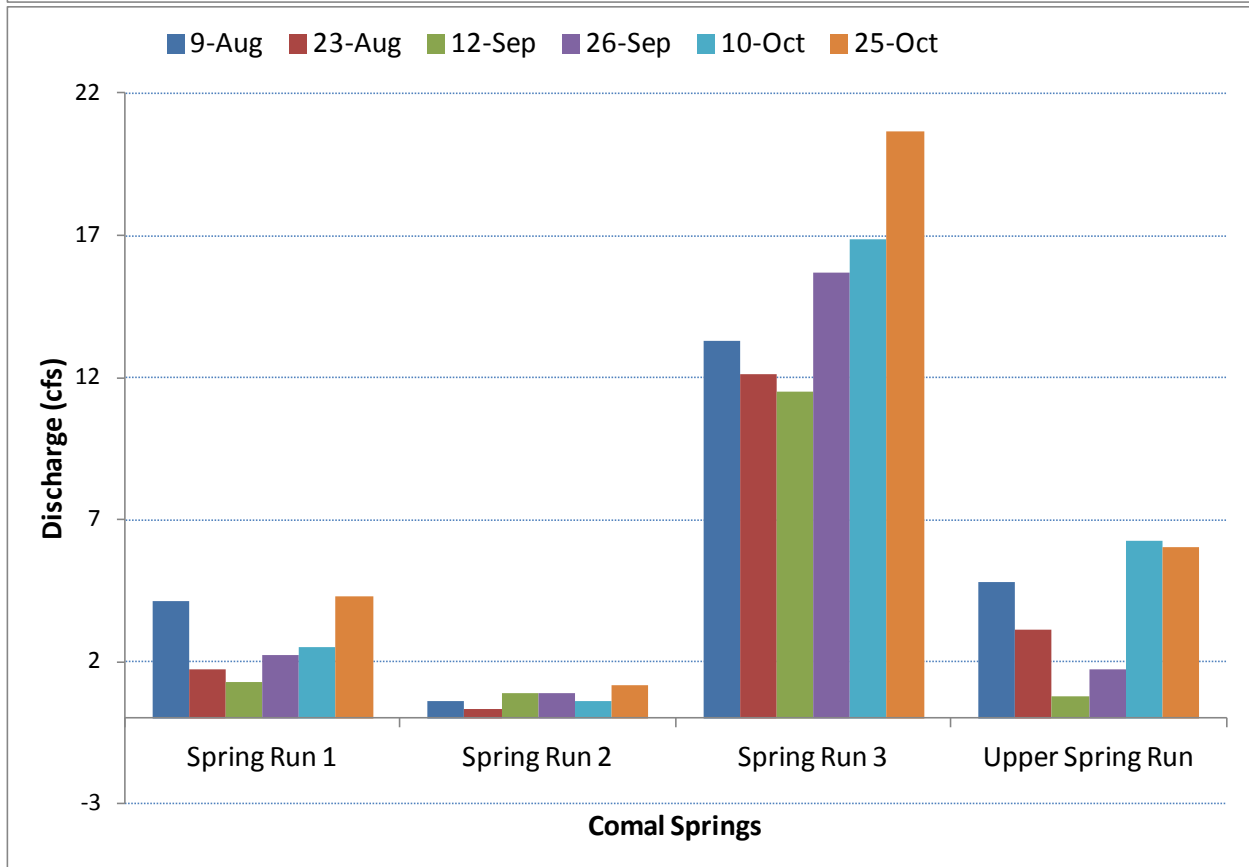
During all full sampling and critical period events, discharge data is collected at HCP Bio-monitoring locations to relate directly to biological monitoring activities being conducted. We conducted Fall comprehensive discharge measurements Thursday (October 24th) with the results of that trip and all measurements taken since the start of the Critical Period event depicted in Figure 2.

Figure 2: Discharge at measured sites since start of 2013 Critical Period sampling – All sites (Top) – Spring runs and Upper Spring run (bottom).

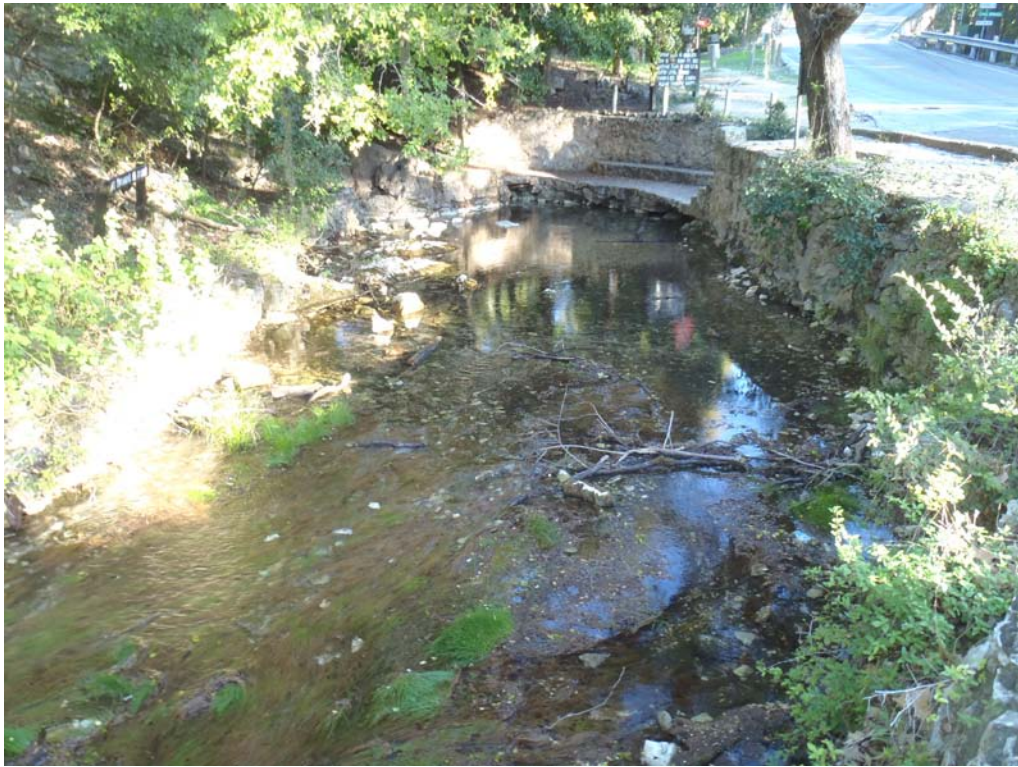
Surface water flow in Spring run 1 continues to improve with increasing springflow (Figure 3). As in all previous weeks, Spring run 3 continues to maintain connectivity throughout the run. Algae is still present in portions of the Upper Spring run reach (Figure 4) but not to the levels experienced in August or even recent weeks. As of this memorandum, aquifer levels have not rebounded to the point to allow flow over the concrete structure at Spring run 5. Increased surface water level and springflow continue to maintain near full inundation around the Spring Island area as well as surface flow in both the northern and southern runs of Spring run 6.

Figure 3: Looking upstream toward Spring run 1 main orifice (continuous surface flow extending bank to bank).

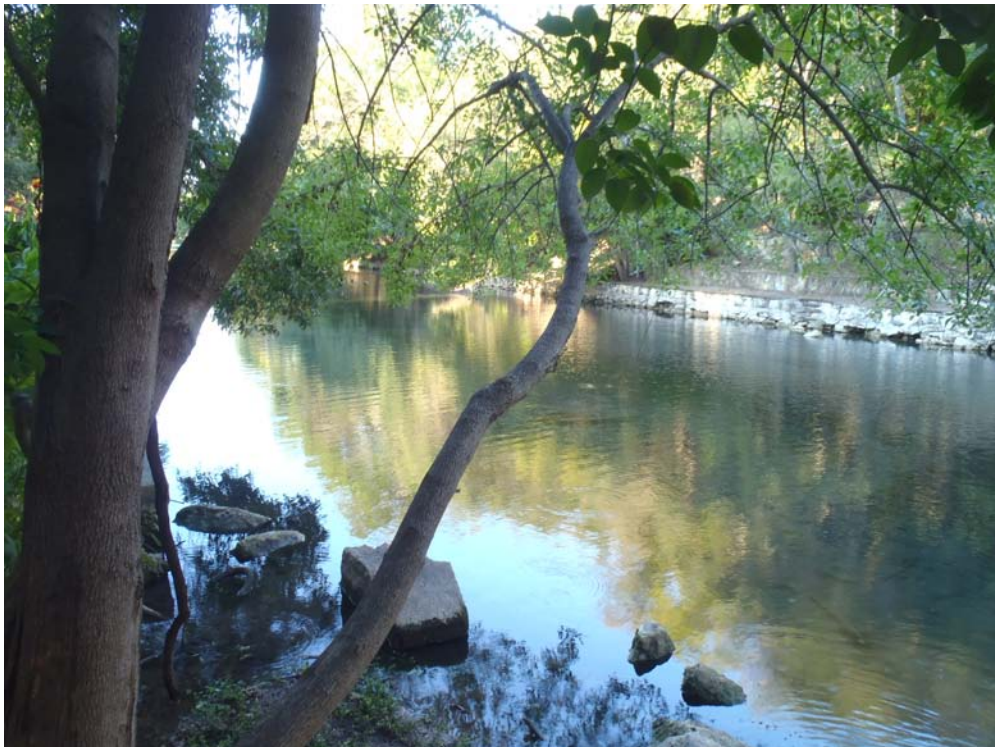
Figure 4: Upper Spring run reach adjacent to Spring run 5.

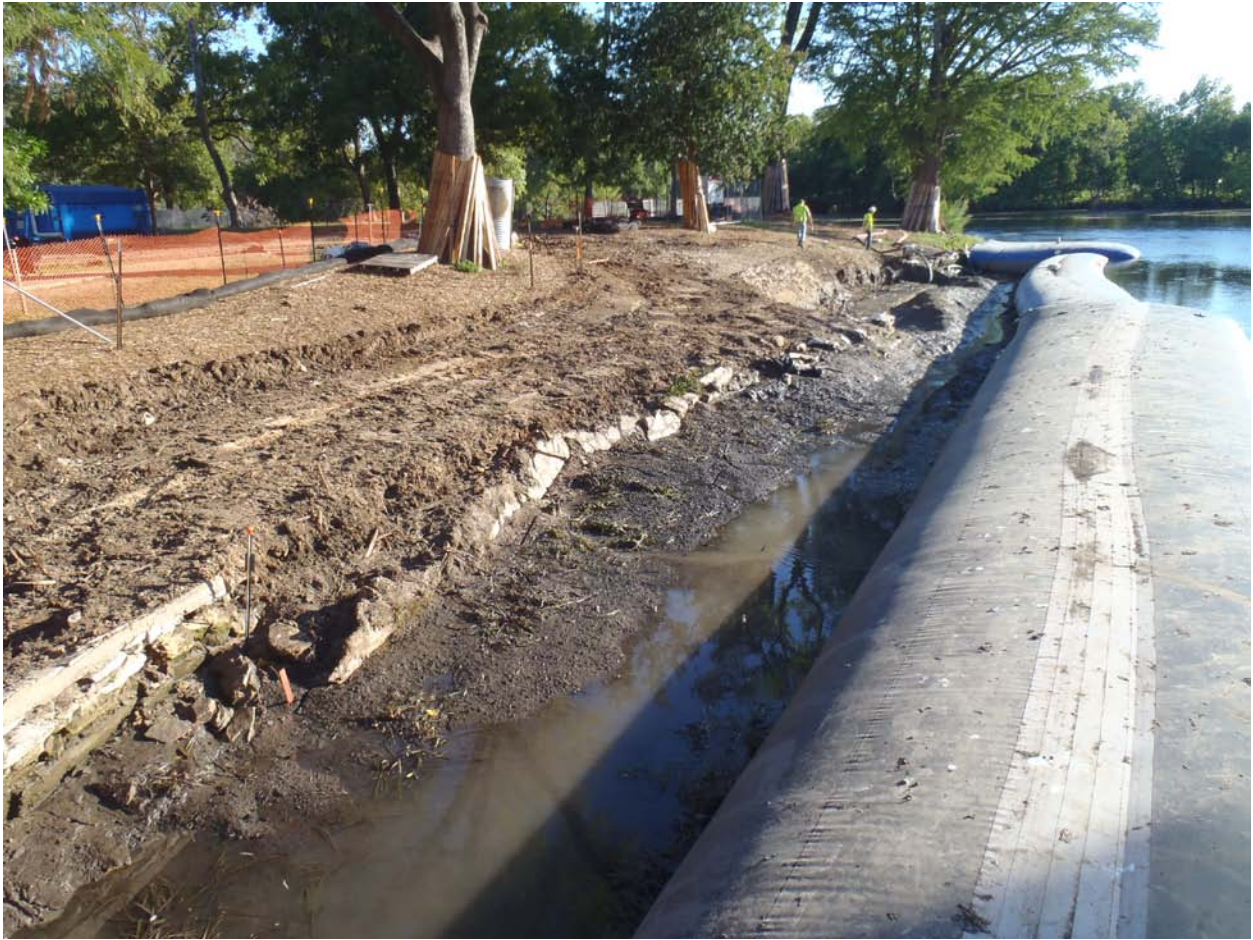
As dirt work was initiated for the Landa Lake walls construction project, I have included a photograph showing the area of wall removal (Figure 5) on river left just above the confluence of the combined Spring run 1 and 2 with Landa Lake.

Figure 5: Landa Lake walls construction project - downstream view towards the lake. Note top of photo shows the old walls removed with the lower part of the photo showing the old walls needing to be removed.

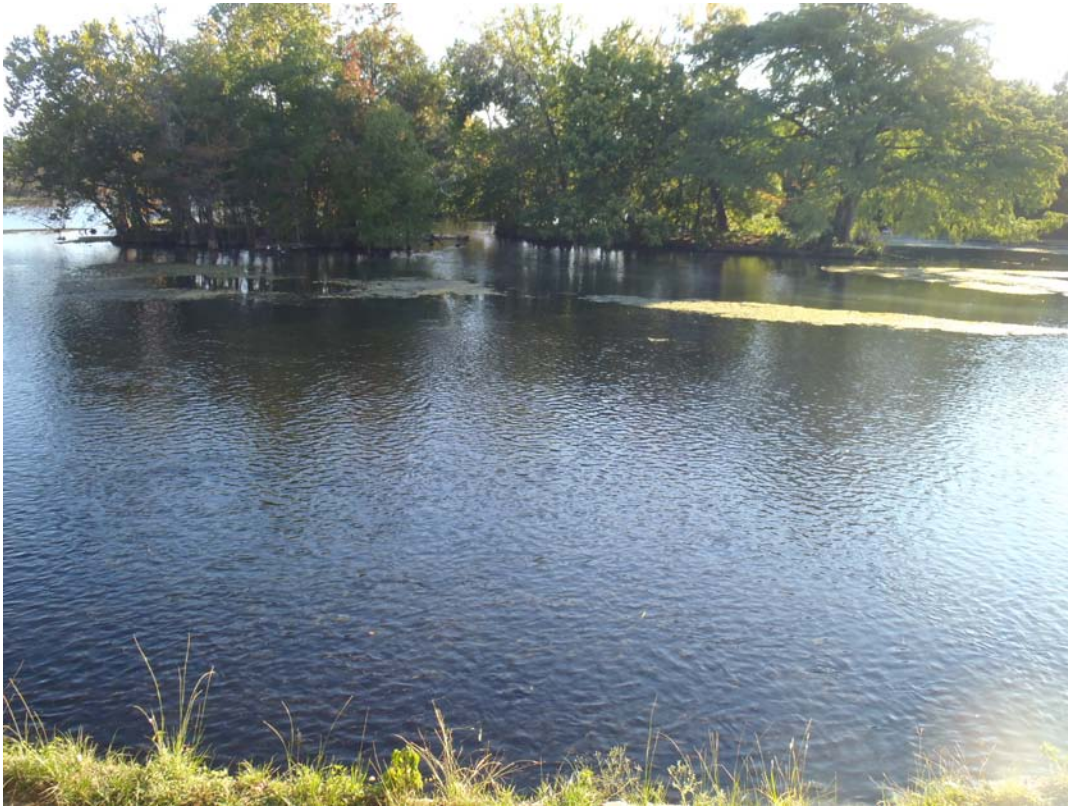
Similar to the first 10 week's memorandums, fountain darter habitat conditions in Landa Lake continue to look really good. The floating vegetation mat condition in Landa Lake continues to be under control (Figure 6). In addition to the lake, fountain darter habitat continues to thrive in the Old Channel (Figure 7) and New Channel (Figure 8).

Figure 6: Floating vegetation mat condition in Landa Lake.

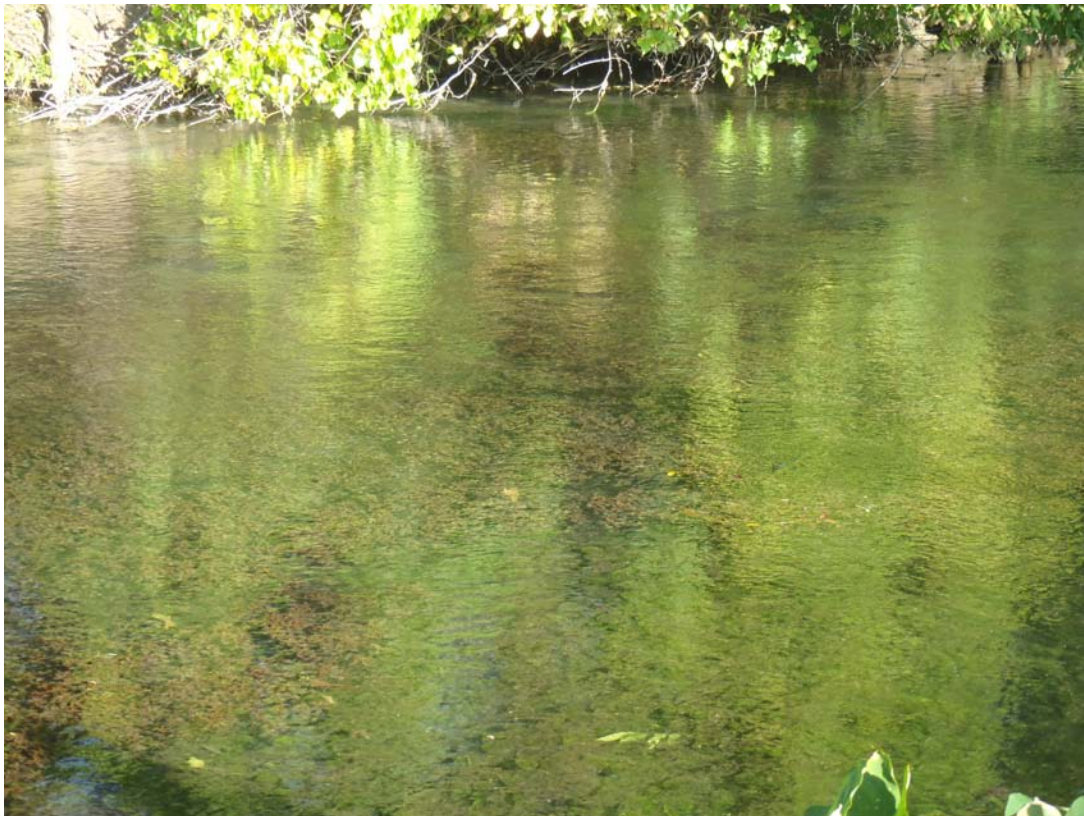
Figure 7: Restored aquatic vegetation in Old Channel.

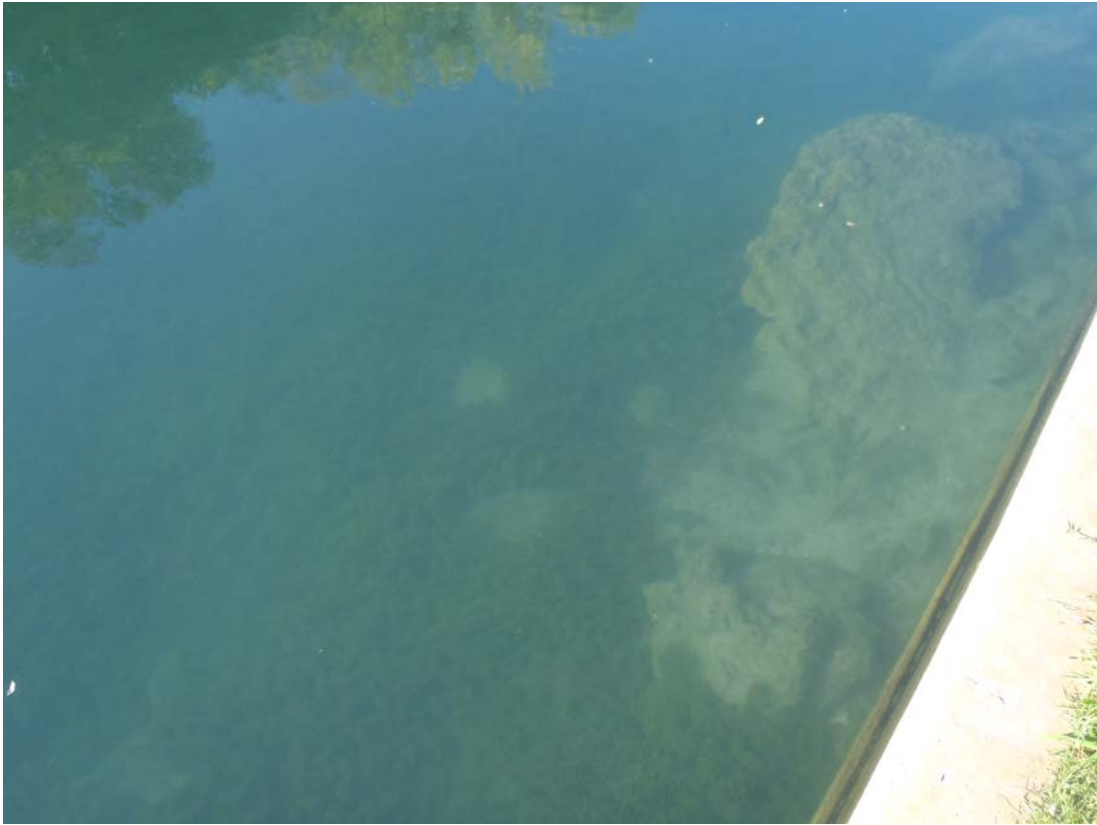
Figure 8: Extensive areas of *Cabomba* in New Channel.
