MEMORANDUM

TO: Nathan Pence
FROM: Ed Oborny (BIO-WEST)
DATE: July 18, 2014
SUBJECT: EA HCP Biological Monitoring – Week 14

BIOLOGICAL MONITORING UPDATES

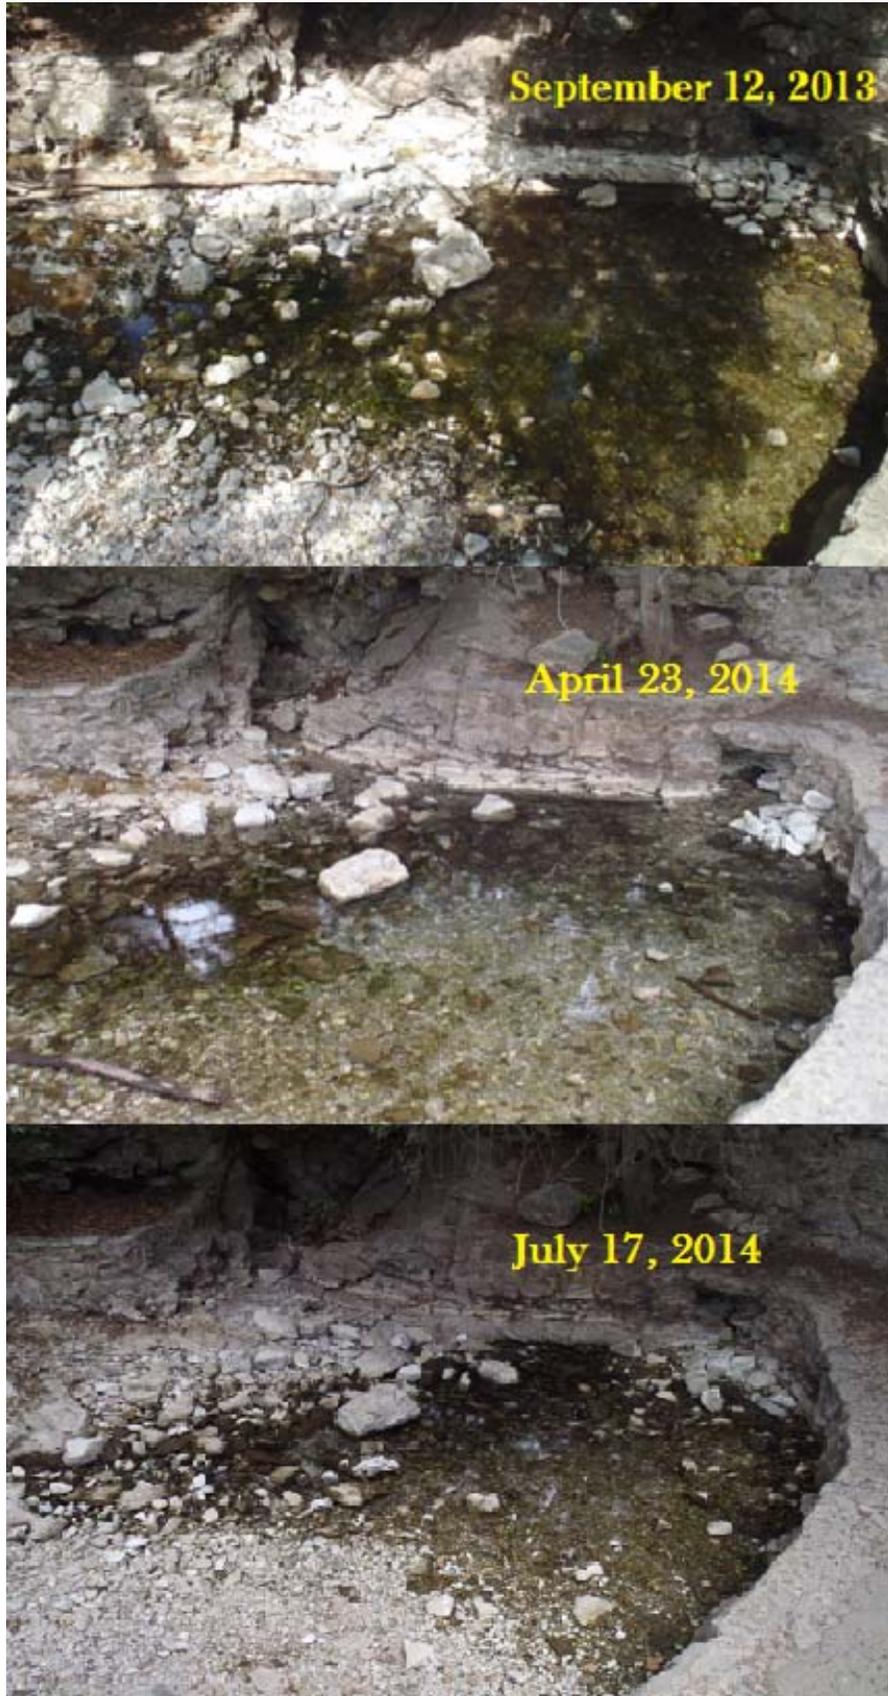
Although total system discharge was slightly higher than that reported last fall, Spring Run 1, Spring Run 3, and the Upper Spring run were exhibiting the lowest discharge conditions observed since the initiation of this monitoring program back in 2000. As a result, surface habitat conditions relative to flow, water level and exposed substrate in these areas again declined this past week. Neither of the two major orifices at Spring Run 1 exhibited surface discharge this week, with Figure 2 highlighting the lowest conditions observed in 2013, conditions during the Spring Comprehensive sampling this past April, and at present (July 17, 2014). Immediately downstream of the main orifice pool, an extended portion of the Spring Run is completely dry at the surface (Figure 3). Downstream of the dry surface portion, wetted surface water habitat reappears but the channel continues to be severely laterally constricted as one proceeds downstream until the confluence with Spring Run 2 outfall. Surprisingly, Spring Run 2 continues to maintain surface flow for the main portion of the channel and actually supports greater surface discharge than Spring Run 1. This is the first time this has been observed over the course of this study. It will be interesting to see if this is just elevation differences at conditions we have not witnessed before or if the considerable amount of wall reconstruction and rock movement in Spring Run 1 the past several months has somehow forced the redistribution of some water towards Spring Run 2. Spring Run 3 continues to maintain connectivity throughout the run (Figure 4) but at the lowest discharge observed during the course of this study it is also experiencing some reductions in lateral connectivity.

Figure 2: Spring Run 1 main orifices (different dates back through last fall).

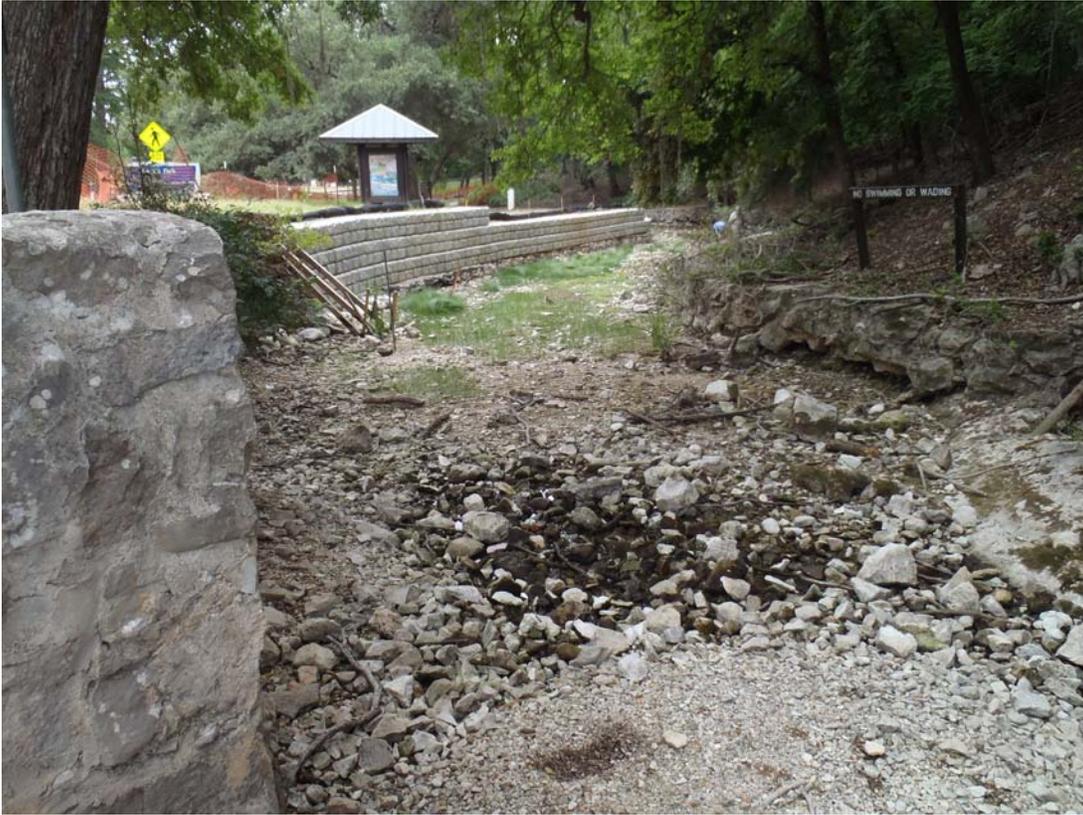
Figure 3: Spring Run 1 main channel looking downstream from main orifices).

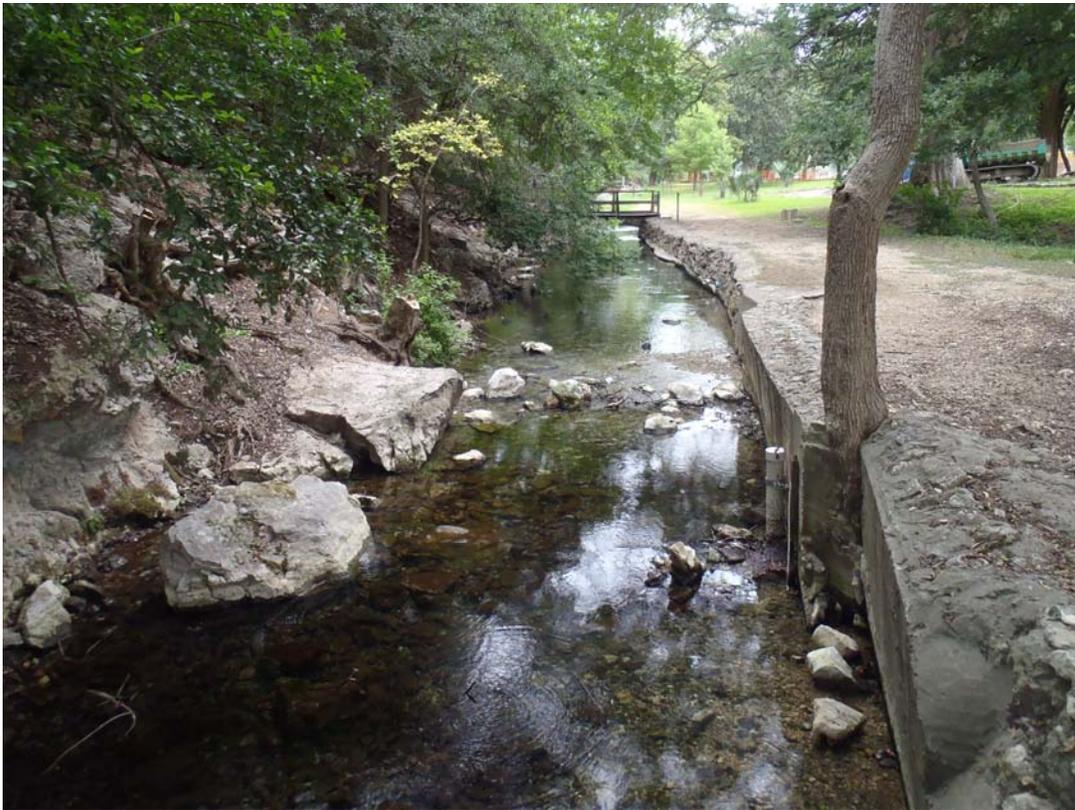
Figure 4: Spring Run 3 looking downstream from headwaters.

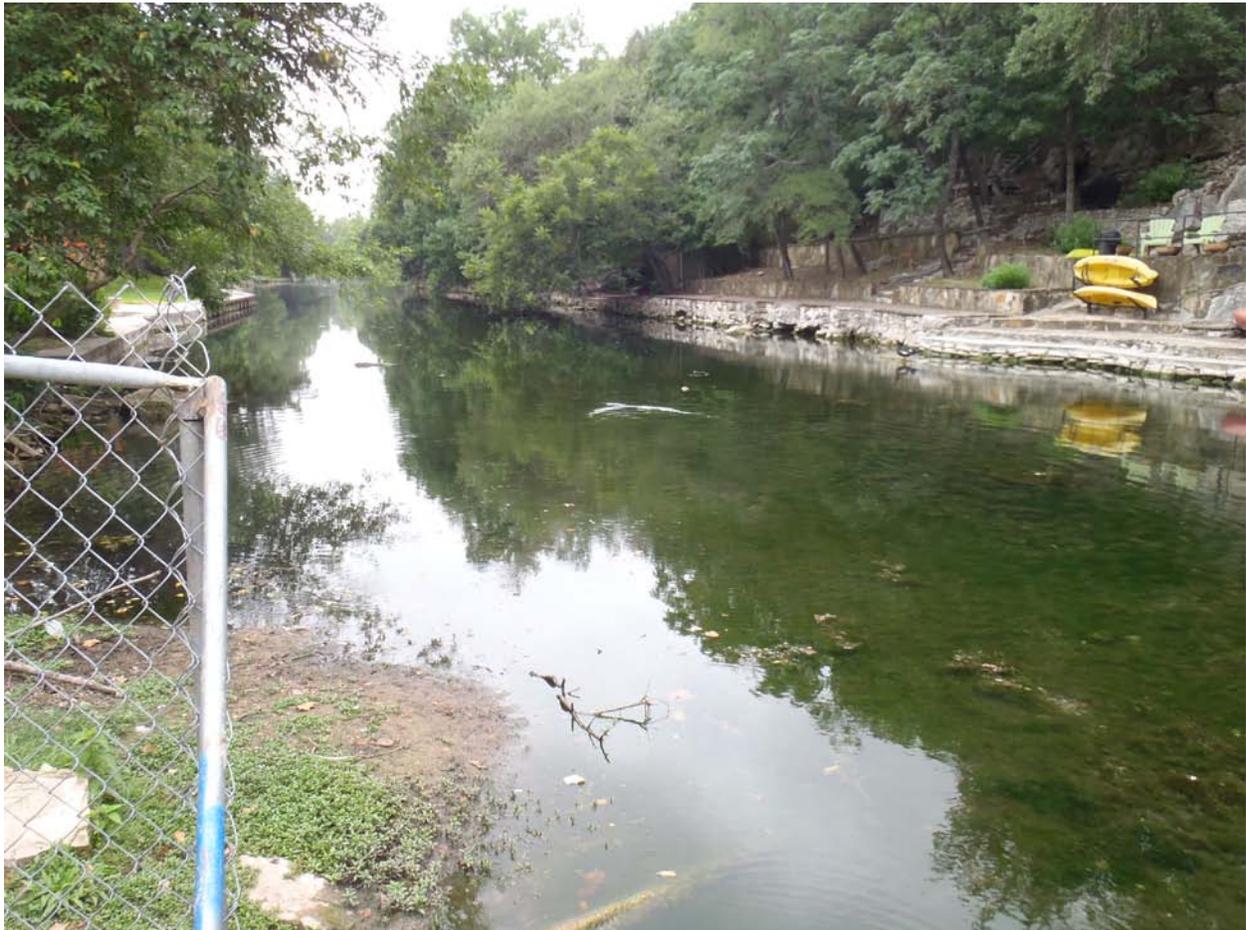
Algae continues to be extremely thick in the Upper Spring Run reach. This intense coverage has eliminated most all native bryophytes at this time and continues to cover remaining rooted aquatic macrophytes (Figure 5). It is encouraging that at a present reach discharge less than 1 cfs (Table 1) and a period now of longer than 3 months of discharge less than 5 cfs, conditions show 1) upwelling flows are still being observed as upstream as the confluence of Blieders creek, 2) rooted aquatic macrophytes, although coated in algae, continue to survive, 3) fountain darters continue to persist in this reach (documented in both dip netting efforts and results of the fountain darter movement study which has not documented any movement out of this reach at this time), and 4) water temperatures remaining for the most part below 26 °C which likely plays a major role in the continued use of this area by fountain darters. With that said, fountain darters are still being observed in Blieders creek with water temperatures approaching 29 °C. Figure 6 shows the crew conducting fountain darter movement observations in the Upper Spring Run reach. Figure 7 shows what the fluorescent marker implanted in a fountain darter looks like at night from the divers view using the specialized flashlight. Echoing all previous summertime memos, unless there is a significant change in flow conditions, algae conditions will only get worse in coming weeks with increased ambient air temperatures.

Figure 5: Extensive algal coverage continues in the Upper Spring Run reach.

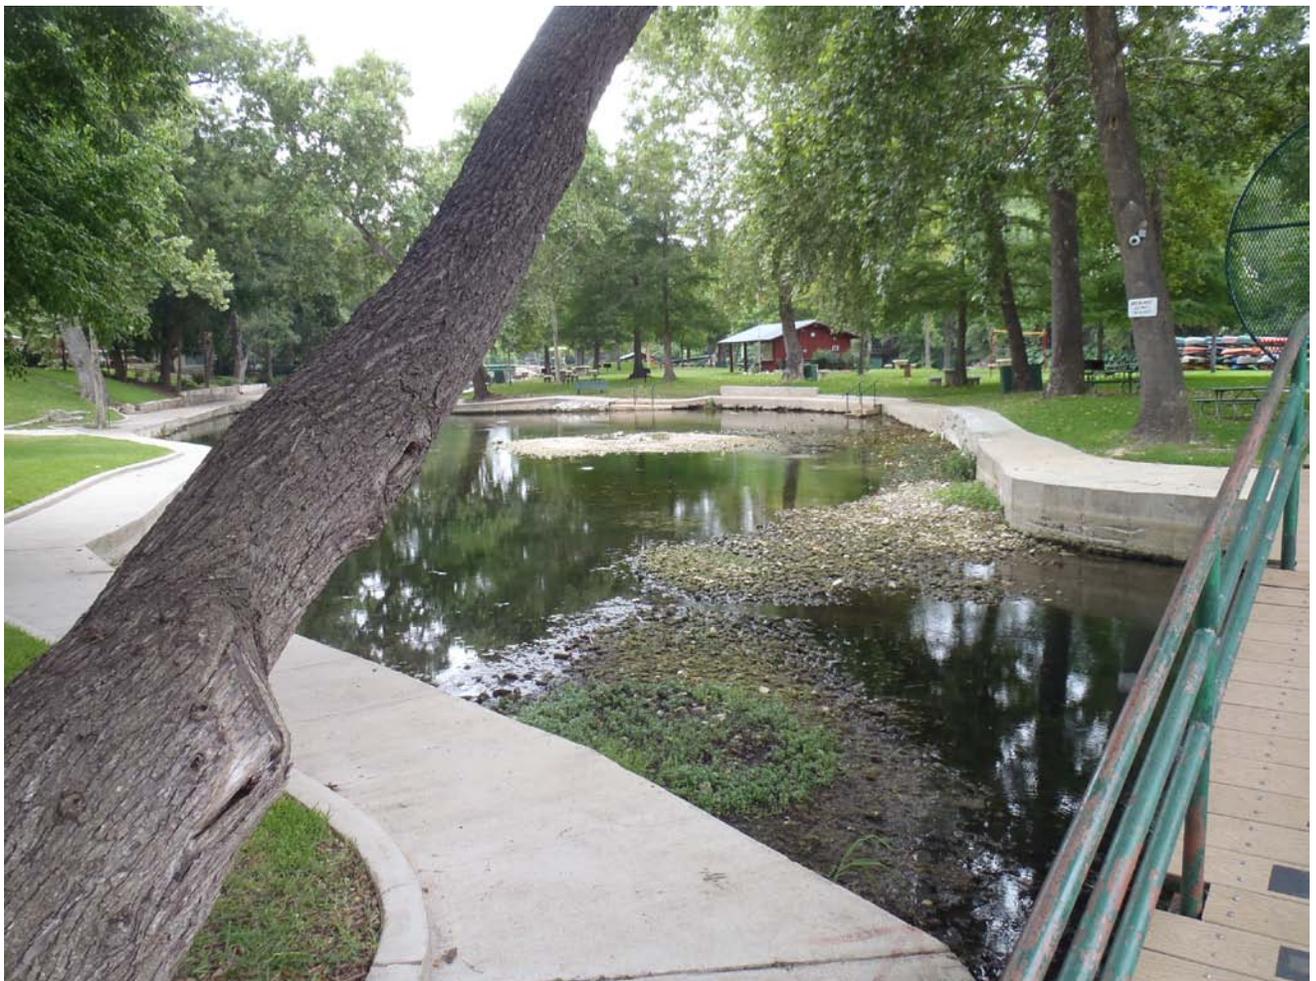
The surface water level in the Spring Island area this week was the lowest observed since the start of the biological monitoring program in 2000. Exposed surface habitat in the area along the eastern side of the island (Figure 8) remained event and both spring runs associated with Spring Island were dry on the surface (Figure 9). Not surprisingly, although the spring runs were dry on the surface, water was still issuing from the island at the base of the spring run documenting that subsurface flow was indeed occurring. Figure 10 shows the crew conducting Comal Springs salamander surveys in the highly constricted Spring Run 1 channel on July 17th. Table 2 shows the long-term average as well as recent counts of Comal Springs salamanders in each of the sample locations. All but Spring Run 3 exhibited lower than long-term study average numbers of Comal Springs salamanders which is not surprising because of the more notable reductions in available surface habitat at these locations. It is interesting that in Spring Run 1 where reductions in surface habitat are the worst witnessed during this biological monitoring program, more salamanders were reported yesterday than during the final 3 sampling events in 2013. This may be explained by clumping in limited available habitat, but regardless, it is encouraging at this point that they are still present at the surface.

Figure 8: Continued exposed surface habitat adjacent to Spring Island.

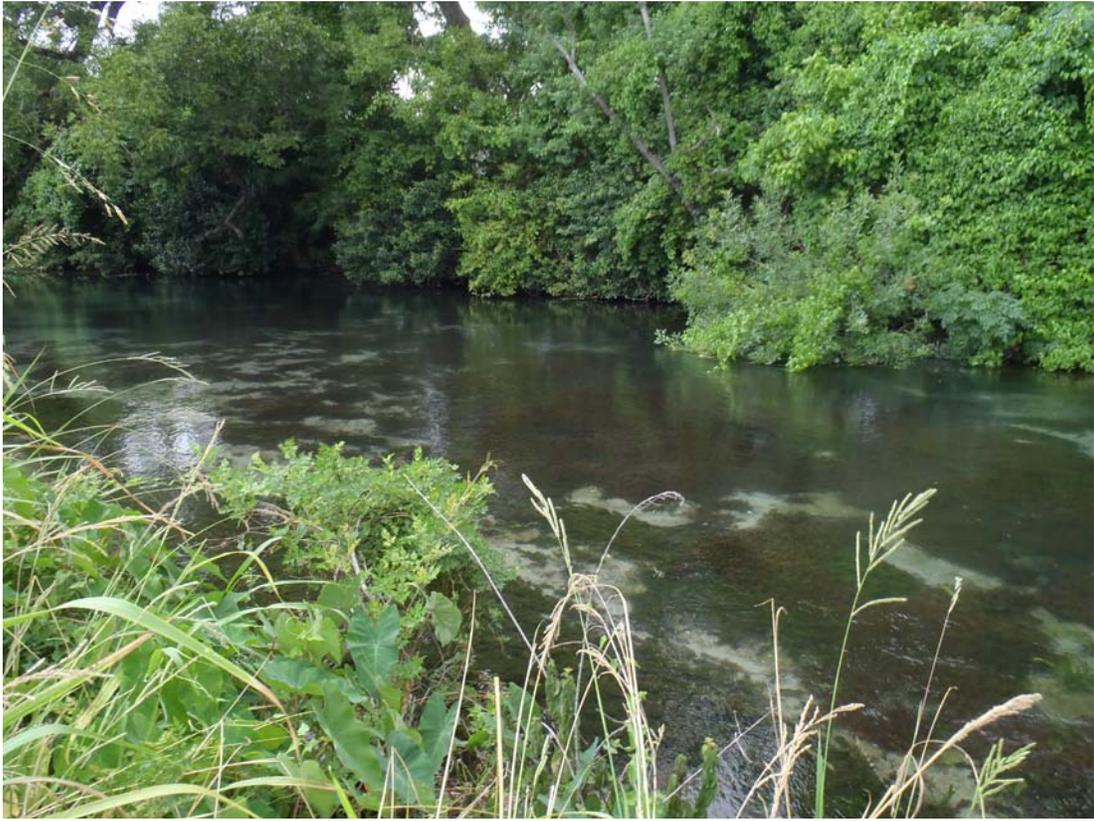
Similar to the last 3 months of these memorandums, aquatic vegetation within Landa Lake, the Old Channel (Figure 11), and New Channel (Figure 12) continue to support quality fountain darter habitat. With the flow-split project now complete, and the fact that over 900 m² of non-native *Hygrophila* was removed in key parts of the Old Channel in early June, and over 2,500 native plants were planted in the month of June alone throughout key locations in the Old Channel, we feel much better as we potentially move into springflow conditions not experienced in the Comal system for nearly 20 years. Per the previous sentence, all aquatic vegetation work performed in June was conducted during that nice window of total system discharge greater than 130 cfs.

Figure 11: Restored native aquatic vegetation continues to thrive in the Old Channel.

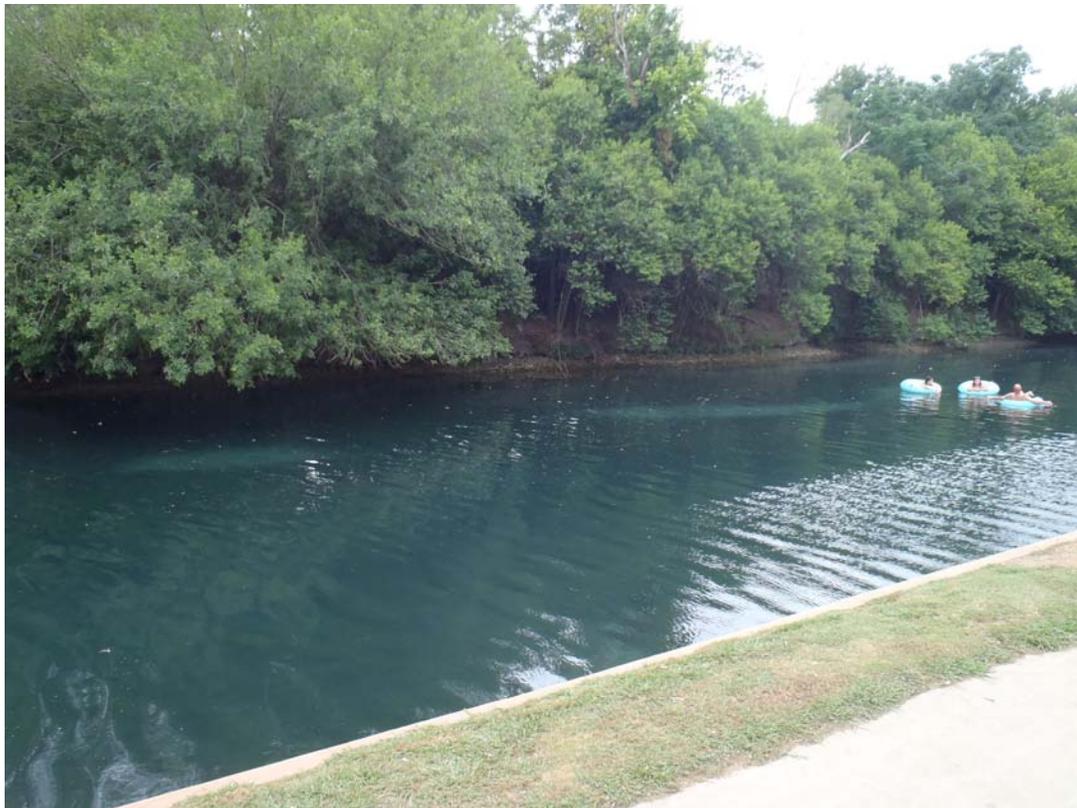
Figure 12: New Channel *Cabomba* continues to support quality fountain darter habitat.
