MEMORANDUM

TO: Nathan Pence
FROM: Ed Oborny (BIO-WEST)
DATE: July 25, 2014
SUBJECT: EA HCP Biological Monitoring – Week 15

COMAL SPRINGS/RIVER - WEEK 15 CONDITIONS:

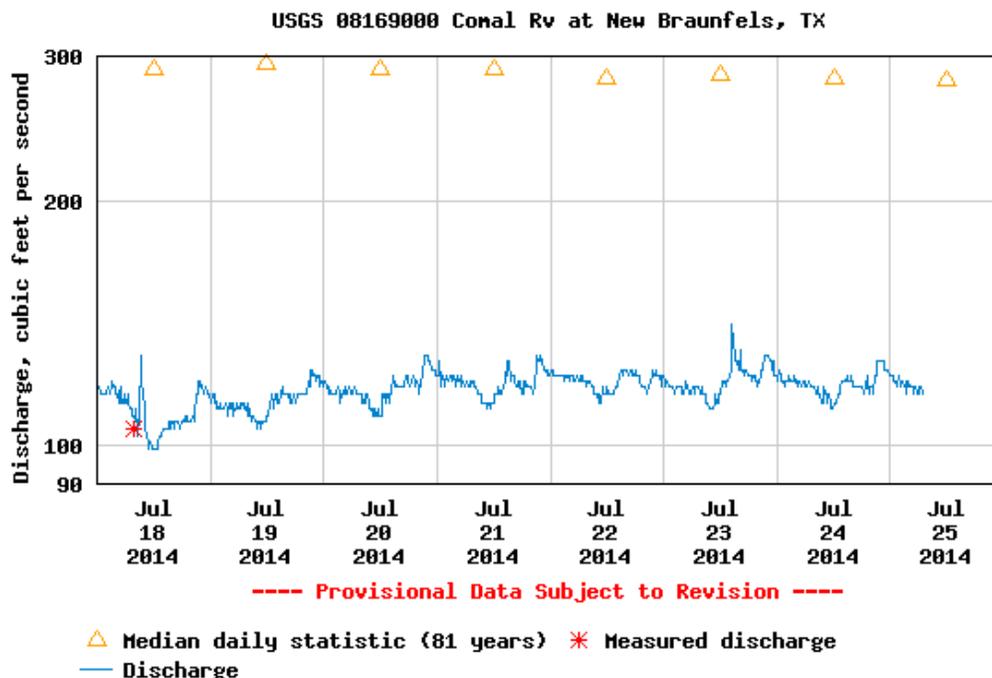
Figure 1: Screen shot of USGS webpage for the *COMAL* gage (08169000) showing total system discharge over the past week.

At the time of this memorandum, the total system discharge at Comal Springs was 116 cfs (Figure 1). This makes the fifteenth consecutive week below 150 cfs, and therefore, the required weekly habitat evaluation was conducted on July 24th. Weekly habitat evaluations and memorandums will continue to occur until total system discharge at Comal Springs/River increases and consistently stays above 150 cfs. Unless significant rainfall over the watershed occurs, total system discharge will likely remain below 120 cfs next week triggering the next round of the every other week Comal Springs riffle beetle, Comal Springs salamander, and Comal discharge measurements/sampling. As described in previous weeks, the next Critical Period full sampling event is not triggered until the total system discharge declines below 100 cfs. The next scheduled routine monitoring is summer fountain darter dip netting which will be initiated next week.

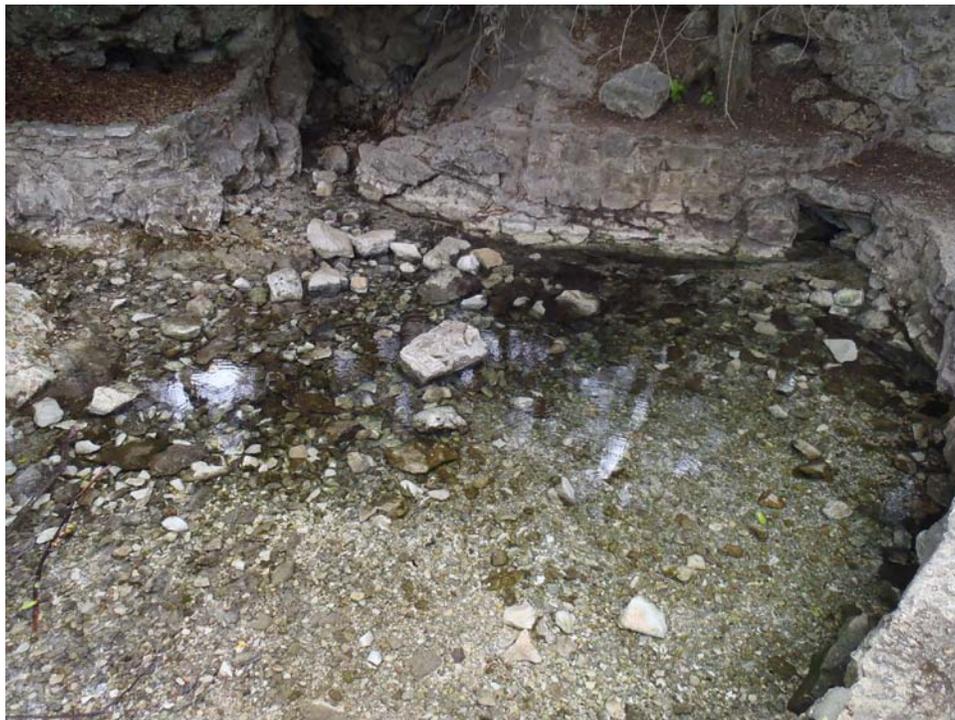
Figure 2: Spring Run 1 main orifices (surface flow has returned).

With the rainfall towards the end of last week, the J17 water level had risen to over 639 early this week which was nearly an 8 foot rise to the week prior. At the time of photo documentation this week, J17 had dropped back down to the 636's. It is quite amazing how a few feet at J17 can so closely relate to the condition of Spring Run 1 in real time. Although the total system discharge at the time of this and last week's memorandums were both reported at 116 cfs, the preceding patterns were very different. Figure 1 shows the increasing trend that occurred throughout this week following the USGS adjustment on July 18th. As a result of this increasing trend and overall rise in total system discharge this week, surface habitat conditions in previously impacted areas improved; considerably in the case of Spring Run 1. Unlike last week, both of the two major orifices at Spring Run 1 exhibited surface discharge this week (Figure 2) with longitudinal surface connectivity throughout the entire spring run and improved lateral connectivity in many places (Figure 3). As in all previous weeks, Spring Run 2 continues to maintain surface flow for the main portion of the channel. Spring Run 3 continues to maintain connectivity throughout the run and observed improved lateral connectivity this week.

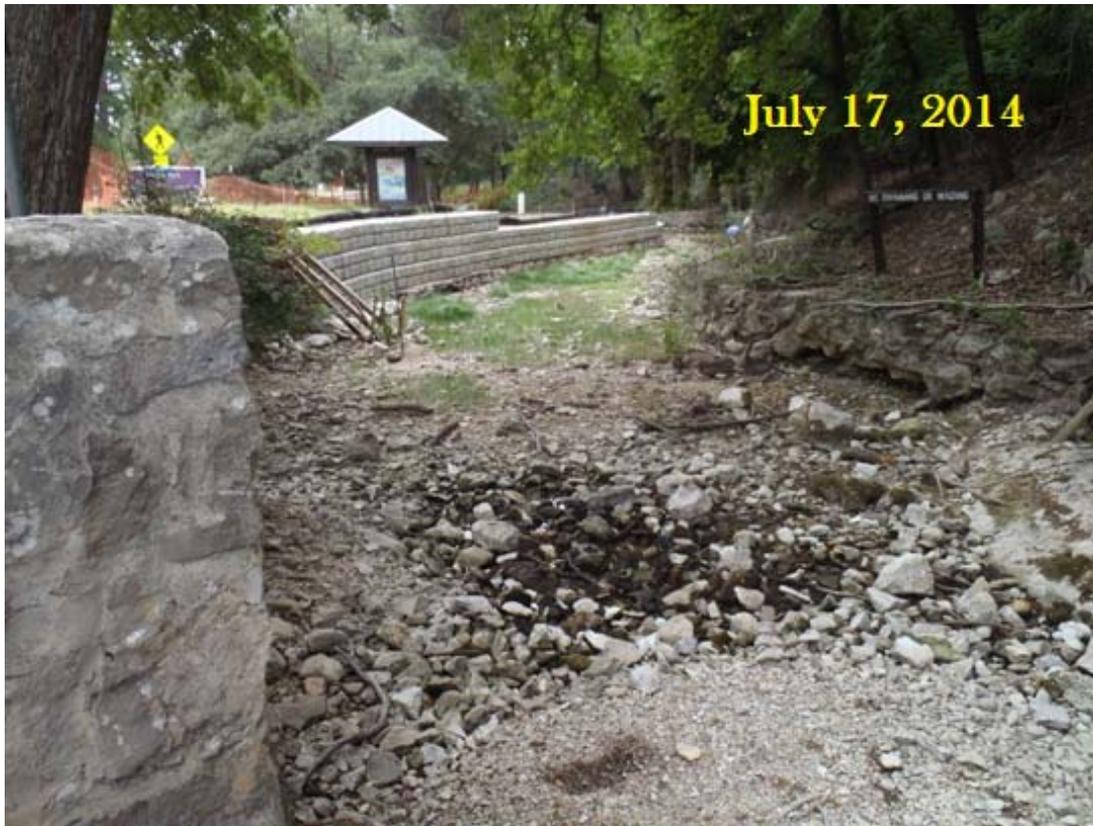
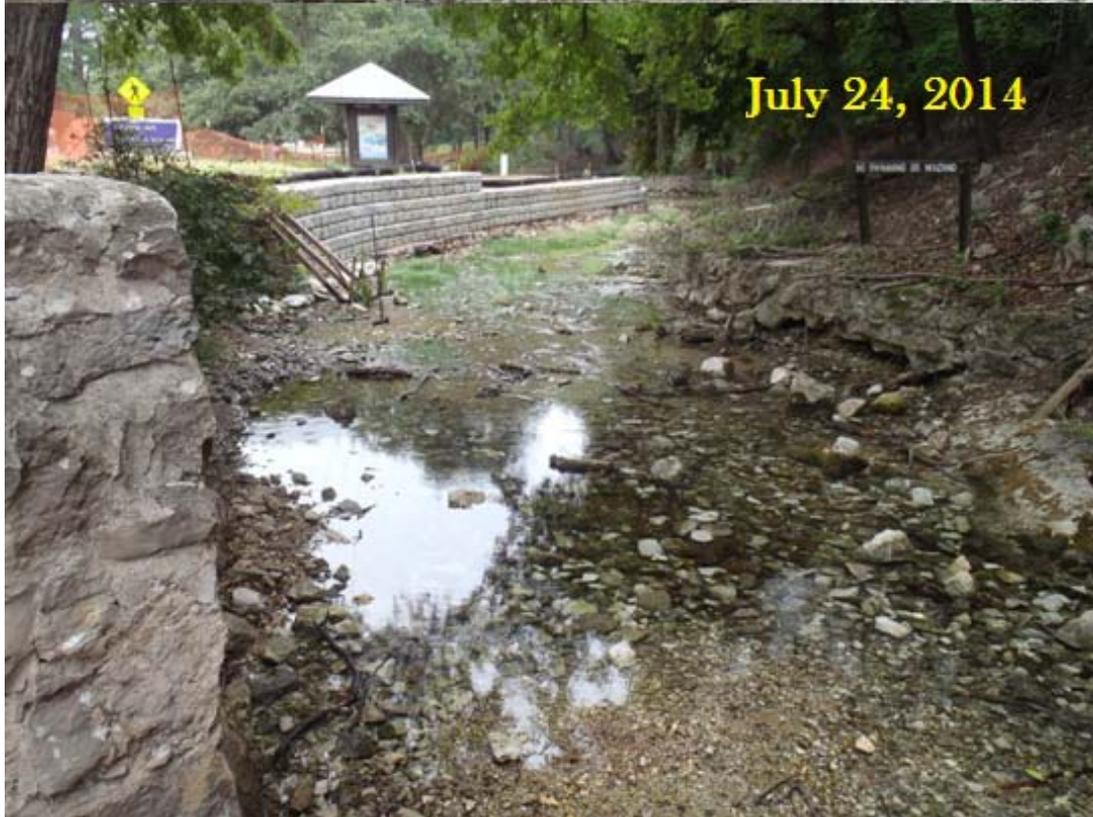
Figure 3: Spring Run 1 main channel looking downstream from main orifices. July 17 – top photo – no surface flow for an extended area; July 24 – bottom photo – surface flow throughout.

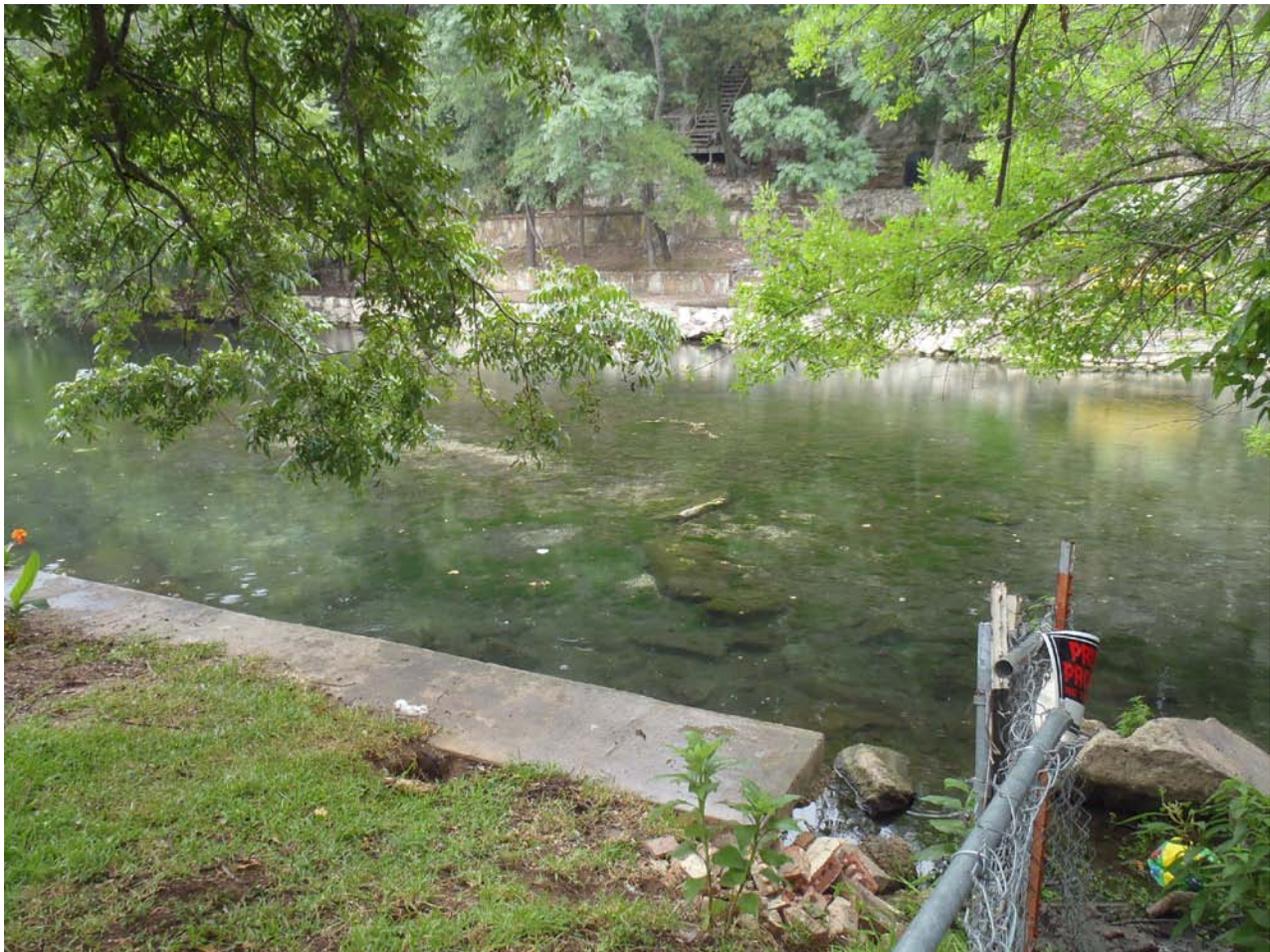
Figure 4: Algal coverage not nearly as thick as previous weeks in the Upper Spring Run reach.

The rains last week also provided some relief to the algae condition in the Upper Spring Run reach (Figure 4). It is encouraging that after nearly 3 months of intense algal coverage in this reach with discharge less than 5 cfs, aquatic macrophytes continue to survive (Figure 5). In addition, biologists conducting night dives associated with the fountain darter movement study this week confirmed the continued presence of fountain darters in this reach. However, even with the nice reprieve, it will likely be very short lived and unless there is a significant change in flow conditions, algae will likely again get worse in coming weeks with increased ambient air temperatures.

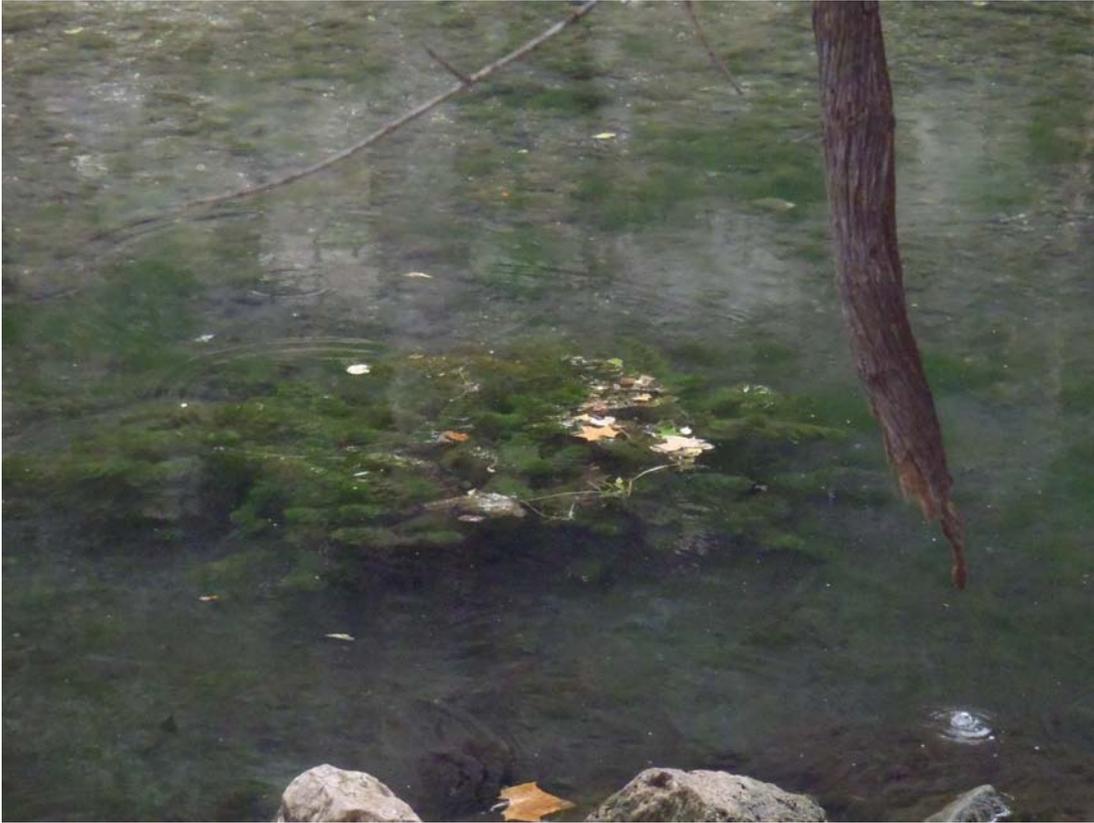
Figure 5: *Cabomba* present in the Upper Spring Run area.

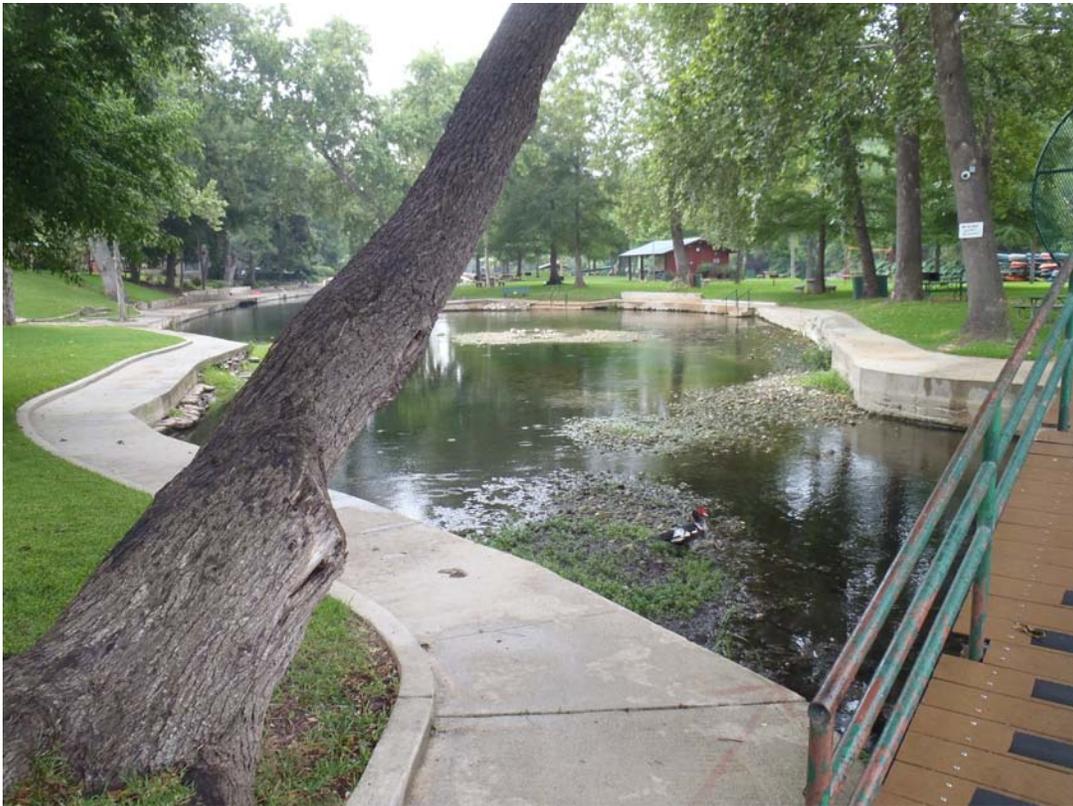
Figure 6: Exposed surface habitat adjacent to Spring Island.

Similar to the main spring runs, the surface water level in the Spring Island area rebounded some this week. Exposed surface habitat in the area along the eastern side of the island (Figure 6) remained event but unlike last week, both spring runs associated with Spring Island had some water and limited surface flow (Figures 7 and 8). As noted in last week's memorandum, cotton lures were placed at each of the designated sampling locations in late June in anticipation of this critical period trigger and will be collected per the 4-week protocol next week.

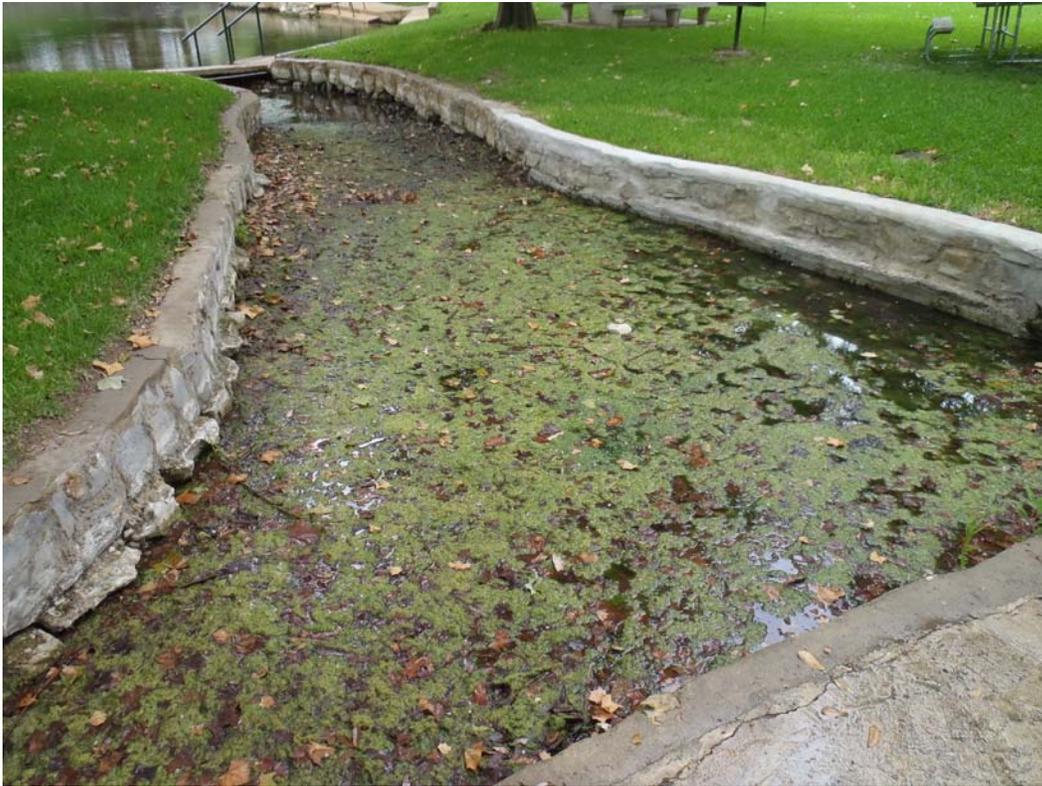
Figure 7: Southern spring run nearly bank to bank wet with some limited surface flow.

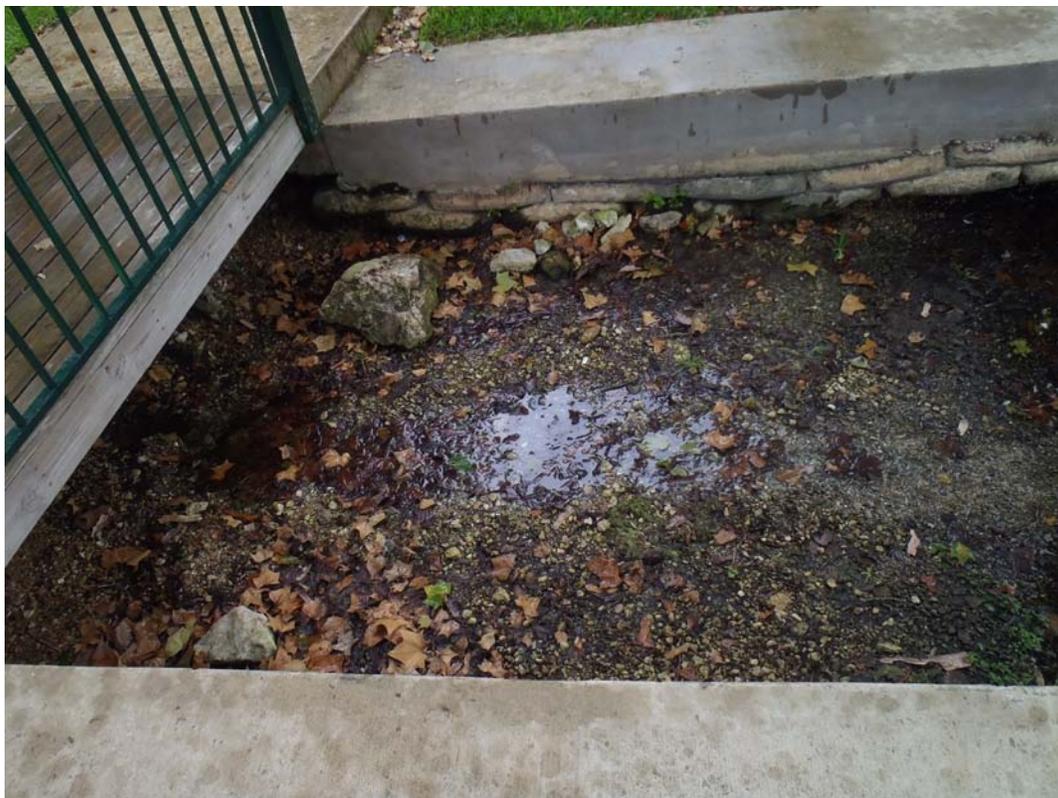
Figure 8: Northern spring run on Spring Island with very limited wetted area and surface flow.

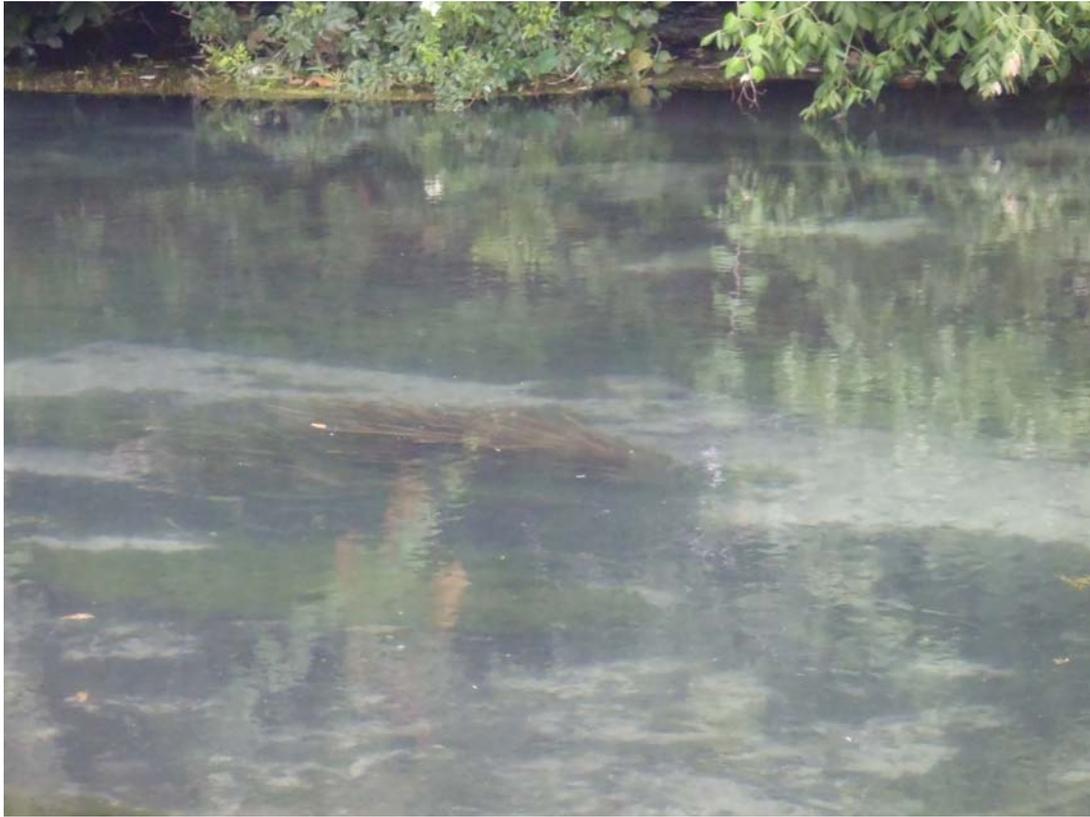
Figure 9: Restored native aquatic vegetation continues to thrive in the Old Channel.

Aquatic vegetation within Landa Lake, the Old Channel (Figure 9), and New Channel (Figure 10) continue to support quality fountain darter habitat.

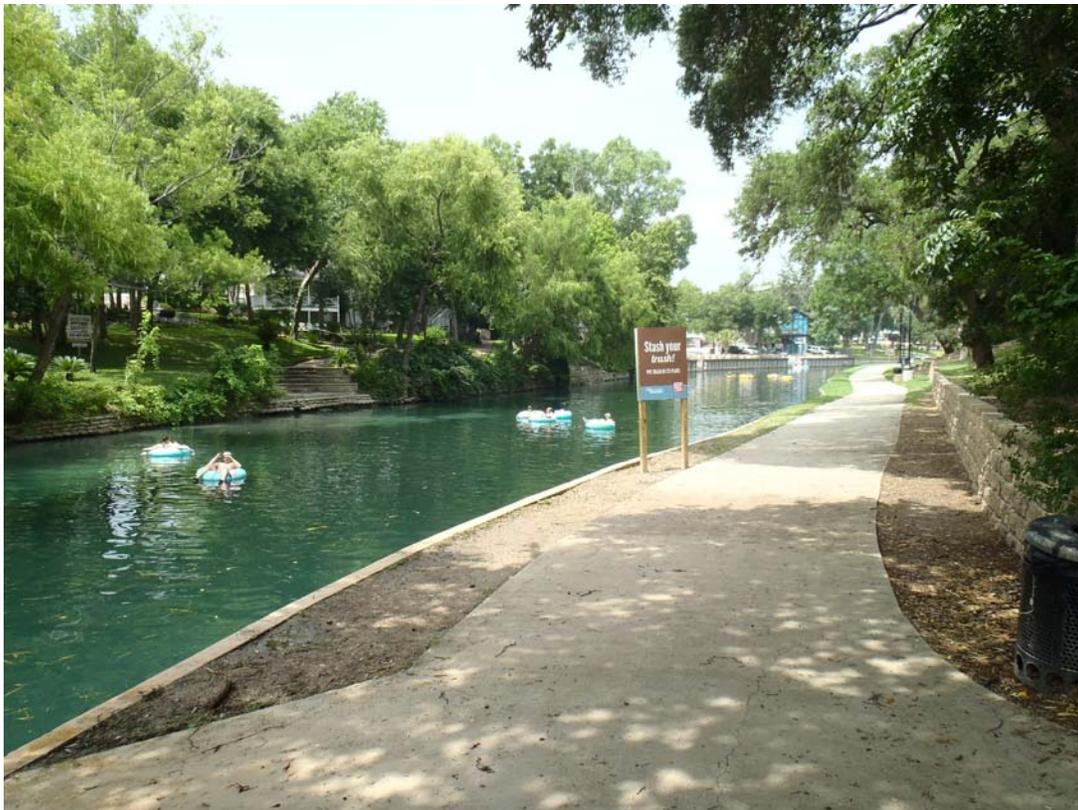
Figure 10: New Channel *Cabomba* continues to support quality fountain darter habitat.
