Edwards Aquifer Authority Well Plugging and Abandonment Study

Report No. 12-01

EDWARDS AQUIFER WELL PLUGGING AND ABANDONMENT STUDY

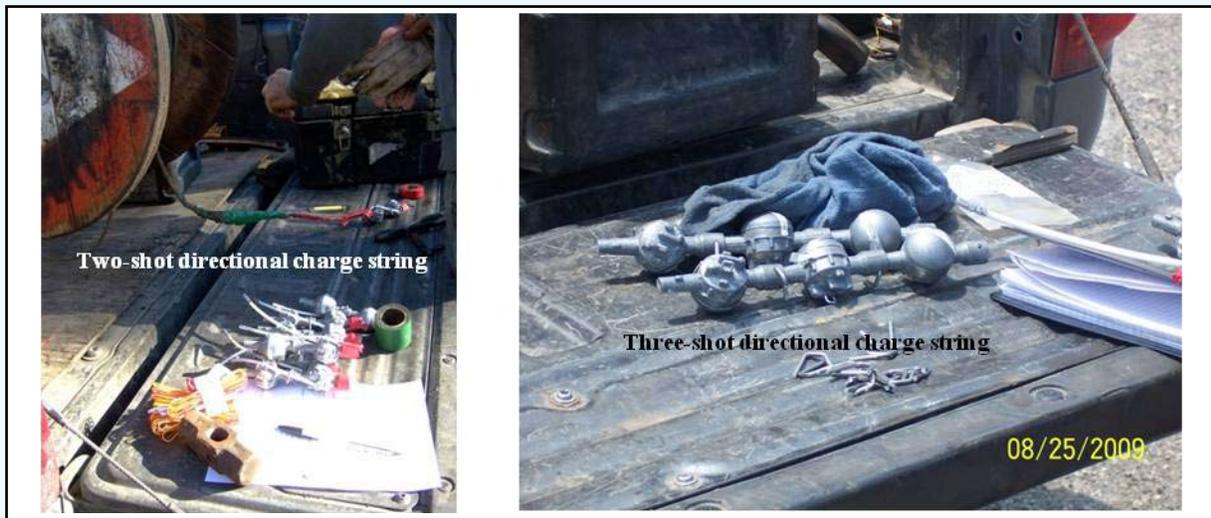
Figure 5. Explosives Used to Perforate Casing; Charges are Approximately Two and Three-Quarters to Three Inches apart Vertically

4. The steel well casing was then perforated using either two or three directional perforation charges at specific depths
- (Figure 5). The three-shot directional charge string was used in the water-filled section of the borehole to compensate for water resistance to the blast. The two-shot directional charge string was used in the air-filled section of the borehole.

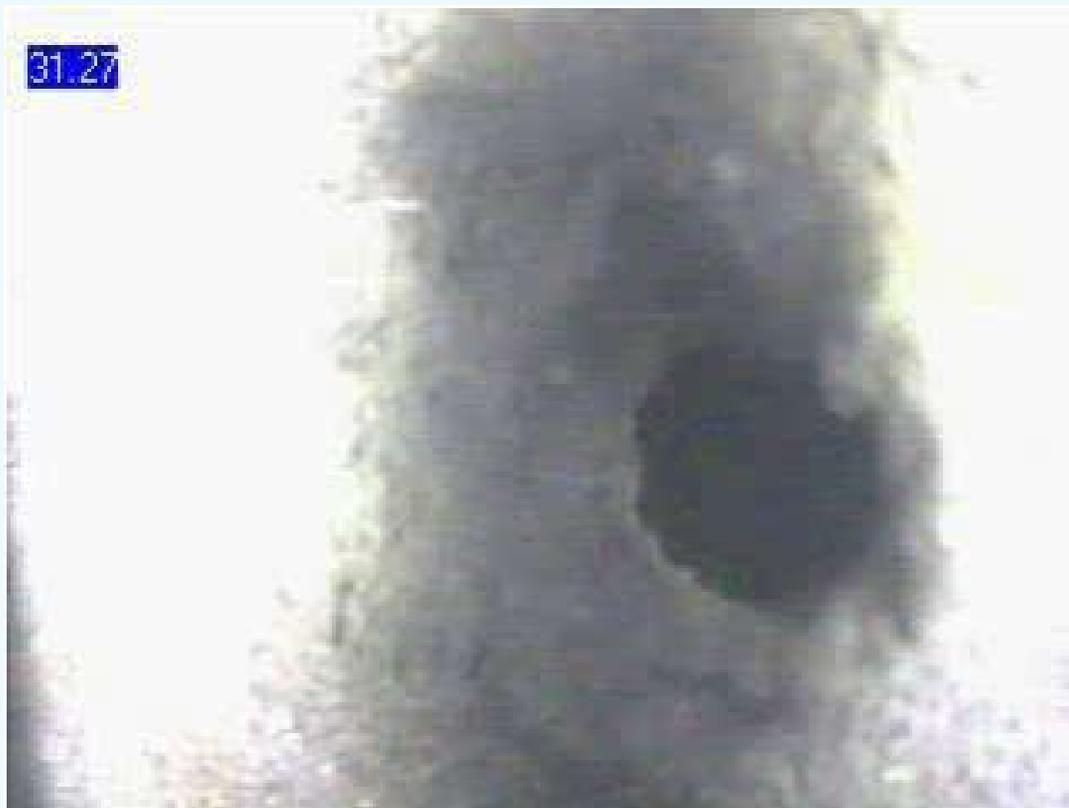
Photograph 1. Perforation at 31 ft bgs in Area Where Nuclear Source Log Indicated Presence of a Void

Response of the casing after perforating indicated the absence or presence of an annular seal, as presented in results of the video log. In areas where the annular space was filled, directional explosive charges punched round holes in the casing. In areas where annular

fill was absent, charges cracked the casing. Under both conditions, explosive charges were effective in penetrating the casing, as indicated in photographs 1 through 7.

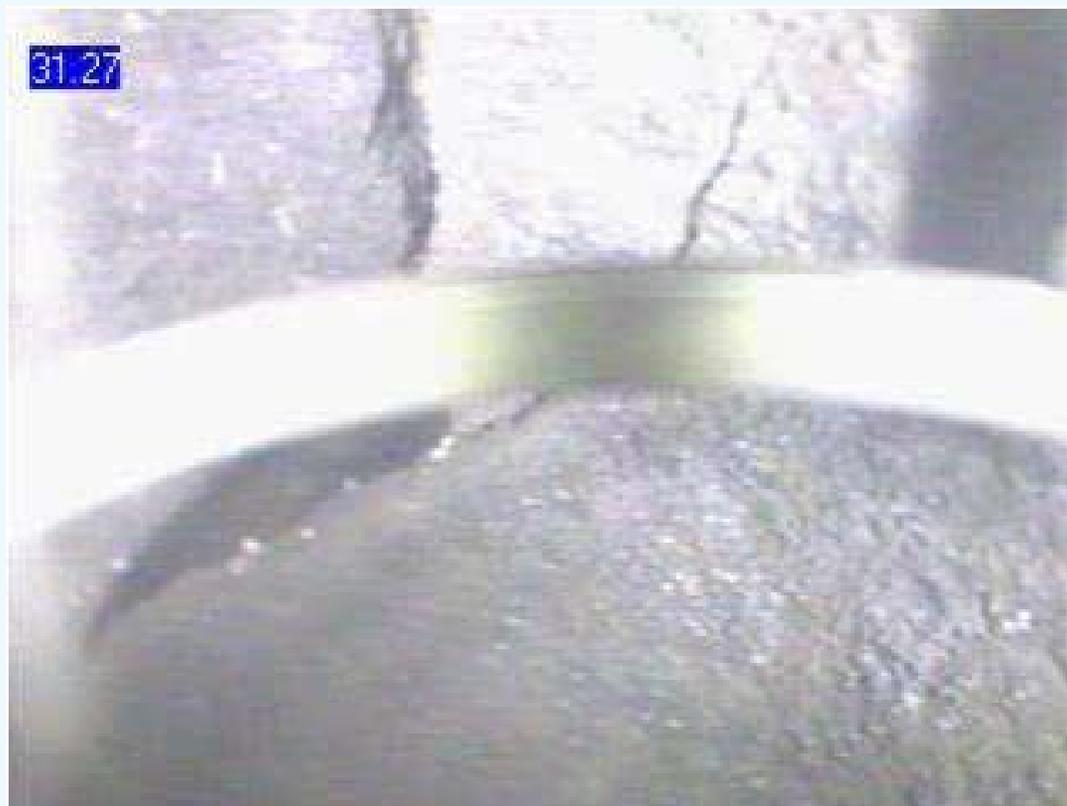
Photograph 2. Split Casing at 31 ft bgs, at Opposite Side of Shot above, in Area Where Nuclear Source Log Indicated Presence of a Void

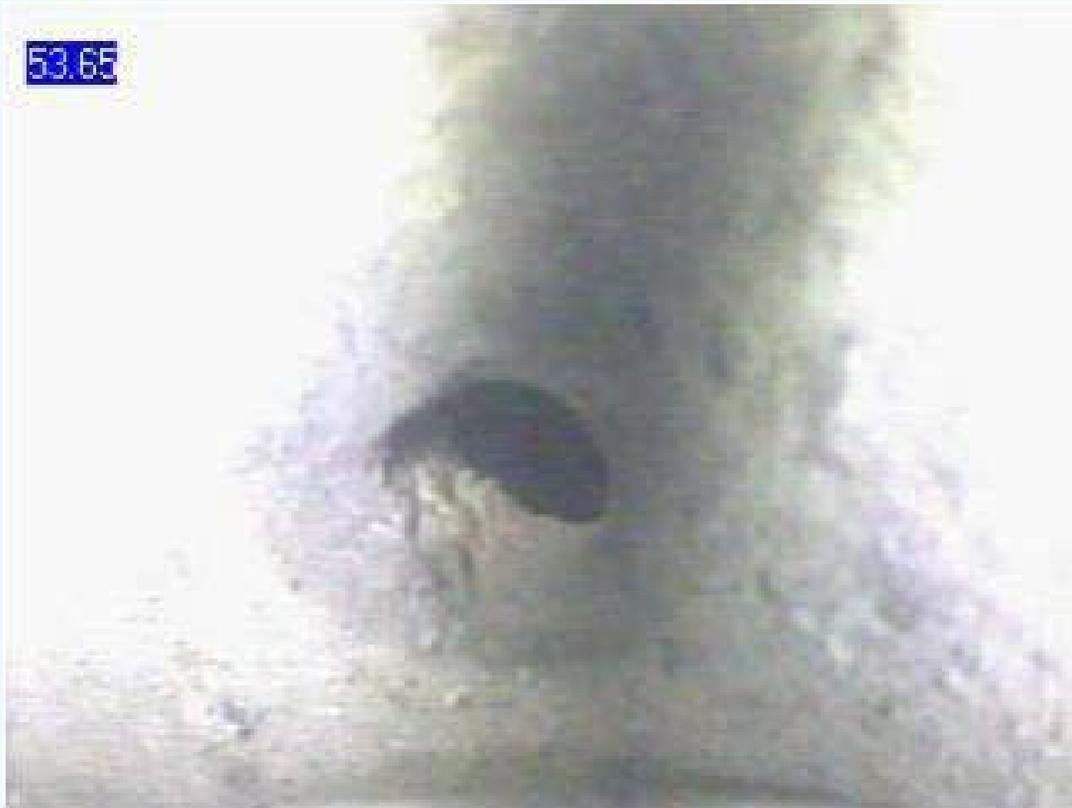
Photograph 3. Perforations at 53 ft bgs in Area Where Nuclear Source Log Indicated Solid Annular Fill

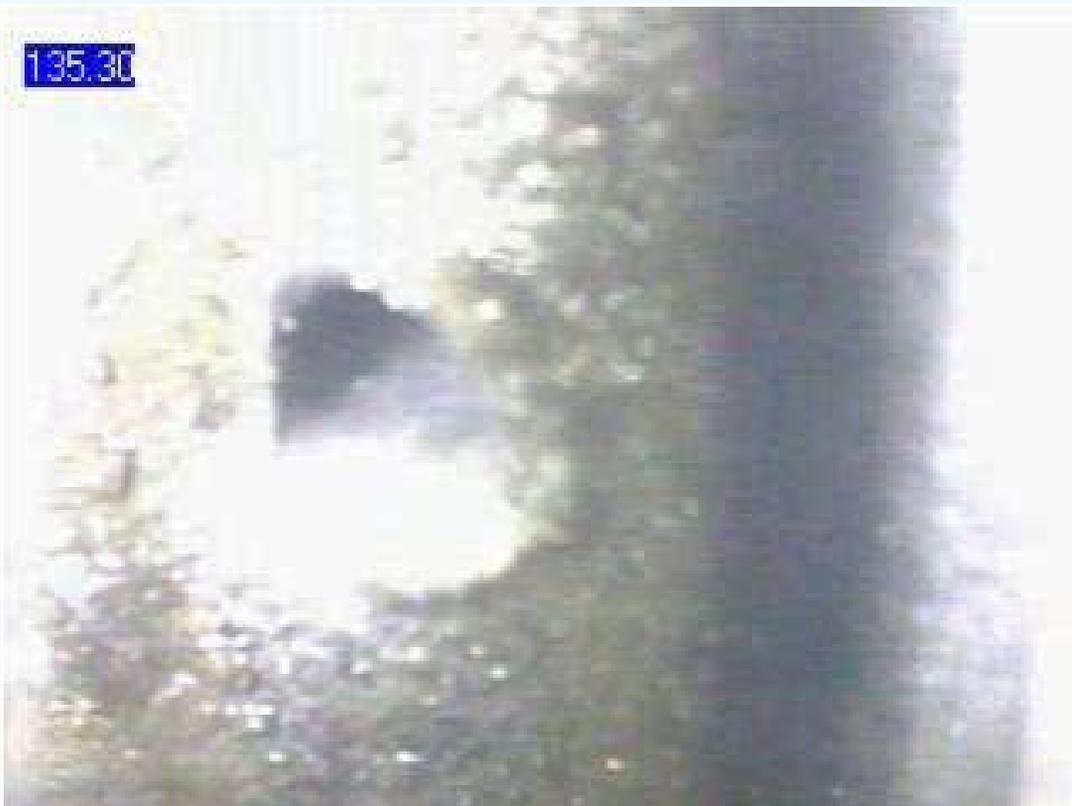
Photograph 4. Perforation at 135 ft bgs in Area Where Nuclear Source Log Indicated Solid Annular Fill

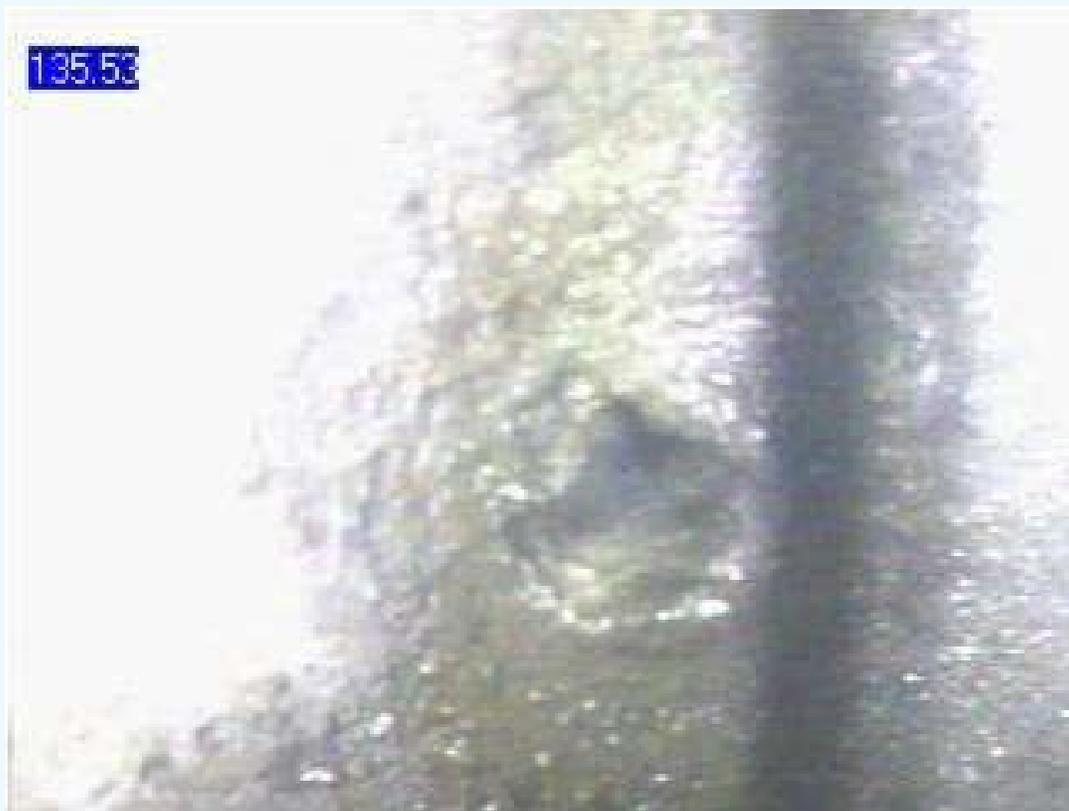
Photograph 5. Perforation at 135 ft bgs in Area Where Nuclear Source Log Indicated Solid Annular Fill

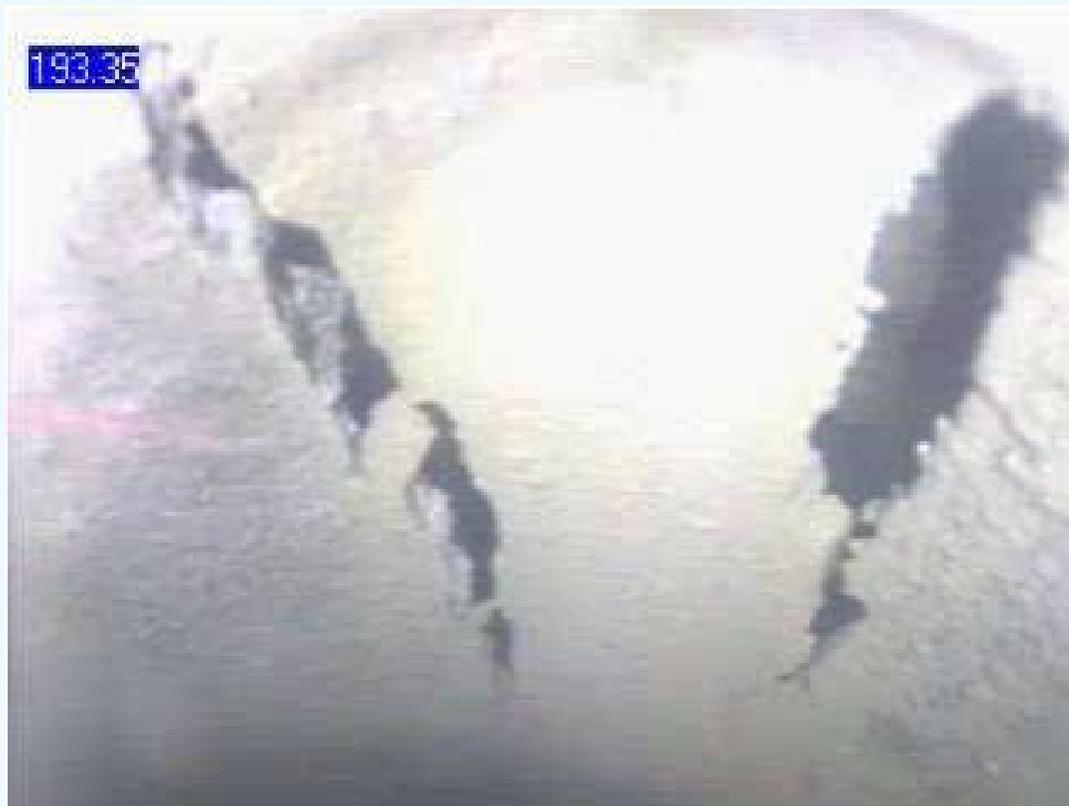
Photograph 6. Split Casing at 193 ft bgs in Area Where Nuclear Source Log Indicated Presence of a Void; Casing is Cracked

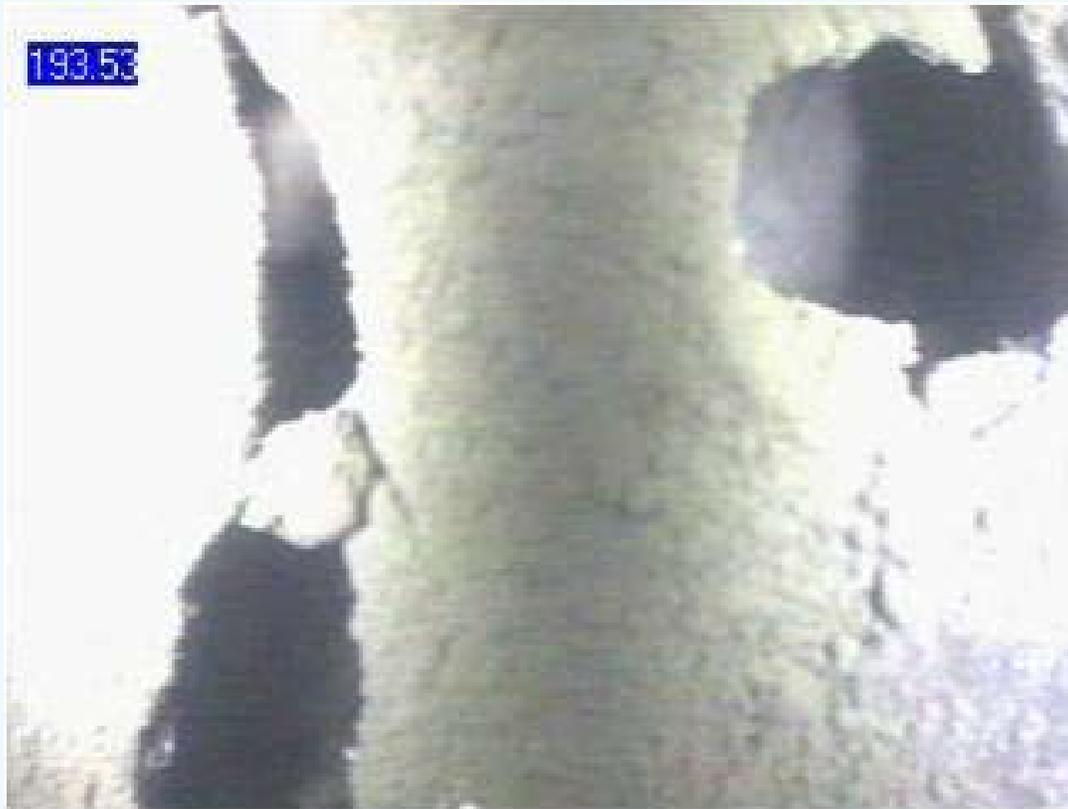
Photograph 7. Perforations at 193.5 ft bgs in Area Where Nuclear Source Log Indicated Presence of a Void; Photograph Indicates Cracked and Perforated Casing with Space behind Casing

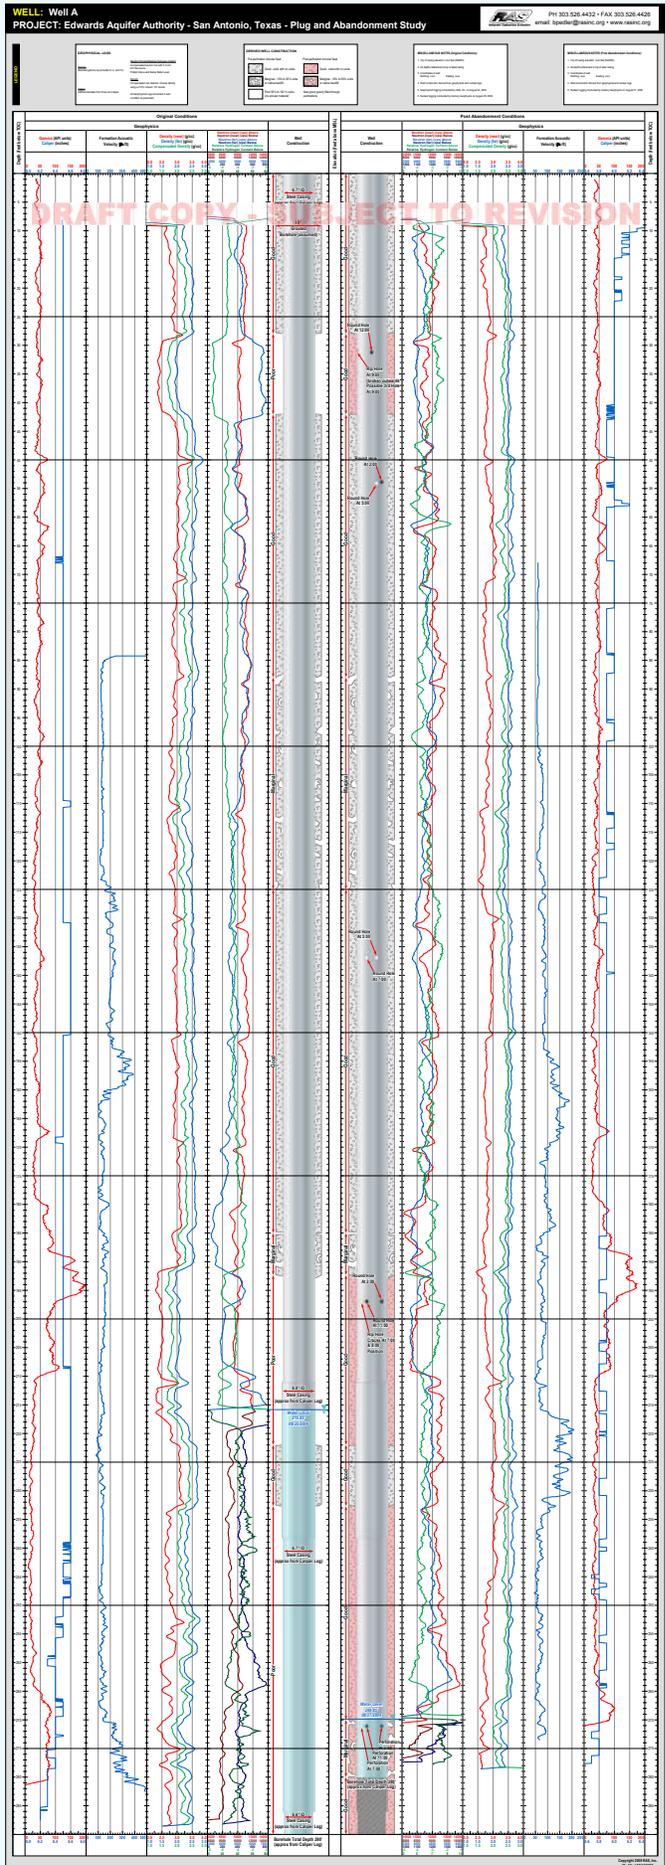
RAS, Inc., Montage
(personal communication,
unpublished report)

On the basis of nuclear logging, significant variations in the integrity of the annular seal were discovered. A nuclear log response for an interval with poor annular seal (i.e., 50–100% voids) was identified from 28 to 42 ft bgs. Over this interval, the CDL and near and far neutron logs were anomalously low compared with logs of the intervals immediately above and below this zone. The low-density response is caused by the absence of an adequate annular fill (air-filled void) because the density of air is effectively 0 gram per cubic centimeter (g/cc), (RAS, Inc., personal communication, unpublished report). The near and far neutron logs and CDL response indicate a decrease in relative hydrogen content (air has effectively no hydrogen content). Similar responses were also observed at the interval from 192.5 to 215 ft bgs (Appendix F—RAS Montage).

RAS, Inc. (personal communication, unpublished report), reported that marginal annular conditions in the unsaturated interval, i.e., above the measured water level of 215.85 ft bgs, described as being 10 to 50% void, are most likely native back-fill material. Figure 6 summarizes parts of the well montage in Appendix F, indicating the quality of the annular seal that is based on interpretation of log data. RAS’s detailed assessment of these logs suggests that approximately 102 ft (35%) of the well had poor annular seal, 45.5 ft (15.6%) had marginal annular seal, and 142.5 ft (49%) had good annular seal, for a total casing length of 290 ft (Appendix F).
