EDWARDS AQUIFER HABITAT CONSERVATION PLAN

2018 Annual Report

MARCH 26, 2019

Blanton & Associates, Inc.

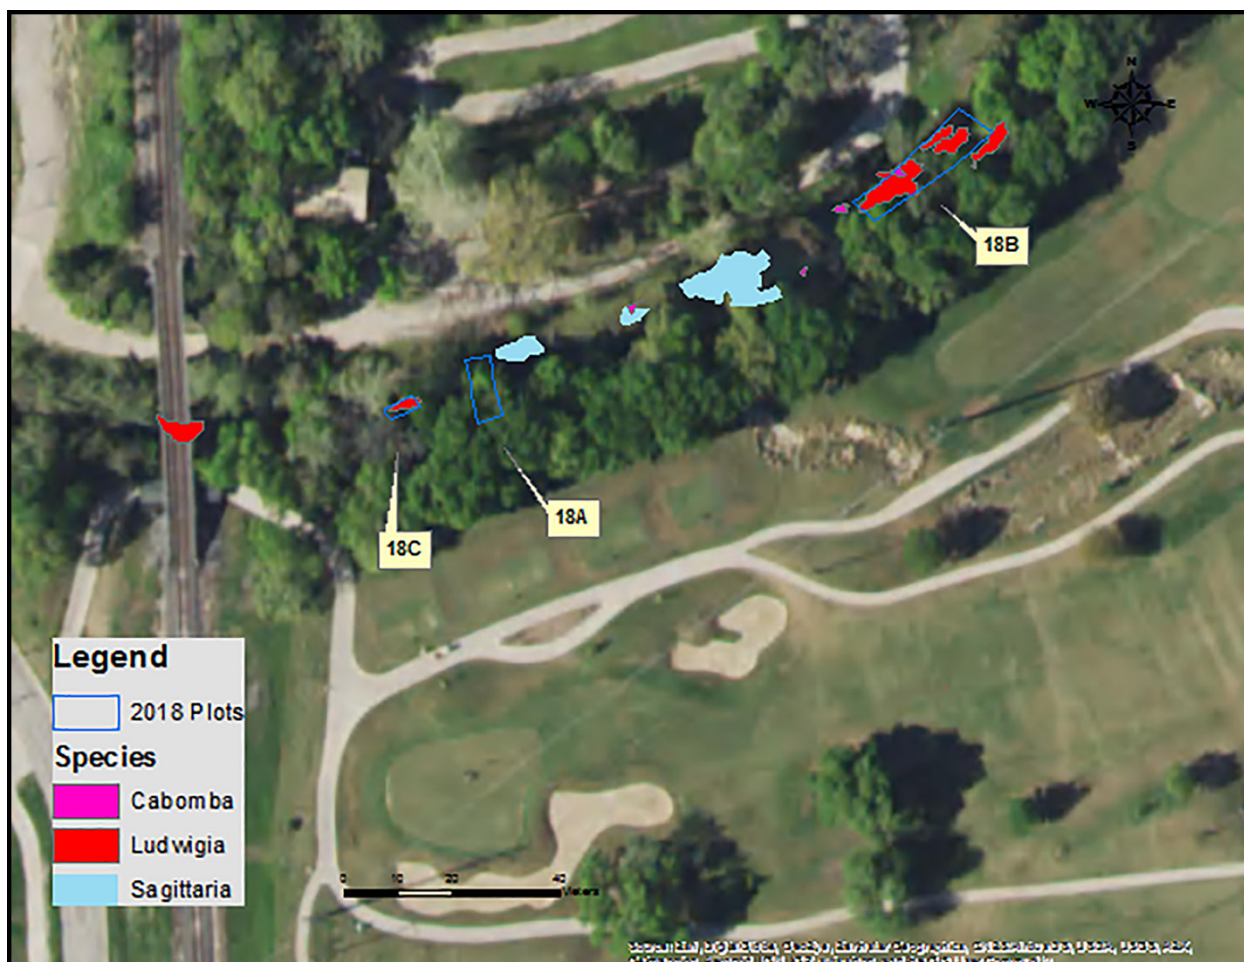
Figure 3.2-4. Location of new restoration plots in the Old Channel Restoration Reach, 2018.

Three new restoration plots were planted in the Old Channel Restoration Reach just downstream of the Elizabeth Street bridge in 2018 (**Figure 3.2-4**). For the Old Channel Restoration Reach, the increase in aquatic vegetative cover achieved as of October 2018 for each target plant species, as well as the 2018 annual restoration goal for that species, is summarized in **Table 3.2-5**.

Two plots (2018B and 2018C) were planted with *Ludwigia* and one plot (2018A) with *Sagittaria*. Although planted in early summer at over twice the annual goal amount, *Sagittaria* was not observed in plot 2018A during the fall mapping event. In contrast, *Ludwigia* planted later in the year was readily observable and seemed to be establishing well.

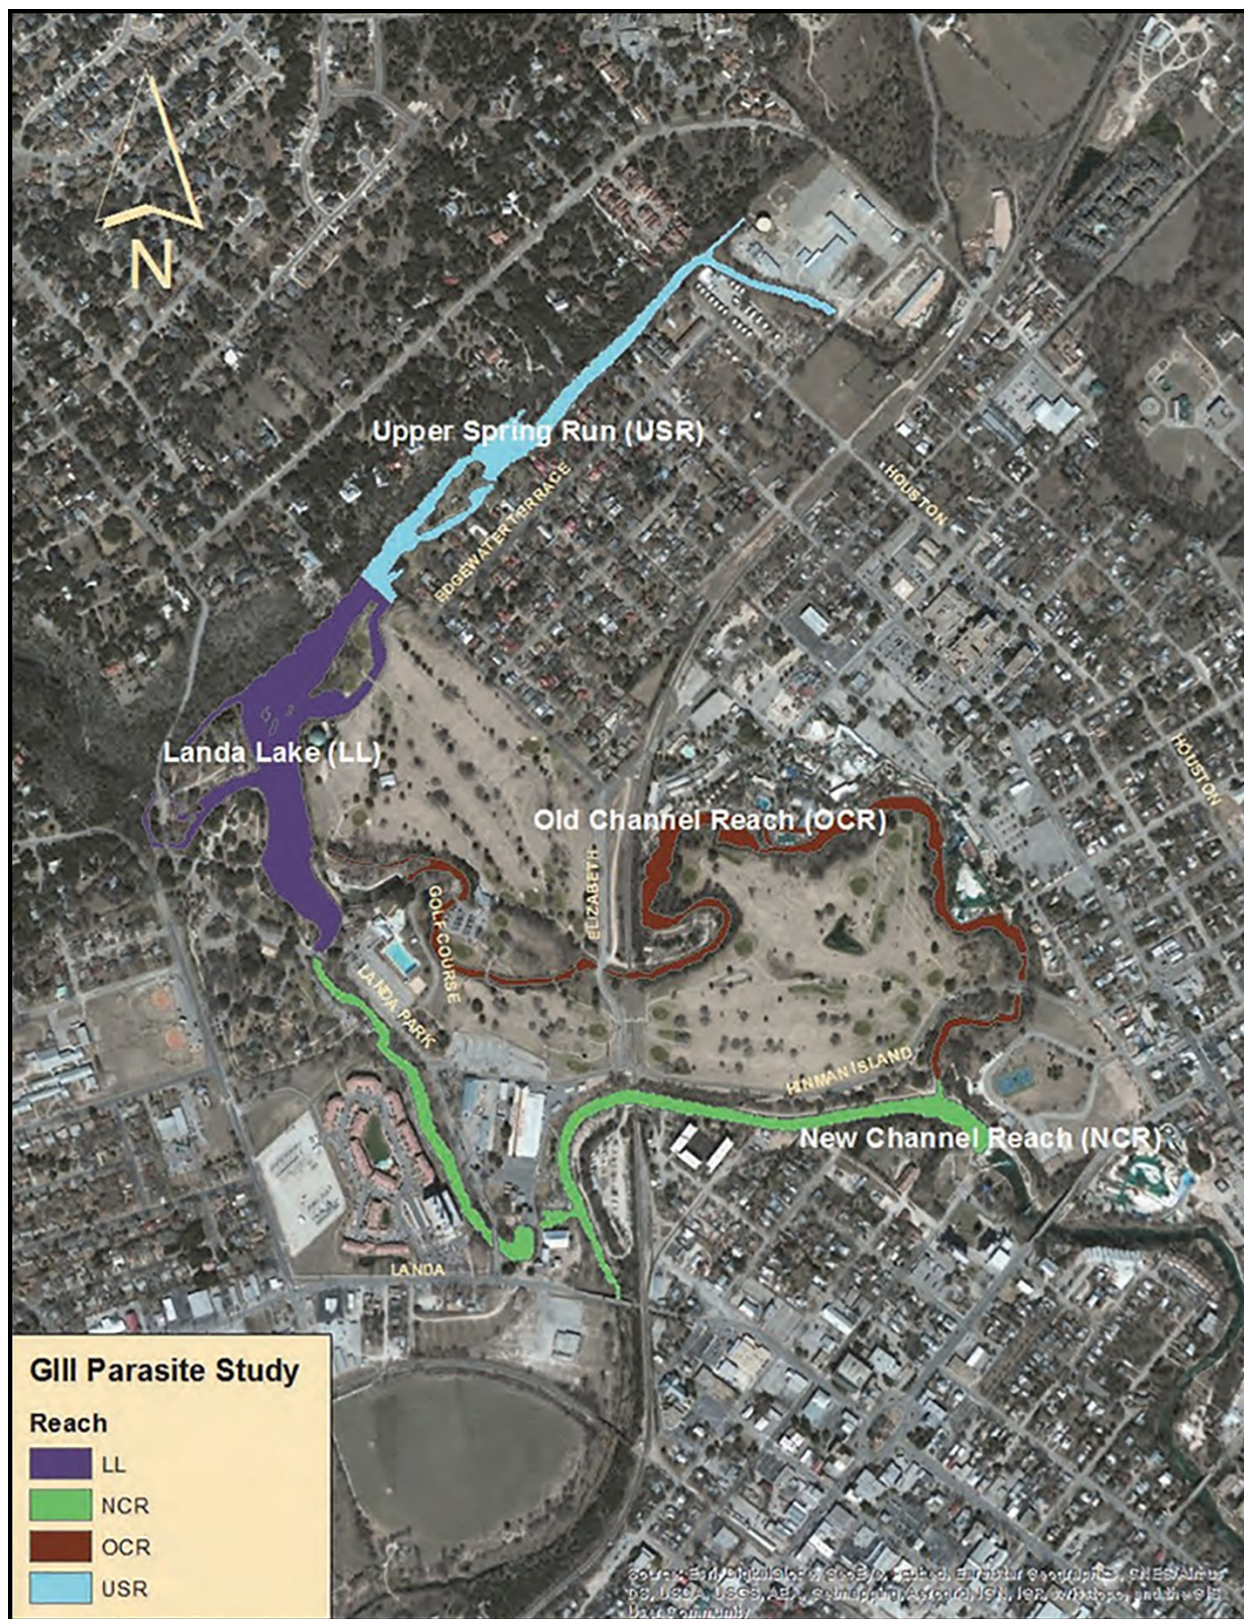
Figure 3.2-10. Gill parasite study reaches within the Comal River system.

Host snail distribution and density monitoring was conducted in the study reaches established in previous years. The intent of the snail distribution and density monitoring is to assess changes in spatial distributions, density and size/class structure of the host snail within the Comal River study area. Host snail monitoring has occurred annually since 2013 within the same four sampling reaches. The study reaches include Landa Lake, New Channel Reach, Old Channel Reach, and the Upper Spring Run, and are depicted in **Figure 3.2-10**.

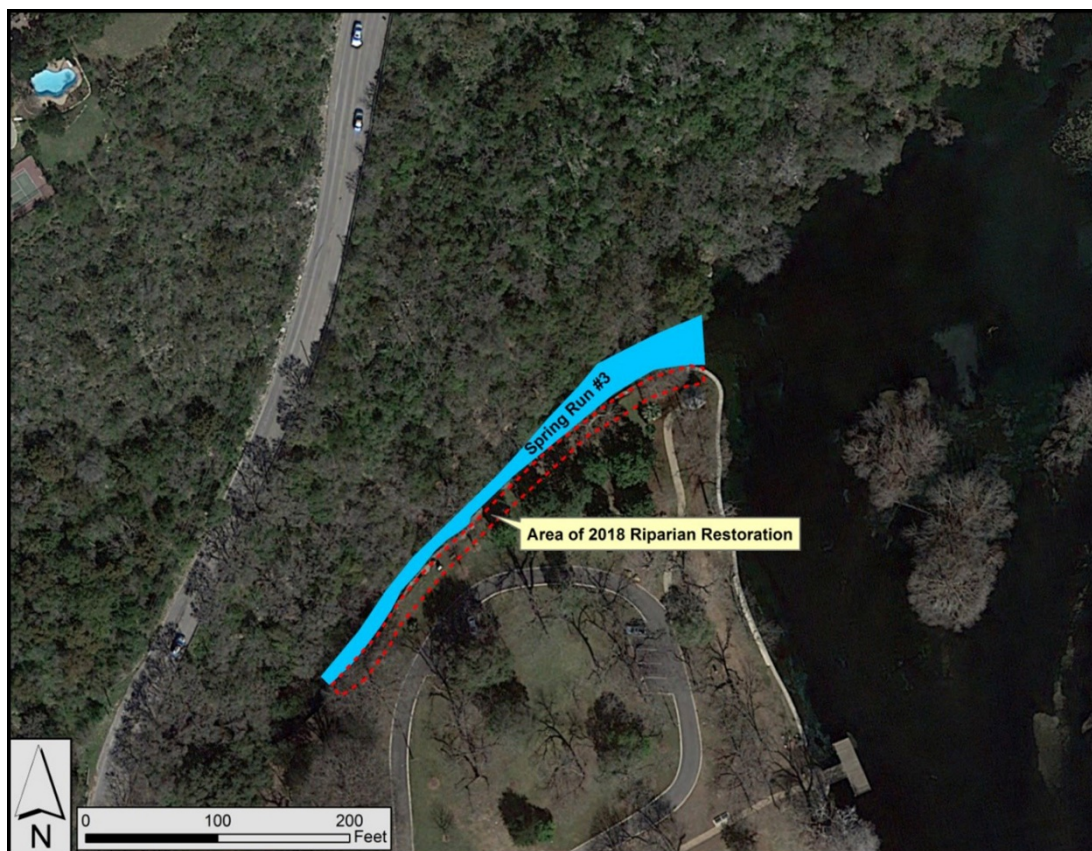
Figure 3.2-14. Location of 2018 riparian restoration activities.

In 2018, the CONB continued to take action to increase the density of riparian vegetation along the banks of Spring Run #3 by converting approximately 430 ft of the southeastern bank from bare ground and turf grass into a riparian buffer zone containing native vegetation commonly found in riparian areas in central Texas. The project area extends from the southwest end of Spring Run #3 and continues along the spring run to near the confluence of Spring Run #3 and Landa Lake (**Figure 3.2-14**). The riparian buffer zone extends up to approximately 20 ft away perpendicularly from the spring run.

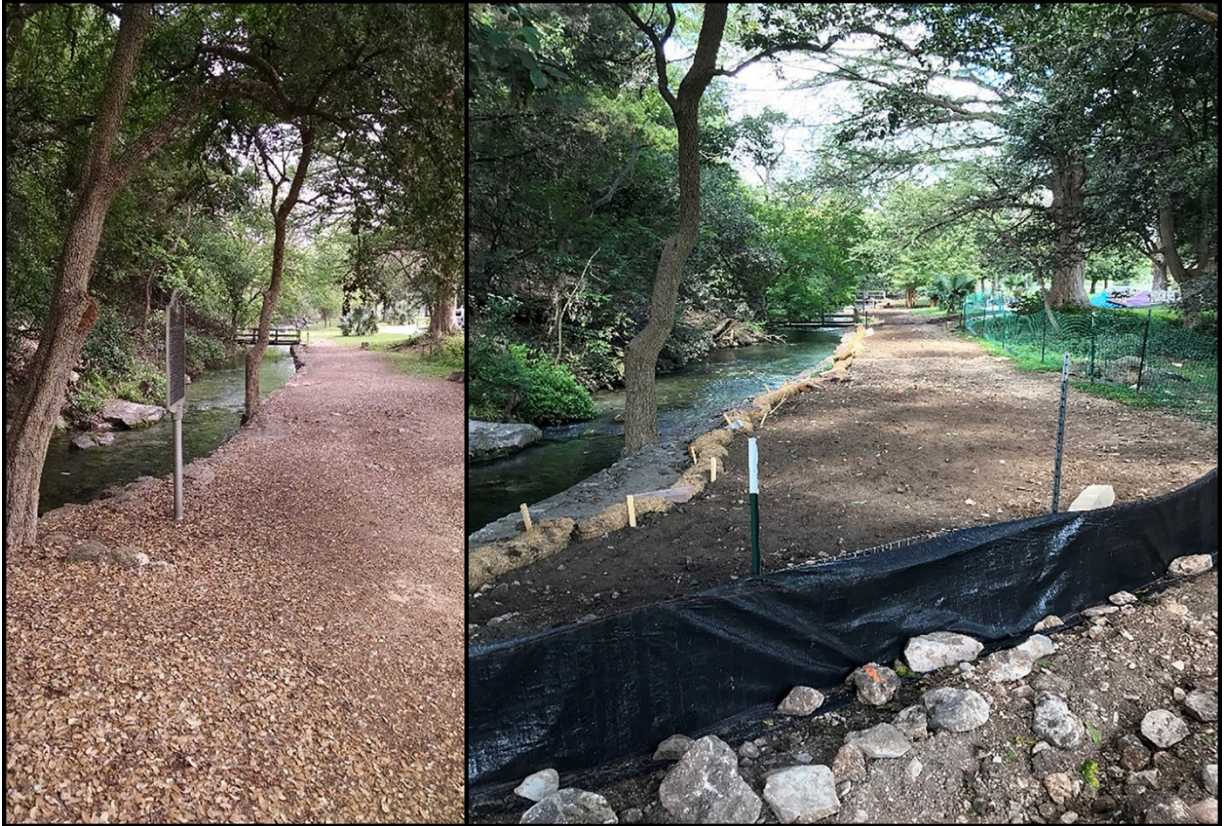
Figure 3.2-15. Photos depicting the Spring Run #3 area prior to the installation of the riparian buffer zone.

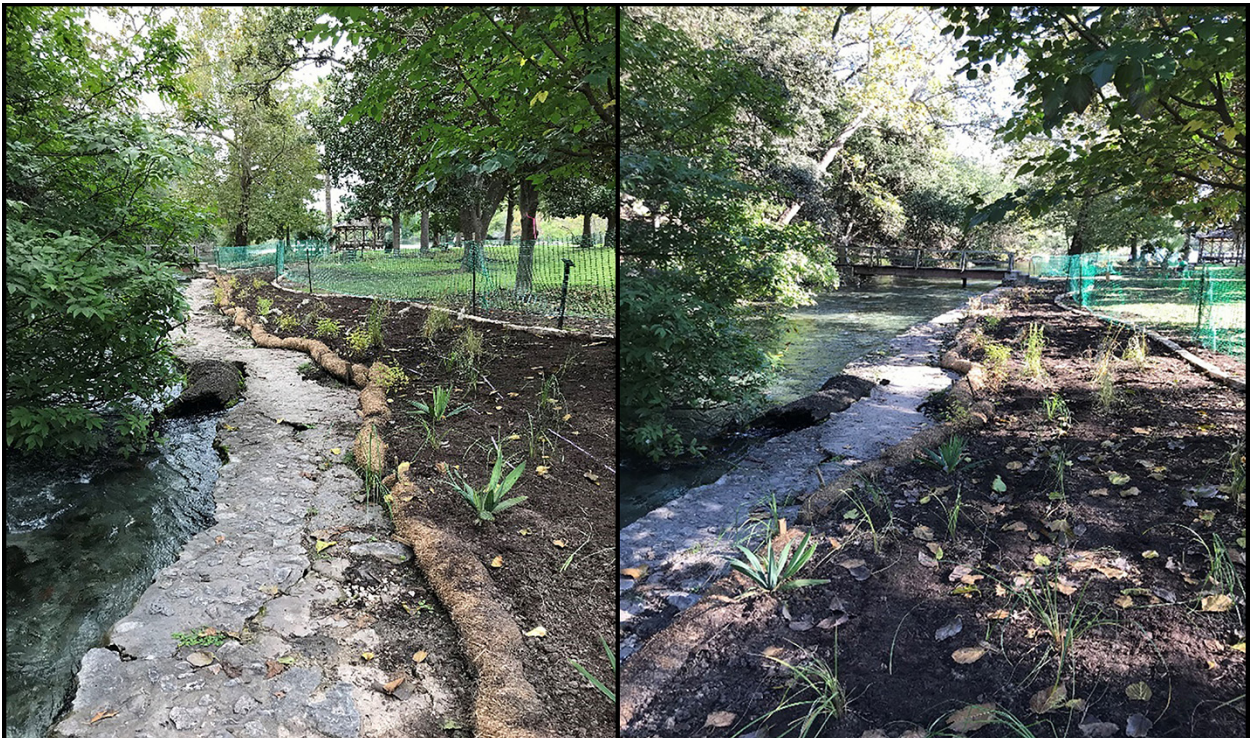
Figure 3.2-16. Photos depicting the Spring Run #3 following the installation of the riparian buffer zone.

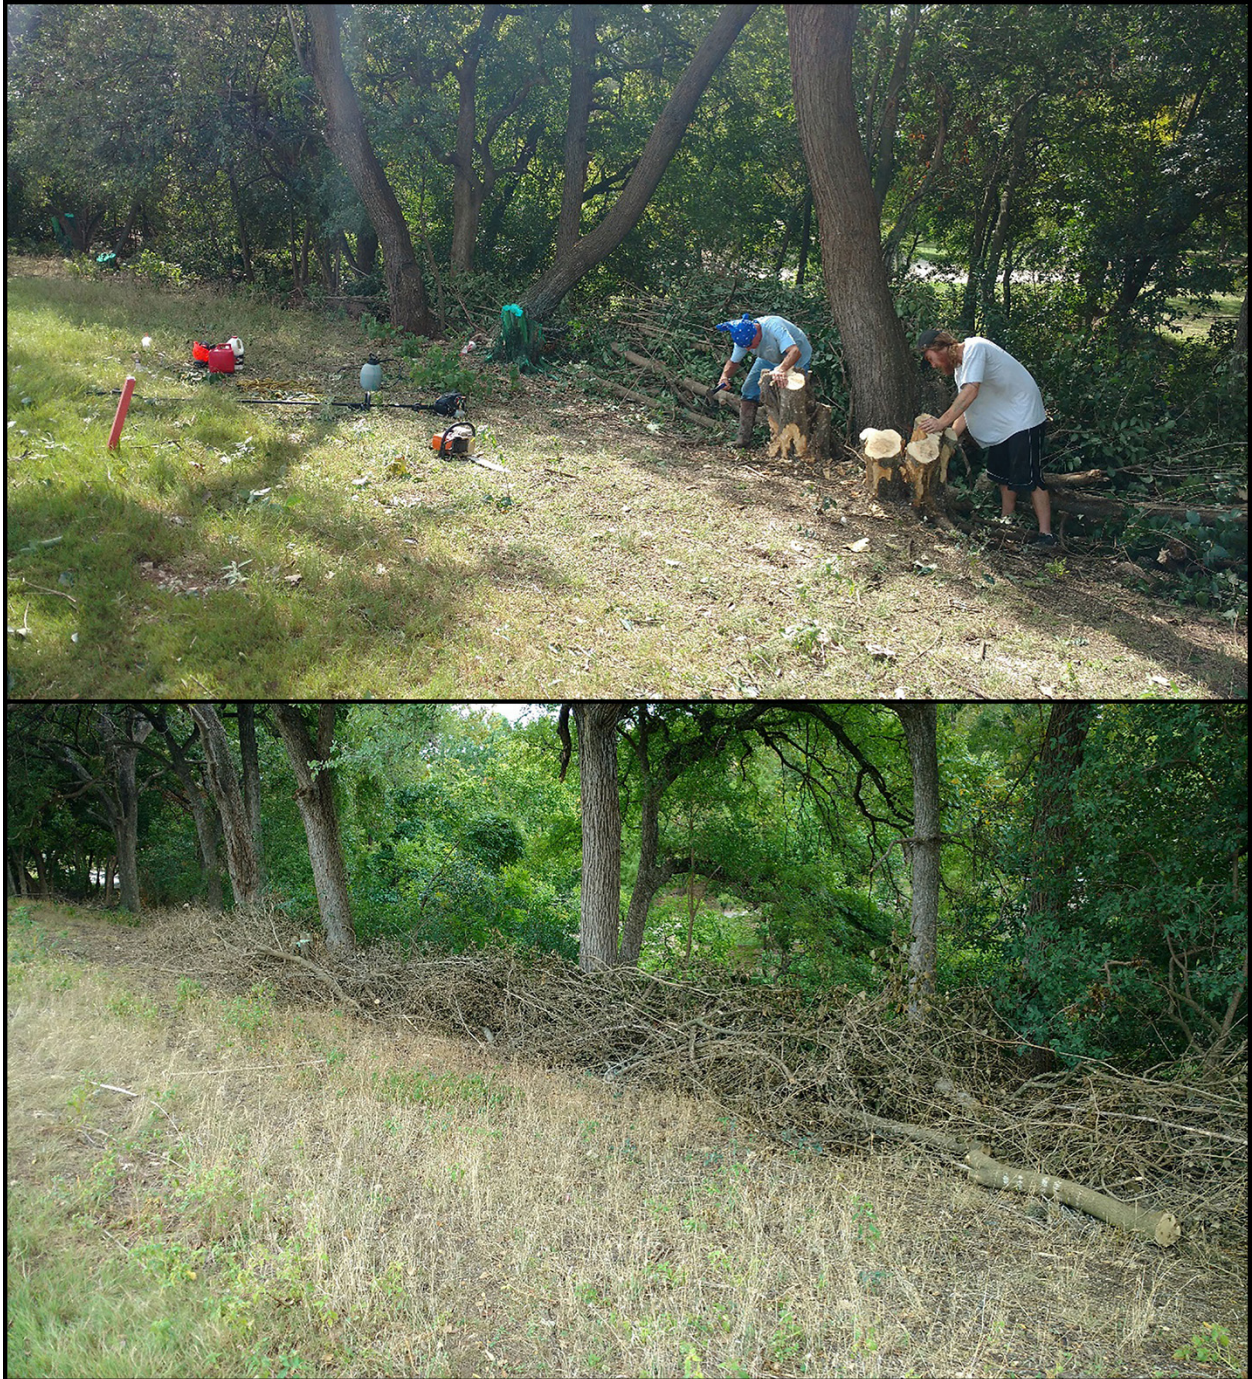
Figure 3.2-20. Herbicide treatment and felling of privet (*Ligustrum* sp.).

Non-native vegetation in Area A was initially treated in 2017 using chemical and/or removed using mechanical methods. In 2018, areas where re-emergent growth of non-native species was observed were treated again with herbicide to ensure the successful elimination of the species. Re-emergent elephant ears were treated with foliar applications of Aquaneat, a Glyphosate-based aquatic herbicide. Additional treatment of this species in area A began in February 2018. Continued follow-up treatment was conducted throughout the year to control the re-emergent elephant ears. Woody non-native vegetation, including privet, Chinese tallow, and chinaberry were treated by scarring the base of the tree to the cambium layer and applying Relegate, a Triclopyr-based herbicide.

In Area B, the target non-native species were treated and in the same manner as in Area A. Additionally, large stands of giant cane were treated and cut in Area B near the Elizabeth Street bridge. Approximately 794 privet trees, 401 Chinese tallow trees, 150 chinaberry trees, and 1,247 giant cane stalks were treated and removed from both areas in 2018. The removed woody vegetation was utilized to construct erosion control berms to promote sediment capture (**Figure 3.2-20**). The felled trees were cut into smaller pieces and used to create berms to catch sediment carried by sheet flow down the slope.

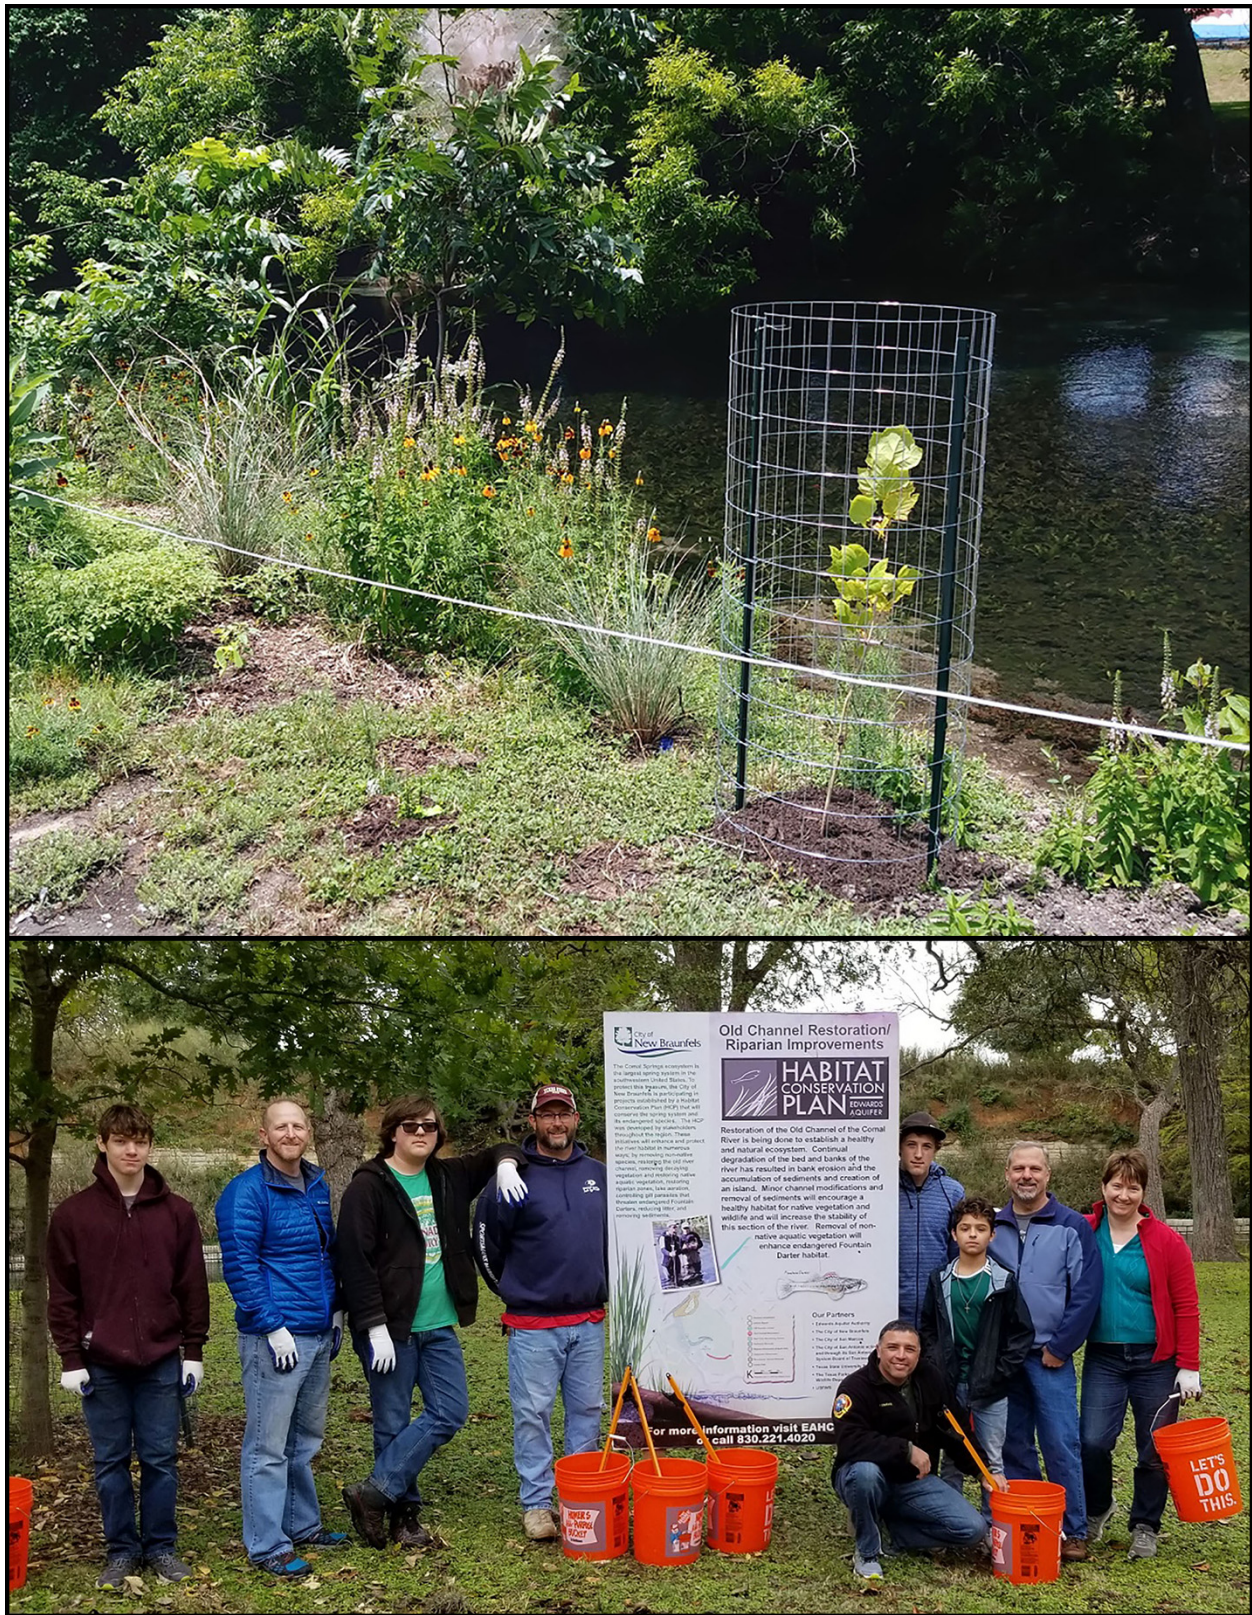
Figure 3.2-21. Riparian zone fencing and exclosures along Old Channel (top photo); Boy Scout Troop 413 participated in a riparian habitat planting and litter collection project in early November 2018 (bottom photo).

Planting of native riparian vegetation occurred in Area A in 2018 with intent to increase the density and vegetative diversity of the riparian zone along the Old Channel. Planting of native vegetation included planting of potted native plants primarily in the spring and fall of 2018. Planting occurred on both sides of the Old Channel in Area A throughout the year. Volunteer assistance helped to reduce project costs and to educate residents on the importance of riparian zones and the EAHCP in general. A list containing the types and quantities of the species planted within Area A in 2018 is presented in **Table 3.2-20**. Fencing was installed in areas adjacent to the golf course parking lot and in select areas along the Old Channel to delineate the riparian zone, create a no-mow zone, discourage pedestrian traffic and to prevent vehicles from parking and negatively impacting riparian vegetation (**Figure 3.2-21**).

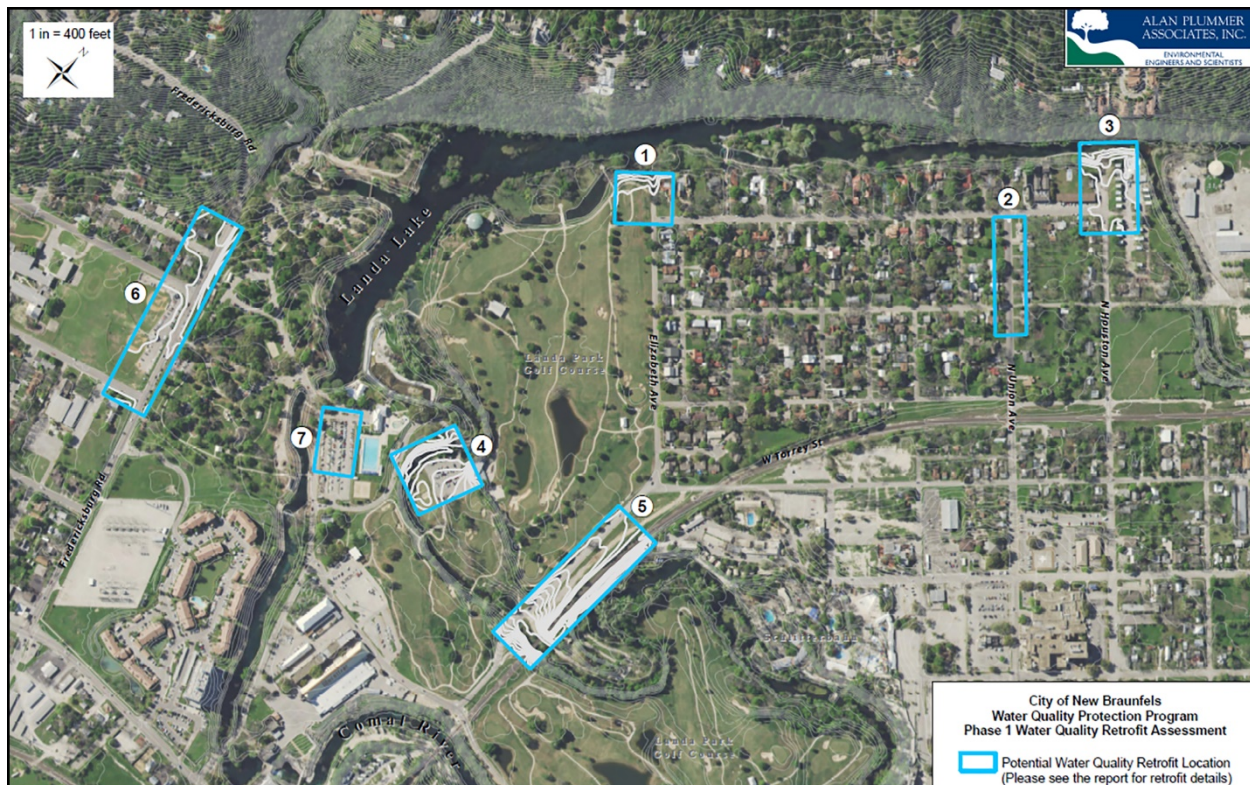
Figure 3.2-23. Locations of proposed water quality retrofit projects.

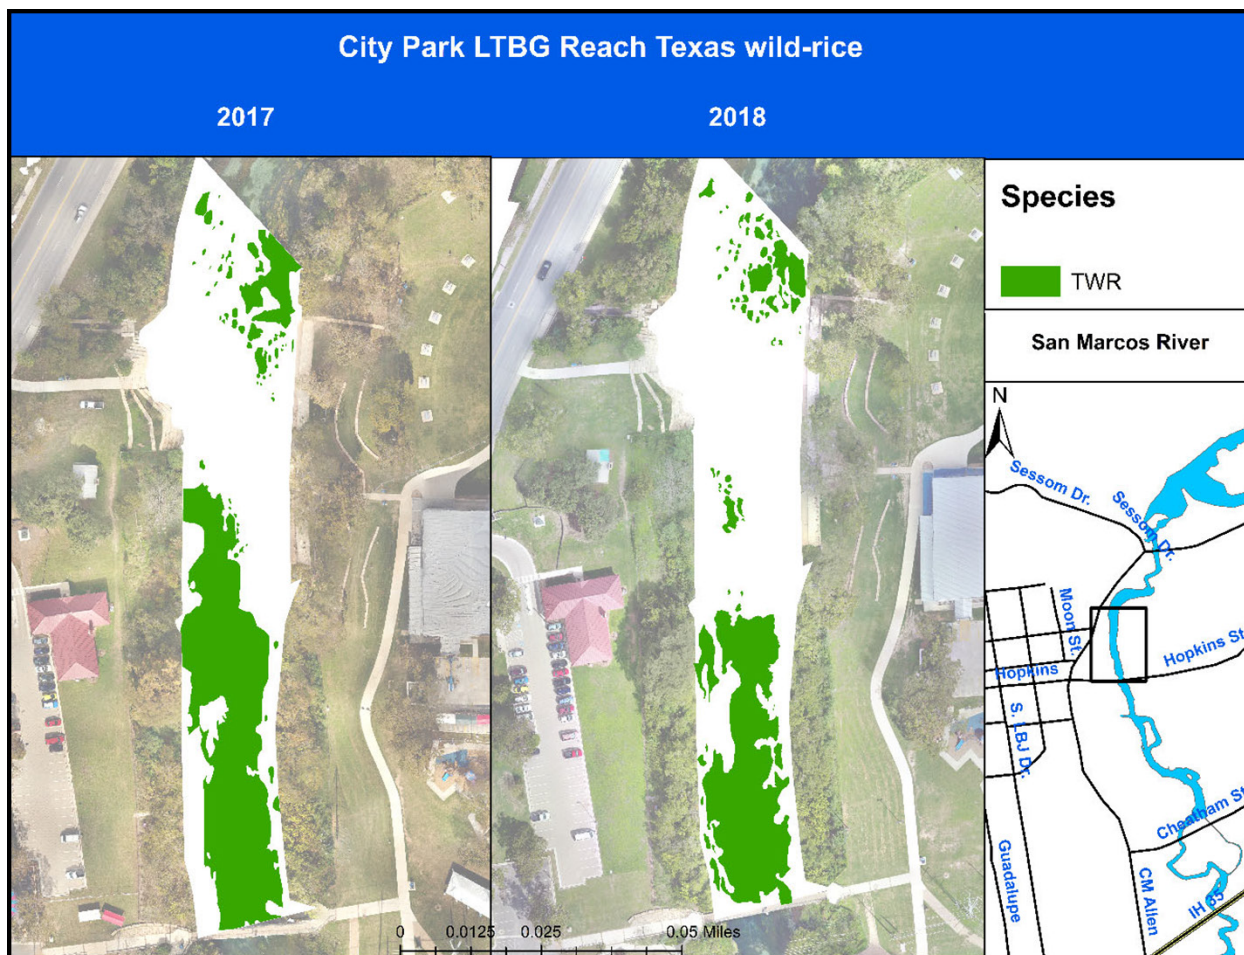
Figure 3.3-3. Texas wild-rice aerial coverage in City Park LTBG Reach in fall 2017 and fall 2018.

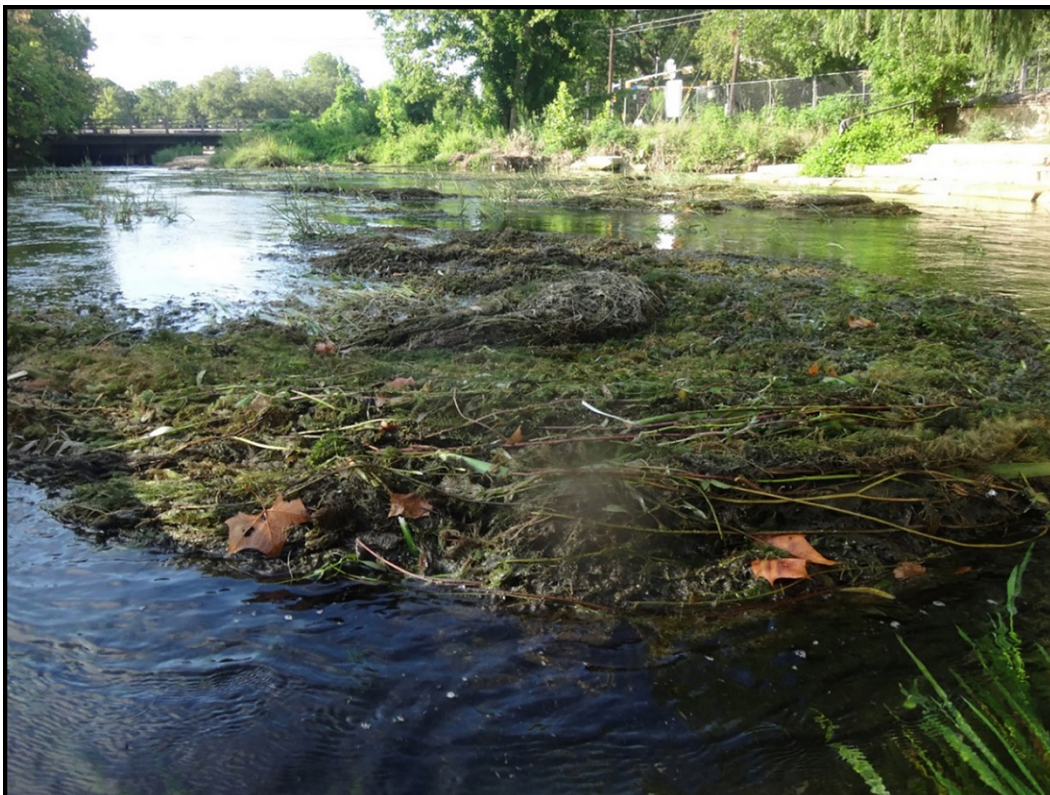
Figure 3.3-9. Vegetation mat composed primarily of *Ceratophyllum* floating down from Clear Springs reach.

From January through October 2018, 132.4 cubic meters (m³) of floating vegetation mats were pulled from the river. These mats are collected via canoe, taken to removal point where they are sorted to remove entrained fauna (**Figure 3.3-9** through **Figure 3.3-11**). The invasive plant species found in the mats are primarily *Hydrilla* and *Hygrophila*, with smaller amounts of *Eichhornia* and *Pistia*. The predominant native species is *Ceratophyllum*, which comprises 50 – 60 percent of the collected mats in Sewell and Clear Spring reaches. Other natives include *Sagittaria*, *Zizania*, and *Cabomba*. The COSM's contractor focuses on the heavy mats shading out Texas wild-rice and other native plant stands.

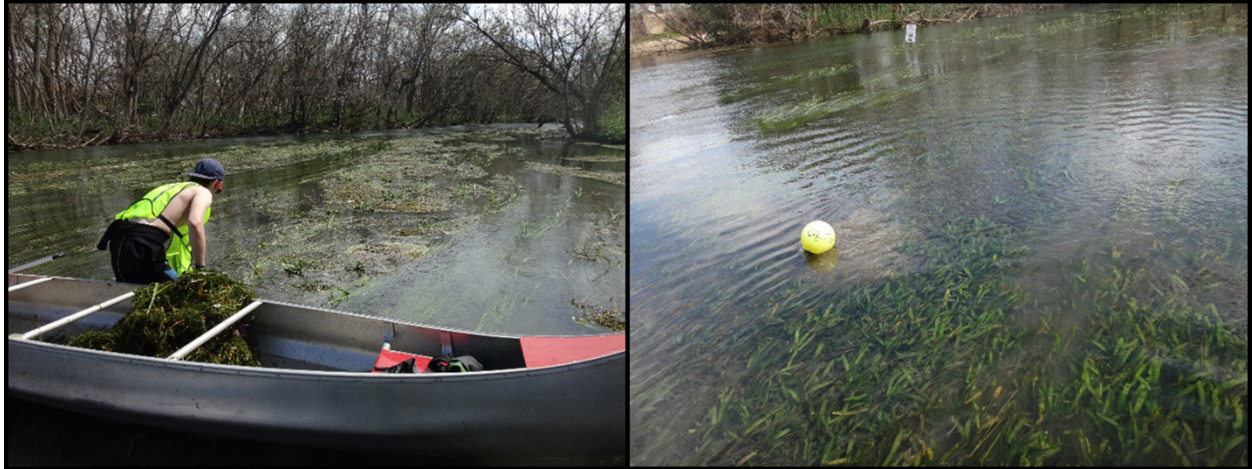
Figure 3.3-10. Before and after vegetation mat removal at Bicentennial Park.

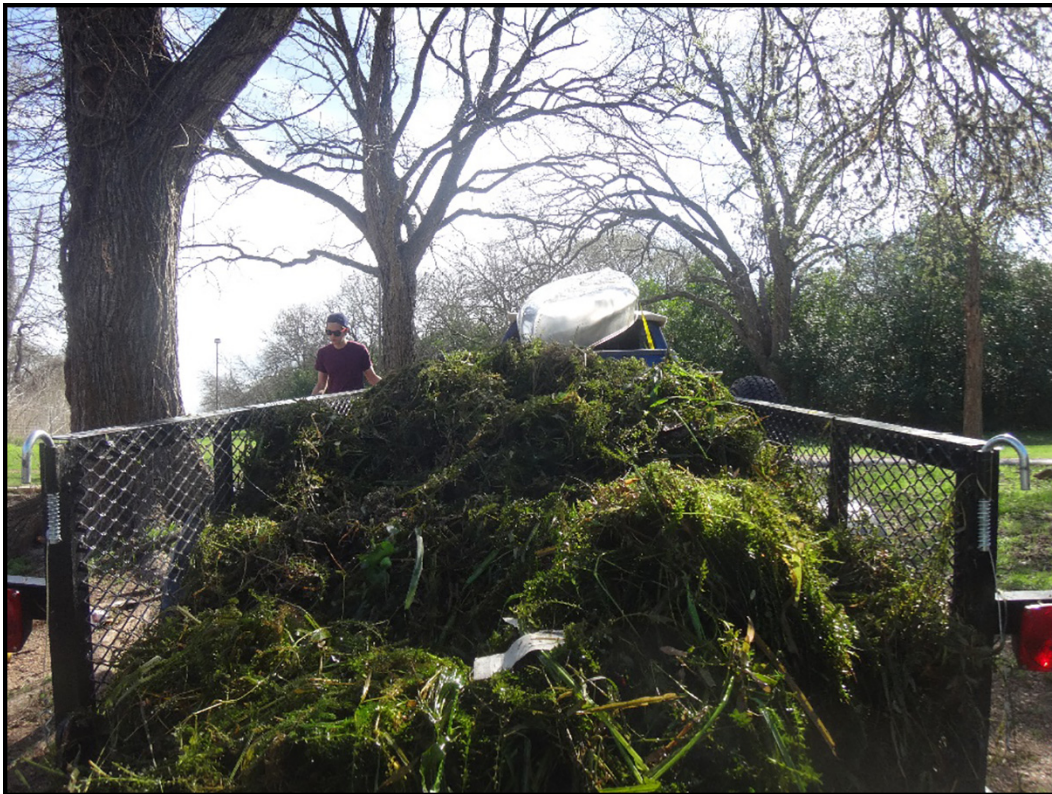
Figure 3.3-11. Removed mats loaded up for disposal at composting site outside the San Marcos River watershed.

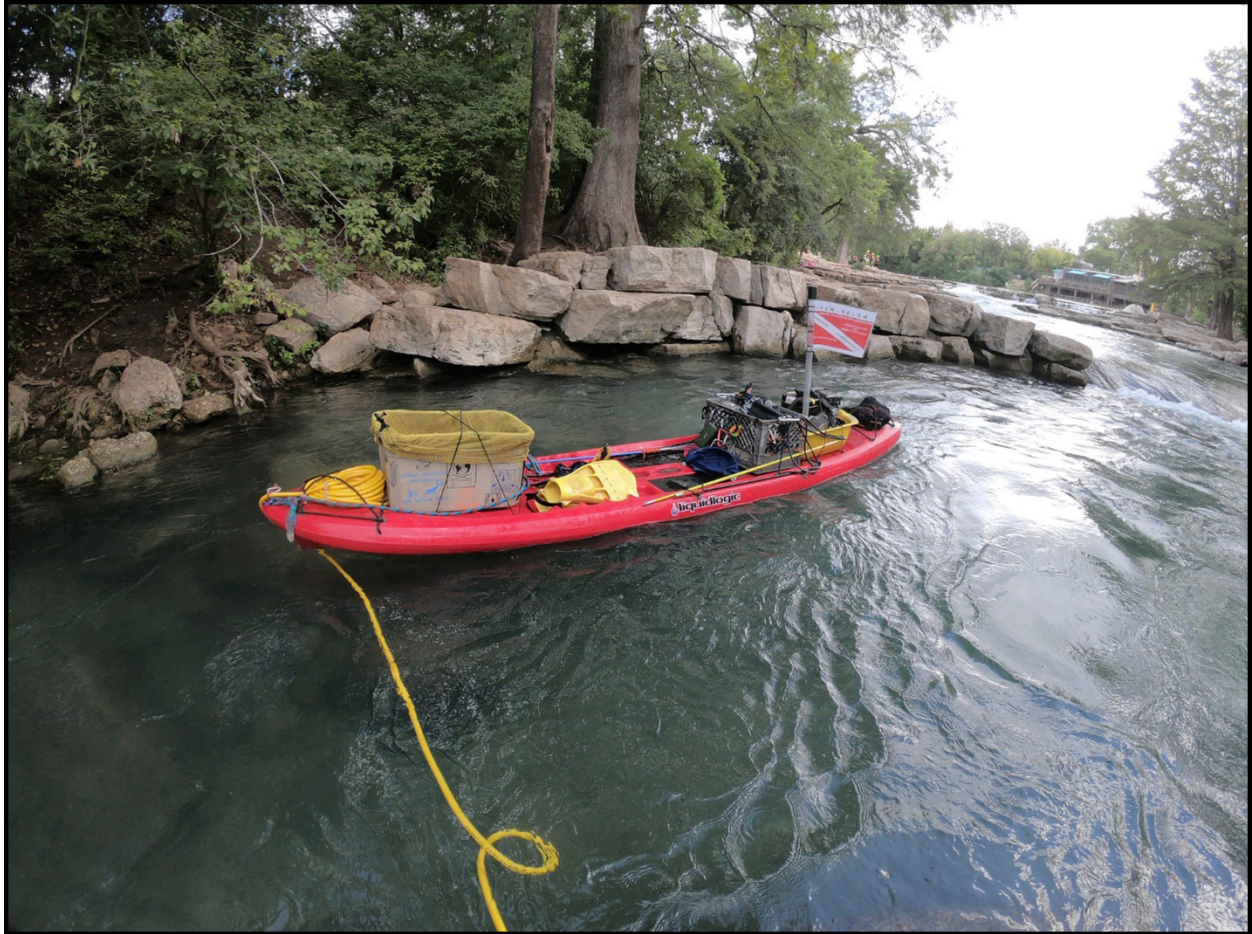
Figure 3.3-12. Litter collection setup.

The COSM's contractor removed inorganic litter from Clear Springs to Stokes Park with the COSM funding the work performed from City Park to IH-35. The contractor removed litter by snorkeling and towing a paddle board. A paddle board was used rather than a canoe or kayak due to the bottom of the boat being flat and more difficult to flip over, it also provided easier to access. Lobster bags were filled with litter then

dumped into totes mounted to the paddle board. The contractor adjusted dives to the conditions, sometimes drifting downstream and other times working upstream. Working upstream was best when there was a lot of litter to be removed because visibility was never lost. When there was a deeper hole with large litter accumulation, the contractor placed a hookah air supply system on the paddle board that allowing workers to stay underwater (**Figure 3.3-12** and **Figure 3.3-13**).

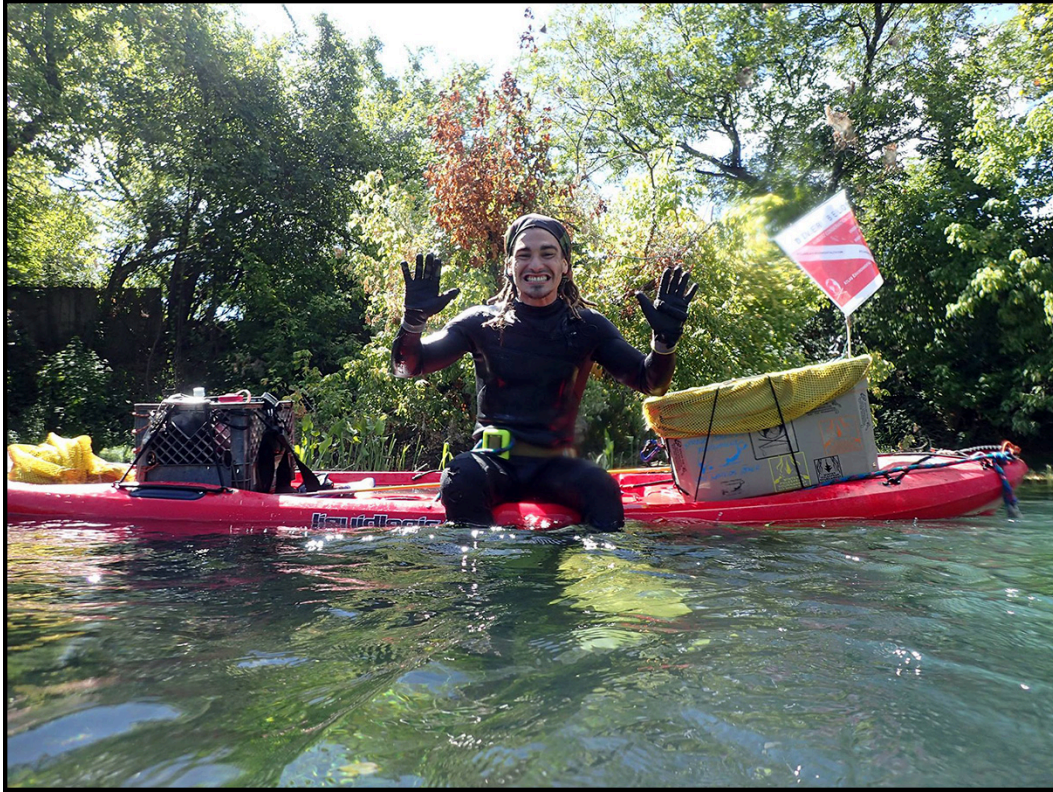
Figure 3.3-13. Litter collection in progress.

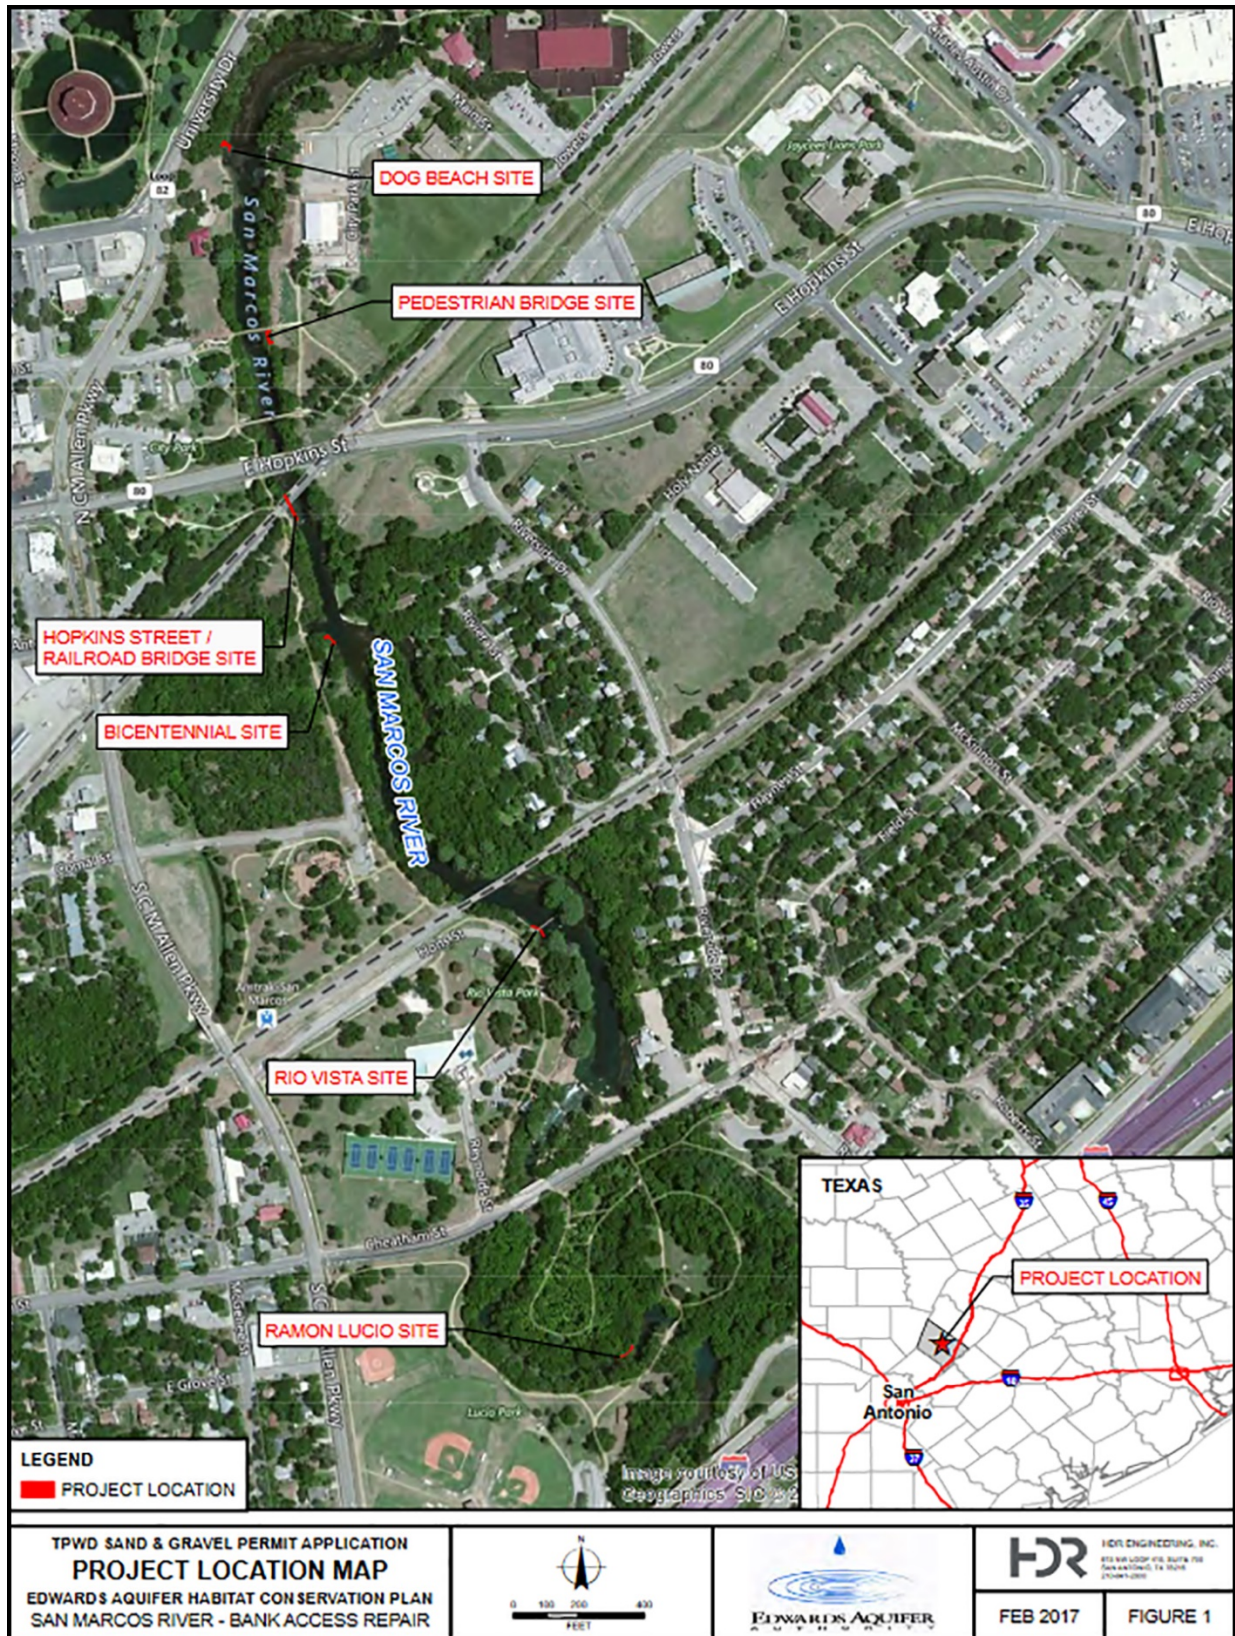
Figure 3.3-16. Locations of stabilized access points along the San Marcos River.

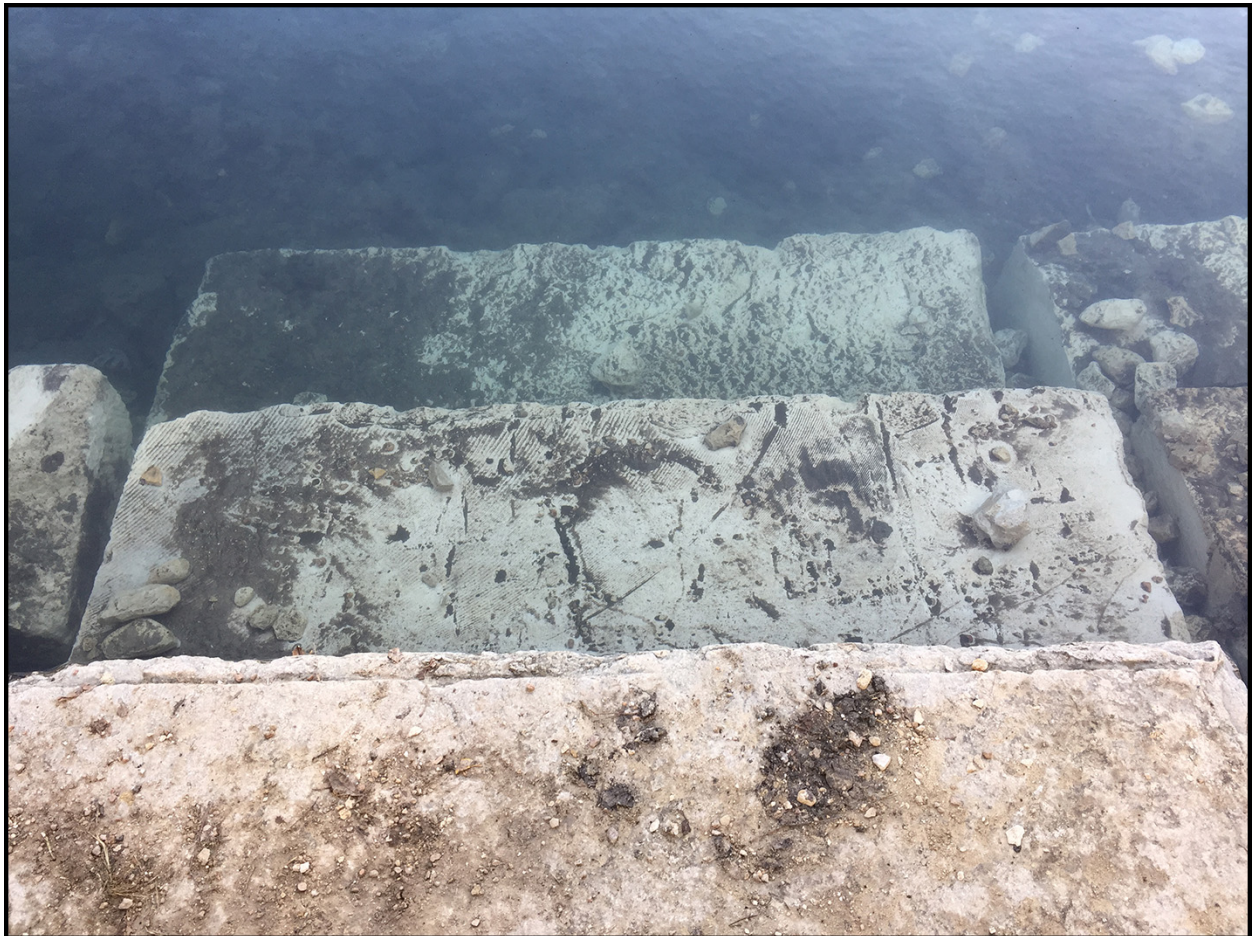
Figure 3.3-17. Measurements taken at each point under bottommost rock, showing undermining.

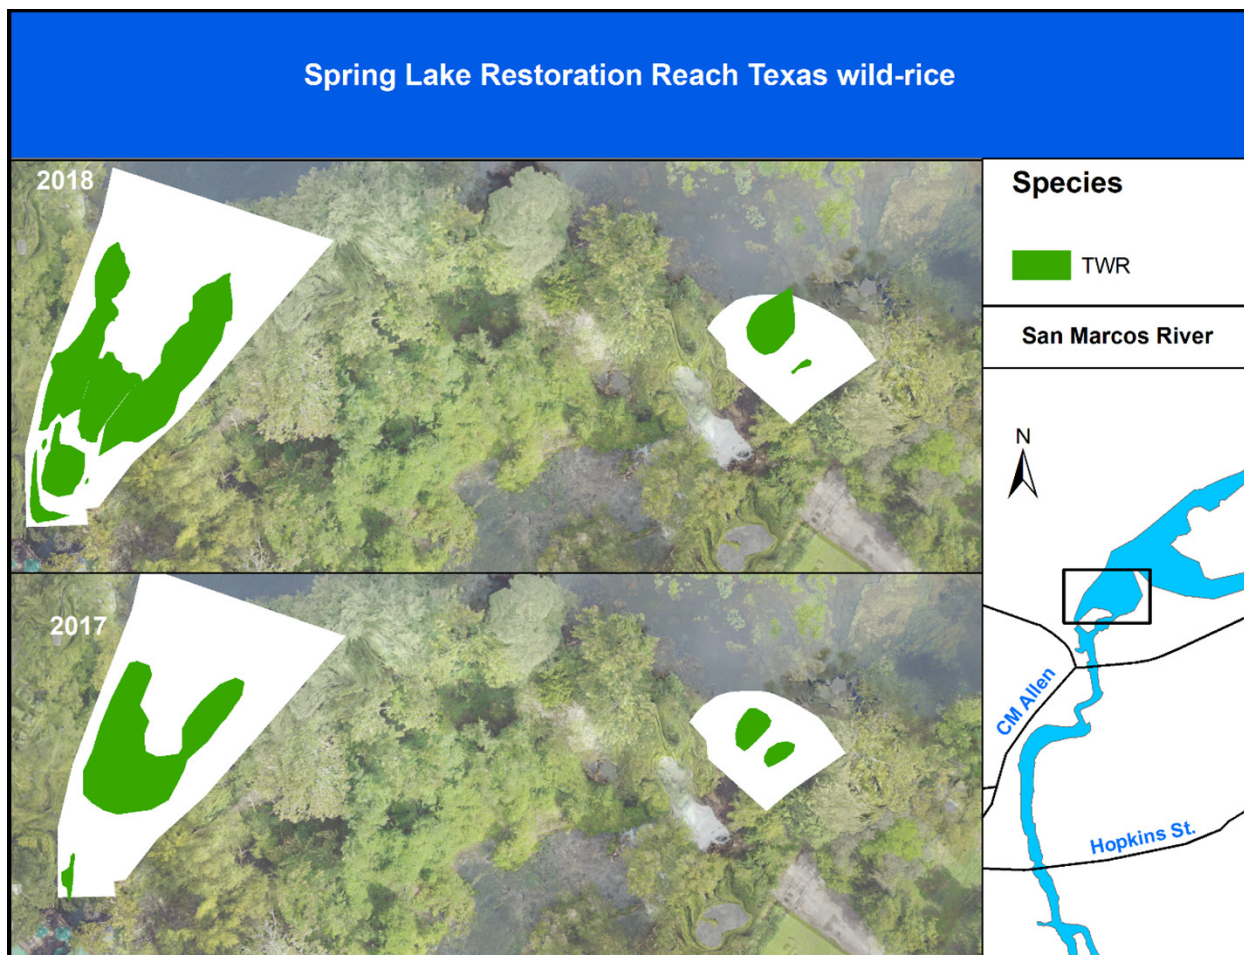
Figure 3.3-20. Aerial coverage of Texas wild-rice in Spring Lake Restoration Reach mapped during fall 2017 and fall 2018.
