EDWARDS AQUIFER HABITAT CONSERVATION PLAN

2018 Annual Report

MARCH 26, 2019

Blanton & Associates, Inc.

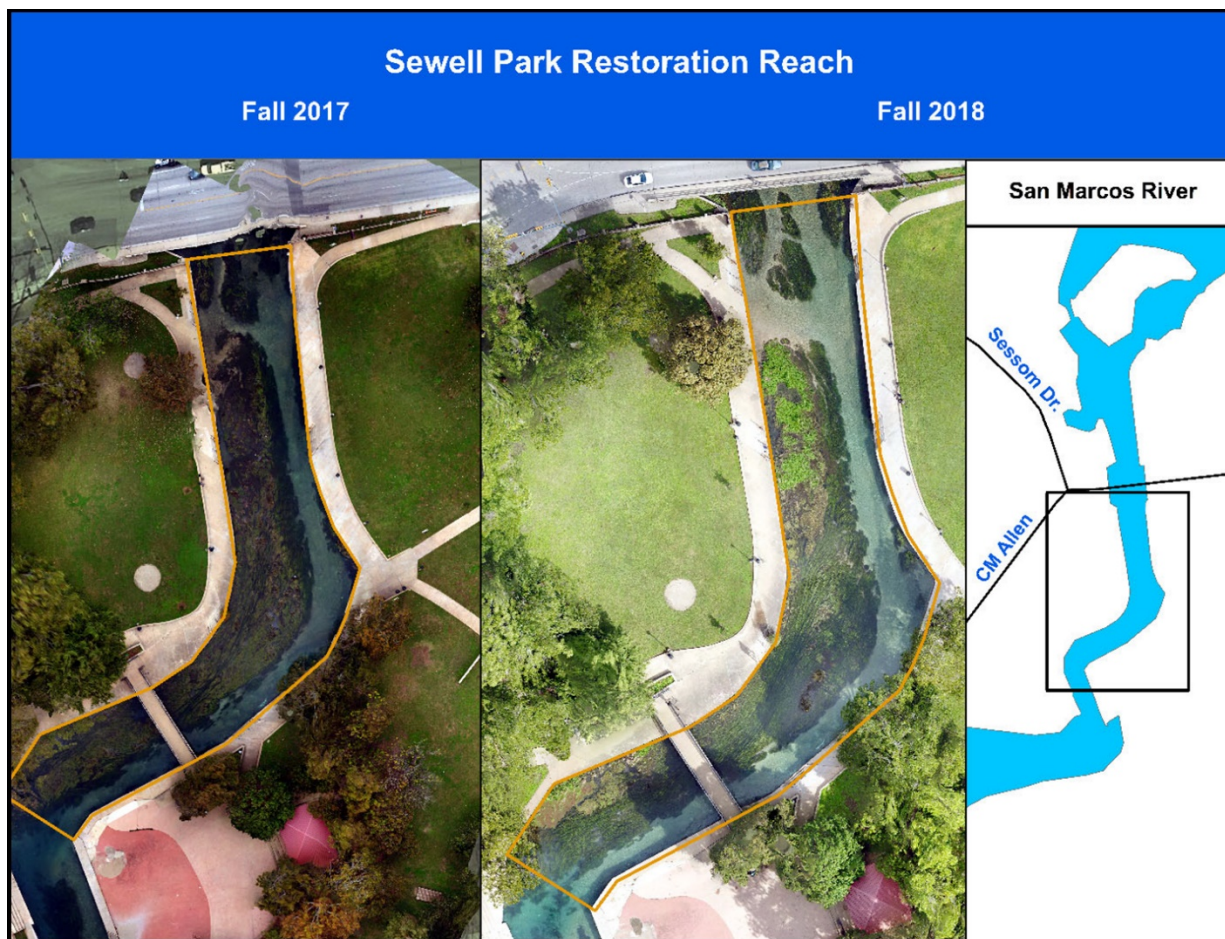
Figure 3.3-24. Imagery of submerged aquatic vegetation coverage in Sewell Park Restoration Reach captured during fall 2017 and fall 2018.

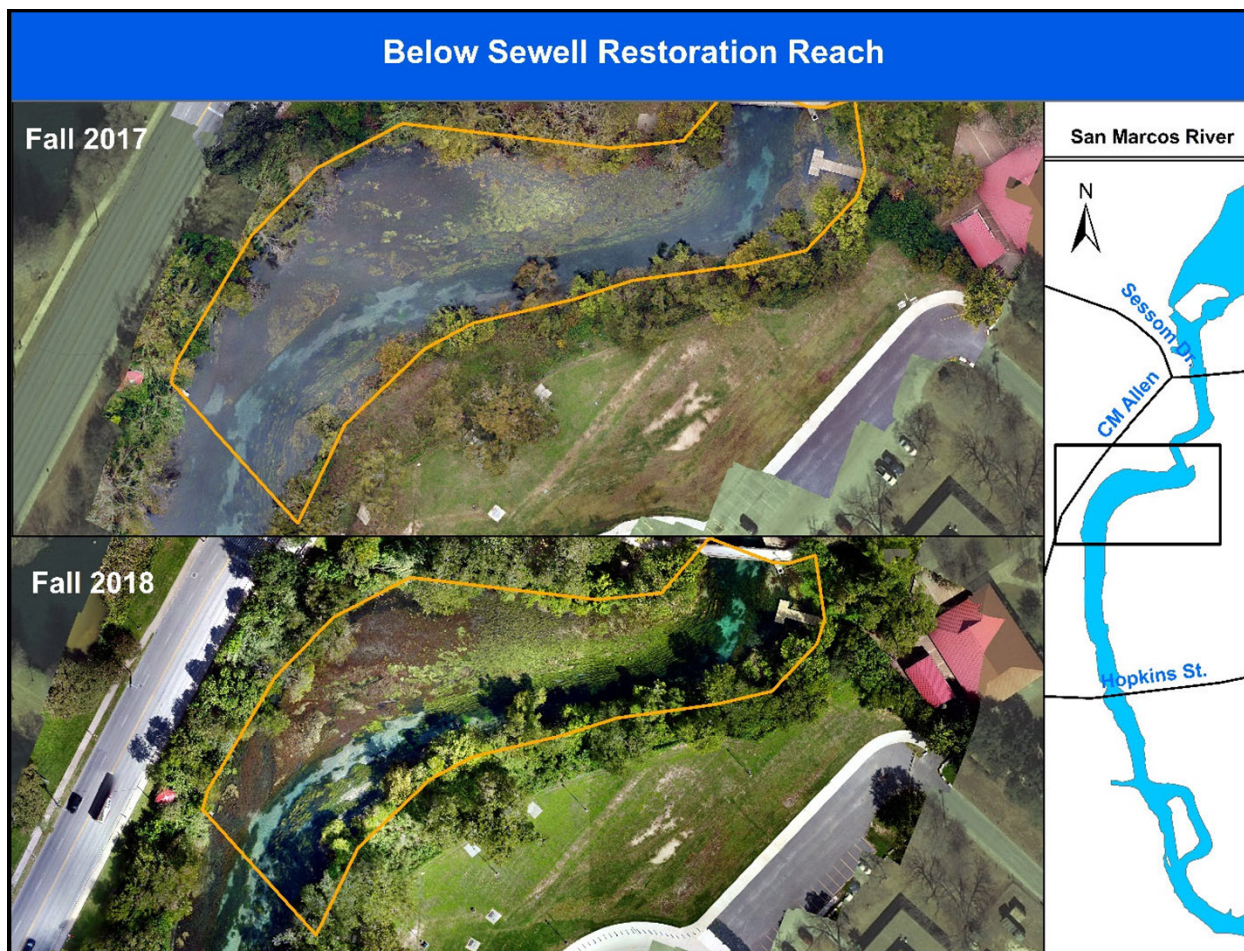
Figure 3.3-25. Imagery of submerged aquatic vegetation coverage in Below Sewell Park – Above City Park Restoration Reach captured during fall 2017 and fall 2018.

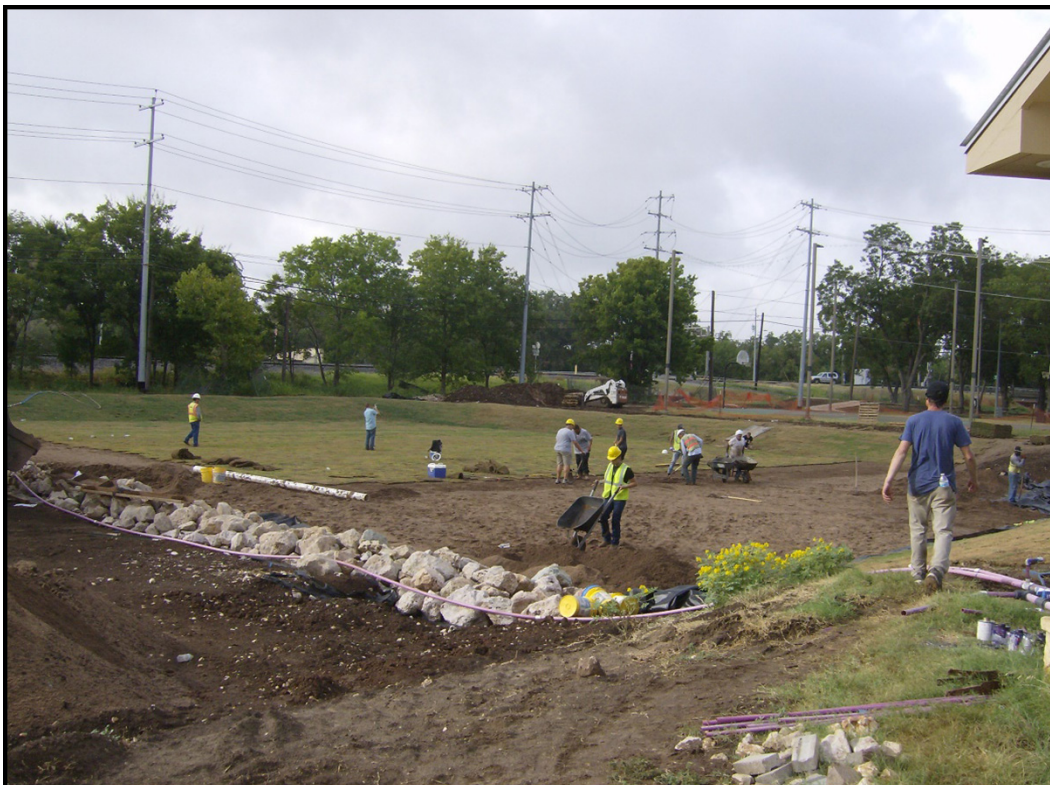
Figure 3.3-40. Final construction stage of City Park pond.
