**APPENDIX M**  
**CITY OF SAN MARCOS (COSM) / TEXAS STATE UNIVERSITY (TEXAS STATE), AND**  
**TEXAS PARKS AND WILDLIFE DEPARTMENT (TPWD) REPORTS/DOCUMENTS**

**Appendix M1**  
**CITY OF SAN MARCOS (COSM) / TEXAS STATE UNIVERSITY (TEXAS STATE), AND**  
**TEXAS PARKS AND WILDLIFE DEPARTMENT (TPWD) REPORTS/DOCUMENTS**  
**2019 San Marcos Aquatic Vegetation Restoration and Floating Vegetation Management Report**

**Appendix M2**  
**CITY OF SAN MARCOS (COSM) / TEXAS STATE UNIVERSITY (TEXAS STATE), AND**  
**TEXAS PARKS AND WILDLIFE DEPARTMENT (TPWD) REPORTS/DOCUMENTS**  
**2019 Management of Recreation in Key Areas**

**Appendix M3**  
**CITY OF SAN MARCOS (COSM) / TEXAS STATE UNIVERSITY (TEXAS STATE), AND**  
**TEXAS PARKS AND WILDLIFE DEPARTMENT (TPWD) REPORTS/DOCUMENTS**  
**2019 Designation of Permanent Access Points and Bank Stabilization**

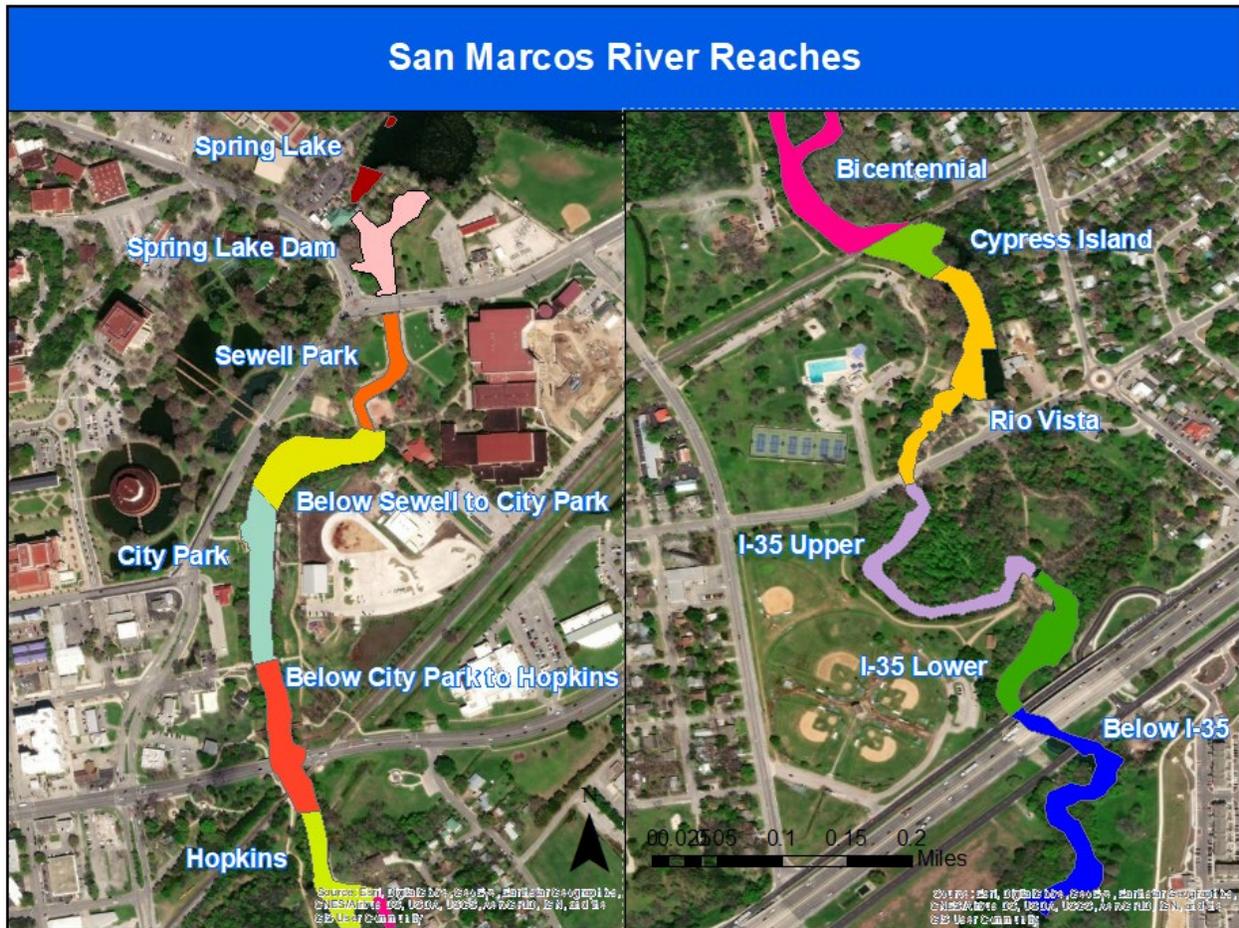
Figure 3.3-22. LTBG, restoration, and non-designated reaches for the 2019 work year.

In 2019, aquatic vegetation treatment work plans were developed based on the new top-down strategy with a focus on thorough non-native removal, starting with the upper most sources. Vegetation treatment efforts included both the non-native removal and native planting starting in the upper most reaches, with planting being limited to LTBG and restoration reaches. Native species approved for planting were *Ludwigia repens* (Ludwigia), *Cabomba caroliniana* (Cabomba), *Sagittaria platyphylla* (Sagittaria), *Potamogeton illinoensis* (Potamogeton), and *Hydrocotyle verticillata* (Hydrocotyle). The non-designed reaches that has historically not been worked are now part of the removal effort. [Fig. 3.3-22](#) shows all the reaches within the EAAHCP area of responsibility.

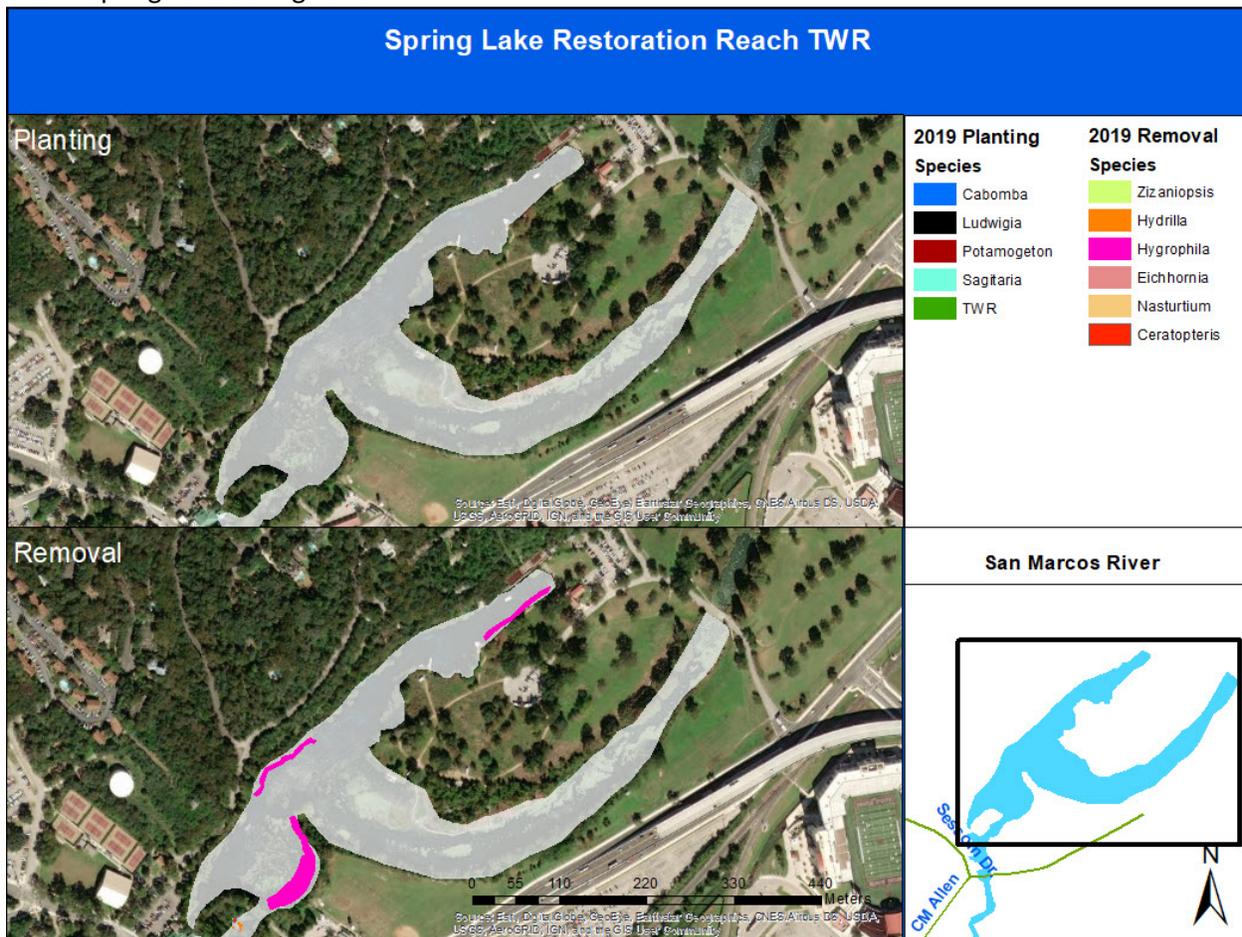
**Figure 3.3.23.** Locations of vegetation removal in Spring Lake restoration reach (2019).

In Spring Lake, vegetation treatment efforts in 2019 were limited due to repair efforts for Spring Lake Dam. This required the MCWE team relocate Texas wild-rice away from the construction areas near the western spillway. Approximately 300 *Sagittaria* individuals were salvaged from the area above the eastern spillway before construction took place and were planted in the Below Sewell reach. The proposed 2020 workplan will shift a large portion of effort to the removal of *Hygrophila* from Spring Lake. In 2019, divers spent six days developing and testing removal methods within Spring Lake following the top-down removal strategy. This allowed for setting up of communication and processes with Spring Lake Management and Dive Coordinator and to build a strategy and timeline for removal efforts. These test days resulted in 1,745.5 m<sup>2</sup> of *Hygrophila* removal (Fig. 3.3.23). No planting occurred within Spring Lake during 2019.

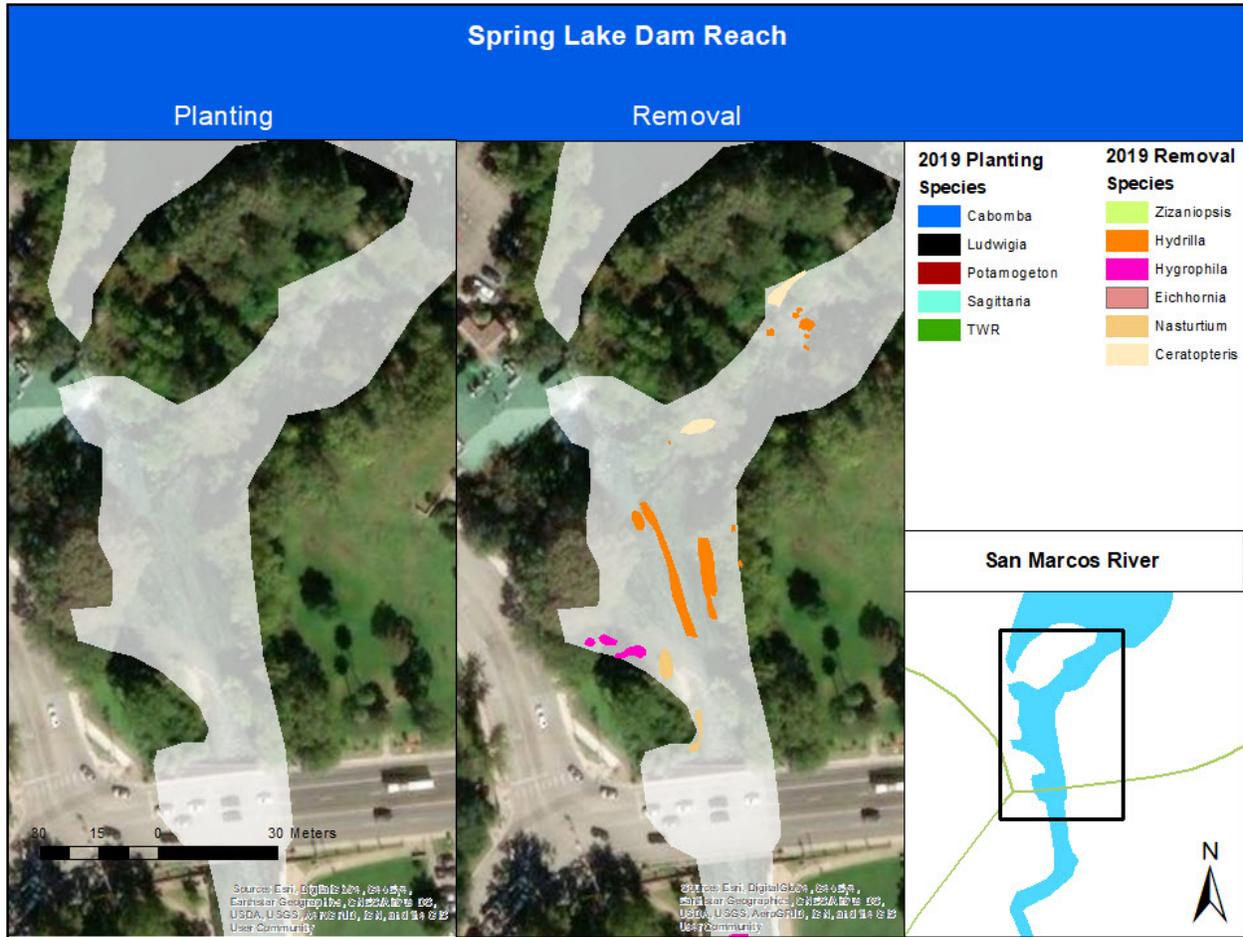
**Figure 3.3.25.** Locations of aquatic vegetation removal in Spring Lake Dam LTBG reach in 2019.

Spring Lake Dam LTBG reach was not a designed work zone for 2019. Vegetation treatment efforts occurred on 8 days during which approximately 11m<sup>2</sup> of Hydrilla, 20m<sup>2</sup> Hygrophila, 17m<sup>2</sup> of watercress, and 22m<sup>2</sup> of water sprite were removed (Fig. 3.3.25). No planting of native species occurred. Natural expansion of existing patches of Ludwigia, Cabomba or Sagittaria were observed throughout the reach, but primarily near the outflow from Sessom Creek drainage. Potamogeton and Hydrocotyle expansion were also observed in areas of higher flow, possible due to higher current velocities and less recreation damage as compared to 2018.

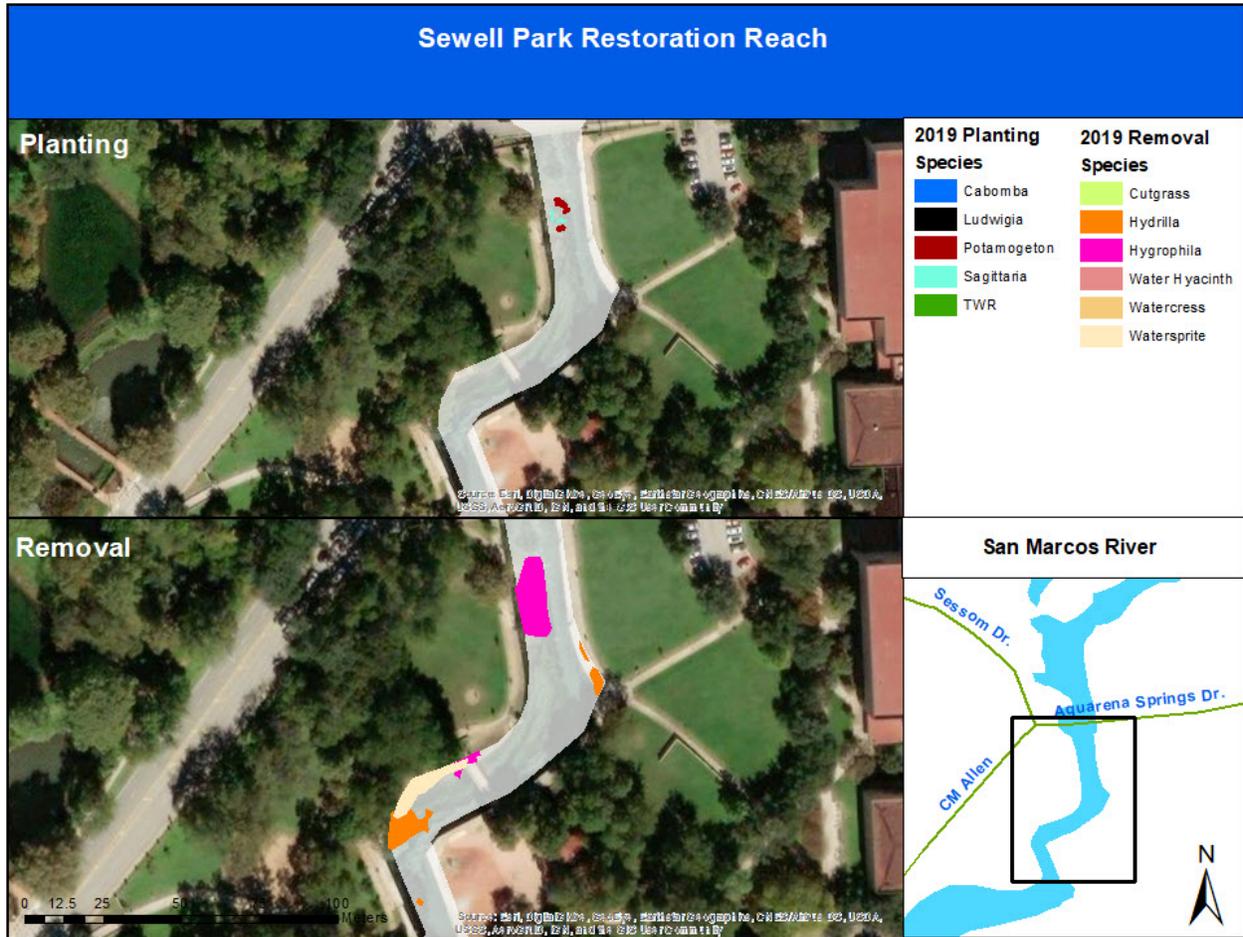
**Figure 3.3.26.** Locations of non-native vegetation removal and native SAV planting in Sewell Park restoration reach in 2019.

For 2019, the Sewell Park Restoration reach was not an active work zone but did require gardening to remove non-native vegetation regrowth within existing patches of native SAV along with planting of both Potamogeton and Sagittaria to help fill in denuded areas from recreation. Non-native removal occurred on a total of 11 days during which approximately 10m<sup>2</sup> of Hydrilla, 28m<sup>2</sup> of Hygrophila, 2m<sup>2</sup> of watercress, and 5m<sup>2</sup> of water sprite were removed (Fig. 3.3.26). A more thorough removal of Hydrilla in 2018 allowed for natural expansion of both Texas wild-rice and Potamogeton into previously unestablished areas.

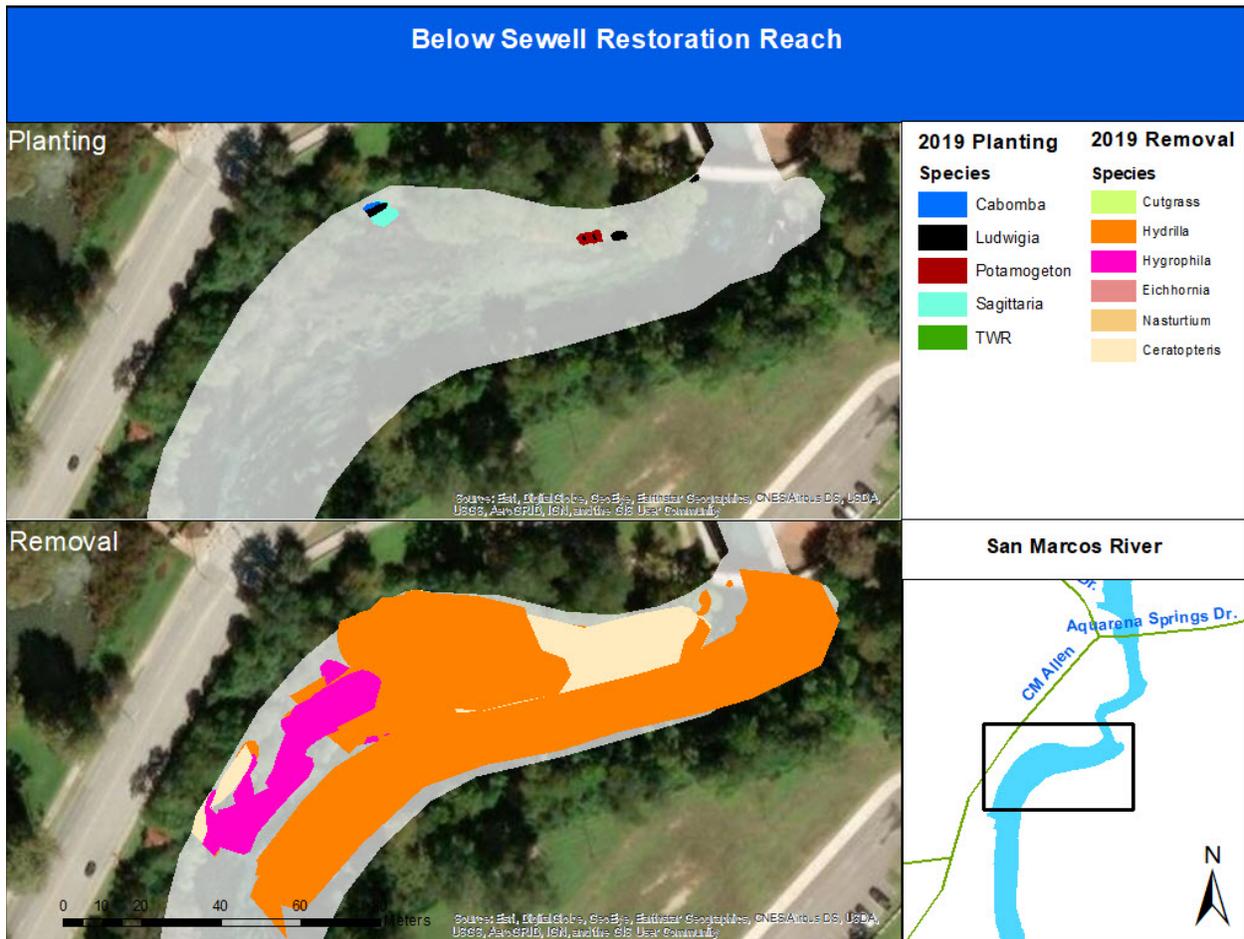
**Figure 3.3.27.** Locations of non-native vegetation removal and native SAV planting in Below Sewell restoration reach in 2019.

For 2019, the Below Sewell restoration reach was designated a work zone with a focus on removal of Hydrilla and to decrease the amount of Hygrophila. Non-native removal was performed on a total of 33 days during which approximately 845m<sup>2</sup> of Hydrilla, 1,002m<sup>2</sup> of Hygrophila, 122m<sup>2</sup> of water cress, 709m<sup>2</sup> of water sprite, 1.4m<sup>2</sup> of water hyacinth, and 2.8m<sup>2</sup> of cutgrass was removed (Fig. 3.3.27). An additional 45m<sup>2</sup> of Hydrilla was removed during maintenance sweeps. Planting of native SAV occurred in the areas where Hydrilla removal began at the end of 2018. A total of five planting days occurred in 2019 with 528 Cabomba, 608 Ludwigia, 750 Potamogeton, and 519 Sagittaria individuals being planted within the reach. Areas in the main river channel that had dense patches of hydrilla removed allowed for the expansion of Texas wild-rice and hygrophila. This supports the shift to the top-down removal of hygrophila.

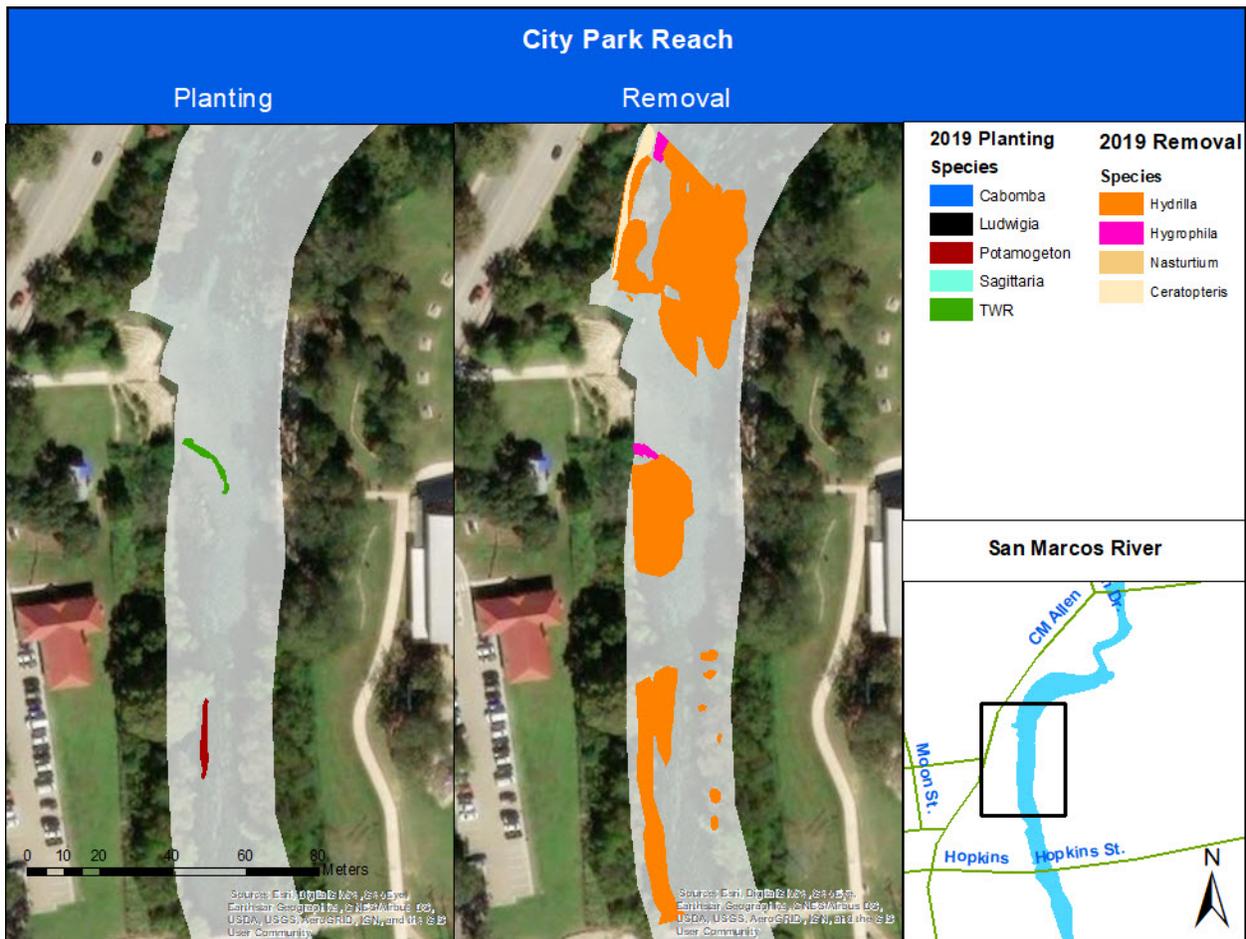
Figure 3.3.28. Locations of removal and planting within City Park LTBG Reach 2019.

The City Park LTBG reach was designated a work zone for 2019 with a focus on removal of Hydrilla and to keep patches of native SAV free from encroaching Hygrophila. Non-native removal was performed on a total of 32 days during which approximately 1,064m<sup>2</sup> of Hydrilla, 106m<sup>2</sup> of Hygrophila, 3m<sup>2</sup> of water cress, and 7m<sup>2</sup> of water sprite was removed (Fig. 3.3.28). Maintenance sweeps resulted in an additional 52m<sup>2</sup> of Hydrilla removal. The planting of native SAV that occurred in this reach was an attempt to create a wall around an area of Ludwigia and Cabomba to keep non-natives from being continually introduced into that area from upstream sources. An area of Potamogeton was planted in the lower section to introduce that species and promote downstream expansion. A total of two planting days occurred in 2019 with 600 Texas wild-rice, and 2,610 Potamogeton individuals being planted (Fig. 3.3.28).

Refer to [Fig. 3.3-28](#) and [Fig. 3.3-31](#) illustrate the areas planted with Texas wild-rice in 2019.

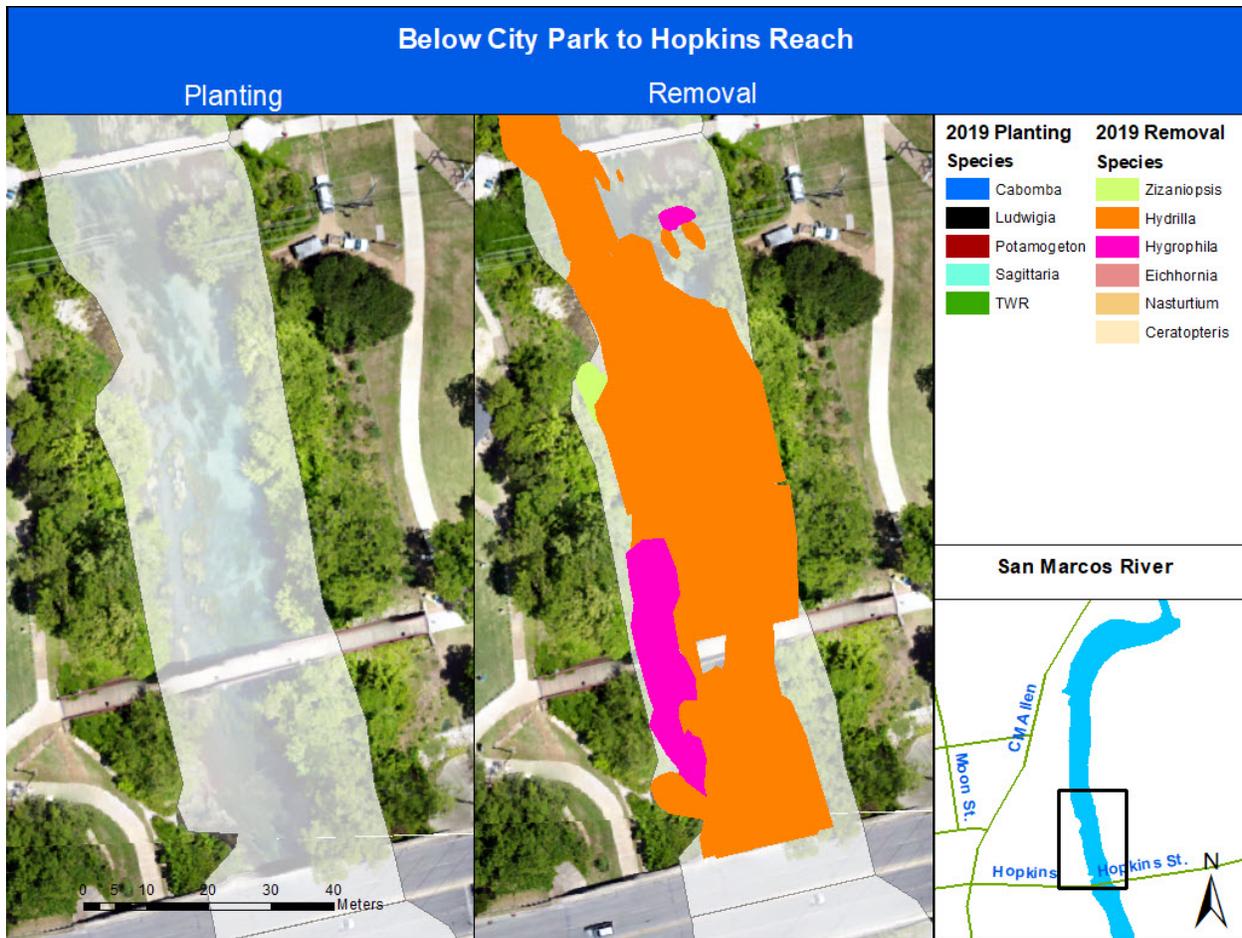
Figure 3.3.29. Locations of removal and planting within Below City to Hopkins reach 2019.

For 2019, the Below City to Hopkins is a non-designated reach that was a work zone for the MCWE crew. Very little effort was put into this reach historically with only a few removal and planting days prior to 2019. The primary focus was on removal of Hydrilla and to promote the natural expansion of native SAV already present in the reach. There was a large percent of Hydrilla within the reach at the start of 2019 that had been present for over a decade. This required a shift in the removal method to include more frequent maintenance sweeps to locate and remove regrowth from the large number of tubers present within the substrate. Non-native removal was performed on a total of 32 days during which approximately 1,987m<sup>2</sup> of Hydrilla, 174m<sup>2</sup> of Hygrophila, and 41m<sup>2</sup> of cutgrass was removed (Fig. 3.3.29). Additionally, 40m<sup>2</sup> Hydrilla was removed during the maintenance sweeps. No planting of native SAV occurred in this reach due to the quantity of Hydrilla present at the start and there are no goals for this reach. Regrowth will be maintained through maintenance sweeps into 2020. Once no regrowth occurs for a period of at least a few months then planting can occur.

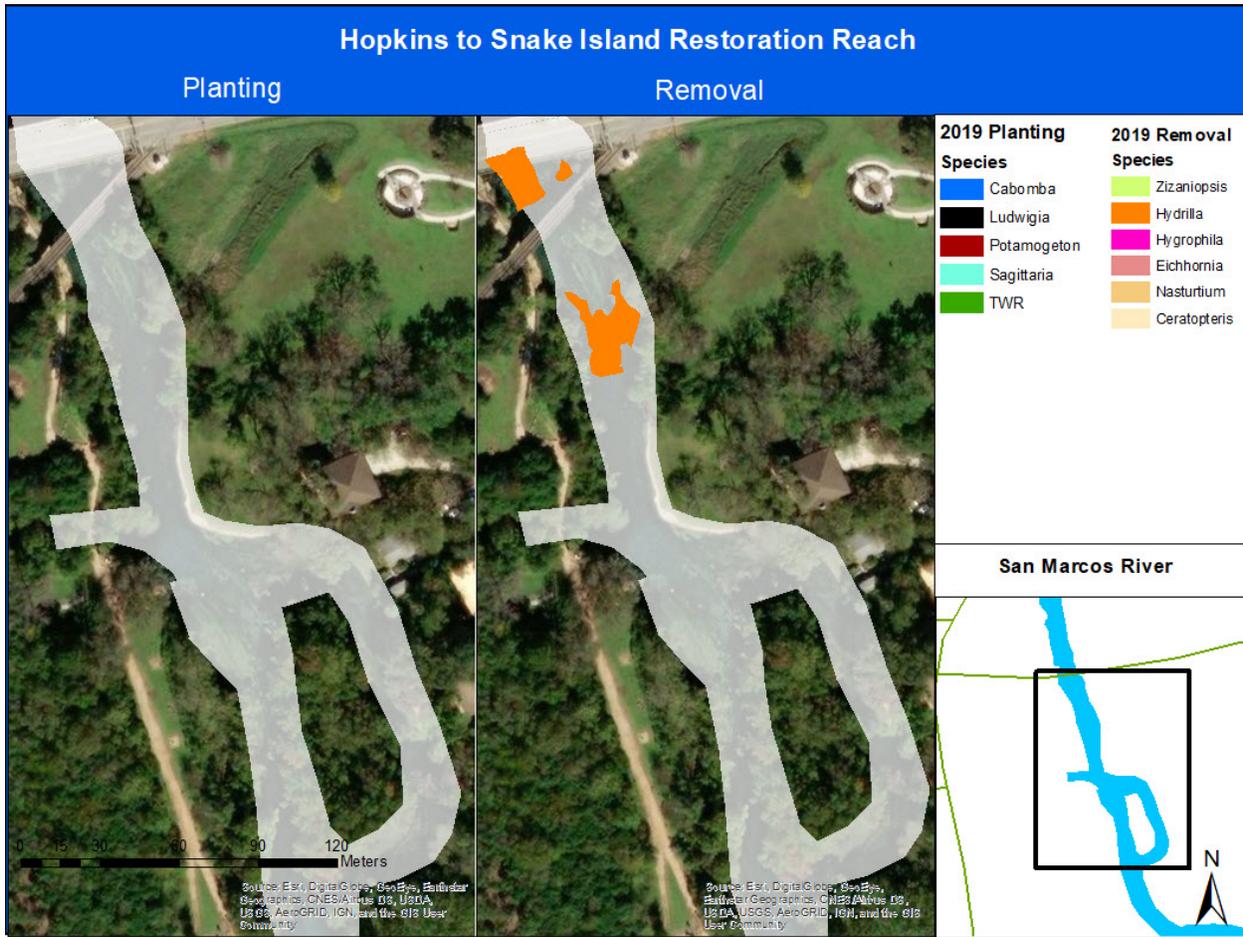
Figure 3.3.30. Locations of removal within the Hopkins to Snake Island reach 2019.

The section of river from Hopkins street to Snake Island includes both a restoration reach and stretch of non-designated area immediately below Hopkins. This reach was not assigned as a work zone in 2019, but some removal effort began in October to further utilize warmer weather and to test some new methodology for areas with such large quantities of Hydrilla. Non-native removal was performed on a total of 4 days during which approximately 404m<sup>2</sup> of Hydrilla and 5m<sup>2</sup> of Hygrophila was removed (Fig. 3.3.30). No planting effort occurred in this reach due to potential reestablishment of non natives.

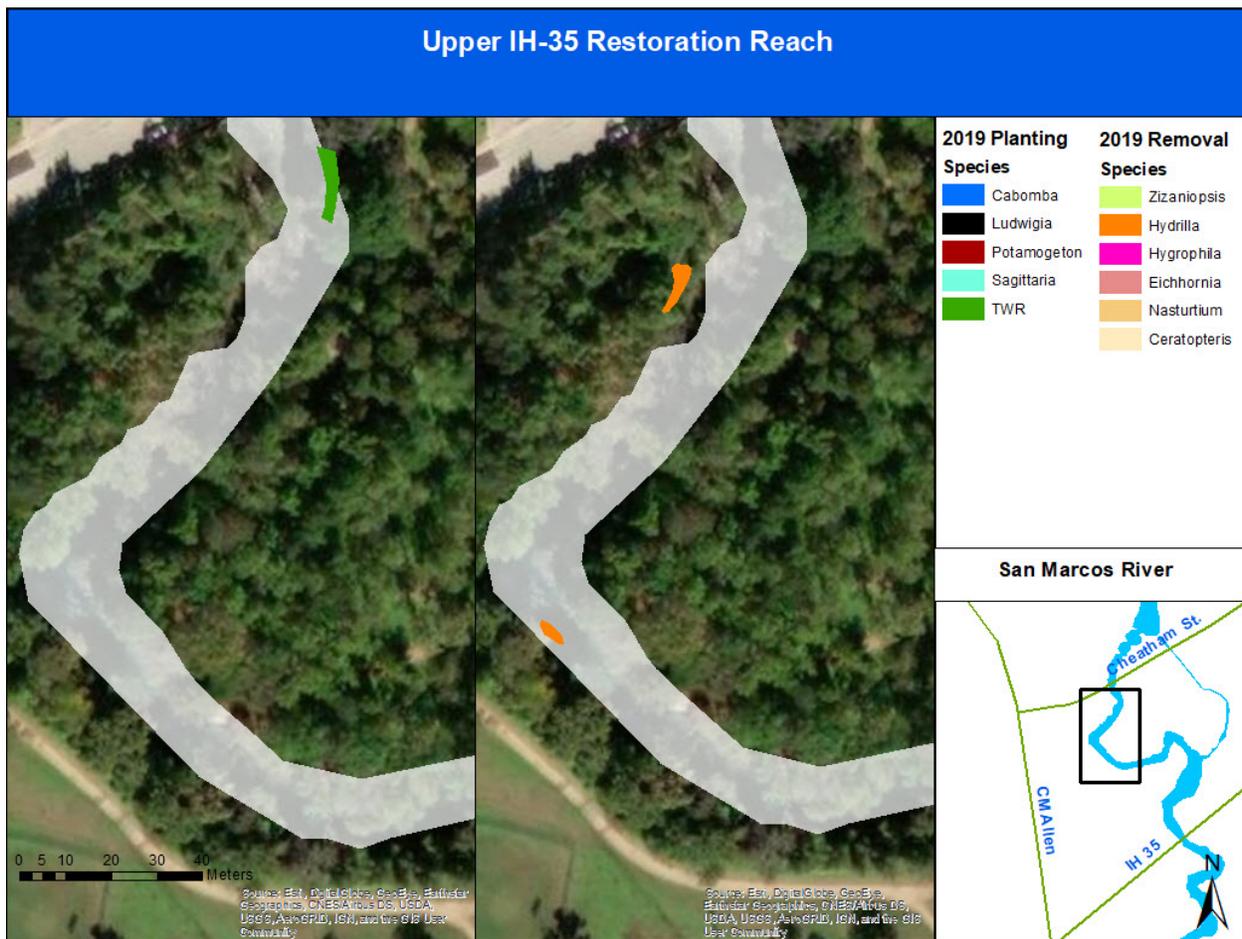
Figure 3.3.31. Locations of non-native SAV removal in IH-35 LTBG reach (2019).

The upper section of the I-35 reach is a LTBG reach. It was not a designated work zone for 2019, but minor efforts were conducted in the IH-35 LTBG reach over this work season, as our primary goals were directed almost entirely at the upper reaches within this river system. Vegetation treatment efforts took place over 3 days with roughly 44m<sup>2</sup> of Hydrilla and 3m<sup>2</sup> Hygrophila being removed from areas immediately downstream from Cheatham Bridge and towards the lower end of this reach (Fig. 3.3.31). One effort day went into planting Texas wild-rice with 660 individuals being planted, but no other native SAV was planted. It was also observed that Texas wild-rice and Potamogeton have maintained aerial coverage in areas previously planted. Populations of Hydrocotyle, Ludwigia, and Sagittaria have all been reduced in number throughout this reach possibly due to disturbance from recreation or potential bank erosion.

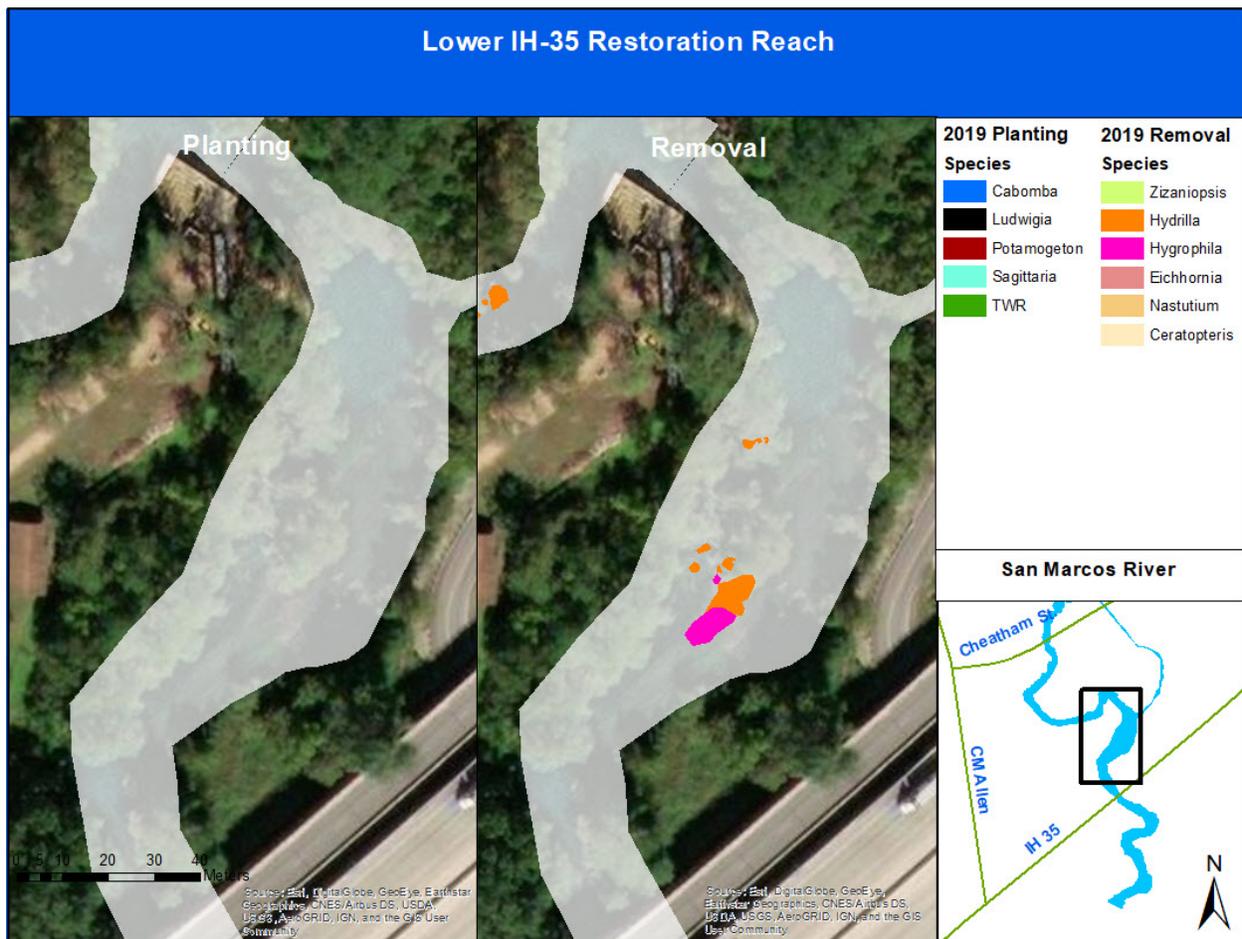
Figure 3.3.32. Locations of non-native SAV removal in IH-35 expanded restoration reach (2019).

The downstream section of I-35 reach is a Restoration reach. Again, this reach was not a 2019 work zone; however, efforts to maintain native SAVs were taken in order to avoid potential losses due to Hydrilla expansion. A total of 18m<sup>2</sup> of Hydrilla and 49m<sup>2</sup> of Hygrophila were removed from this reach over the course of 3 treatment days (Fig. 3.3.32). No planting effort occurred in this reach for 2019. It appears that the Sagittaria population in this reach has maintained its foothold and possibly increased its aerial coverage in the upstream direction. Ludwigia and Hydracotyle have also maintained patches throughout this location, though Hydrocotyle is only established below the island. In addition to the vegetation observation, it was noted that flow conditions above the island have shifted due to a large pecan tree that has fallen in on river right: this tree is currently covering a small portion of Texas wild-rice that is located in the immediate vicinity.

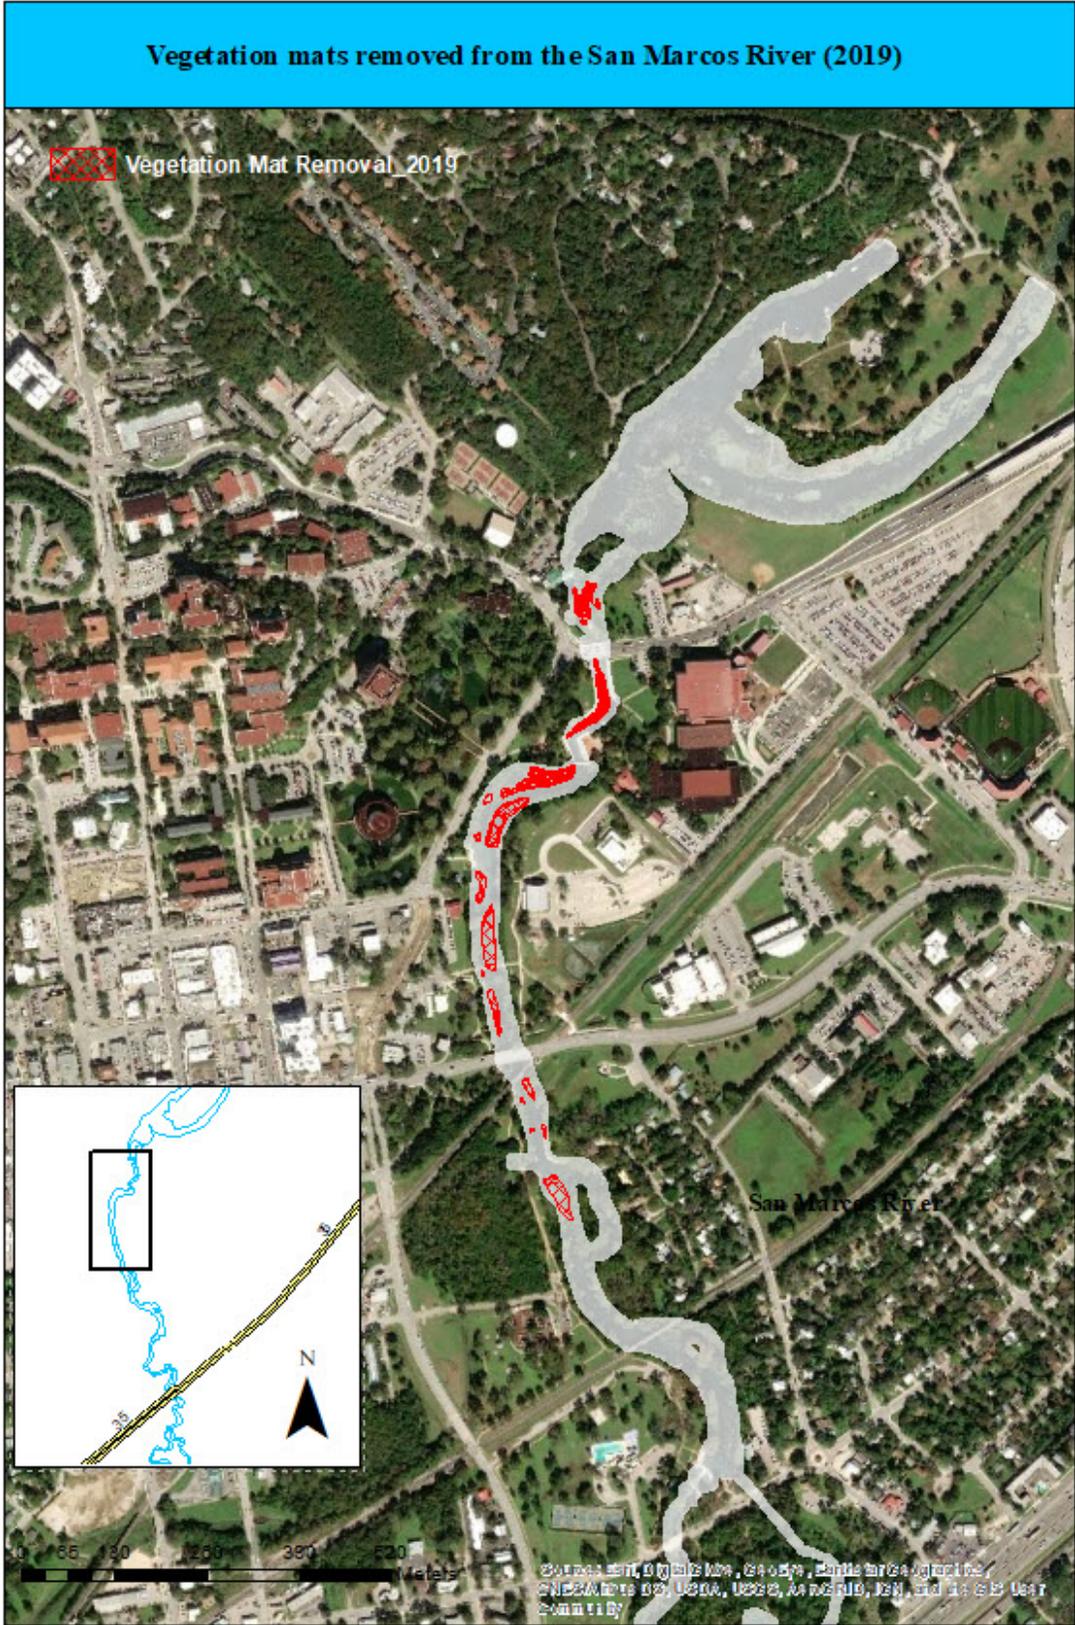
Figure 3.3-x. Upper three reaches, including polygons, where vegetation mat removal efforts were focused.

Vegetation mats were removed primarily from Texas wild-rice stands in Spring Lake Dam reach, Sewell Park reach, and Below Sewell reach in 2019. This was the first year to fully remove the vegetation mats from the river instead of pushing them downstream, which was done to prevent them from building up on Texas wild-rice stands downstream. A total of 17,272.6 m<sup>2</sup> were removed from in and around Texas wild-rice over 762.3 labor hours throughout 2019 ([Fig. 3.3.33](#)). Additionally, vegetation mats downstream of these reaches were pushed when vegetation treatment work occurred within Texas wild-rice stands. The removed vegetation mats were also quantified by volume to give a better representation of how much vegetation was being removed, which could vary significantly in thickness and density, as opposed to estimating the area of vegetation mat coverage. This also allowed the collection of consistent data for the Spring Lake aquatic vegetation boom study. The area of removal consisted on approximately 2600m<sup>2</sup> Texas wild-rice stands within the three focus reaches. A total of 216.7m<sup>3</sup> was removed from the San Marcos river, in 45 effort days, through the collaboration of the MCWE and conservation crews from mid-May through mid-October.

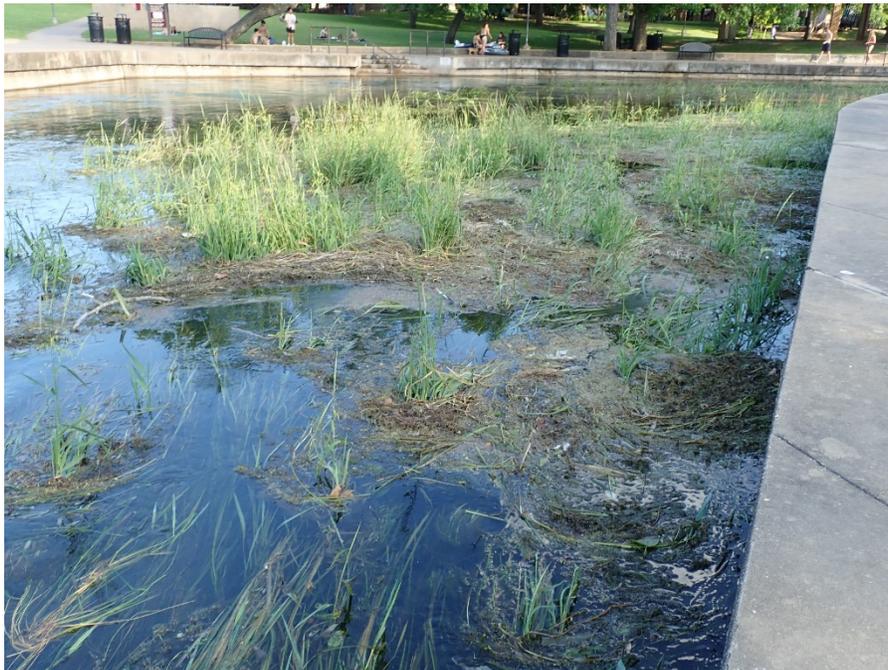
Figure 6: Veg mats before removal at Sewell.

- Pushed floating veg mats off TWR stands primarily at City Park, and Bicentennial where accumulation persisted due to low flow. Regularly worked with the Meadows Crew removing veg mats from headwaters to lower Sewell Park as part of the Spring Lake boom study. See Figures 6-9.

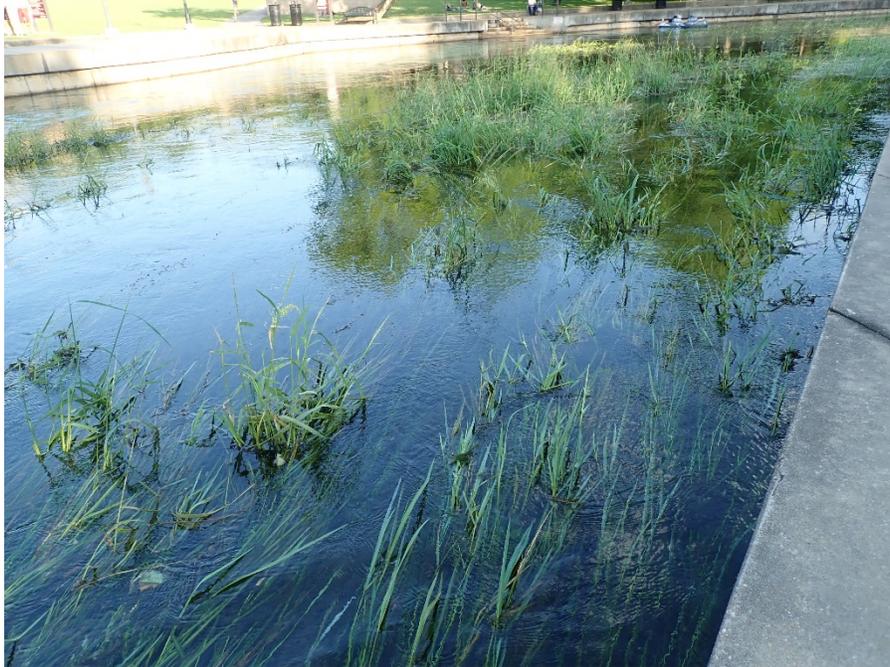
Figure 7: Veg mats after removal at Sewell.

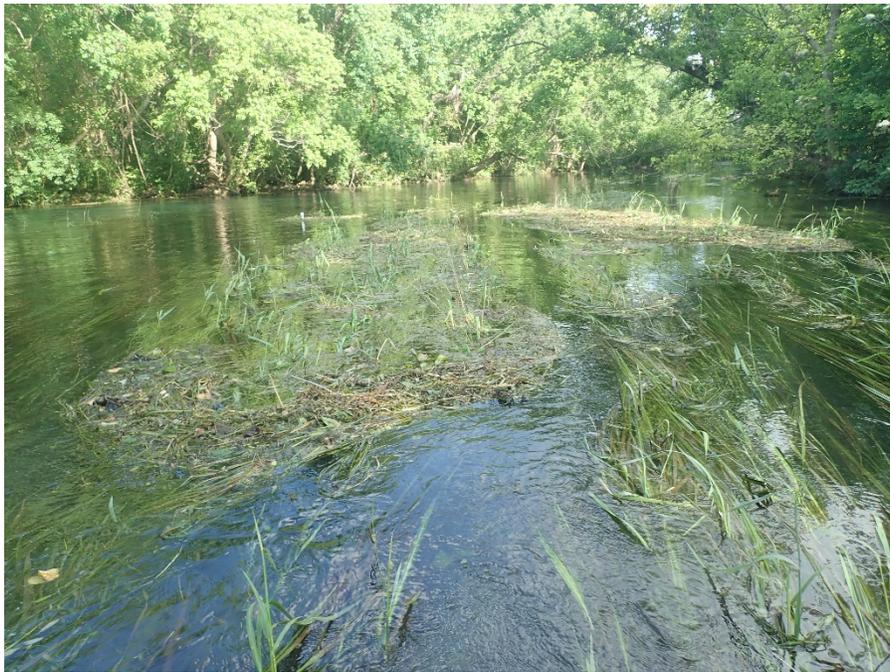
Figure 8: Veg mats before removal at Bicentennial.

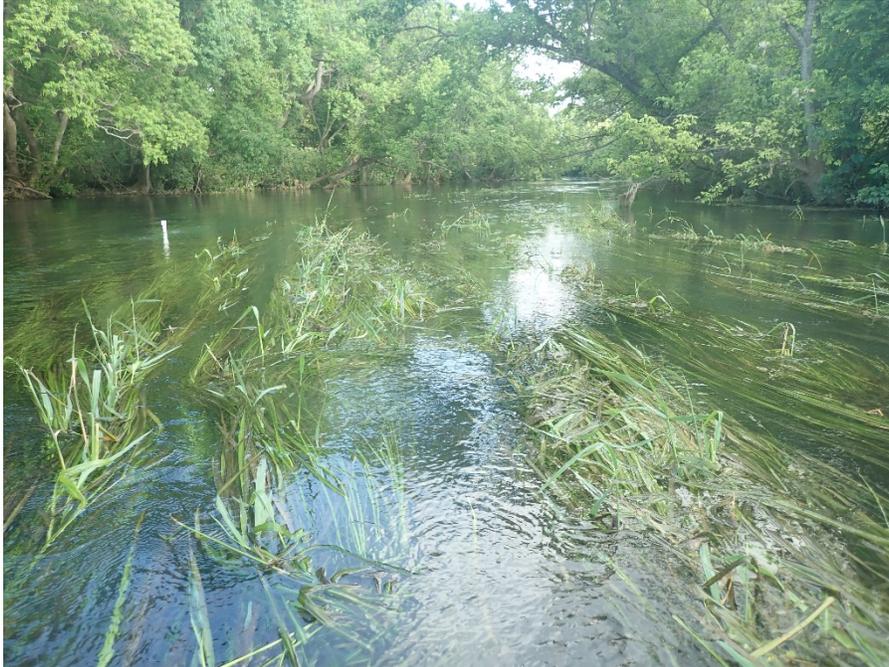
Figure 9: Veg mats after removal at Bicentennial.

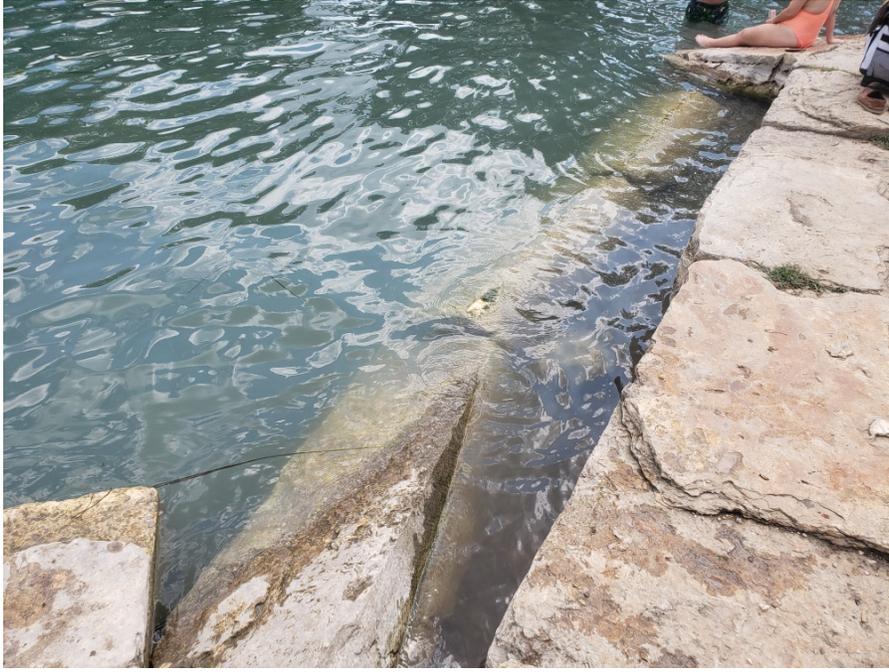
Figure 15: Bottom row of Dogbeach access point settled considerably, but remains stable.

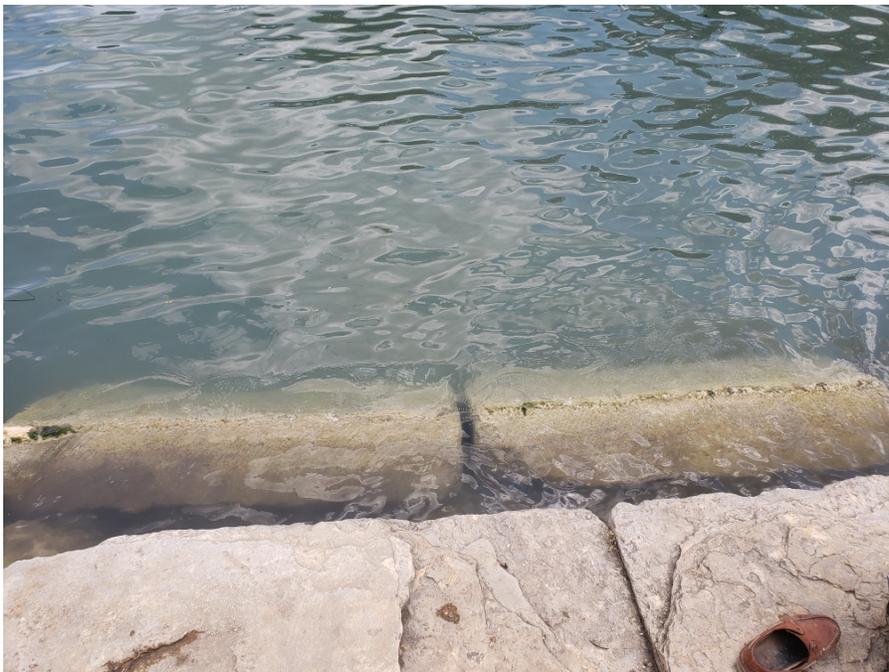
Figure 16: Bottom row of Dogbeach access point settled considerably, but remains stable.

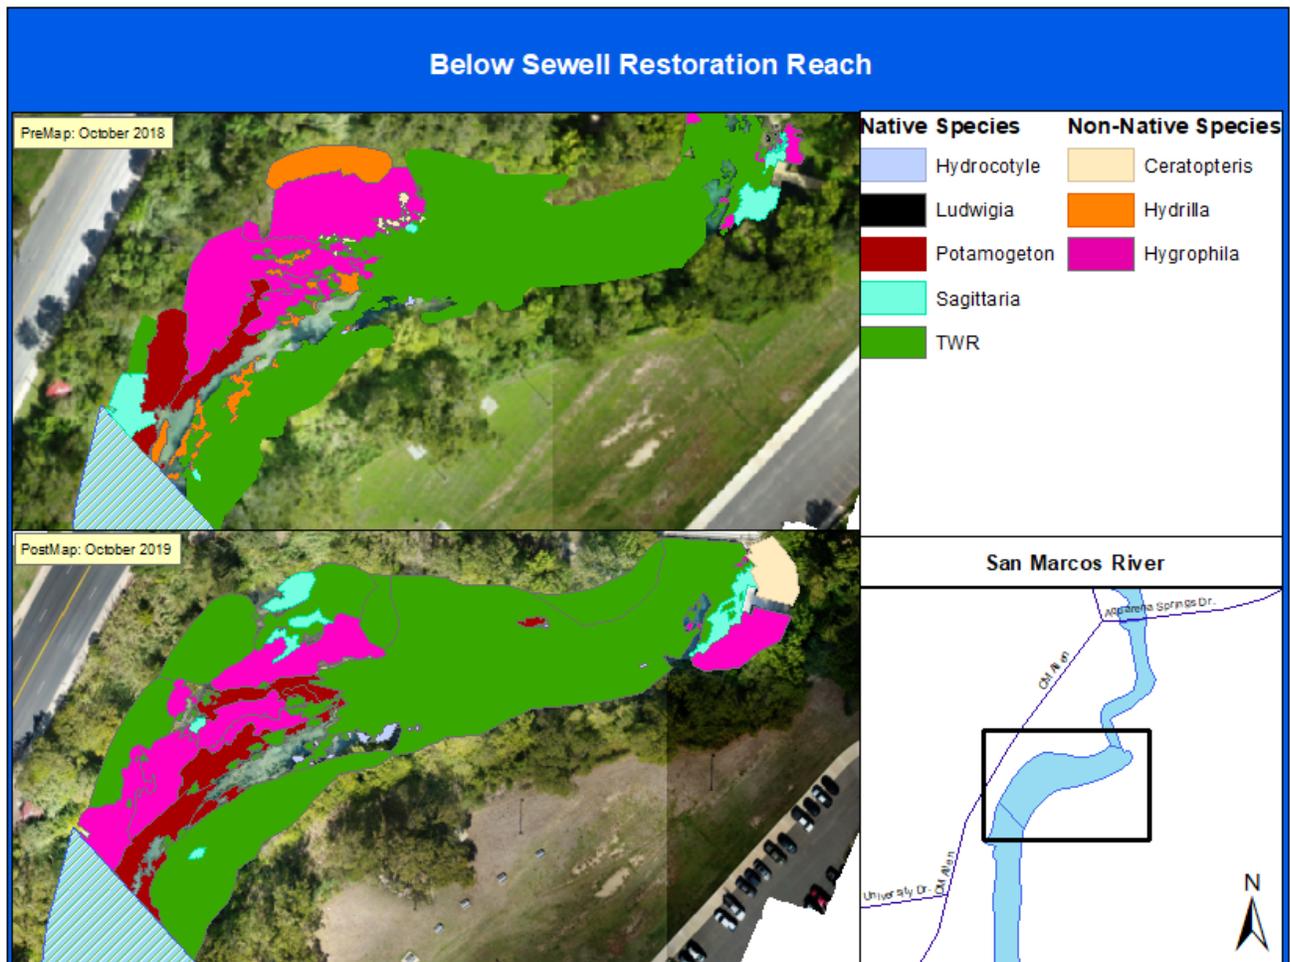
For 2019, the Below Sewell restoration reach was designated as a work zone with a focus on removing Hydrilla and decreasing the amount of Hygrophila. The process of removing non-native species and the subsequent growth of native species over the course of a year (between October 2018-2019) is visualized in the following map and table. The removal of Hydrilla was particularly successful as its coverage was reduced from 751.2 m<sup>2</sup> to near zero, resulting in 15.12% coverage decrease throughout the year. Hygrophila's coverage was reduced from 1103.9 m<sup>2</sup> to 682.9 m<sup>2</sup> resulting in a 9.6% coverage decrease when referencing the total area with vegetation. Another non-native species' coverage, Ceratopteris, was reduced from 44.7 m<sup>2</sup> to near zero as well. The most prominent and ecologically significant native species, Texas Wild Rice, saw a substantial increase in coverage from 2432.956 m<sup>2</sup> to 3535.1 m<sup>2</sup>. That growth results in a 16.33% increase throughout the year. Other notable native species that experienced growth throughout the year are Sagittaria and Potamogeton. Sagittaria increased its coverage by 4.32% while Potamogeton increased its coverage by 2.63%.

**Figure 1.1.** Locations of native and non-native aquatic vegetation species within the Below Sewell to City Park restoration reach, PreMap (Top, Oct. 2018), PostMap (Bottom, Oct. 2019).
