**APPENDIX M**  
**CITY OF SAN MARCOS (COSM) / TEXAS STATE UNIVERSITY (TEXAS STATE), AND**  
**TEXAS PARKS AND WILDLIFE DEPARTMENT (TPWD) REPORTS/DOCUMENTS**

**Appendix M1**  
**CITY OF SAN MARCOS (COSM) / TEXAS STATE UNIVERSITY (TEXAS STATE), AND**  
**TEXAS PARKS AND WILDLIFE DEPARTMENT (TPWD) REPORTS/DOCUMENTS**  
**2019 San Marcos Aquatic Vegetation Restoration and Floating Vegetation Management Report**

**Appendix M2**  
**CITY OF SAN MARCOS (COSM) / TEXAS STATE UNIVERSITY (TEXAS STATE), AND**  
**TEXAS PARKS AND WILDLIFE DEPARTMENT (TPWD) REPORTS/DOCUMENTS**  
**2019 Management of Recreation in Key Areas**

**Appendix M3**  
**CITY OF SAN MARCOS (COSM) / TEXAS STATE UNIVERSITY (TEXAS STATE), AND**  
**TEXAS PARKS AND WILDLIFE DEPARTMENT (TPWD) REPORTS/DOCUMENTS**  
**2019 Designation of Permanent Access Points and Bank Stabilization**

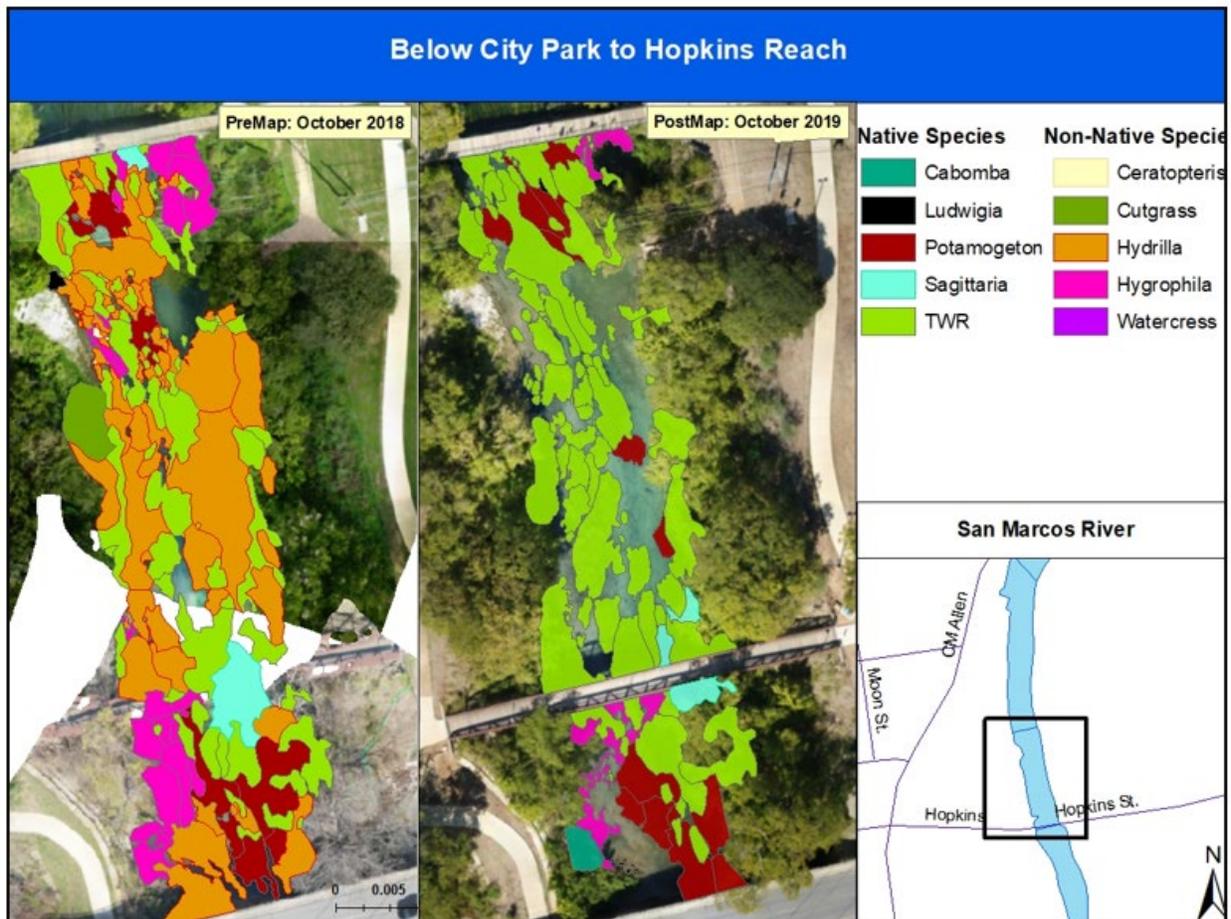
In 2019, the Below City Park to Hopkins restoration reach was designated as a work zone with a focus on removing and decreasing the amount of non-native species such as Hydrilla and Hygrophila. The following map and table depict the process of non-native species removal and the subsequent growth of native species over the course of a year from October 2018 to October 2019. Hydrilla removal was successful as the total coverage was reduced from 1,007.51 m<sup>2</sup> to 6.21 m<sup>2</sup>, resulting in a 44.55% decrease throughout the year. The coverage of Hygrophila was reduced from 259.17 m<sup>2</sup> down to 67.92 m<sup>2</sup> resulting in an overall 7.28% decrease. Species with coverage that decreased to near zero in 2019 were Ceratopteris, Cutgrass, and Watercress. The endangered Texas Wild Rice coverage saw a substantial increase from 628.27 m<sup>2</sup> to 1084.59 m<sup>2</sup>, a difference of 40.42%. This species now represents approximately 68.45% of the total aquatic vegetation of the restoration reach.

**Figure 1.2.** Locations of native and non-native aquatic vegetation species within the Below City Park to Hopkins restoration reach, PreMap (Left, Oct. 2018), PostMap (Right, Oct. 2019).

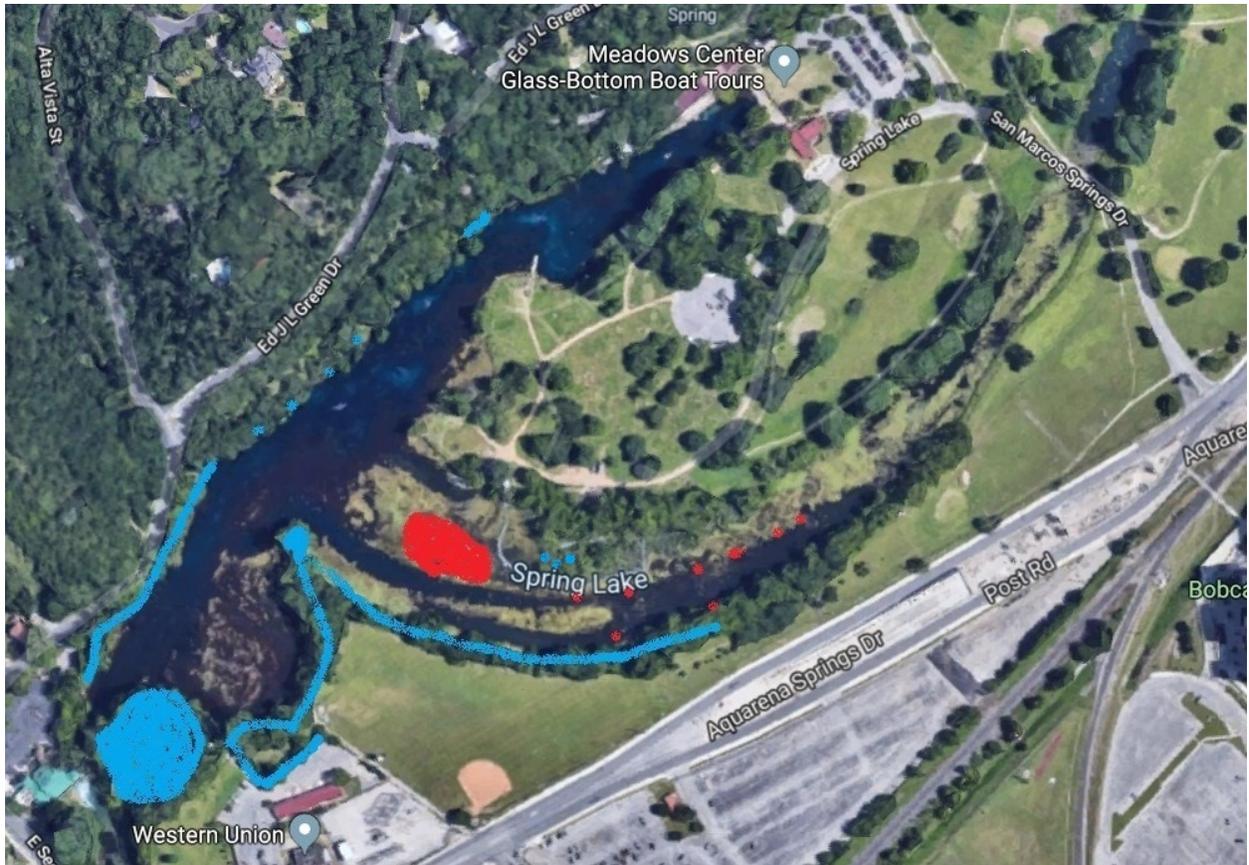
Figure 7. Remaining San Marcos River headwater areas to be treated after 2019 removal efforts. Red = Elephant Ears, Blue = Chinese Tallow, Chinaberry, Ligustrum, Chinese Privet

All of the littoral areas from Sink Creek to Capes Dam are now under control in regard to littoral invasive, exotic plants. The exceptions are still the large stands of Elephant Ears on private property just downstream of IH-35. Otherwise, the public and semi-public lands along Sink Creek, Spring Lake, and the San Marcos River, are all in good shape. All of the Elephant Ears that could be found in Spring Lake and the spillway island have now been treated. Water Hyacinth removal was stepped up in 2019, and they were narrowed down to a few small stands and a large mat in Sink Creek at and near the Wetland Boardwalk area. A portion of this mat has been treated as well. Mop up activities are becoming shorter and shorter, allowing for new areas to be attended to.
