BIO-WEST, Inc.
1812 Central Commerce Court
Round Rock, Texas 78664

MEMORANDUM

SUBJECT: **ITEM M NET DISTURBANCE AND INCIDENTAL TAKE
ASSESSMENT FOR 2020 EARIP ITP ANNUAL REPORT**

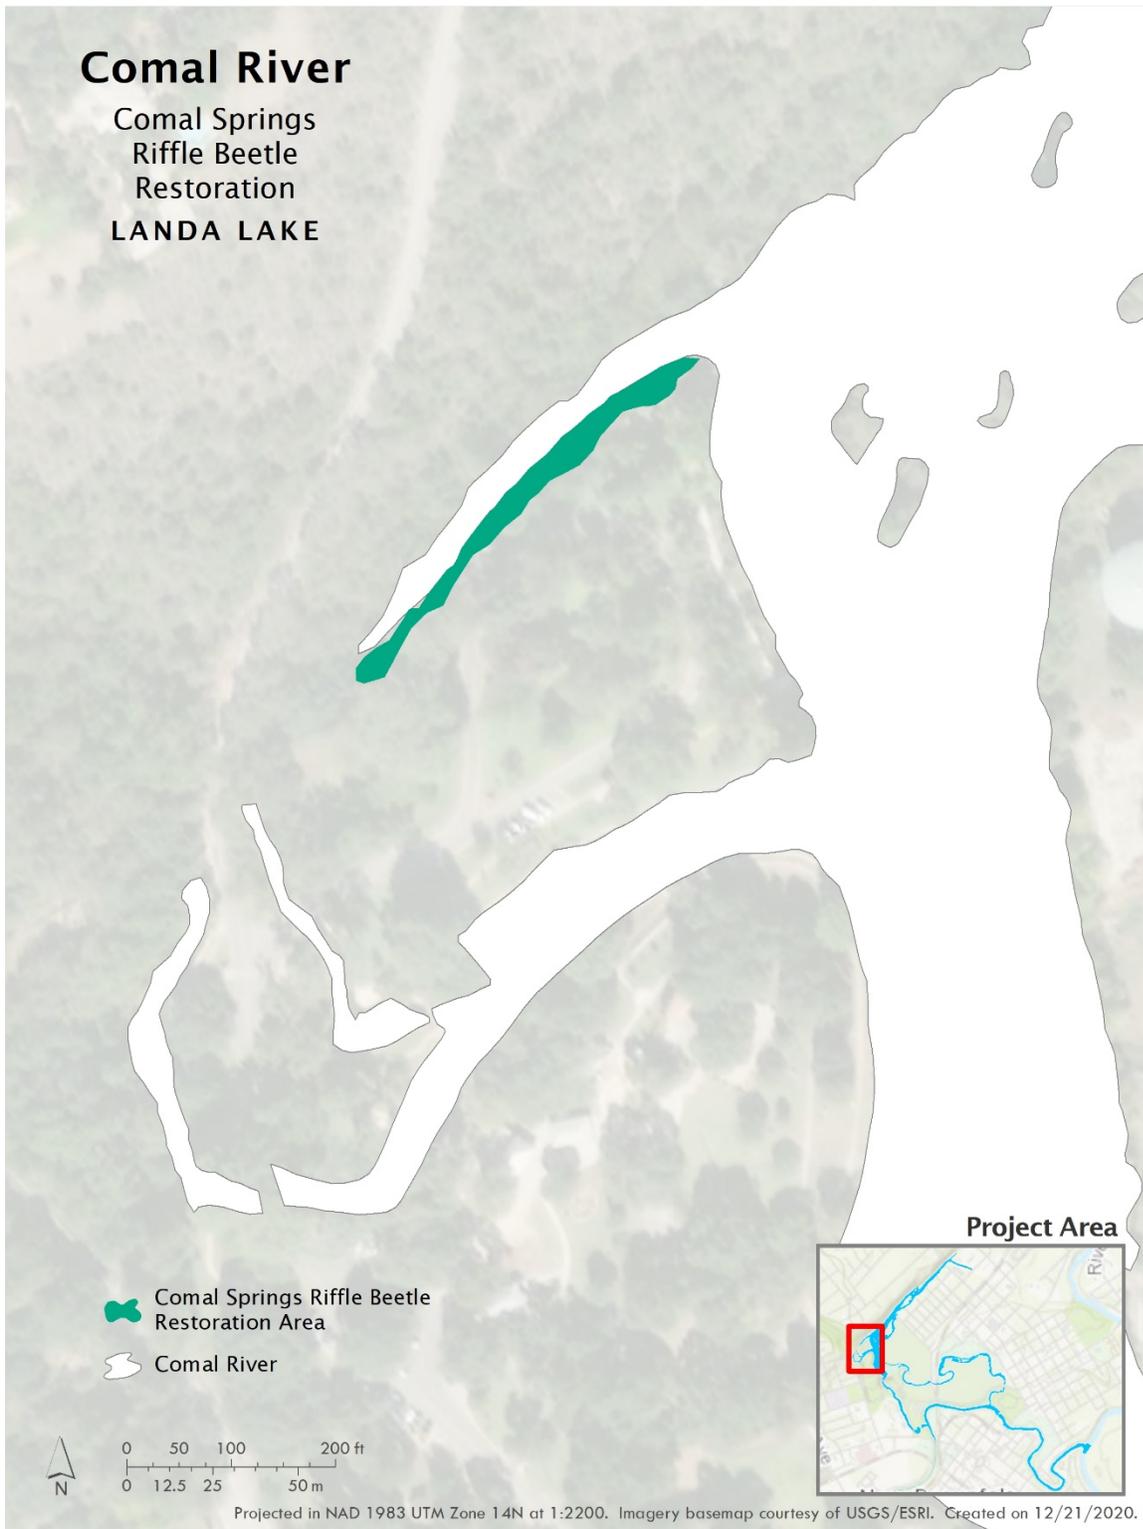
Figure 2. Comal Springs Riffle Beetle Restoration project – Comal System.

The **Gill parasite** project was reduced to one-time water sampling at designated cross sections in 2020 via kayak and thus no impacts were noted for this activity. The **Riffle beetle restoration** project involved only on shore activities in 2020 (Figure 2). The project footprint occurred on the bank adjacent to Spring Run 3 where restoration consisted of planting native vegetation as a buffer between the park sidewalk and the spring run edge. The **Non-native animal species removal** project had a change of contractors in 2019 to Atlas Environmental who continued these duties in 2020. There is no project footprint map per their methodologies as it is now conducted throughout Landa Lake and the Comal River without permanent or temporary installation of equipment. Most all work was conducted via snorkel or SCUBA in areas of high fish density with non-native fish being speared. **Riparian restoration** was initiated in the upper Spring Run and continued around Landa Lake in 2020 and involved a project footprint of 7,947 m². The riparian treatment areas are depicted on Figure 3 and quantified in Table 2. Similar to the more established HCP riparian restoration project in the San Marcos system, all activities were conducted on the banks and water's edge and did not overlap with any occupied habitat for the covered species.
