Appendix H | **2021 City of New Braunfels Reports**

H1 | **Native Aquatic Vegetation Restoration in the Comal River System**

2021 Native Aquatic Vegetation Restoration and Maintenance in the Comal River

November 10, 2021

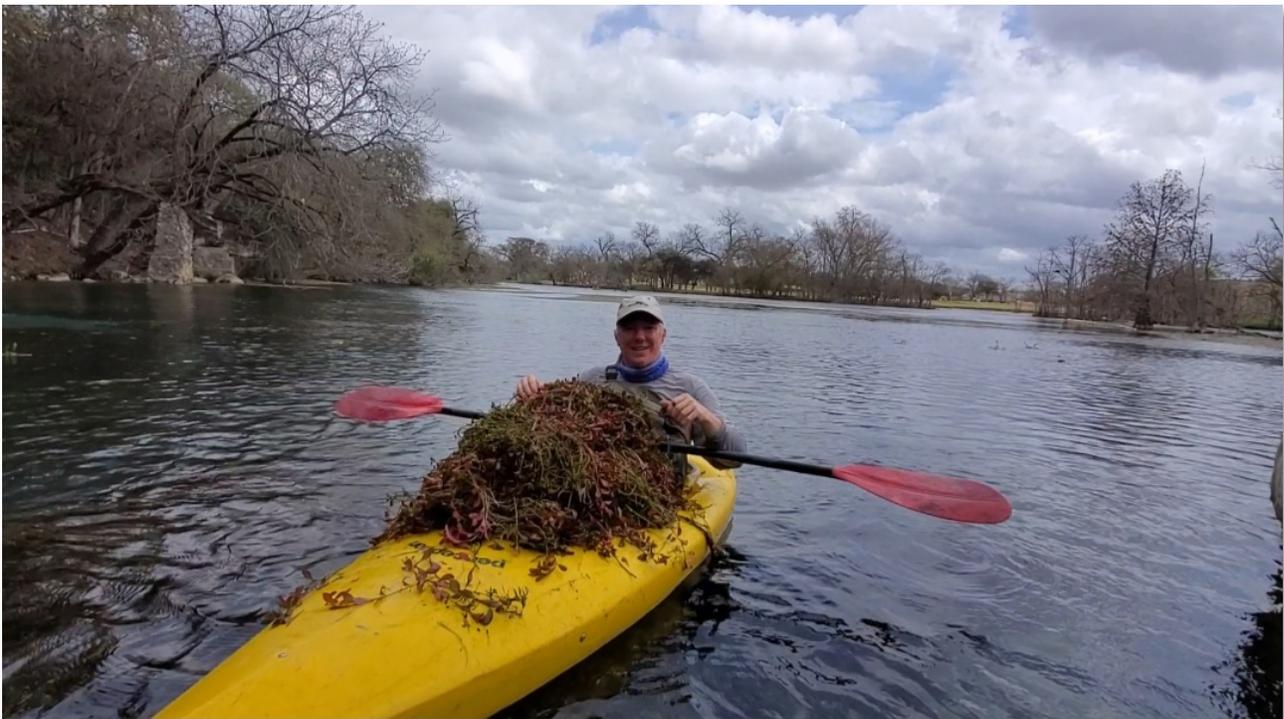
Figure 4 Collecting Ludwigia trimmings from overgrown colonies for planting elsewhere in Landa Lake.

stands in Landa Lake. Trimming provides sprigs for supplemental plantings as well as propagative material for MUPPTs, while also promoting persistence of individual patches by reducing the top growth of the Ludwigia plants and in turn lessening buoyancy of the patches (**Figure 4**). Ludwigia stands that have a high degree of top growth, sometimes extending three to four feet into the water column, tend to be uprooted by water currents over time. Therefore, removal of top growth aids in persistence of these patches.

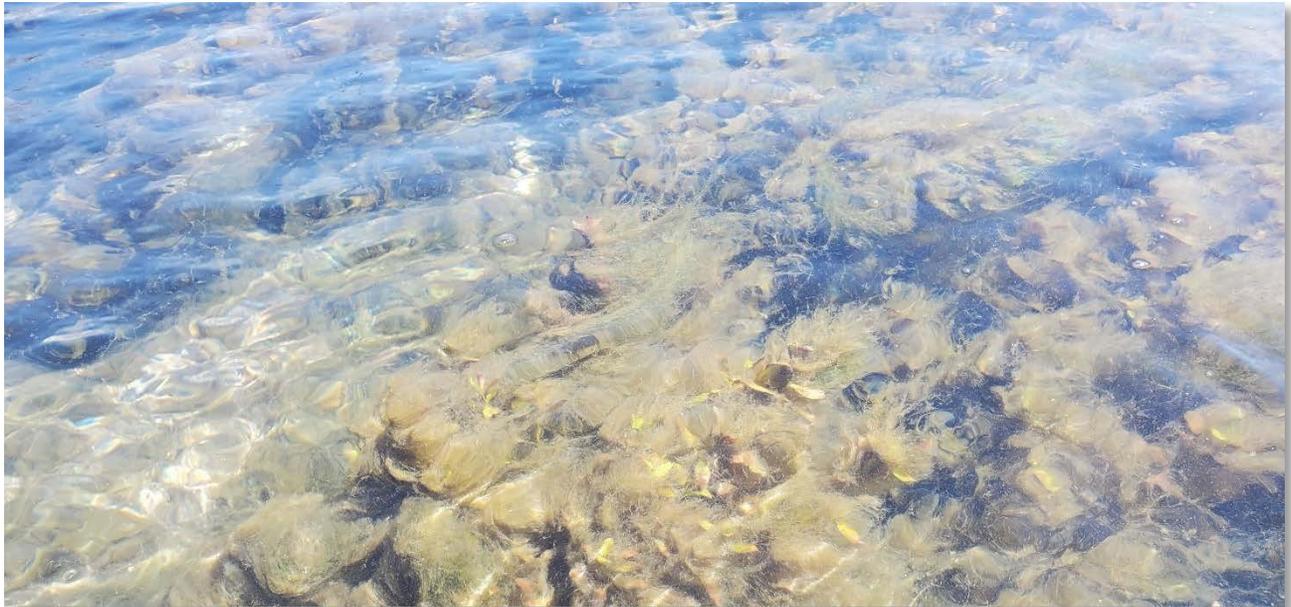
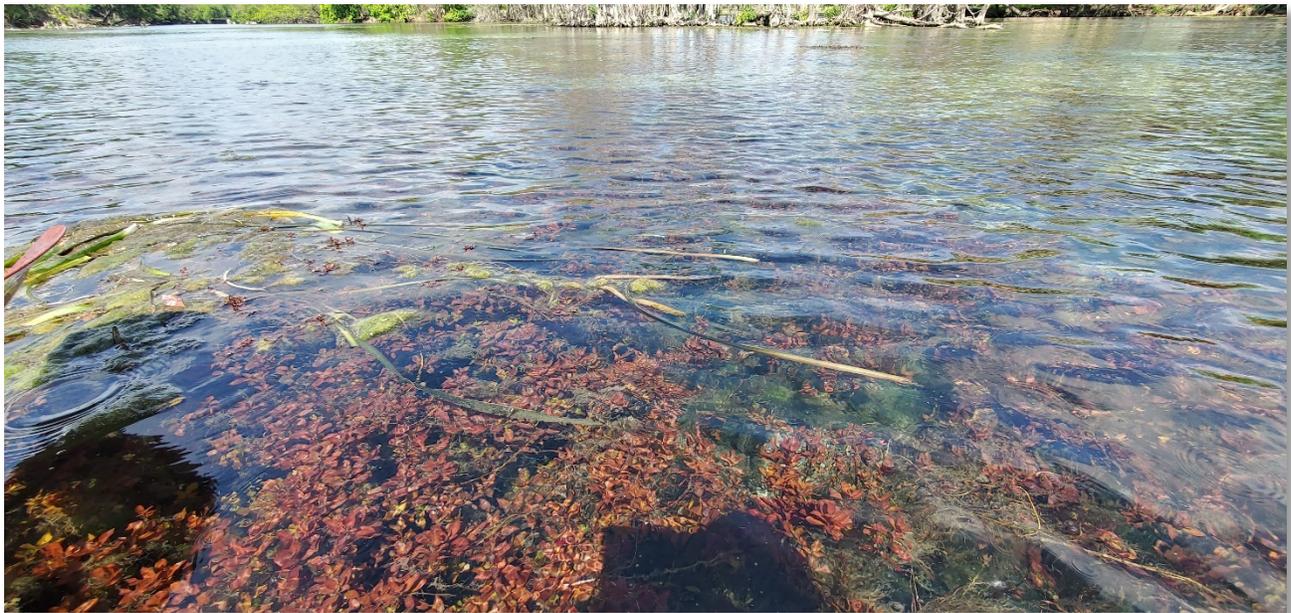
Figure 10 The blue green algae *Phormidium amoenum* and green algae *Scenedesmus acutus* were growing densely on Ludwigia in Landa Lake throughout the winter and into spring (top). The algae was so thick that Ludwigia health was in decline. By May, the algae disappeared almost completely (bottom).

A noteworthy observation from this reach includes the persistence of winter and spring epiphytic algae. The algae reached problematic levels in December. Its growth began smothering most Ludwigia patches throughout the winter and into late spring (**Figure 10**). Attempts to dislodge the algae from Ludwigia patches were ineffective as it would return quickly. Algae persistence contributed to a notable decline in plant health as the enveloped Ludwigia began looking chlorotic and proceeded to lose leaves. In April, algae samples were taken at various locations and sent to algae taxonomists at EnviroScience Inc. (Stow, OH) for expert determination. The green algae *Scenedesmus acutus* and blue-green algae *Phormidium amoenum* were determined to be the major component of the epiphytic algae masses growing on Ludwigia patches in the Three Islands area and upper Landa Lake. By mid-May, epiphytic algae began to rapidly decline in thickness allowing Ludwigia patches time to recover and begin their spring expansion. It will be important to monitor

this invasive algae in the upcoming winter and spring time periods to see if this pattern of rapid growth, smothering and then sudden decline is again experienced in 2022.

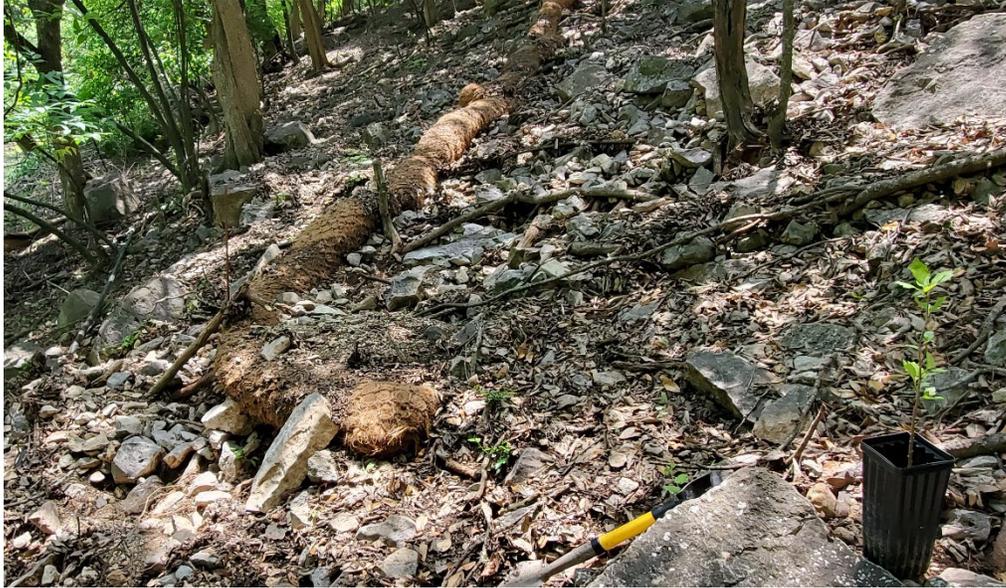
Figure 1 Coir log showing a buildup of debris behind the capture device.

Overall, the area continues to fill in nicely with plants and density of plants increasing. The biggest issue this year was sediment accumulation from several large rainfall events. Stormwater runoff from large storms (>2") causes sediment catchment structures installed along the hillslope adjacent to Spring Run #3 to accumulate sediment to their full capacity. Although the logs stayed in place the sediment load proved to be too much in rainfall events of 2" or more. During larger storms it was observed that sediment made it down to Spring Run #3, filled in around some of the spring openings. It is recommended that gabion baskets filled with mulch are placed in strategic areas to help create sediment control structures that can handle sediment volume from large storms and help filter the water.

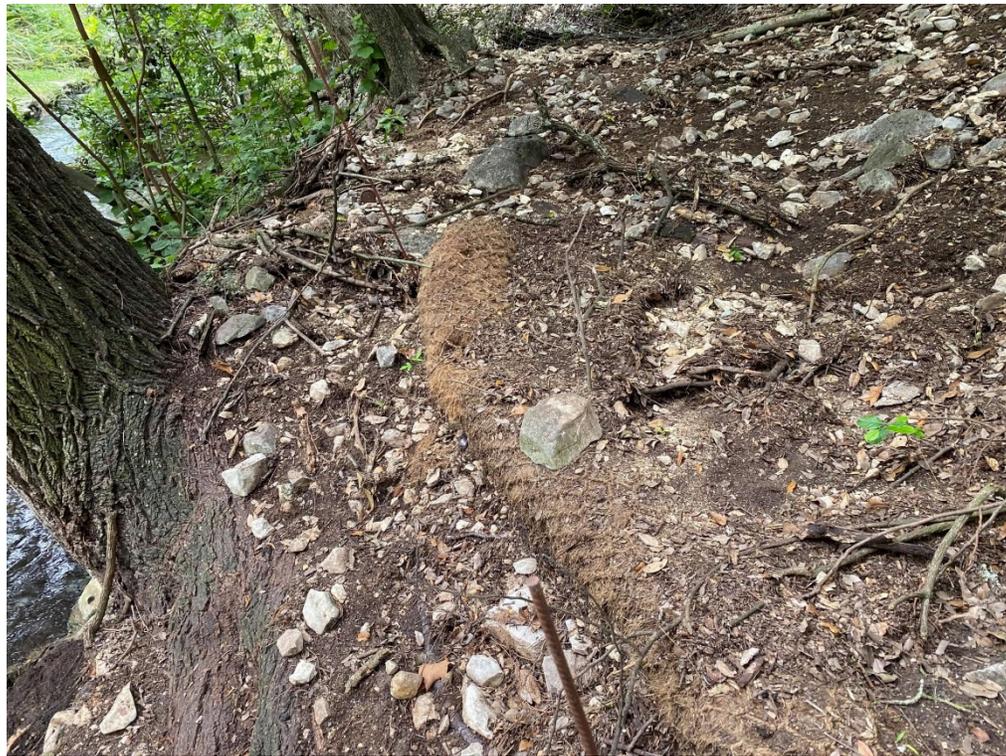
Figure 2 Sediment captured by coir log. This shows how overwhelmed with sediment the coir logs can become after a heavy rainfall.

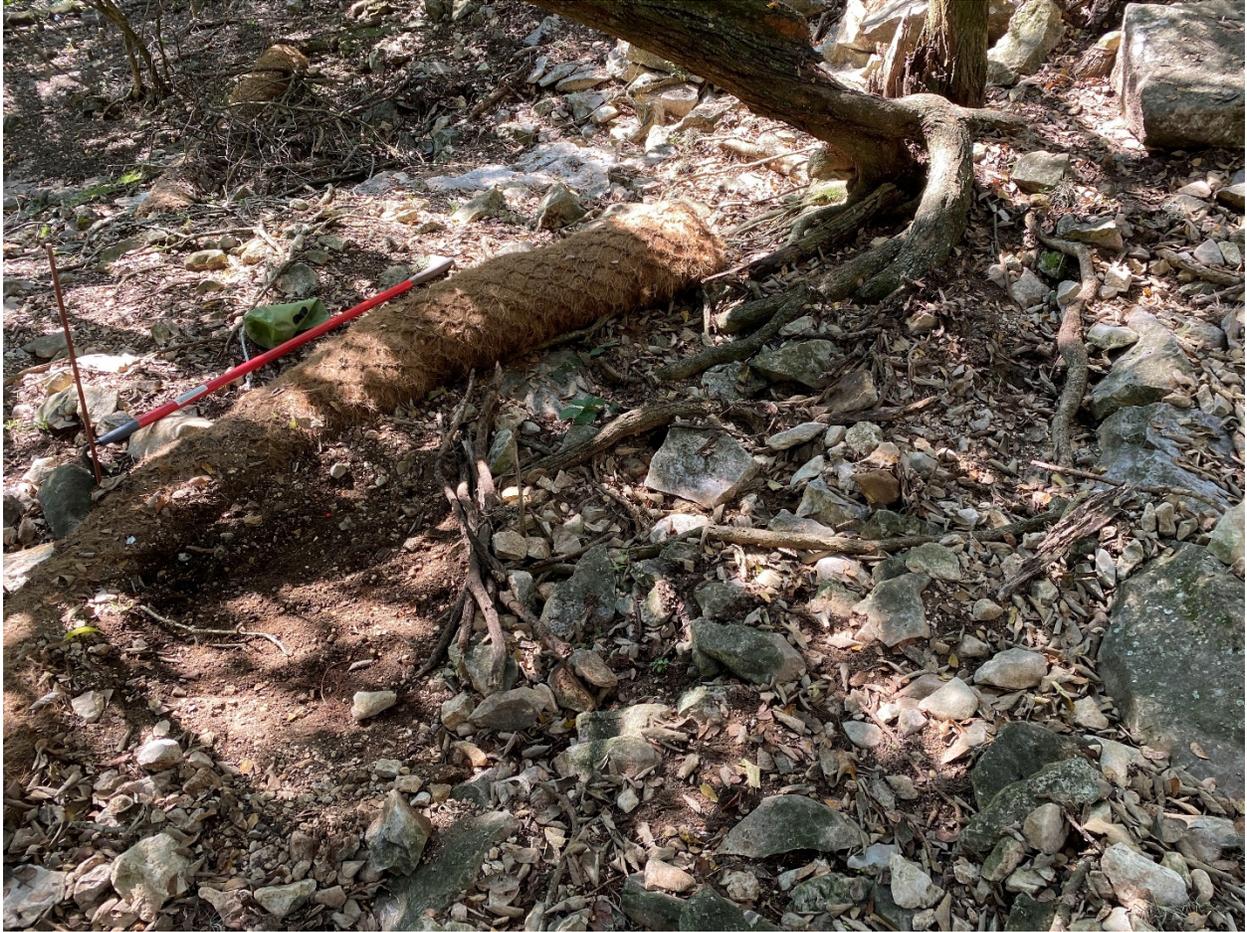
Figure 3 Sediment removed from behind log to allow for more sediment to be captured.

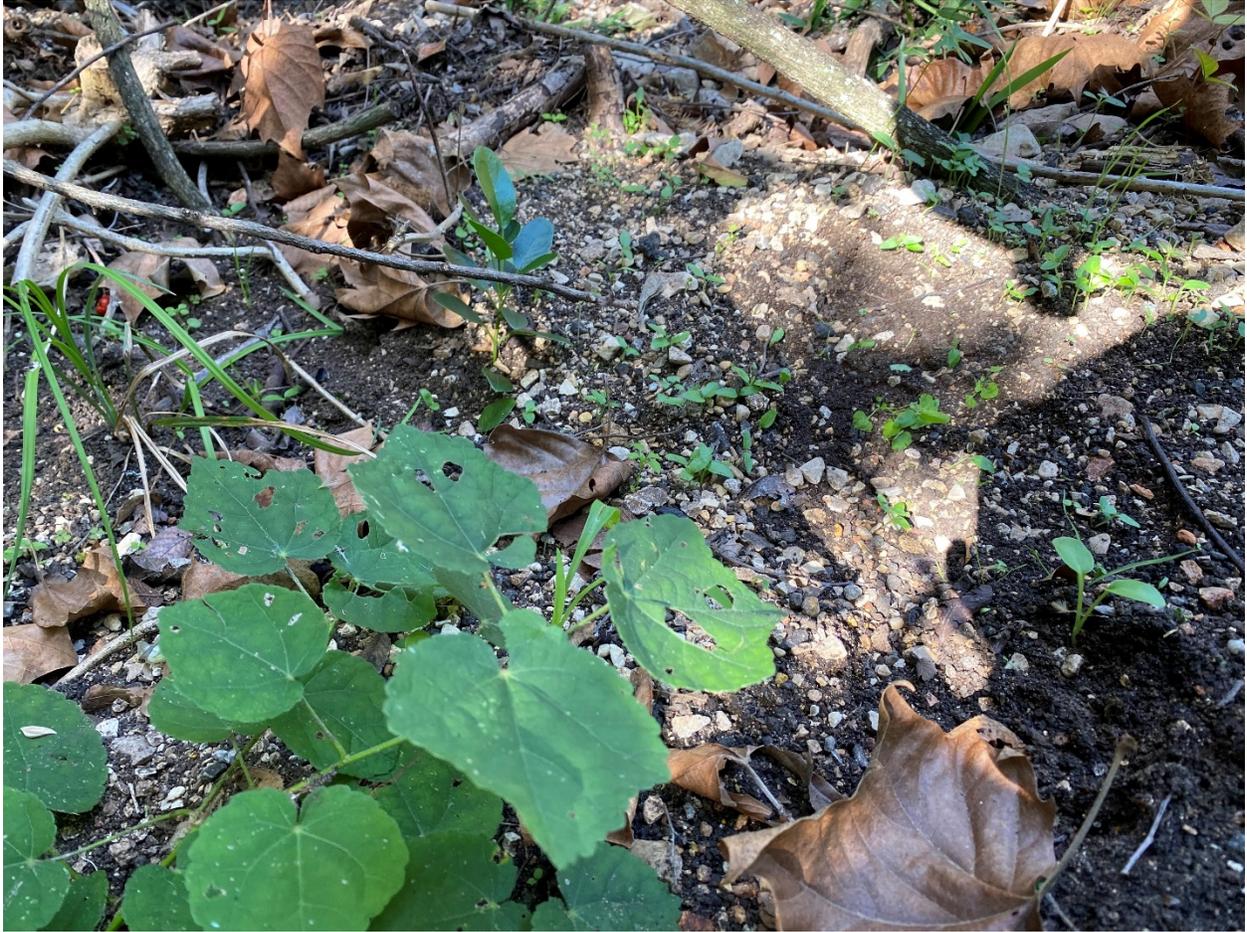
Figure 6 Vegetation cover is slowly expanding along the hill side adjacent to spring run #3. As more sediment is captured along the hillside the opportunity for more vegetation to establish increases. Better sediment capture devices will help speed this along.

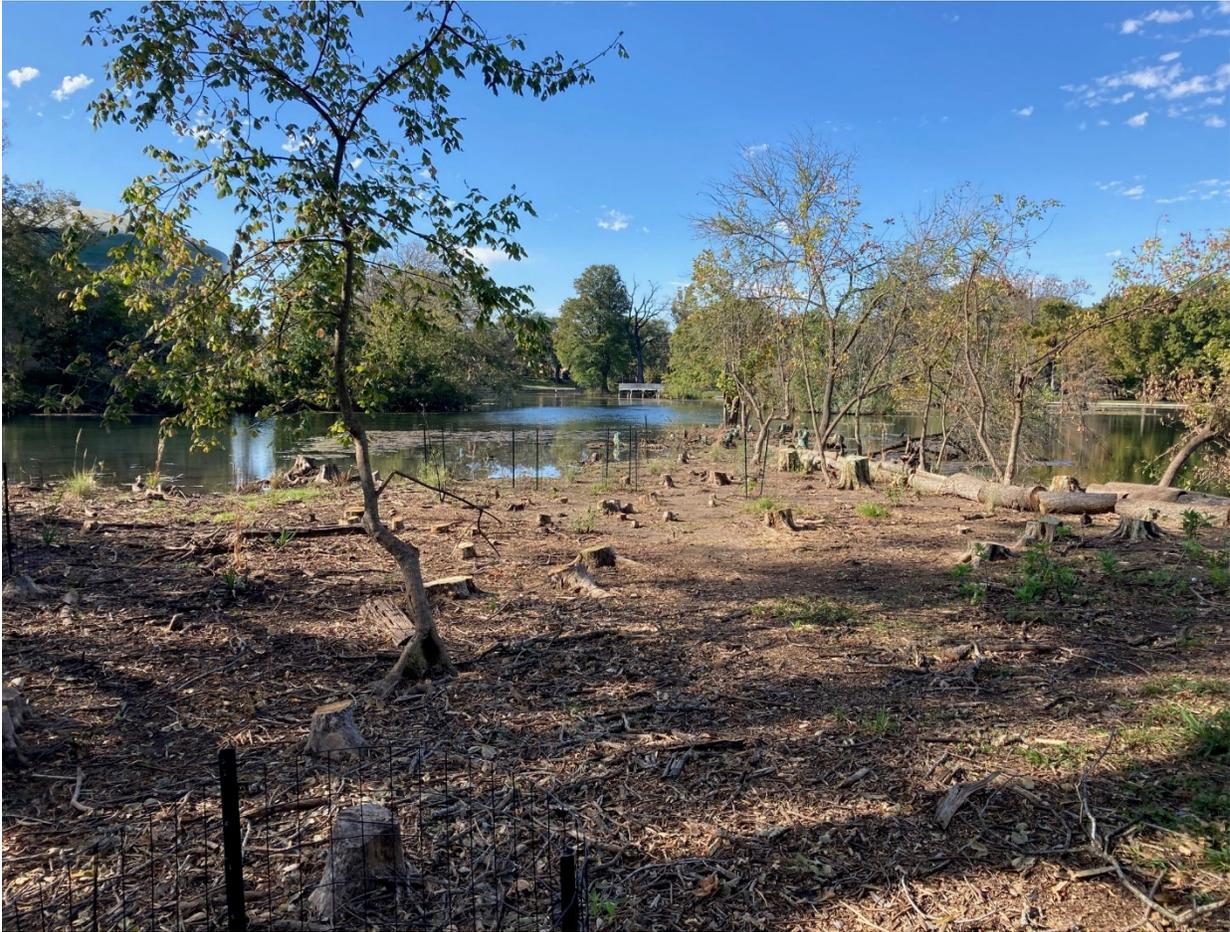
Photo 1. Photo of the southern portion of Pecan Island along Landa Lake where extensive removal of non-native vegetation (primarily Chinese tallow and Ligustrum) occurred in 2021. Note the number of tree stumps shown in the photo which are the remnant of removed non-native trees. The Pecan Island was previously dominated by non-native trees.

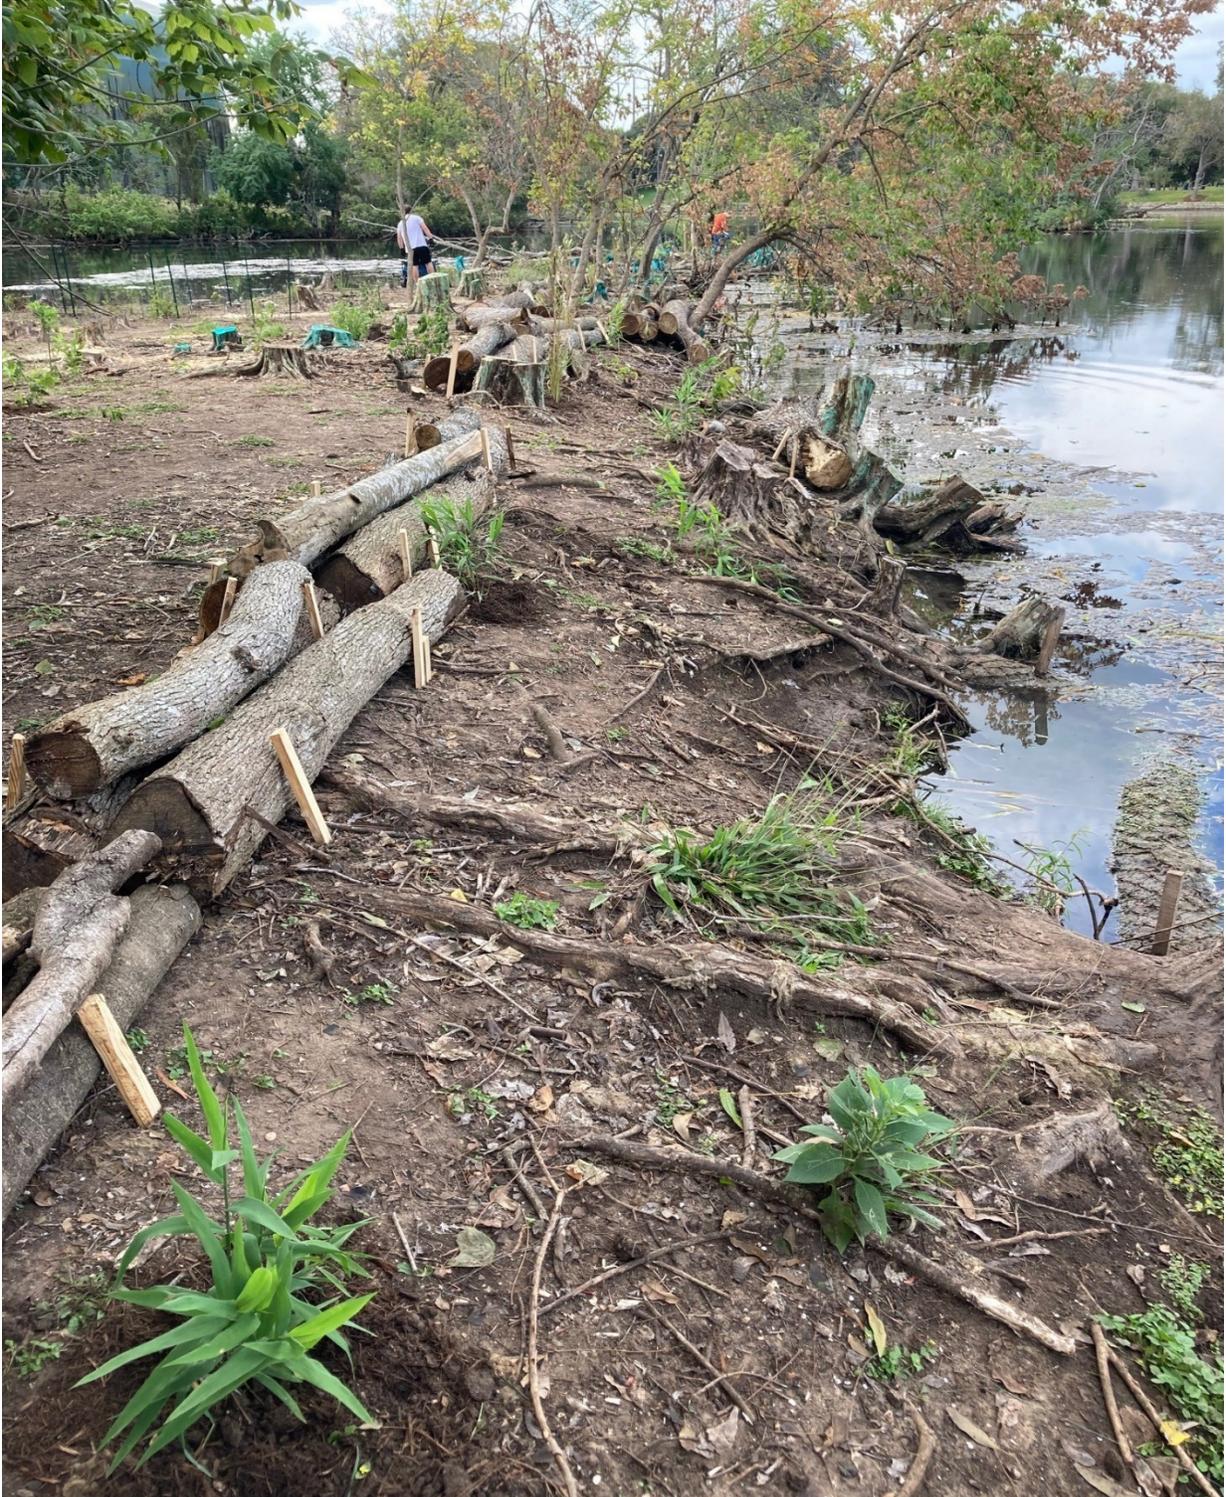
Photo 2. Photo of the southern portion of Pecan Island showing erosion/ sediment control berms and native plantings in the area where non-native trees were removed. The sediment control berms were constructed using trunks and slash from removed non-native trees.

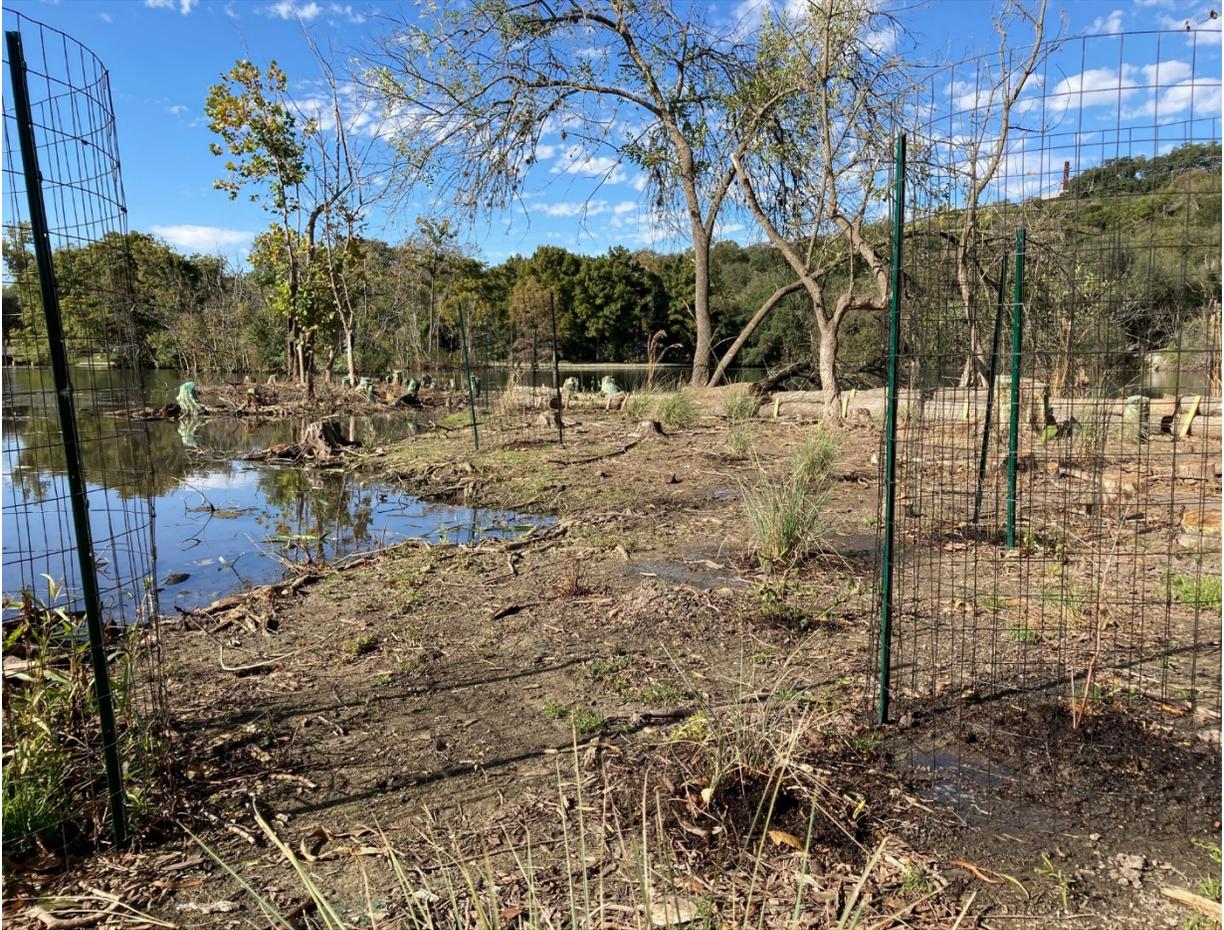
Photo 3. Photo of Pecan Island area showing the area where non-native trees were removed and native plants were planted. Wire cages were utilized to protect planted tree saplings.

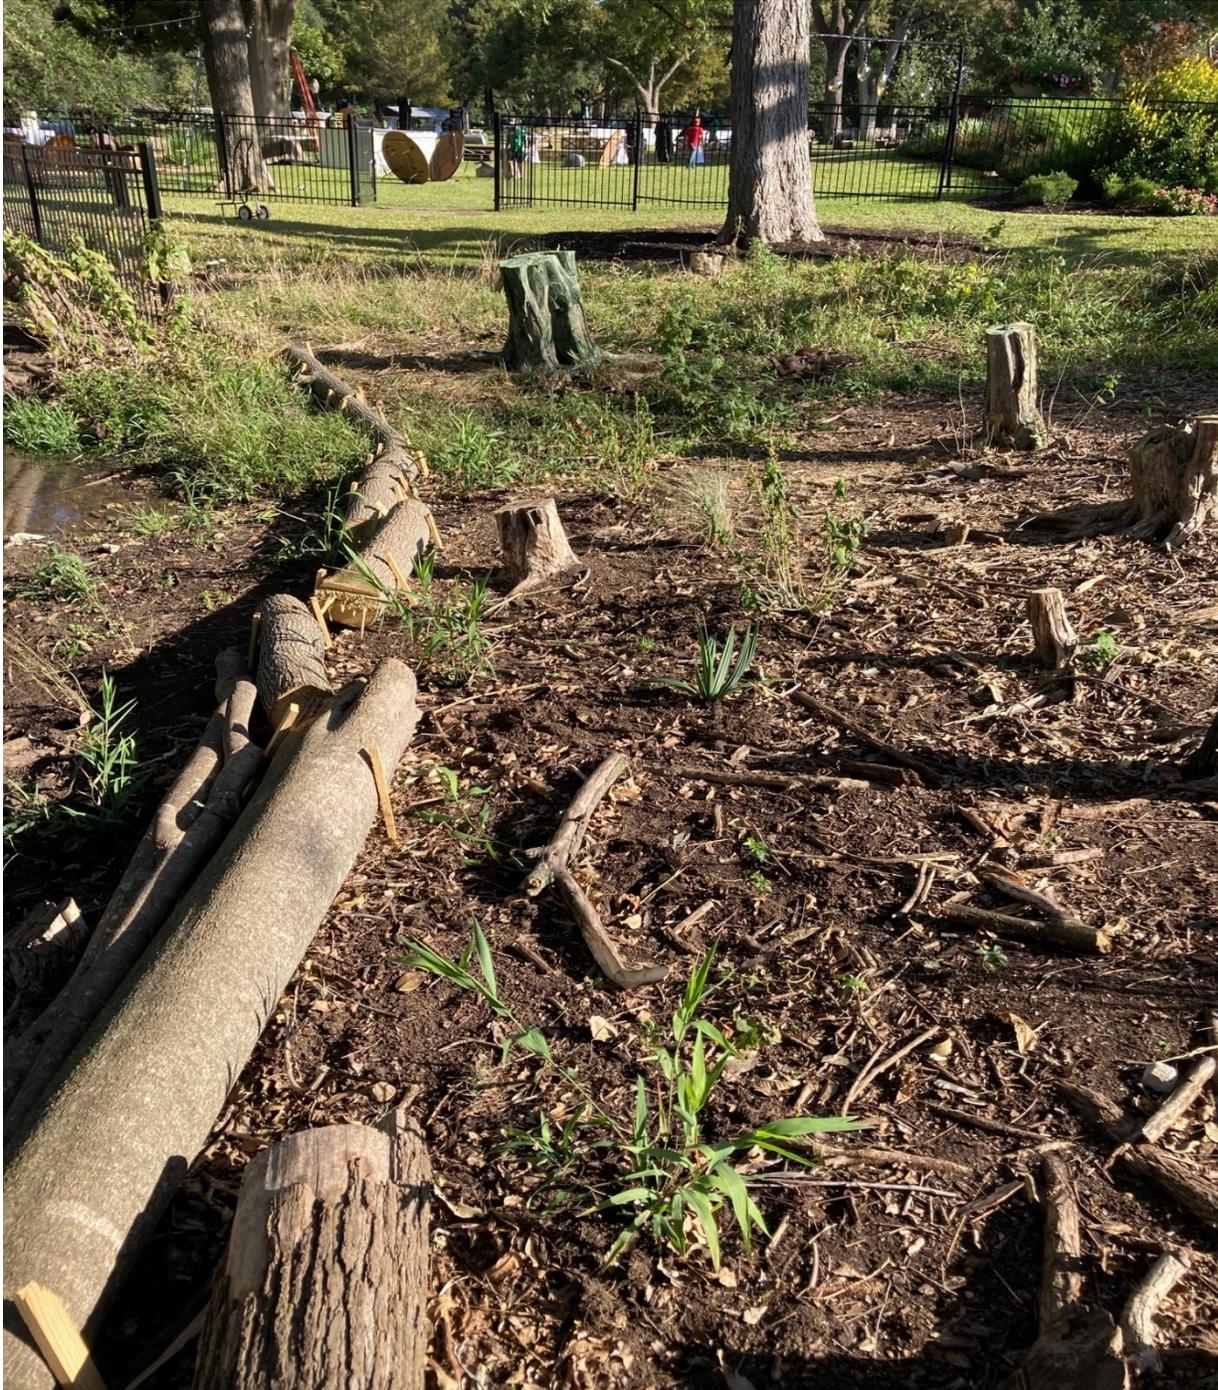
Photo 4. Photo showing riparian zone along Landa Lake near the dead end of Elizabeth Ave where non-native vegetation removal and native planting occurred in 2021.

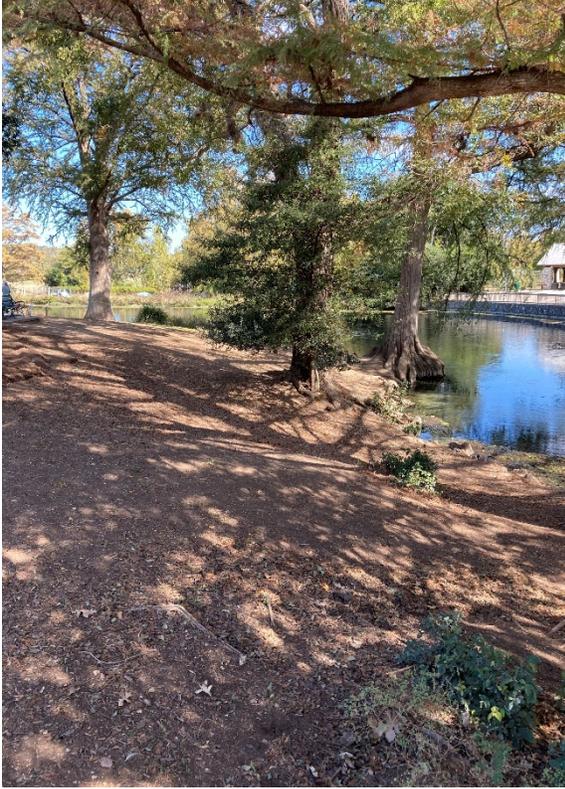
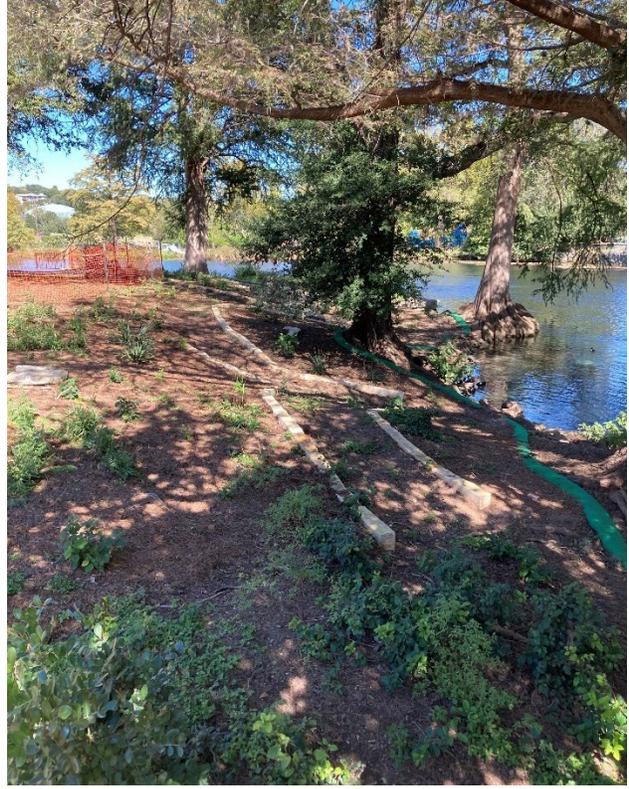
Photos 5 & 6. Riparian zone along Landa Lake near the outflow into the Mill Race of the Comal River near the Landa Park Train Depot. The photo on the left shows the riparian zone prior to restoration in late 2020. The photo to the right was taken in Oct 2021. The initial restoration of this area occurred in late 2020 with supplemental planting occurring in 2021.

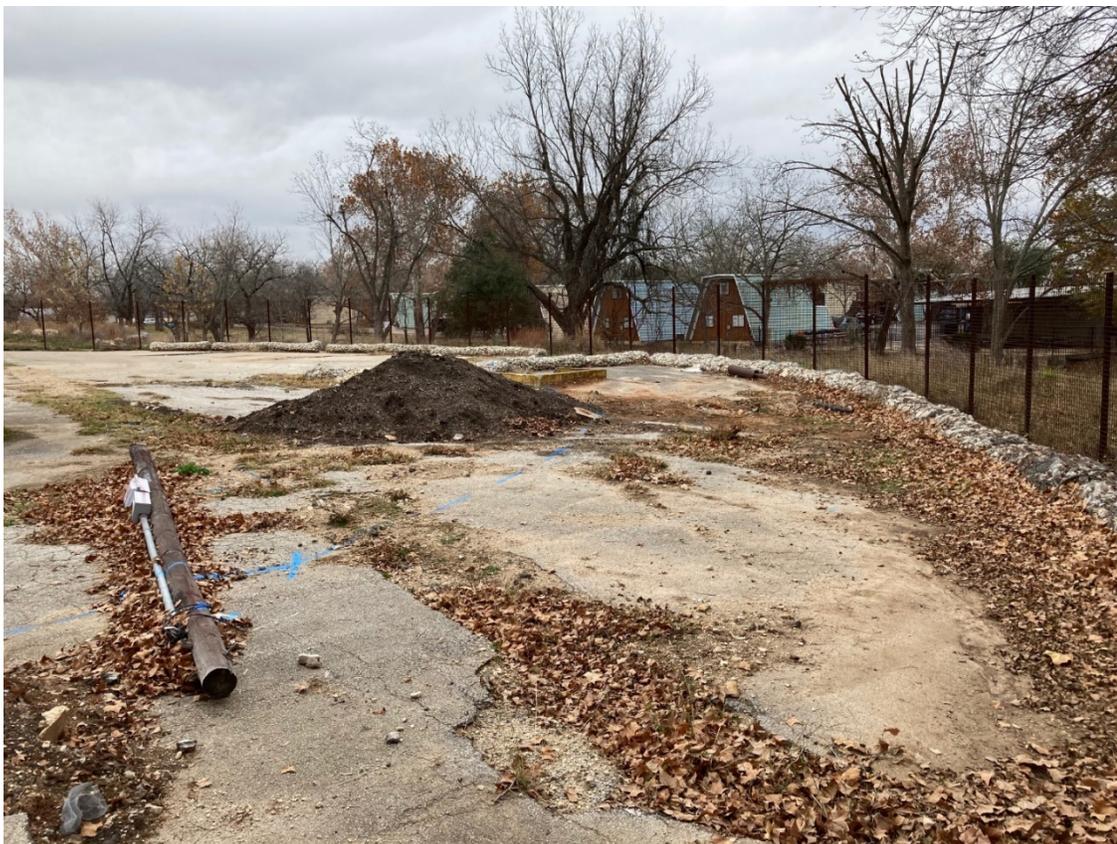
Photo 1. Project area within the NBU Well Yard at the Headwaters at the Comal prior to construction of the bioretention basin

- **Construction of a bioretention basin at the Headwaters at the Comal:** This bioretention basin captures and treats stormwater runoff from existing impervious cover within the NBU well yard area prior to discharging to the Upper Spring Run of Landa Lake. The project included the removal of existing asphalt and installation of a 2,600 ft² vegetated bioretention basin with underdrain system and outfall. The basin has a total capture volume of approximately 1911 ft³ and is designed to reduce total suspended solid (TSS) loading to Landa Lake by approximately 350-400 lbs/ year. Construction of the basin was completed in February 2021. NBU/ Headwaters at the Comal will assume the responsibility for maintenance of the basin upon completion. **Photos 1 & 2** show the project prior to and following construction.

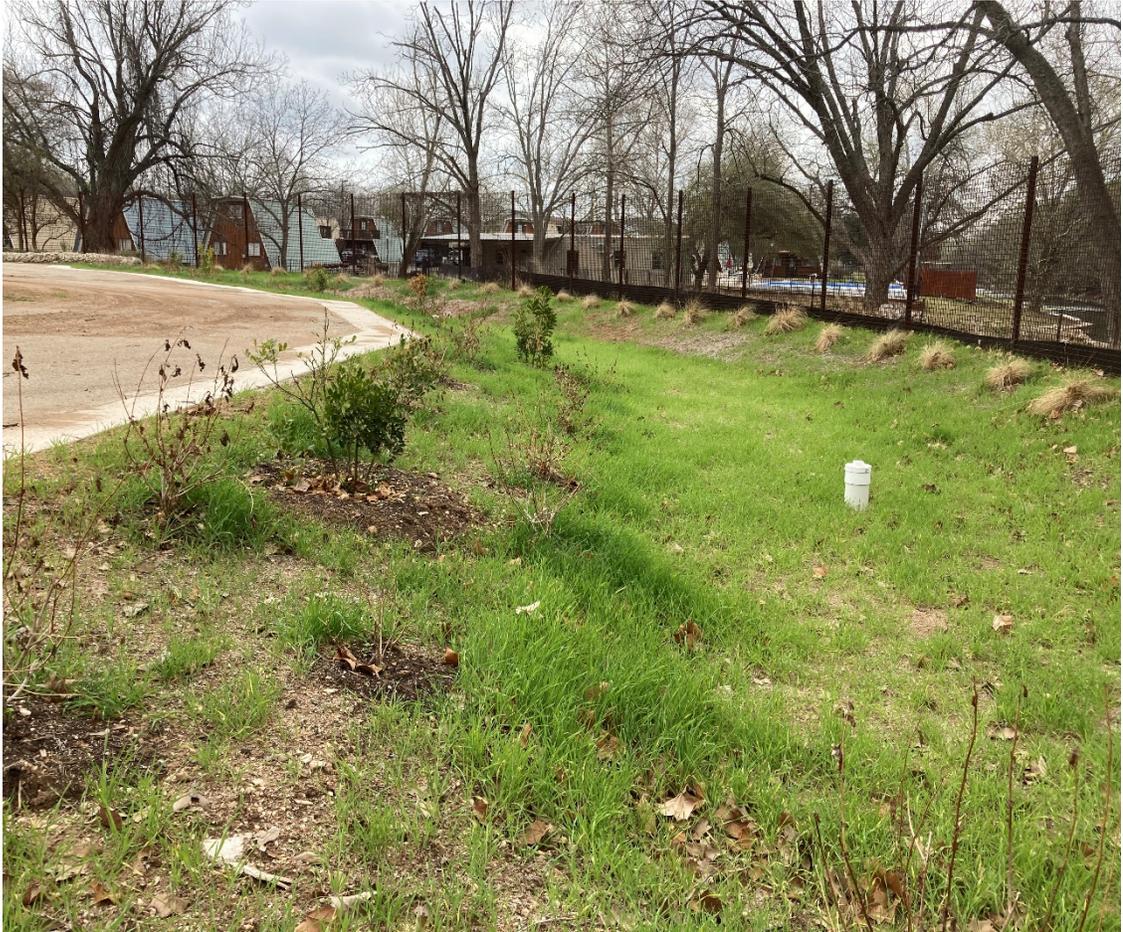
Photo 2. Photo of the completed bioretention basin at the NBU Well Yard at the Headwaters at the Comal

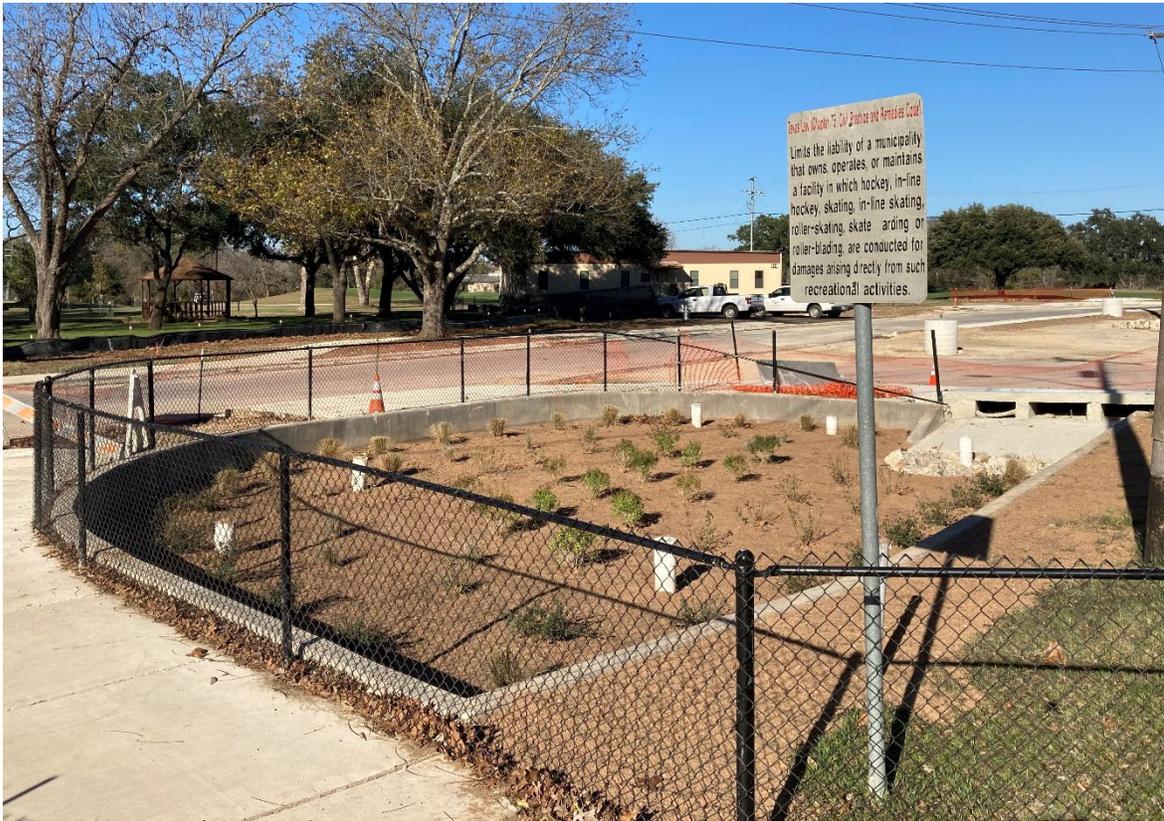
Photo 3. Photo of the completed bioretention basin at the intersection of Landa Park Dr and Elizabeth Ave

- **Construction of a bioretention basin at the corner of Elizabeth Ave and Landa Park Drive:** The bioretention basin captures and treats stormwater runoff from an impervious street segment (Elizabeth Ave) and parking lot prior to discharging to the Mill Race of the Comal River. Construction was completed in late 2021. The project included the removal of existing asphalt and installation of a 1,300 ft² vegetated bioretention basin with underdrain system and outfall. The basin has a total capture volume of approximately 1,722 ft³ and is designed to reduce TSS loading to Landa Lake by approximately 365 lbs/ year. CoNB will assume the responsibility for maintenance of the basin in the future to ensure that it remains functional. **Photo 3** shows the completed bioretention basin.
