MEMORANDUM

TO: Chad Furl, Jamie Childers
 FROM: Ed Oborny (BIO-WEST)
 DATE: **September 30, 2022**
 SUBJECT: EAHCP Critical Period Habitat Evaluation – 85 cfs – San Marcos System

SAN MARCOS SYSTEM: **85 cfs Habitat Evaluation**

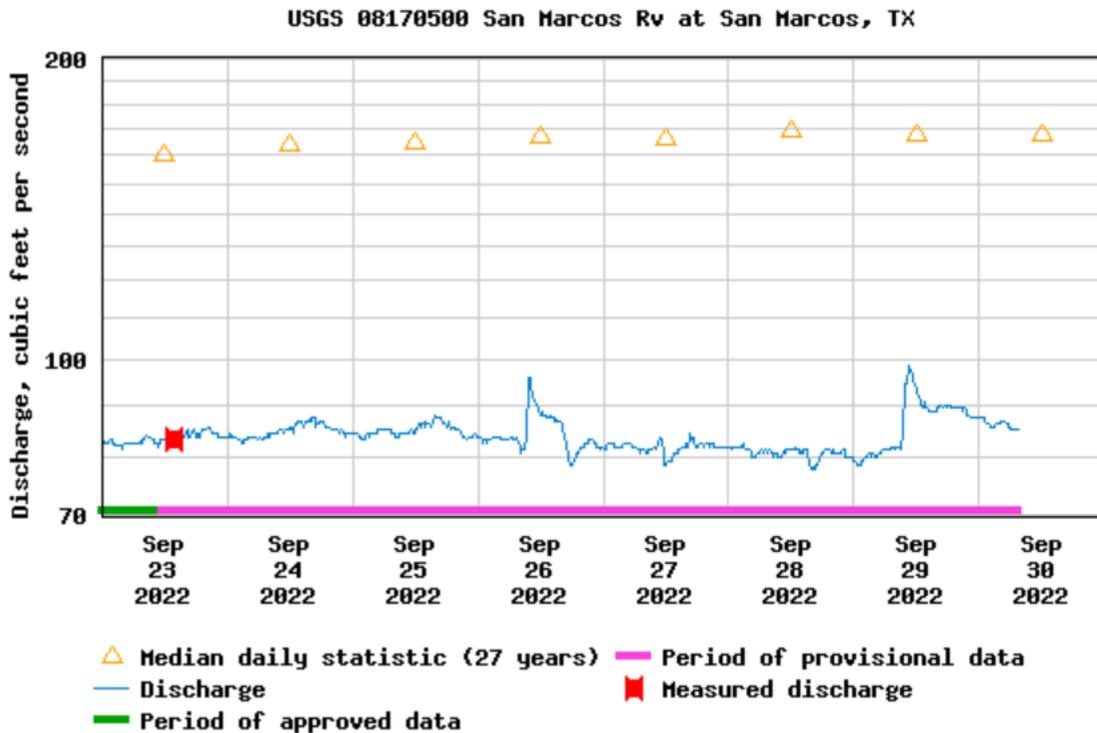
Figure 1. Total San Marcos River discharge over the past two weeks (USGS 08170500 at San Marcos, Texas).

As total system discharge continued to decline in September, the 85 cfs Habitat Evaluation was triggered. The 95 cfs Habitat Evaluation was completed on July 27th; the 90 cfs evaluation was completed on August 19th; and the 85 cfs evaluation was conducted on September 28th. Per requirement, the next habitat evaluation is scheduled for 80 cfs. As of this memorandum, the total system discharge in the San Marcos River is approximately 85 cfs (Figure 1).

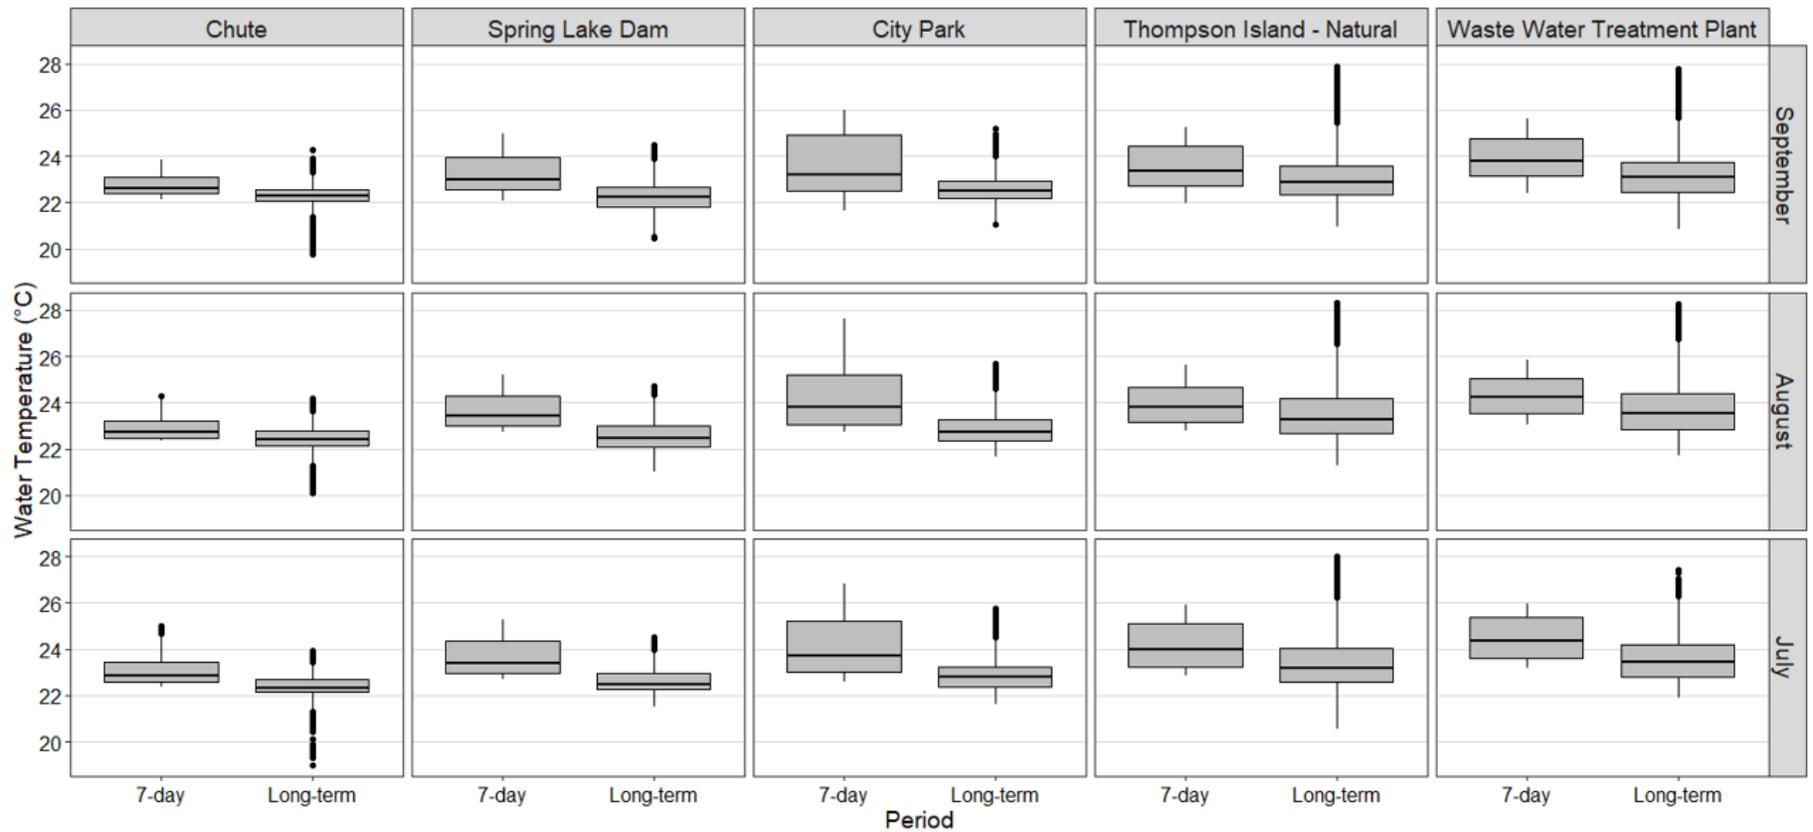
Figure 2. Boxplots comparing recent 7-day and long-term water temperature trends at five monitoring stations from the Chute (Spring Lake Dam western spillway) to the Waste Water Treatment Plant for the month of September. August and July results are also included for comparison. The thick horizontal line in each box is the median and the upper/lower bounds of each box represents the interquartile range. Whiskers represent minimum/maximum values up to 1.5 times the interquartile range, and outliers beyond this are designated with solid black circles.

Water temperature is a key component system-wide as it is an underlying driver of spring-related aquatic assemblages. Recent 7-day trends in water temperature (°C) for September Critical Period sampling were assessed using temperature data loggers (HOBO Tidbit v2 Temp Loggers) at 5 permanent monitoring stations in the upper San Marcos River. Data for each monitoring station are based on 10-minute intervals and dates for recent trends extended from the last day that each data logger was downloaded to 7 days prior. For all stations, 7-day trends were examined from September 9 – 15. Recent 7-day trends were compared to long-term water temperature data measured at 4-hour intervals in September from 2001 – 2021 or to the greatest temporal extent available. For analysis, 7-day trends were compared to long-term trends using boxplots to visualize differences in central tendency (i.e., median) and variation (e.g., interquartile range). Boxplots from August and July Critical Period 2022 sampling were also included for comparison. Similar to previous months, no water temperatures are noted as a concern at stations longitudinally down the San Marcos River at this time (Figure 2).

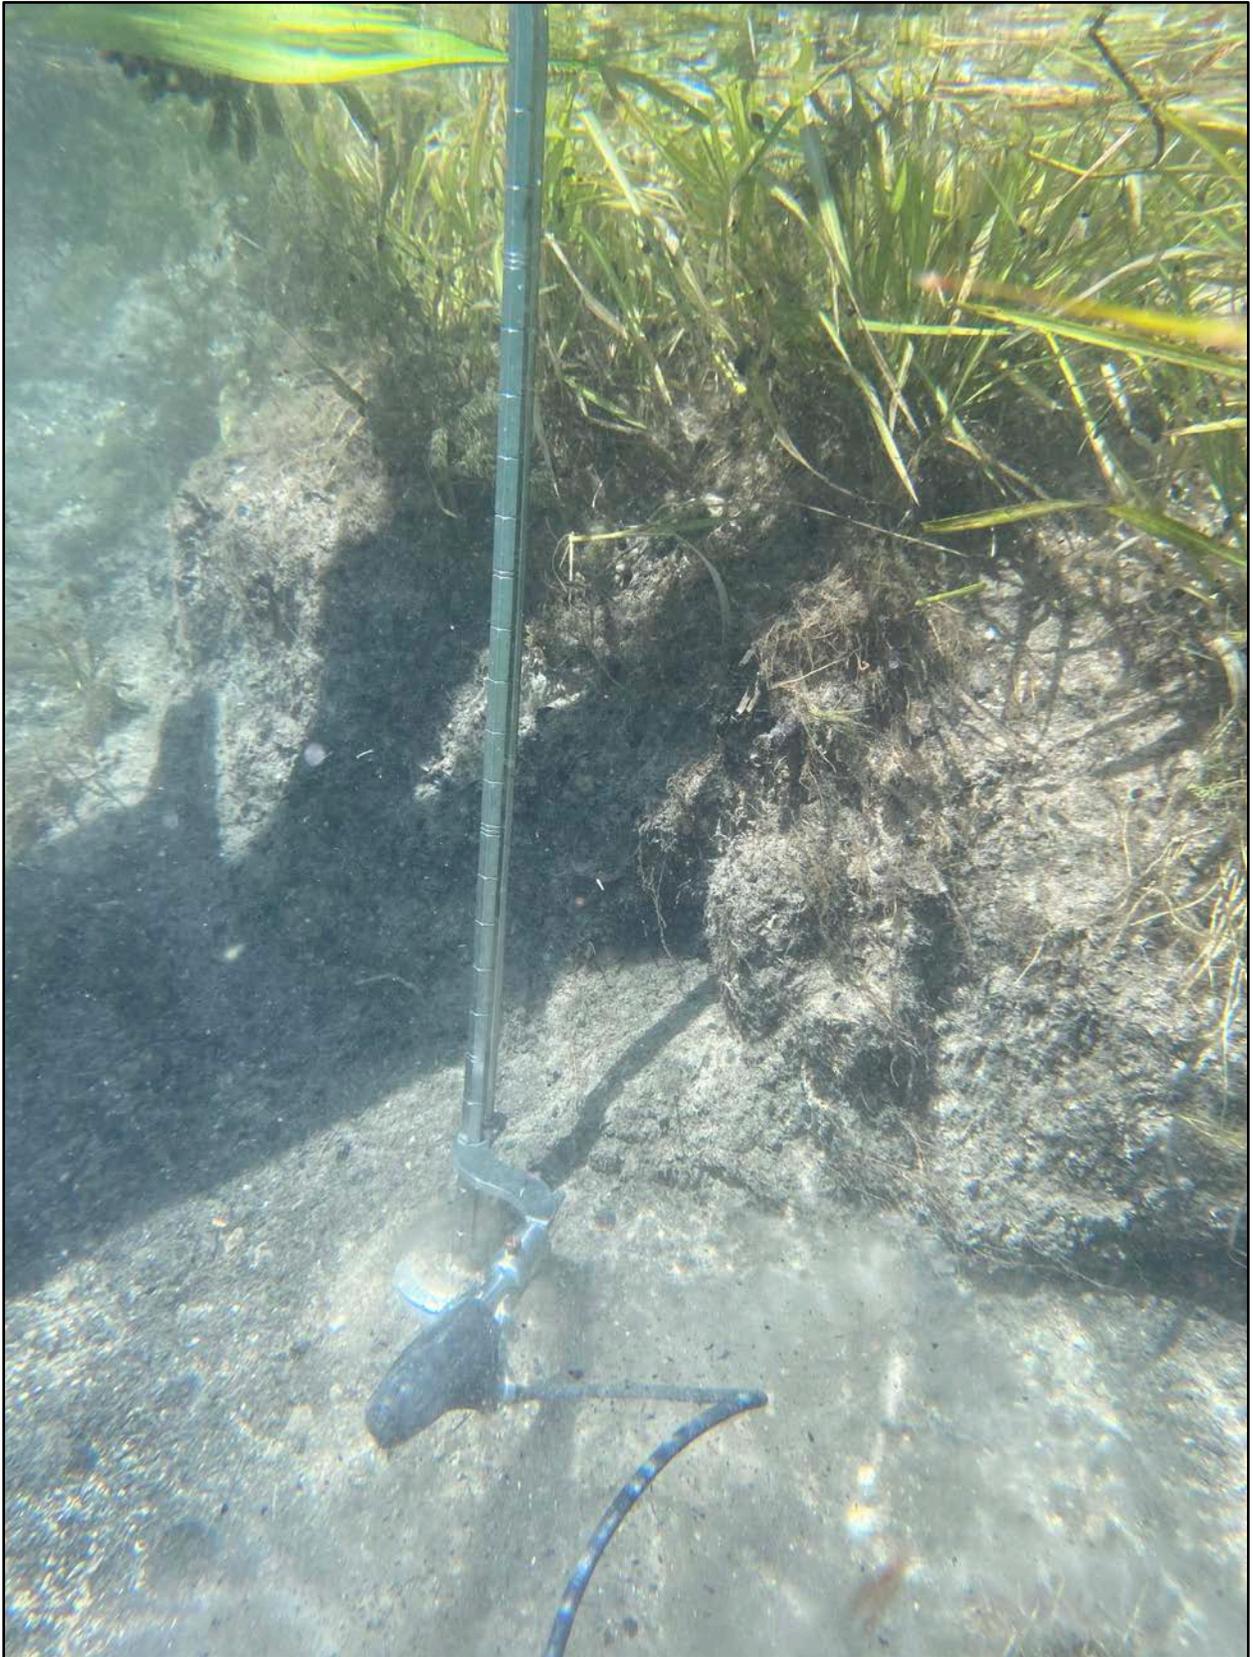
Figure 3: Texas Wild-rice root ball exposure on September 29, 2022.

Aquatic vegetation mapping was conducted in late September as required by Task 3 and to subsequently serve as baseline establishment of the Fall Routine biological monitoring. Each of the three study reaches experienced a continued decline in aquatic vegetation coverage from mid-July to mid-September. This was most notable at the Spring Lake Dam reach (approximately a 16% decline) with lesser declines at the City Park reach (≈2%) and I35 reach (≈8%). Additionally, a Texas Wild-rice vulnerable stand survey was conducted on September 29th. Figure 3 highlights extensive root ball exposure that are presently occurring to Texas Wild-rice in these vulnerable areas. A full Routine Biological Monitoring event (Fall) is scheduled to start next week. To maximize efficiencies while minimizing disturbance during these low-flow conditions, the Fall Routine Event will double as the 85 cfs Critical Period Event.

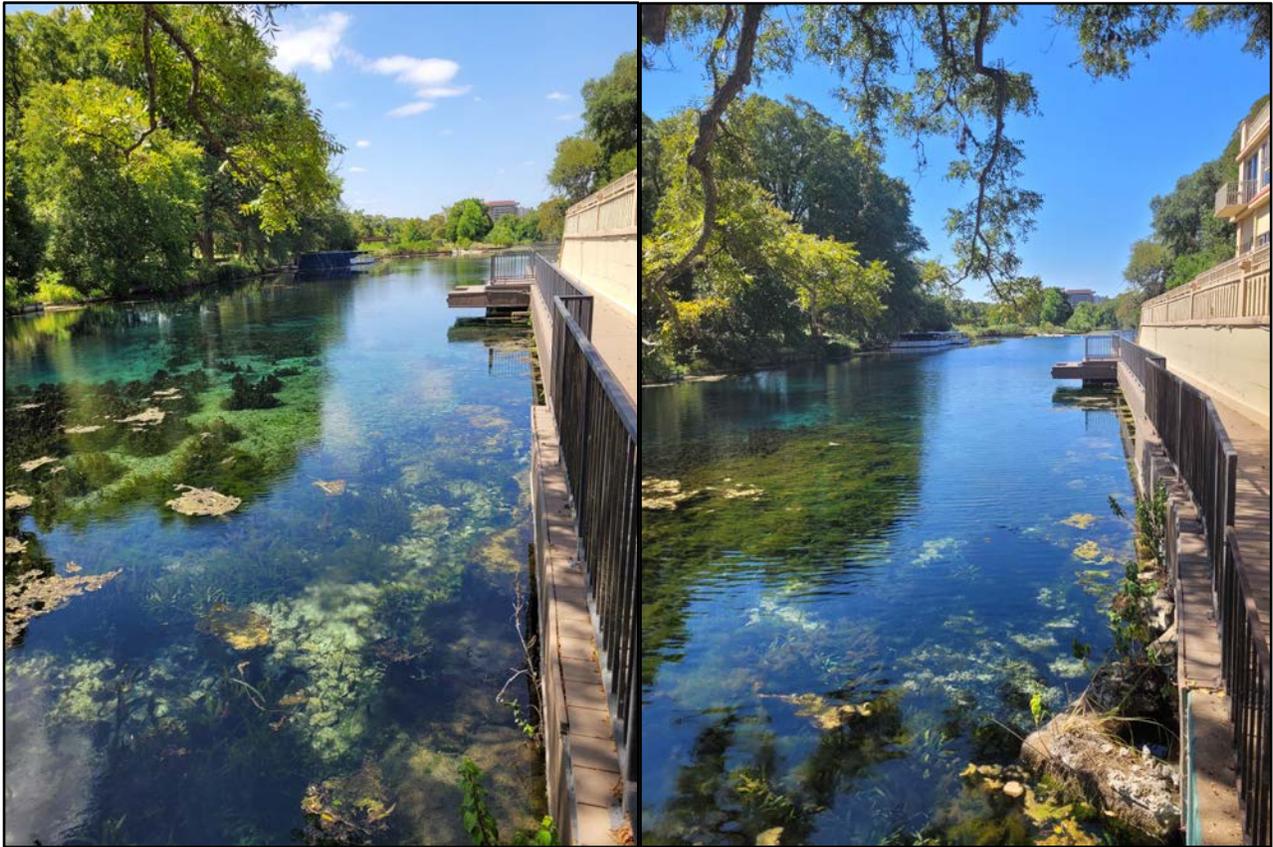
Habitat conditions for San Marcos Salamanders and Fountain Darters in Spring Lake remain similar but slightly degraded compared to July and August. As noted last month, the reduced water flow throughout Spring Lake with lower discharge has resulted in higher-than-average levels of algal build up and siltation within San Marcos Salamander habitat. This was notably evident in September, but portions of the Hotel site salamander habitat is still supporting clear, clean substrate (Figure 4).

Figure 4: Headwaters of Spring Lake looking downstream at San Marcos Salamander Hotel study site on August 19 (left) and September 28, 2022 (right).

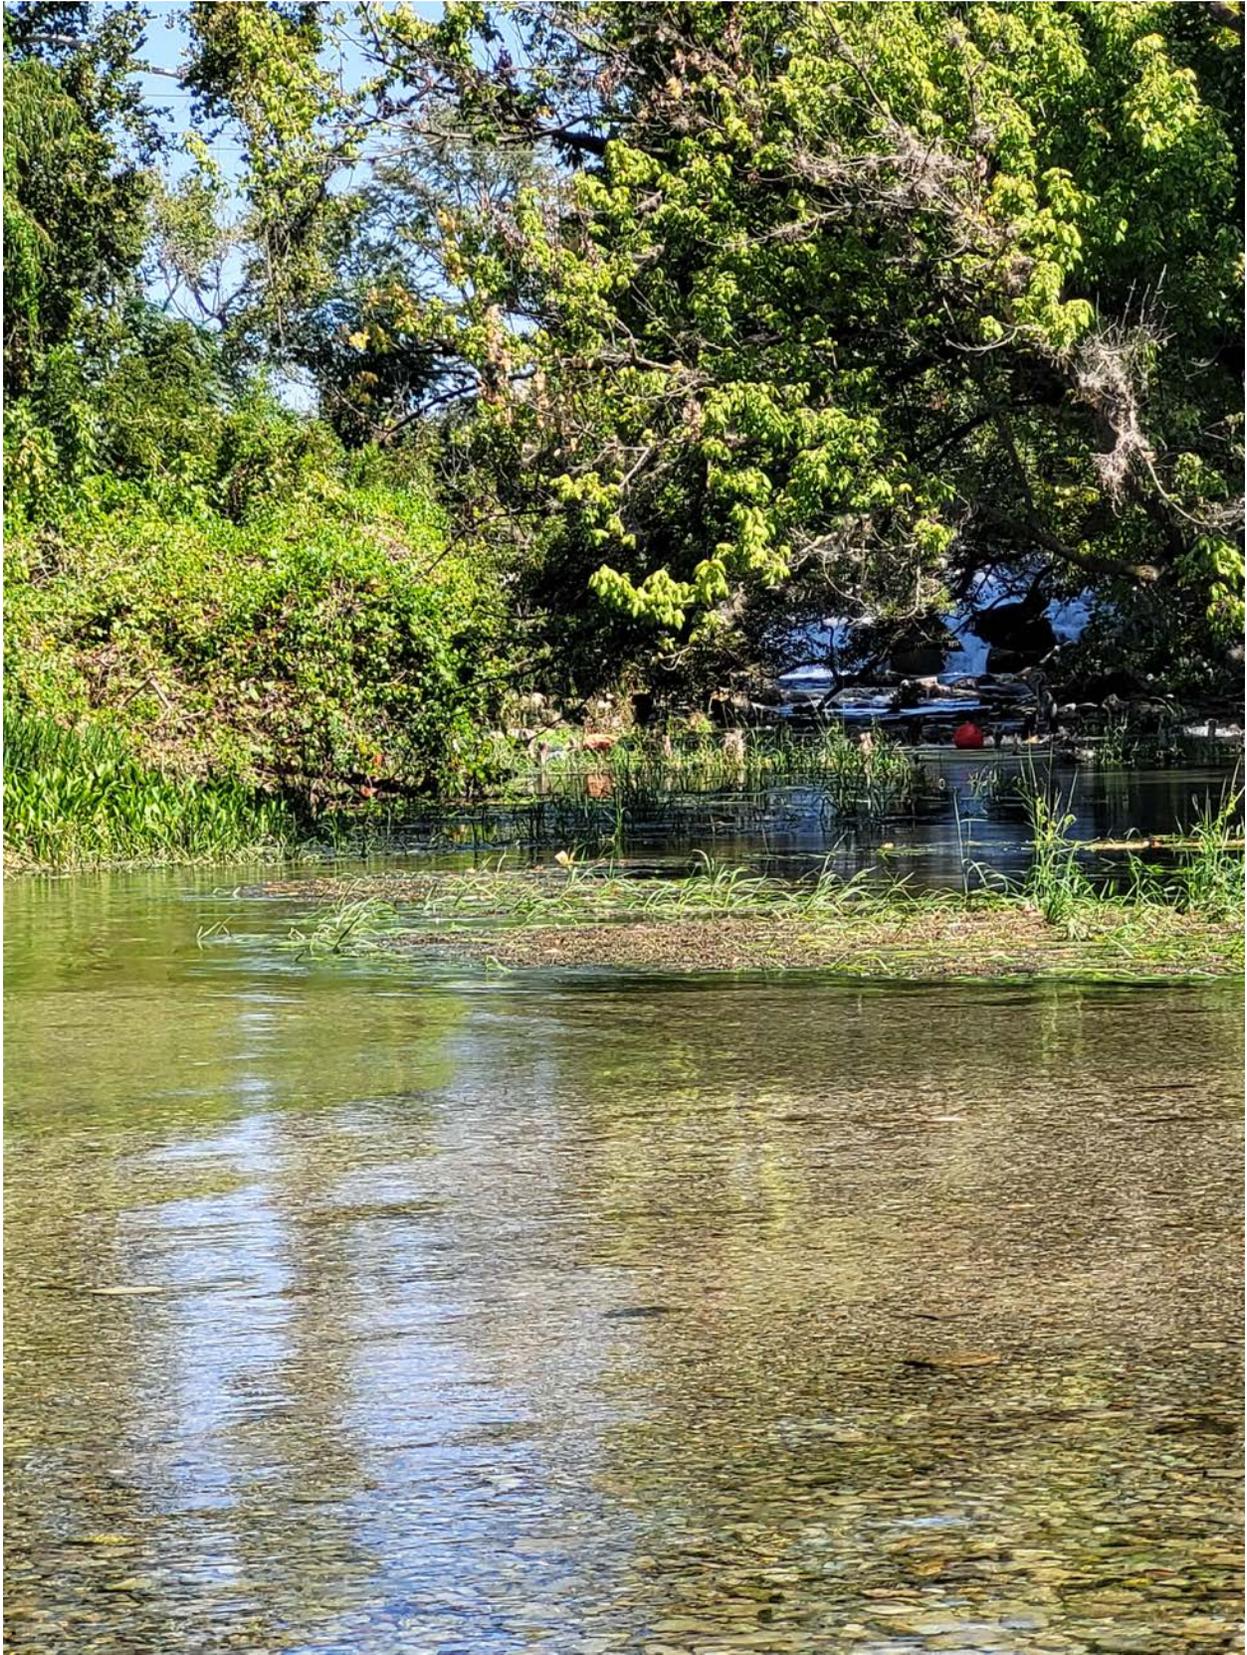
As evident in Figure 5, considerable San Marcos Salamander and Fountain Darter habitat are being maintained in the Spring Lake Dam study site. There continues to be evidence of recreational activities such as rock relocating which disturbs both species habitat. As previously mentioned, aquatic vegetation within the Spring Lake Dam (Figure 5 and 6) and City Park (Figure 7) study reaches continue to be dominated by Texas Wild-rice, while the I35 study reach (Figure 9) supports a more diverse aquatic vegetation community. The following photographs highlight Fountain Darter habitat conditions moving downstream in the San Marcos River.

Figure 5: Spring Lake Dam spillway water level on September 28, 2022.

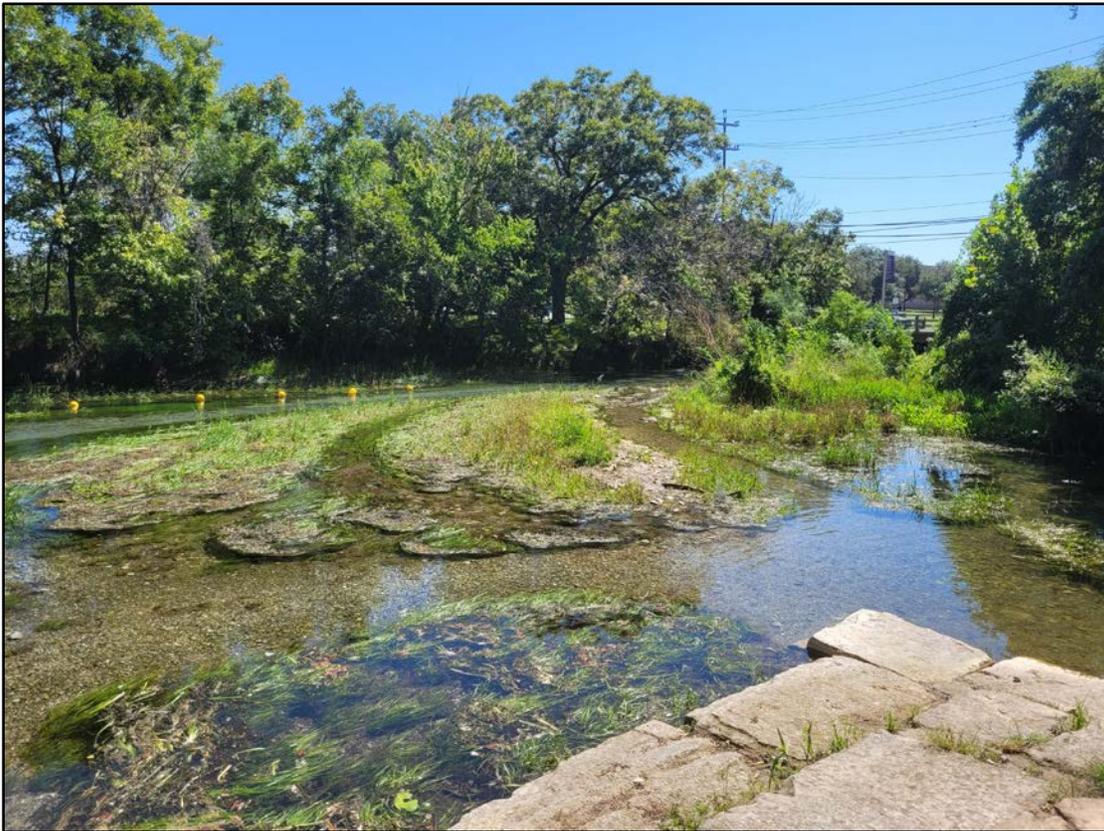
Figure 6: Spring Lake Dam Sessom's Island on September 28, 2022.

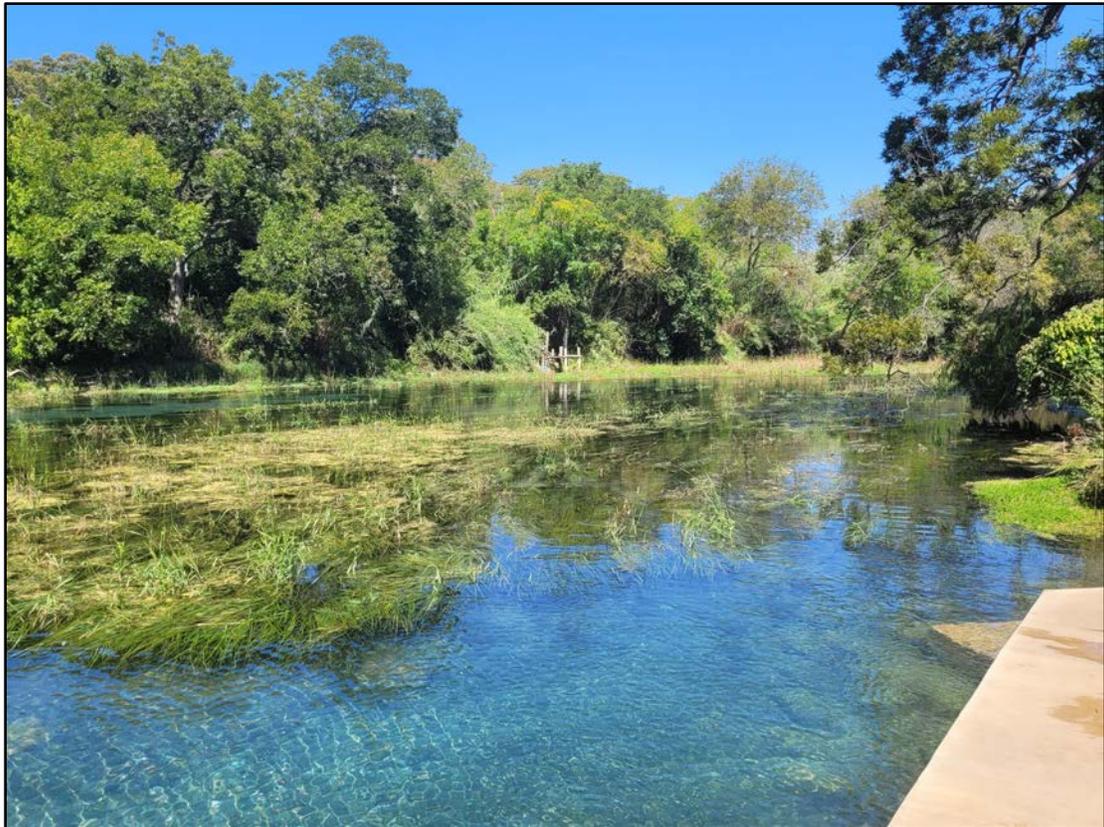
Figure 7: City Park habitat conditions looking upstream on September 28, 2022.

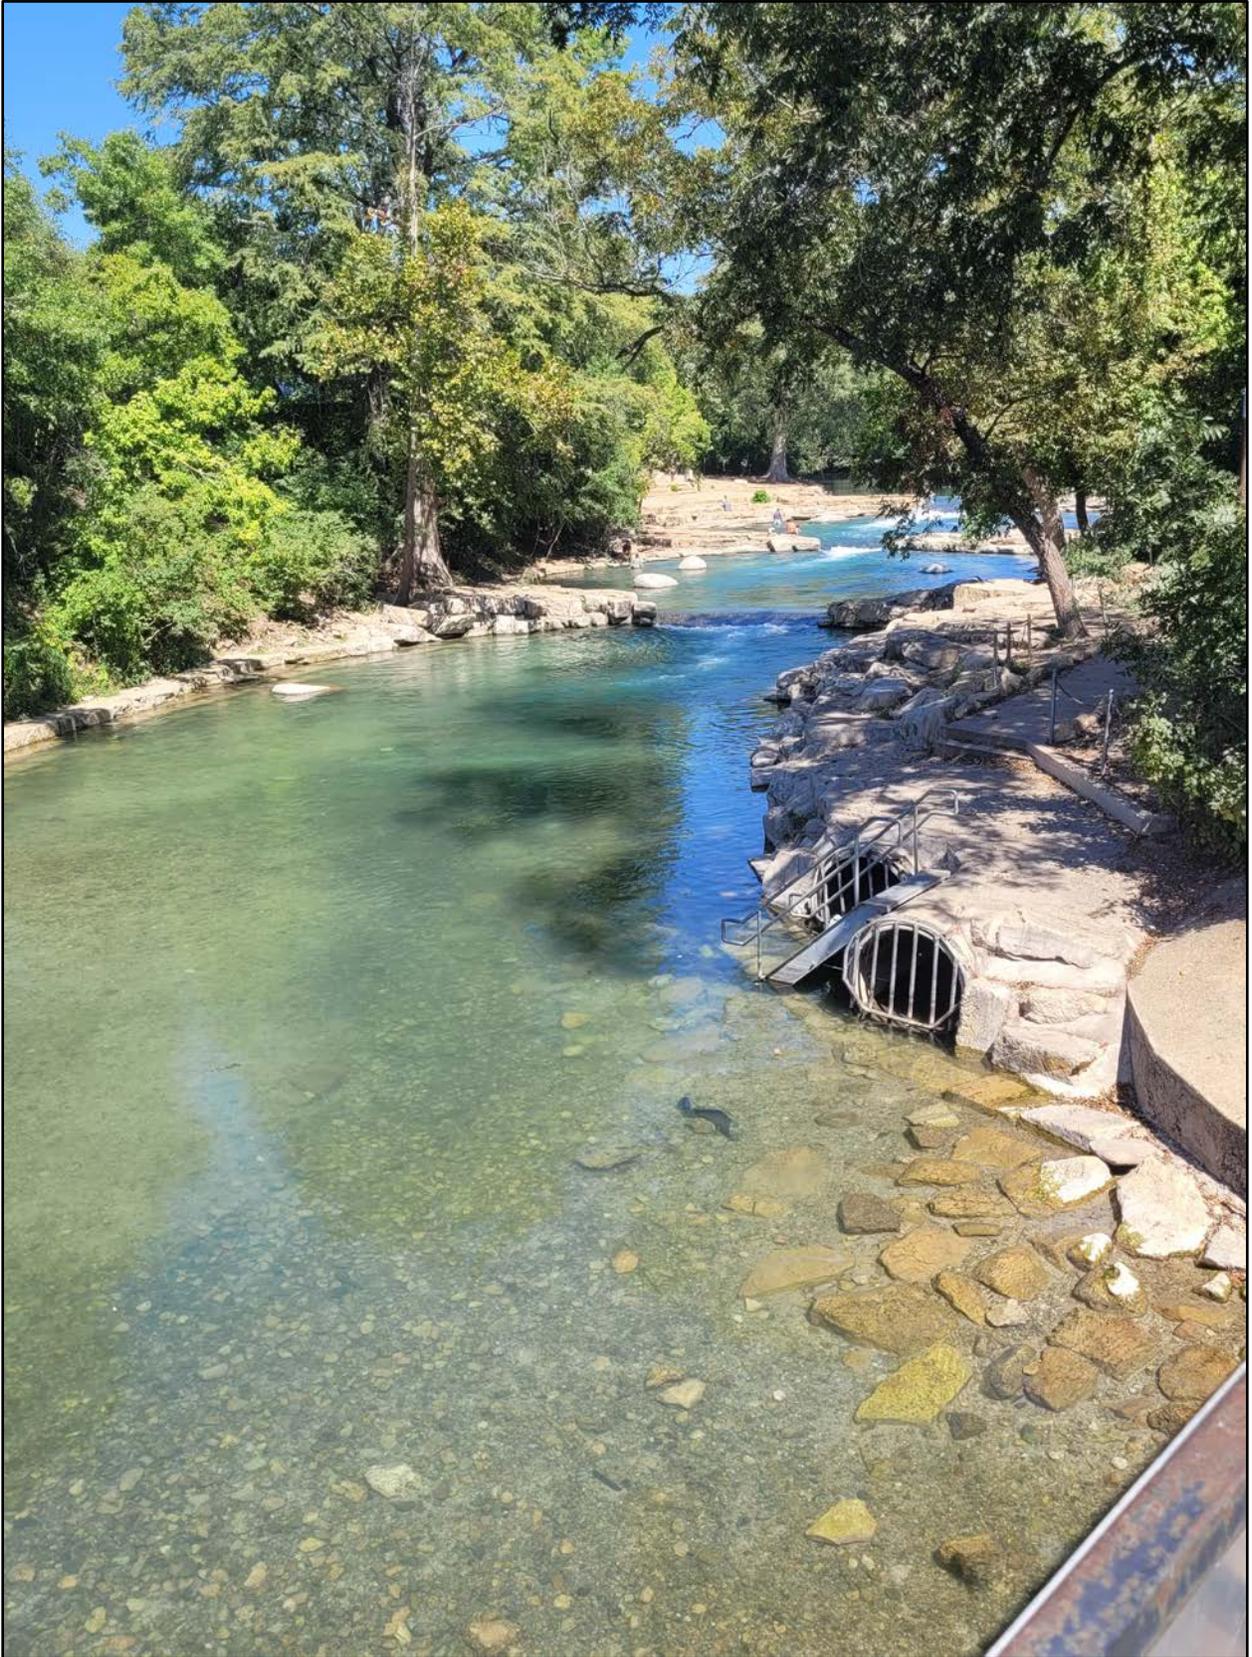
Figure 8: Rio Vista habitat conditions looking upstream on September 28, 2022.

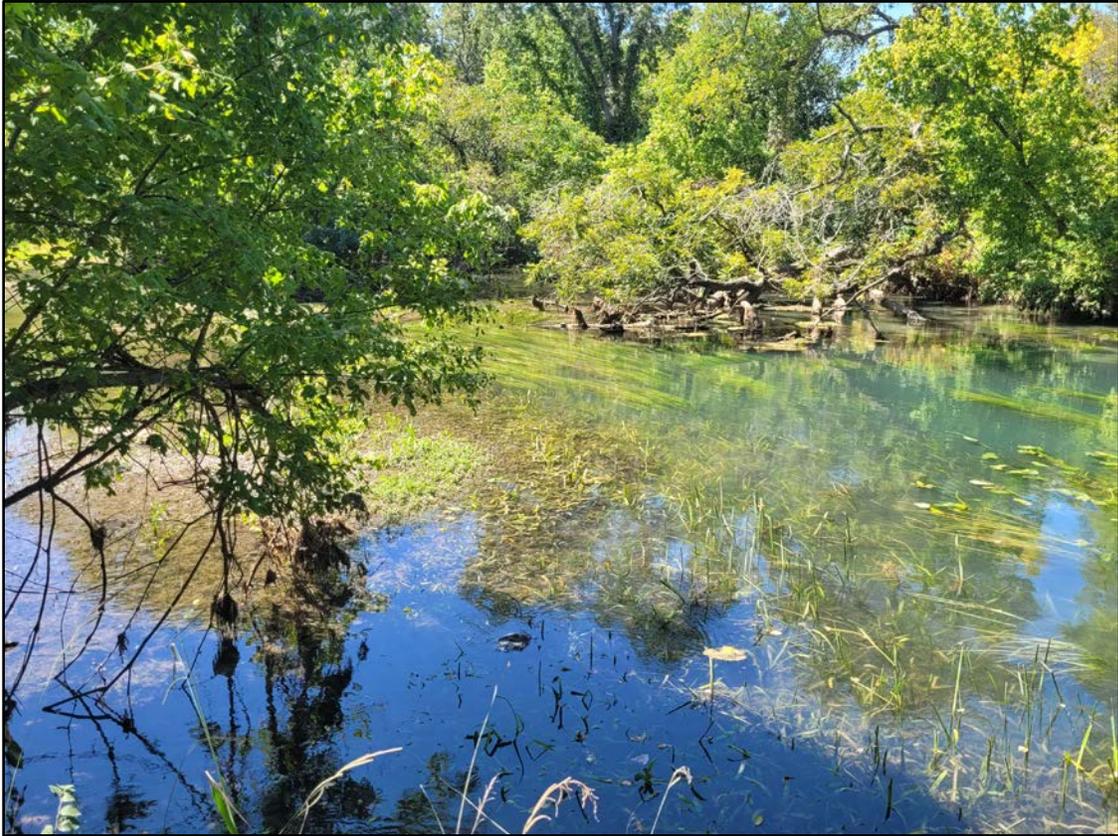
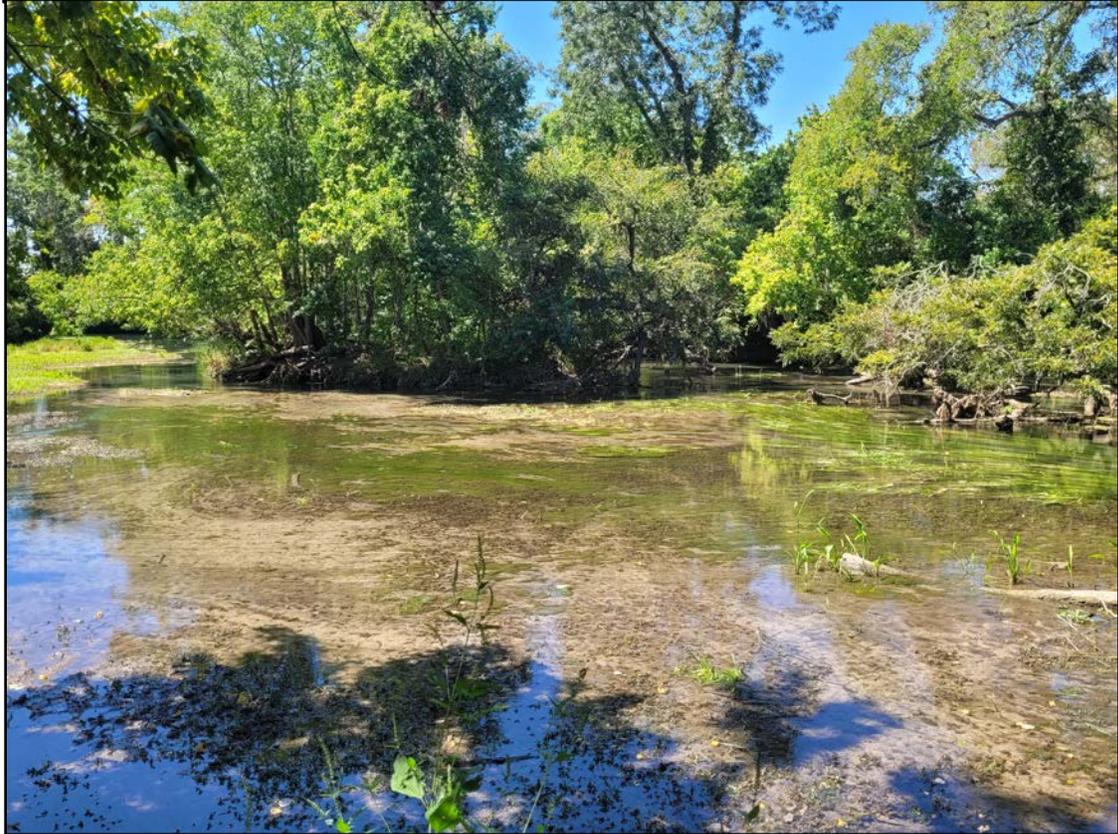
Figure 9: I35 habitat conditions on September 28, 2022.
