Appendix H | **2022 City of New Braunfels Reports**

2022 Native Aquatic Vegetation Restoration and Maintenance in the Comal River

**City of New Braunfels
550 Landa Street
New Braunfels, Texas 78130**

**BIO-WEST, Inc.
1812 Central Commerce Court
Round Rock, Texas 78664**

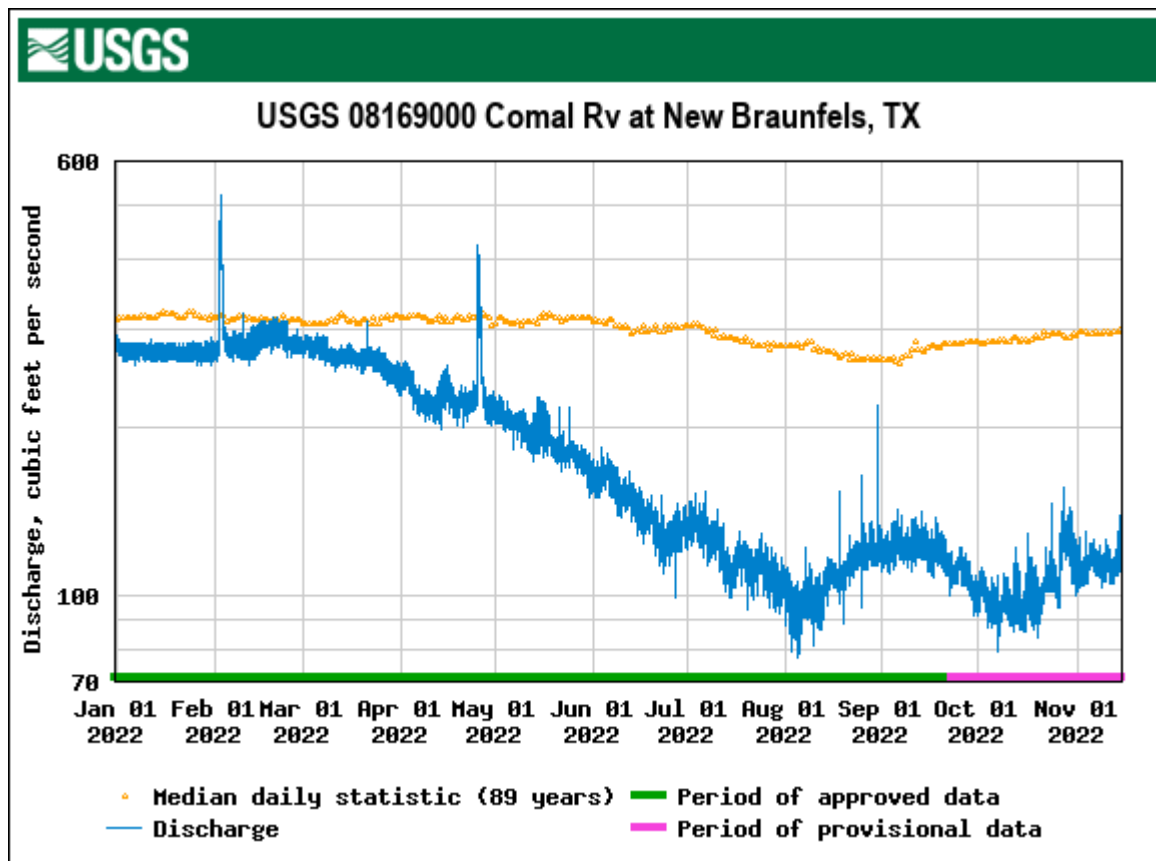
Figure 2 Discharge in the Comal River from January through November 2022 (USGS 2022).

This project year was dominated by below-average flows. Comal River discharge maintained a steady but lower-than-average rate during the first quarter of 2022. After spring rains failed to materialize, Comal spring discharge began to depart drastically from the historical mean (**Figure 2**). Precipitation recorded for March, April, and May at the San Antonio International Airport totaled 3.46 inches. As of September 30, rainfall totaled 8.5 inches.

By July, Comal spring discharge dropped below 130 cfs, enacting Provision M of the Habitat Conservation Plan. At this time all large-scale restoration activities were halted including large scale plantings, plant removal as well as relocating benthic barriers. Although late-summer rain provided a small boost to discharge, Provision M remained in place through November 2022 and the submittal of this report.

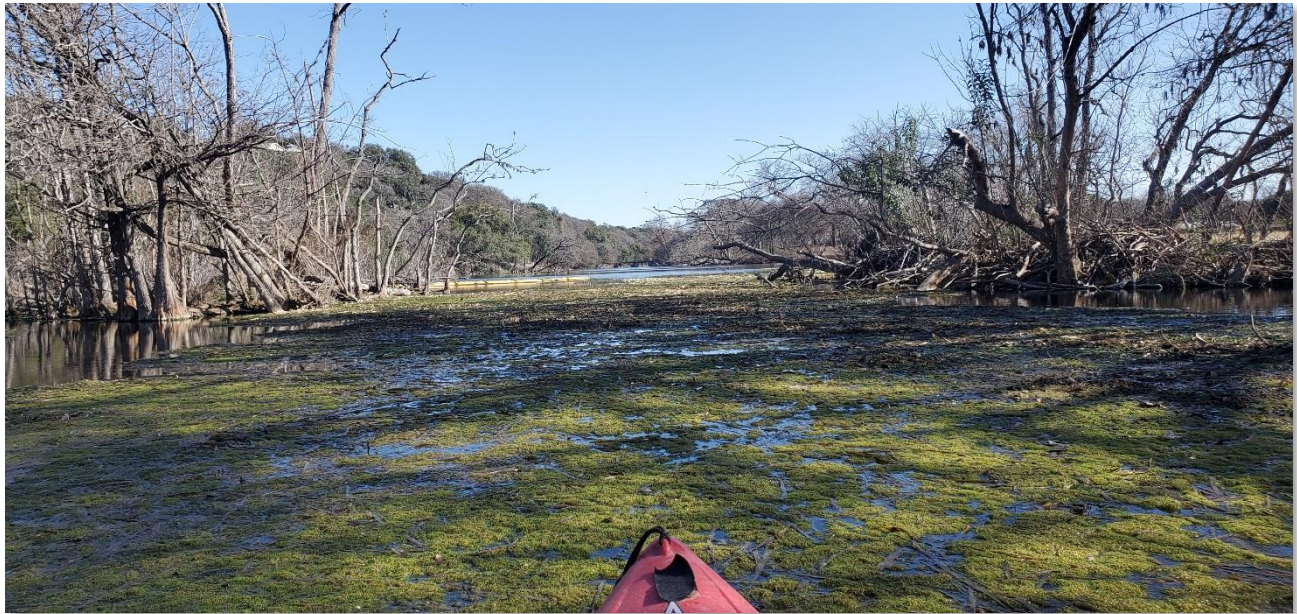
Figure 4 Vegetation mats were more problematic around restored vegetation in Landa Lake early in 2022. Removal and maintenance through the year helped improve site conditions.

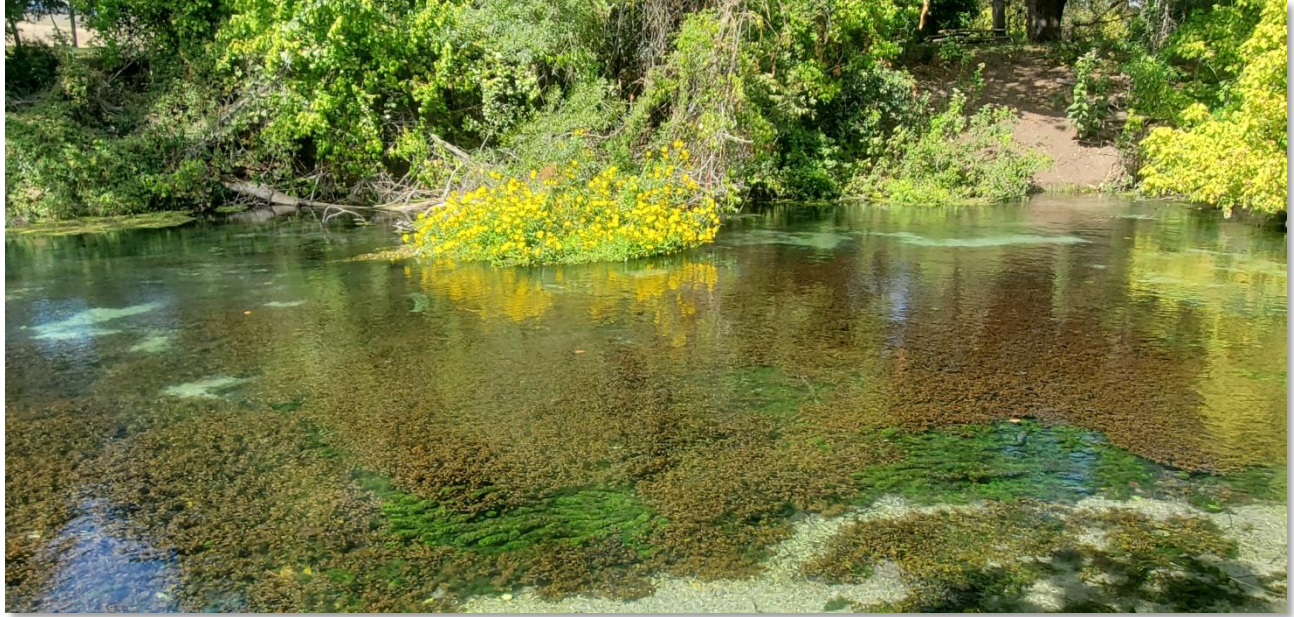
Figure 6 The aquatic vegetation in the Old Channel Restoration Reach in October.

In the Old Channel Restoration Reach, *Ludwigia* coverage trended downward over the course of the year, while *Cabomba* trended upward. However, healthy stands of both plants were present throughout the year (**Figure 6**). Some other plant species also lost coverage. Observations indicate

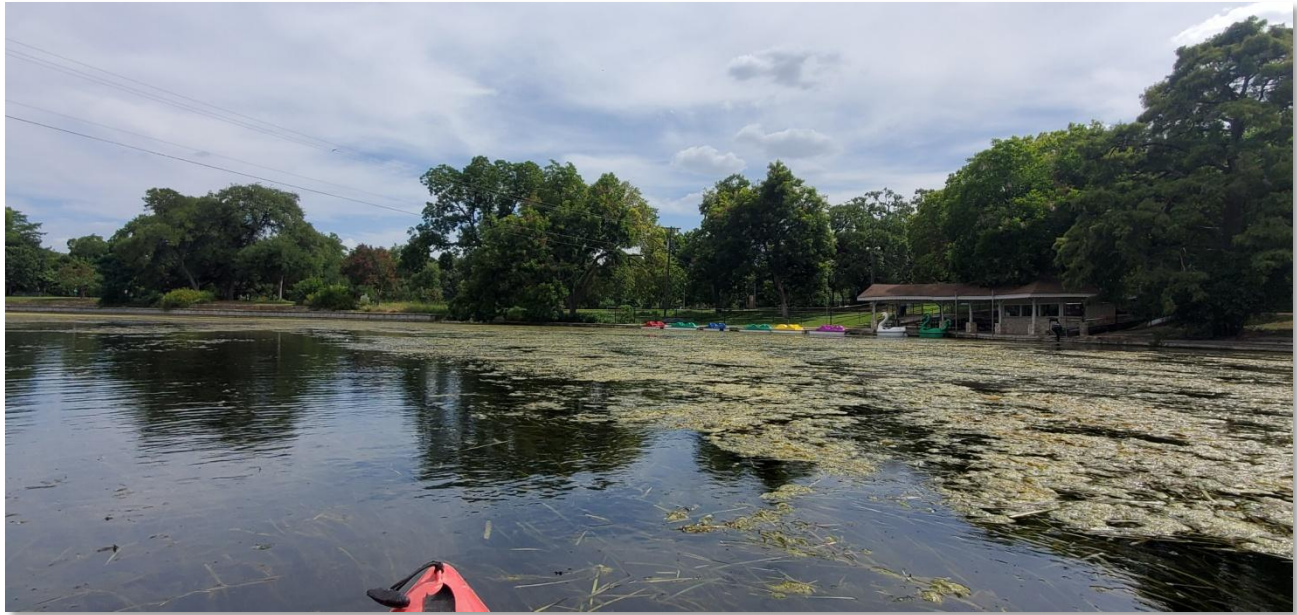
Figure 13 Vegetation mat buildup in Lower Landa Lake Restoration Reach.

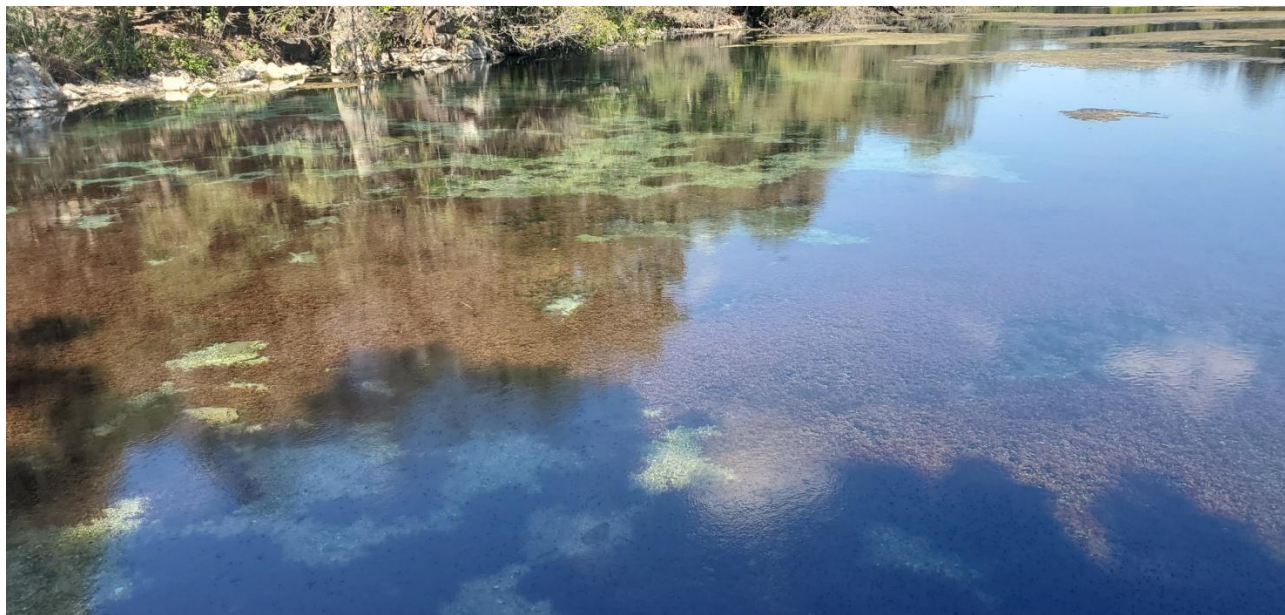
Figure 14 Ludwigia in the Landa Lake Long Term Biological Goal Reach.

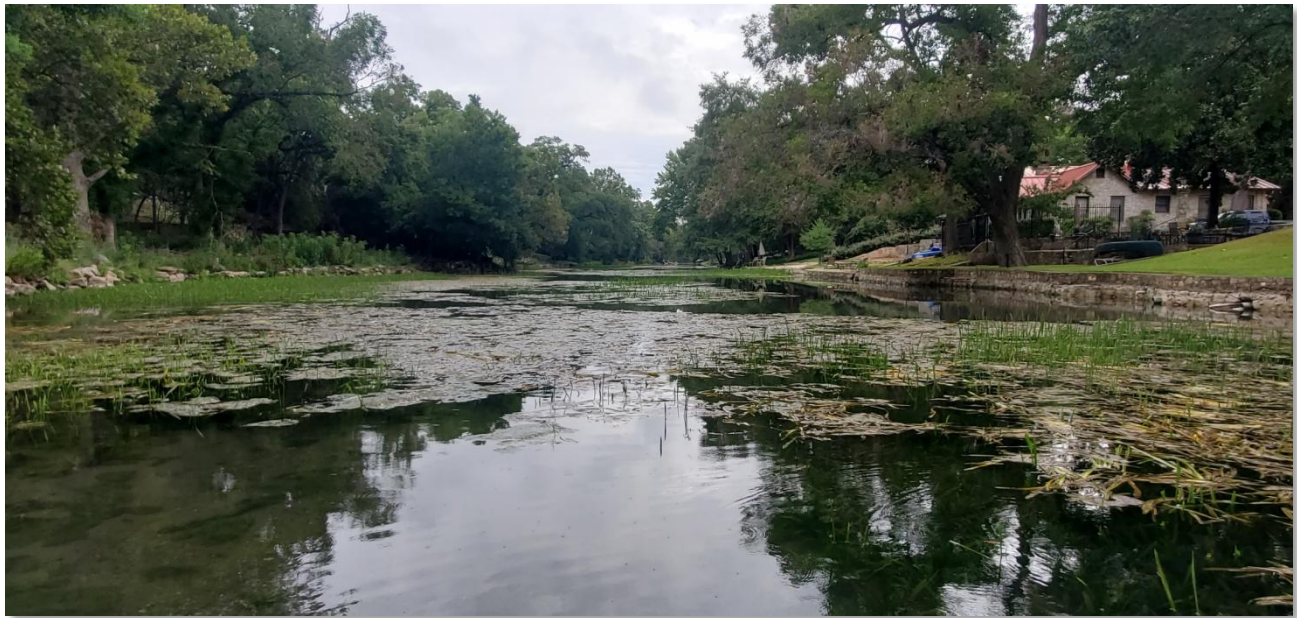
Figure 20 Vegetation mats in the Upper Spring Run Long Term Biological Goal Reach.

No active restoration plantings occurred in the Upper Spring Run Restoration Reach in 2022. As the drought persisted, the water level in this reach dropped significantly, such that *Sagittaria* in most of the reach began emerging (**Figure 20**). The emergent stems created catch points for floating algae and detritus. During multiple observations, large areas of Upper Spring Run were covered in floating algal mats and leaf debris, and the water flow in this area diminished.

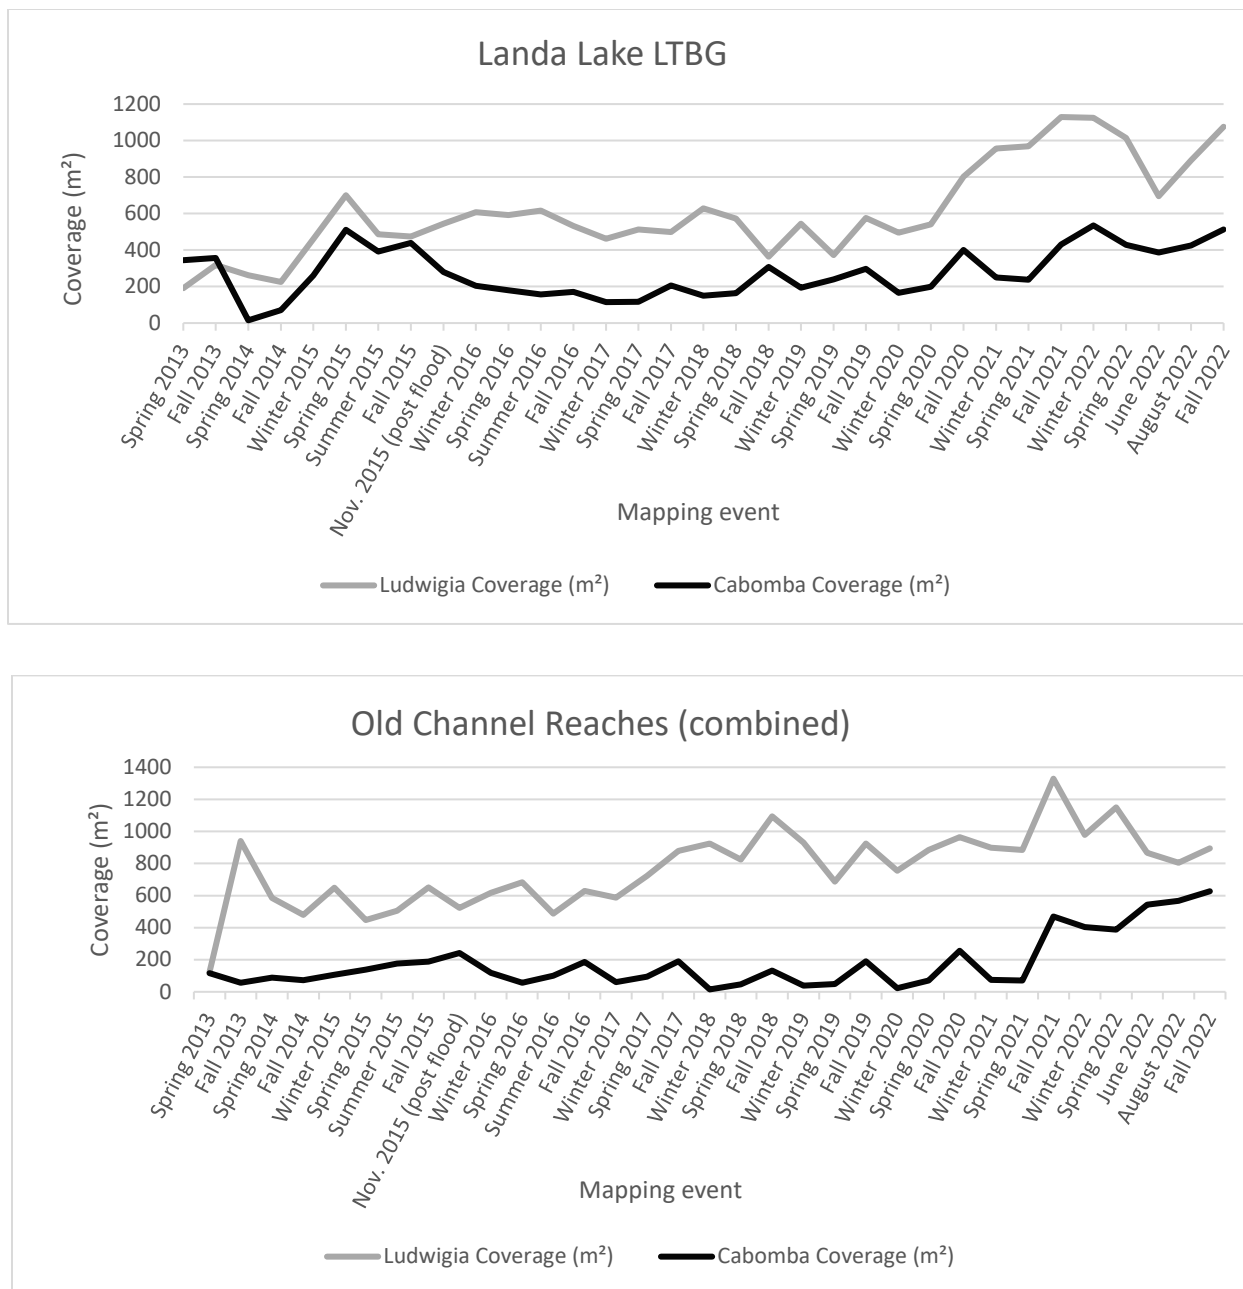
Figure 26 The 9-year trend for coverage of Ludwigia and Cabomba in the Landa Lake LTBG Reach (top) and the combined reaches of the Old Channel (bottom).

Figure 26 tracks the long-term changes in Ludwigia and Cabomba coverage since restoration began in 2013. These graphs highlight the inherent fluctuation in coverage of these two species. There are several explanations for this pattern. First, senescence is a natural process in which plants undergo a reduction in biomass as a seasonal reaction (e.g., reduced daylight, cooler water temperatures) or a life cycle change (e.g., maturation, post-blooming). Senescence can also be a response to changes in growing conditions.

A strong senescence period was seen in June when low flow conditions set in. This inevitably caused a reduction in plant biomass. Sometimes the plants habituate to the changing conditions and they may recover, while at other times senescence leads to death as the plant has entered its final life stage and lacks the energy to recover. Second, loss of cover can be caused by competition and later complete exclusion due to the expansion of other more aggressive native species, as previously detailed in this report. These two factors together commonly lead to a reduction in cover that is equal to or higher than the amount planted, making consistent year-to-year coverage difficult. Despite the fluctuation, coverage is generally increasing. The alteration in methodology toward creating larger contiguous patches of *Ludwigia* and *Cabomba* is anticipated to reduce losses and improve sustainability. Expectations are that the coverage trend will show a more consistent pattern within the next year and annual gains will be greater than achieved in the past. The native aquatic plant restoration and maintenance activities conducted in 2022 continue to enhance the aquatic ecosystem of the Comal River and provide valuable lessons. Additionally, the continued decline and subsequent rarity in nonnative aquatic vegetation in the Comal system has been an incredible success story in this ongoing habitat restoration project.

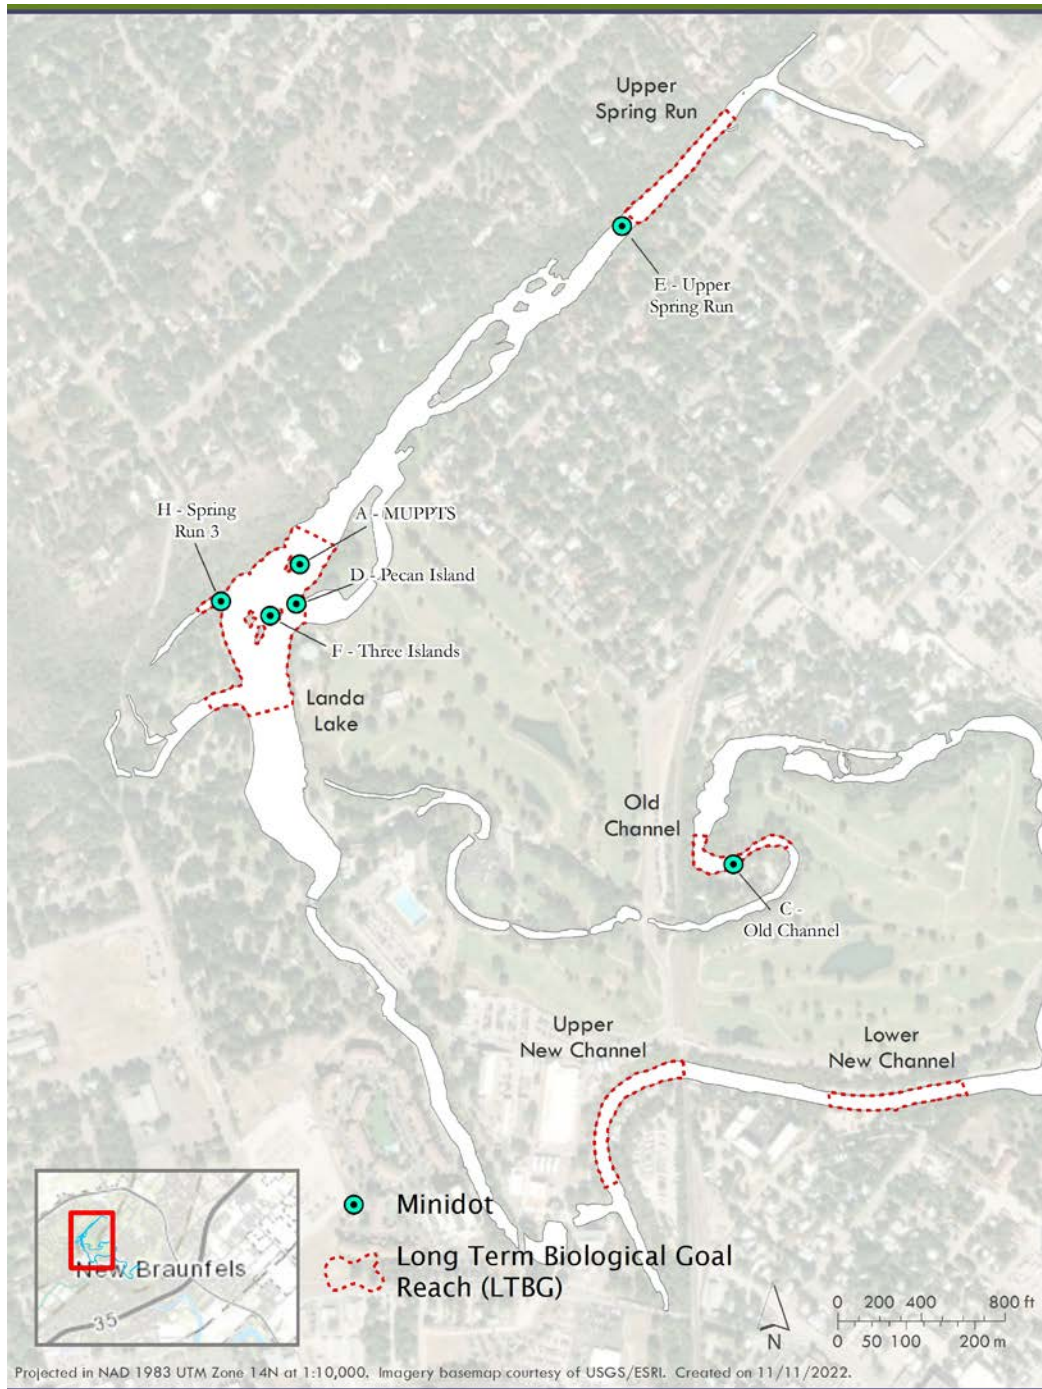
Figure 1. Six Dissolved Oxygen continuous monitoring Low flow sites in the Comal System.

Six strategic locations were selected in 2022 based on previous years sampling and continuously monitored when total system discharge declined below 100 cfs during summer 2022. The six sites include one in the Upper Spring Run, four in Landa Lake, and one in the Old Channel (**Figure 1**).

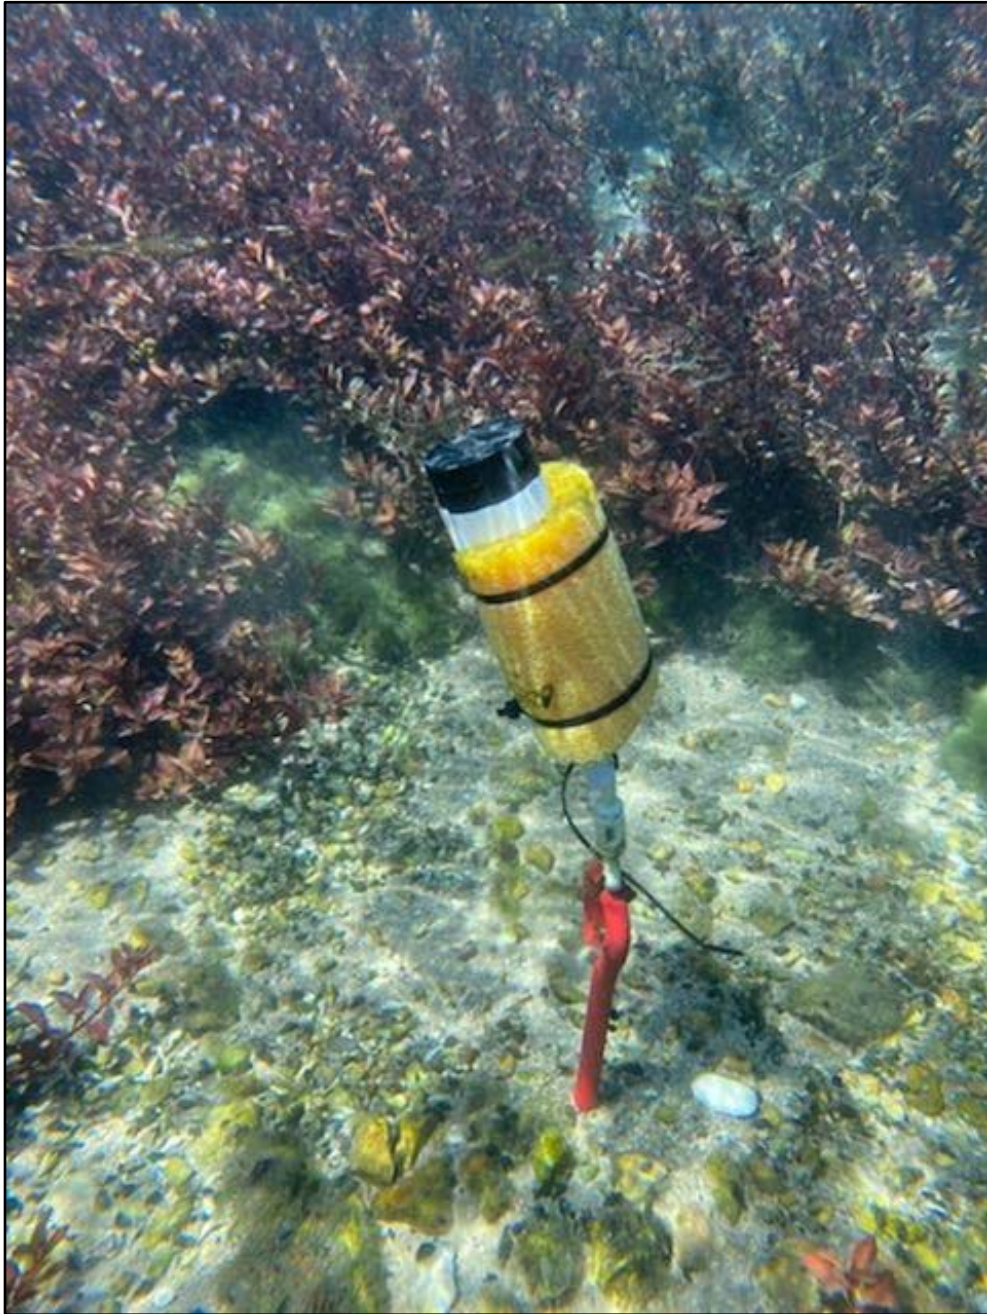
Figure 2. MiniDOT sonde deployed at Landa Lake (Three Islands) Study Site.

With coordination and approval from the City of New Braunfels, BIO-WEST deployed all six MiniDOT sondes on August 3, 2022. Figure 2 shows a MiniDot sonde deployed at the Landa Lake (Three Islands) site. Per recommendations in 2018, a more solid anchoring device was used in 2022. The sensors were purposely installed off the bottom to examine the portion of water column utilized directly by the Fountain Darter. Unlike 2018, there were no probes that were tampered with or stolen during 2022 deployment.

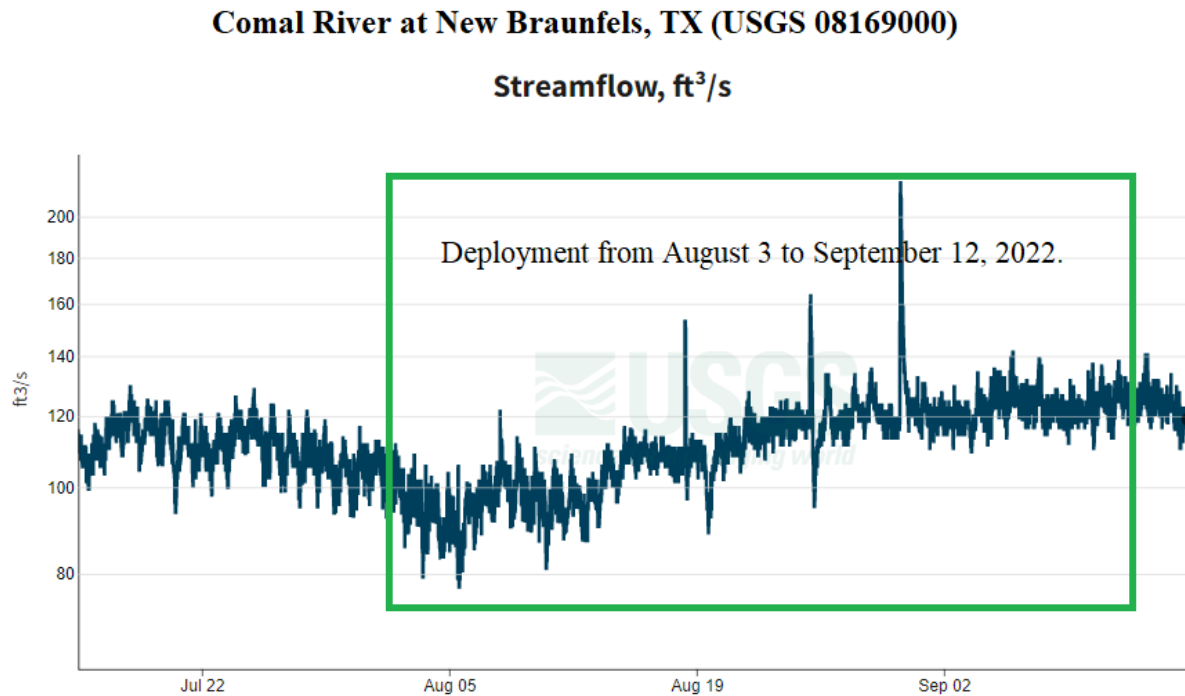
Figure 3. USGS recorded Total System Discharge at Comal River at the New Braunfels USGS gage over the MiniDOT deployment.

During the August 3rd through September 12th deployment period, MiniDots were downloaded multiple times and cleaned approximately once per week in between downloads. All sondes were downloaded, retrieved, cleaned and stored in mid-September following an increase in Comal Total System Discharge above 100 cfs (**Figure 3**).

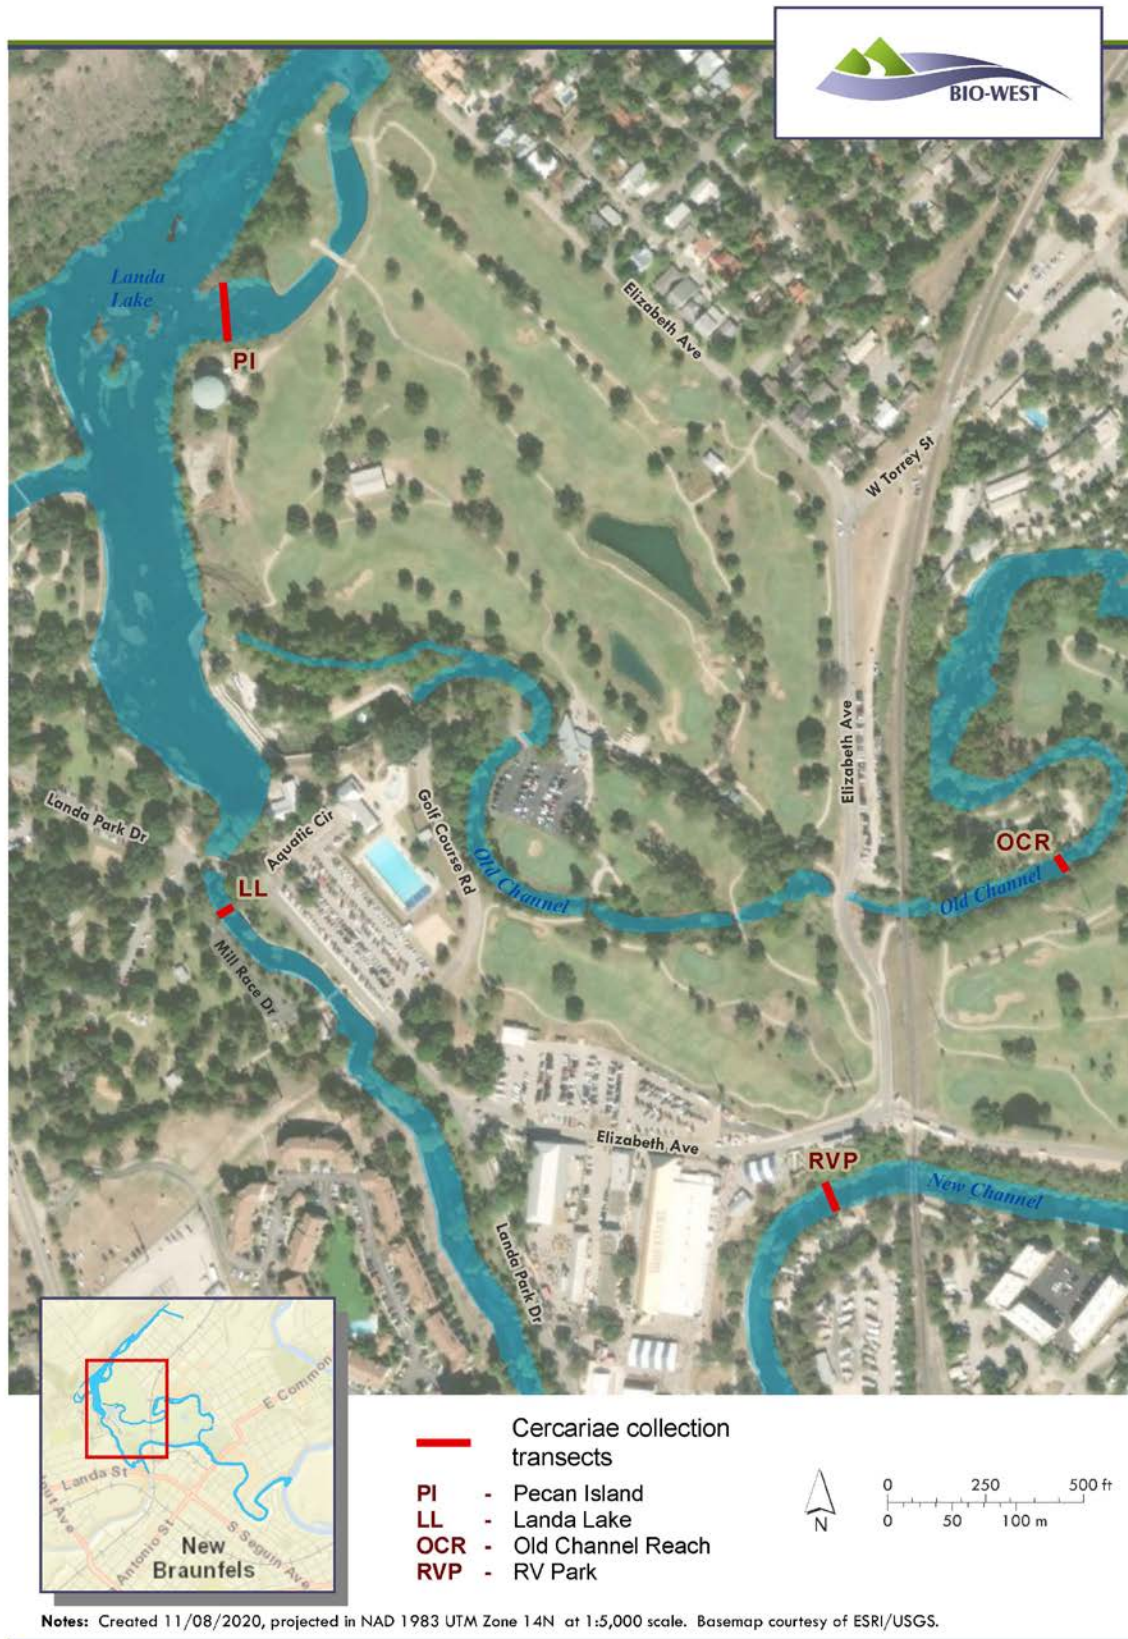
Figure 1. Map of cercariae collection transects in the Comal River system.

From 2014 through 2018, parasite cercariae monitoring was conducted three times per year (Winter, Spring, and Summer seasons) at three transects (Landa Lake [LL], Old Channel Reach [OCR], and RV Park [RVP]; **Figure 1**). In 2019, at the request of the City of New Braunfels and Edwards Aquifer Authority, monitoring efforts were decreased to one event per year, and a fourth sampling transect was added at Pecan Island (PI) due to concerns of potentially high parasite concentrations at this location (**Figure 1**). Since 2019, BIO-WEST biologists have conducted a single summer-season parasite monitoring event at these four transects in the Comal River system. In 2022, this data collection took place on August 15-16, and included quantification of cercariae densities for both *C. formosanus* and *H. pumilio* at each transect. This data was combined with previously collected data from 2014-2021 and the full dataset was analyzed with updated statistical techniques to examine the relationship between multiple predictor variables (discharge, year, season, and site) and parasite concentrations. Details of the methods utilized, a summary of the results and subsequent analyses, a discussion on the utility of this information, and recommendations for further research and monitoring are provided below.

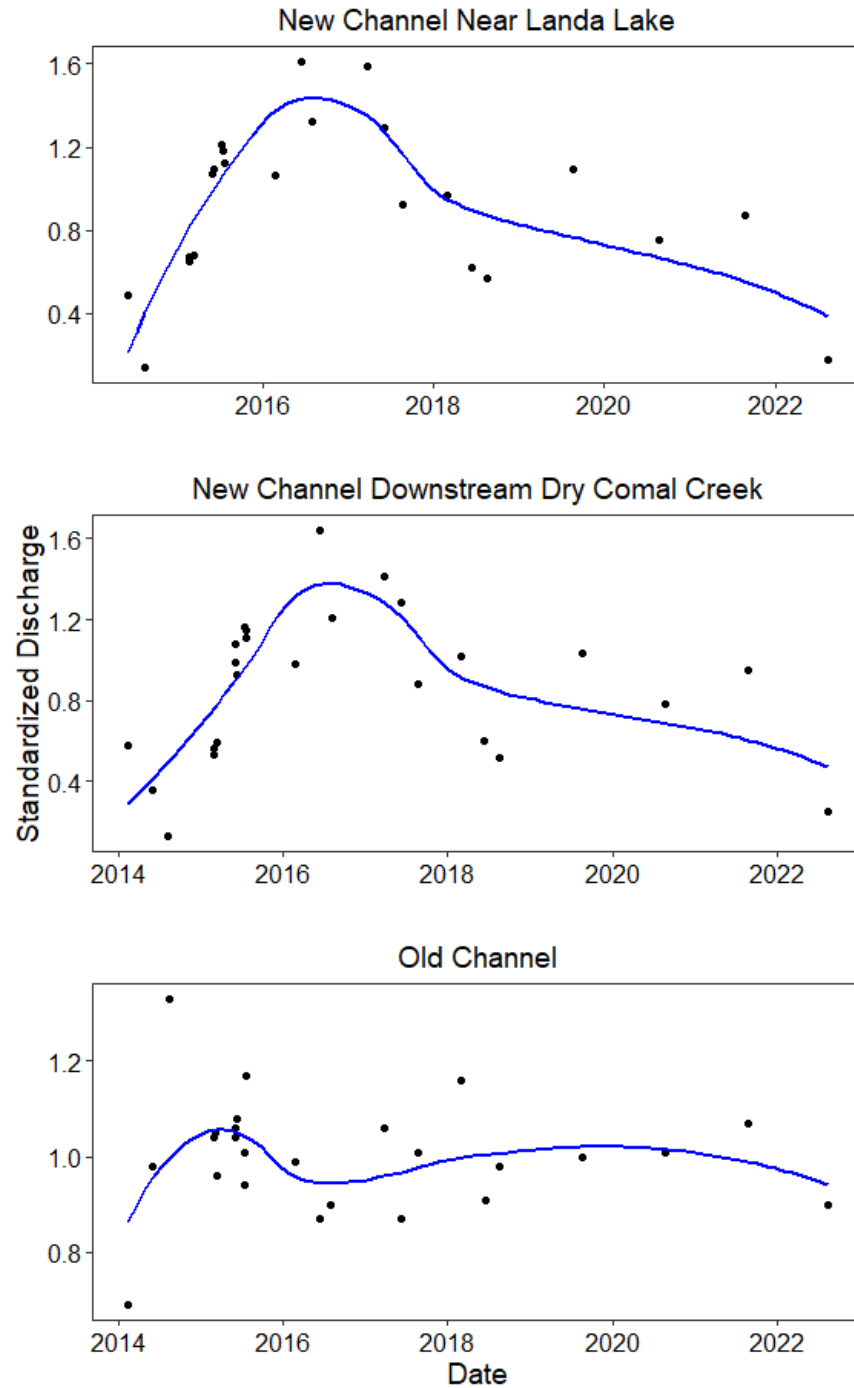
Figure 2. Times series displaying trends in standardized discharge during parasite monitoring. The blue line denotes LOESS smoothed regression fitted to observed standardized discharge values (black dots).

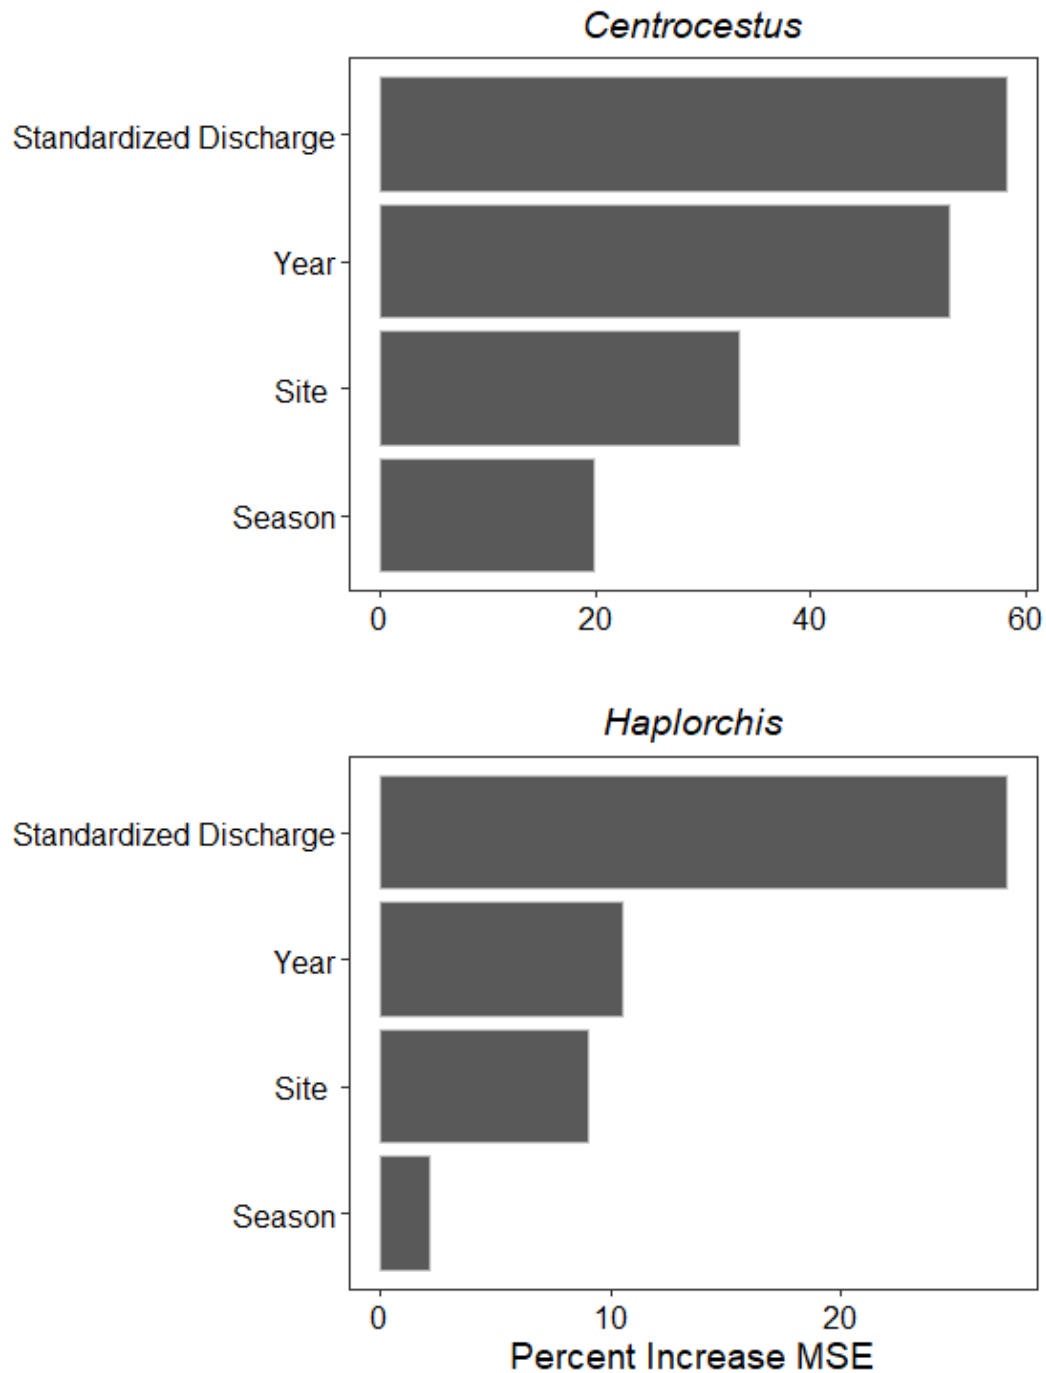
Figure 3. Bar graph displaying the percent increase in mean squared error (MSE) of variables used to predict *Centrocestus formosanus* and *Haplorchis pumilio* density in the Comal Springs/River system.

Random forest models used to predict parasite concentrations varied in performance. The strong correlation between observed and predicted values supports that there is an association between parasite concentration and model covariates. However, lower percent variation explained for *H. pumilio* suggests that other important covariates may be missing, though may instead be due to

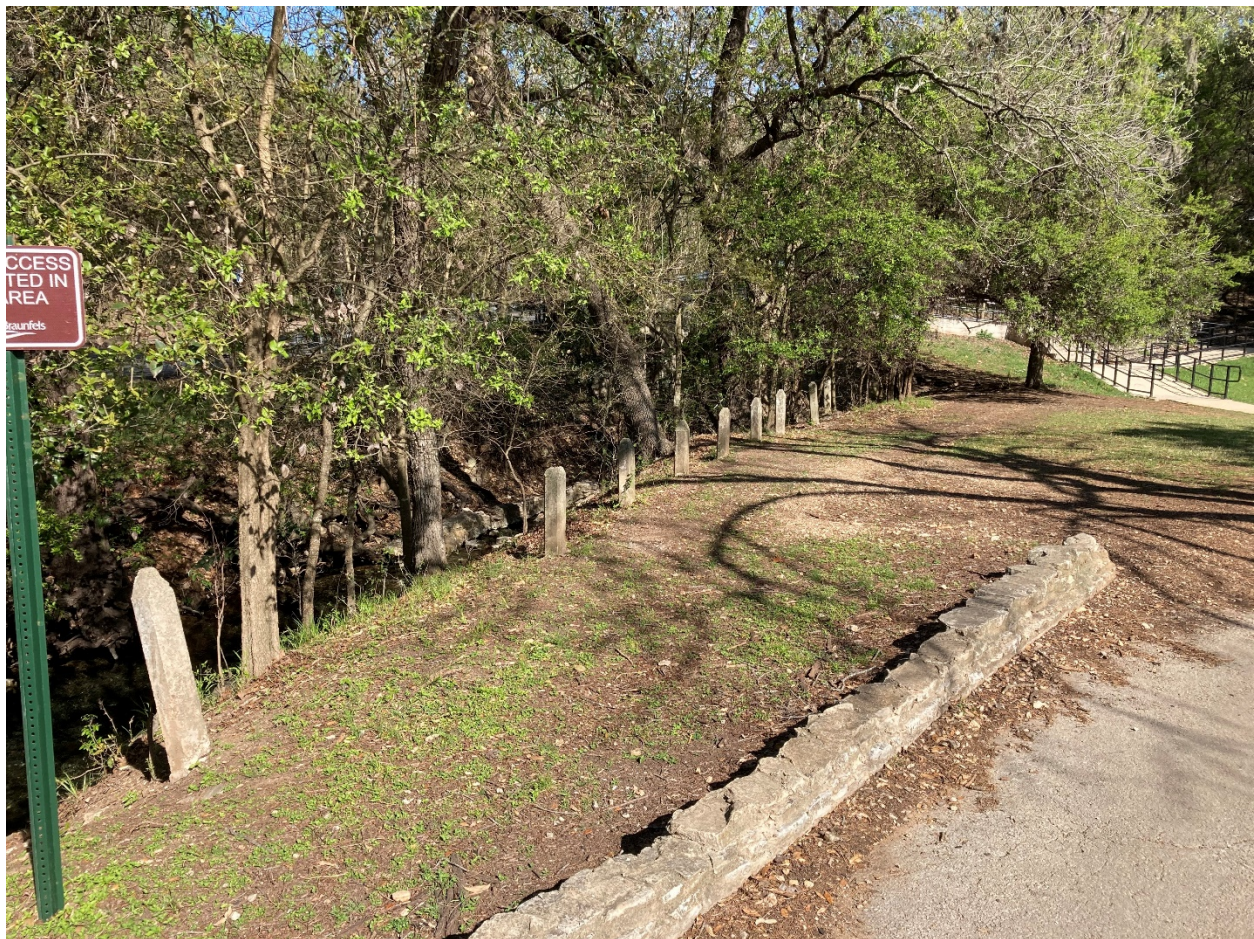
Figure 2. Photographs of project area along Spring Run 2 after the installation of the planting beds.

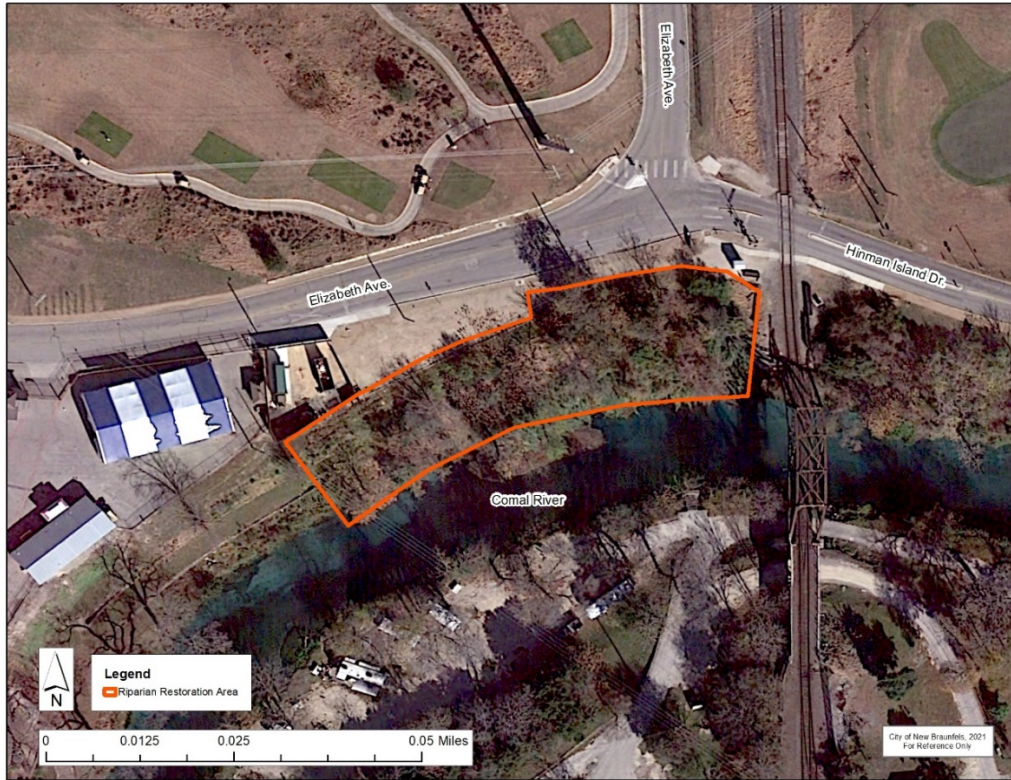
Figure 2. Map of 2022 restoration area along the New Channel of the Comal River on Wurstfest property. Restoration in this area to include removal of non-native vegetation, installation of erosion/sediment control berms, and planting of native plants.

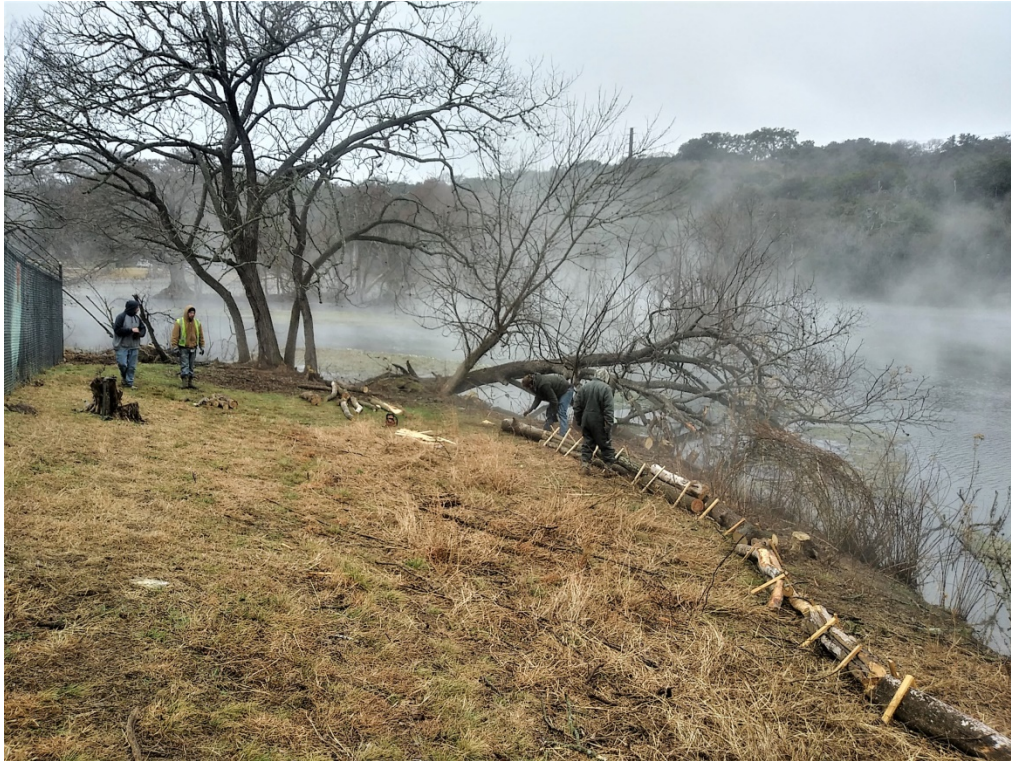
Photo 1 Photo of erosion control berms being installed along the Landa Lake shoreline in the area where non-native trees were removed (Figure 1). The sediment control berms were constructed using trunks and slash from removed non-native trees.

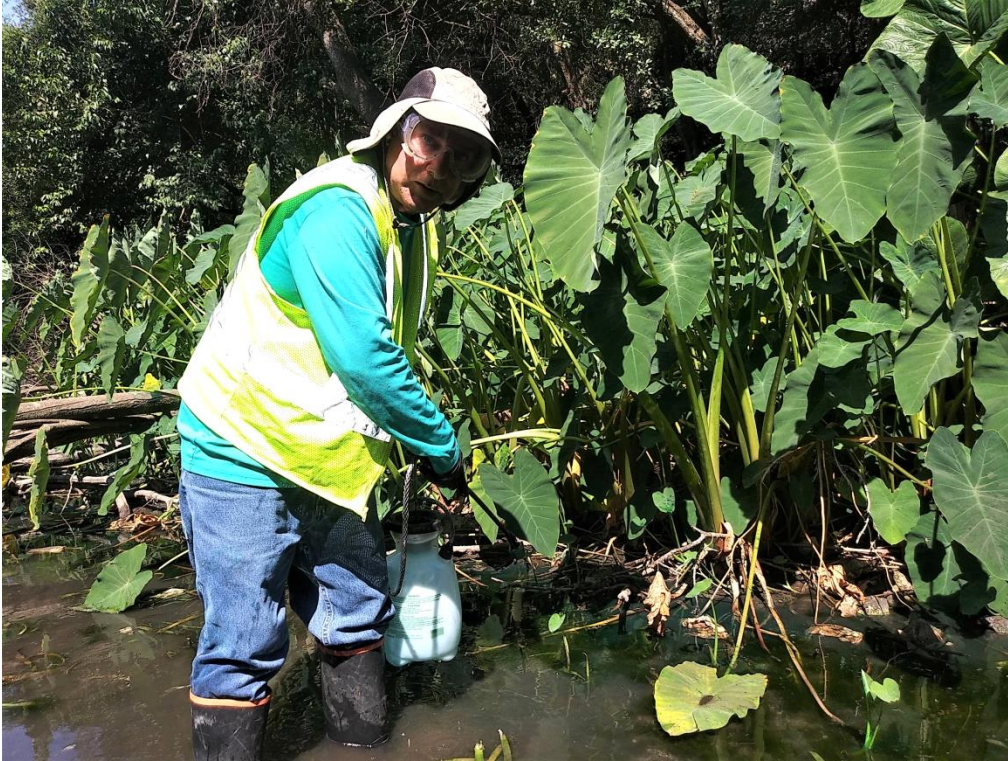
Photo 2. Photo of elephant ears being treated with aquatic herbicide near Spring Island (Figure 1).

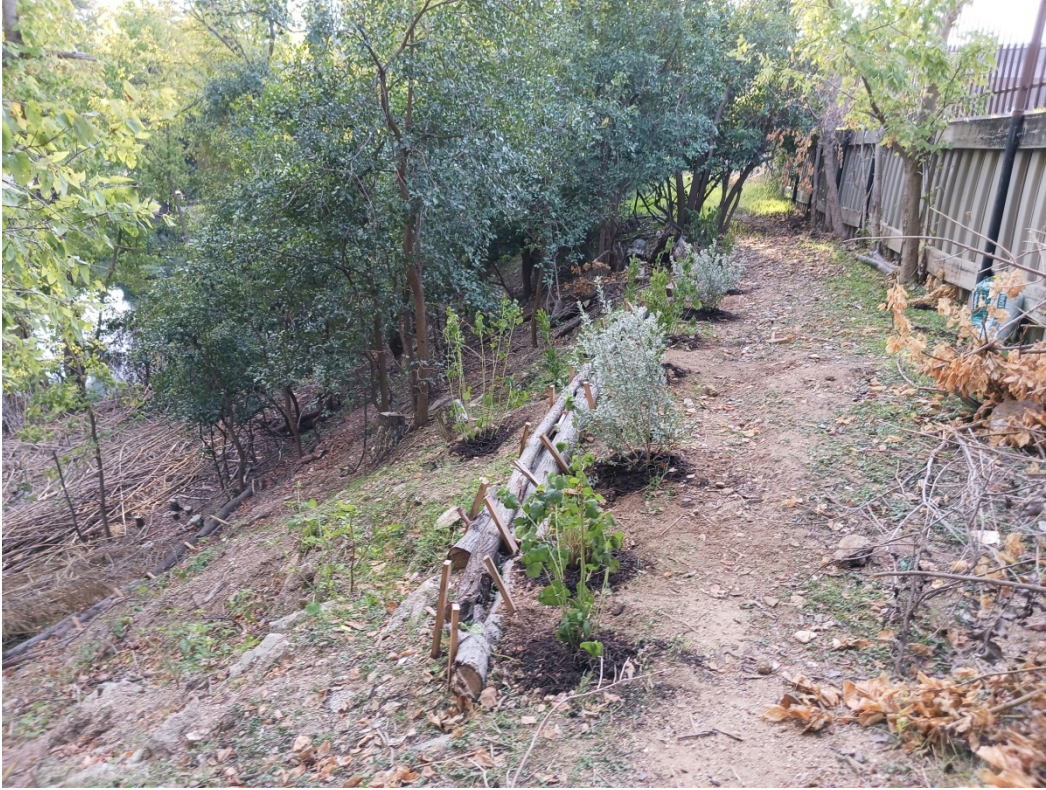
Photo 3. Photo of the Wurstfest property showing the area where non-native trees were removed, erosion control berms built using the slash, and native plants were planted (Figure 2).

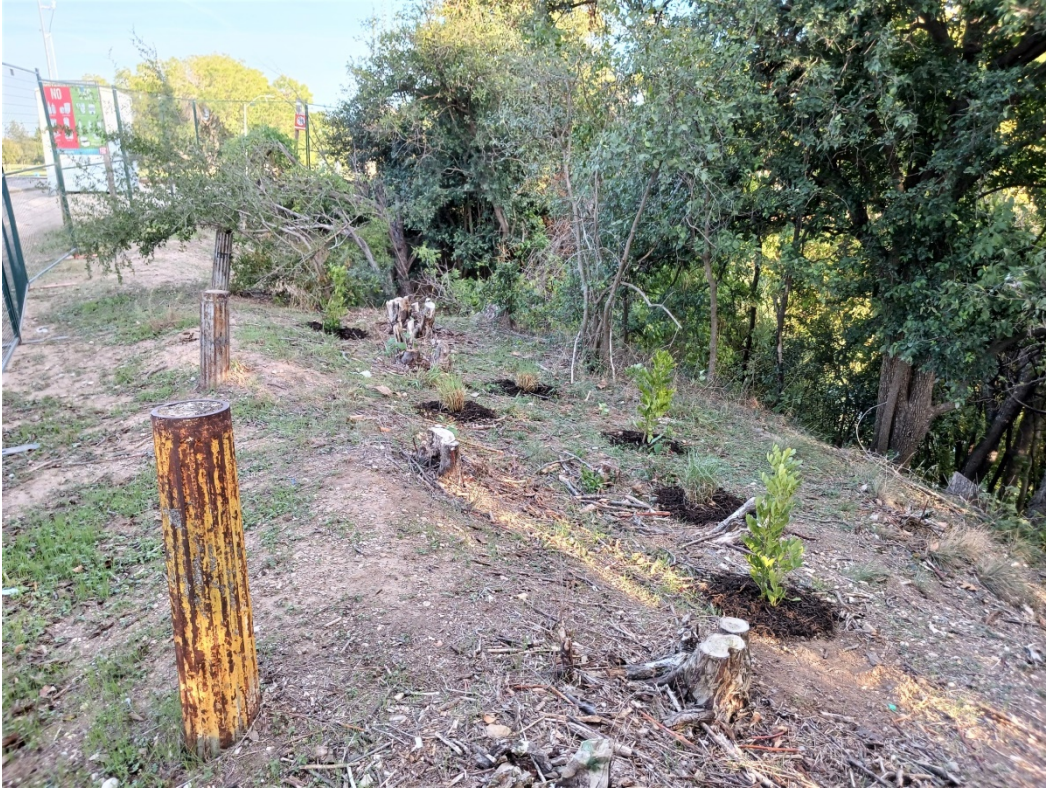
Photo 4. Photo of the Wursthfest property showing the area where non-native trees were removed and native plants were planted (Figure 2).
