Appendix H | **2022 City of New Braunfels Reports**

2022 Native Aquatic Vegetation Restoration and Maintenance in the Comal River

**City of New Braunfels
550 Landa Street
New Braunfels, Texas 78130**

**BIO-WEST, Inc.
1812 Central Commerce Court
Round Rock, Texas 78664**

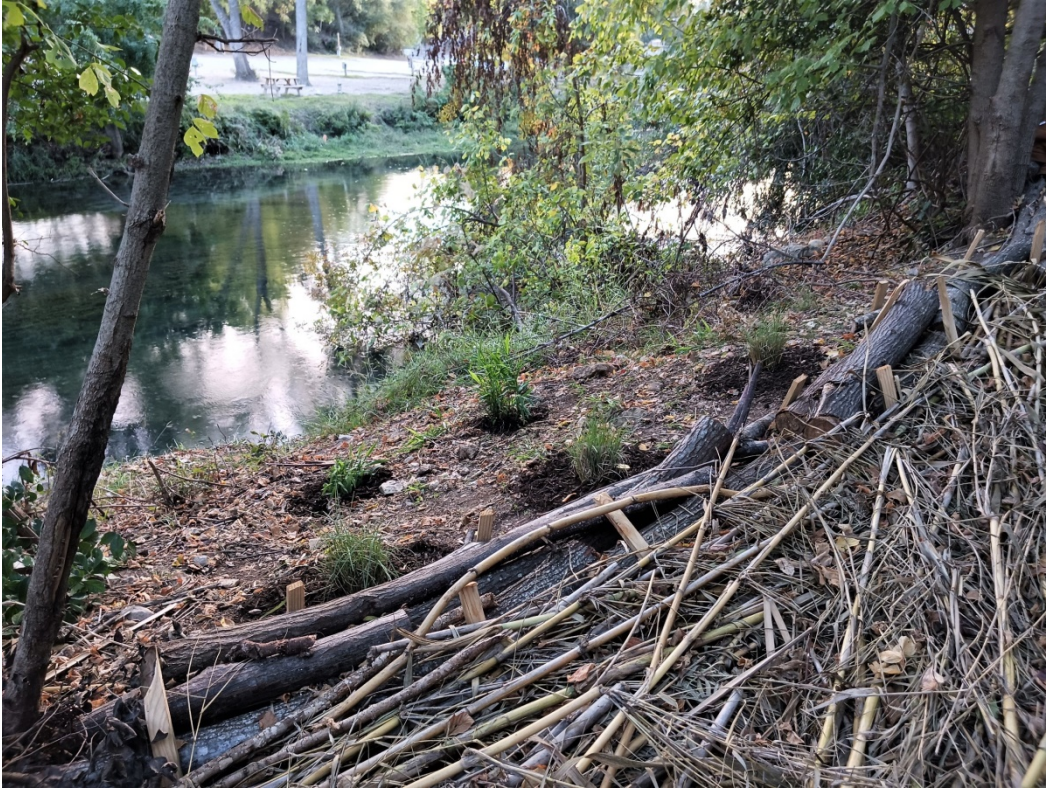
Photos 5. Photo of the Wurstfest property showing the area where non-native trees were removed, erosion control berms built using the slash, and native plants were planted (Figure 2).
