Appendix I | 2022 City of San Marcos and Texas State University Reports

Appendix I1 | **Aquatic Vegetation Restoration**

Edwards Aquifer Habitat Conservation Plan Annual Report

Texas Wild-Rice Enhancement, Non-Native Aquatic Vegetation Removal and Vegetation Mat Mitigation in the Upper San Marcos River for Year 2022

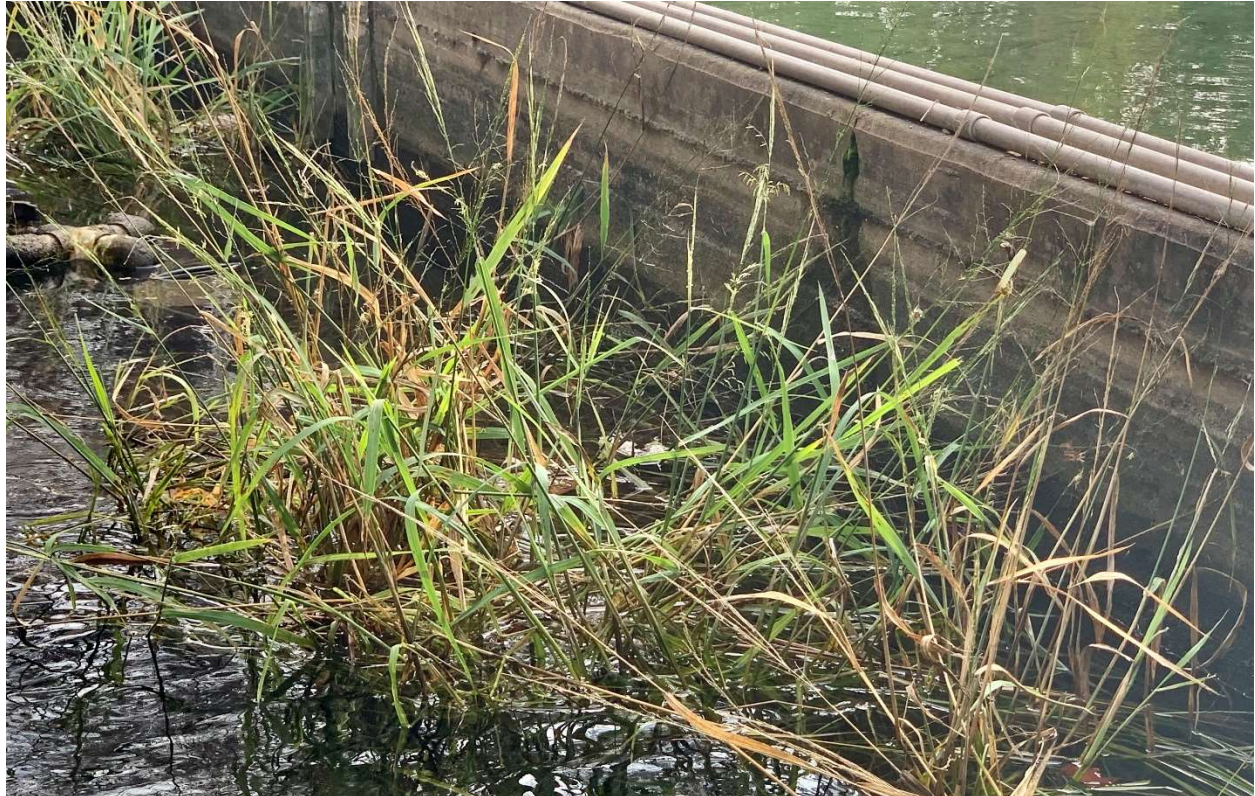
Figure 1. Texas wild-rice plants Texas State University raceways.

Texas wild-rice that was grown from seedlings is being maintained in the outdoor, aquifer fed, raceways at the Freeman Aquatic Building (FAB) on the campus of Texas State University. Planting did not take place in 2022 due to Condition M protocols and natural expansion in the river. Texas wild-rice has also exceeded its coverage goals in many reaches. The effort in planting of other native plants was prioritized to help promote a more heterogeneous native aquatic plant community. Texas wild-rice expansion is continually observed in the river via both seed and tiller reproduction. Seedling growth is frequently observed in freshly denuded areas. Care is taken to allow this expansion to occur naturally when conducting maintenance removal in those areas.

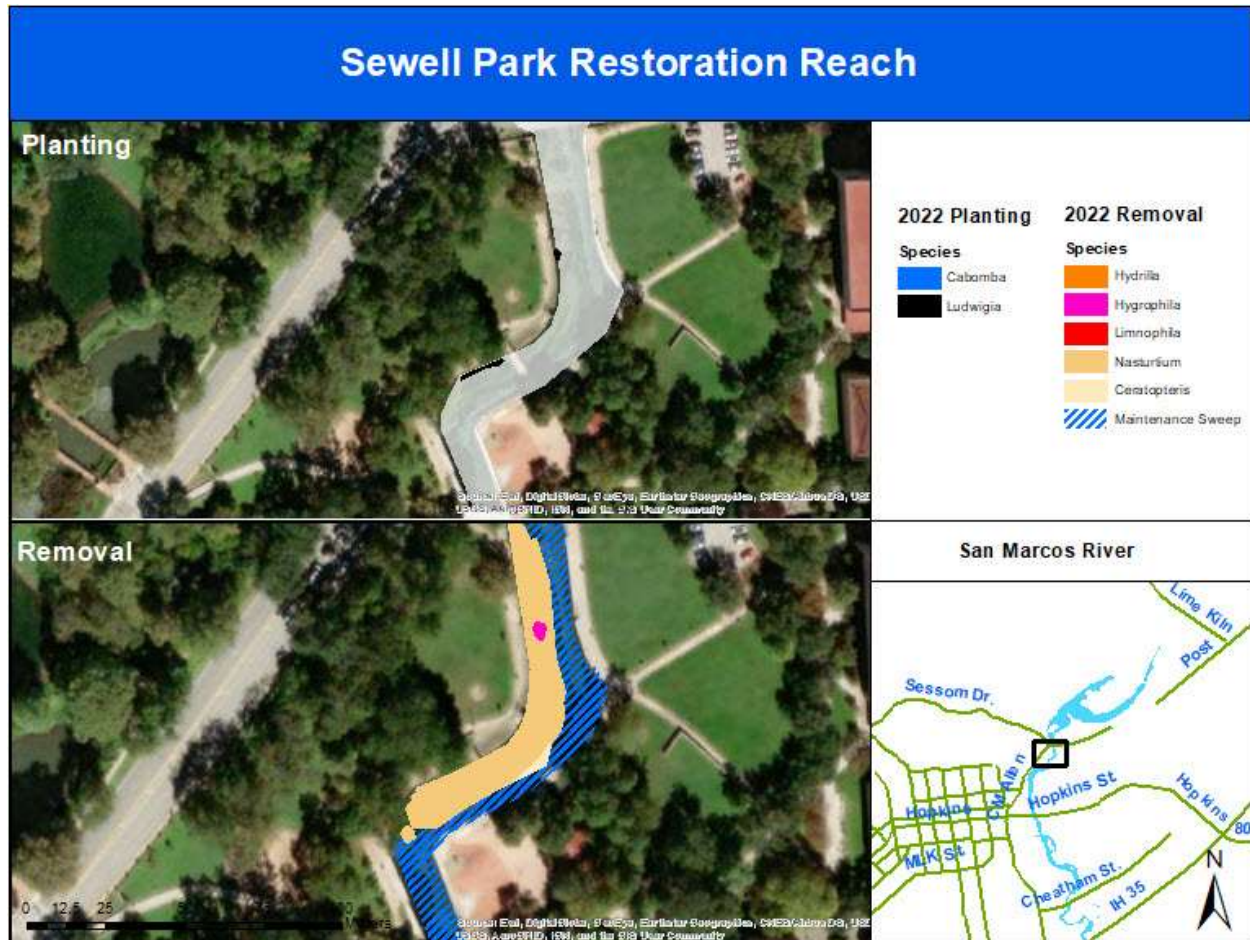
Figure 5. Locations of non-native vegetation removal and native SAV planting in Sewell Park restoration reach in 2022.

The Sewell Park Restoration reach was designated as a Maintenance Zone in 2022 and required occasional maintenance to remove non-native vegetation growth within existing patches of native SAV. Non-native removal occurred on a total of 13 days during which approximately 0.4 m² of Hydrilla, 17.1 m² of Hygrophila, 90.4 m² of Nasturtium, and 35.6 m² of Ceratopteris were removed. Low flows during 2022 caused shallow areas of native SAV to be overtaken by other semi-aquatic species. Non-native floating vegetation also expanded during low flows. Planting effort to fill in gaps between Texas wild-rice plants consisted of 470 Ludwigia individuals. This reach will be a Maintenance Zone in 2023 and will continue to receive routine maintenance and limited non-Texas wild-rice SAV planting. **(Figure 5).**

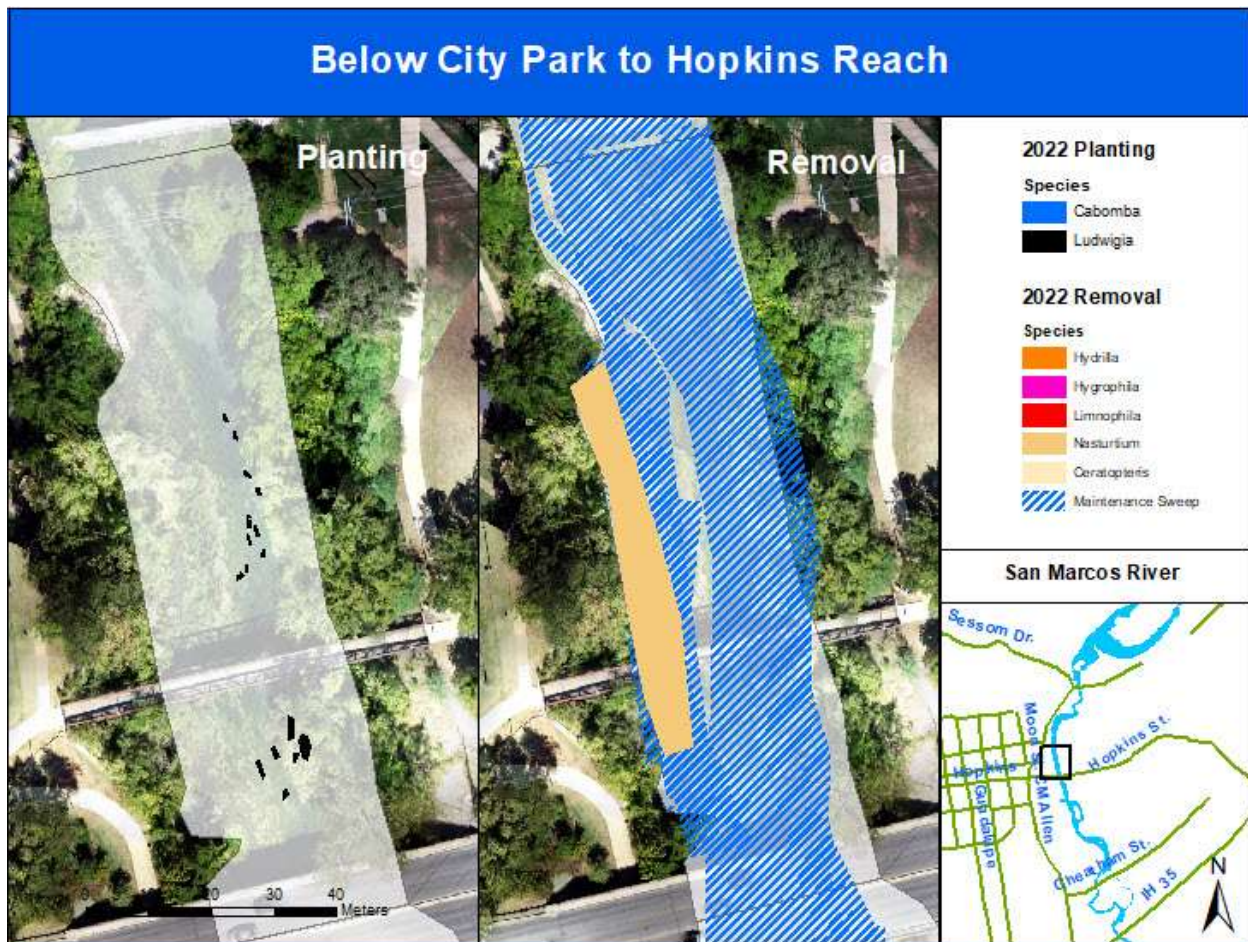
Figure 8. Locations of non-native vegetation removal and native SAV planting within Below City to Hopkins reach in 2022.

The Below City to Hopkins reach is a non-designated reach that was a Recovery Zone for 2022. Non-native removal was performed on a total of 27 days during which approximately 81.7 m² of Hydrilla, 87.9 m² of Hygrophila, 24.8 m² of Nasturtium, and 12.4 m² of Ceratopteris were removed. Planting effort focused on filling in areas where dense patches of Hygrophila were removed to promote SAV diversity. A total of 1040 Ludwigia individuals were planted. Texas wild-rice along with other native plants were denuded by heavy recreation but some recovery is expected from October to March. This reach will be a Maintenance Zone in 2023. **(Figure 8).**

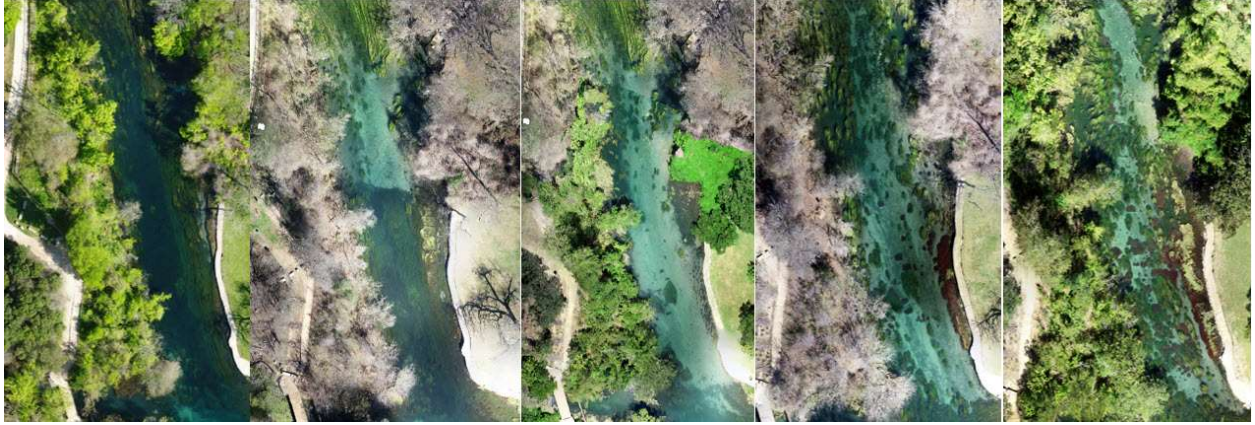
Figure 12. Hopkins Street to Snake Island restoration reach removal and planting progress in 2022. Before treatment (left, 2020), after treatment and initial planting, and progress of native SAV expansion (right, Nov 2022).

Hydrilla removal occurred in the Bicentennial reach in 2022. This reach consisted of a large, dense area of non-native vegetation that was removed on an expedited timeline. Low flows, resulting in the implementation of Condition M protocols, were expected so increased effort was made to finish bulk removal efforts while flows were still above Condition M levels. This resulted in a large, denuded area of approximately 2,100 m² that contained a significant amount of Hydrilla tubers, requiring regular sweep dives every few days to prevent regrowth. Even though maintenance is still ongoing in this area, native plants have begun to expand. Texas wild-rice and Cabomba are expanding in the Bicentennial reach but Ludwigia, Heteranthera, and Sagittaria are also becoming established to a lesser degree (**Figure 13 & 14**). Planting in this reach will commence when Condition M protocols end.

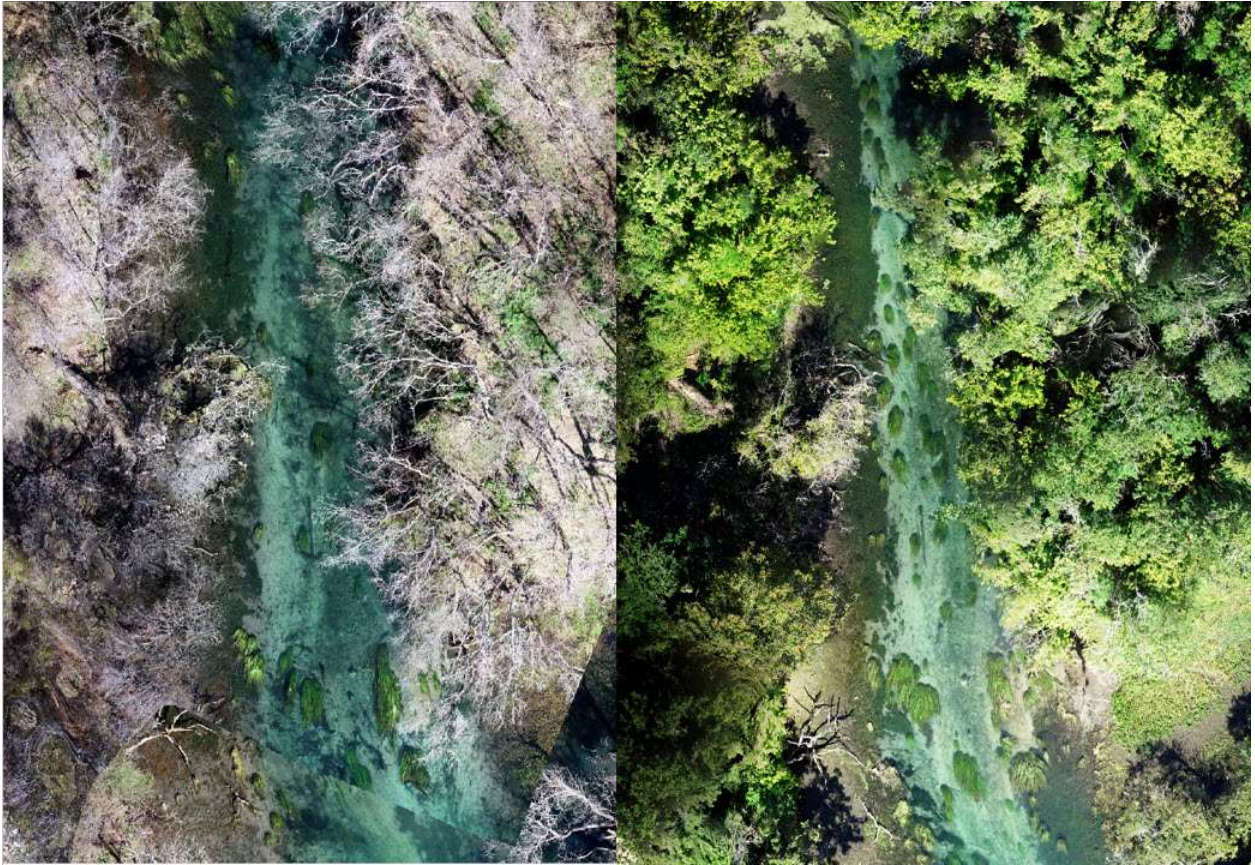
Figure 13. Expansion of Texas wild-rice and Cabomba in the right channel adjacent to Snake Island (left, Feb 2022, right, Nov. 2022).

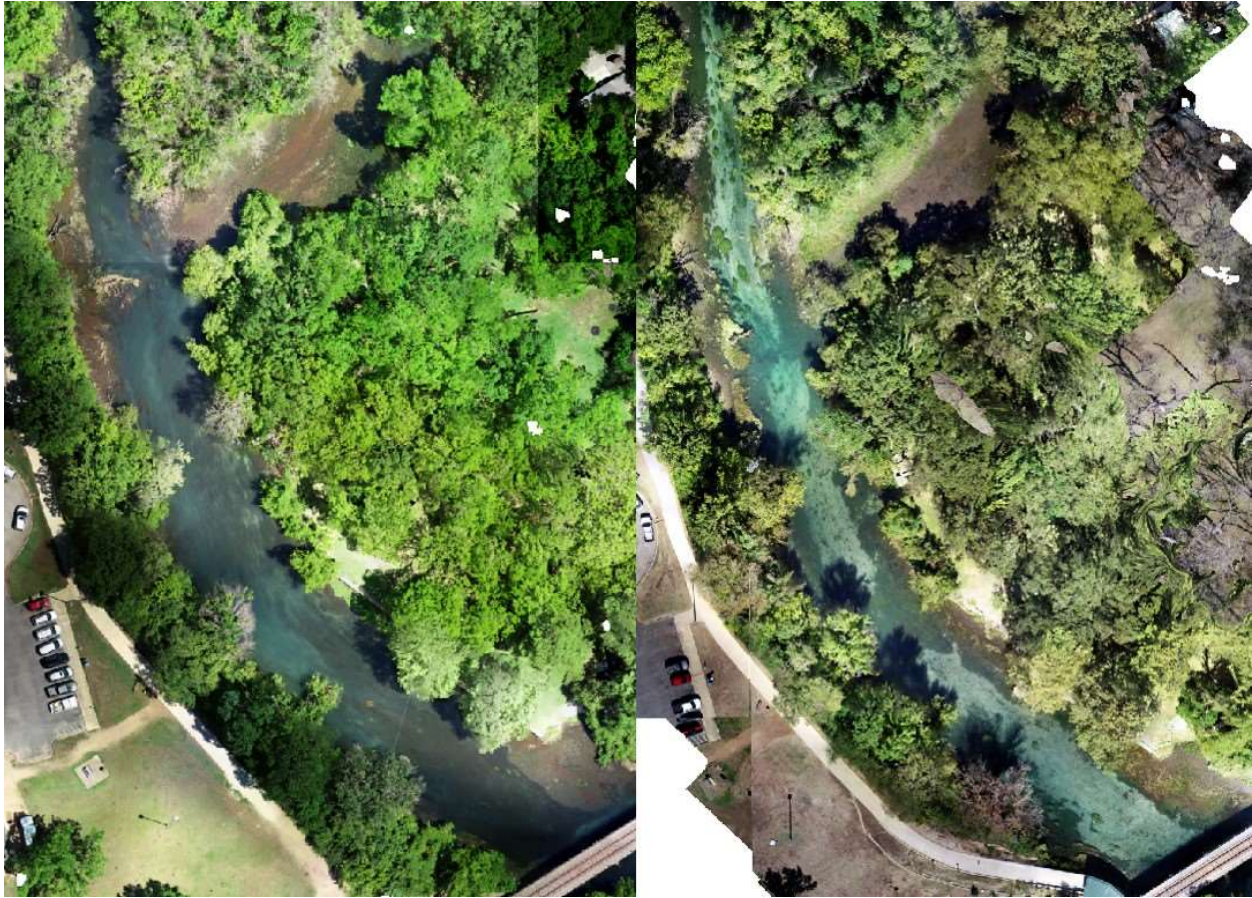
Figure 14. An aerial view of the 2022 work zone (left, pretreatment, right, Nov. 2022).

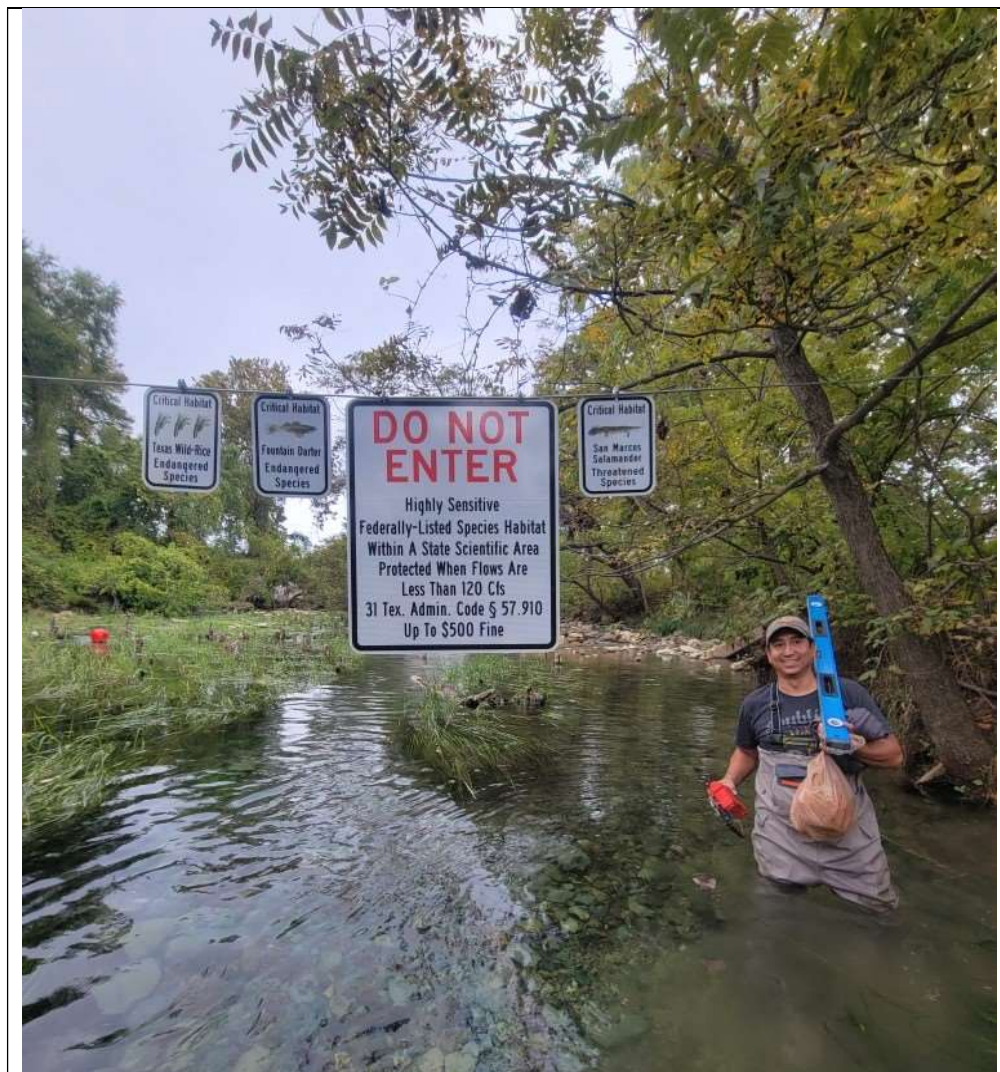
Figure 1. Signage installed within the Eastern Spillway area of the San Marcos River

fountain darter and endangered TWR. **Figure 1** shows the installed signage in the Eastern Spillway area.

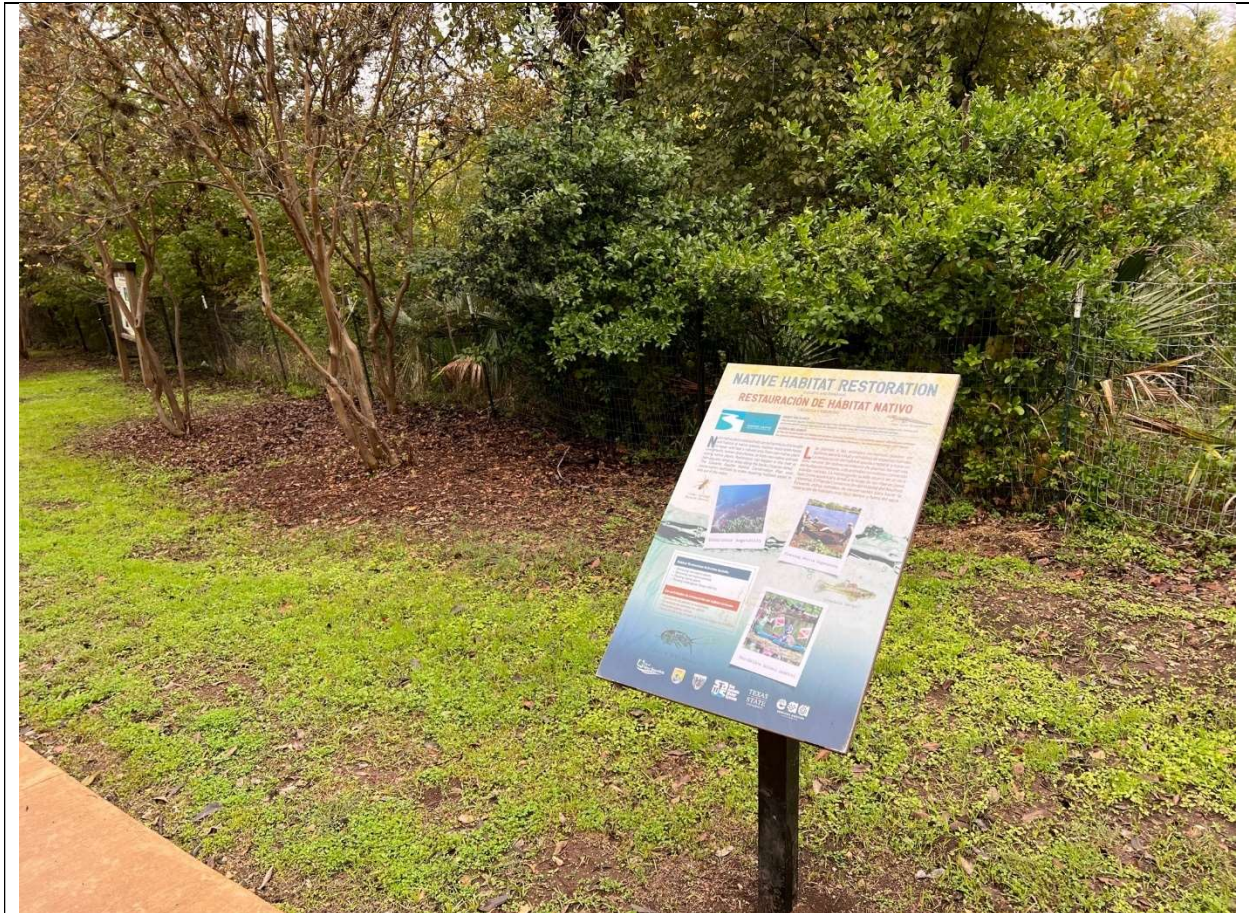
Figure 2. Example of EAHCP signage installed in 2022. This sign was installed in Bicentennial Park and informs park visitors of EAHCP riparian restoration work and the importance of a healthy riparian zone buffer.

In coordination with the EAA, CoSM installed EAHCP educational signage at City river parks that include Ramon Lucio Park (1), Rio Vista Park (2), Bicentennial Park (2) and City Park (1). The signage helps to inform river and park visitors of the EAHCP, threatened/ endangered species and protection initiatives. **Figure 2** shows an example of the education signage installed in 2022.

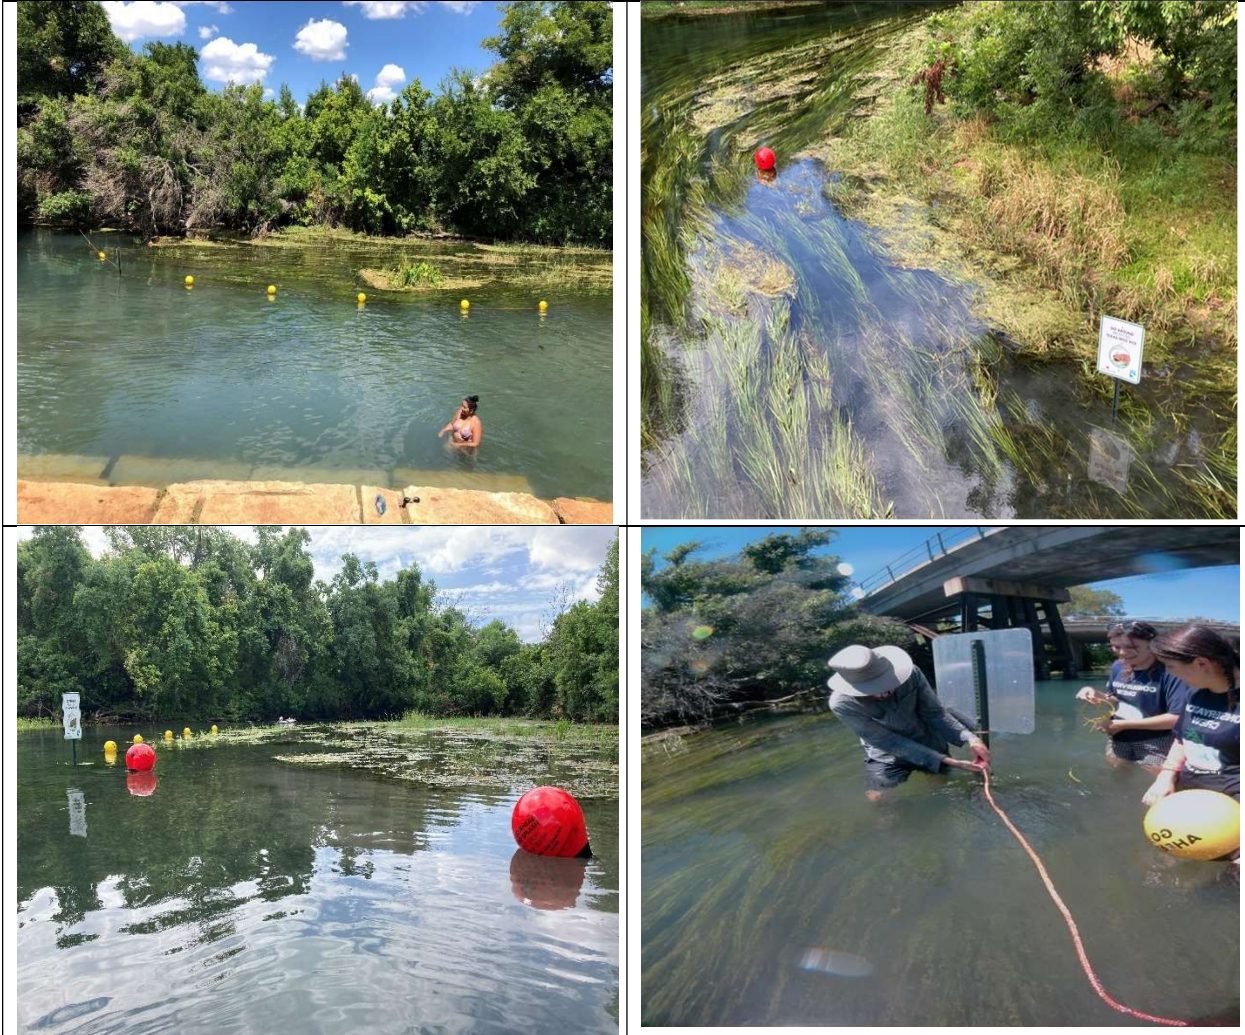
Figure 4. Photos showing the buoys, signage and exclosures that were installed to denote the TWR protection zones in the San Marcos River. The photo on the upper left is in the river immediately downstream of the Hopkins St. bridge, photo on the right is immediately downstream of Sewell Park, photo on bottom left is at Bicentennial Park and photo on bottom right is the Conservation Crew installing the exclosure and buoys.

In July 2022, as San Marcos River flow decreased below 120 cfs, the Conservation Crew installed the TWR exclosures and buoys around the defined State Scientific Areas that have been established to protect TWR stands during low-flow periods. **Figure 3** shows the location of the TWR protection zones, and **Figure 4** shows examples of the installed protection zones. The Conservation Crew routinely monitored and maintained the exclosures throughout 2022. The exclosures remained in place from July-December 2022 and will remain in place until river flow increases above 120cfs.

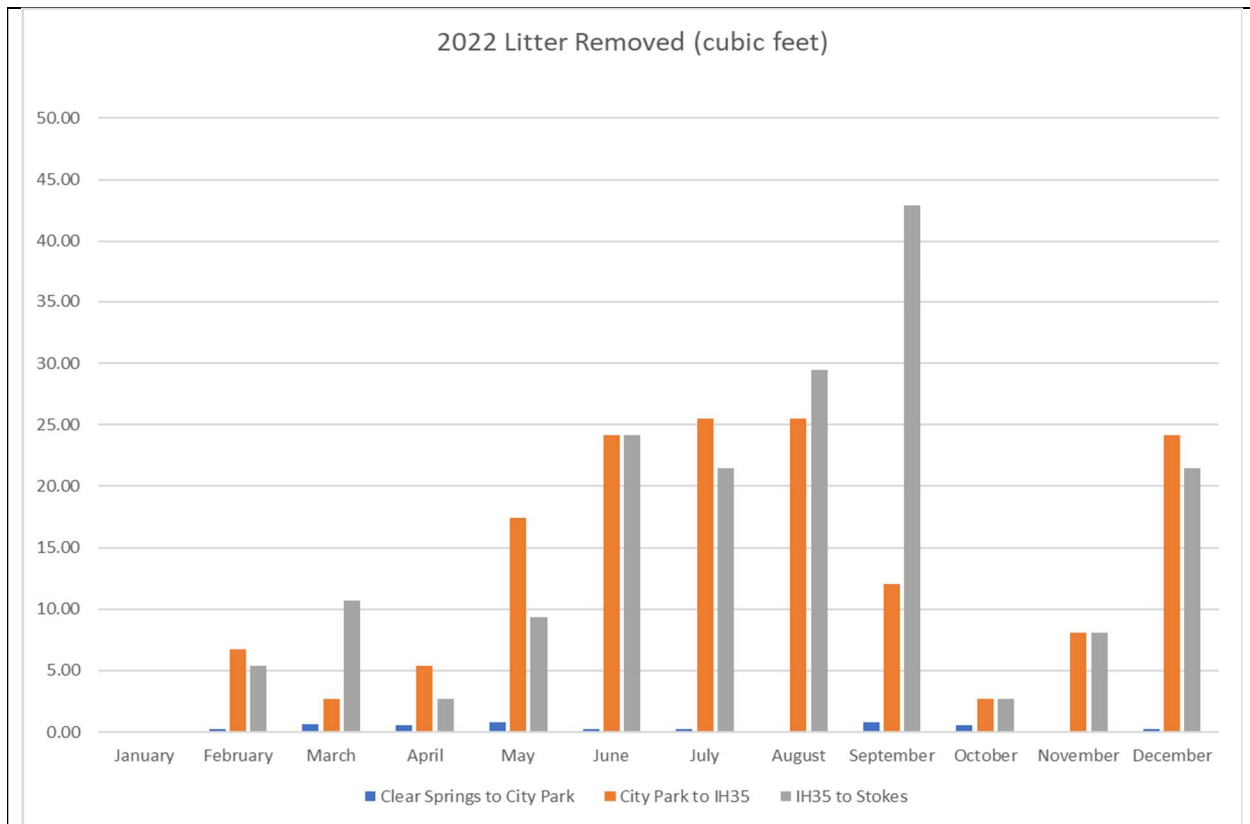
Figure 1. Volume of litter collected, per month, from the San Marcos River in 2022.

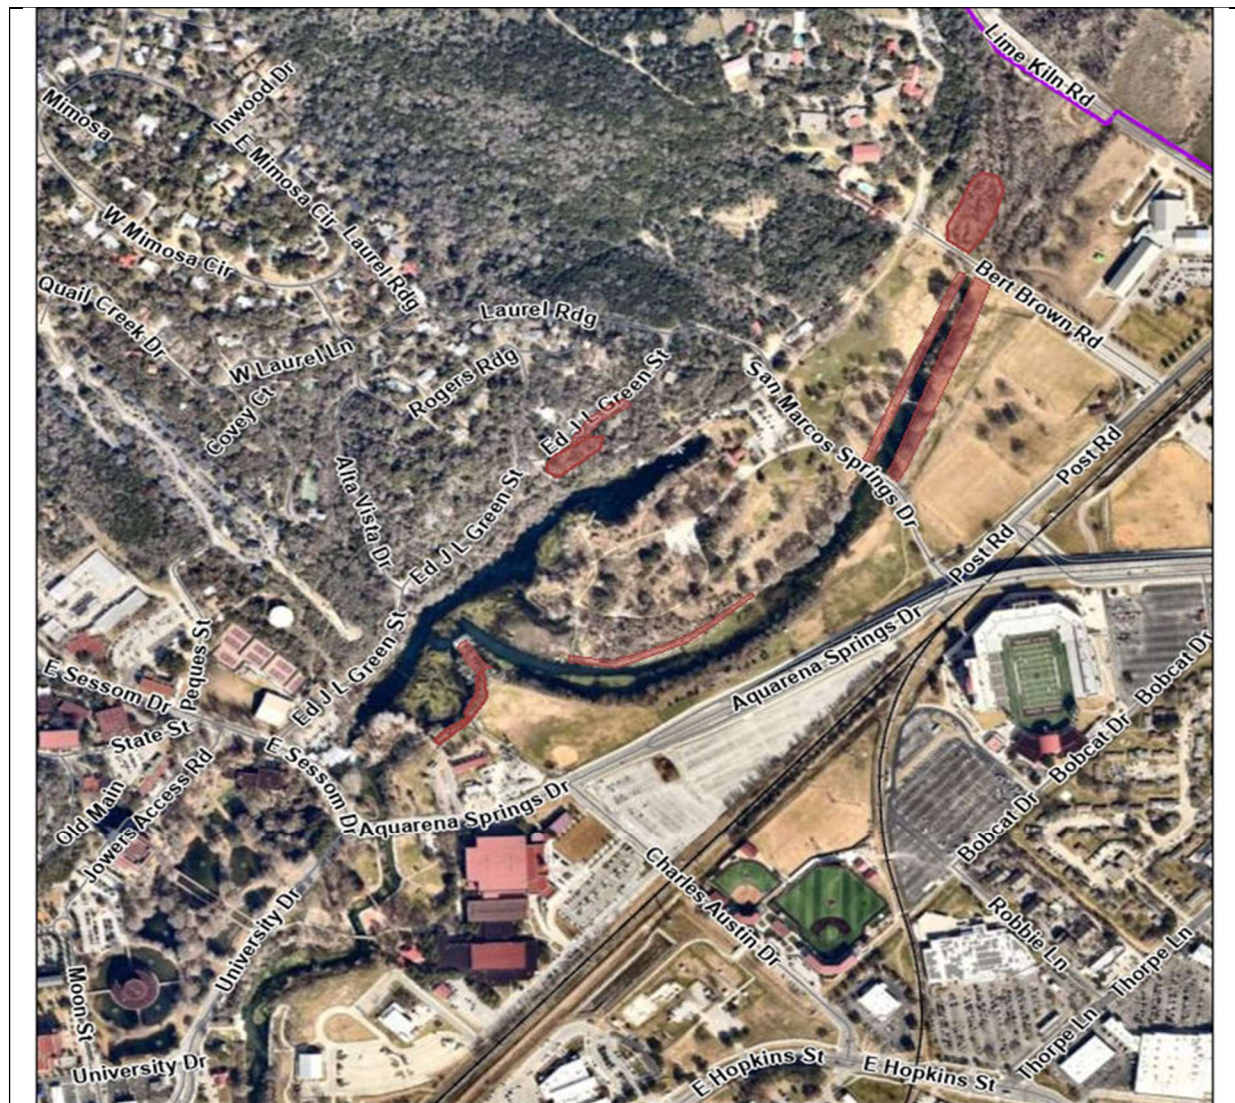
Figure 1. 2022 Non-native littoral vegetation management focus areas

In 2022, non-native riparian/ littoral vegetation removal efforts consisted of treatment of invasive, exotic vegetation along the San Marcos River from above Bert Brown Road (upstream of Spring Lake) to IH-35. Removed non-native species included: Brazilian Vervain, Caribbean Lantana (and hybrids), Cat's Claw Vine, Chinaberry, Chinese Elm, Chinese Privet, Chinese Tallow, Eleagnus sp., Elephant Ears, English Ivy, Japanese Honeysuckle, Johnson Grass, Ligustrum, Limnophila, Nandina, Parrot's Feather, Periwinkle, Purple Trailing Lantana, Umbrella Sedge, Vasey Grass, Water Hyacinth, and Wisteria. While non-native treatment occurred throughout the San Marcos River from Sink Creek to IH-35, focus areas included locations around Spring Lake & in lower Sink Creek (**Figure 1**).

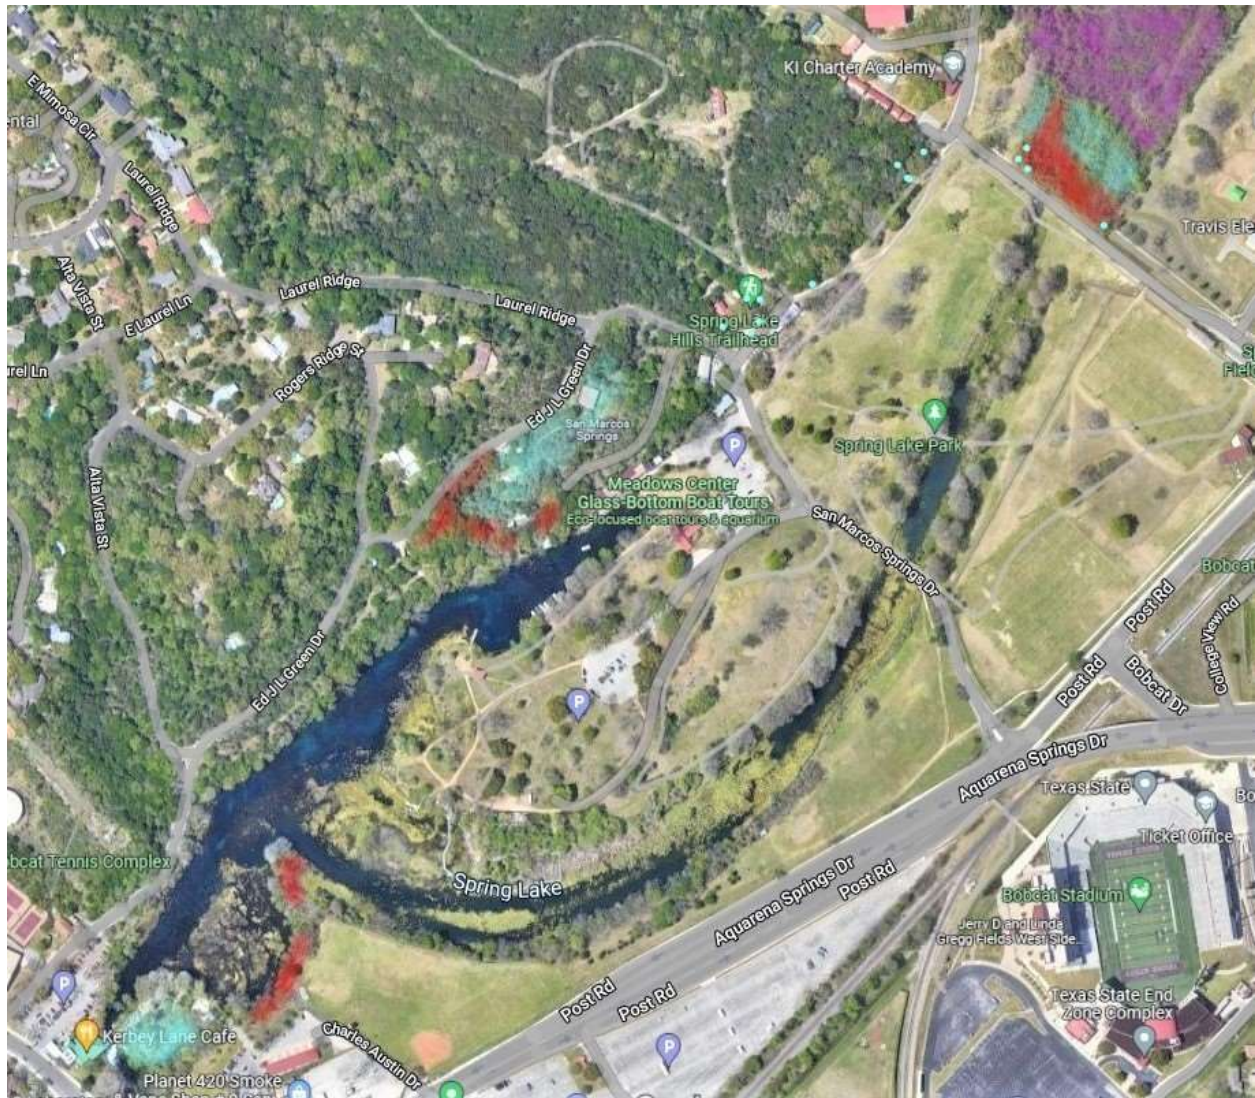
Blue – Cat's Claw Vine (Hillside Trails Area), Chinaberry, Chinese Tallow, Ligustrum and/or other invasive, exotic, woody species. **Purple** – Possible Future Expansion

Red – Areas that Were Worked on in 2022 (other than maintenance runs)

Remaining San Marcos River areas to be treated after 2022 removal efforts.

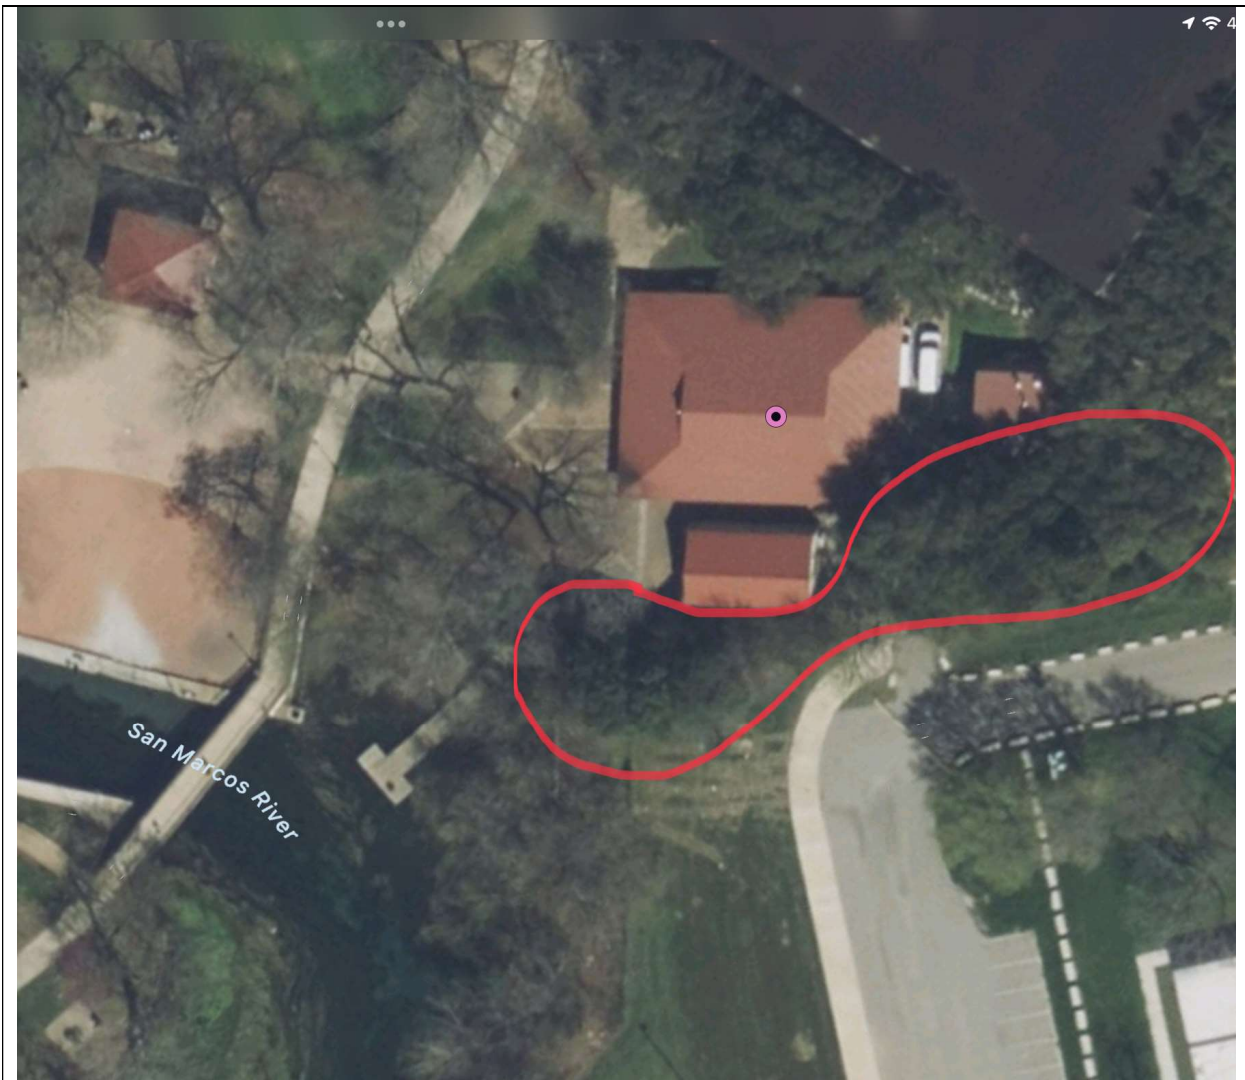
Figure 1. Location of where non-native vegetation was removed in Sewell Park adjacent to the TXST Outdoor Center boat storage area. Ligustrum was the dominant non-native species targeted for removal at this location.

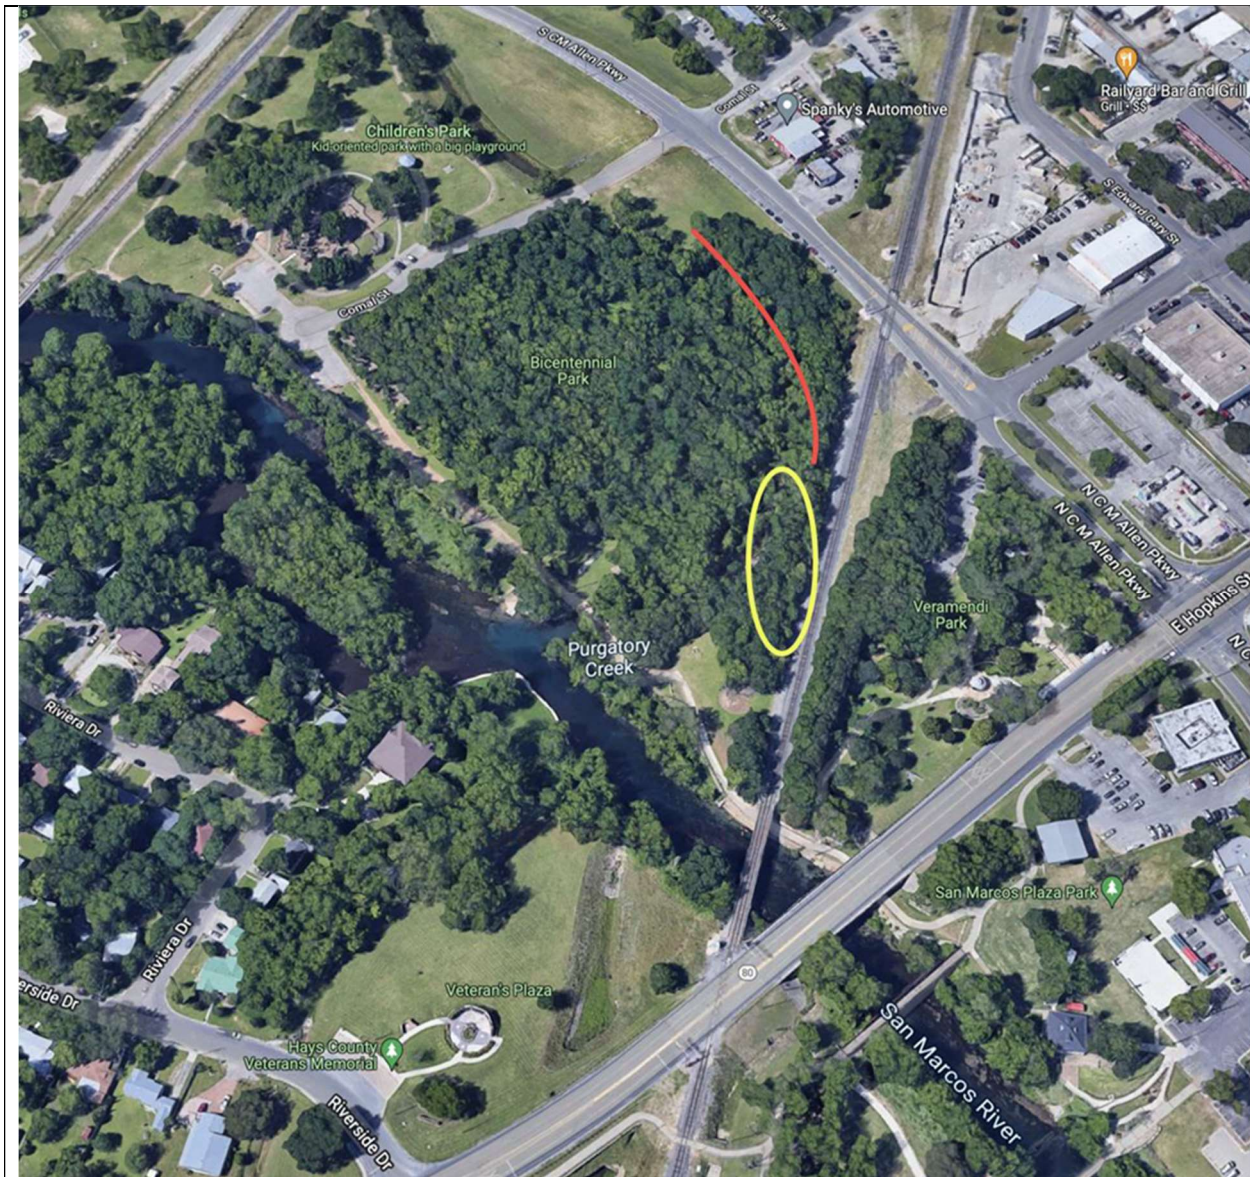
Figure 2. Location of non-native vegetation removal along Purgatory Creek near its confluence with the San Marcos River as denoted with yellow circle.

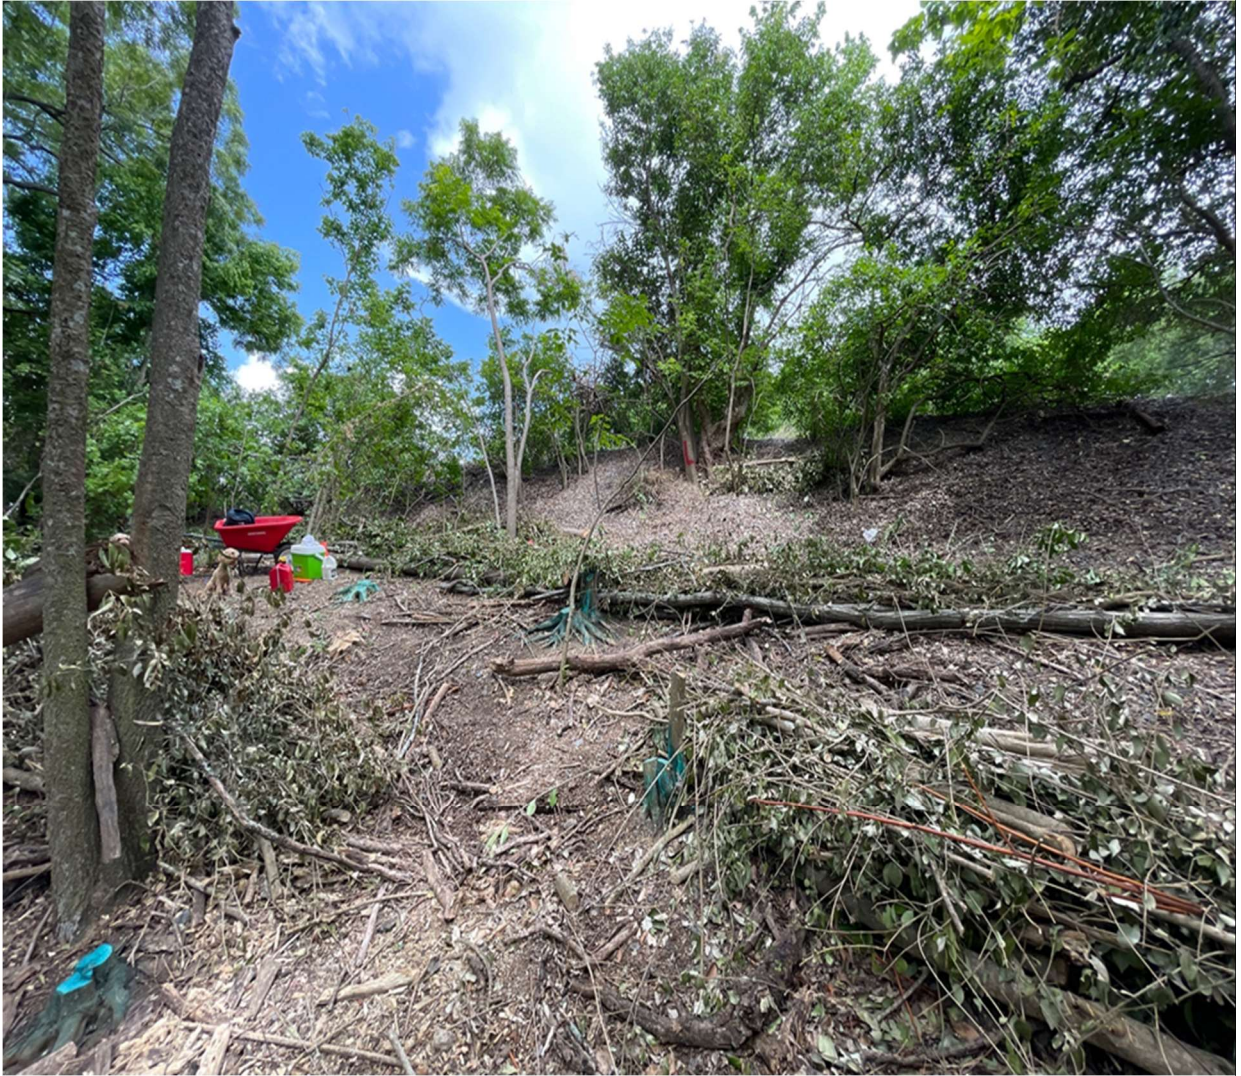
Figure 3. Photo showing cut and treated Ligustrum & brush berms constructed using slash material from cut trees.

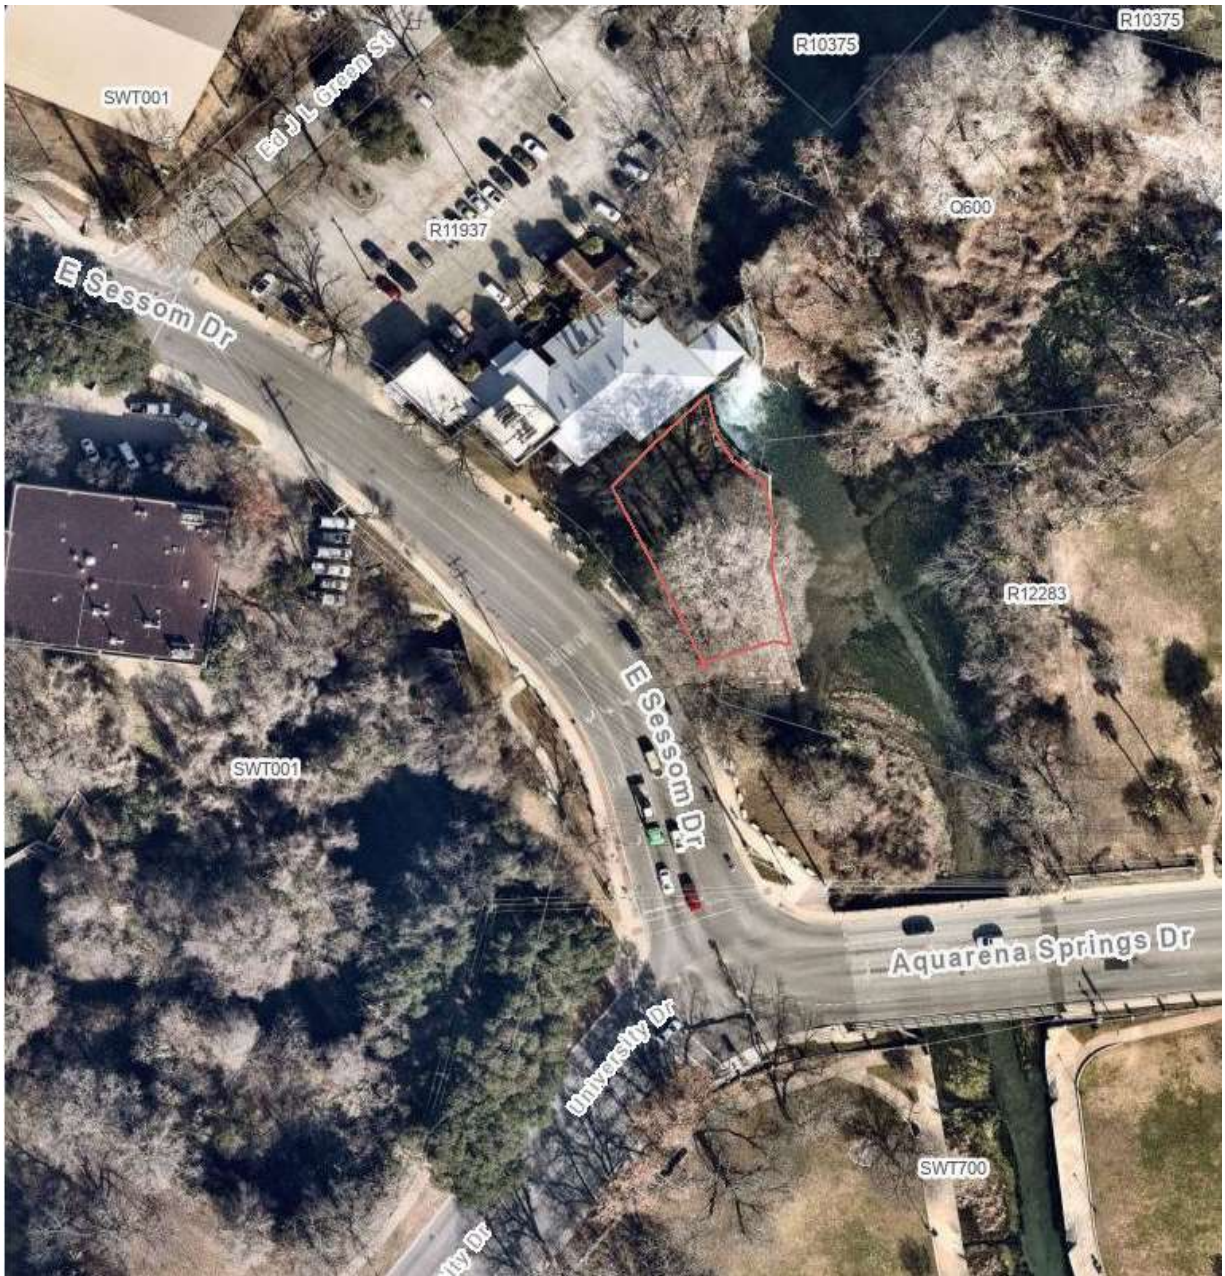
Figure 4. Upper Sewell Park Riparian Planting Area. Planting area denoted by red outline.

In addition, City of San Marcos and Texas State University (TXST) coordinated a volunteer planting event in the Upper Sewell Park area along the San Marcos River immediately downstream of the Kerbey Lane Café on river-right (**Figure 4**). This planting included planting of over 100 native plants that included Montezuma Cypress, Sycamore, Turk's Cap, Inland Sea Oats, Mountain laurel, Texas Redbud, Fragrant Mimosa, Agarita, Switchgrass, American Beautyberry & Corralbean. Native plants were purchased and provided by TXST. Approximately 30 volunteers participated in the planting event. Photos are included in **Figure 5**.
