**Appendix J | 2022 Item M Net Disturbance and
Incidental Take Assessment for EARIP ITP
Annual Report**

MEMORANDUM

SUBJECT: **ITEM M NET DISTURBANCE AND INCIDENTAL TAKE
ASSESSMENT FOR 2022 EARIP ITP ANNUAL REPORT**

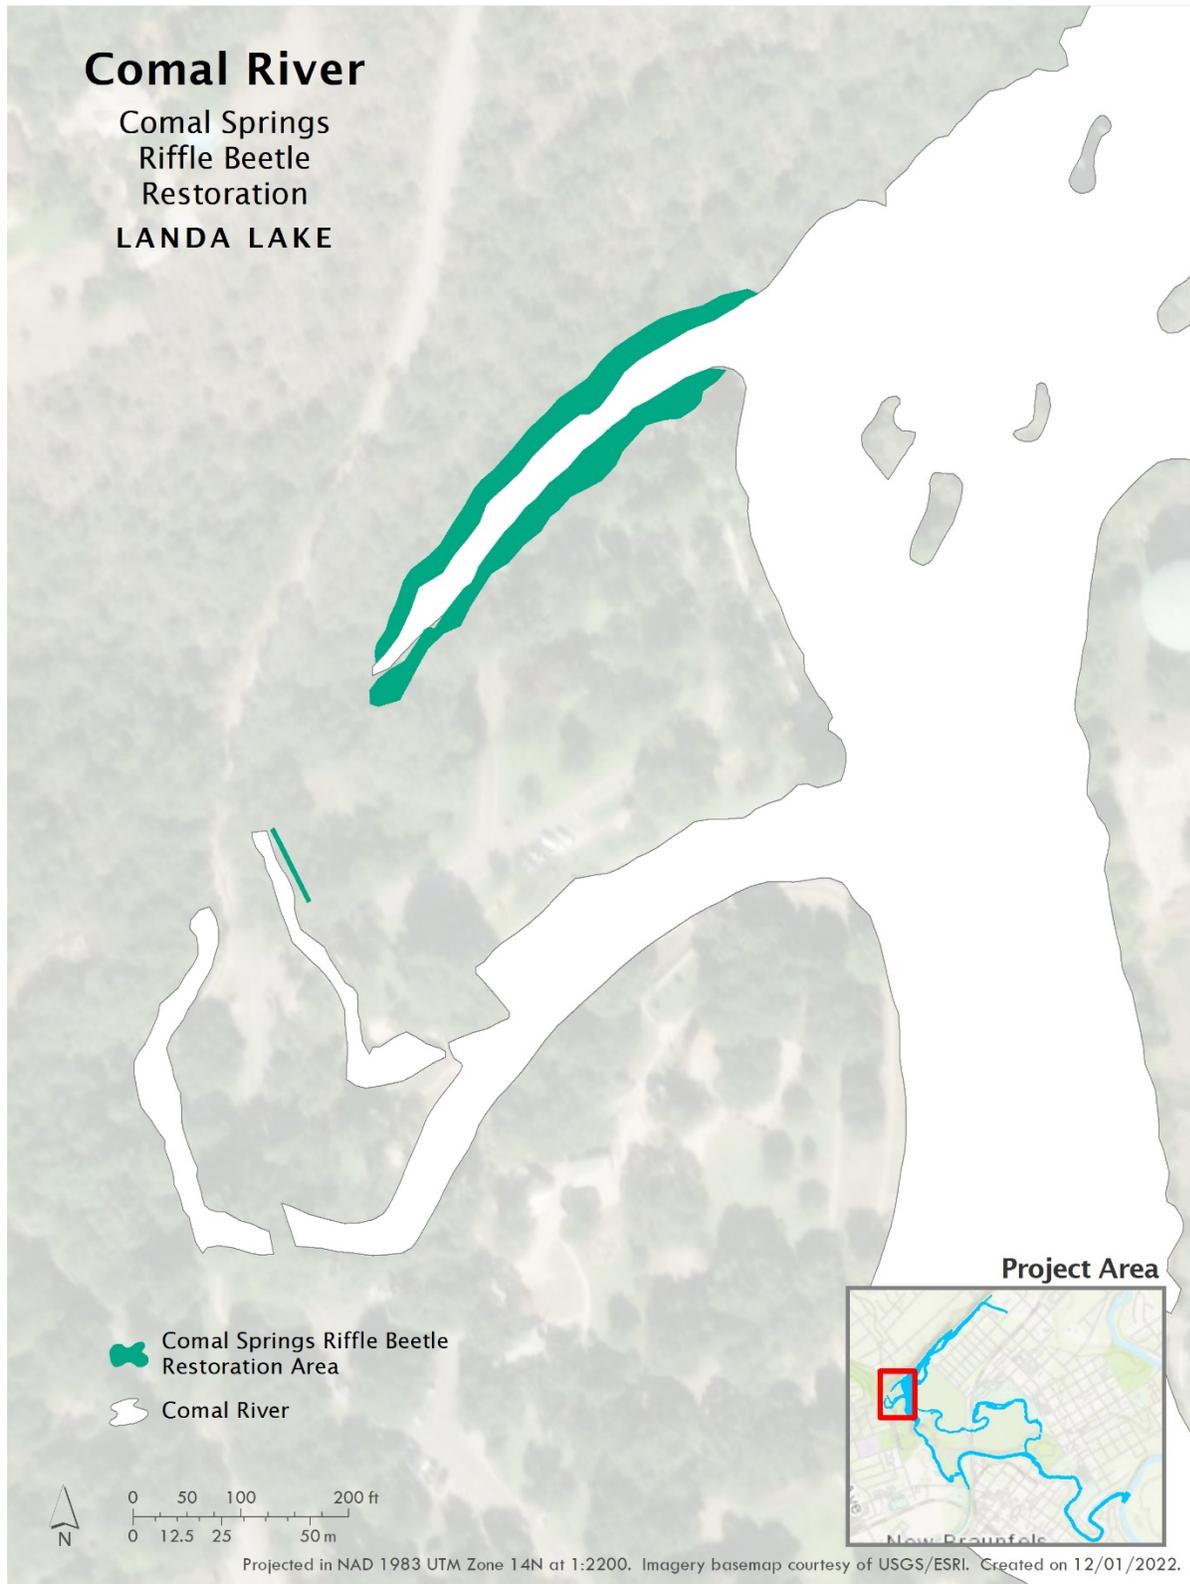
Figure 2. Comal Springs Riffle Beetle Restoration project – Comal System.

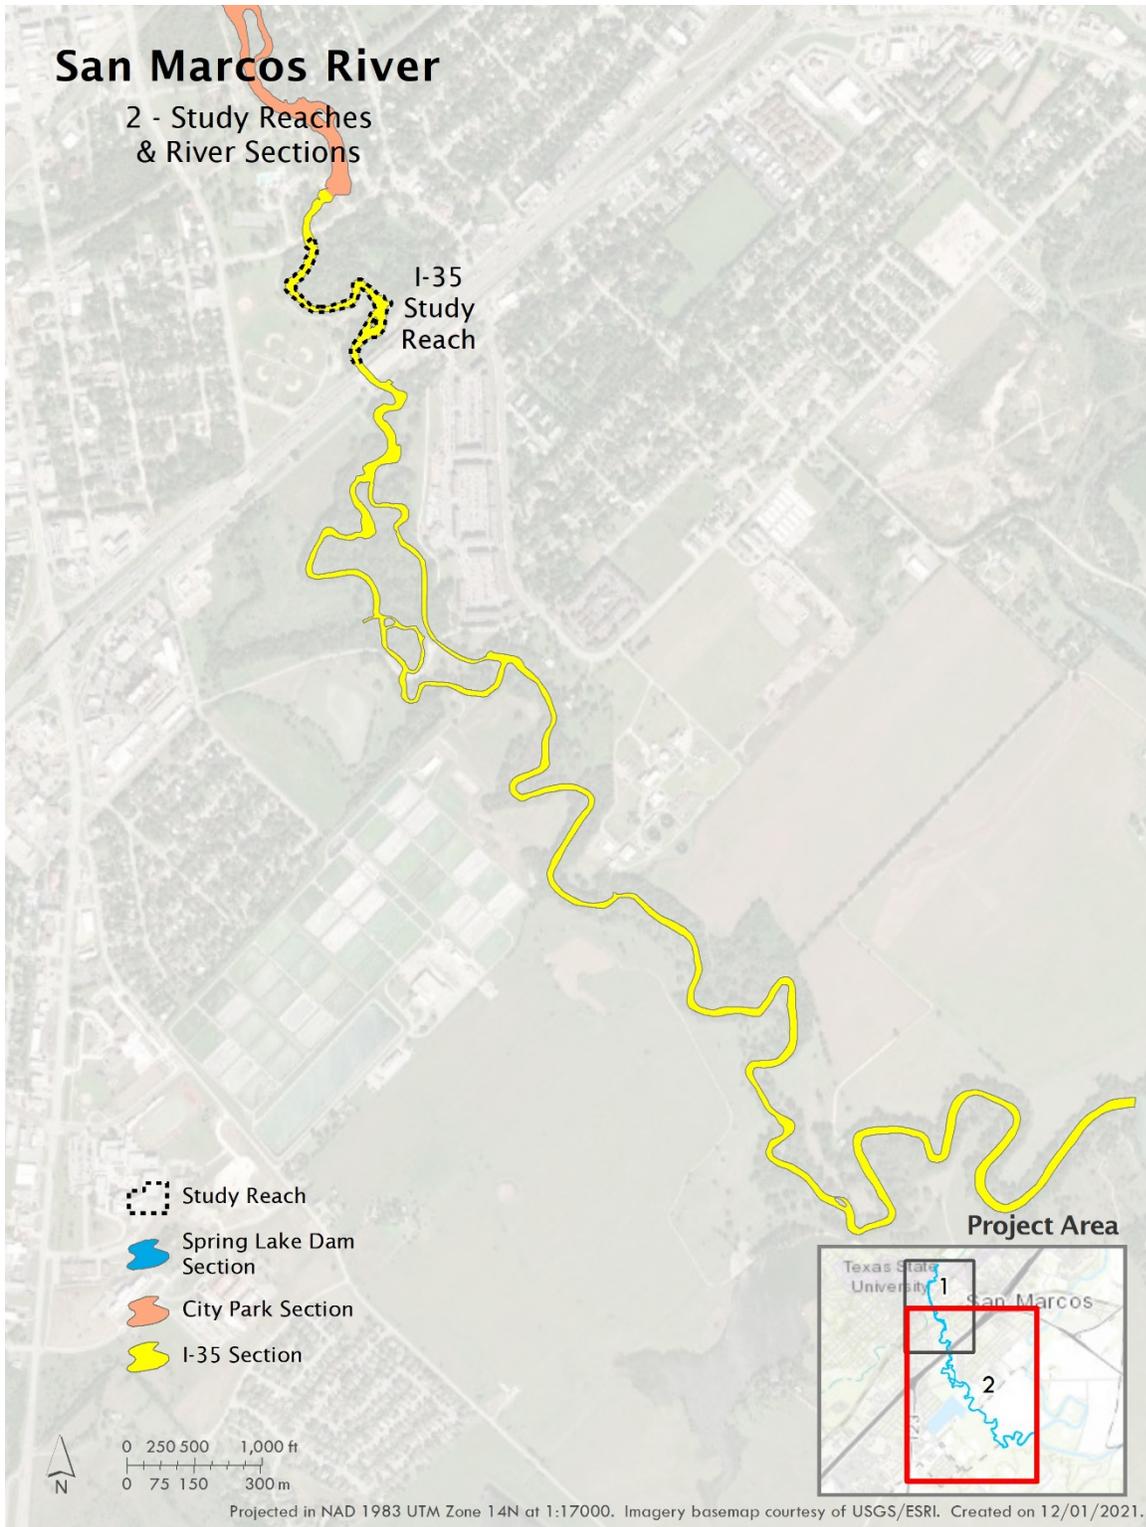
Figure 9 cont. I35 Study Reach and Corresponding Lower River Section in the San Marcos System.
