MEMORANDUM

DATE: December 28, 2023

SUBJECT: **ITEM M NET DISTURBANCE AND INCIDENTAL TAKE
ASSESSMENT FOR 2023 EARIP ITP ANNUAL REPORT**

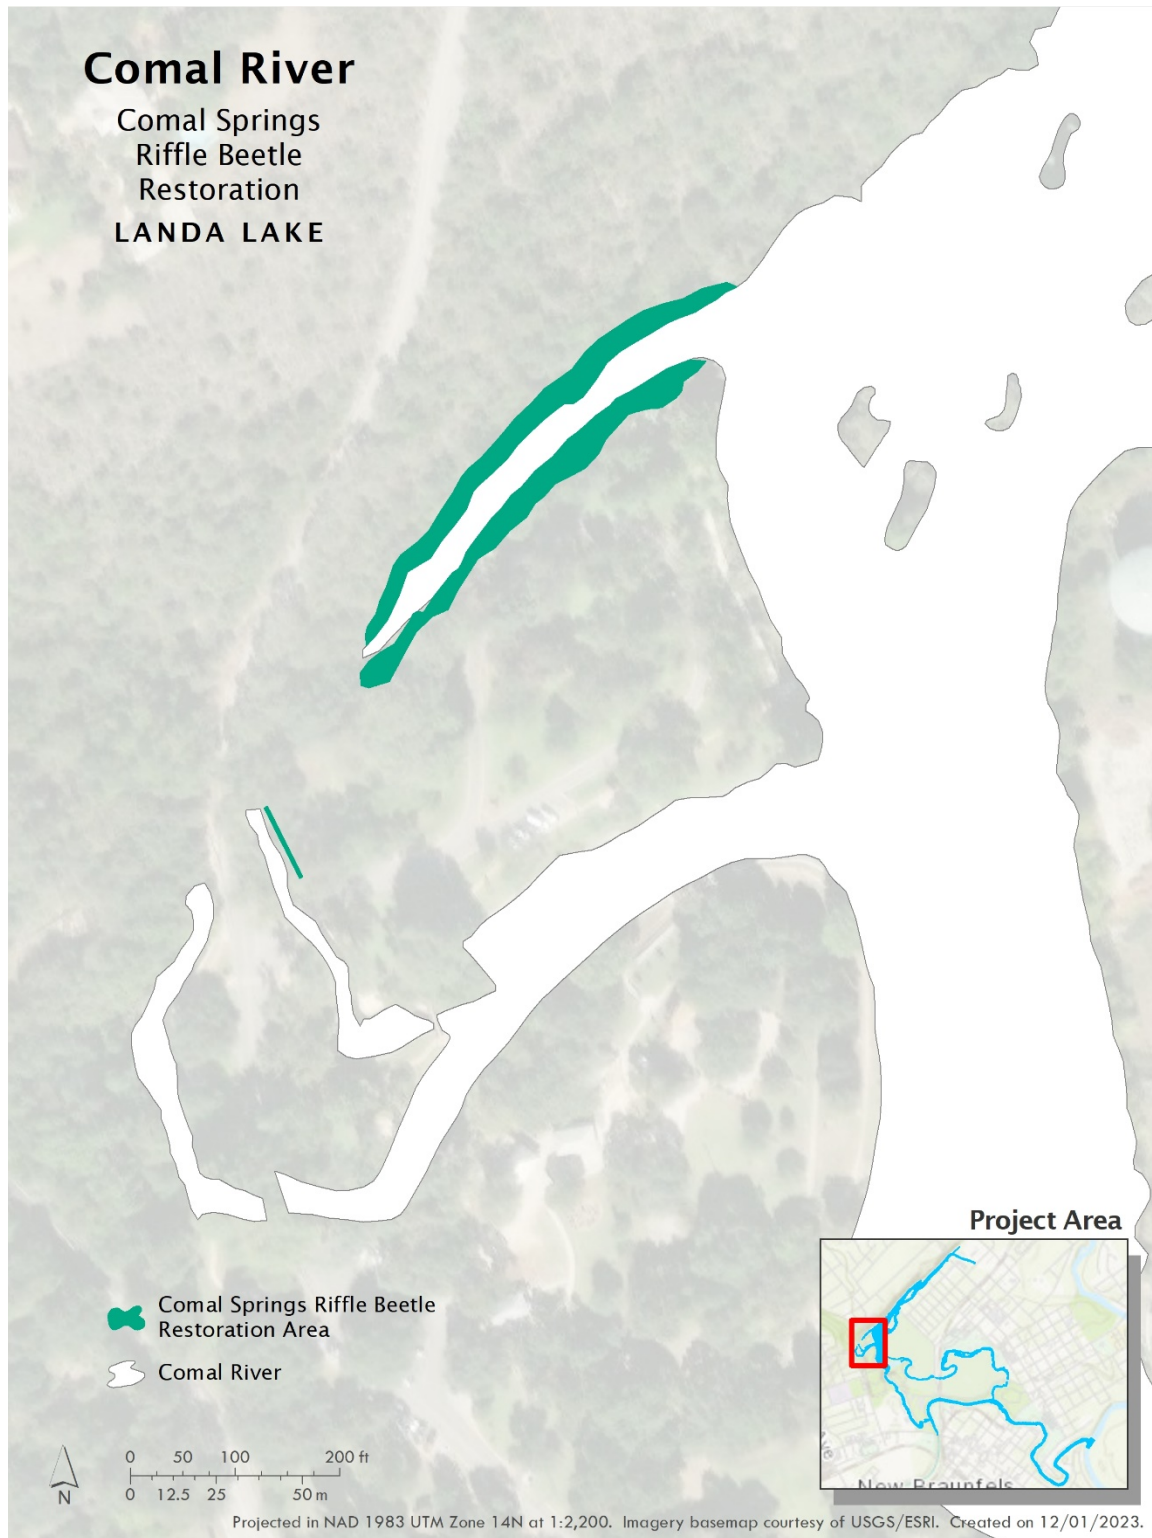
Figure 2. Comal Springs Riffle Beetle Restoration project – Comal System.
