Appendix I | 2023 City of San Marcos and Texas State University Reports

Appendix I1 | Aquatic Vegetation Restoration/Floating Vegetation Mat Management

Texas Wild-Rice Enhancement, Aquatic Vegetation Restoration and Floating Vegetation Mat Management in the Upper San Marcos River

January 5, 2024

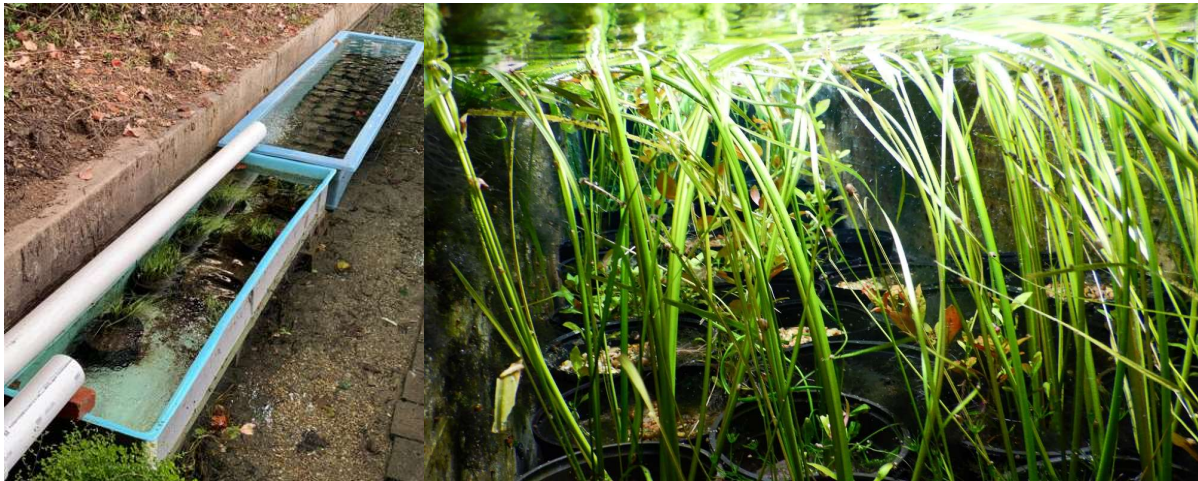
Figure 1. Texas wild-rice seed propagation and grow out in Texas State University raceways.

TWR that was grown from seedlings is maintained in the outdoor, aquifer-fed, raceways at the Freeman Aquatic Building (FAB) on the campus of Texas State University (**Figure 1**). TWR planting did not take place in 2023 due to Condition M protocols and healthy population size in the river. Since TWR has also exceeded its coverage goals in many reaches, planting of other native plants was prioritized to help promote a more heterogeneous native aquatic plant community to help support fountain darter densities. Texas wild-rice expansion is continually observed in the river via both seed and tiller reproduction, with seedling growth occurring in freshly denuded areas. Care is taken to allow this expansion to take place naturally when non-native SAV is removed in those areas.

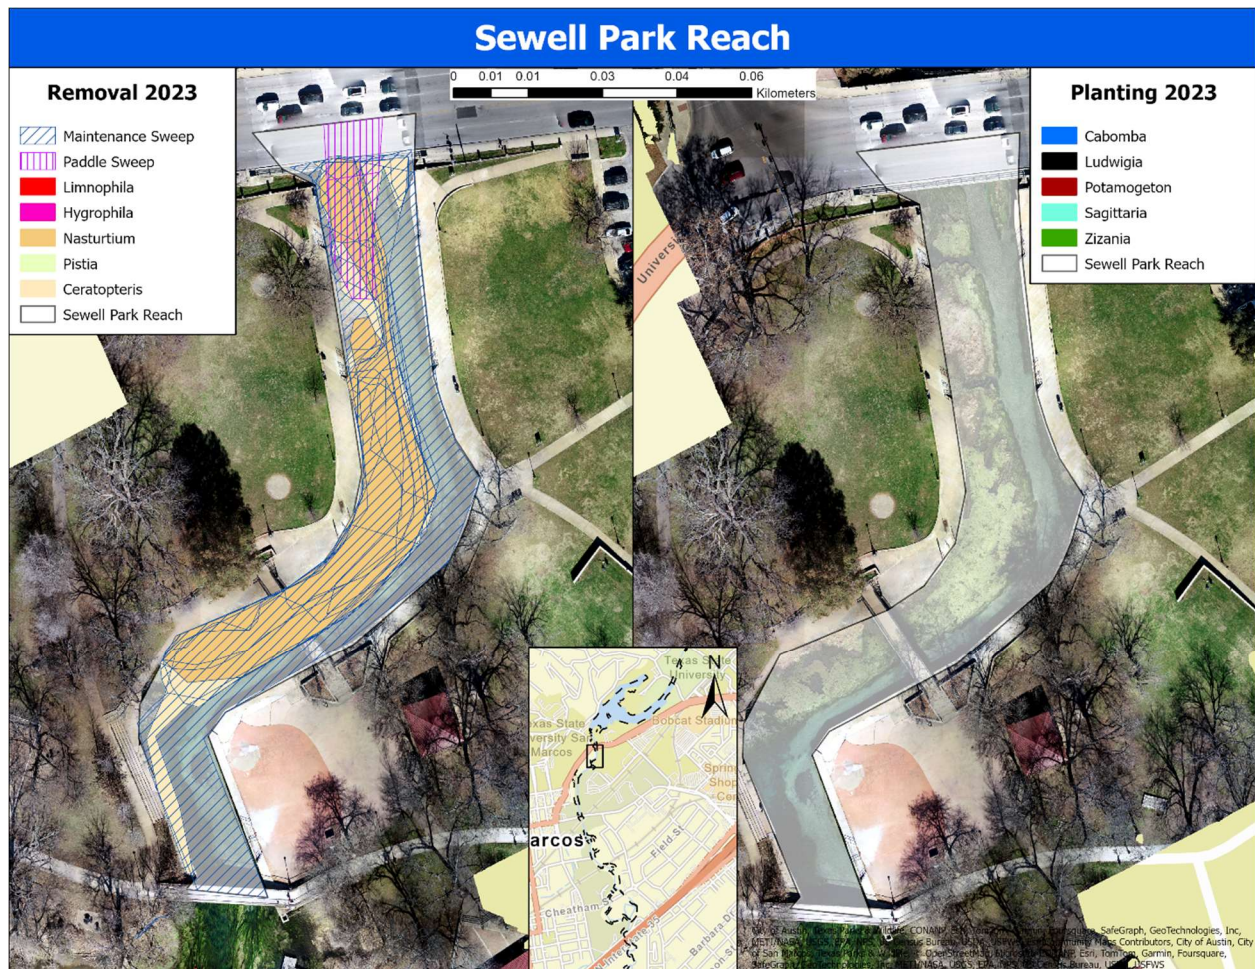
Figure 5. Locations of non-native vegetation removal and native SAV planting in Sewell Park Restoration reach in 2023. No planting occurred in 2023 within this reach.

The Sewell Park Restoration reach was designated as a Maintenance Zone in 2023 and required occasional maintenance to remove non-native SAV within existing patches of native SAV. Maintenance effort resulted in the removal of 24.85 m² of Hygrophila, 0.36 m² of Hydrilla, 9.04 m² of Nasturtium, and 14.94 m² of Ceratopteris (**Figure 5**). Persistent low-flow conditions experienced throughout 2023 caused native SAV within shallow areas to be overtaken by other semi-aquatic and terrestrial species. Non-native floating vegetation also expanded in areas where river levels declined and created extremely shallow or dewatered areas because of low-flow conditions. This is anticipated to continue to be problematic so long as source populations persist upstream. This reach will be designated as a Maintenance Zone in 2024 and will continue to receive routine maintenance and limited native, non-TWR SAV planting.

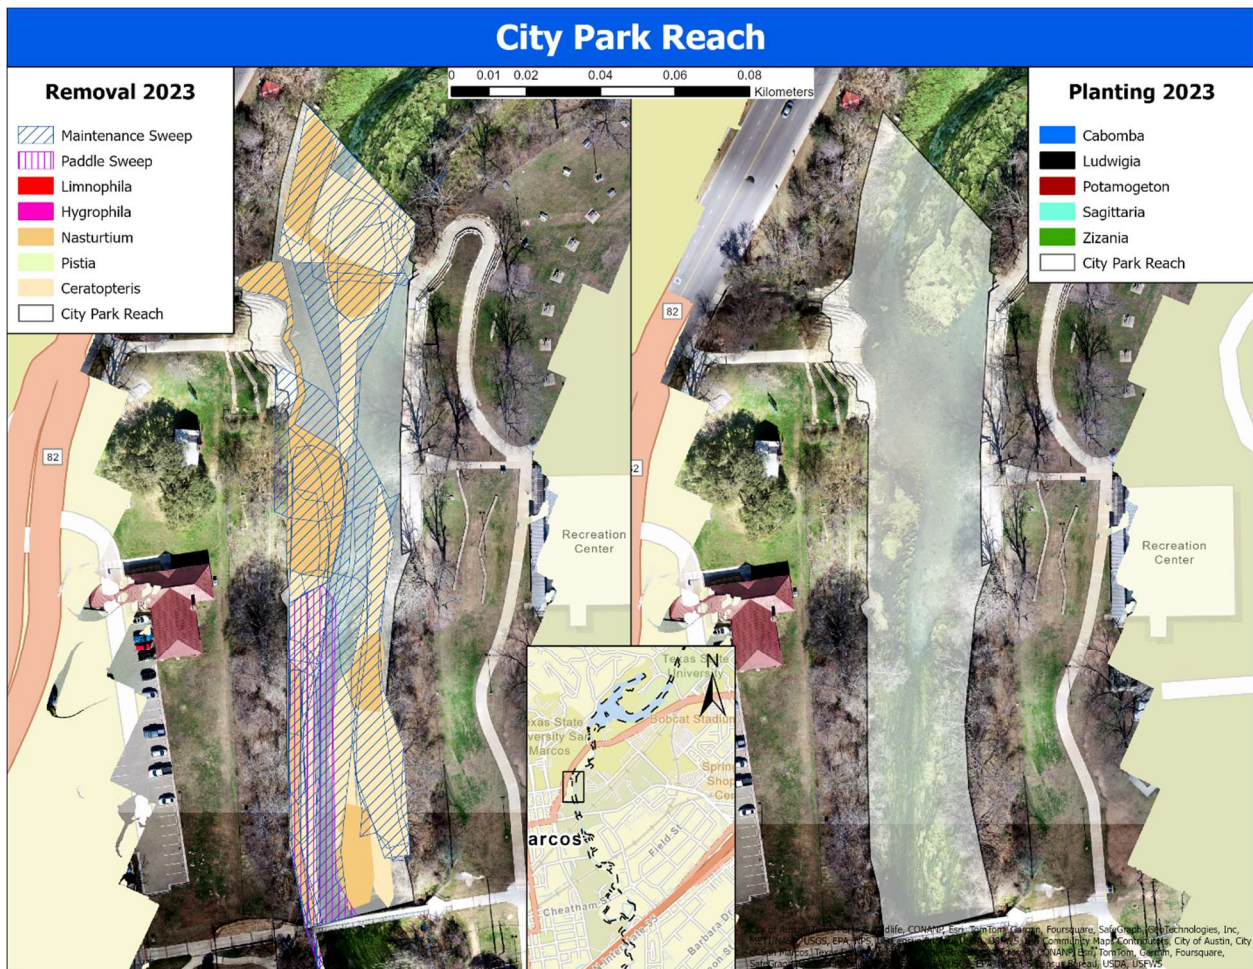
Figure 7. Locations of non-native vegetation removal and native SAV planting within City Park Long Term Biological Goal Reach in 2023. No planting occurred in 2023 within this reach.

The City Park LTBG reach was designated as a Maintenance Zone for 2023, having already received large-scale removal in prior years. Maintenance effort resulted in the removal of 37.43 m² of Hygrophylla, 3.73 m² Hydrilla, 89.62 m² of Nasturtium, and 55.13 m² of Ceratopteris (**Figure 7**). TWR, along with other native SAV along Dog Beach (i.e. river-right), where significantly affected by a combination of recreation and low-flow conditions. Supplemental plantings of native, non-TWR SAV will likely be required in 2024 and future years to reach target SAV goals. This reach will remain a Maintenance Zone in 2024.

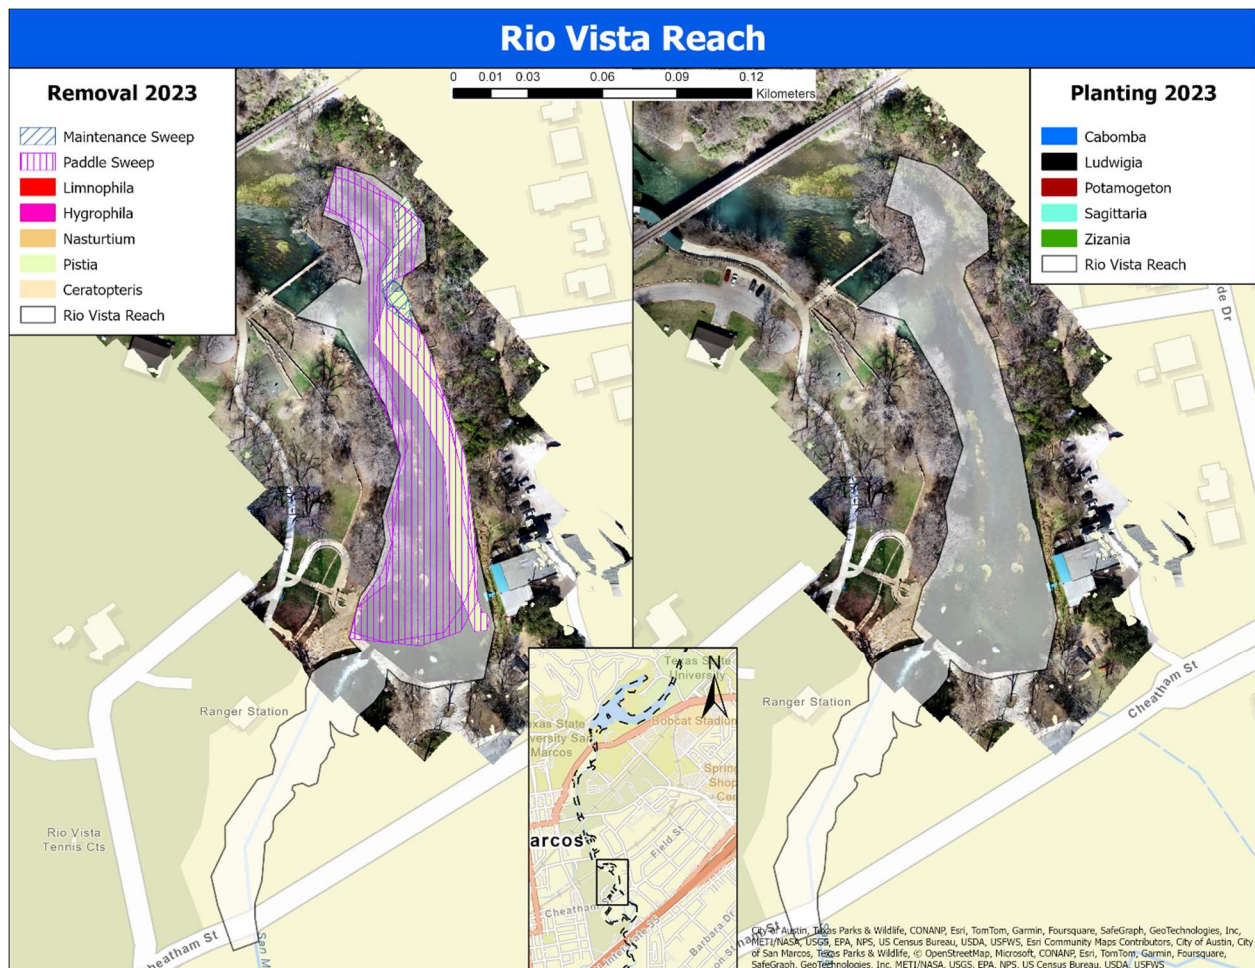
Figure 12. Locations of non-native vegetation removal and native SAV planting within the Rio Vista reach in 2023. No planting occurred in 2023 within this reach.

Rio Vista is a non-designated reach which was a part of the Work Zone in 2023. Similar to the Cypress Island reach, no bulk non-native SAV removal has been conducted since mid-2022 due to the implementation of Condition M; however, recreational affects coupled with low-flow conditions, resulted in the significant denudation of all SAV species. Nearly all non-native SAV populations were removed as a result of recreational foot traffic, and with approval from USFWS, non-native regrowth was suppressed post-recreation season through repetitive maintenance sweeps. Removal effort for this reach only began after the end of recreation season, only accounting for a short period of maintenance before the annual reporting period ended, resulting in the removal of 10.1 m² of Hygrophila, 0.14 m² of Hydrilla, and 13.33 m² of Pistia (**Figure 12**). Cabomba displayed the greatest resilience to the recreational damage that occurred and has expanded into areas previously occupied by Hydrilla earlier in the year. Planting efforts in this reach will take place in 2024 in areas outside recreation foot-traffic and after frequent maintenance sweeps. These plans will prioritize diversifying the native SAV community. This reach will become a Recovery Zone in 2024.

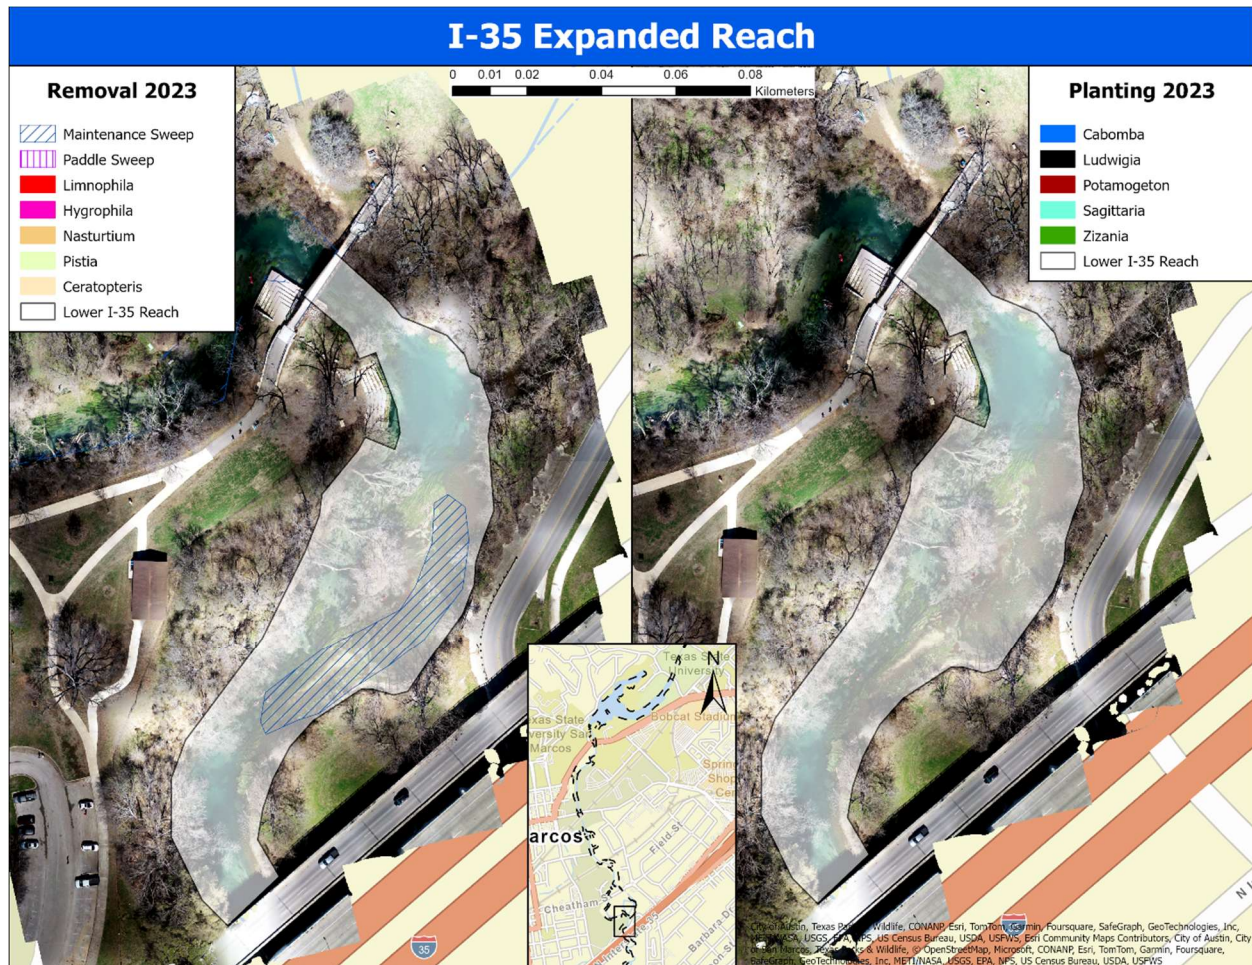
Figure 14. Locations of non-native vegetation removal and native SAV planting within the Expanded I-35 reach in 2023. No planting occurred in 2023 within this reach.

The expanded I-35 reach will be a designated Work Zone in 2024. Like the Upper I-35 Reach, this reach received some removal in 2023 to conserve effort that has previously occurred to minimize regrowth and expansion of non-natives. A total of 7.49 m² of *Hygrophila* and 4.68 m² of *Hydrilla* were removed by maintenance sweeps (**Figure 14**). This reach was treated heavily for removal efforts early in the implementation of the EAHCP; thus, an effort was made to maintain progress. Native SAV were planted in previous years and continue to occupy suitable habitat in this reach, suggesting successful restoration of the native SAV community. No plantings took place during 2023 while under Condition M.

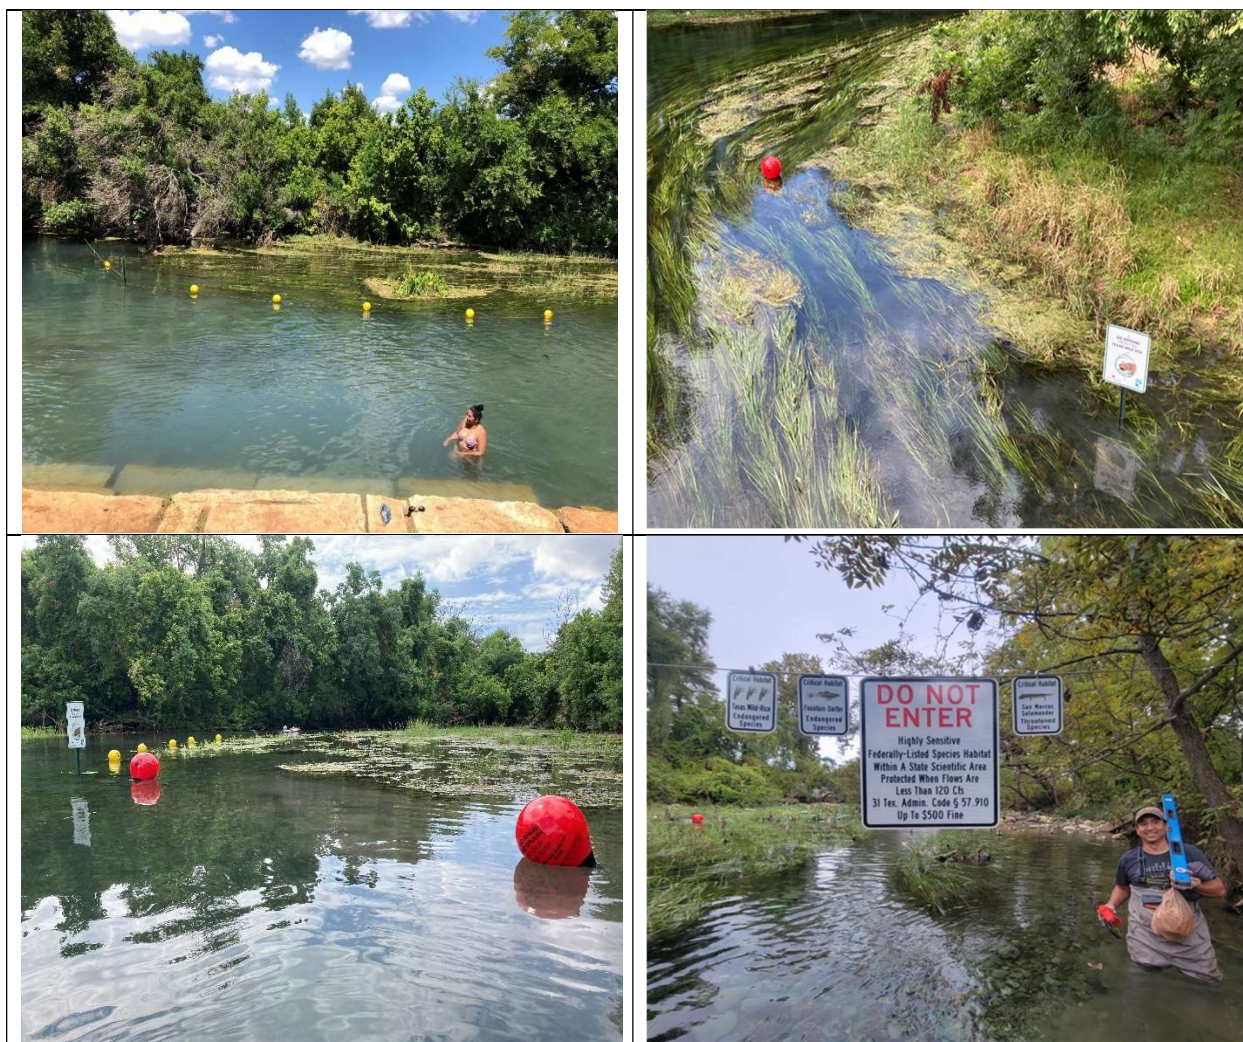
Figure 3. Photos showing the buoys, signage and exclosures that were installed to denote the TWR protection zones in the San Marcos River. The photo on the upper left is in the river immediately downstream of the Hopkins St bridge, photo on the right is immediately downstream of Sewell Park, photo on bottom left is at Bicentennial Park at the Purgatory Creek confluence and photo on bottom right is the signage in place at the Eastern Spillway area just below Spring Lake dam.

San Marcos River flow remained below 120 cfs for the duration of 2023. As such, TWR exclosures, buoys and signage established to protect TWR stands and sensitive habitat during low-flow periods remained in place throughout the entire year. **Figure 2** shows the location of the TWR protection zones and **Figure 3** shows examples of the installed protection zones. The Conservation Crew routinely monitored and maintained the exclosures throughout 2023. The exclosures will remain in place until river flow increases above 120cfs.

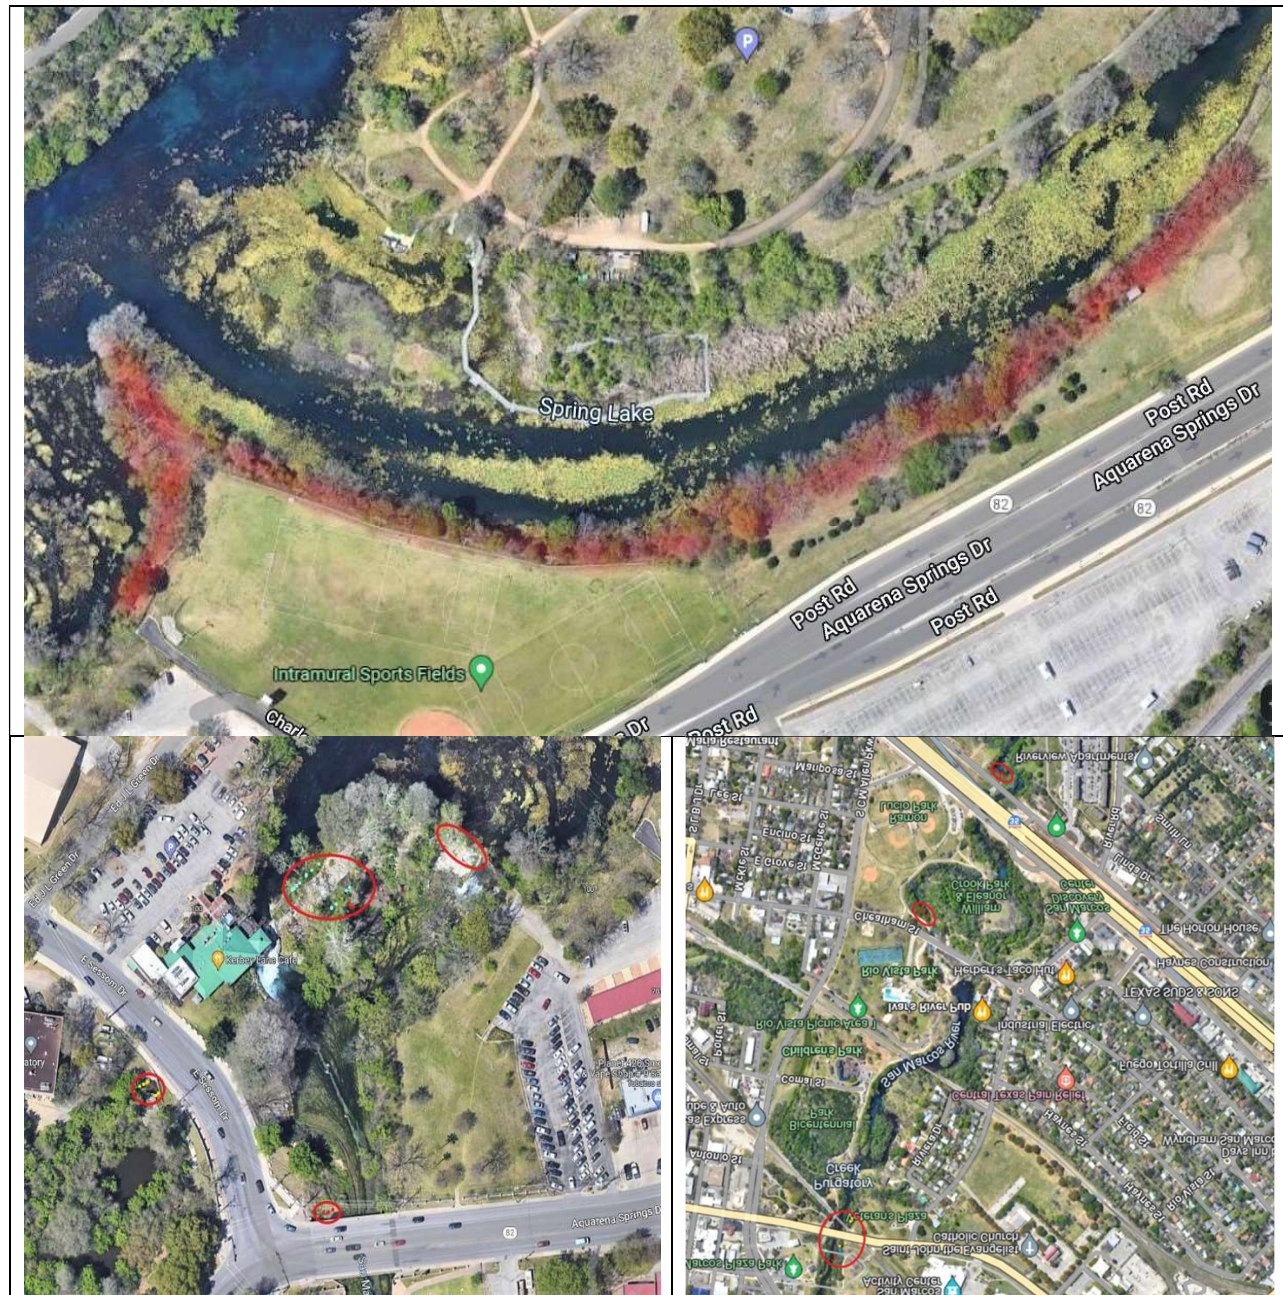
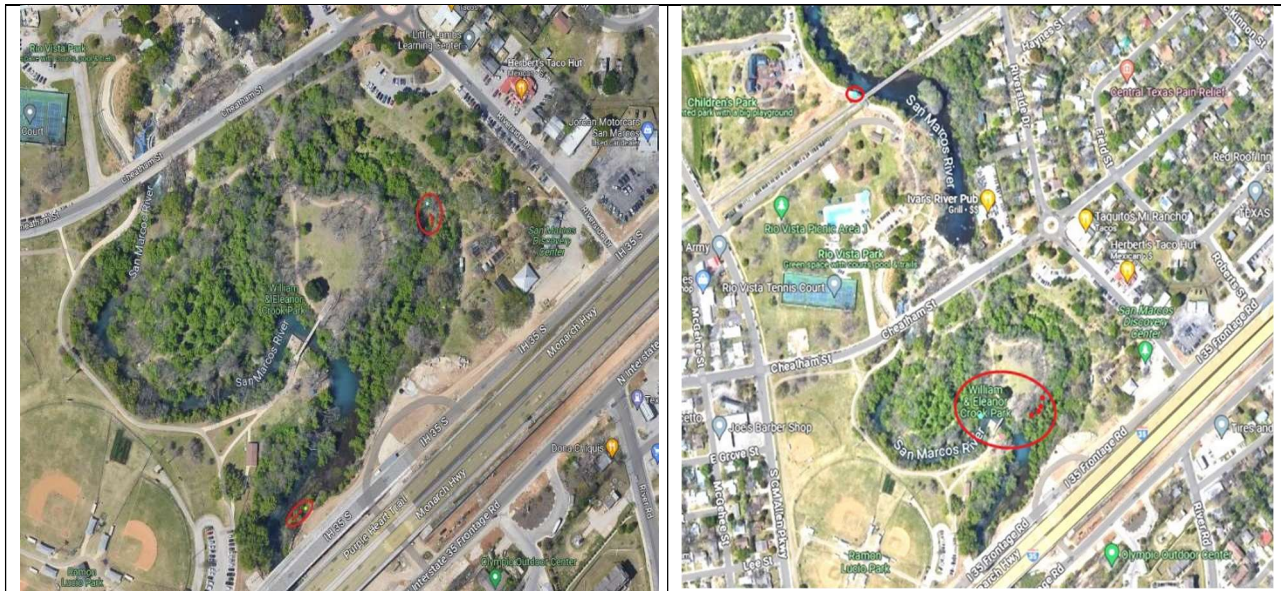
Figure 2. Locations where intensive non-native, invasive vegetation maintenance occurred in 2023.

Routine maintenance included monthly monitoring of the littoral zone along the San Marcos River from Sink Creek to just downstream of IH-35 and herbicide-treatment of any observed re-emergent non-native vegetation. Locations where intensive maintenance was required included the slough arm of Spring Lake (i.e. lower Sink Creek), Spring Lake Dam “Island” area, Crook Park, Ramon Lucio Park and the IH-35 area (**Figure 2**).

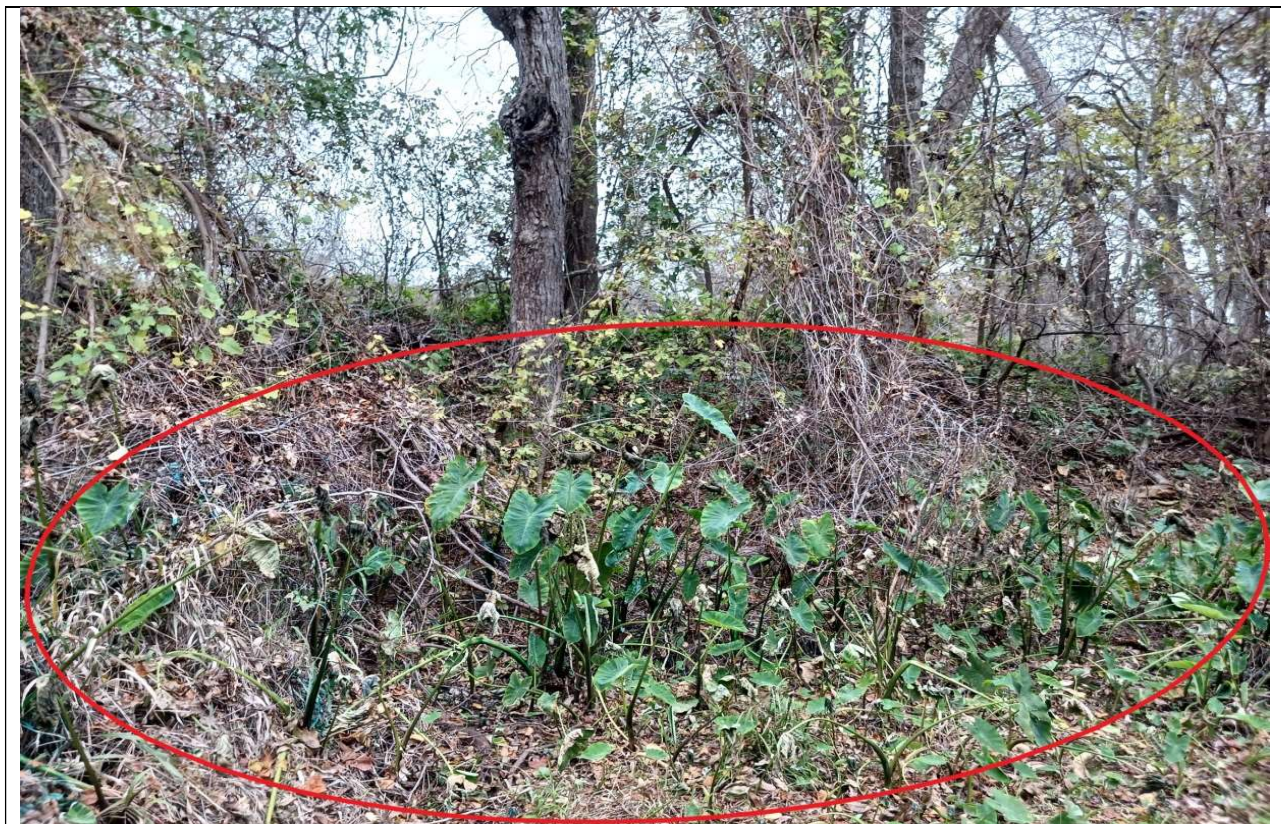
Photo 1. Re-emergent elephant ears in Crook Park that were identified and treated with herbicide.

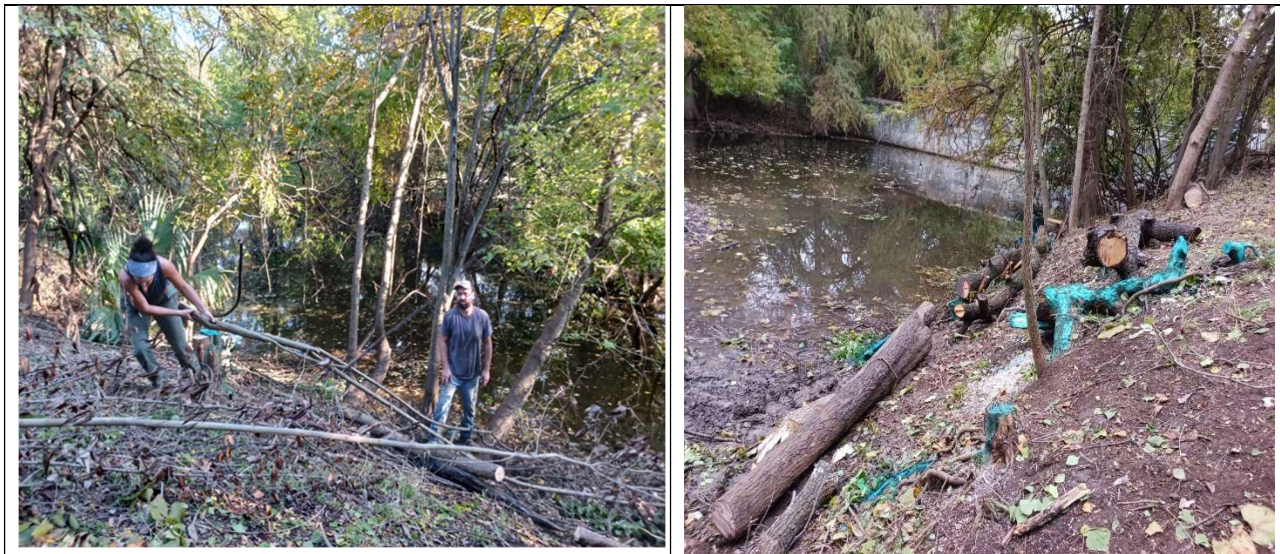
Photo 2a & 2b. Cutting and treatment of non-native trees adjacent to the TXST Freeman Aquatic Building Ponds.

Chemicals (herbicides) were applied with a 1- or 2-gallon pump-up sprayer, set on a steady stream for a more precise target hit, to minimize leaching and non-target plant damage. The sides of stumps and root flares of woody plants were scarred up with a machete or other blade to expose more of the cambium layer and then treated with herbicide.

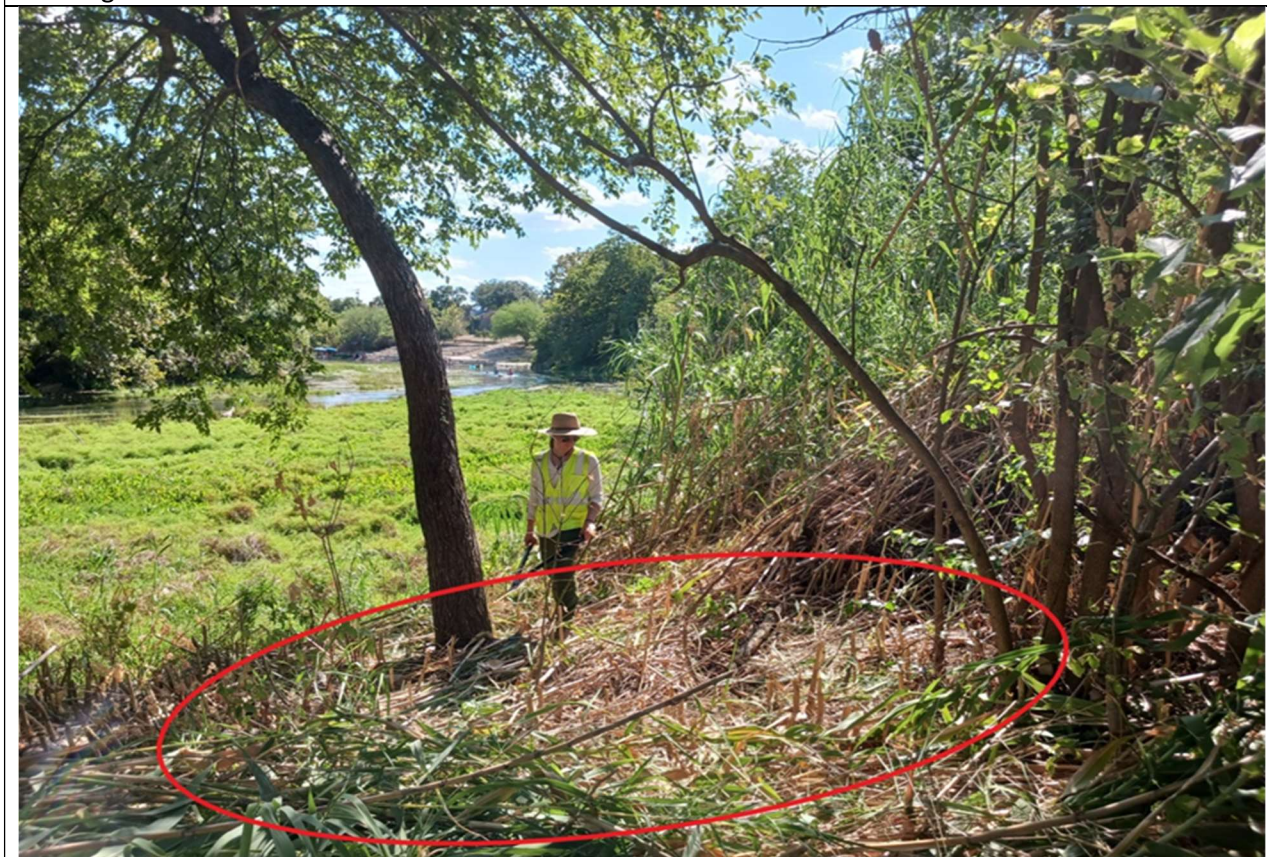
Photo 3. Cutting and treatment of Arundo Cane along the San Marcos River in Lower Sewell Park.

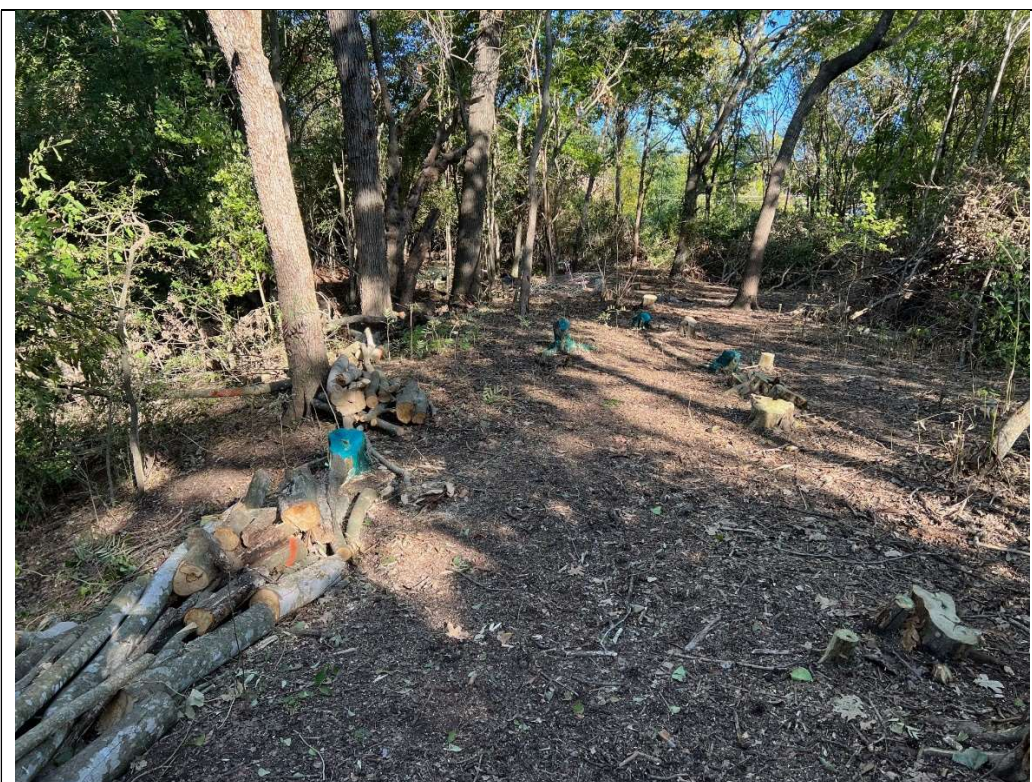
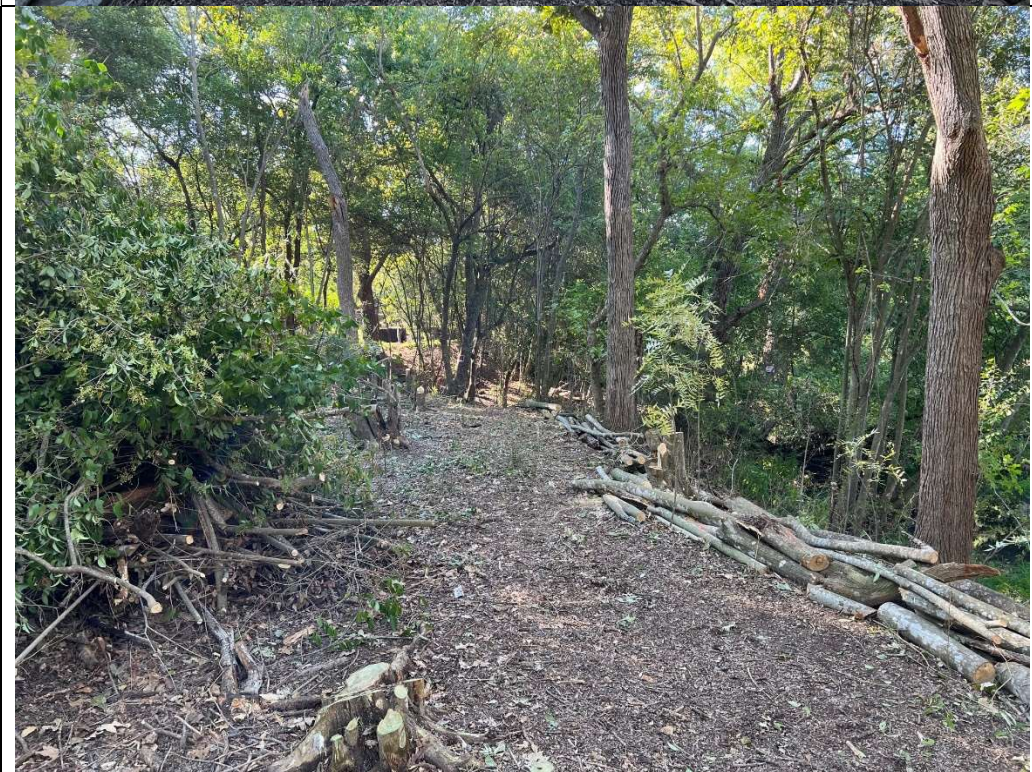
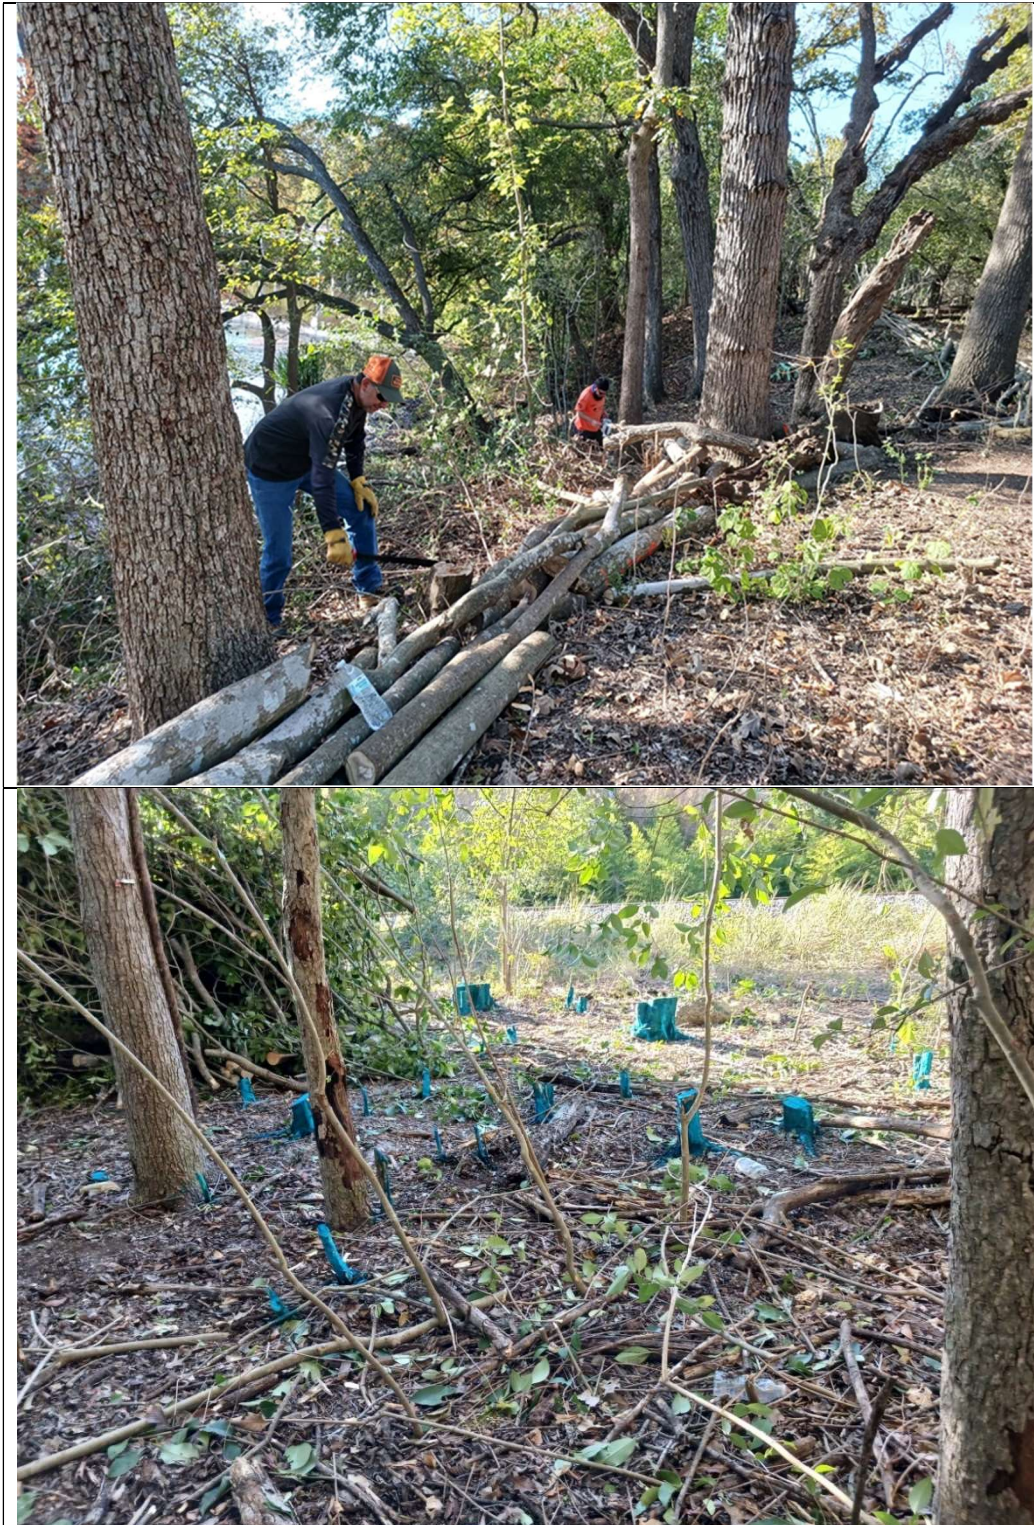
Figure 2. Photos of riparian restoration activity along the San Marcos River at the “Riverside” property across from the Cypress Island of Rio Vista Park. Photos primarily depict removed and treated ligustrum trees and formation of sediment control berms.

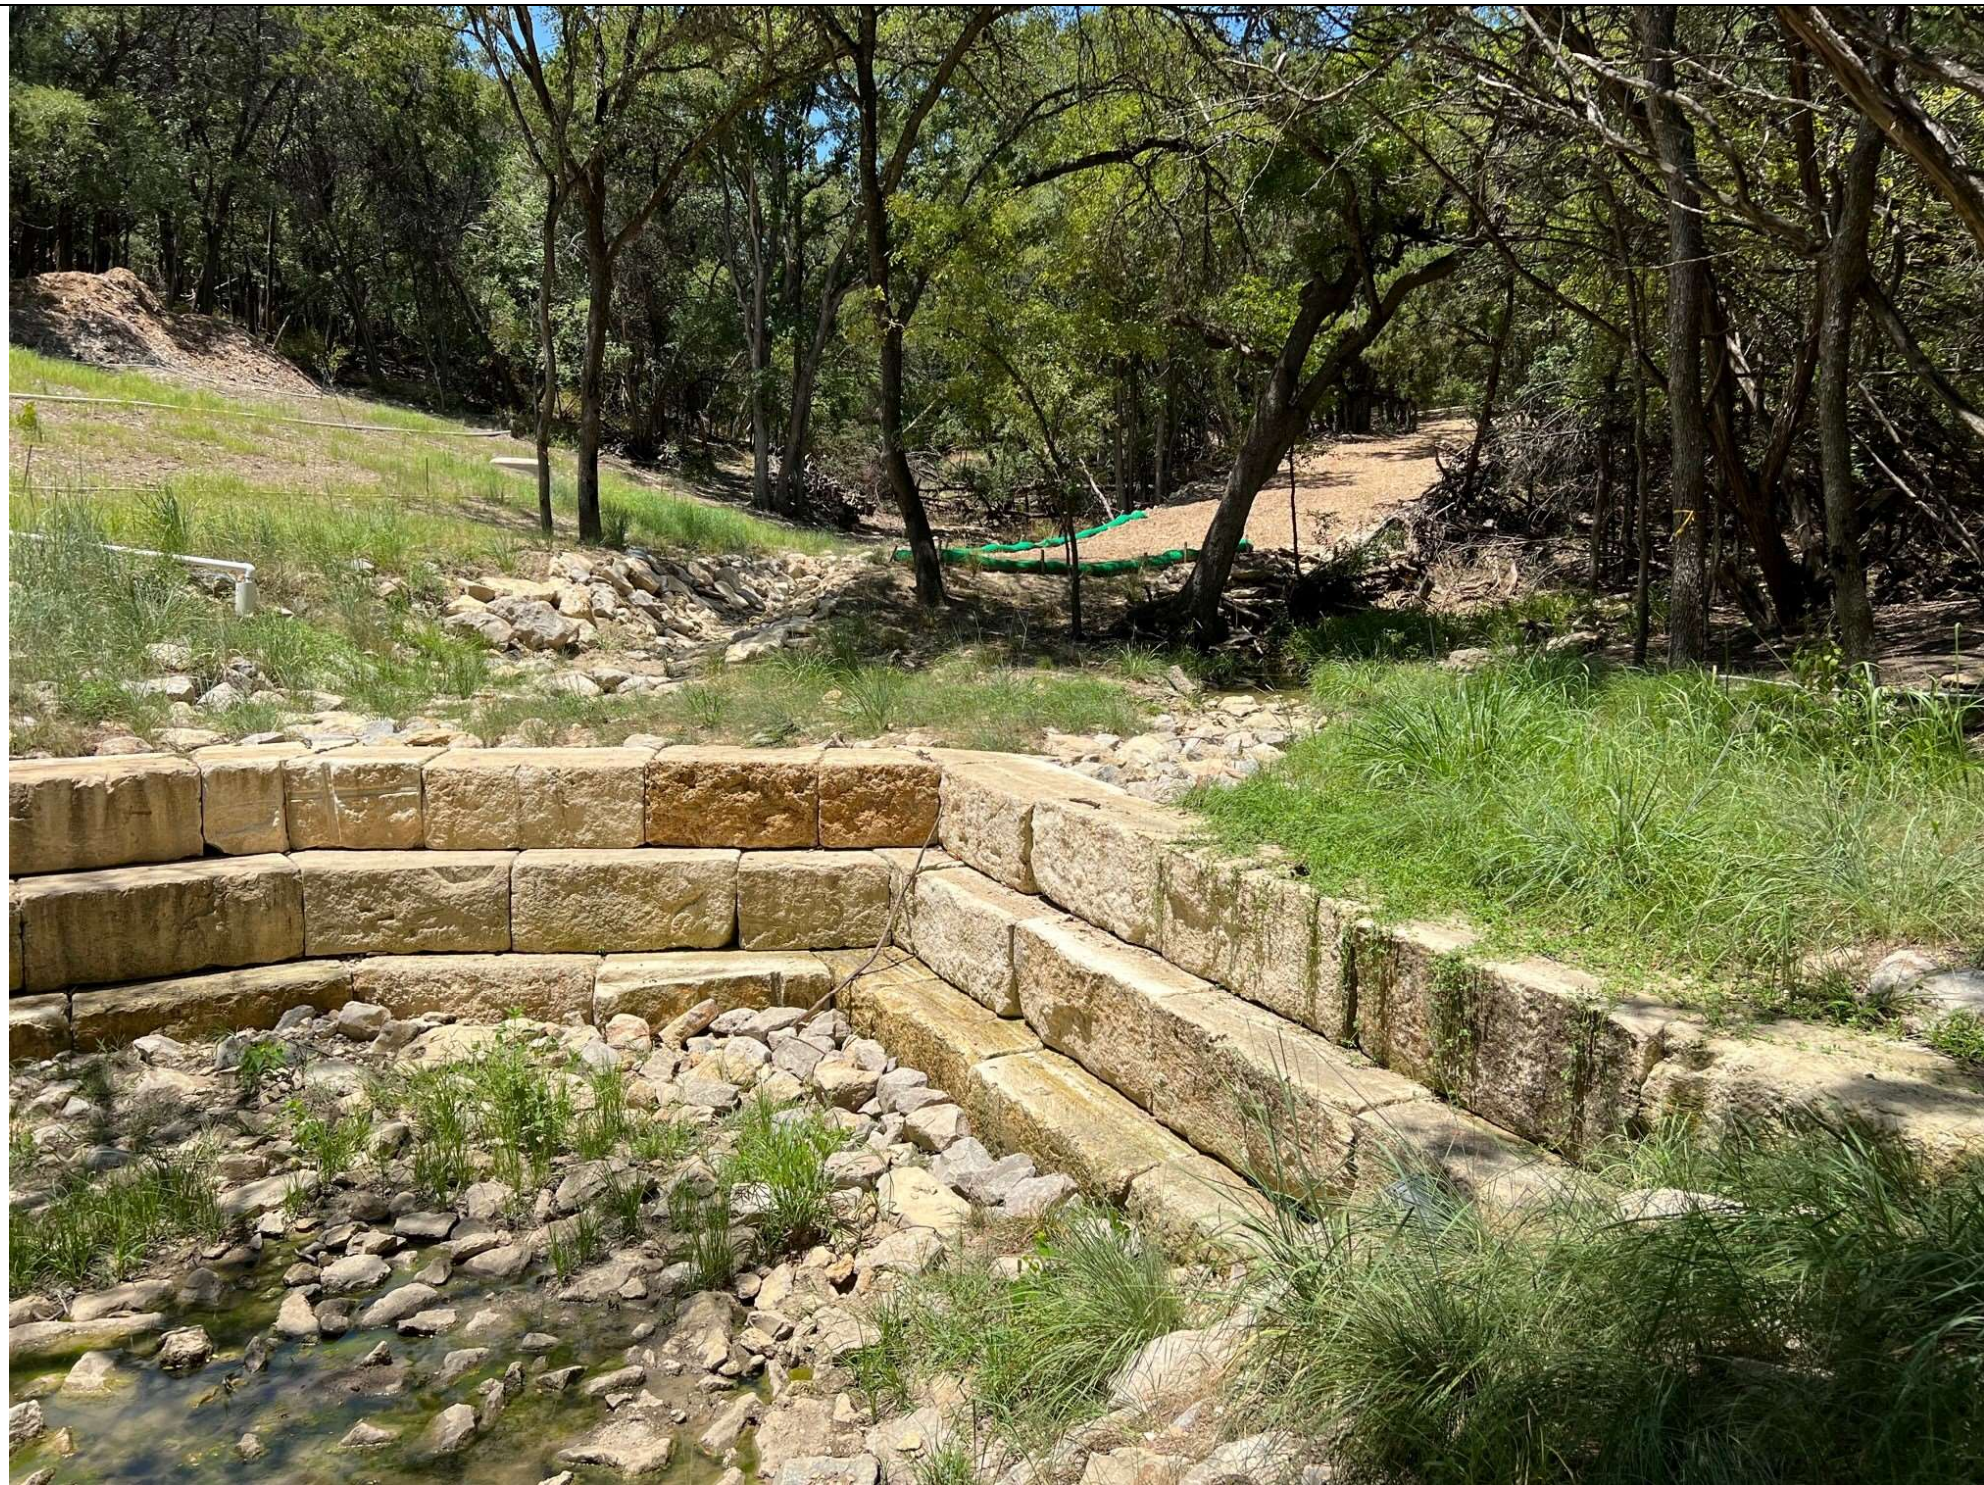
Upper-project area as of August 2023

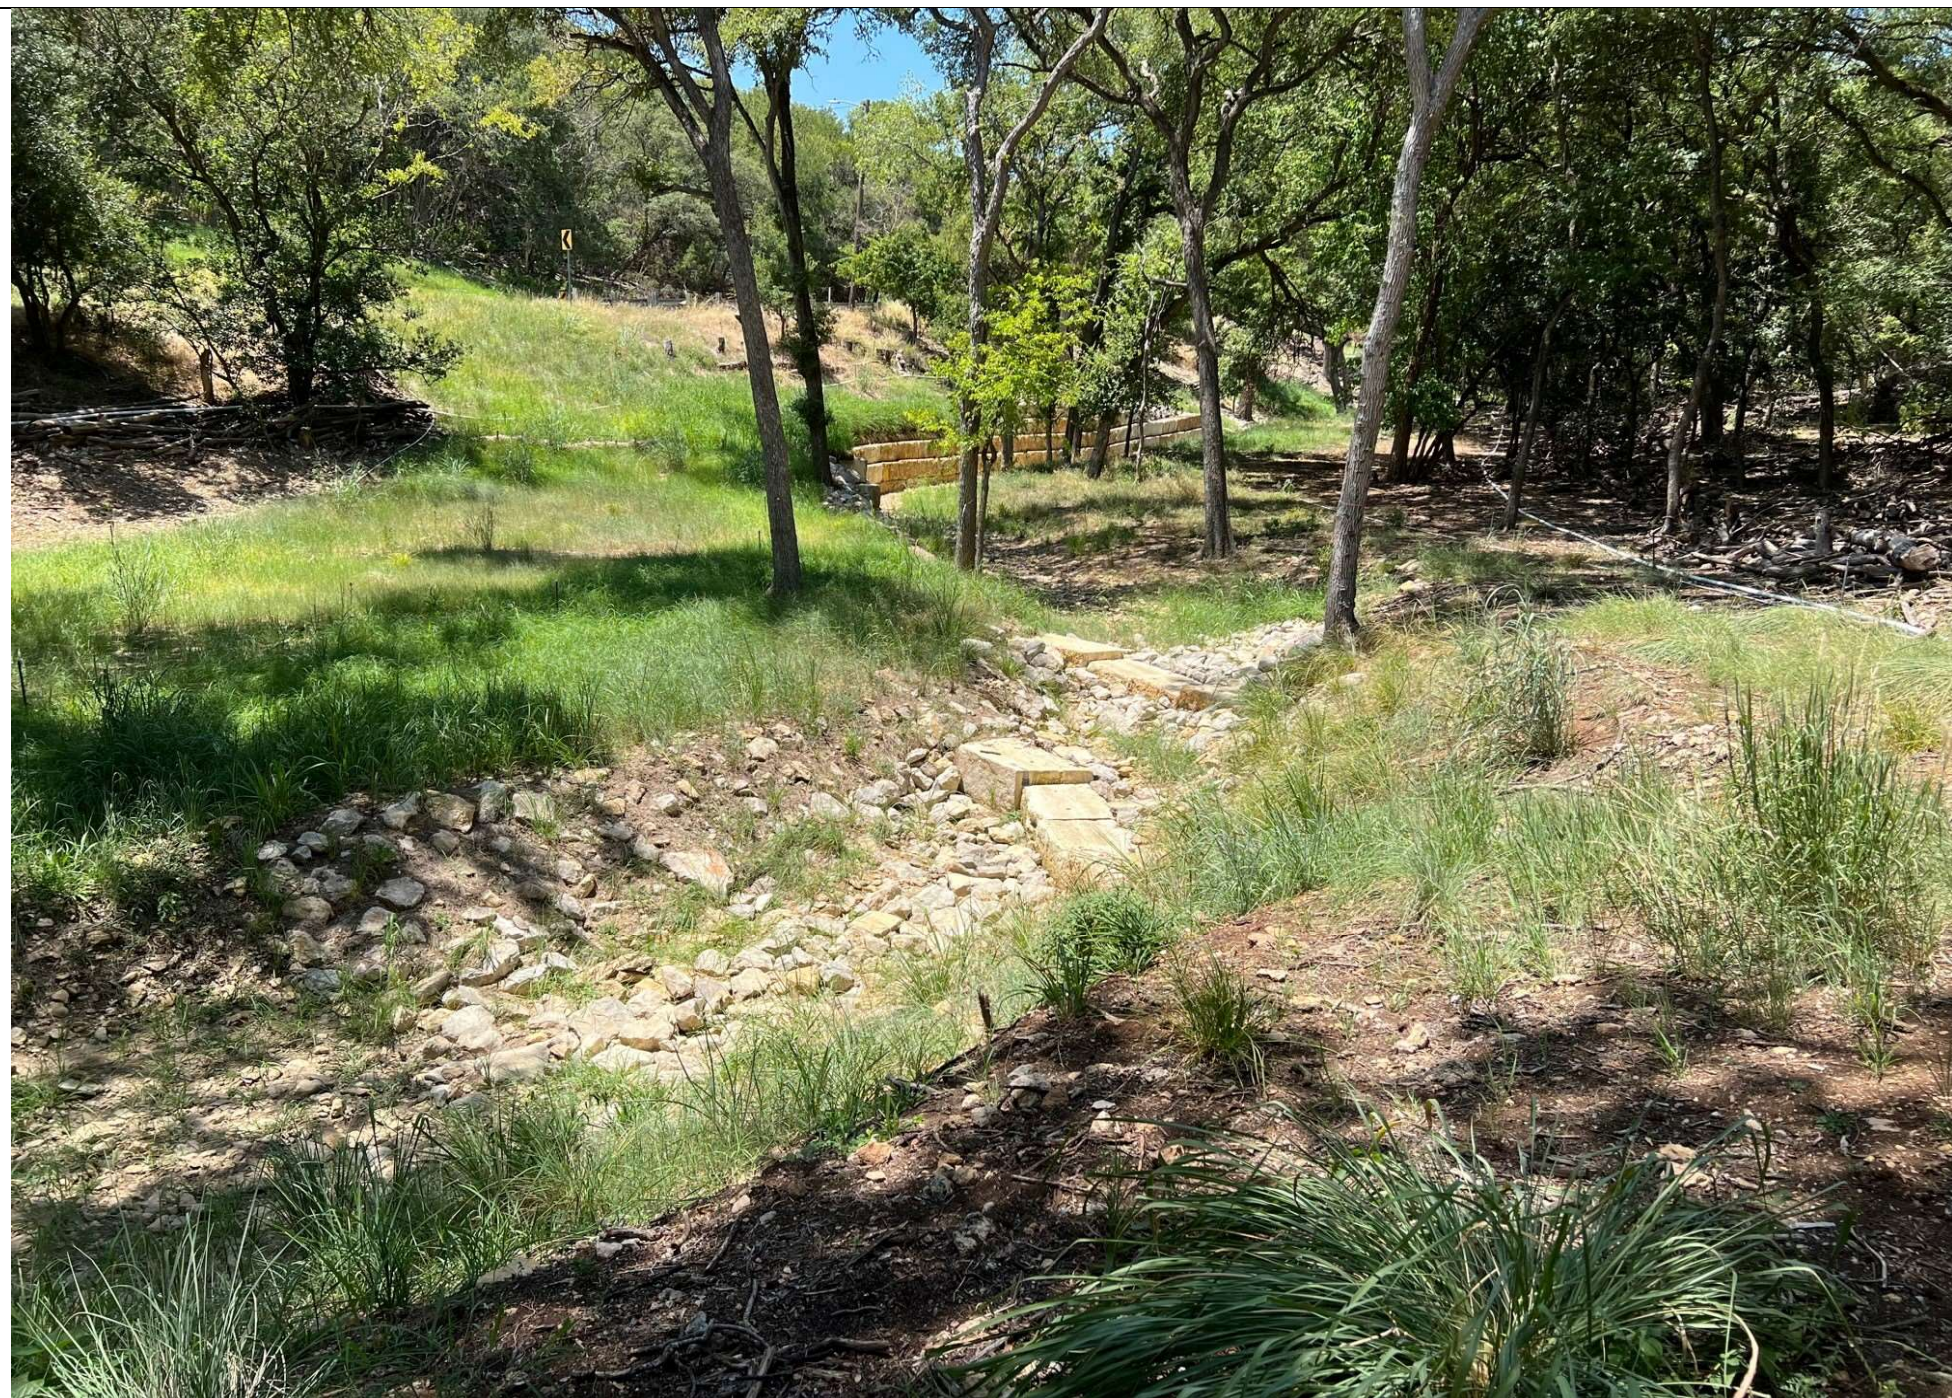
Mid-project area as of August 2023
