# HABITAT CONSERVATION PLAN BIOLOGICAL MONITORING PROGRAM San Marcos Springs/River Ecosystem

ANNUAL REPORT

December 2018

BIO-WEST, Inc.  
1812 Central Commerce Court  
Round Rock, Texas 78664-8546

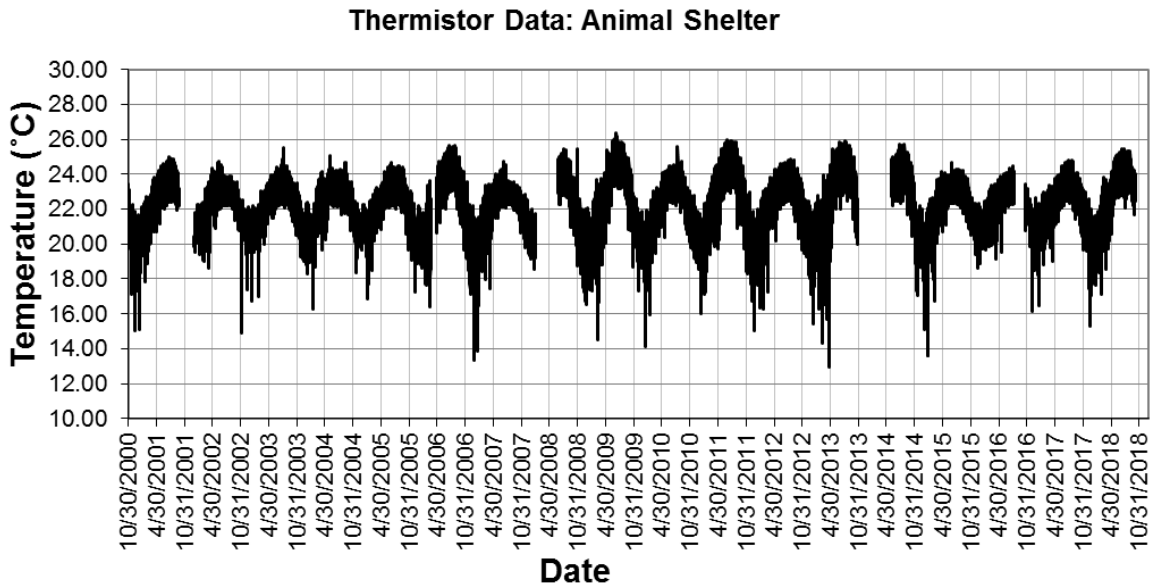
**Figure 7. Thermistor data from the Animal Shelter Reach.**

Further downstream, ambient conditions exert a greater influence on water temperature due to increased exposure time and runoff from rain events. Figures 6 and 7 display this relationship; higher temperature fluctuations occur at the downstream thermistor (Animal Shelter) compared to thermistors that are closer to spring inputs (I-35, City Park). The Sessoms creek thermistor was the only thermistor that collected readings exceeding the TCEQ water quality standard of 26.7 °C for the San Marcos River in 2018 (Appendix C.1). This occurred in late June and again in late July 2018 during a period of above average air temperatures for the region. This has happened in the past and is likely due to Sessoms creeks shallow depths and increased influence by ambient temperatures and runoff.

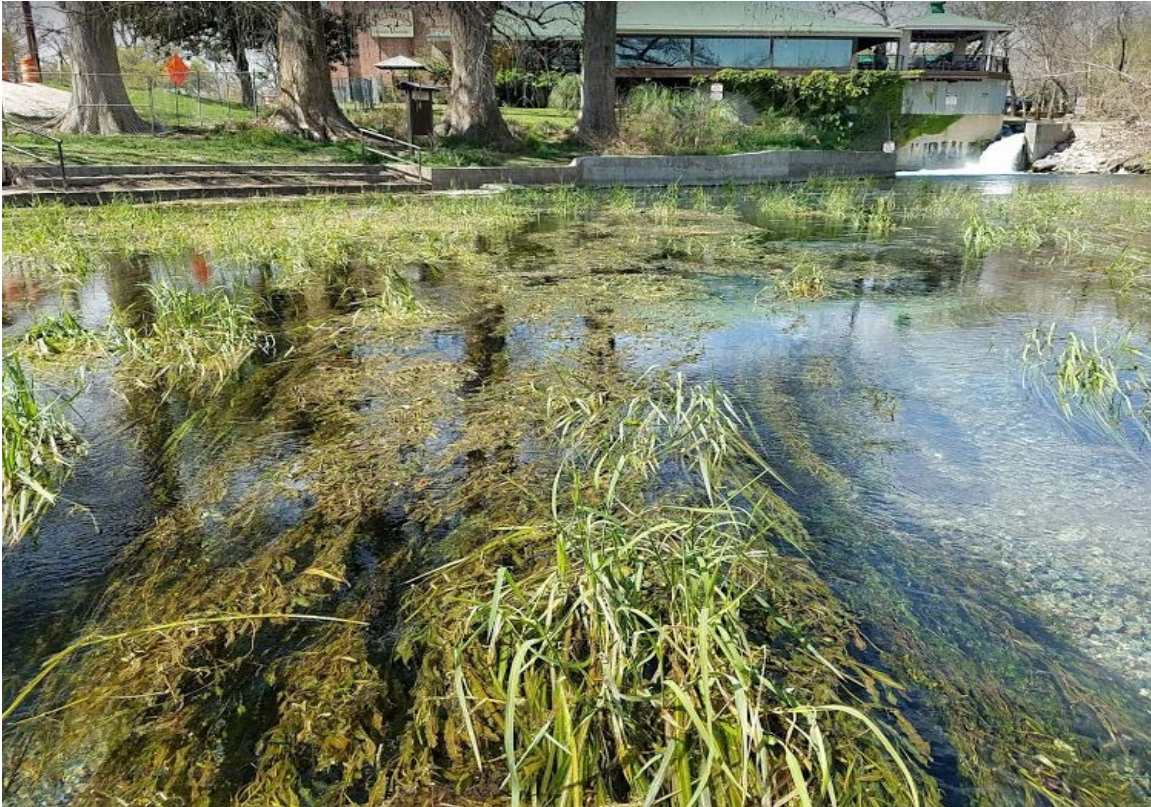
*Texas Wild-rice dominates the Spring Lake Dam Study Reach.*

predominately existing stands as well as established new plants introduced as part of the restoration program. Texas wild-rice accounts for a significant portion of vegetation in this reach (60 % or more) with smaller amounts of *Potamogeton*, *Hydrocotyle* and *Hygrophila* among others making up the rest of the community.

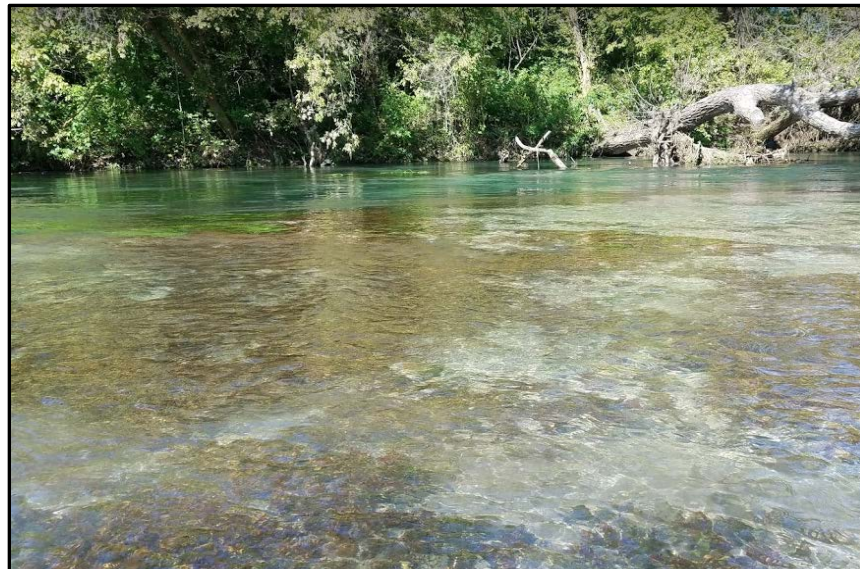
Native and non-native mixed stand of aquatic vegetation reduced due to river bed scour.

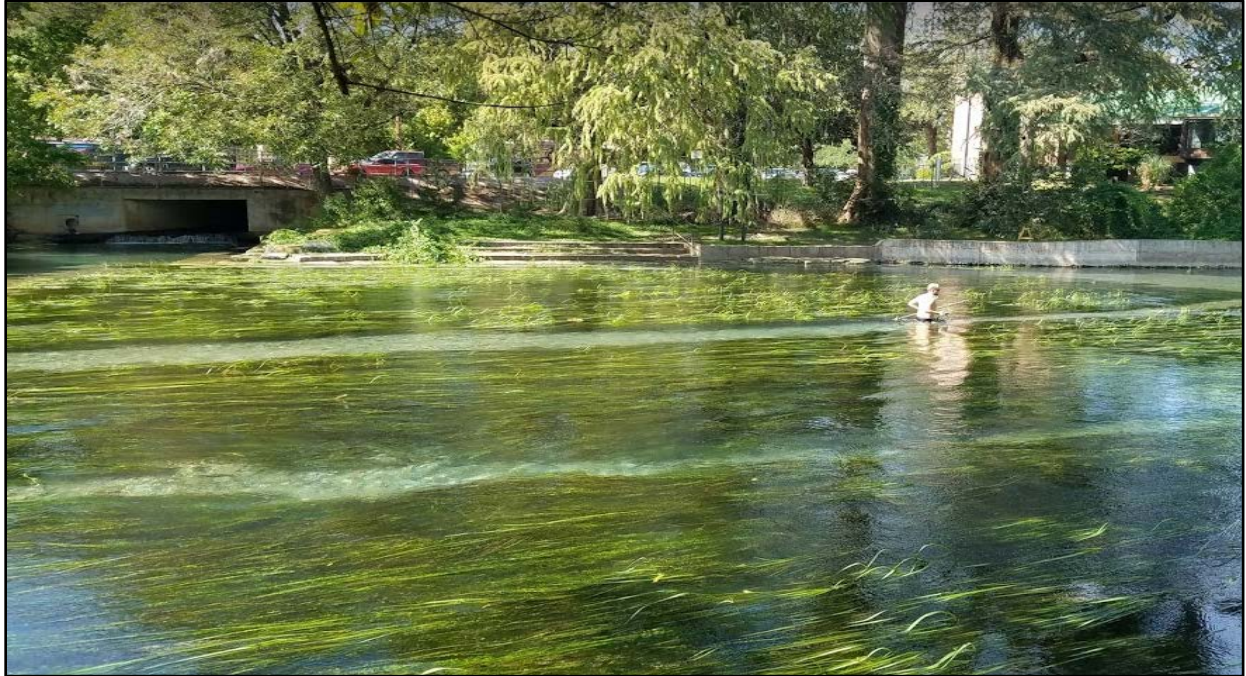
**Figure 14. Wading paths through Texas wild-rice were evident above Aquarena Springs Drive bridge.**

During spring sampling, velocity at individual stands ranged from 0.38 ft/sec. to 0.94 ft/sec and depths at all stands were deeper than 0.5 ft. Little root exposure from scouring was noted in this section, with only excessive scouring at stand # 4/5. Three stands, # 1, #3 and # 4, were noted in bloom. Floating vegetation on average was about 20%. For the Low-flow sampling event, velocities ranged from 0.10 ft/sec to 2.3 ft/sec. Root exposure was higher across the board with excessive exposure noted on stand # 2 and # 4/5. The occurrence of stands located in water less than 0.5 ft of depth was higher. As much as 30% of stand # 4/5 was located in water less than 0.5 ft depth and 100% of stand # 6 occurring out of the water. During the fall sampling event velocity ranged from 0.04 ft/ sec to 2.19 ft/sec with all stands returning to water depths deeper than 0.5 ft. Root exposure was still noted as medium in stands # 2 and # 4/5. Stand # 7 had excessive amounts of exposed roots and significant river bed scour around the upper portion of the stand.

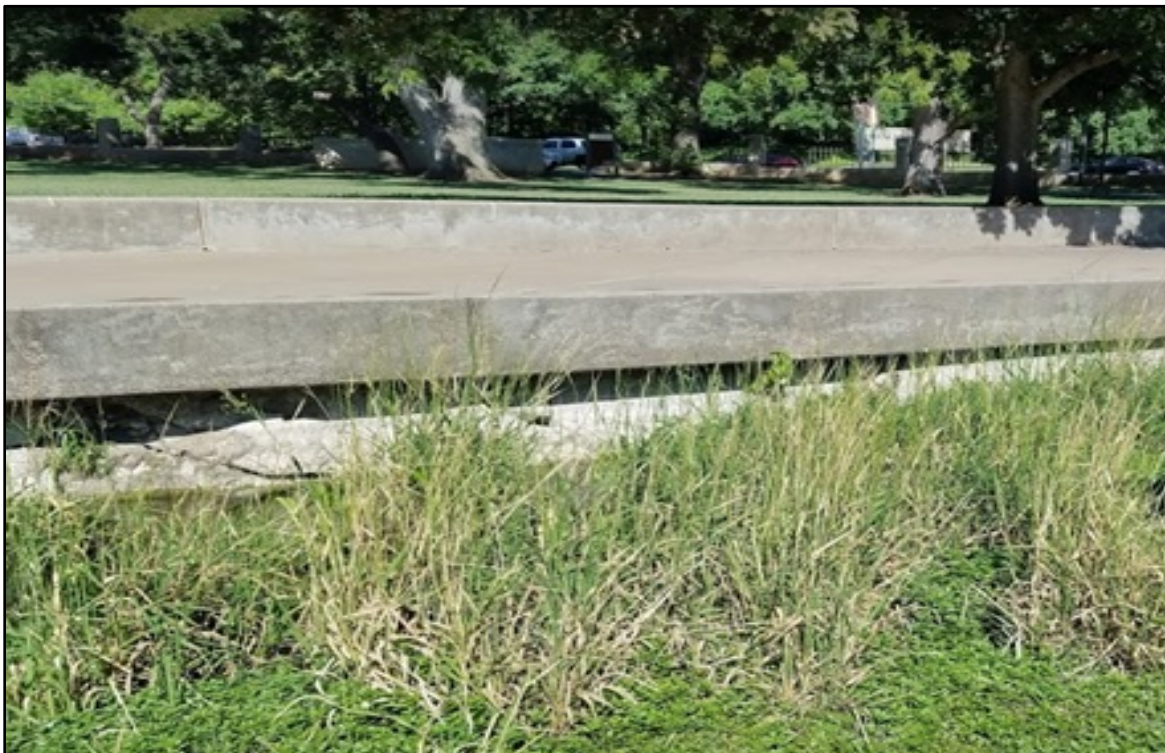
**Figure 15. Vulnerable stand # 6 emergent and dry during Low-flow sampling.**

The stands in this reach have continued to maintain a high degree of cover due to the decrease in recreational pressure since river access has been limited. However, the 2018 monitoring exhibited increasing evidence of recreational damage in this stretch (Figure 14). The total coverage of vulnerable stands exhibited an initial increase from fall 2017 to spring 2018 with stand # 7 and stand # 2 expanding enough to merge together. However, over the course of 2018 total cover decreased falling below all coverages for the previous year. Stand # 1 located above Aquarena Drive Bridge accounts for the largest amount of cover for vulnerable stands in this sample reach. Expansion and loss of coverage in this single stand can dramatically change the total coverage. Although this stand expanded over the first several sampling periods in 2018, it saw a decrease of 70 m<sup>2</sup> in cover between the Low-flow sampling event and the fall 2018 comprehensive sampling event. Stand # 7 has also seen major fragmentation and loss in 2018. This stand, located in a shallow area, saw increased fragmentation from foot traffic and trampling during the summer, especially in July and August when river flows approached 120 cfs. During the Low-flow sampling event stand # 6 was observed as a terrestrial patch of Texas wild-rice (Figure 15). During the fall sampling period, some regrowth of stand # 8 had appeared.

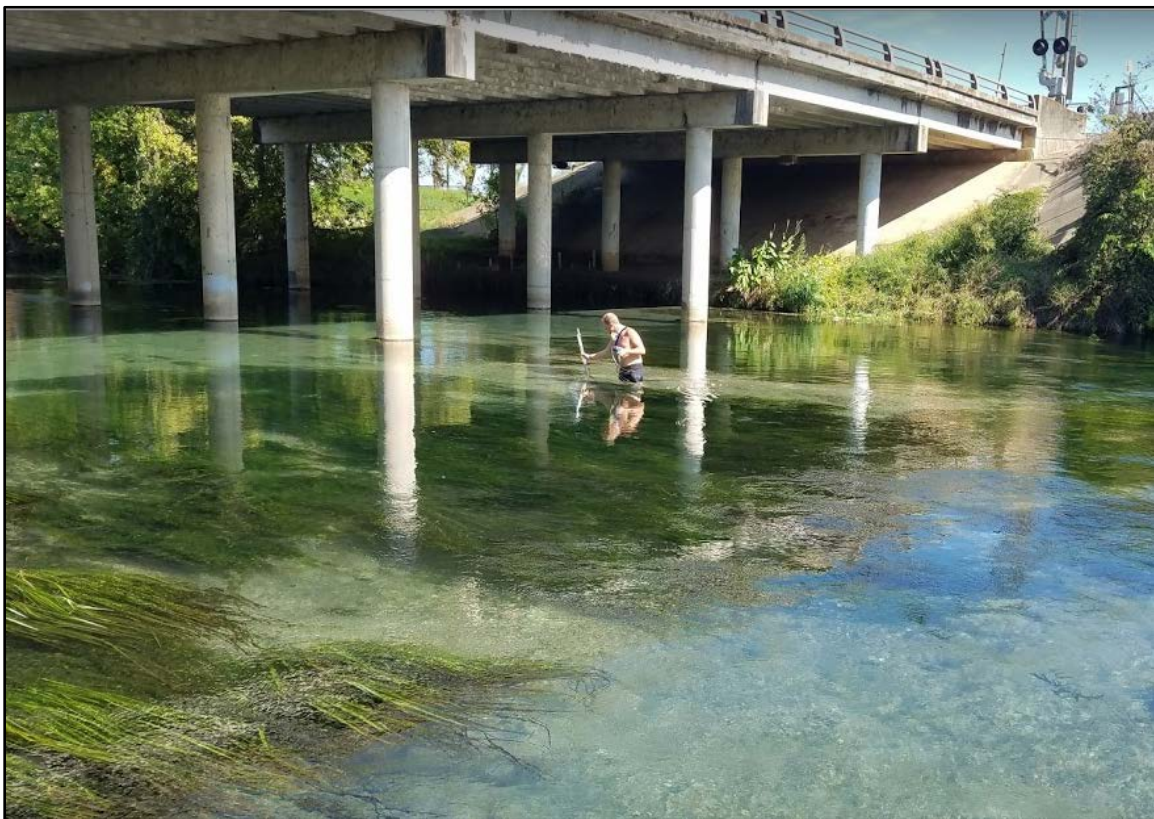
**Figure 16.** Condition of vulnerable Texas wild-rice stands at Veramendi Park during fall 2018 showing high degree of bare substrate due to loss of vegetation in the area.

During the spring sample period, velocities ranged from 0.82 ft/ sec. to 1.3 ft/sec. All stands were noted occurring in water depths deeper than 0.5 ft. Stand # 1 was noted as having a high degree of root exposure. During the Low-flow sampling event, velocities ranged from 0.75 ft/ sec. to 1.03 ft/ sec with all stands still occurring in water deeper than 0.5 ft. Root exposure was noted as medium to excessive and signs of recreational damage were obvious with fragmentation being noted in each stand as well as thin growth. During the fall sampling event, velocities ranged from 0.88 ft/sec. to 1.23 ft/ sec. No stands were noted occurring in water less than 0.5 ft in depth but root exposure was high to excessive with large areas of streambed eroding from around the stands and a high degree of loss in other vegetation types (Figure 16)

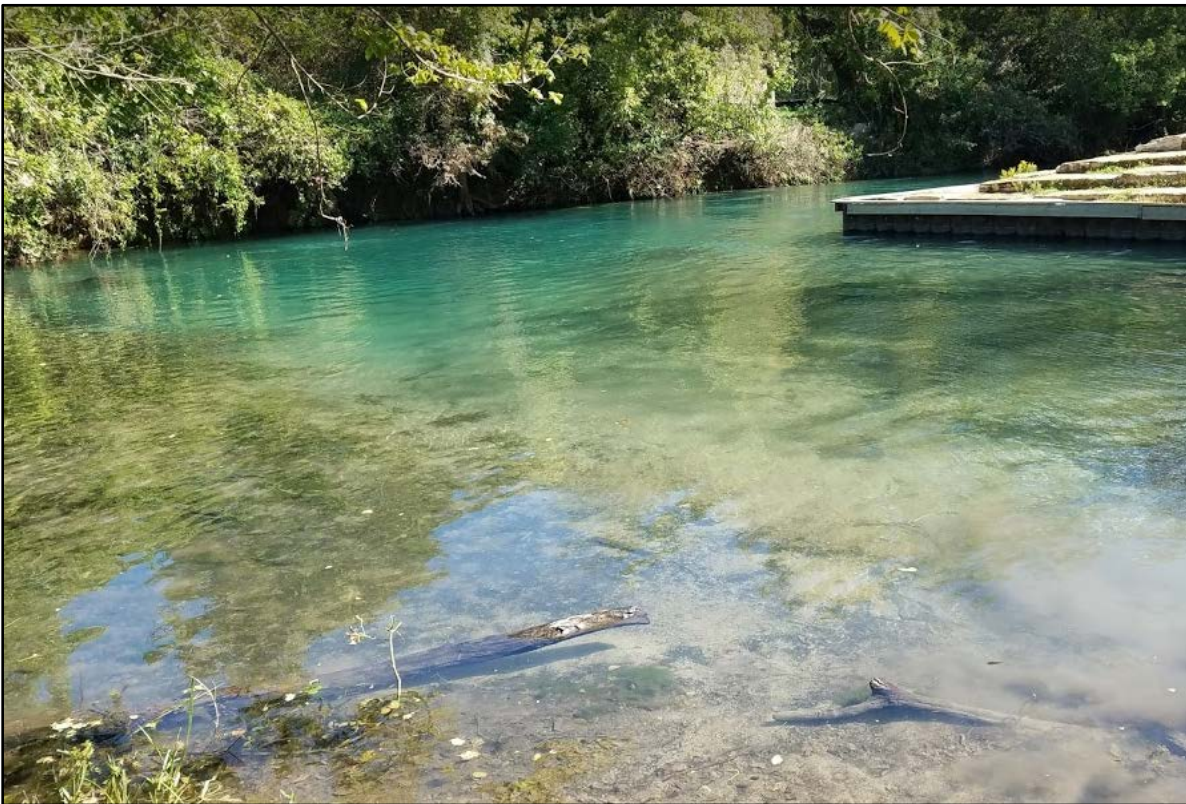
**Figure 17. Former location of Texas wild-rice stand # 9 and stand #10 in the I-35 Study Reach during the fall 2018 observation.**

Velocities for the spring sampling event ranged from 0.14 ft/ sec to 2.05 ft/ sec. with no stands observed in water 0.5 ft deep or less. Root exposure was minimal except in stand # 10 which showed excessive exposure with roots barely attached to the substrate. Very few stands were in flower. During Low-flow sampling, velocities ranged from 0.11 to 1.61 ft/sec with a few stands located in shallow water, 0.5 ft or less. Root exposure was minimal. Stands # 9 and # 10 were completely gone and stand # 4 was highly fragmented. During fall sampling velocities ranged from 0.17 to 1.07 ft/ sec. Root exposure was noted as medium. Expansion in cover was noted in stand # 4 and stand # 8 although expansion in the other stands remained minimal. Stand # 4 was likely expanded due to planting of Texas wild-rice in adjacent areas.

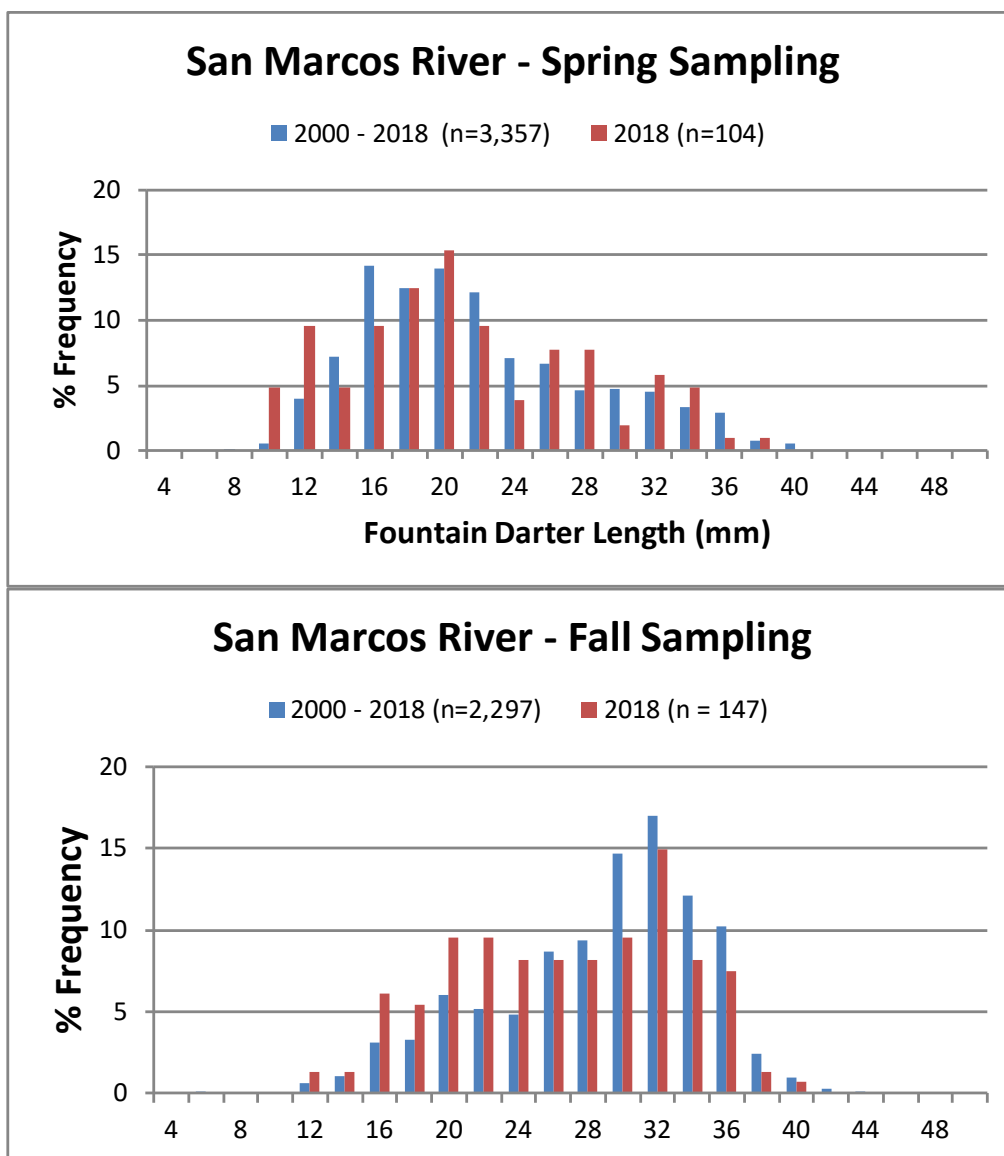
**Figure 18.** Length frequency distribution of Fountain Darters collected from the San Marcos system during all routine spring (top) and fall (bottom) drop-net events (2000–2018), and during 2018 only.

The length-frequency distributions for Fountain Darters collected by drop nets in the San Marcos system during spring and fall sampling events over the entire sampling period and specific to 2018 are presented in Figure 18. Laboratory studies have shown that Fountain Darters of 16 mm total length are approximately 63 days old (Brandt et al. 1993). Therefore, the presence of Fountain Darters at or below this size threshold suggests recent reproduction. Studies on Fountain Darter reproduction found that reproductive effort peaks in late winter/early spring and declines throughout the summer before beginning to increase in the fall (BIO-WEST 2014c). Both collection events in 2018 follow the long-term trend with spring collections from all reaches showing a larger proportion of small Fountain Darters and a peak in reproduction in early spring (Figure 18). In contrast, fall samples are usually dominated by larger individuals due to less recent reproductive activity. The overall similarities in patterns in 2018 confirms a consistent life-stage distribution relative to previous years.

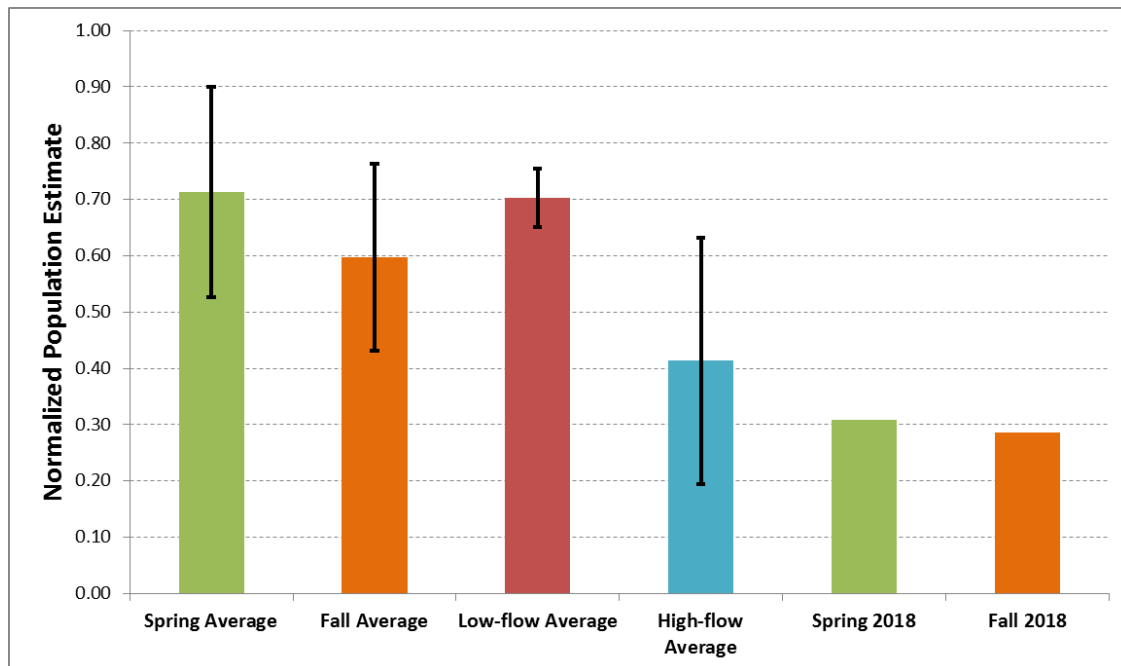
**Figure 19. Normalized population estimate for all events 2000–2018. Long-term study averages are provided with error bars representing one standard deviation from the mean.**

Fountain Darter normalized population estimates in all reaches (Figure 19) were based on vegetation composition and abundance, and the long-term average density of Fountain Darters found in sampled vegetation typed from 2000-2018. For the third consecutive year, both the spring and fall 2018 population estimates were lower than the long-term average and outside of one standard deviation from the mean. It was hypothesized in last year’s annual report that the higher flow conditions experienced the past several years had been a deterrent to establishment and expansion of native aquatic vegetation (e.g. *Cabomba*) that provides quality Fountain Darter habitat. The return to average or slightly below average flows in 2018 did not immediately reverse this trend. An additional contributing factor might be the large increase in Texas wild-rice coverage in all sample reaches, which has more than doubled since fall 2014. This increase

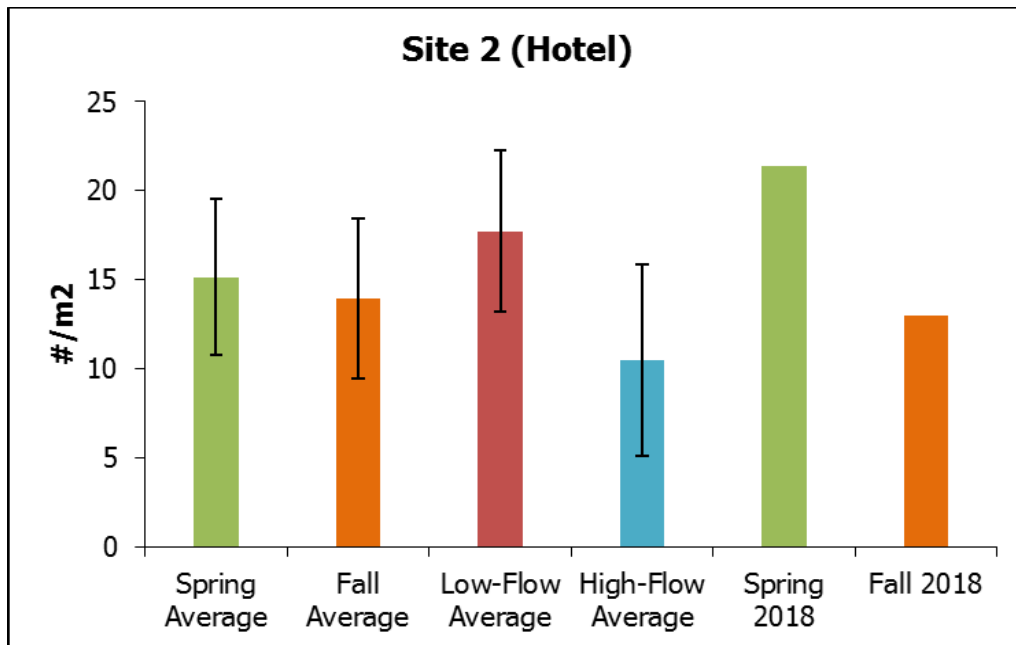
Figure 21. San Marcos salamander observations at Site 2 (Hotel Site) in 2018. Long-term monitoring averages are provided with error bars representing one standard deviation of the mean.
