## MEMORANDUM

TO: Nathan Pence  
FROM: Ed Oborny (BIO-WEST)  
DATE: **August 29, 2014**  
SUBJECT: EA HCP Biological Monitoring – **Week 20**

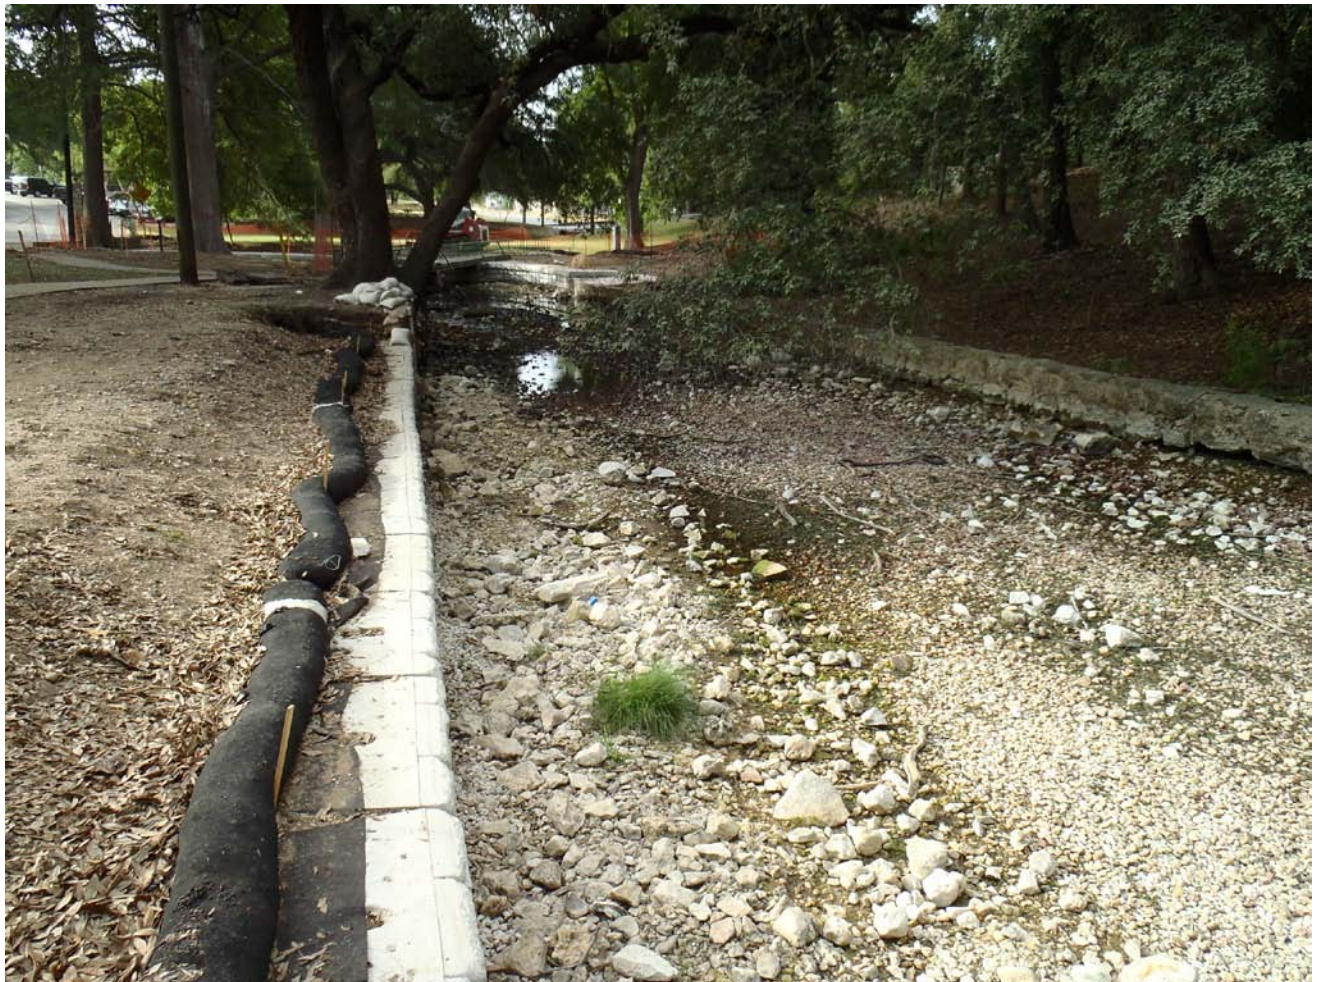
**Figure 2:** Extremely limited surface water habitat in Spring Run 1.

The J17 water level at the time of photo documentation this week had declined to the 625's and total system discharge has consistently declined below 70 cfs for the first time since 1990. As mentioned last week, each week sets a new all time low relative to the initiation of the biological monitoring program in fall 2000. Surface habitat conditions at all major spring runs, the Spring Island area and the Upper Spring run continue to deteriorate relative to flow, water level and exposed substrate. Surface water flow and surface habitat in Spring Run 1 is extremely limited (Figure 2) down past the confluence of Spring Run 2 where a wetted channel is being maintained. However, most of the water past that confluence is backwater from Landa Lake as Spring Run 1 has less than 0.1 cfs of surface flow and Spring Run 2 is not presently flowing (Table 1). Figure 3 shows a riffle beetle subsurface monitoring station recently installed by the U.S. Fish and Wildlife Service in Spring Run 1. Spring Run 2 is essentially devoid of any surface habitat at this time (Figure 4). Spring Run 3 continued to exhibit drying of surface habitat at the headwaters this

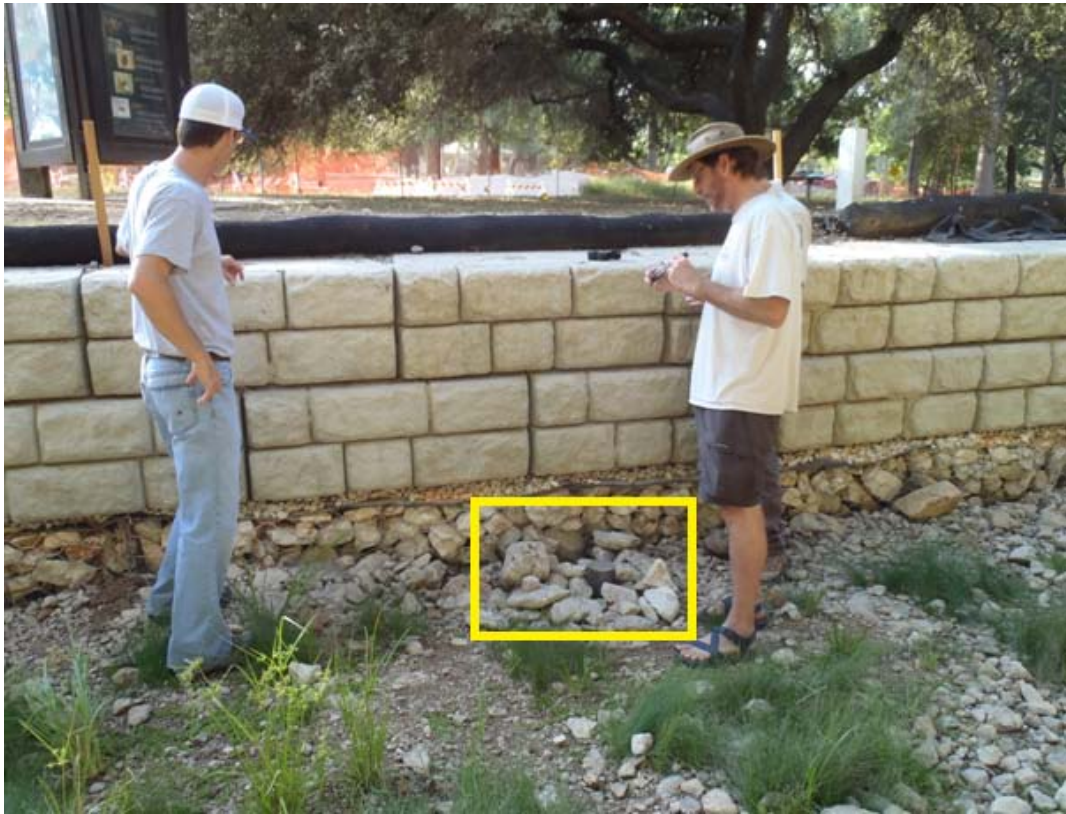
**Figure 3:** Randy Gibson (USFWS- right) and Chad Norris (TPWD - left) discussing the recent installation of the Comal Springs riffle beetle subsurface monitoring station.

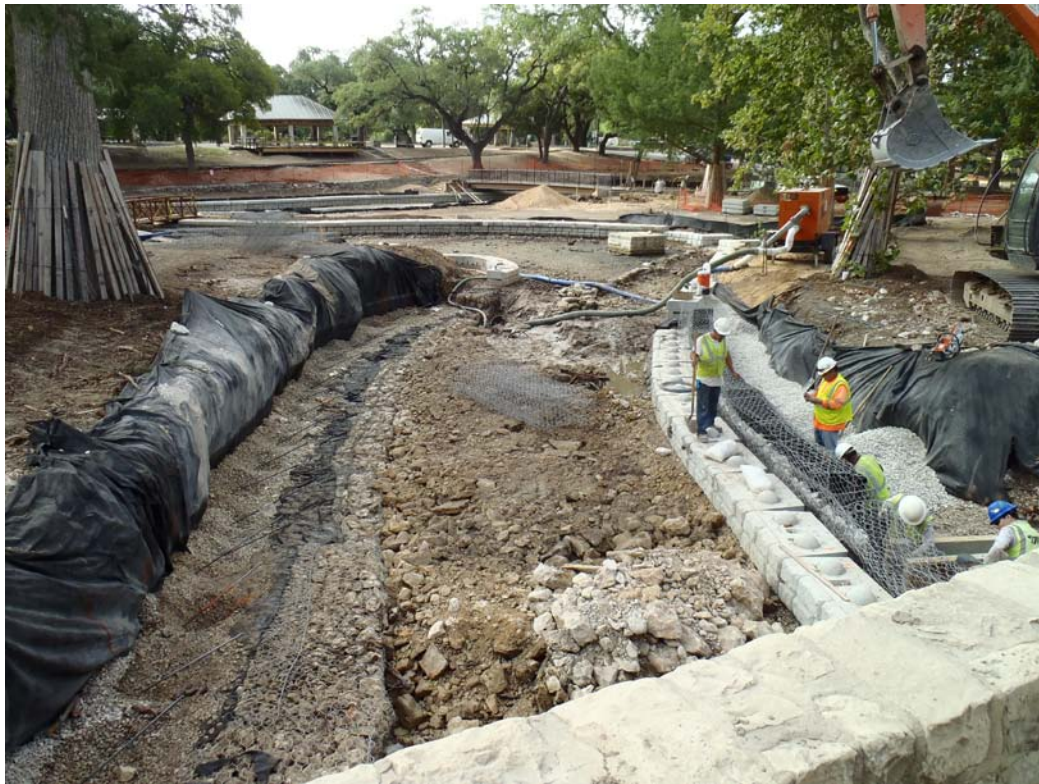
**Figure 4:** Spring Run 2 – no surface habitat below park entrance road.

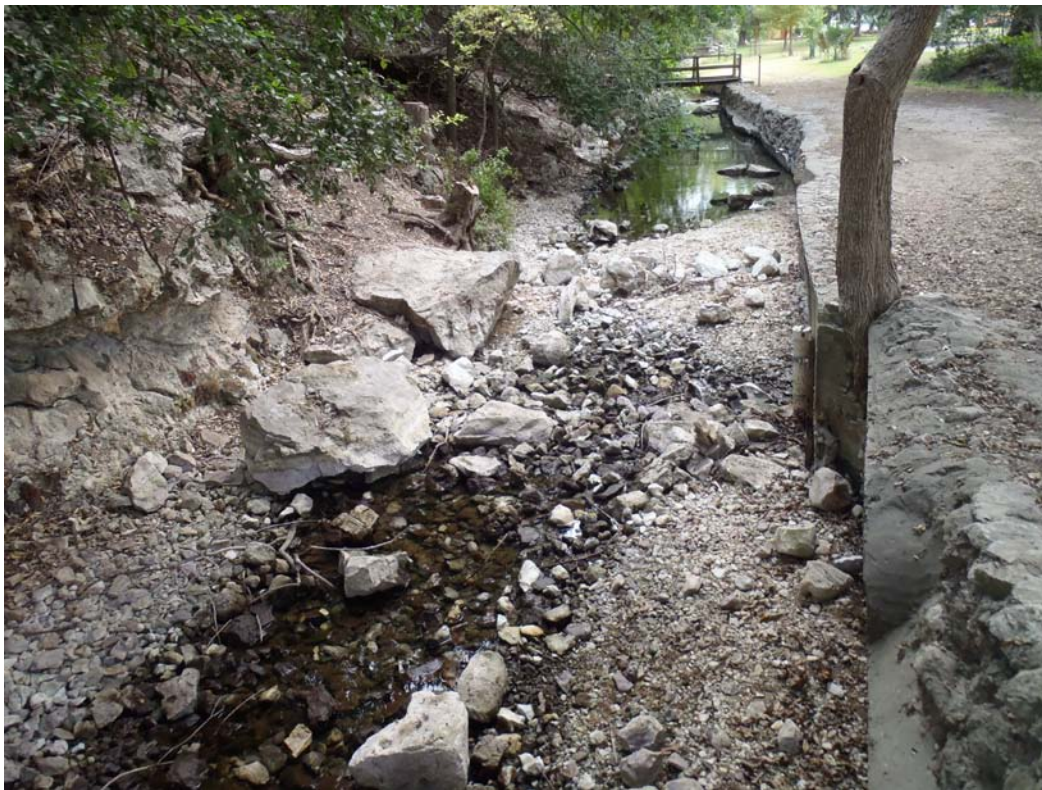
**Figure 5:** Spring Run 3 drying of surface habitat near headwaters and constrictions downstream.

week (Figure 5) with the channel constricting in several locations downstream. Although Spring Run 3 continues to support the most discharge of any of the major spring runs at this time, it too is impacted with a considerable reduction in surface habitat.

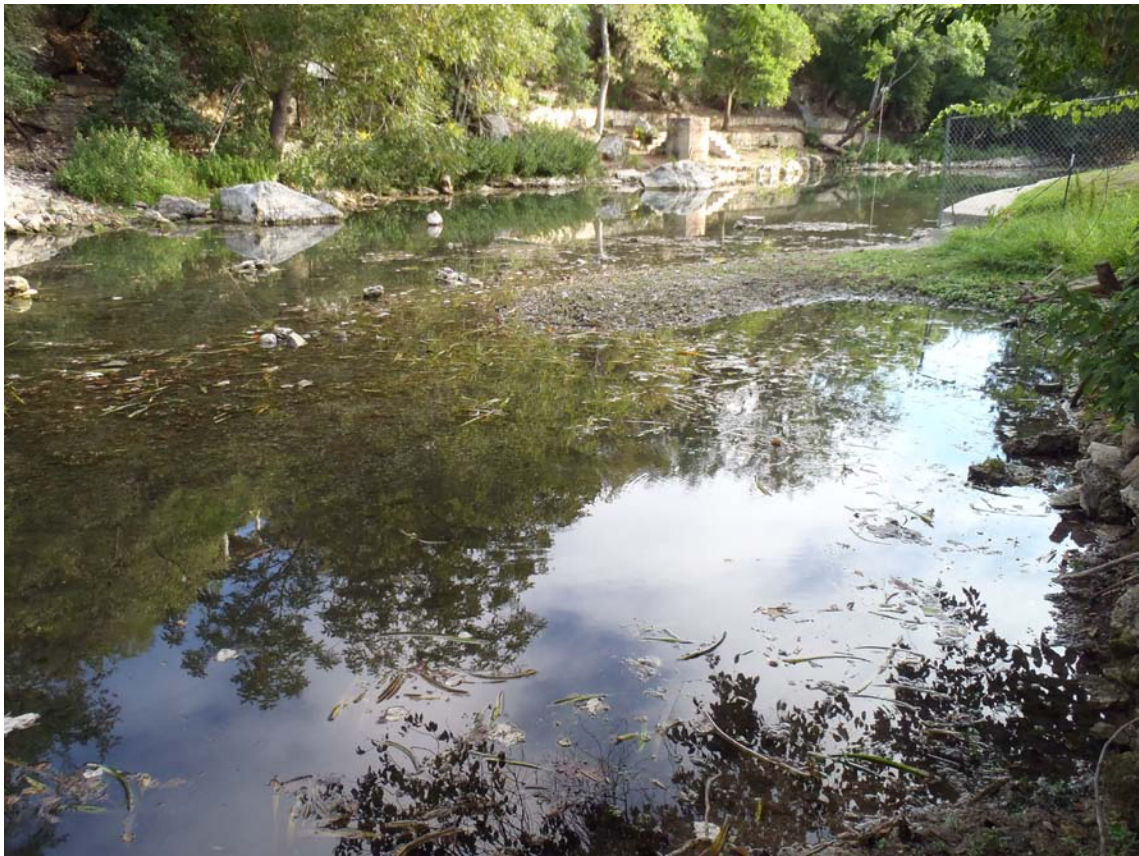
**Figure 6:** Extremely poor fountain darter habitat in the Upper Spring Run reach.

Fountain darter habitat continues to deteriorate in the Upper Spring run reach and is in extremely poor condition (Figure 6). Yet, a night dive on Tuesday for the movement study confirmed recaptures of fountain darters within the tagging sites again this week. Remarkably, water temperatures continue to be maintained in this uppermost reach of the system (Figure 7). Figure 7 is a graph of water temperature data taken from a thermister in the Upper Spring Run reach as well as in Blieders Creek. Water temperatures as of this most recent download were below 27 °C in the Upper Spring Run reach but exceeded 30 °C in Blieders Creek. Water quality data (conventional parameters) measured as part of the Critical period full sampling <100 cfs triggered event are presented in Table 2. Data is presented from upstream to downstream in the system, with sample locations for water quality measurements and nearby thermisters shown in Figure 8. Nothing in this round of water quality grab samples stood out relative to historically collected conventional parameter data on the Comal system.

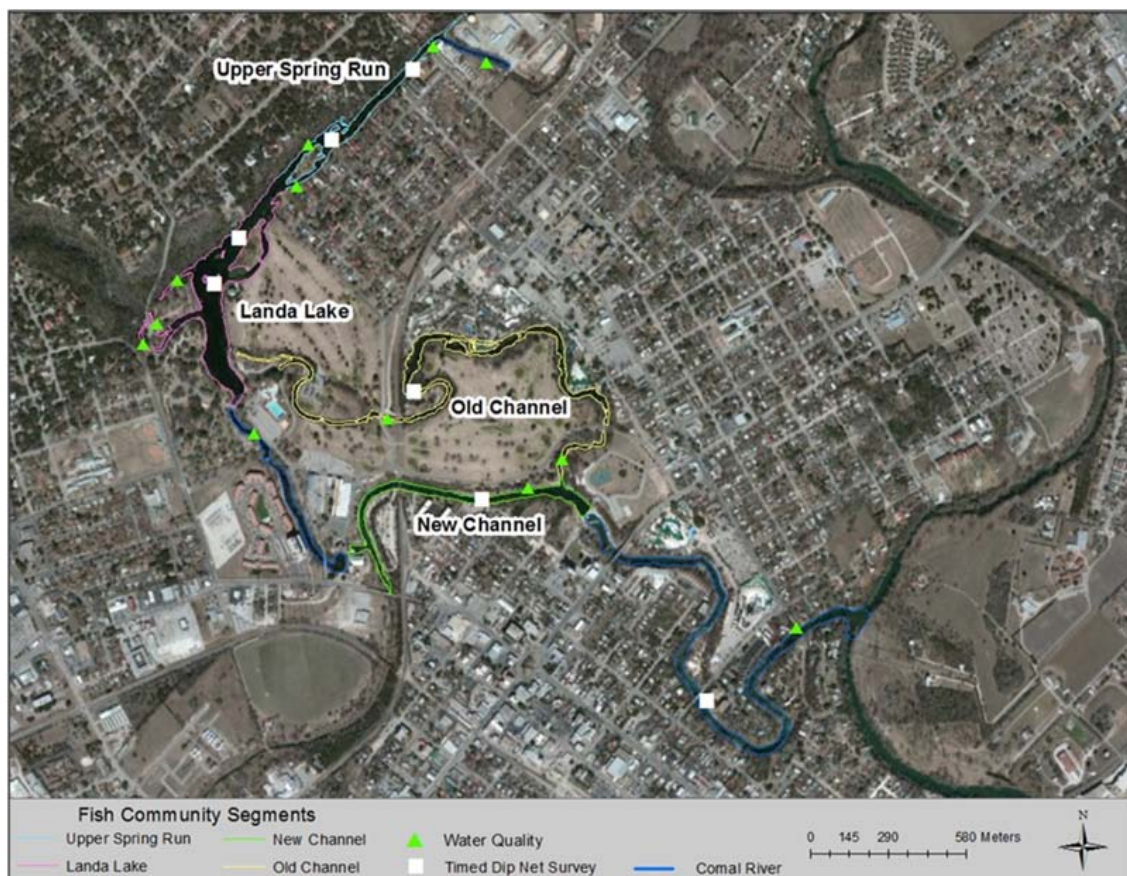
**Figure 8:** Water Quality grab sample locations – Comal System (Green triangles)

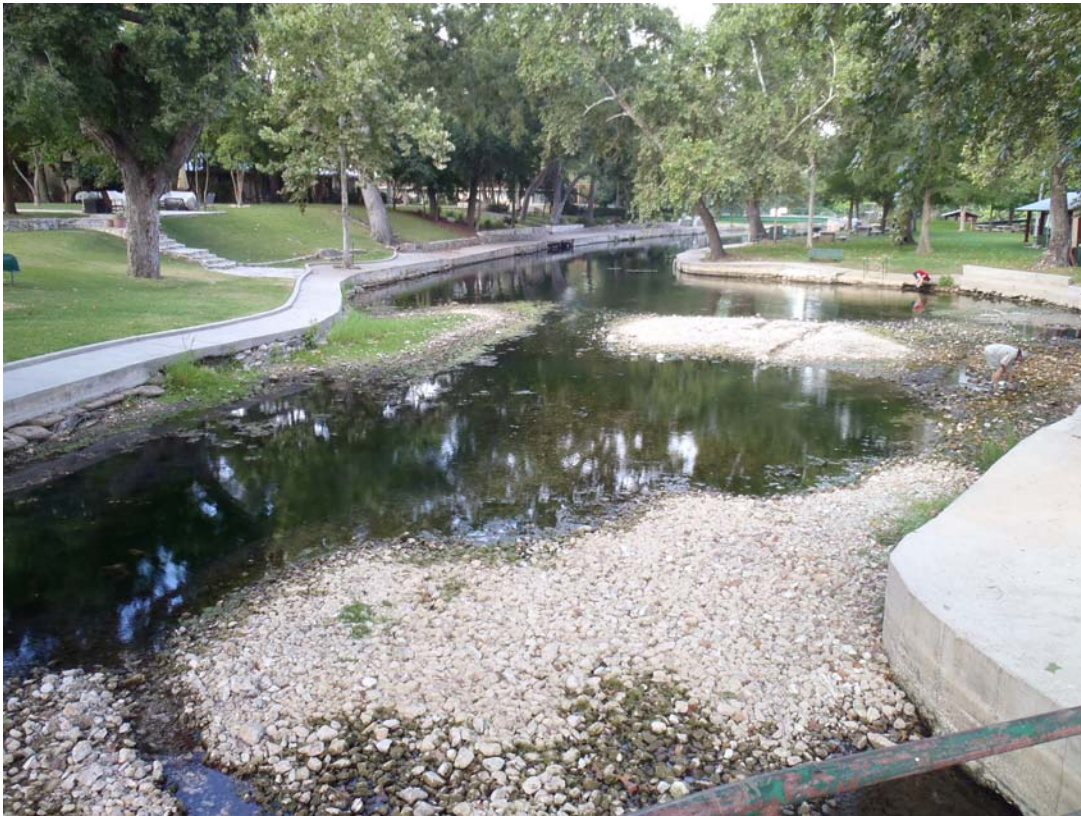
**Figure 9:** Exposed surface habitat adjacent to Spring Island. Crew conducting Comal Springs salamander survey.

The surface water level in the Spring Island area this week continued to decline with exposed surface habitat along large portions of the eastern and northern side of the island. Figure 9 shows the exposed surface habitat as well as the BIO-WEST crew conducting Comal Springs salamander surveys last Thursday. Water from springs on river left continue to flow upstream and around the island on river right (Figure 10) because surface flow has been mostly blocked (other than the mysterious channel cut through- Figure 9) by exposed substrate all the way across the river left side. Both spring runs associated with Spring Island continue to remain completely dry on the surface with subsurface flow still evident at the base of the island.

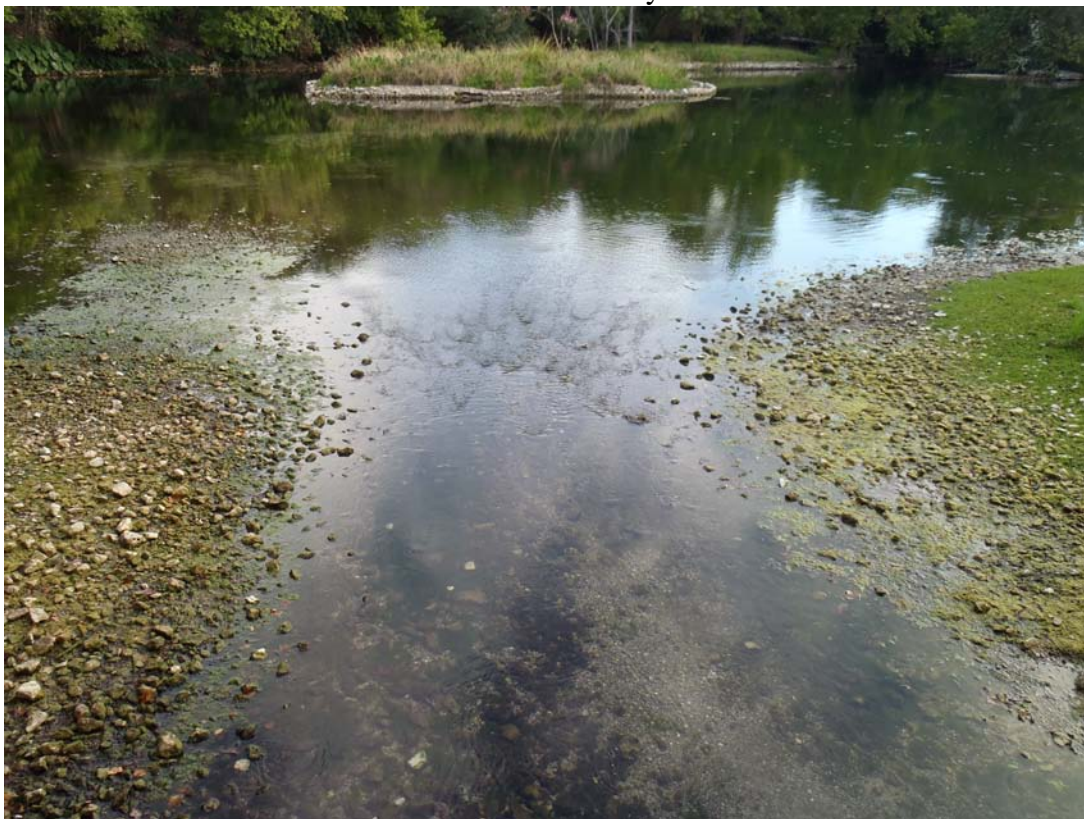
**Figure 10:** Upstream flow adjacent to Spring Island.

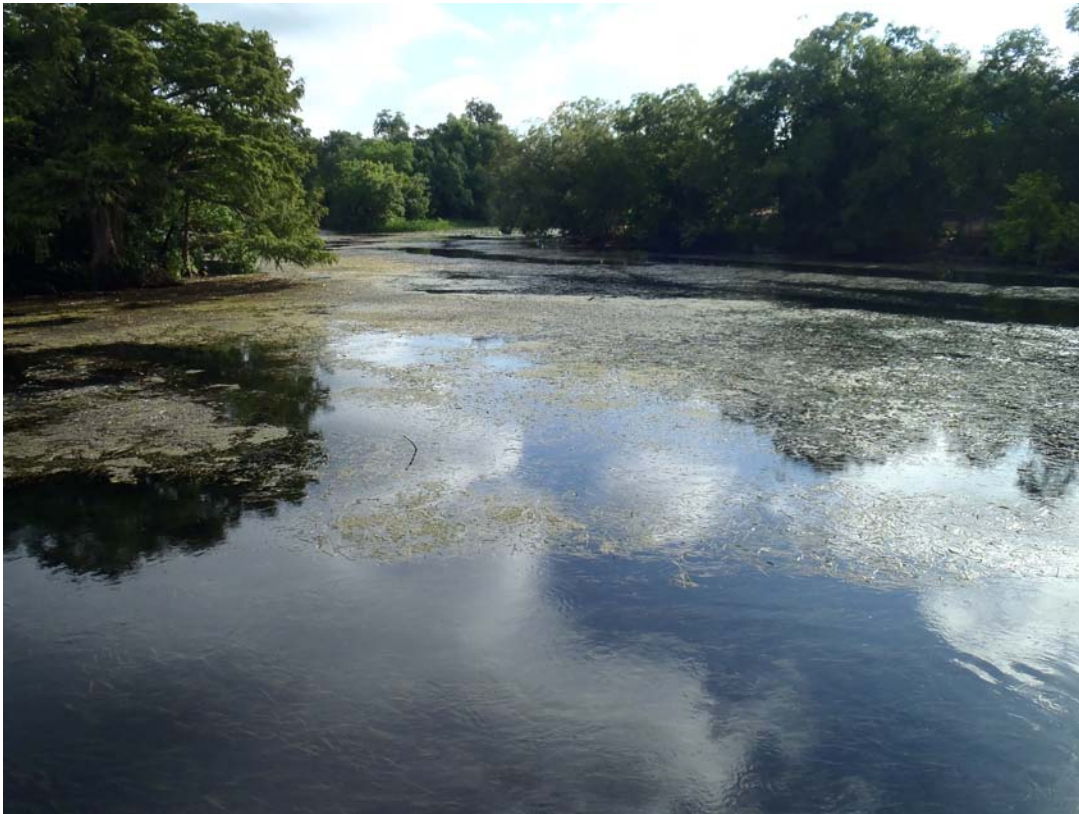
**Figure 11:** Floating vegetation mats in Landa Lake.

Downstream in the main portion of Landa Lake, floating mats of aquatic vegetation continue to build up at these lower than average discharge conditions (Figure 11) and are again in need of attention. The restored habitat within Landa Lake is continuing to expand in areas not impacted by extremely shallow water levels and/or build up of floating mats of aquatic vegetation on the surface. Overall, quality fountain darter habitat continues to be supported in Landa Lake but impacts are occurring. The Old Channel continues to support high quality fountain darter habitat with thriving restored native aquatic vegetation (Figure 12). Figure 13 shows that water temperature is also being maintained within the Old Channel but showing more daily variability with lower overall total system discharge this year. The New Channel continues to support aquatic vegetation throughout most of the reach above the confluence of the Old Channel, but fountain darter habitat is of lesser quality than in either Landa Lake or the Old Channel at this time. Figure 14 shows the very minimal flows currently occurring in the New Channel.

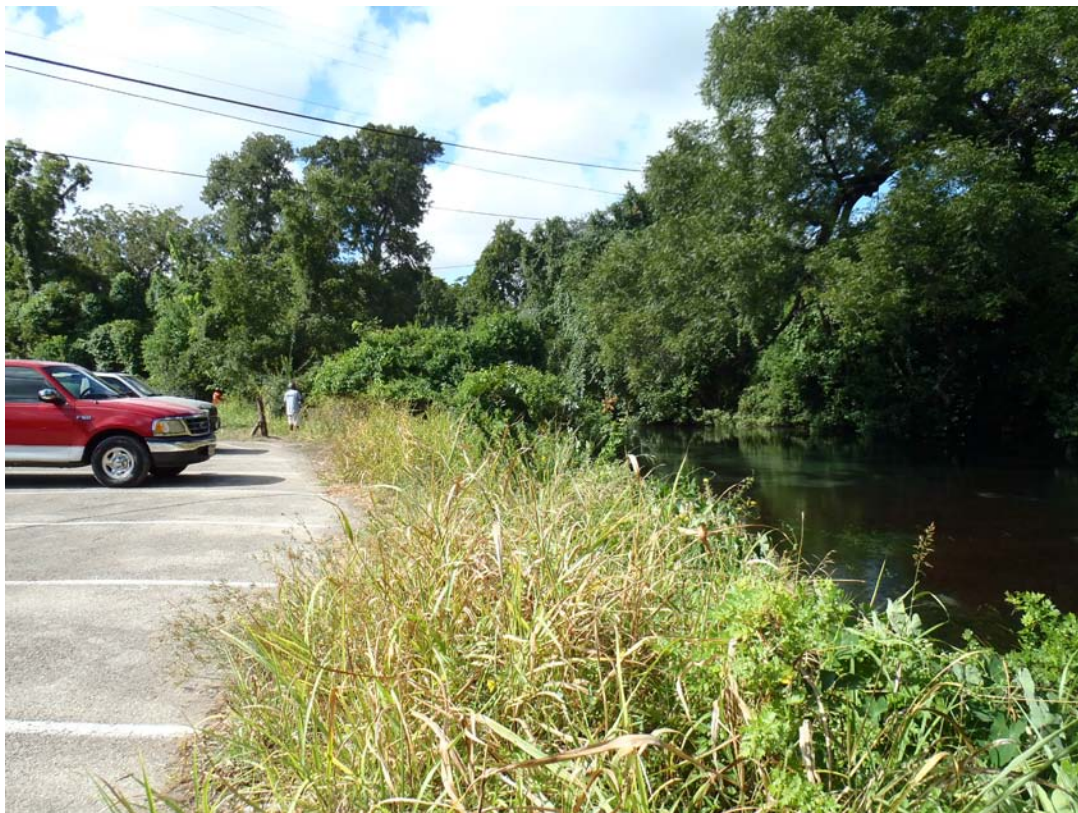
**Figure 12:** Two fishermen enjoying the restored habitat conditions in the Old Channel.

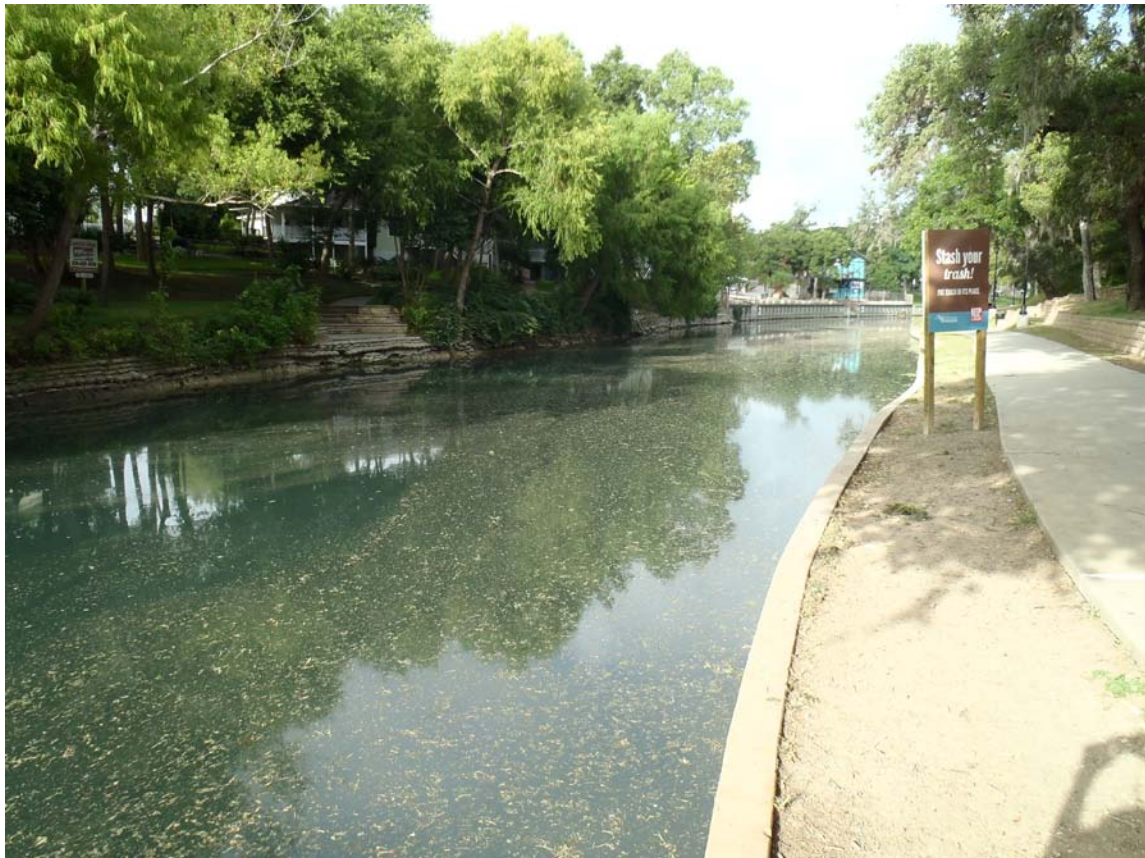
**Figure 14:** Very limited flow in New Channel study reach.
