BIO-WEST, Inc.
1812 Central Commerce Court
Round Rock, Texas 78664

MEMORANDUM

SUBJECT: **ITEM M NET DISTURBANCE AND INCIDENTAL TAKE
ASSESSMENT FOR 2021 EARIP ITP ANNUAL REPORT**

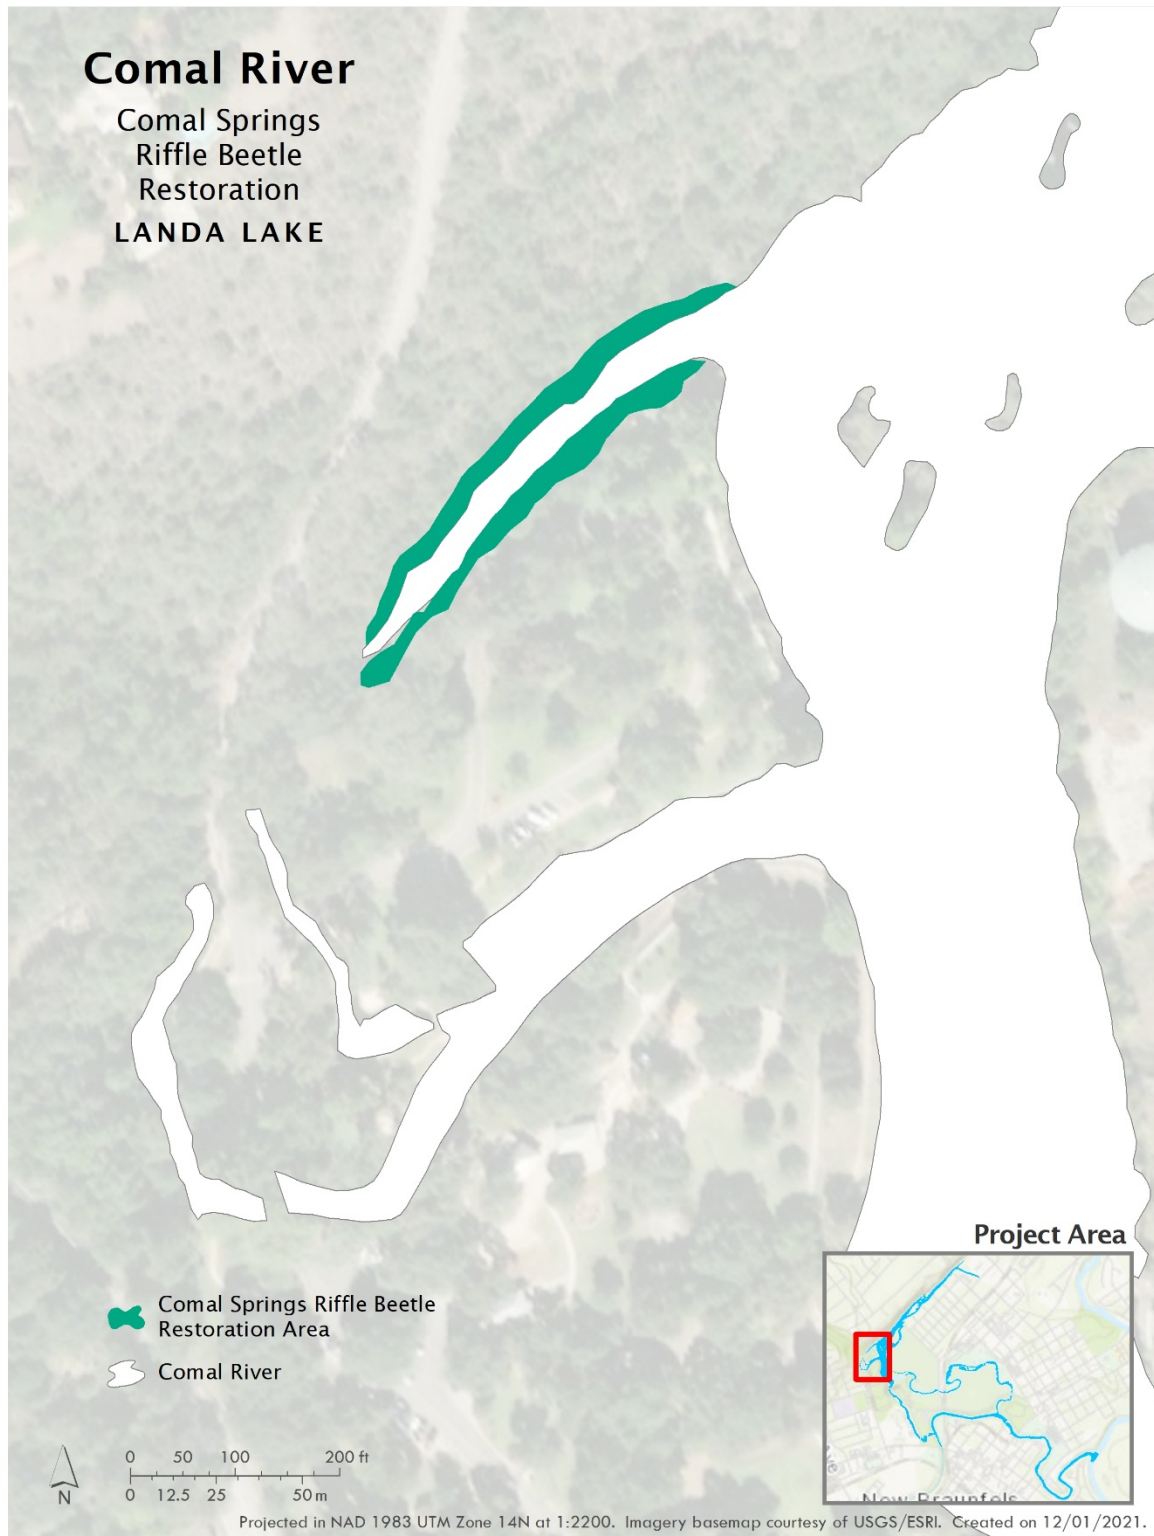
Figure 2. Comal Springs Riffle Beetle Restoration project – Comal System.

The **Gill parasite** project was reduced to one-time water sampling at designated cross sections in 2021 via kayak and thus no impacts were noted for this activity. The **Riffle beetle restoration** project involved only on shore activities in 2021 (Figure 2). The project footprint occurred on the bank adjacent to Spring Run 3 where restoration consisted of planting native vegetation as a buffer between the park sidewalk and the spring run edge. The **Non-native animal species removal** project had a change of contractors in 2019 to Atlas Environmental who continued these duties in 2021. There is no project footprint map per their methodologies as it is now conducted throughout Landa Lake and the Comal River without permanent or temporary installation of equipment. Most all work was conducted via snorkel or SCUBA in areas of high fish density with non-native fish being speared. **Riparian restoration** was continued around Landa Lake in 2021 and involved a project footprint of 2,115 m². The riparian treatment areas are depicted on Figure 3 and quantified in Table 2. Similar to the more established HCP riparian restoration project in the San Marcos system, all activities were conducted on the banks and water's edge and did not overlap with any occupied habitat for the covered species.

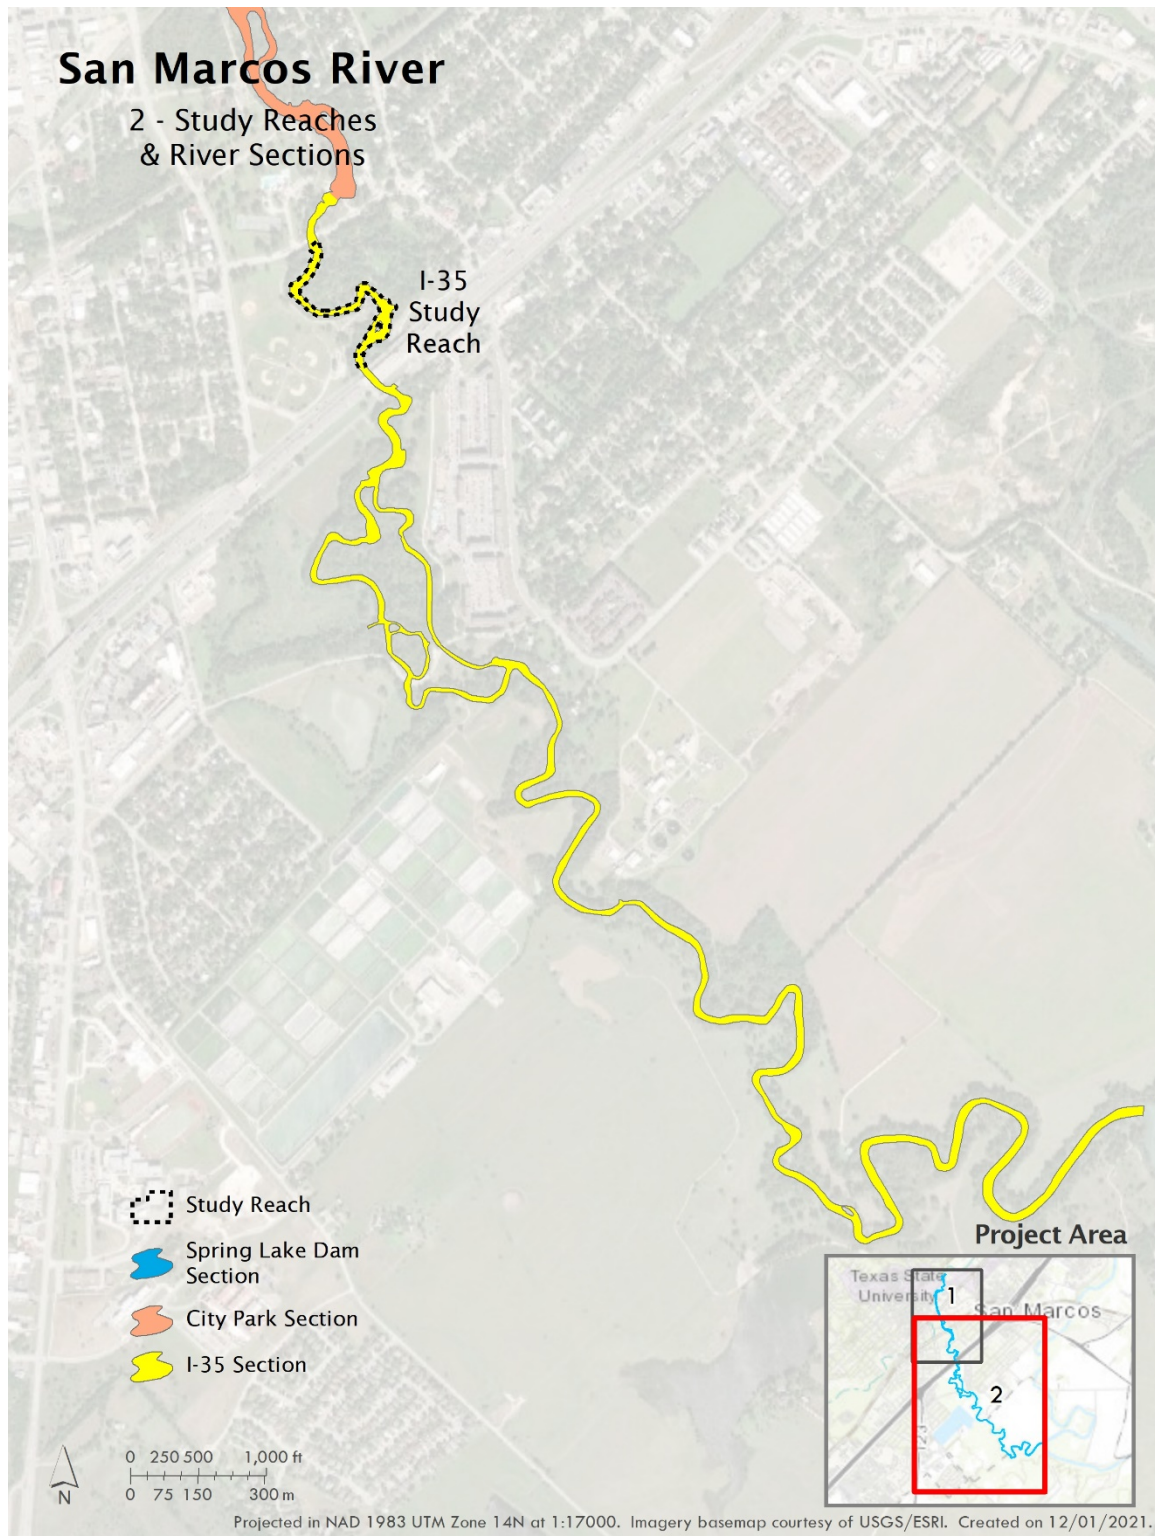
Figure 8 cont. I35 Study Reach and Corresponding Lower River Section in the San Marcos System.
