WATER QUALITY SUMMARY 2021

EDWARDS
AQUIFER
AUTHORITY

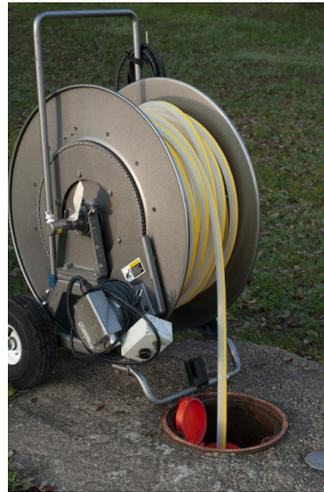
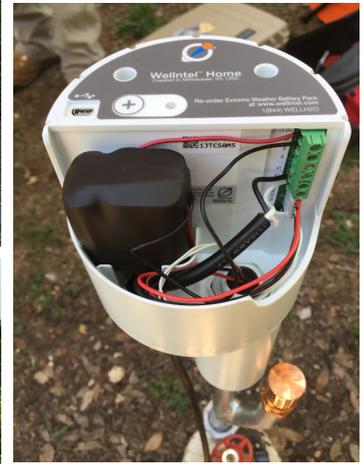
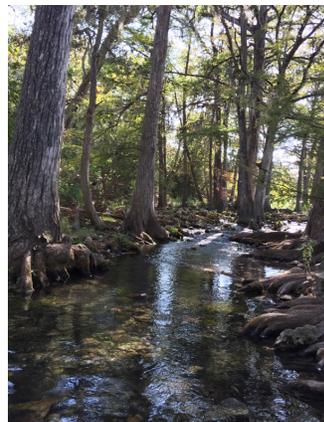
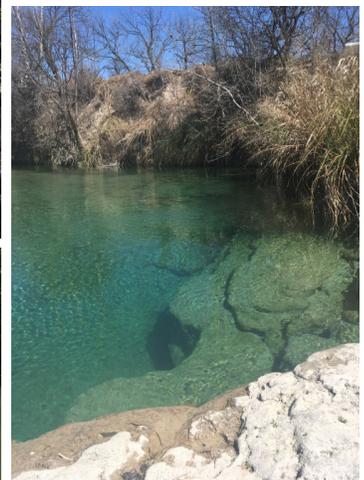
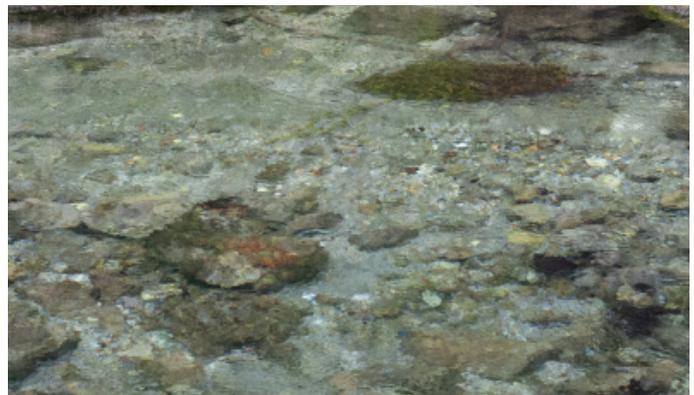
Clockwise from top left: Pump used to sample water from wells. Amber glass sample bottles. WellIntel system used to remotely measure water levels. Array of sample containers. Deep pool in the Nueces River. Clear, cool water at Comal Springs. The Guadalupe River at Guadalupe River State Park. Honey Creek near its headwaters. View of the Hill Country near Seco Creek, in the Contributing Zone.
