TO: Nathan Pence
FROM: Ed Oborny (BIO-WEST)
DATE: **July 4, 2014**
SUBJECT: EA HCP Biological Monitoring – **Week 12**

COMAL SPRINGS/RIVER - WEEK 12 CONDITIONS:

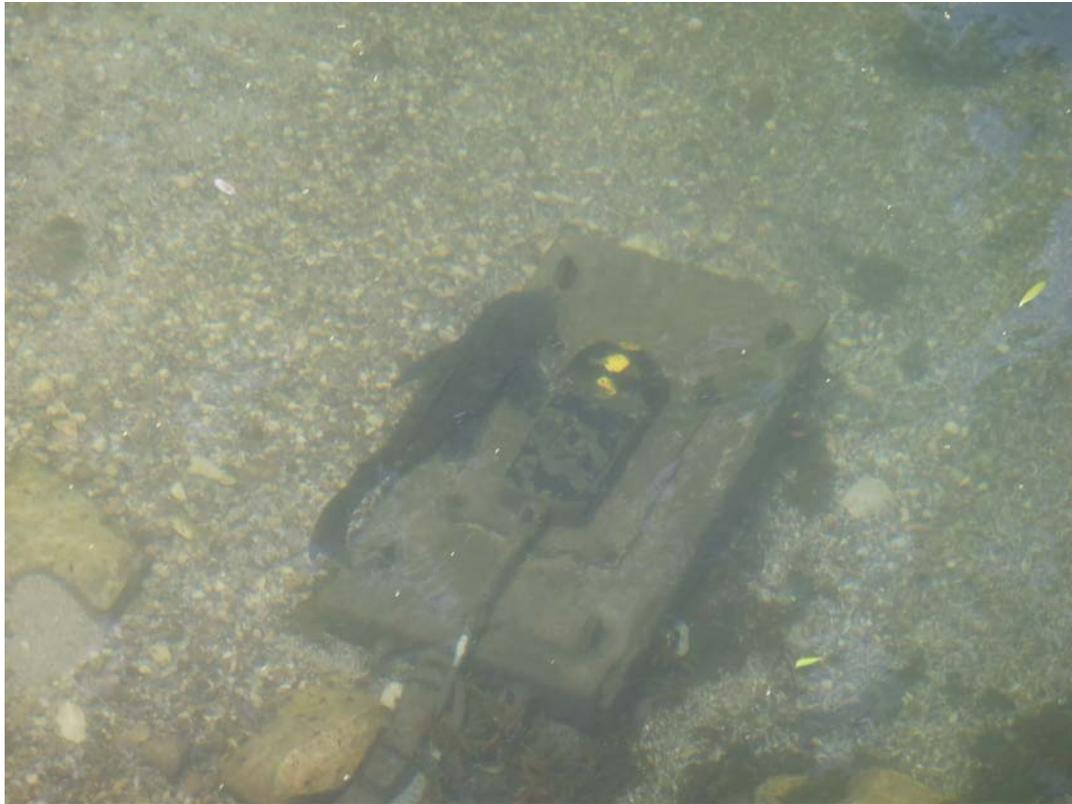
Finally, I have included a photo of the sealed off old culverts on the downstream end from the Flow Split Management project (Figure 14) and Figure 15 is a poor attempt at some independence day humor. As always, if you have any questions, please give me a shout. Have a wonderful 4th of July weekend! Ed

Figure 15: Possible reason for discharge discrepancies at USGS old channel gage ☺
