Appendix K | **2021 Permit Oversight– Cultural Resources Coordination**

April 7, 2021

Re: Antiquities Code of Texas Cultural Resource Coordination Letter for the City of San Marcos, Edwards Aquifer Authority, and Texas State University's Proposed Habitat Conservation Plan Activities for 2021 along the San Marcos River, San Marcos, Hays County, Texas.

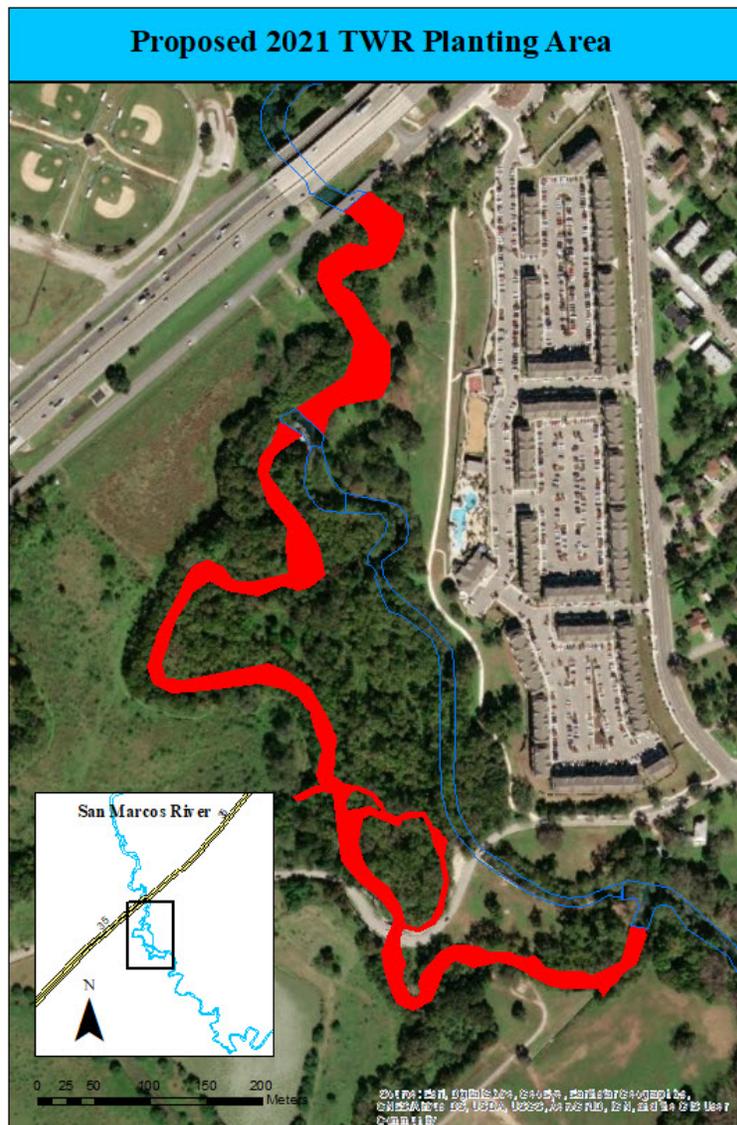
Figure 1. Proposed TWR planting area for 2021

The target area for planting TWR in 2021 is in-between I35 and Stokes Park (Figure 1). This reach of the river has seen an increase in TWR and we will promote this expansion through planting and gardening as necessary. From Spring Lake Dam to IH-35, TWR will be encouraged to expand naturally through the continued removal of invasive species within and around the perimeter of TWR stands, or planted as needed. These efforts work towards attaining the 2027 biological goals as shown in Table 1.

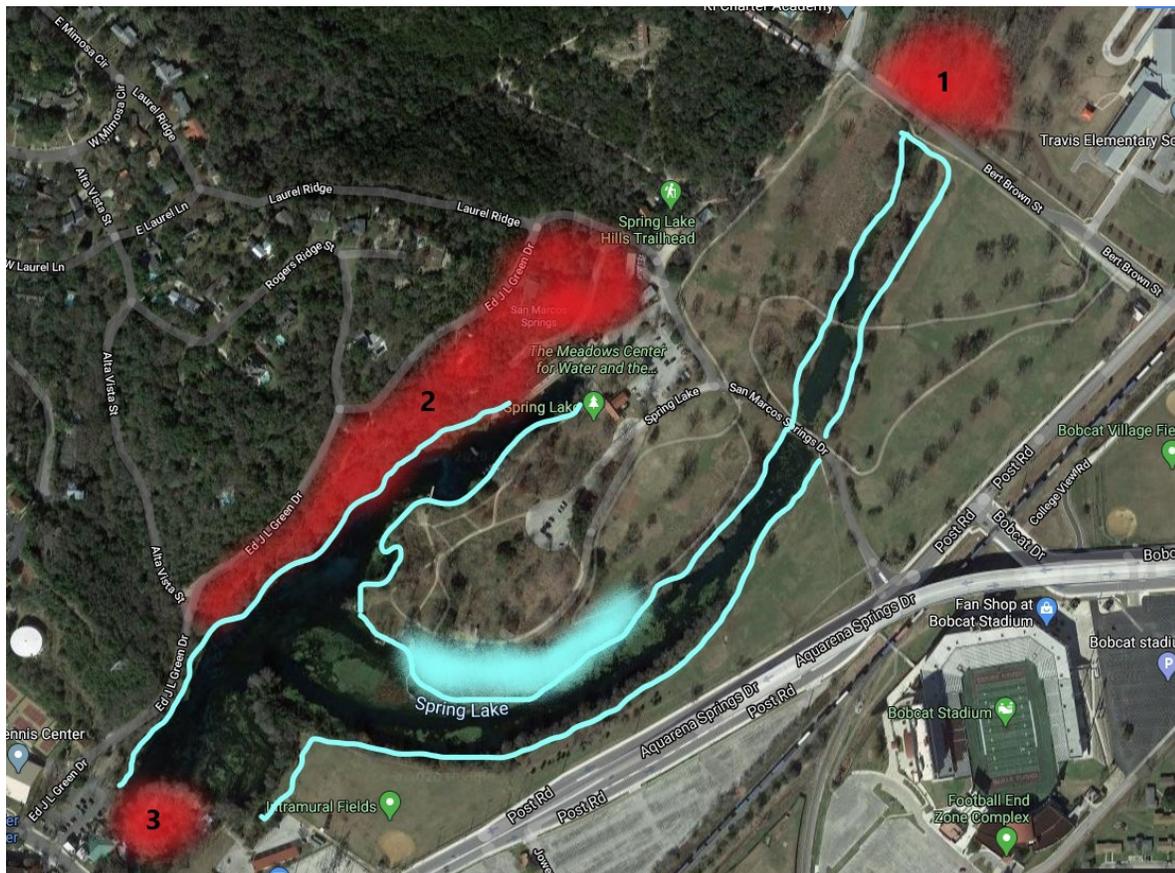
Figure 3. Spring Lake and Sink Creek Zones

1. The area along **Sink Creek** upstream of **Bert Brown Road** is still full of Chinese Tallow trees. This area must be worked on to reduce the amount of Chinese Tallow seedlings found every year along Sink Creek. Japanese Honeysuckle and an occasional Elephant Ear can also be found here.
2. The **western shoreline** of **Spring Lake** is in a maintenance state, but the rest of the **hillside** has a number of invasive, exotic plant infestations. Cat's Claw Vine is prevalent at the top of the hill.
3. The **Spillway Island** has several Chinaberry, Chinese Tallow, and Ligustrum that need to be removed. Erosion control berms composed of cut debris will be created.

In 2021, removal efforts for littoral invasive species will target areas shown in Figure 3 - 6 below. Most work areas are now in maintenance mode; requiring periodic regrowth removal. Seven regions that have spots of intense removal work still remain. Addressing these seven zones will connect a buffer zone along the river that does not contribute seed source.

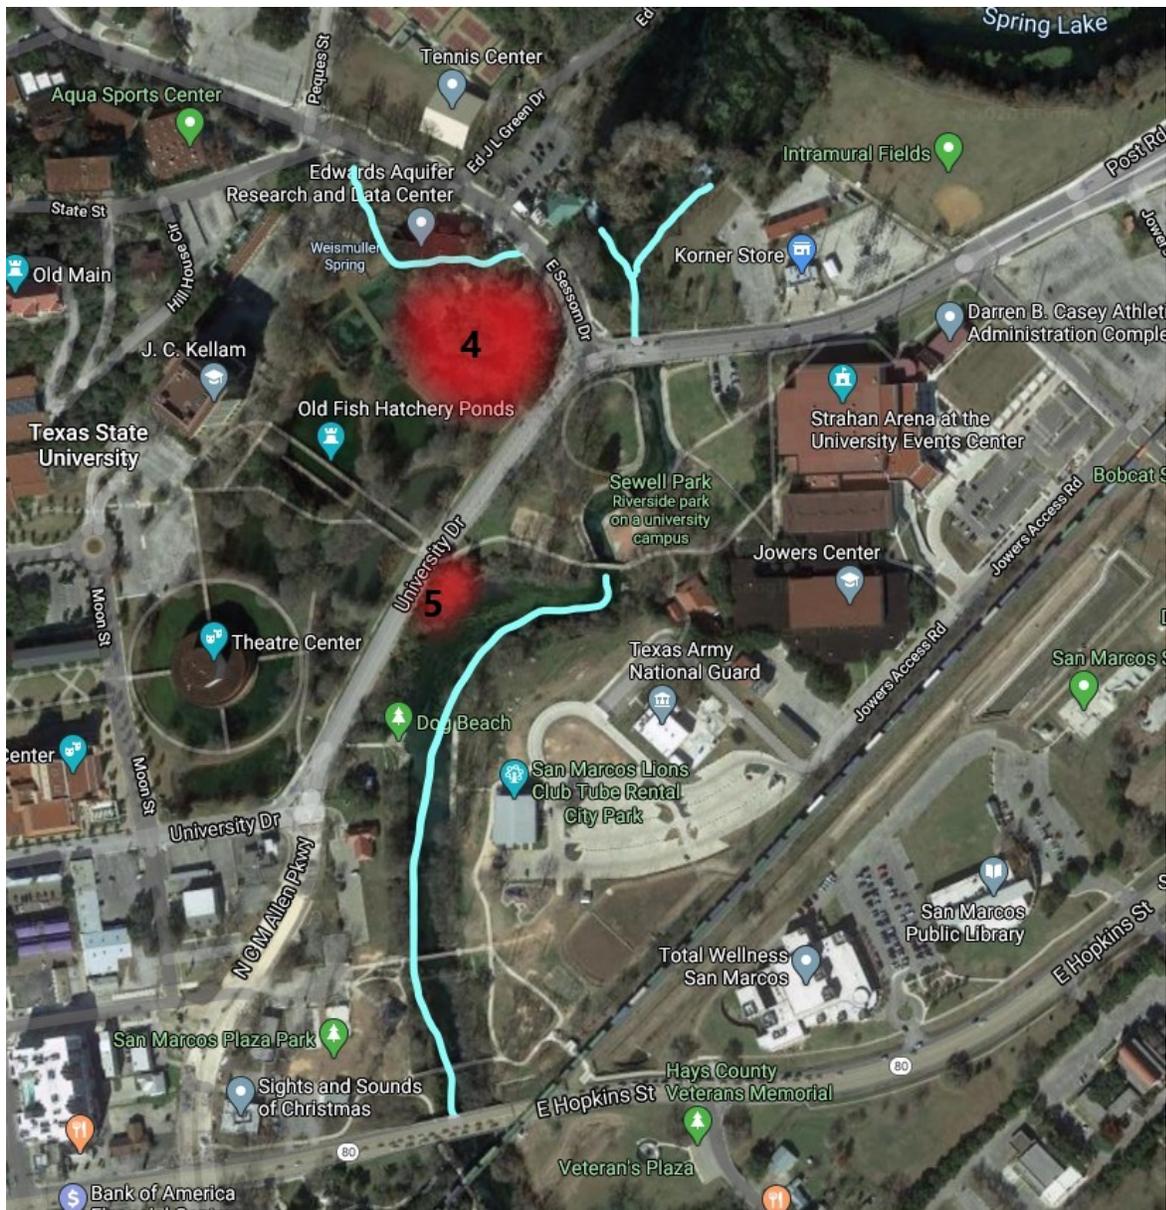
Figure 4. Freeman Aquatic Center, Headwaters, and City Park

4. The **pond** area adjacent to **Sessom Creek** at the **Freeman Aquatic Center** has a number of large Chinese Tallow, Ligustrum, Loquat, and Chinaberry. These had been paint marked in the past and the University was going to take them down, but that has not happened to date. They are an unnecessary seed source that continues to pose a threat to other nearby completed work. A couple of invasive, exotic trees still exist along the creek through here, but otherwise it is in a maintenance state.
5. An area along **University Drive**, across from **City Park** has a large stand of Giant Reed – *Arundo donax*. If this stand continues to thrive unchecked, it could continue to grow and occupy spaces where Ligustrum was removed. The river through this area is in a maintenance state.

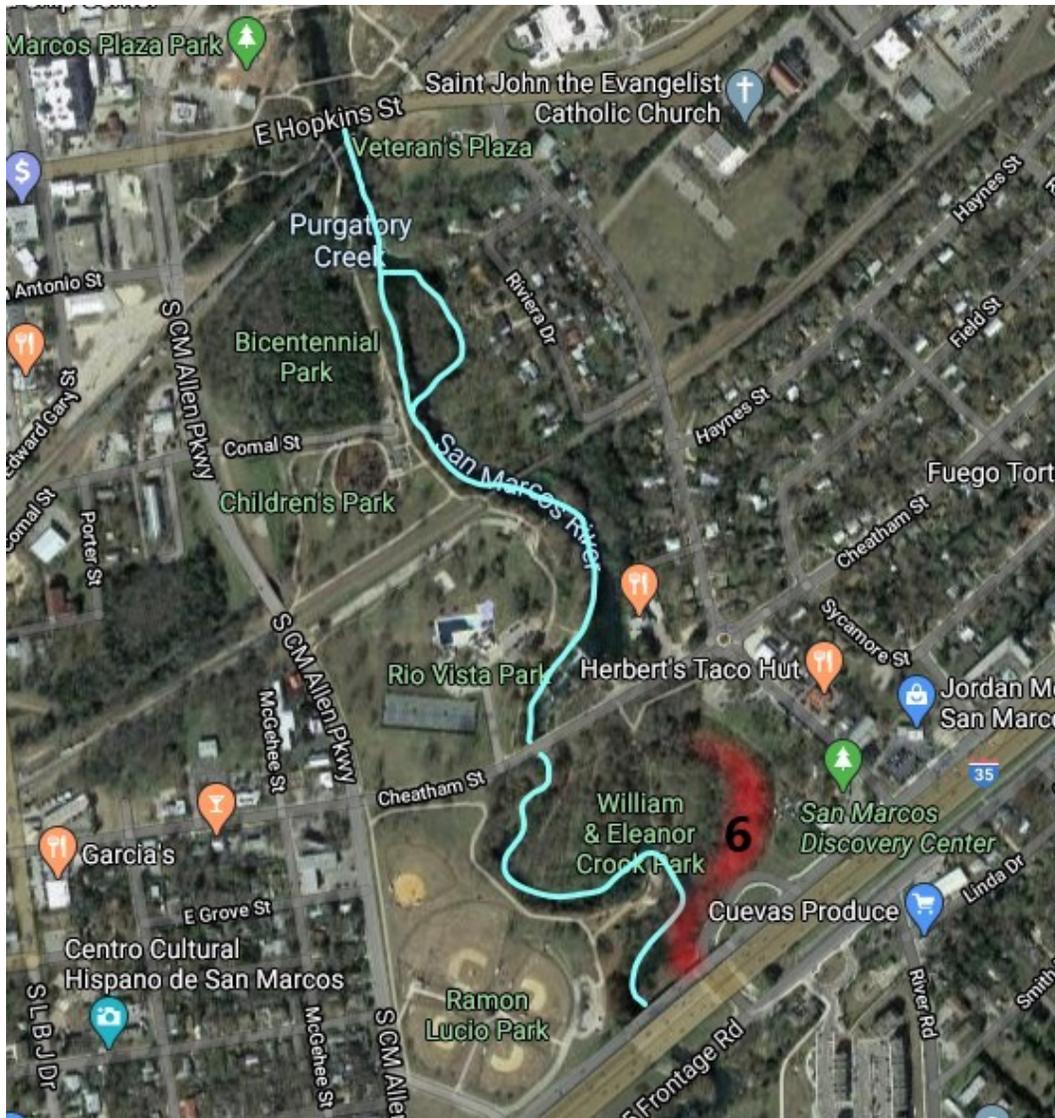
Figure 5. Veteran's Plaza, Bicentennial Park, Rio Vista Park, Ramon Lucio Park, Crook Park

6. Most of the area between E. Hopkins and I-35 is in a maintenance state. However, the old mill run in **Crook Park** is an exception. It still has a huge number of Paper Mulberry trees that are up and down the bank close to the Discovery Center. Collaborative projects are needed upstream of Cheatham St. and in Bicentennial Park to work on Ligustrum removal.

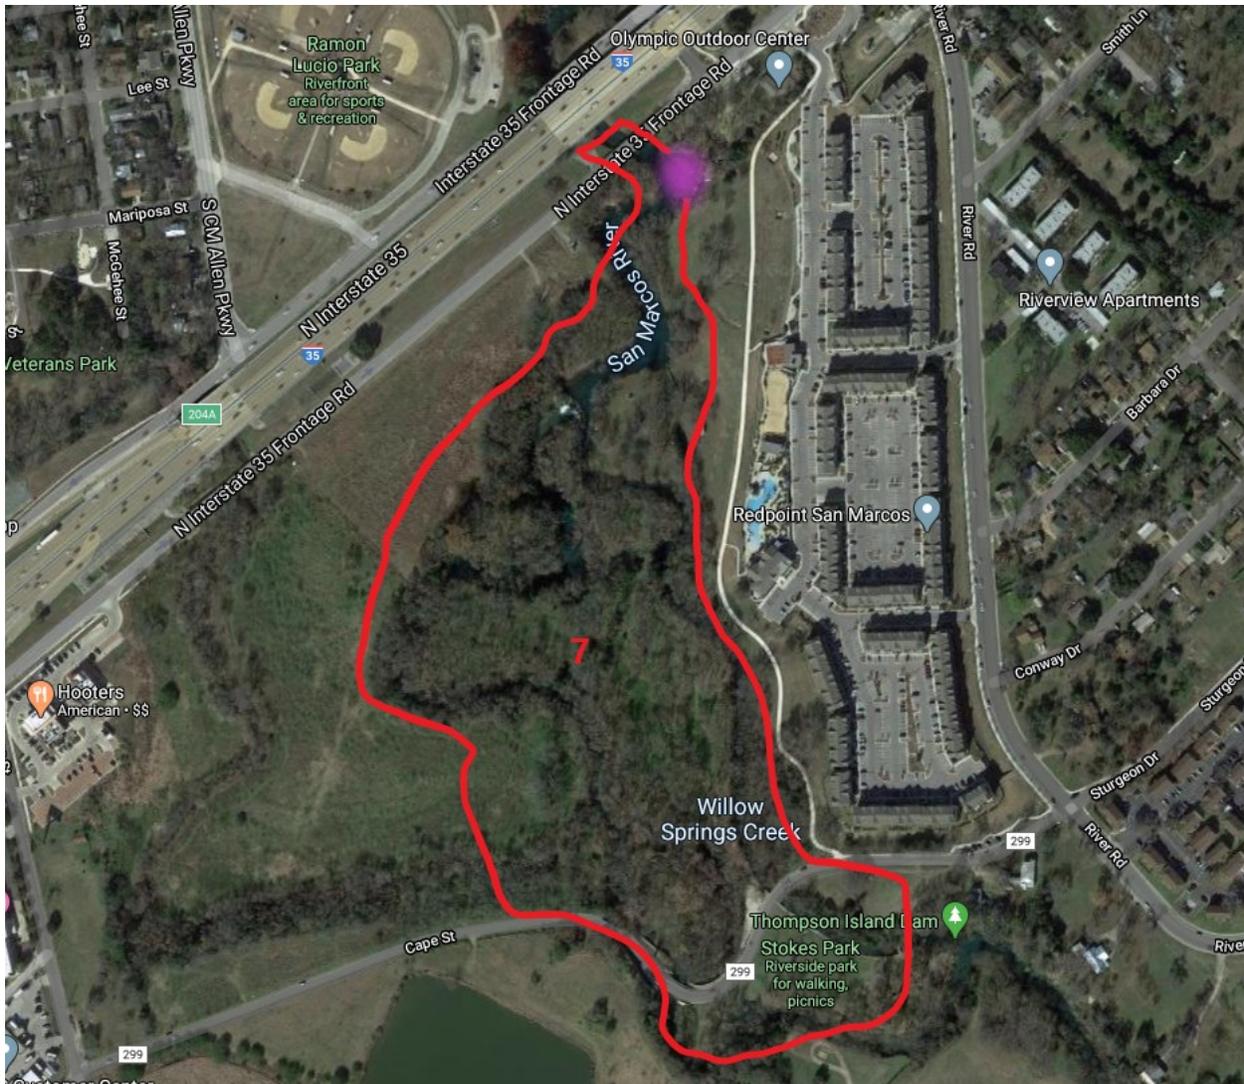
Figure 6. Stokes Park/SMRF Property

7. The contractor has worked these areas, but not on the same level as the upstream sections. One private landowner has a large stand of Elephant Ears at I-35 that hinders success downstream. In addition to Elephant Ear removal, we will remove other invasive, exotic plant species in conjunction with other HCP contractors.

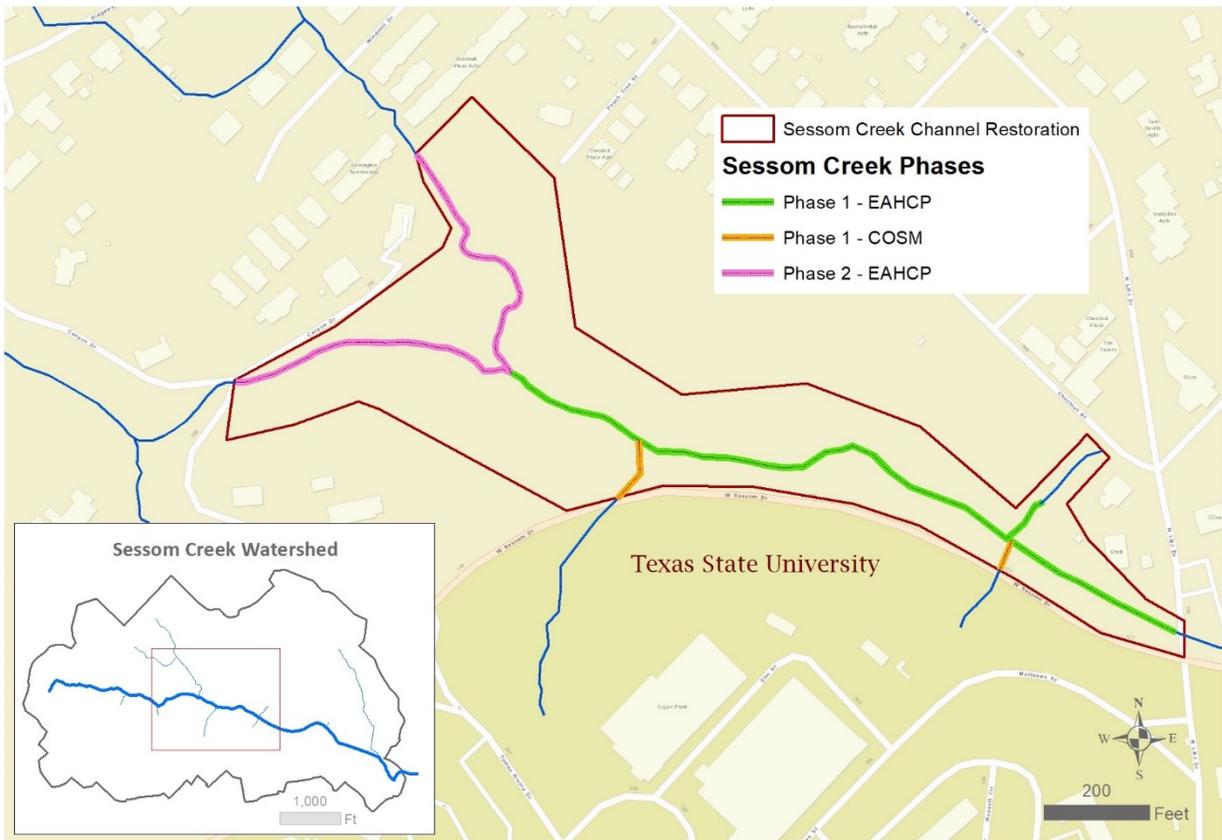
Figure 7. Sessom Creek Proposed Project Reaches - Phase 1 (green outline), Phase 2 (blue outline), Phase 3 (purple area)

The preliminary recommendations address Phase 1, approximately 1400 linear feet of Sessom Creek, from above North LBJ Drive upstream to the Windmill Tributary confluence and Phase 2, approximately 565 linear feet from the confluence to the Loquat/Canyon intersection, plus 550 linear feet of Windmill Tributary. A future potential Phase 3 addresses Sessom Creek above the Loquat/Canyon intersection (an additional 800 linear feet) (Figure 7). Stream and watershed restoration practices identified for each project reach include grade control, bank stabilization, gully control, stormwater management ponds, natural channel design, and riparian restoration.
